DSHS

OLYMPIC HERITAGE BEHAVIORAL HEALTH

WA STATE PROJECT NUMBER: 2024-429 N (11)

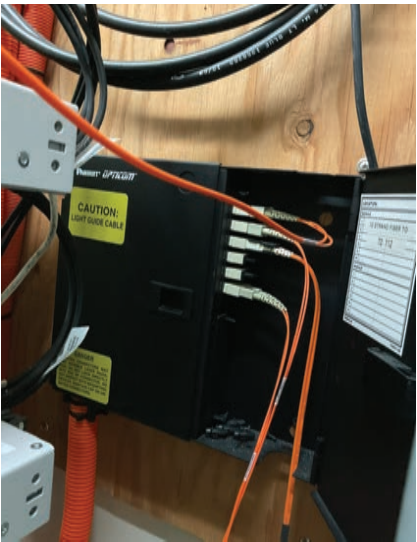
and/or future technologies. The existing optical fiber infrastructure, consisting of OM1 62.5-micron multi-mode optical fiber cable, is antiquated and is unable to support the deployment of new technologies. Improving the IP backbone connectivity will be a fundamental component to creating an environment that will permit Olympic Heritage Behavioral Health Facility and DSHS to identify, adapt, and implement new technologies that contribute to safety and operational improvements. New single and multi-mode optical fiber cabling will be required to provide the required backbone capacity.

Existing OM1 MM OFC

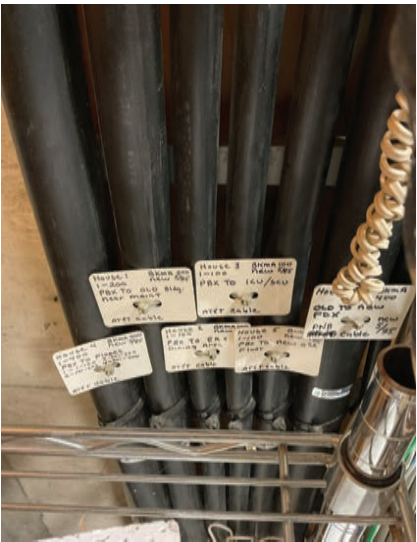
Existing Twisted-Pair Copper Backbone Cabling

The Category 3 cabling supporting the voice cabling is inadequate to support new technologies being proposed for implementation at Olympic Heritage Behavioral Health. The voice network should be collapsed to a single converged IP based network, and the existing Category 3 cabling should be demolished.

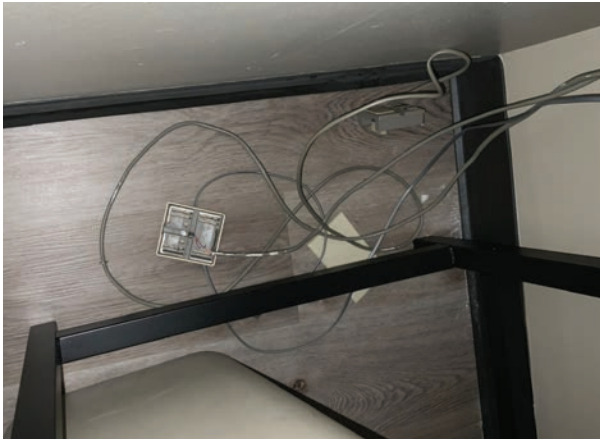
Abandoned Phone Outlet

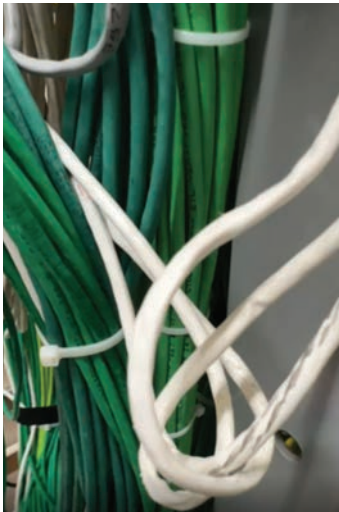
Existing Category 5e & 6 Cabling

The existing Category 5e and 6 infrastructure is not adequate to meet the current and future needs of Olympic Heritage Behavioral Health. The Category 5e and 6 cabling are also not in compliance with TIA standards for infrastructure in healthcare facilities. It is recommended that the existing cabling infrastructure be replaced with a new Category 6A cabling infrastructure and that additional data ports be added throughout the facility to provide employees with an adequate quantity of network port connections to support required device connections. New cabling infrastructure installation requires cabling to be secured and outlet boxes to be fitted with the appropriate faceplates to protect the cabling.

Meeting TIA-1179 standards will require the entire channel to be Category 6A certified. Meeting this standard will require all new patch panels, modular jacks, and wall outlets comprising a replacement of the entire infrastructure. Existing Category 5, Category 5e, and Category 6 patch panels will be removed in favor of the Category 6A infrastructure. See Sequencing and Recommendations for sequencing of the project to minimize down time while the infrastructure is replaced.

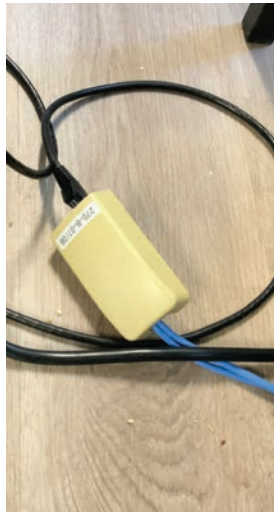
Existing Biscuit Jack On Floor

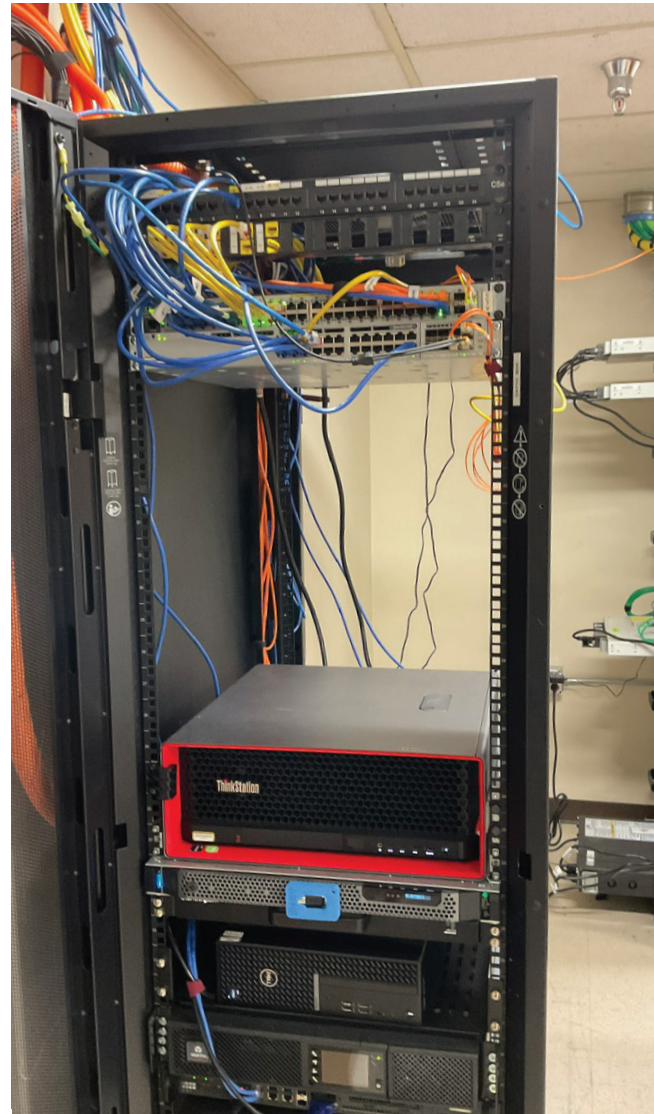
There is currently space for expansion on the rack, as well as space for adding additional racks in the room. There is no telecommunications grounding bus bar present in the room. There is cooling and humidity control present in the room. There are a few convenience receptacles, but no dedicated equipment receptacles. UPS power is available to provide clean, uninterrupted power for the equipment. The room can be locked but there is no other access control on the room.

Existing Telecom Room

To meet industry standards, it is recommended to provide a ladder rack for cable support. It is also recommended to provide a telecommunications grounding busbar to create a consistent potential across all components. New standards compliant backbone and horizontal cabling are recommended. The addition of card-based access control is recommended to control access and track access to the space.

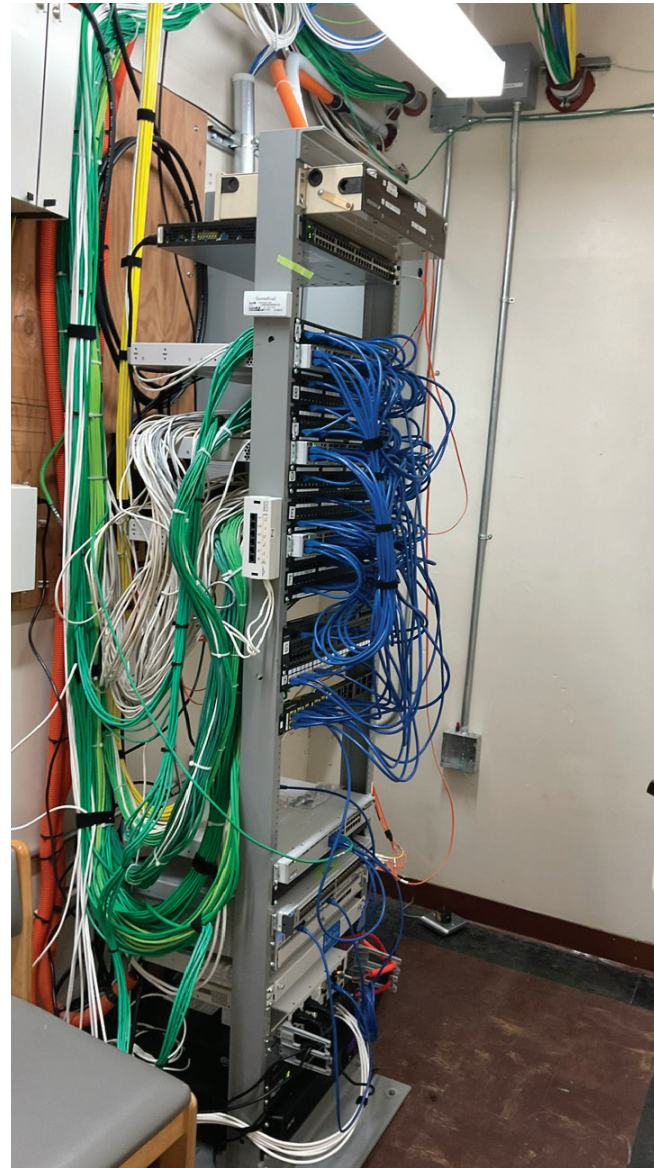
There is currently space for expansion on the rack, as well as space for adding additional racks in the room. There is a grounding bus bar in the room, but the size of the bus bar does not meet industry standards. The bus bar is also not bonded to the telecom equipment. There is cooling and humidity control present in the room. There are a few convenience receptacles, but no dedicated equipment receptacles. UPS power is available to provide clean, uninterrupted power for the equipment. The room can be locked but there is no other access control on the room.

Existing Telecom Rack

To meet industry standards, it is recommended to provide a ladder rack for cable support. It is also recommended to provide a telecommunications grounding busbar to create a consistent potential across all components. New standards compliant backbone and horizontal cabling are recommended. The addition of card-based access control is recommended to control access and track access to the space.

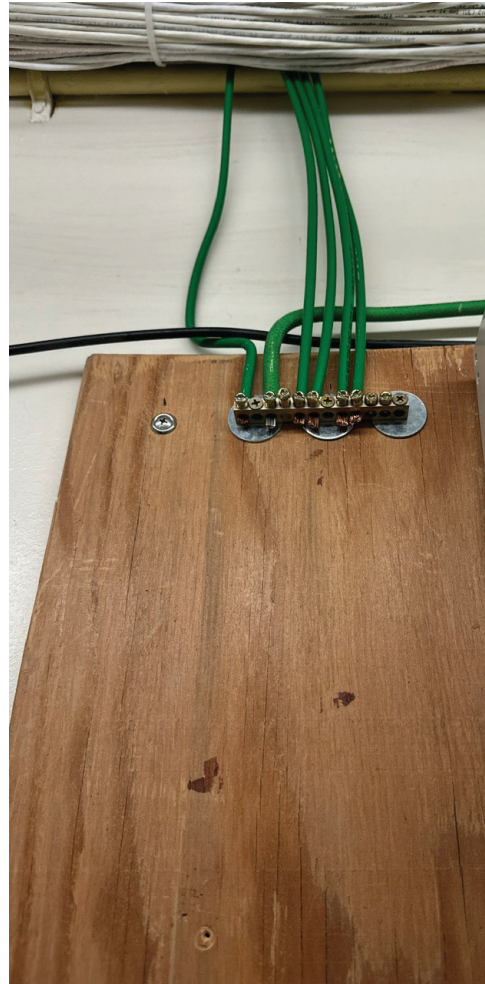
- » Horizontal Cabling infrastructure does not meet minimum standards per TIA-1179.
- » Backbone Cabling Infrastructure does not meet minimum standards per TIA-1179.
- » No overhead ladder tray for cable support, leading to cables being draped or placed directly on equipment.
- » Inadequate grounding busbar for the telecommunications equipment.
- » Equipment is not bonded to the Telecommunications Grounding Busbar.
- » Electrical infrastructure does not meet minimum requirements per standards.
- » Uncontrolled access to space with no identity verification

Existing Grounding

- » Upgrade existing port locations to Category 6A.
- » Add additional Category 6A 8P8C RJ45 ports to meet standards.
- » Provide new 12-strand OS2 single-mode and 12-strand OM4 multi-mode optical fiber backbone to ER-112/W108, TR-121, and TR-Penthouse.
- » Add ladder tray and cable management as needed.
- » Add Telecommunications Grounding Busbar and bond to telecom equipment.
- » Add power circuits and receptacles as needed.
- » Control access to authorized individuals.

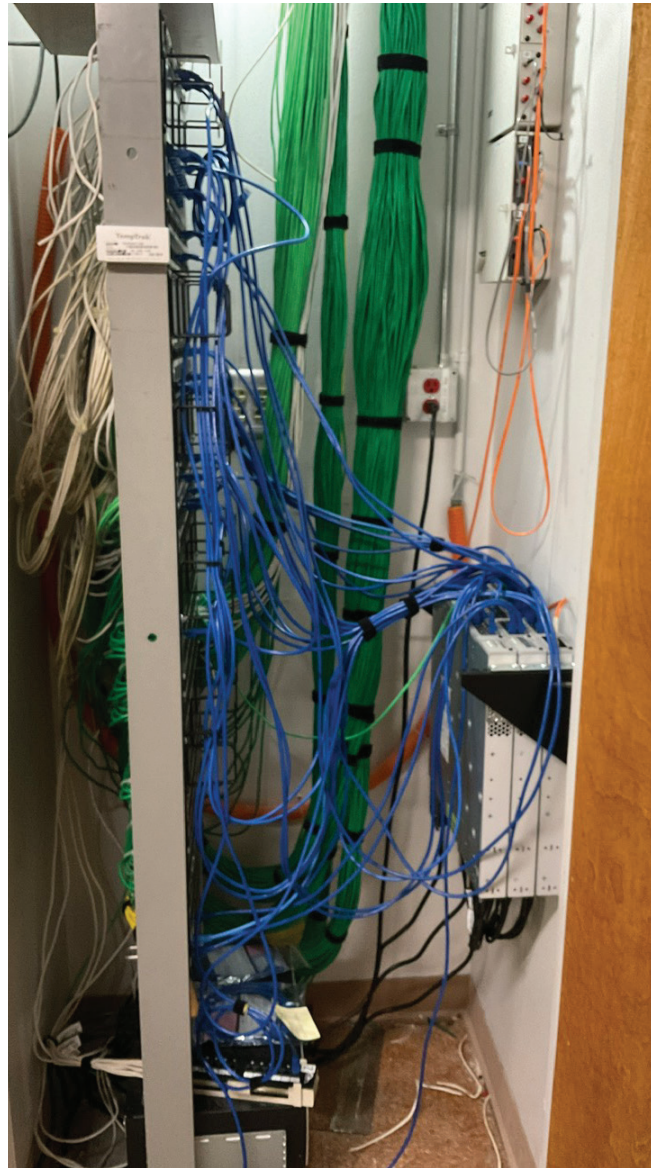
This is not an adequate location for the equipment, and it does not meet TIA standards. There is no space for expansion on the rack and due to the small size of the closet, there is also no space for adding additional racks. There is no grounding bus bar in the room. The closet does not contain cooling or humidity control. There is only one convenience receptacle, and it is not a dedicated equipment receptacle. UPS power is available to provide clean, uninterrupted power for the equipment. The room can be locked but there is no other access control on the room.

Existing Telecom Room

The telecommunications equipment should be moved to a new, larger, standards compliant telecommunications room.

- » Abandon the closet and move telecommunications equipment to room W122.
See Room W122 – Future TR later in this document

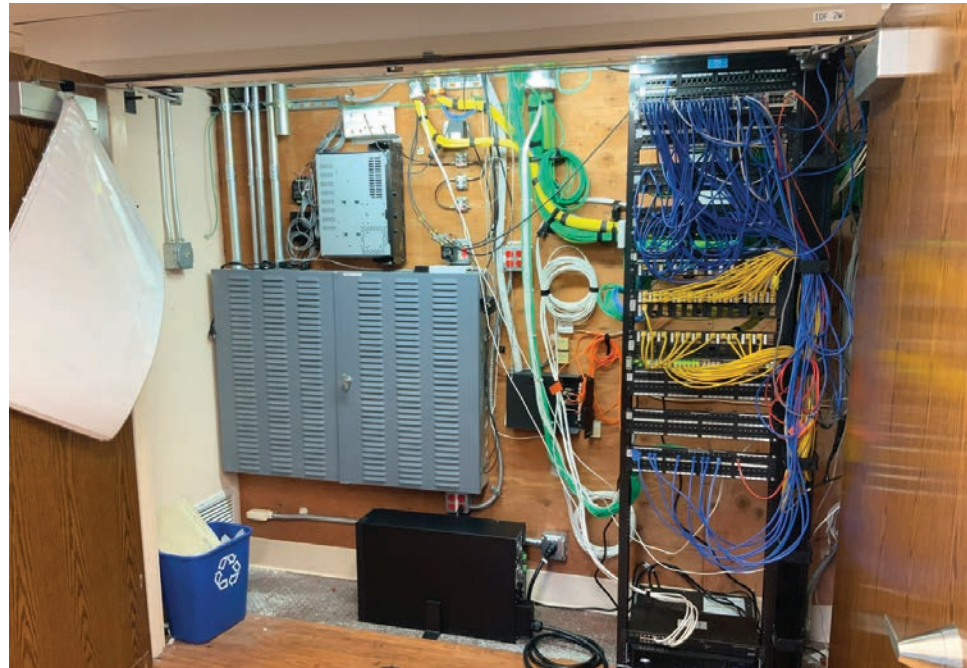
Space for expansion is present in the existing rack, but due to the small size of the closet, there is no room for adding additional racks. There is no telecommunications grounding bus bar present. The space does not contain cooling or humidity control. There are a few convenience receptacles, but no dedicated equipment receptacles. UPS power is available to provide clean, uninterrupted power for the equipment. The room can be locked but there is no other access control on the room.

Existing Telecom Room

To meet industry standards, it is recommended to provide a ladder rack for cable support. It is also recommended to provide a telecommunications grounding busbar to create a consistent potential across all components. New standards compliant backbone and horizontal cabling are recommended. The addition of card-based access control is recommended to control access and track access to the space. Ductless split-system cooling unit is also recommended to be installed to provide adequate cooling in the room.

- » Upgrade existing port locations to Category 6A.
- » Add additional Category 6A 8P8C RJ45 ports to meet standards.
- » Provide new 12-strand OS2 single-mode and 12-strand OM4 multi-mode optical fiber backbone from ER-112/W108, TR-121, and TR-270/S206.
- » Add ladder tray and cable management as needed.
- » Add Telecommunications Grounding Busbar.
- » Add power circuits and receptacles as needed.
- » Add ductless split-system cooling unit.
- » Control access to authorized individuals.
- » Remove unused equipment.

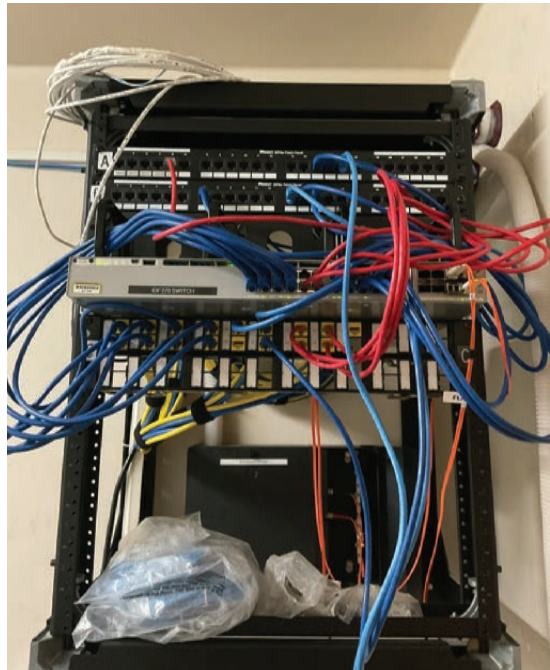
The wall-mounted rack and fiber cabinet are mounted directly above a sink and behind the swing of the door. There is limited space for expansion on the rack, and there is also room for adding additional wall-mounted and floor standing racks. There is no grounding bus bar in the room. The room does not contain cooling or humidity control. There are a few convenience receptacles, but no dedicated equipment receptacles. UPS backed power is not available. The room can be locked but there is no other access control on the room.

Existing Telecom Rack

To meet industry standards, it is recommended to provide ladder racks for cable support. A new floor-standing rack should be installed to provide better organization and space for future growth. It is also recommended to provide a telecommunications grounding busbar to create a consistent potential across all components. New standards compliant backbone and horizontal cabling are recommended. The addition of card-based access control is recommended to control access and track access to the space. Ductless split-system cooling unit is also recommended to be installed to provide adequate cooling in the room.

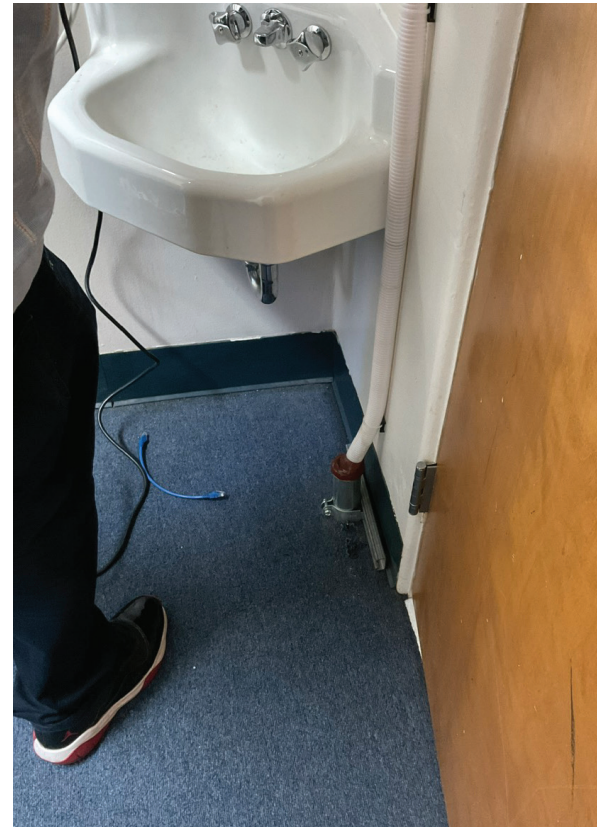
Existing Sink

- » Upgrade existing port locations to Category 6A.
- » Add additional Category 6A 8P8C RJ45 ports to meet standards.
- » Provide new 12-strand OS2 single-mode and 12-strand OM4 multi-mode optical fiber backbone from TR-2W/W202 and TR-3A/A312.
- » Add ladder tray and cable management as needed.
- » Add Telecommunications Grounding Busbar.
- » Add power circuits and receptacles as needed.
- » Add ductless split-system cooling unit.
- » Control access to authorized individuals.
- » Provide new two-post equipment rack away from the door and sink.
- » Relocate existing telecom equipment from wall-mounted rack to new rack to allow for more space to expand.
- » Remove existing sink and cap water line into the room.

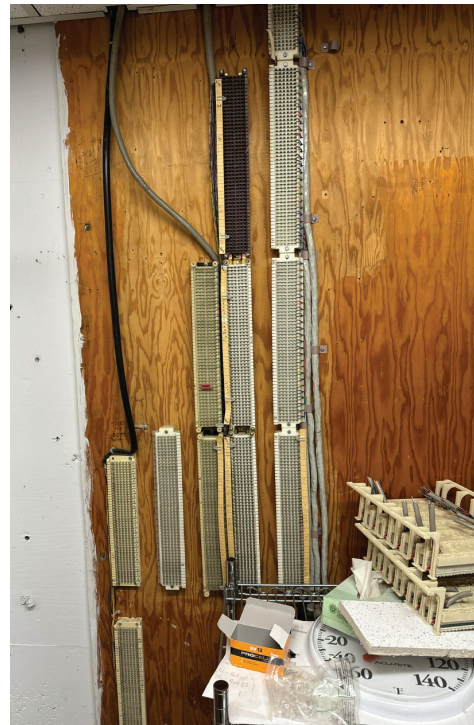
Abandoned Phone Patching

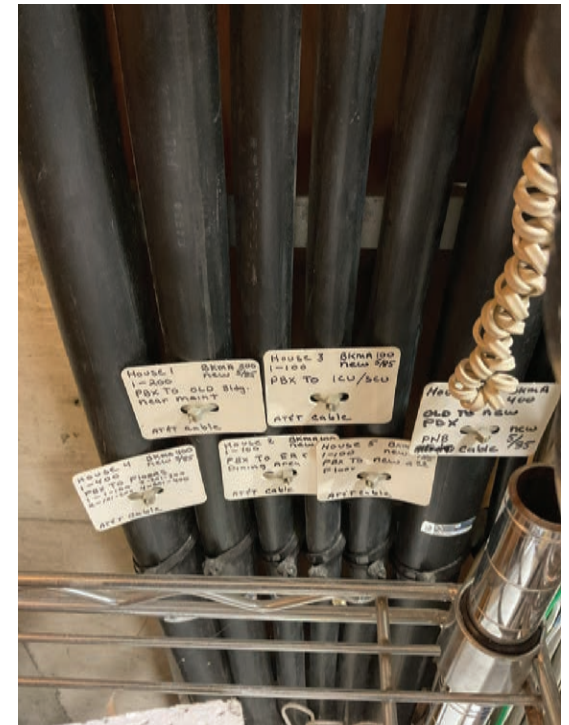
Existing Category 3 Cabling

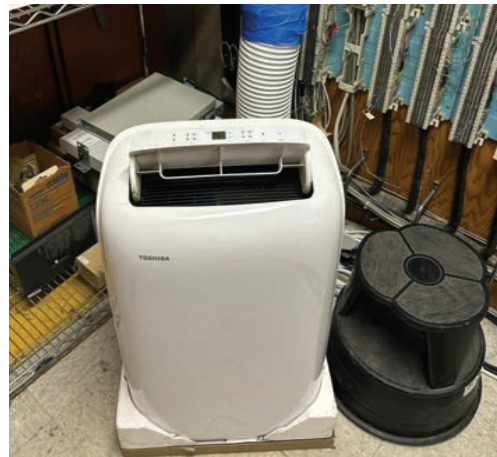
There is currently space for expansion on the rack. A grounding bus bar has been installed in the room, but there is no proper bonding to the telecom equipment. A portable AC unit is being used to provide cooling and humidity control. There are a few convenience receptacles, but no dedicated equipment receptacles. UPS power is available to provide clean, uninterrupted power for the equipment. The room can be locked but there is no other access control on the room.

Existing Portable AC Unit

To meet industry standards, it is recommended to provide a ladder rack for cable support. It is also recommended to provide proper bonding of the telecom equipment to create a consistent potential across all components. New standards compliant backbone and horizontal cabling are recommended. The addition of card-based access control is recommended to control access and track access to the space. A ductless split-system cooling unit is also recommended to be installed in place of the portable AC to provide adequate cooling in the room.

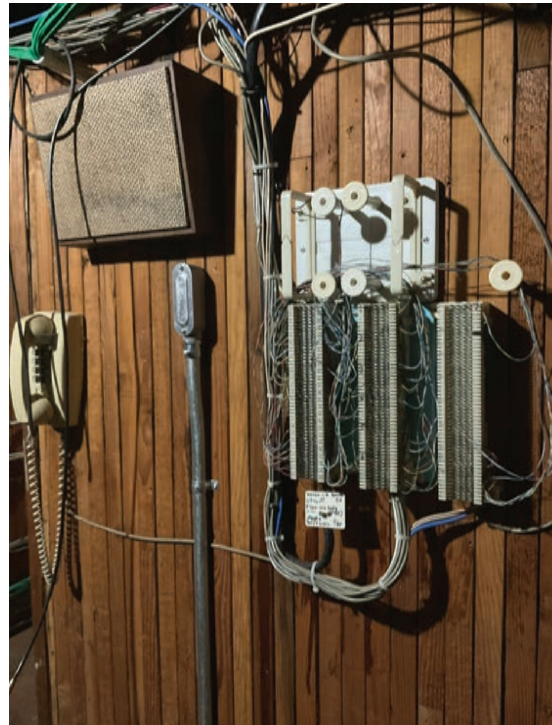
The attic space is currently used as a large cross-connect point for the existing voice Category 3 cabling. Multiple walls contain service entrance protections, splice boxes, and 66 and 110-blocks for voice cross connection. Half of the cross-connects were not in use and left abandoned.

Existing Phone Cross-Connect

- » Abandon the attic and route all future cabling to TR-Penthouse.
- » Remove all unused equipment

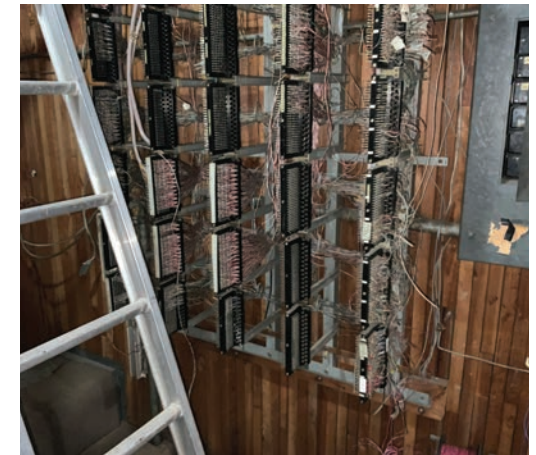
Abandoned Phone Cross-Connects
