EASTERN STATE HOSPITAL

WA STATE PROJECT NUMBER: 2024-429 C (3)

EXECUTIVE SUMMARY

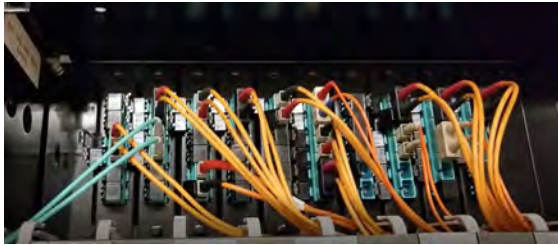
Existing Fiber Patching Mismatch.

The existing ethernet network is supported by multi-mode optical fiber backbones between buildings and telecommunication rooms. The current OM1 fiber backbone is extremely limited in bandwidth and data speeds. OM1 fiber is obsolete, is not readily available through distribution, and is not being manufactured in great quantity. TIA standards for healthcare facilities dictate the use of single-mode optical fiber or a minimum of OM4 rated multi-mode fiber. To allow future network expansion, technology growth, and meet current standards, it is recommended that the existing OM1 optical fiber backbone be replaced with an optical fiber backbone utilizing a minimum of 12-strands of OS2 single-mode outside plant optical fiber cable and a minimum of 12-strands of OM4 multi-mode outside plant optical fiber cable supporting each Cottage. The existing OM1 optical fiber backbone cabling should be demolished.

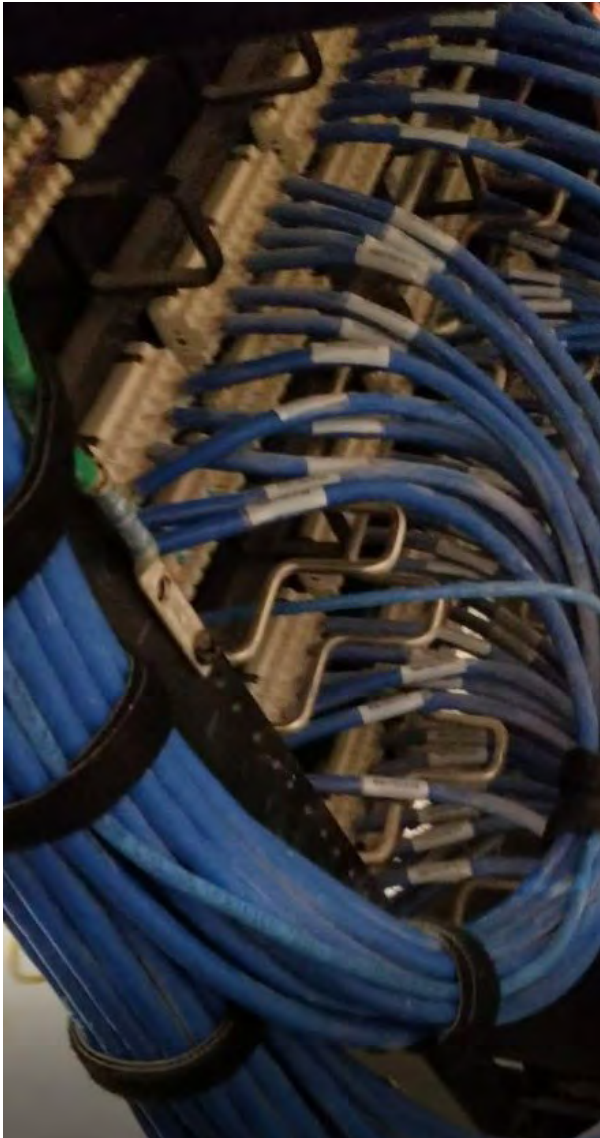
Existing Category 5e Cabling.

The existing Category 3, and Category 5 infrastructure is not adequate to meet the current and future needs of EHS. The Category 5 cabling is not in compliance with TIA standards for infrastructure. It is recommended that the existing cabling infrastructure be replaced with a new Category 6A cabling infrastructure.

Meeting TIA-1179 standards will require the entire channel to be Category 6A certified. Meeting this requirement will require all new patch panels, modular jacks, and wall outlets comprising a replacement of the entire infrastructure. Existing Category 5, Category 5e, and Category 6 patch panels will be removed in favor of the Category 6A infrastructure. See sequencing and recommendations for sequencing of the project to minimize down time while the infrastructure is replaced.

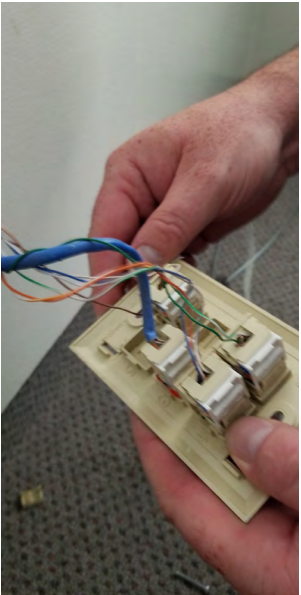
Upon review of the voice infrastructure, it was found to be inadequate to serve the current and future needs of YVS. The current phone system utilizes Category 3 cabling, patched at multiple points to provide phone service to the user. 66 and 110 blocks are used to patch the cable. 66 and 110 blocks are types of cable termination blocks used to interconnect runs of on-premises wiring in a structured cabling system. The service enters each of the buildings, patches on building entrance protectors, then patches again from 66 blocks to 110 blocks to be distributed to the appropriate floor. Once on the respective floor, the cable is patched again on 110 blocks to the workstation cabling.

The overall effect of the multiple patches is a degradation of the signal and introduction of noise, resulting in grainy, poor-quality audio.

Category 3 cabling does not meet TIA-1179-A standards for horizontal cabling. Industry wide, its use has been on a rapid decline for years as it is not manufactured to meet current bandwidth or data rate standards. The existing voice cabling is in such poor condition that it is barely supporting the existing phone system. After years of modifications and multiple generations of cabling it is nearly impossible to maintain. It is recommended that all Category 3 cabling be removed, and the voice network be collapsed onto a converged network infrastructure utilizing standards compliant Category 6A cabling.

Split Pair Voice Line

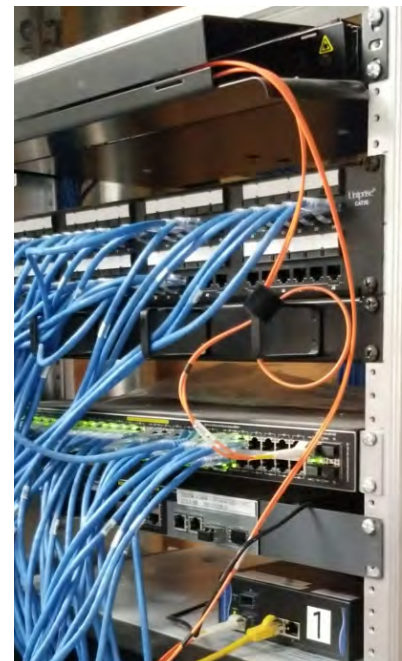
To meet industry standards, it is recommended to upgrade the existing backbone and horizontal cabling. Additional Category 6A data ports are required to meet standards. Dedicated cooling is required to meet standards. The addition of card-based access control is recommended to control access and track access to the space.

Existing Telecom Rack.

- » Upgrade existing port locations to Category 6A.
- » Provide labels for all new cabling and existing cables to remain
- » Add additional Category 6A 8P8C RJ45 ports to meet standards.
- » Provide new 12-strand OS2 single-mode and 12-strand OM4 multi-mode optical fiber backbone from WSH MER in Admin Building.
- » Add cable management as needed.
- » Add ductless split-system cooling unit or connect to building environmental system.
- » Add power circuits and receptacles as needed.
- » Control access to authorized individuals.

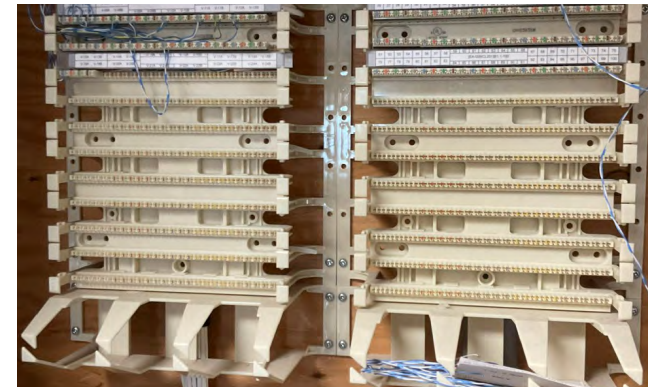
To meet industry standards, it is recommended to upgrade the existing backbone and horizontal cabling. Additional Category 6A data ports are required to meet standards. Dedicated cooling is required to meet standards. The addition of card-based access control is recommended to control access and track access to the space.

Existing Voice Patching.

- » Upgrade existing port locations to Category 6A.
- » Provide labels for all new cabling and existing cables to remain.
- » Add additional Category 6A 8P8C RJ45 ports to meet standards.
- » Provide new 12-strand OS2 single-mode and 12-strand OM4 multi-mode optical fiber backbone from ESH MER in the Admin Building.
- » Add cable management as needed.
- » Add ductless split-system cooling unit or connect to building environmental system.
- » Add power circuits and receptacles as needed.
- » Control access to authorized individuals.

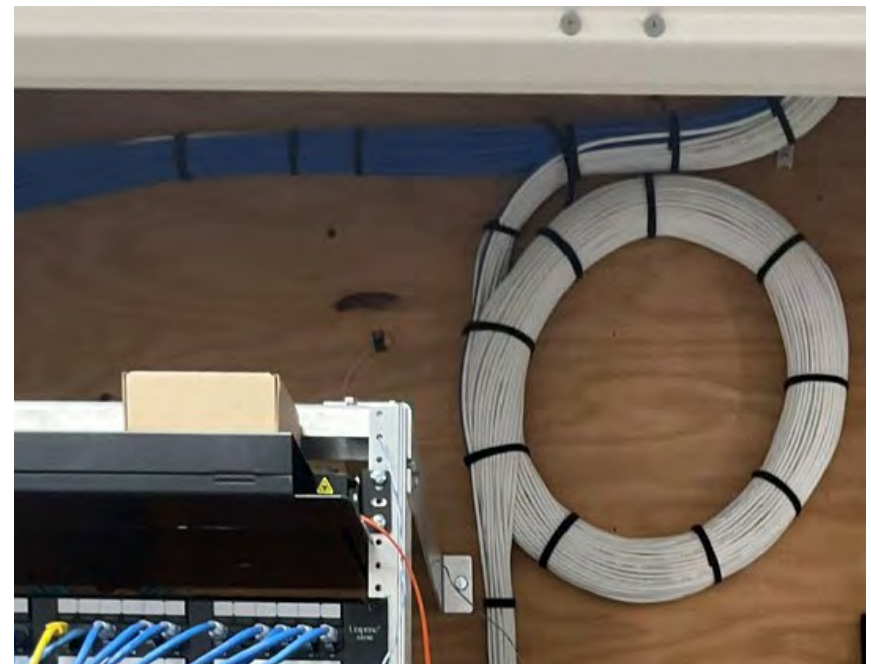
To meet industry standards, it is recommended to upgrade the existing backbone and horizontal cabling to OM4/OS2 and Category 6A. Additional Category 6A data ports are required to meet standards. It is also recommended to provide a telecommunications grounding busbar to create a consistent potential across all components. Dedicated cooling, cable management, and dedicated equipment receptacles are required to meet standards. The addition of card-based access control is recommended to control access and track access to the space.

Existing Horizontal Cabling.

- » Upgrade existing port locations to Category 6A.
- » Provide labels for all new cabling and existing cables to remain.
- » Add additional Category 6A 8P8C RJ45 ports to meet standards.
- » Provide new 12-strand OS2 single-mode and 12-strand OM4 multi-mode optical fiber backbone from ESH MER in the Admin Building.
- » Add cable management as needed.
- » Add ductless split-system cooling unit or connect to building environmental system.
- » Add power circuits and receptacles as needed.
- » Control access to authorized individuals.

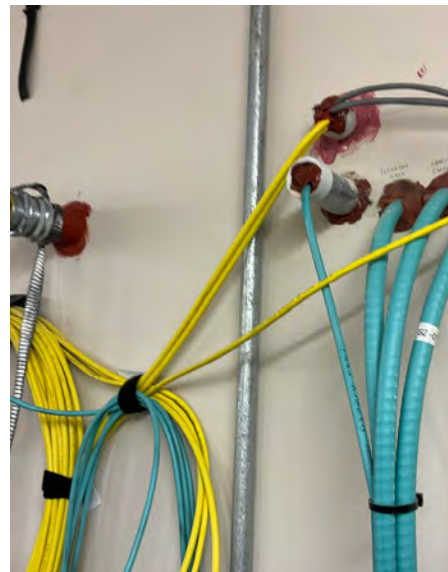
To meet industry standards, it is recommended to upgrade the existing backbone and horizontal cabling to OM4/OS2 and Category 6A. Additional Category 6A data ports are required to meet standards. Dedicated cooling, ladder rack, cable management, and dedicated equipment receptacles are required to meet standards. The addition of card-based access control is recommended to control access and track access to the space.

Existing Twisted-Pair Copper And OFC

- » Upgrade existing port locations to Category 6A.
- » Provide labels for all new cabling and existing cables to remain.
- » Provide new 12-strand OS2 single-mode and 12-strand OM4 multi-mode optical fiber backbone from the MER in the Admin Building basement.
- » Add ladder tray and cable management as needed.
- » Add ductless split-system cooling unit.
- » Add power circuits and receptacles as needed.
- » Control access to authorized individuals.

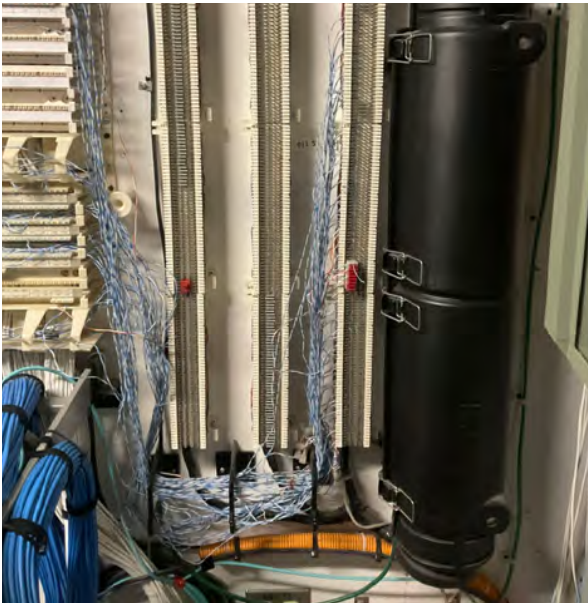
To meet industry standards, it is recommended to upgrade the existing backbone and horizontal cabling to OM4/OS2 and Category 6A. Additional Category 6A data ports are required to meet standards. Dedicated cooling, ladder rack, cable management, and dedicated equipment receptacles are required to meet standards. The addition of card-based access control is recommended to control access and track access to the space.

Existing Voice Patching.

- » Upgrade existing port locations to Category 6A.
- » Add additional Category 6A 8P8C RJ45 ports to meet standards.
- » Provide labels for all new cabling and existing cables to remain.
- » Provide new 12-strand OS2 single-mode and 12-strand OM4 multi-mode optical fiber backbone from the MER in the Admin Building basement.
- » Add ladder tray and cable management as needed.
- » Add ductless split-system cooling unit.
- » Add power circuits and receptacles as needed.
- » Control access to authorized individuals.

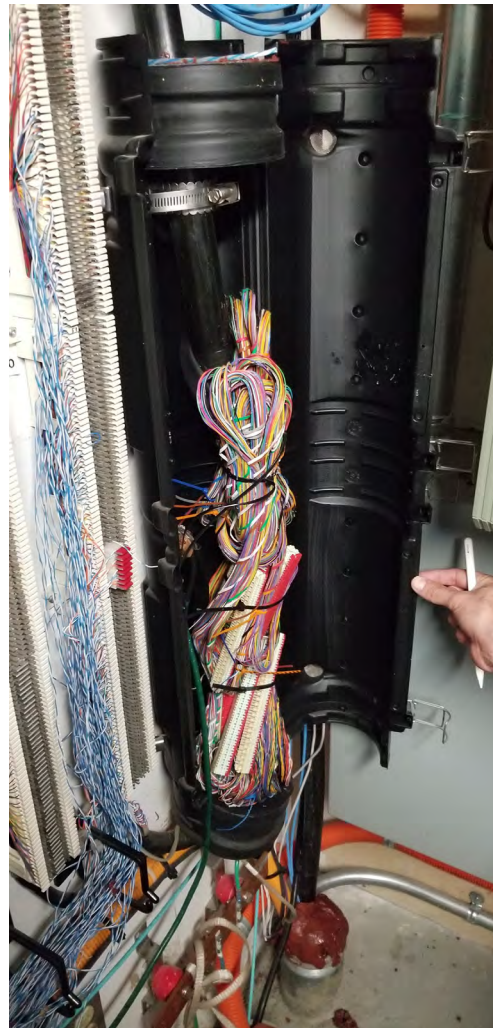
Existing Voice Backbone.

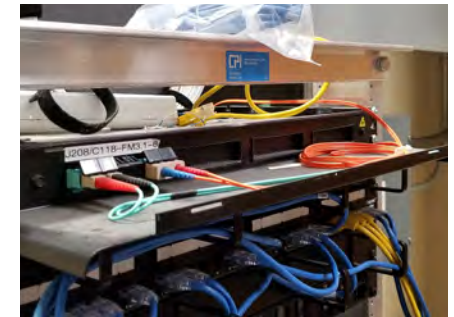
Existing Mismatch Fiber Patching.

- » Upgrade existing port locations to Category 6A.
- » Add additional Category 6A 8P8C RJ45 ports to meet standards.
- » Provide labels for all new cabling and existing cables to remain.
- » Provide new 12-strand OS2 single-mode and 12-strand OM4 multi-mode optical fiber backbone from ESH MER in the Admin Building.
- » Add ladder tray and cable management as needed.
- » Add ductless split-system cooling unit.
- » Add power circuits and receptacles as needed.
- » UPS should be replaced with a properly sized UPS to handle the electrical load and duration.
