# **TRANSITIONAL CARE CENTER OF SEATTLE**

**WA STATE PROJECT NUMBER: 2024-429 O (12)**

## EXECUTIVE SUMMARY

Telecommunications Infrastructure Assessment Recommendations  
Transitional Care Center of Seattle

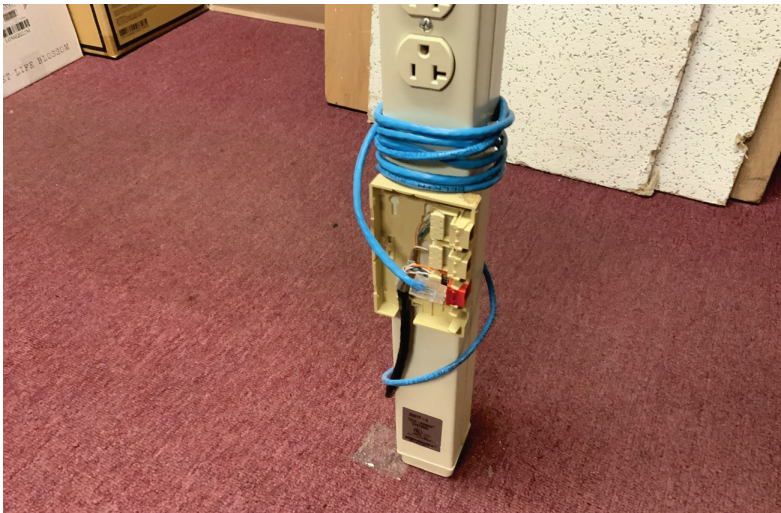
Existing Telecommunications Outlet

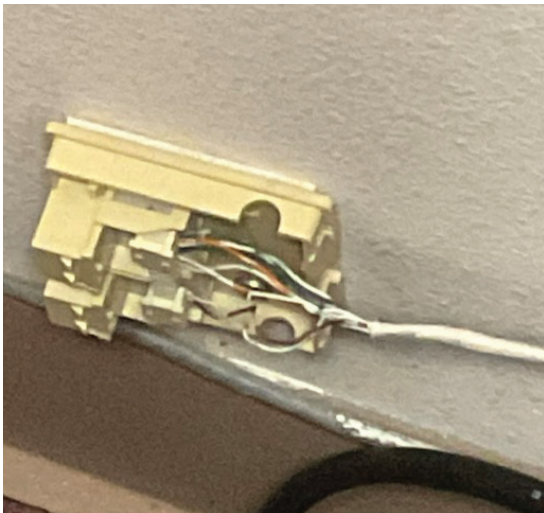
Existing Biscuit Jack.

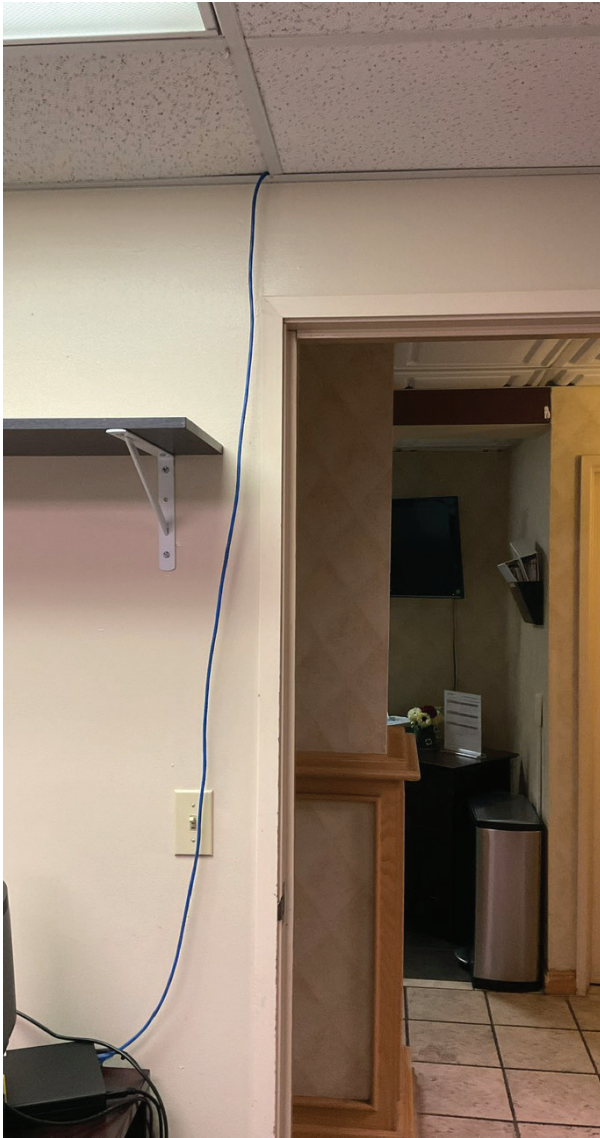
Existing Ceiling Data Cable, Administration

The existing ethernet network is comprised of Category 5e cabling. The existing patch panels, connectors, and patch panels meet Category 5e and 6 standards. There are also multiple areas where horizontal cabling is left dangling from the wall or ceiling without a wall-plate. This not only presents a potential safety hazard but also impacts the performance and reliability of the network connection.

The existing Category 5e is not adequate to meet the current and future needs of Transitional Care Center of Seattle. The Category 5e cabling is also not in compliance with TIA standards for infrastructure. It is recommended that the existing cabling infrastructure be replaced with a new Category 6A cabling infrastructure. It is also recommended that additional data ports are added throughout the facilities to adequately provide employees with enough network port connections for their devices. New Category 6A cabling will also require to be secured and all outlet boxes should be fitted with the appropriate faceplates to protect the cabling.

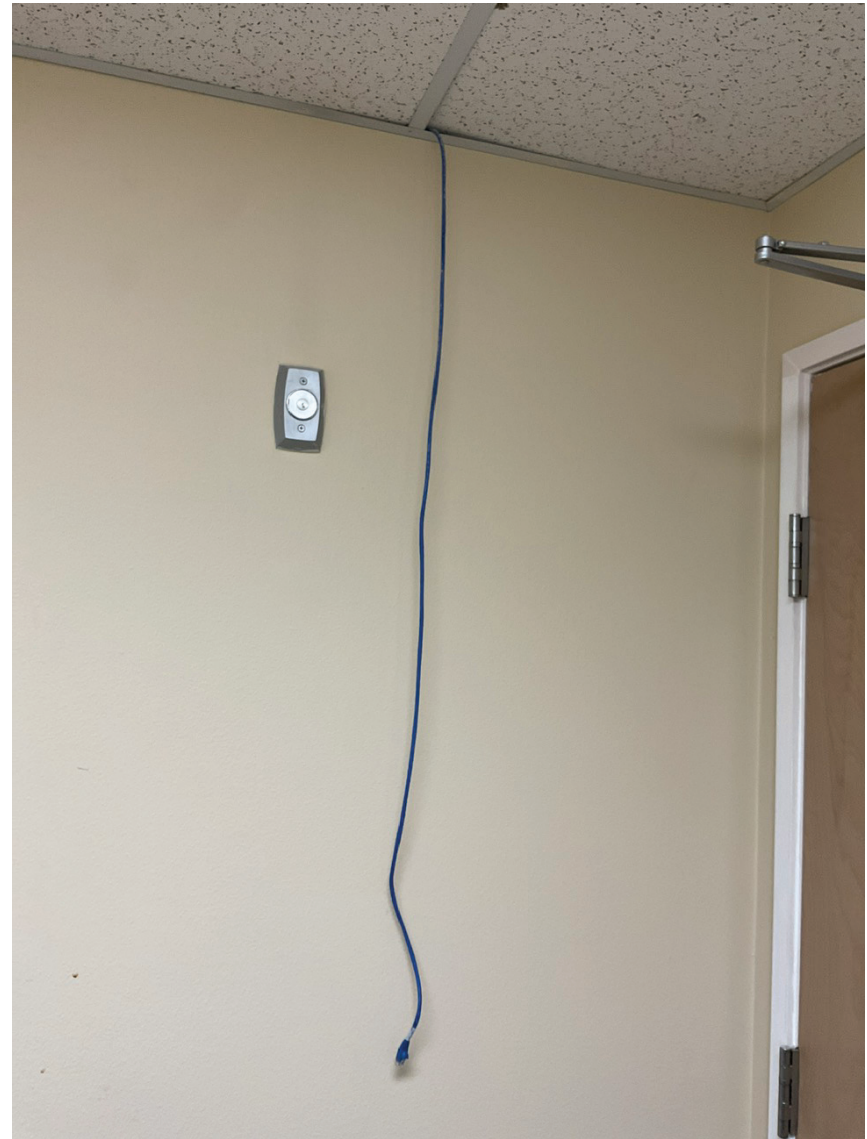
*Existing Copy Room Ceiling Data Cable*

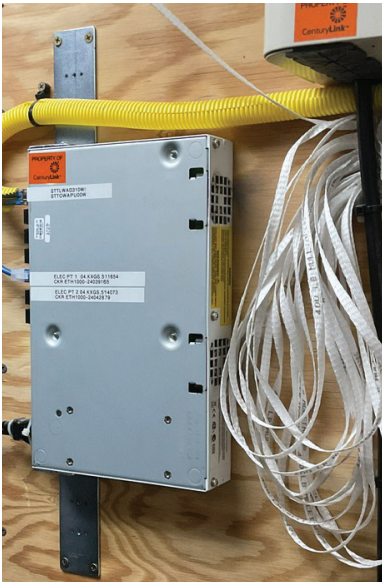
Service Provider Equipment

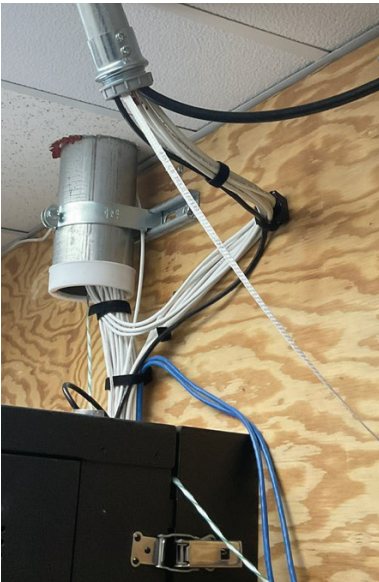
Existing Backbone Cabling

- » Horizontal Cabling infrastructure does not meet minimum standards per TIA-1179.
- » Backbone Cabling Infrastructure does not meet minimum standards per TIA-1179.
- » No overhead ladder tray for cable support, leading to cables being draped or placed directly on equipment.
- » No grounding busbar for the telecommunications equipment.
- » Electrical infrastructure does not meet minimum requirements per standards.
- » Uncontrolled access to space with no identity verification.
- » No dedicated cooling equipment.
- » No rack space for expansion.

- » Upgrade existing port locations to Category 6A.
- » Add additional Category 6A 8P8C RJ45 ports to meet standards.
- » Provide new 12-strand OS2 single-mode and 12-strand OM4 multi-mode optical fiber backbone to TR-129, TR-229, and TR-329.
- » Add ladder tray and cable management as needed.
- » Add Telecommunications Grounding Busbar.
- » Add power circuits and receptacles as needed.
- » Add dedicated cooling system.
- » Control access to authorized individuals.
- » Replace wall-mounted enclosure with new two-post equipment rack to house telecom equipment

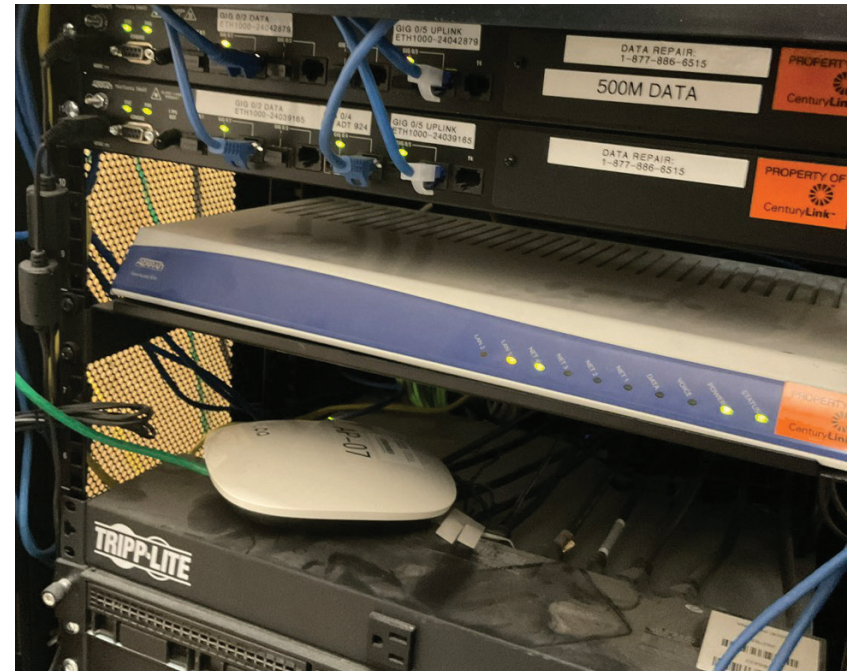
There is currently no space for expansion on the rack. There is no grounding bus bar in the room. The room does not contain cooling or humidity control. There are a few convenience receptacles, but no dedicated equipment receptacles. UPS power is available to provide clean, uninterrupted power for the equipment. The room can be locked but there is no other access control on the room.

*Existing Telecom Rack*

*To meet industry standards, it is recommended to upgrade the existing backbone and horizontal cabling to OM4/OS2 and Category 6A. Additional Category 6A data ports are required to meet standards. It is also recommended to provide a telecommunications grounding busbar to create a consistent potential across all components. The wall-mounted enclosure should be replaced with a floor standing rack to allow more rack space for future growth. Dedicated cooling, ladder rack, cable management, and dedicated equipment receptacles are required to meet standards. The addition of card-based access control is recommended to control access and track access to the space.*

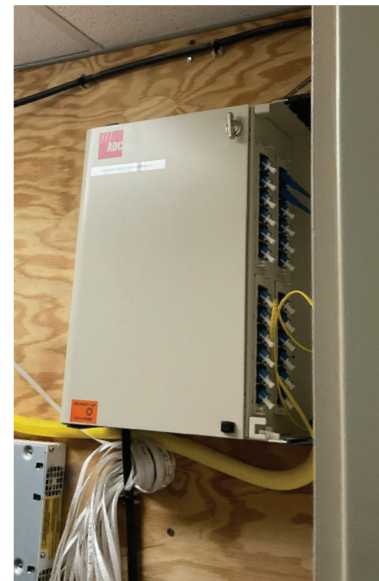
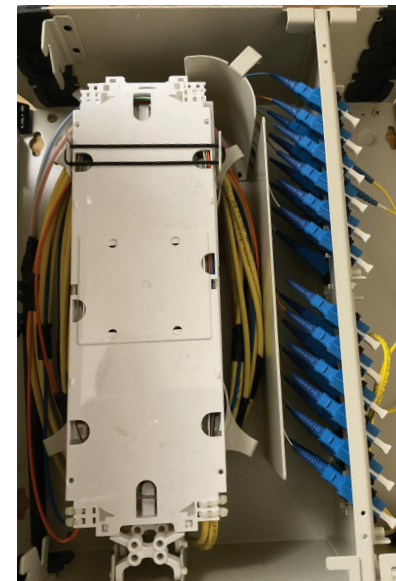
*Service Provider Fiber*

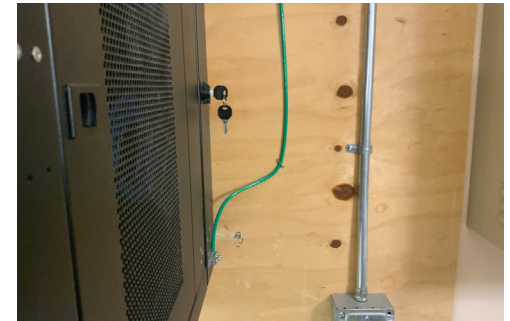
There is currently no space for expansion on the rack, but there is space in the room for additional floor standing racks. There is also no grounding bus bar in the room. The room does not contain cooling or humidity control. There are a few convenience receptacles, but no dedicated equipment receptacles. UPS power is available to provide clean, uninterrupted power for the equipment. While the room can be locked, in practice, it is often left open because it is also used as an employee's workspace, allowing access to anyone walking by.

Existing Grounding

***To meet industry standards, it is recommended to upgrade the existing backbone and horizontal cabling to OM4/OS2 and Category 6A. Additional Category 6A data ports are required to meet standards. It is also recommended to provide a telecommunications grounding busbar to create a consistent potential across all components. The wall-mounted enclosure should be replaced with a floor standing rack to allow more rack space for future growth. The employee should be moved to a new space to create a dedicated telecommunications room. Dedicated cooling, ladder rack, cable management, and dedicated equipment receptacles are required to meet standards. The addition of card-based access control is recommended to control access and track access to the space.***

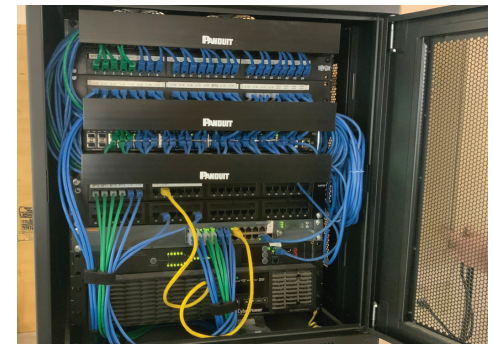
Existing Telecommunications Enclosure

- » Upgrade existing port locations to Category 6A.
- » Add additional Category 6A 8P8C RJ45 ports to meet standards.
- » Provide new 12-strand OS2 single-mode and 12-strand OM4 multi-mode optical fiber backbone to MER-B03B.
- » Add ladder tray and cable management as needed.
- » Add Telecommunications Grounding Busbar.
- » Add power circuits and receptacles as needed.
- » Add dedicated cooling system.
- » Control access to authorized individuals.
- » Relocate the employee workspace to allow room to be a dedicated telecom space.
- » Replace wall-mounted enclosure with new two-post equipment rack to house telecom equipment

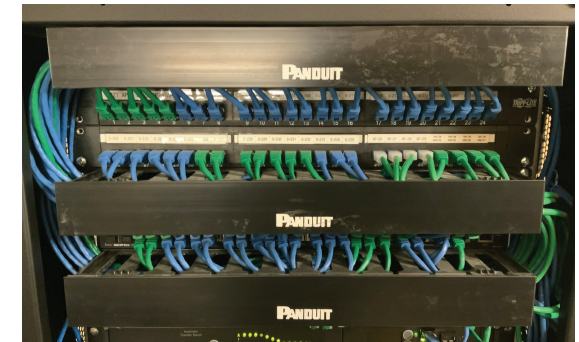
There is currently no space for expansion on the rack, but there is space in the room for additional floor standing racks. There is also no grounding bus bar in the room. The room does not contain cooling or humidity control. There are a few convenience receptacles, but no dedicated equipment receptacles. UPS power is available to provide clean, uninterrupted power for the equipment. While the room can be locked, in practice, it is often left open because it is also used as an employee's workspace, allowing access to anyone walking by.

Existing Patch Panel

- » Upgrade existing port locations to Category 6A.
- » Add additional Category 6A 8P8C RJ45 ports to meet standards.
- » Provide new 12-strand OS2 single-mode and 12-strand OM4 multi-mode optical fiber backbone to MER-B03B.
- » Add ladder tray and cable management as needed.
- » Add Telecommunications Grounding Busbar.
- » Add power circuits and receptacles as needed.
- » Add dedicated cooling system.
- » Control access to authorized individuals.
- » Relocate the employee workspace to allow room to be a dedicated telecom space.
- » Replace wall-mounted enclosure with new two-post equipment rack to house telecom equipment

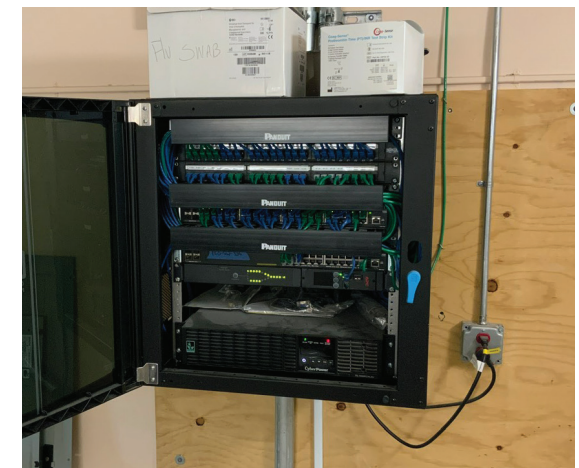
Existing Telecommunications Enclosure

**To meet industry standards, it is recommended to upgrade the existing backbone and horizontal cabling to OM4/OS2 and Category 6A. Additional Category 6A data ports are required to meet standards. It is also recommended to provide a telecommunications grounding busbar to create a consistent potential across all components. The wall-mounted enclosure should be replaced with a floor standing rack to allow more rack space for future growth. The employee should be moved to a new space to create a dedicated telecommunications room. Dedicated cooling, ladder rack, cable management, and dedicated equipment receptacles are required to meet standards. The addition of card-based access control is recommended to control access and track access to the space.**

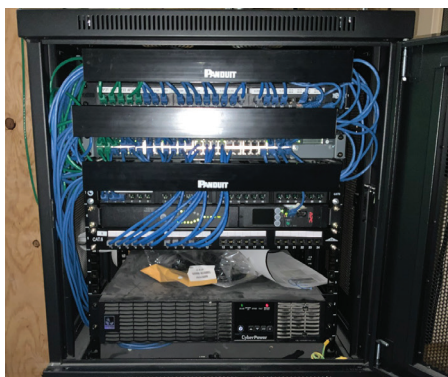
There is currently no space for expansion on the rack, but there is space in the room for additional floor standing racks. There is also no grounding bus bar in the room. The room does not contain cooling or humidity control. There are a few convenience receptacles, but no dedicated equipment receptacles. UPS power is available to provide clean, uninterrupted power for the equipment. While the room can be locked, in practice, it is often left open because it is also used as an employee's workspace, allowing access to anyone walking by.

Existing Telecommunications Enclosure

***To meet industry standards, it is recommended to upgrade the existing backbone and horizontal cabling to OM4/OS2 and Category 6A. Additional Category 6A data ports are required to meet standards. It is also recommended to provide a telecommunications grounding busbar to create a consistent potential across all components. The wall-mounted enclosure should be replaced with a floor standing rack to allow more rack space for future growth. The employee should be moved to a new space to create a dedicated telecommunications room. Dedicated cooling, ladder rack, cable management, and dedicated equipment receptacles are required to meet standards. The addition of card-based access control is recommended to control access and track access to the space.***

- » Upgrade existing port locations to Category 6A.
- » Add additional Category 6A 8P8C RJ45 ports to meet standards.
- » Provide new 12-strand OS2 single-mode and 12-strand OM4 multi-mode optical fiber backbone to MER-B03B.
- » Add ladder tray and cable management as needed.
- » Add Telecommunications Grounding Busbar.
- » Add power circuits and receptacles as needed.
- » Add ductless split-system cooling unit.
- » Control access to authorized individuals.
- » Relocate the employee workspace to allow room to be a dedicated telecom space

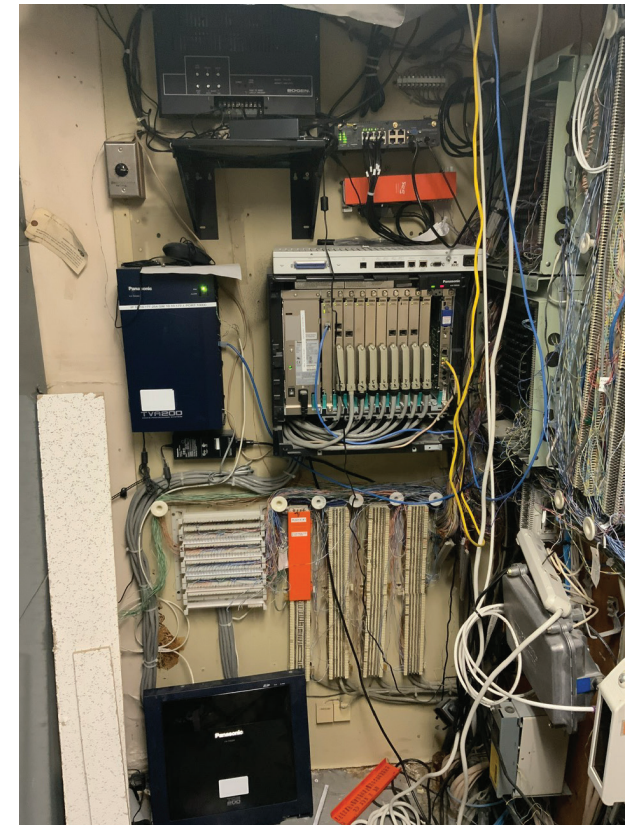
Cross-connect room B02 is on the basement level. The room contains the unused analog phone cabling, as well as the new Panasonic PBX for the current phone system. The space is only 75 sq ft and is also being shared with electrical equipment. Two walls contain multiple 66 and 110-blocks for voice cross connection.

*Current And Abandoned Phone Headend*

***Due to the small size, it is recommended that the room be abandoned with all new voice cabling being routed to ER-B03B on the same floor.***

- » Abandon the closet and route all future cabling to ER-B03B.
- » Relocate the current phone headend to ER-B03B.

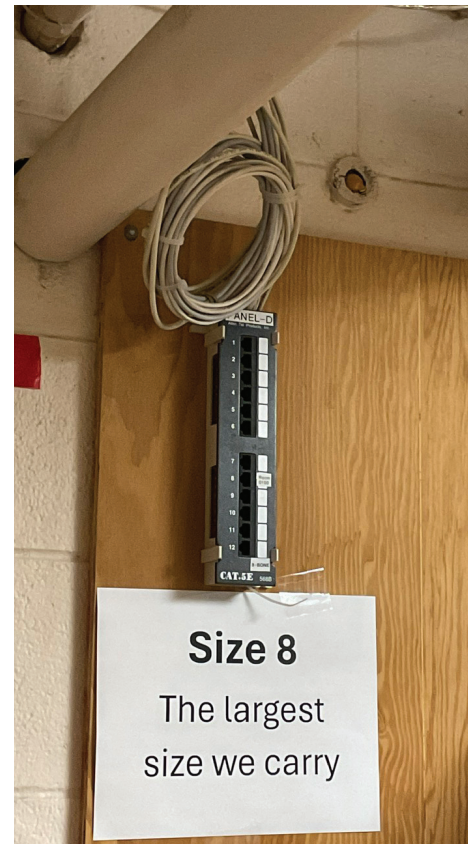
Abandoned Category 5e Patch Panel

***It is recommended that the room be abandoned with all new voice cabling being routed to ER-B03B on the same floor.***

- » Remove the unused equipment and route all future cabling to ER-B03B

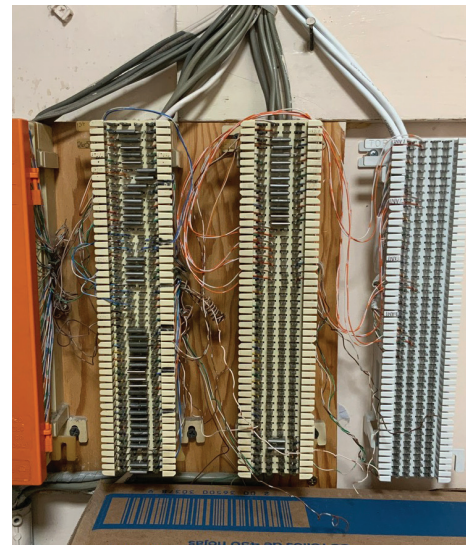
**Abandoned 66-blocks**

***Due to the small size, it is recommended that the room be abandoned with all new voice cabling being routed to TR-129 on the same floor.***

- » Remove the unused equipment and route all future cabling to TR-129.

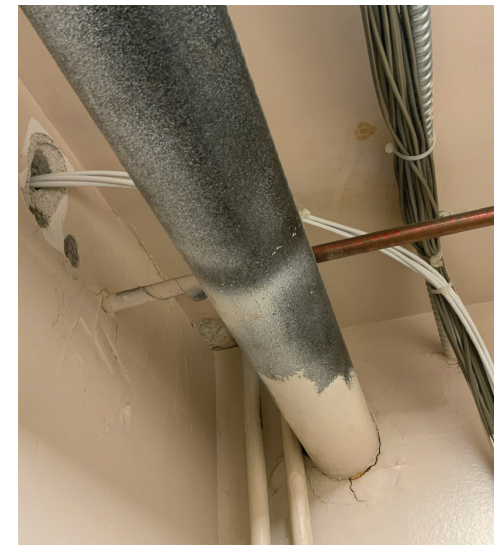
**Abandoned Category 3 Cables**

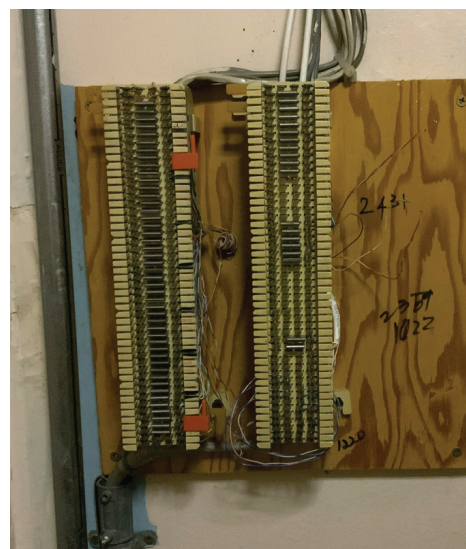
**Abandoned 66-blocks**

***Due to the small size, it is recommended that the room be abandoned with all new voice cabling being routed to TR-229 on the same floor.***

- » Abandon the closet, remove all unused equipment, and route all future cabling to TR-229

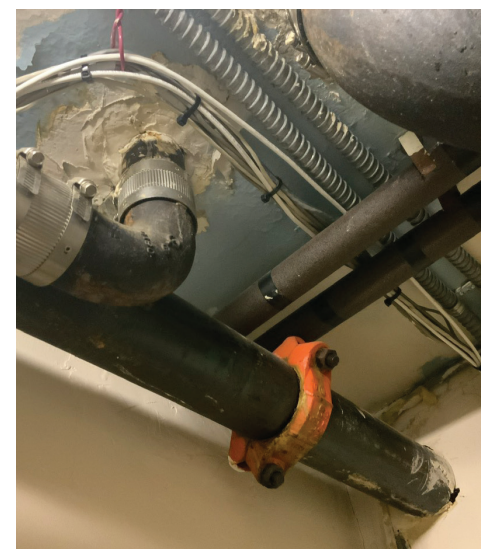
**Abandoned Category 3 Cables**

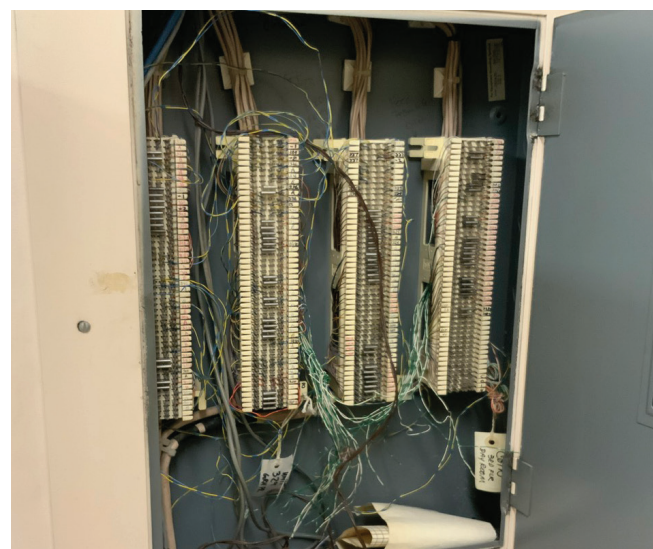
Abandoned 66-blocks

***Due to the location, it is recommended that the cross-connect be abandoned with all new voice cabling being routed to TR-329 on the same floor.***

- » Remove the unused equipment and route all future cabling to TR-329.

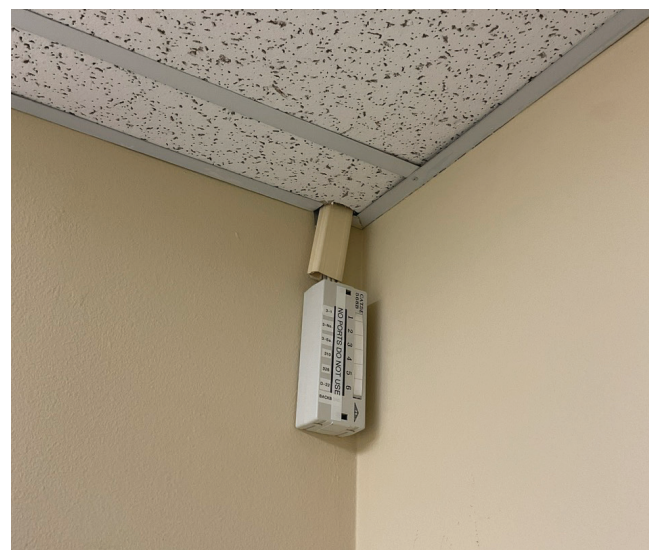
Abandoned Category 5e Patch Panel

***Due to the location, it is recommended that the cross-connect be abandoned with all new voice cabling being routed to TR-329 on the same floor.***

- » Remove the unused equipment and route all future cabling to TR-329.
