DSHS  
**WESTERN STATE  
HOSPITAL**

**WA STATE PROJECT NUMBER: 2024-429 B (2)**

## EXECUTIVE SUMMARY

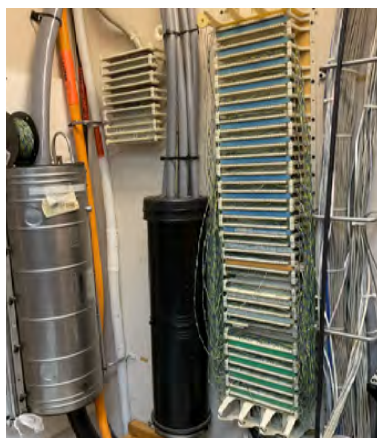
The existing voice infrastructure is not adequate to meet the current and future needs of Western State Hospital, and is not in compliance with TIA standards for infrastructure. It is recommended that the existing cabling infrastructure be replaced with new cabling infrastructure, and the voice network be collapsed onto a converged network infrastructure utilizing standards compliant Category 6A cabling.

*Building 17 Voice Backbone Cabling.*

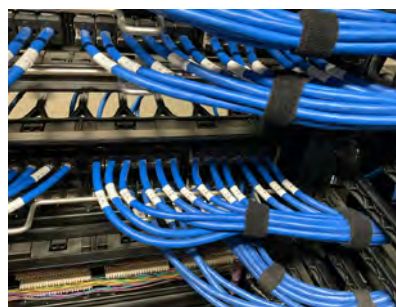
*Existing Category 6A Cabling.*

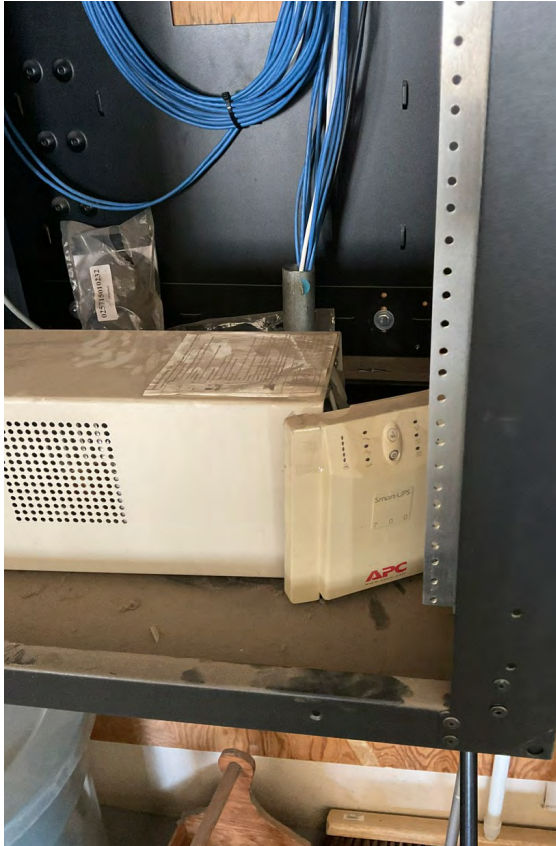
*Existing Broken UPS.*

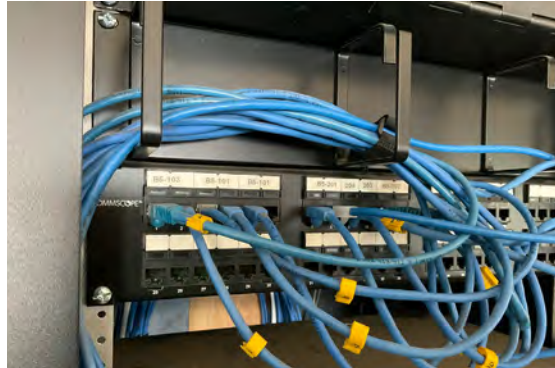
*Existing Data Patching.*

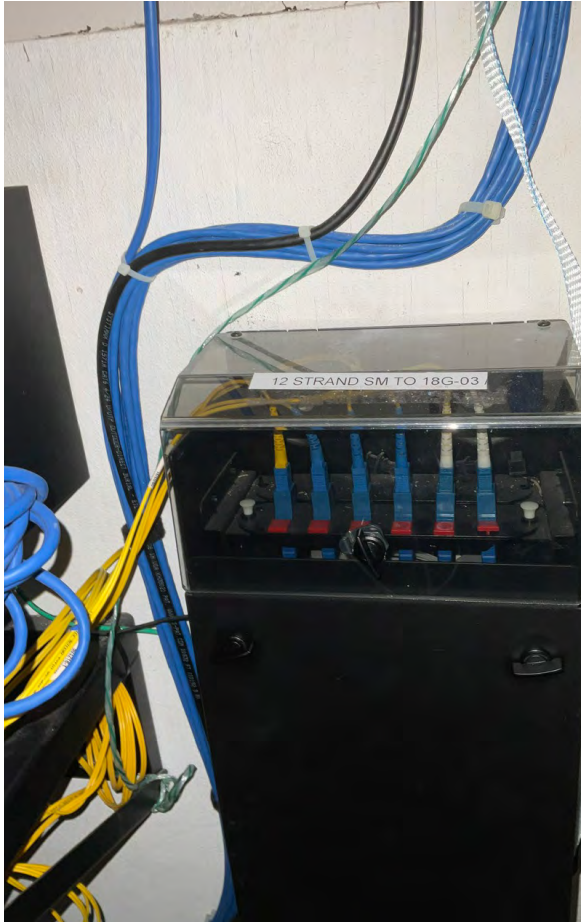
*Existing Fiber Cabinet.*

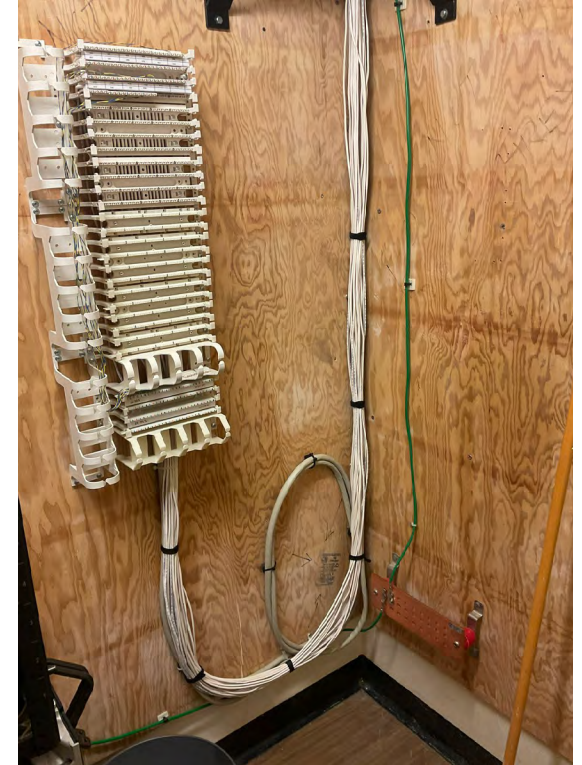
*Existing Voice Patching.*

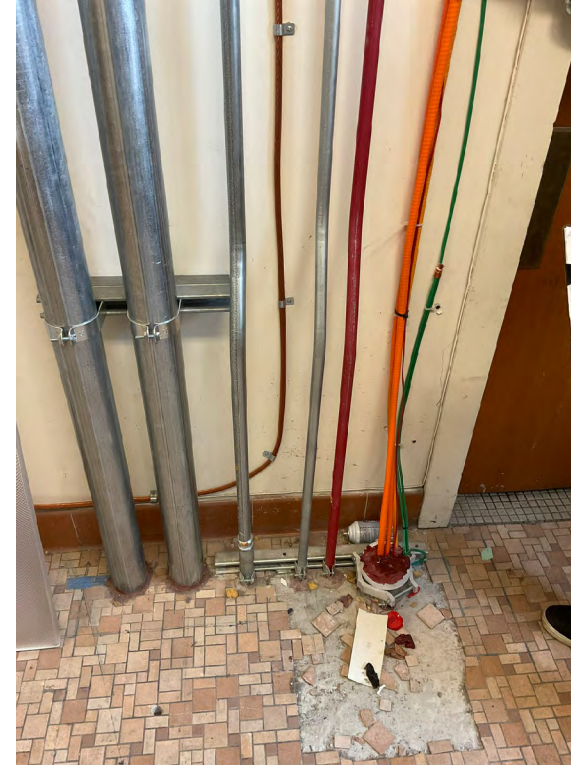
*Existing Conduit Sleeve.*

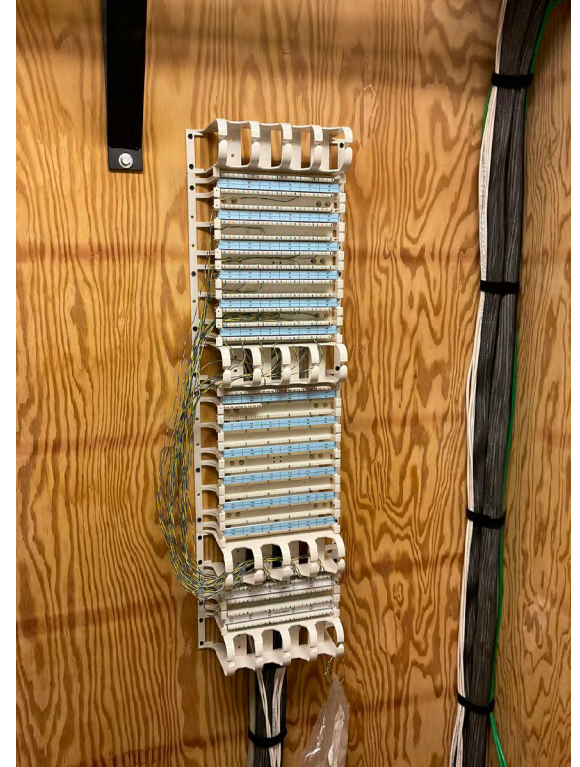
*Existing Voice Patching.*

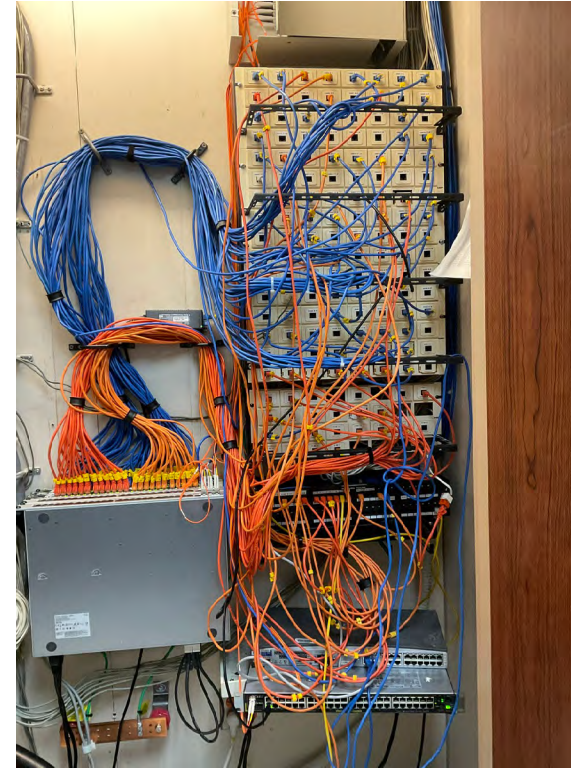
Existing Telecom Rack.

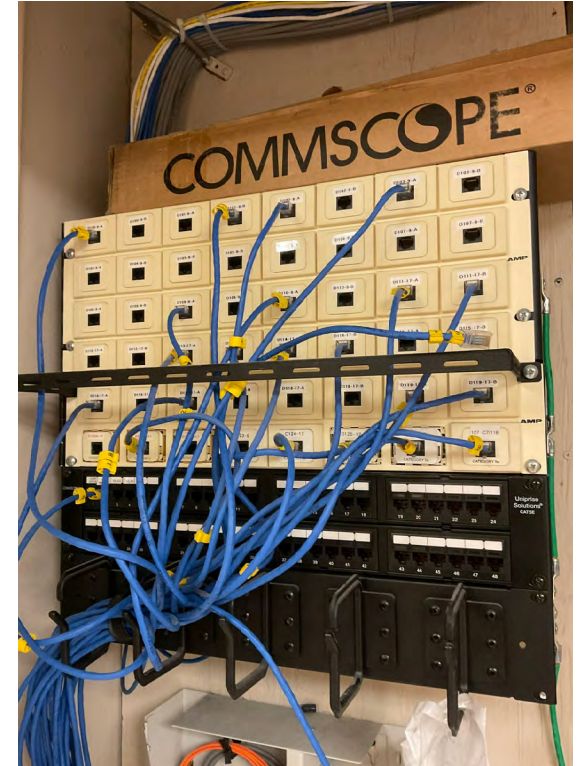
*Existing Data Patching.*
