# McNeil Island Repair and Replacement Options 10182200022

Prepared by KPFF Consulting Engineers  
Draft Repair and Replacement Options  
June 30, 2022

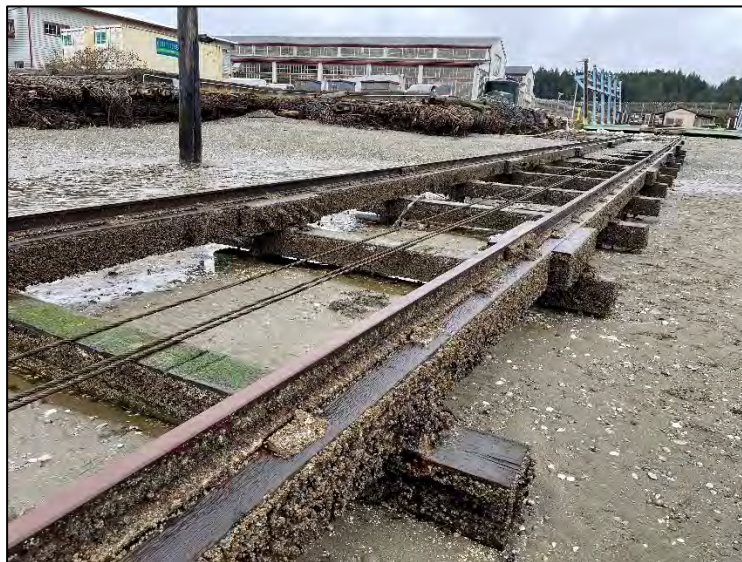
Photo 1A: Marine Railway Dry Dock

Most of the fasteners within the system have heavy marine growth and surface corrosion. Surface corrosion is caused by electrochemical reactions that destroy the structure of the material. These occurrences result in fatigue of the metal and reduce the structural capabilities that they once had. The pile cap brackets and pile fasteners are all heavily corroded. These members are a concern because of the decrease in strength of their structure. The rail

base plates south of the bulkhead are all severely corroded with section loss. This severe corrosion is a typical occurrence when metals of different carbon content are in contact in a saltwater environment. The rails are not fully secured laterally by the rail base plates due to the section loss. This is of high concern because the rails are free to move in unsecured locations and could result in failure of the system during operation. The overall rating of the fasteners in the system is a three and requires immediate action.

The rails north of the bulkhead have minor uniform surface corrosion and pitting in sections. The rails south of the bulkhead have heavy surface corrosion, pitting and marine growth. The rail splice bars are heavily corroded and have heavy marine growth. The conditions gradually worsen down the rail system toward the anchor point at the southern end. If the rails get any worse, they may pose a threat to the operational capabilities of the system. The overall rating of the rails is a 3 and will require immediate action.

The timber rail beams, pile caps, and piles are covered in marine growth, green moss algae, they are hollow in sections along the system, and there is evidence of Teredo ship worm activity. The hollowing of the timber rails, pile caps, and piles is a major concern because the structural capacity of the members is severely degraded. Teredo shipworm activity can result in a major loss of volume in timber members. When the shipworm borers itself into timber, it leaves a small opening for respiration. Once shipworm activity has occurred, the only way to eliminate the issue is to suffocate the borers by covering the member with a plastic material. If a timber rail beam, pile, or pile cap were to fail from any of these issues, the system would be out of operation.

The cradle has sections with surface corrosion and delaminating paint. Areas where welded joints are and exposed elements, have heavier surface corrosion. If this is not dealt with, the cradle system will worsen over time and will require significant repairs rather than typical maintenance. The cradle's wheels and axle retainers are heavily corroded. This is a major concern because the wheels are frozen, and the cradle is not able to function as designed without replacement of the necessary mechanical components.

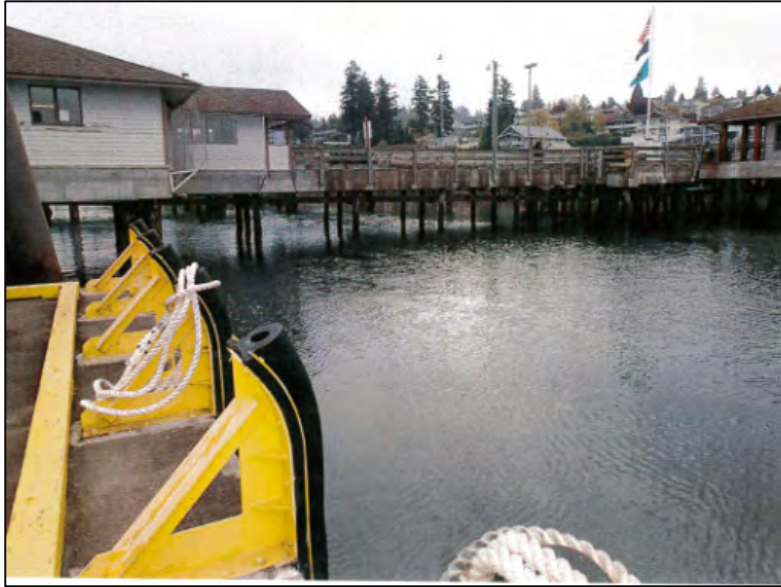
Photo 1B: Steilacoom building trestle

Some of the significant deficiencies include deterioration/marine borer entry of piles supporting the fixed pier, cracking of the welds on the cover plate between the pier and upland entrance, deterioration/splitting of timber curbing, and loose wraps around dolphin piles.

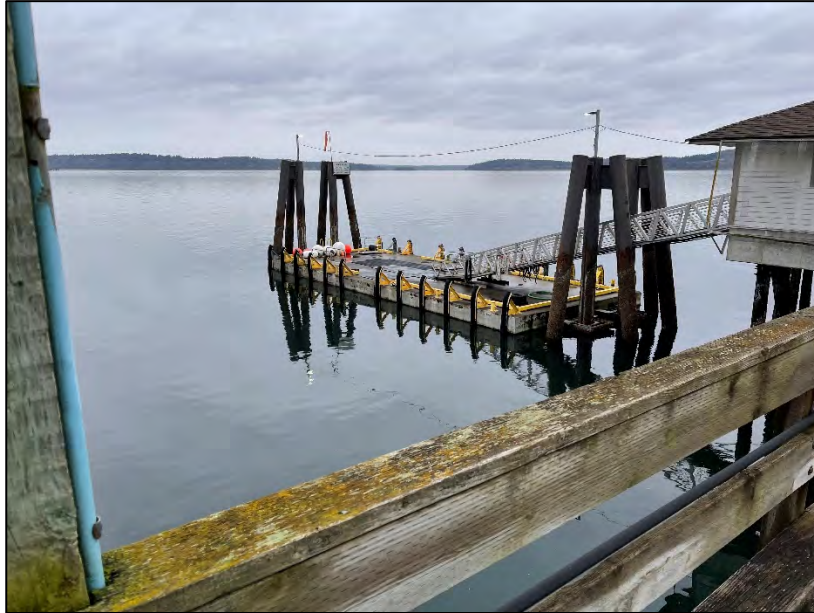
Photo 2: Steilacoom mooring float

Some of the significant deficiencies include water intrusion into the float, broken fenders and fender anchorage, damage from the pile guides on the float due to jamming between the battered piles during extreme high tides, deteriorated piles, the shackle hangers at the upland end of the gangway are deteriorated, and damage to utilities on the bottom of the gangway due to extreme high tides.

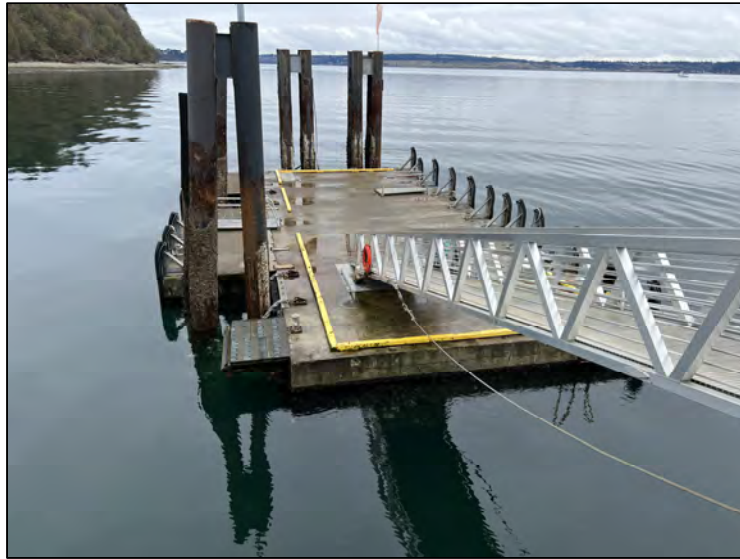
Photo 3: Island Mooring Float

Some of the significant deficiencies include damaged concrete on the floats, deteriorated piles, damaged rub strips on the piles, broken fenders and fender anchorage, damaged connections between floats, deterioration of the hinge at the upland end of the gangway, and deteriorated emergency ladder.

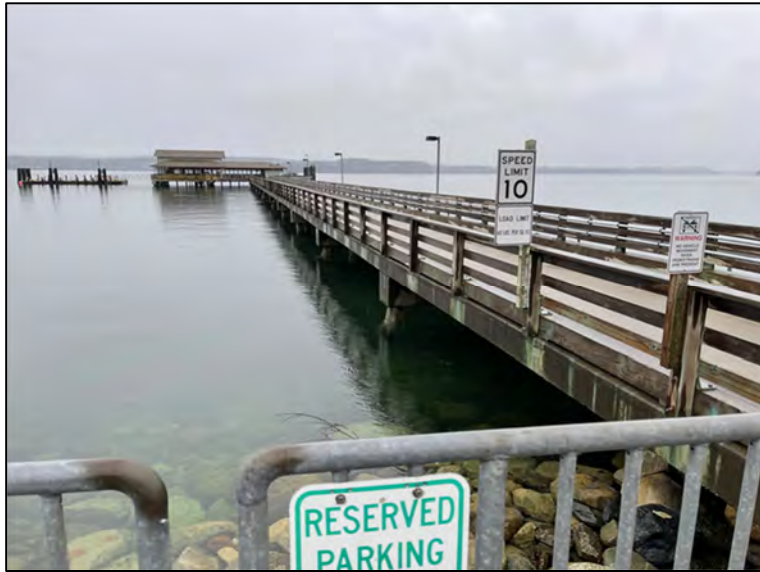
Photo 4: Island Trestle

Some of the significant deficiencies include delamination of the concrete deck on the trestle, broken piles, deteriorating dolphin piles, timber handrail splitting, and deteriorated emergency ladders. The boat lift is not included in the cost estimate or the WSDOT condition assessment.

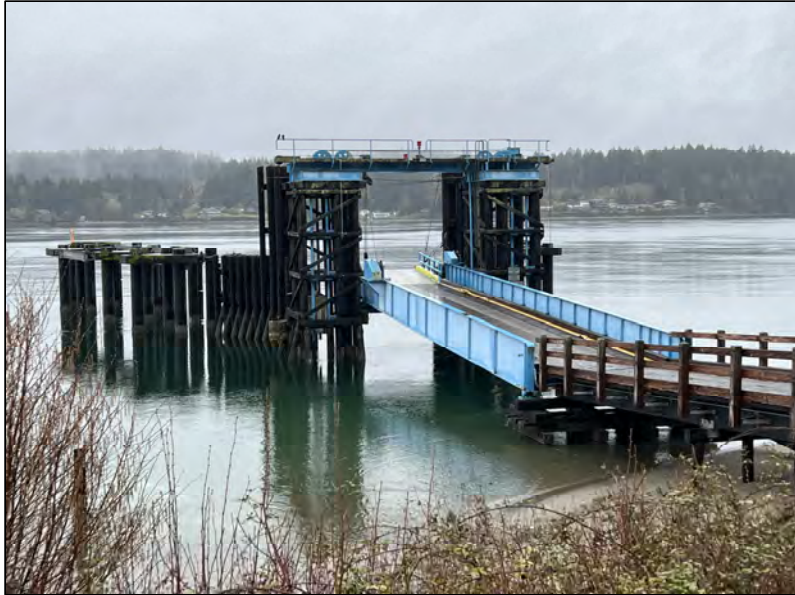
Photo 5: Barge Dock

Some of the significant deficiencies include soft timber decking at the upland end of the trestle, worn deck boards, loose deck bolts, corroded brackets, deterioration at the top of the wing wall piles, deterioration on lower wingwalls, and missing and worn hardware at the waterside end of the apron.

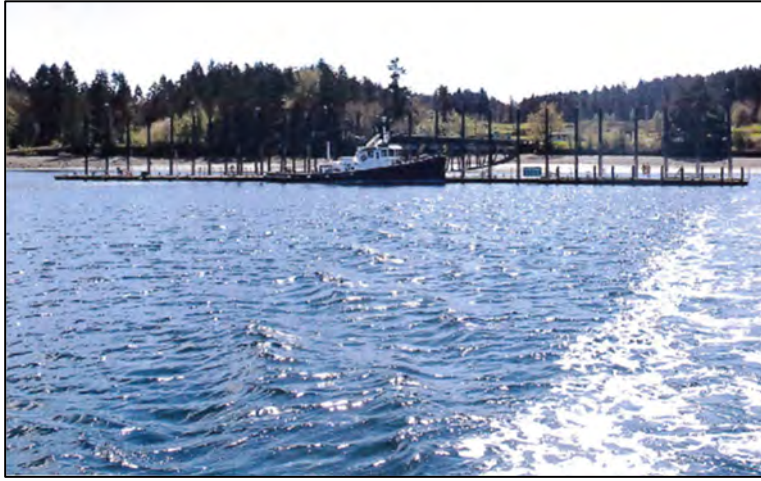
Photo 6: Still Harbor Dock

The Still Harbor Dock is used as the backup ferry landing as well as the primary dock for the emergency vessel and other vessels and barges that are out of service. The dock consists of concrete floats arranged in a T which are held in place by steel guide piles. The floats are accessed by a hinged aluminum gangway supported at the end of a concrete trestle. The trestle is supported by concrete piles. The only issue known at this time is that the steel guide piles have deteriorated.

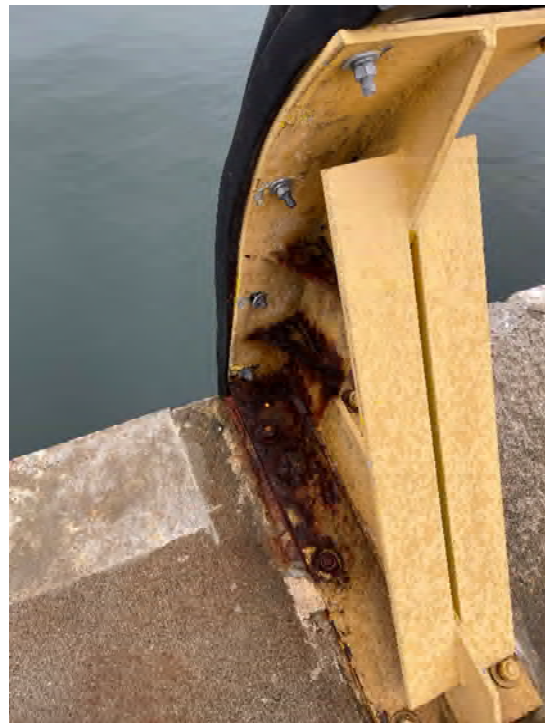
Photo 24: Fender with surface corrosion

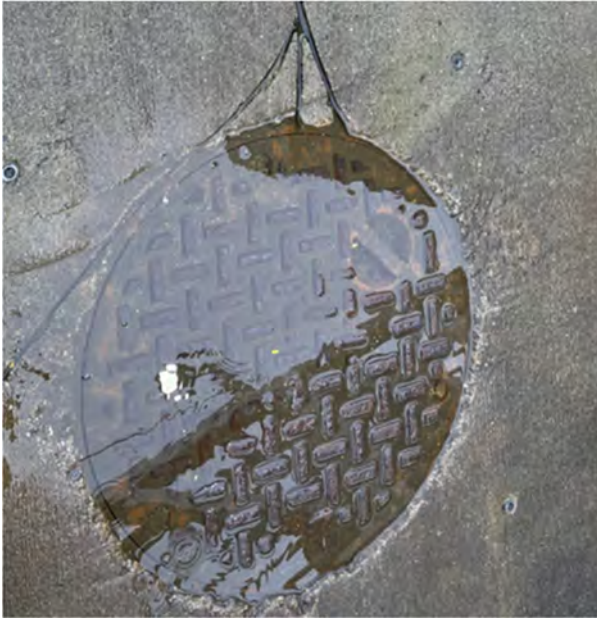
Photo 25: Cell hatch

Steilacoom Mooring Float								
Item	Location	Defect	Condition Rating	Details	Repair	Priority Rating	Photo	Total Rating
Fenders	Perimeter of floating dock	Delamination and surface corrosion	C2	Delamination, surface corrosion, bent fender foot plates, and bent bolts	Sandblast and recoat, replace bolts	P1	24	3
Cells	Floating dock	Leaking	C2	Regular pumping is required to reduce the volume of water inside the cells	Locate source of the leak and repair	P3	25	5
Loading Ramp Handrail	Base of loading ramp	Sharp exposed edge	C2	There is no cap on the end of the handrail, cutting hazard for passengers	Cap the edge of the handrail	P3	21	5
Loading Ramp Keeper Bolt	Top of loading ramp	Bolt head broken off	C2	The South side bolt head is broken off	Replace the bolt	P3	N/A	5
Hatch Bolts	Top of hatches	Hatch bolts missing	C1	Hatch bolts missing on all hatches	Install new bolts	P1	25	2

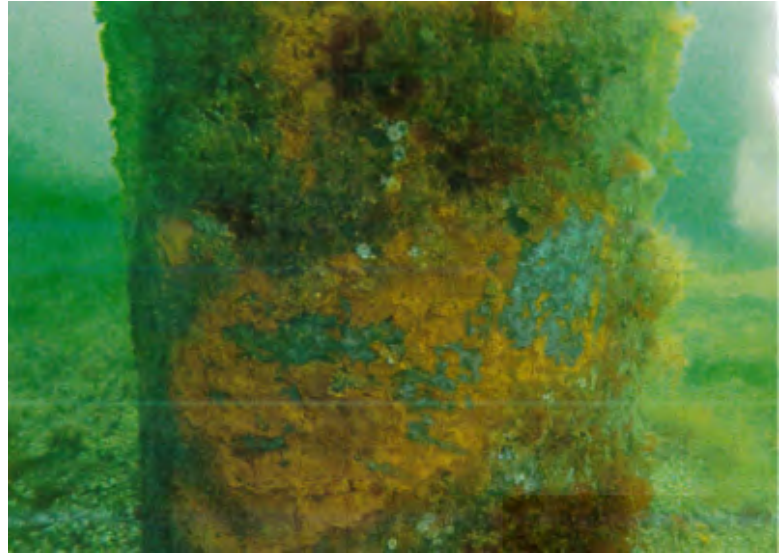
SP4, Pile C	SP4	Delamination and surface corrosion	C2	25% coating loss, UT thickness reading 0.390"/0.250"	Sandblast and recoat	P2	28	4
----------------	-----	--	----	--	----------------------------	----	----	---

Photo 34: SP4 coating failure and surface corrosion

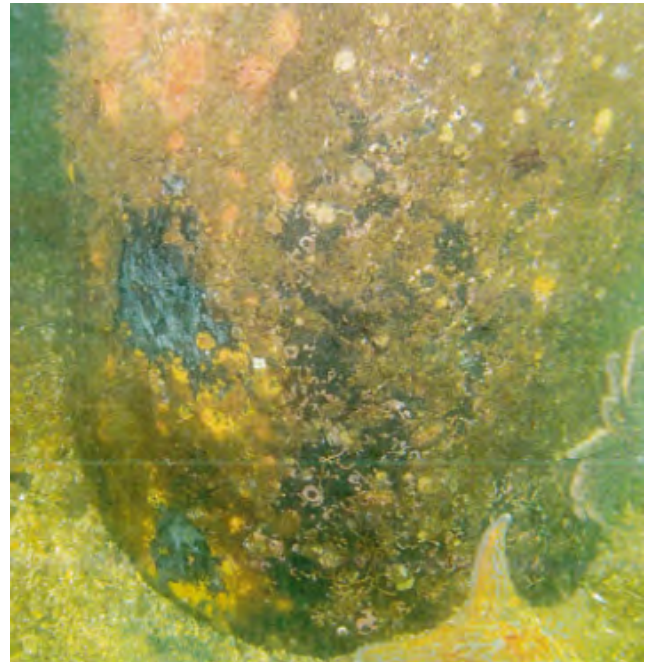
Photo 42: SP4-B typical coating failure and surface corrosion

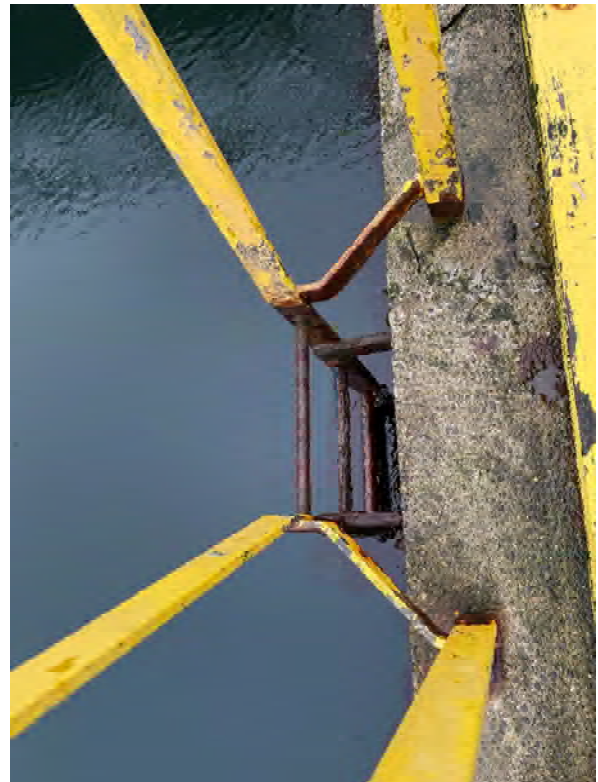
Photo 46: Ladder at Southwestern  
corner of float

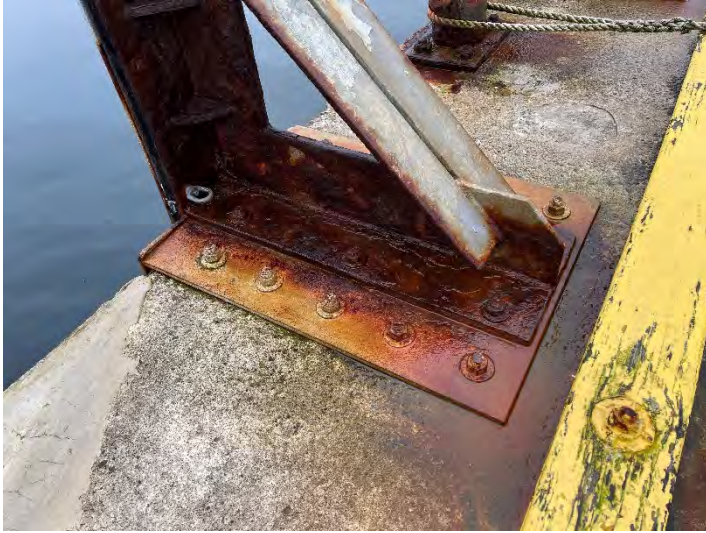
Photo 47: Fender with surface corrosion

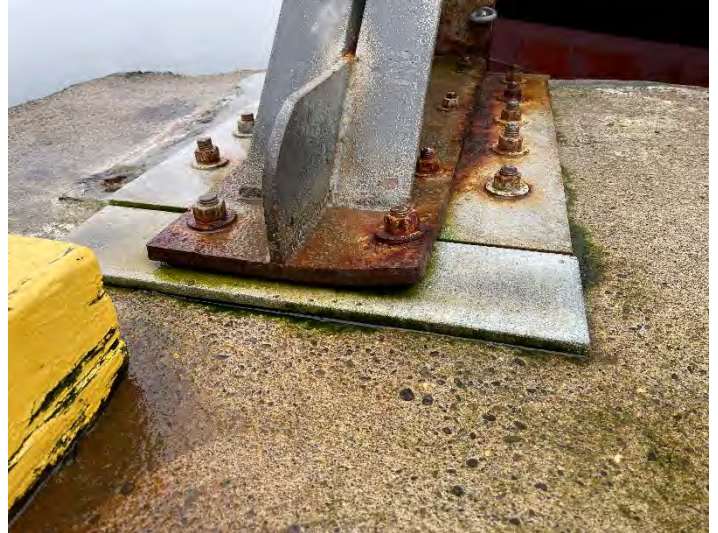
Photo 48: Bent fender with surface corrosion

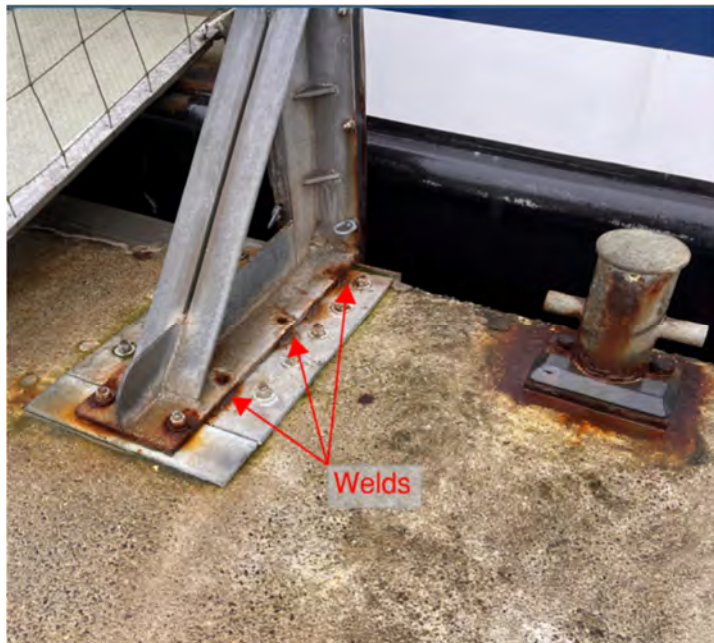
Photo 49: Missing fasteners on fender, secured by welds

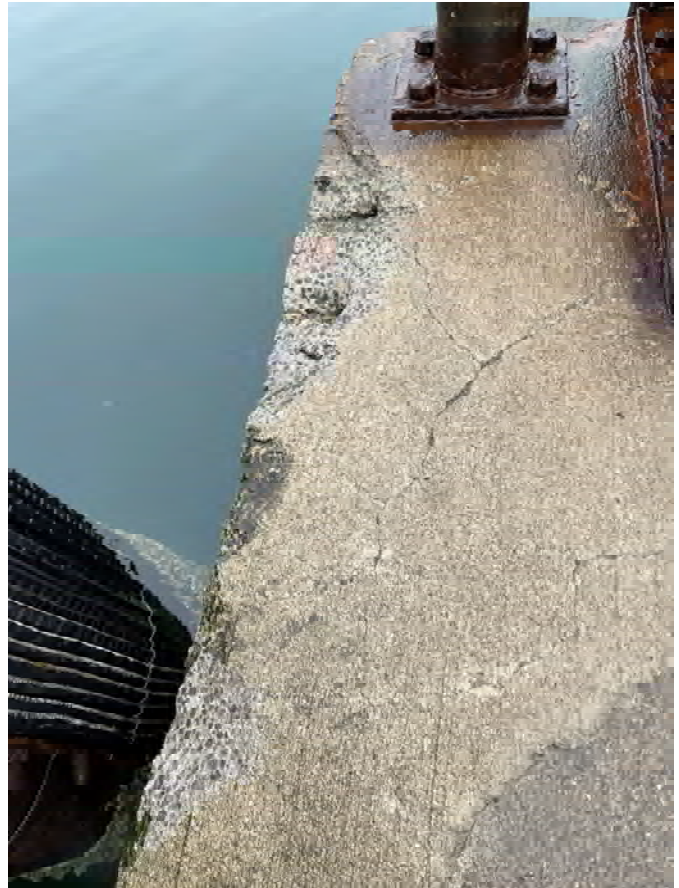
Photo 52: Concrete spalling along edge of float

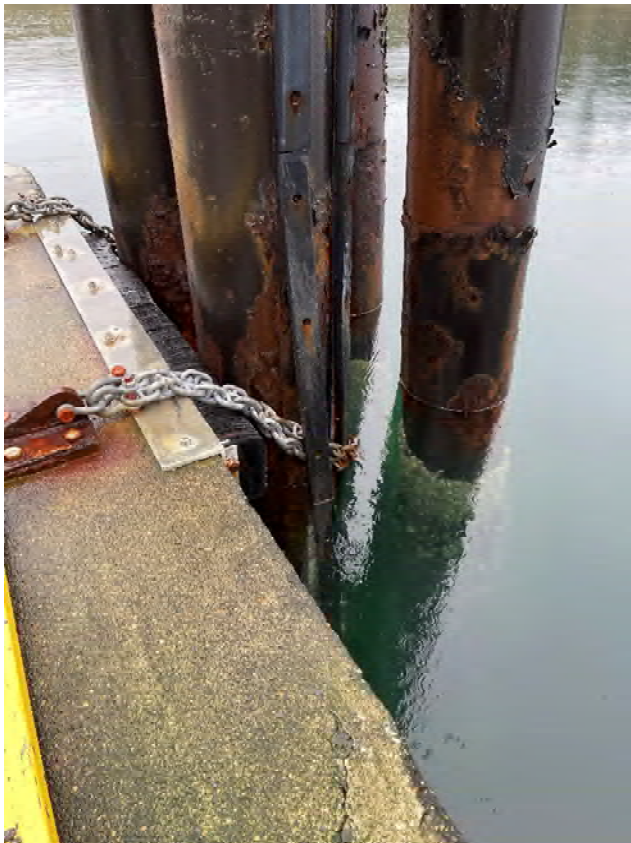
Photo 53: Chain rubbing on pile, UHMW rub rails failing

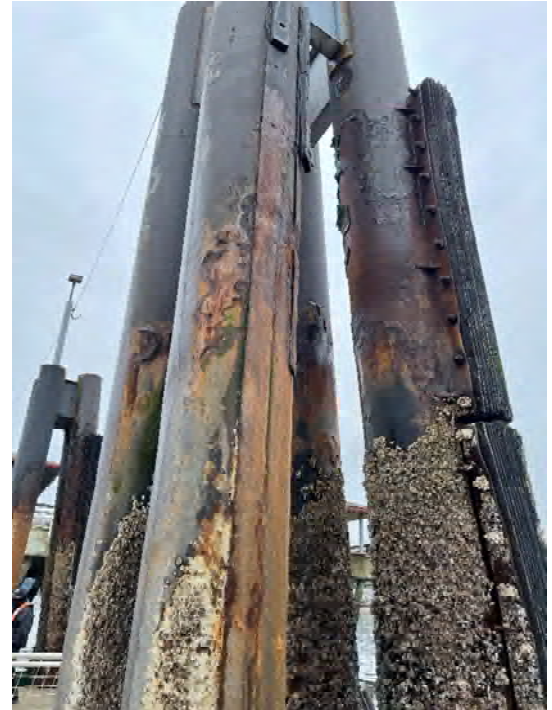
SP2, Pile C	SP2	Delamination , pitting, and surface corrosion	C2	10% coating loss, surface corrosion, pitting @ 3/8" deep, thickness = 0.480", and heavy marine growth	1. Replace pile with new pile or 2. Insert sleeve w/ new sect.	P2	56	4
SP2, Pile D	SP2	Delamination and surface corrosion	C2	10% coating loss, surface corrosion, and heavy marine growth	1. Replace pile with new pile or 2. Insert sleeve w/ new sect.	P2	56	4
SP3, Pile A	SP3	Delamination , surface corrosion, and pitting	C2	10% coating loss, surface corrosion, pitting @ 0.25" deep, thickness = 0.225" @ MDL +18, heavy marine growth	1. Replace pile with new pile or 2. Insert sleeve w/ new sect.	P2	57	4
SP3, Pile B	SP3	Delamination , surface corrosion, and section loss	C3	15% coating loss, 3" dia. hole at center of 2' (h) x 6" (w) section of heavy surface corrosion, thickness = 0.490"	1. Replace pile with new pile or 2. Insert sleeve w/ new sect.	P3	57	6

Photo 56: SP2 coating failure, surface corrosion, and heavy marine growth

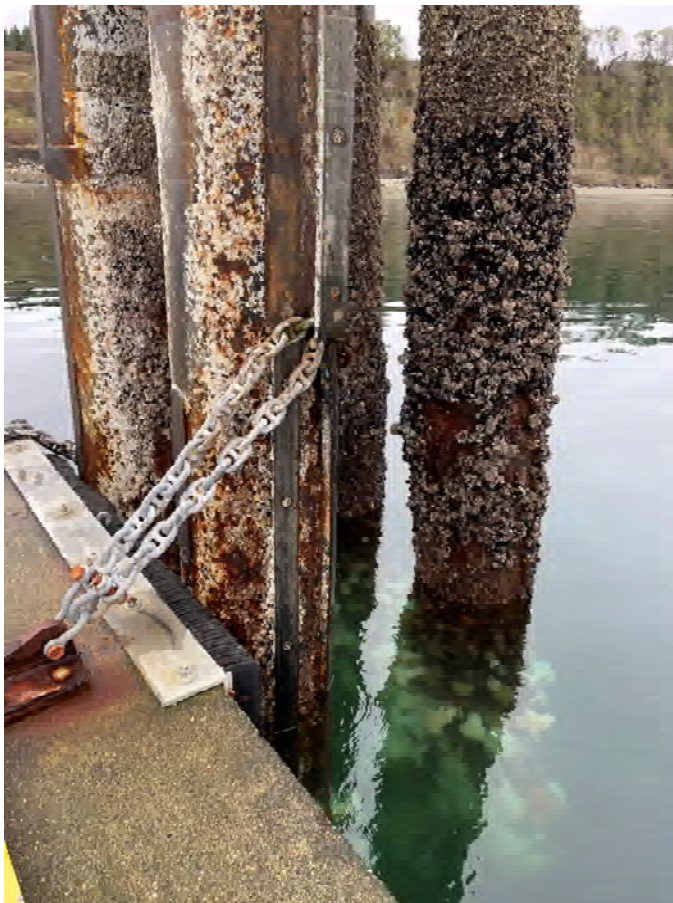
SP3, Pile C	SP3	Delamination , surface corrosion, and section loss	C3	10% coating loss, surface corrosion, 3" dia. hole, 1" (h) x 3" (w) hole, 1" dia. hole	1. Replace pile with new pile or	P3	57	6

Photo 57: SP3 chain catching on UHMW rub rails

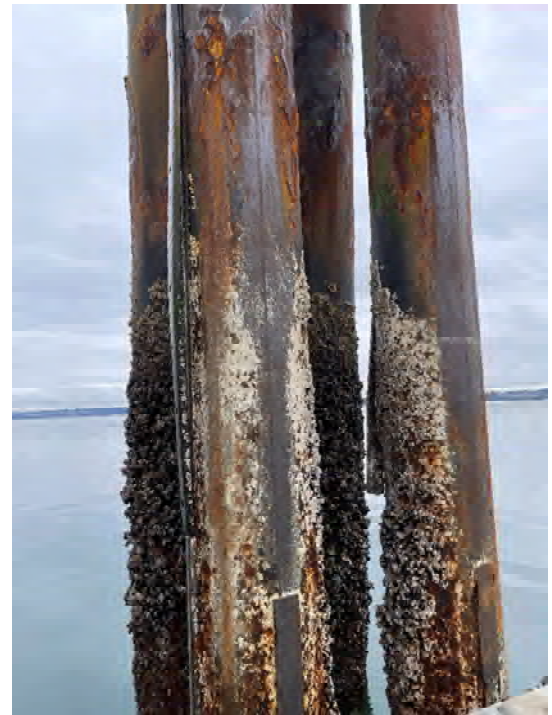
Photo 58: SP4 coating failure, surface corrosion, and heavy marine growth

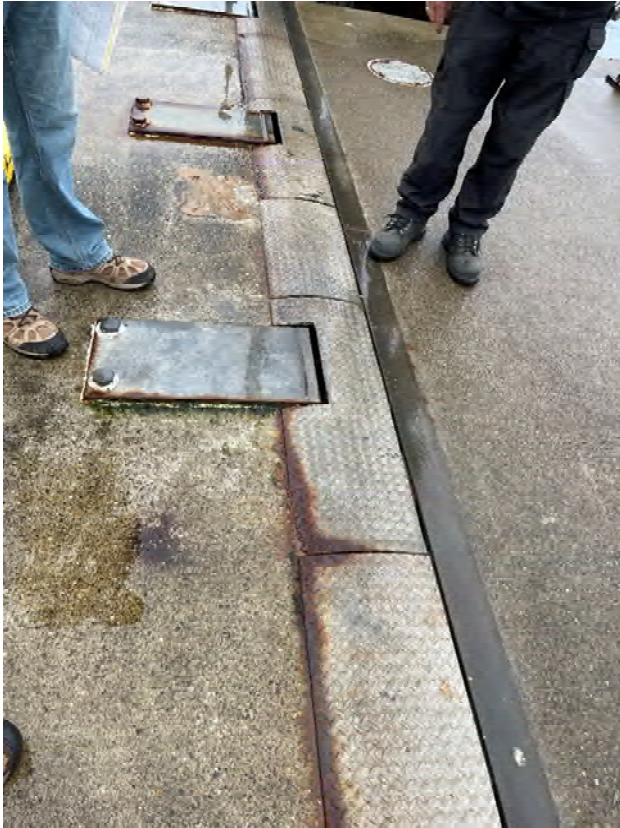
Cover Plates	Between Flanker Pontoons and Float	Surface corrosion	C1	The cover plates and pin assembly are corroded	Disassemble, sandblast and recoat or replace	P2	59, 60	3
-----------------	---	----------------------	----	---	---	----	--------	---

Photo 59: Surface corrosion on cover plate

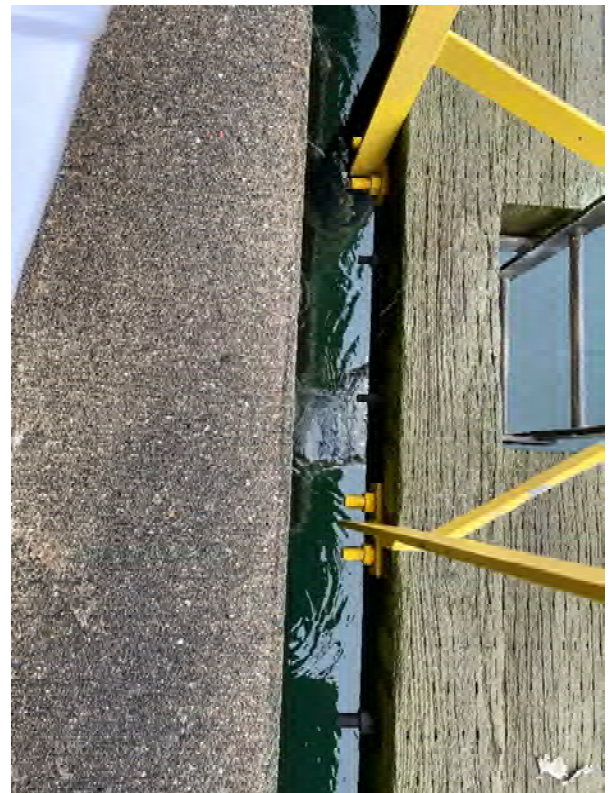
Photo 62: Pile F10 broken, South ladder is unsecured

**Minimum Repairs** – Repair trestle piles F10, D1, D2, D3, and D4. Patch concrete spalling, replace ladders, sandblast and coat mooring float piles, replace UHMW, sandblast and coat fenders, replace balcony loading platform, repair tie back cable attachment, and replace pile collar chain securement.

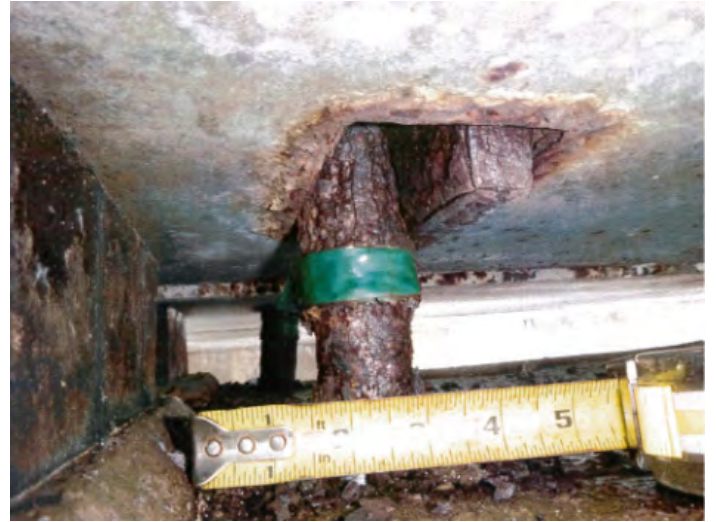
Photo 64: Deck panel 7B hold down bolt is necked down to 1.1875" at pier 7

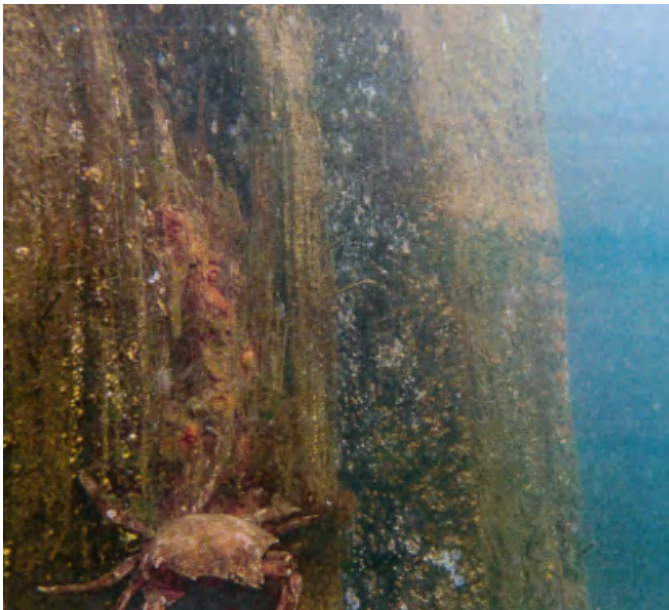
Photo 65: Dolphin D1, mechanical damage, and MBE holes

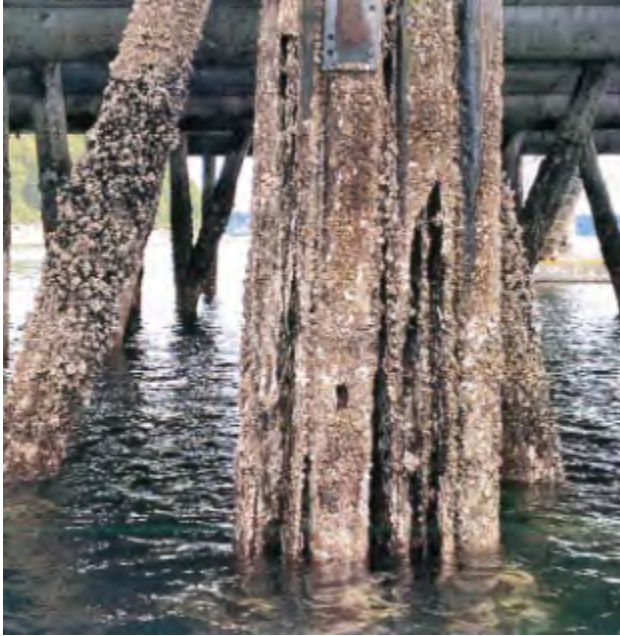
Photo 67: Dolphin D3 with abrasion damage and internal decay

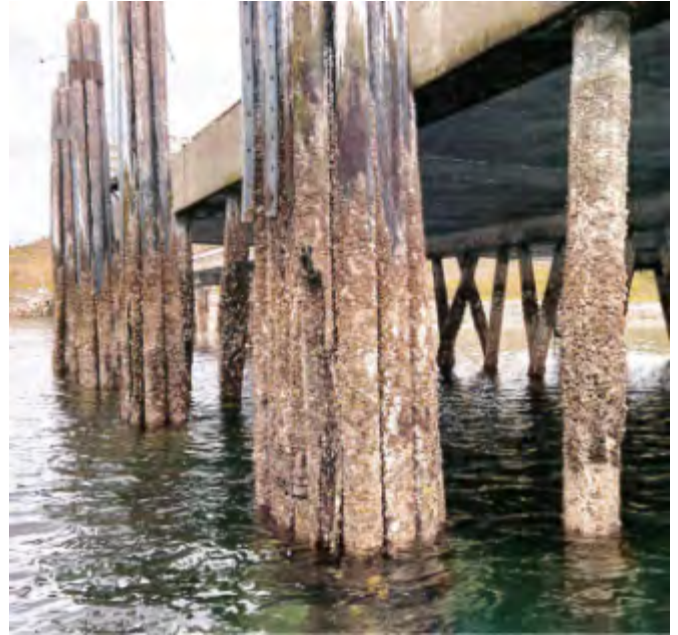
Photo 68: Dolphin D4 with abrasion damage and internal decay

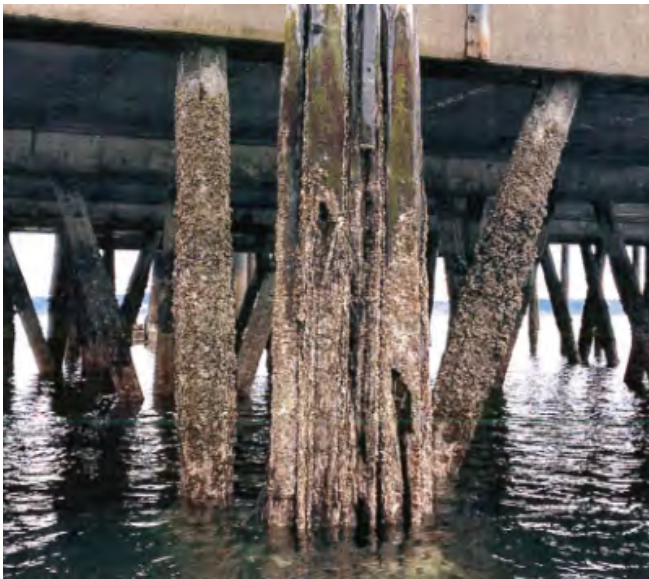
Photo 69: Dolphin D1 with abrasion damage and internal decay

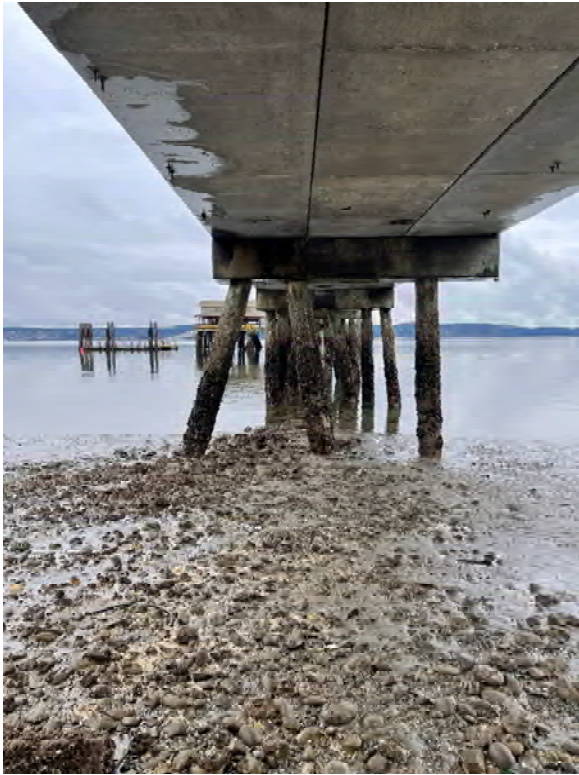
Photo 71: Concrete spalling below trestle

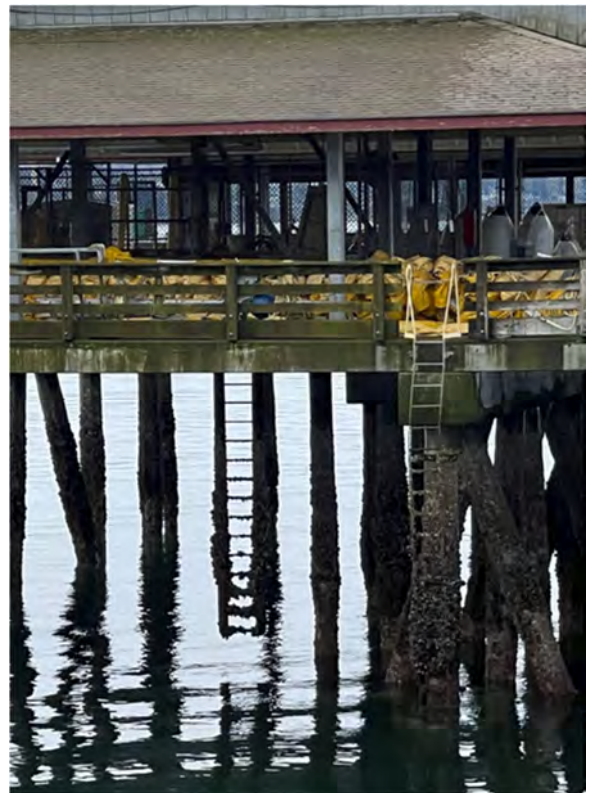
Photo 74: Northern and boat lift access ladders are in very poor condition

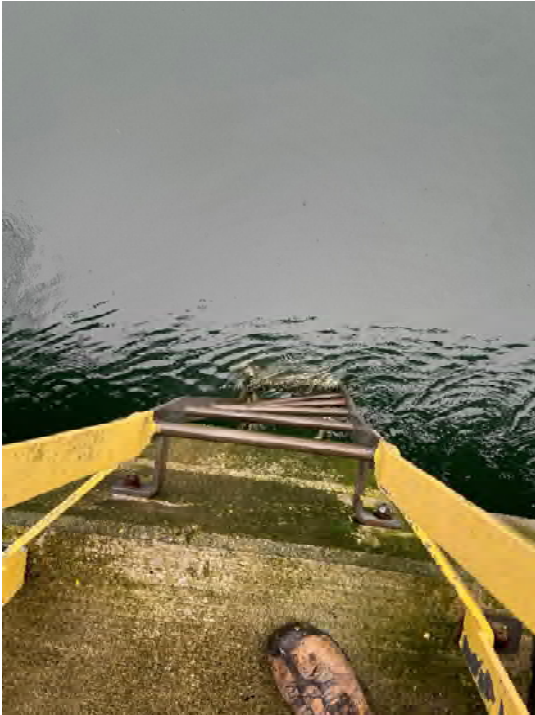
Photo 75: Bent southern ladder

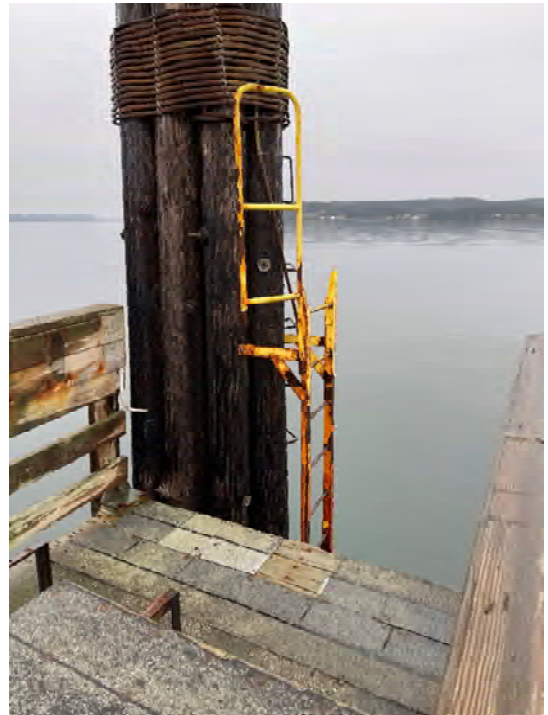
Photo 76: Dolphin ladder broken

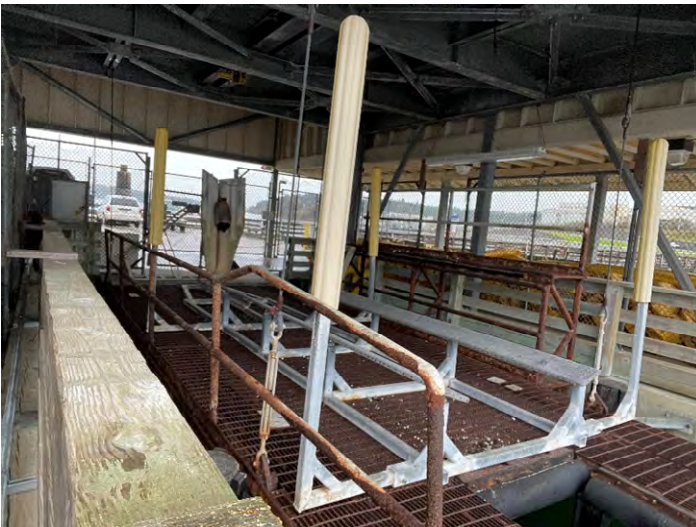
Photo 77: Boat lift

Boat Lift Cover	Eastern section	White rust	C1	The galvanized structural framing members have white rust	Recoat the members	P2	77	3
Fascia on Roof	Eastern section cover roof assembly	Wood rot	C2	The Fascia boards (edge of roof), have significant rot damage along the western side of the cover	Replace the members	P3	79	5

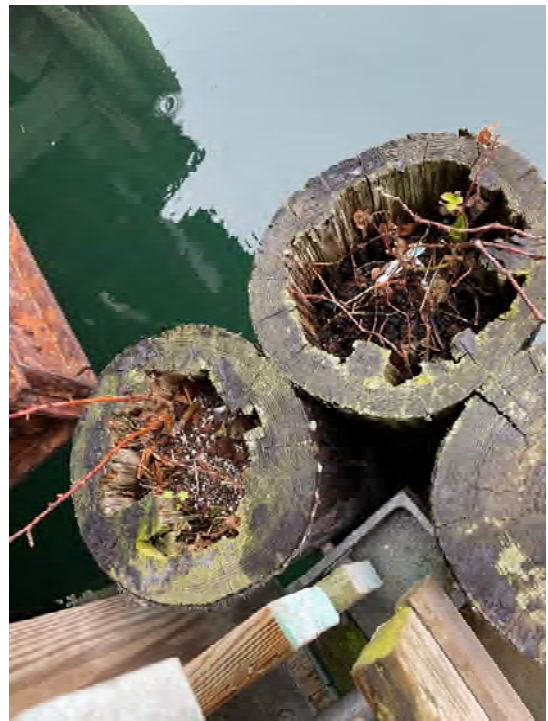
Photo 78: Piles F2A,B,C rot at top of piles

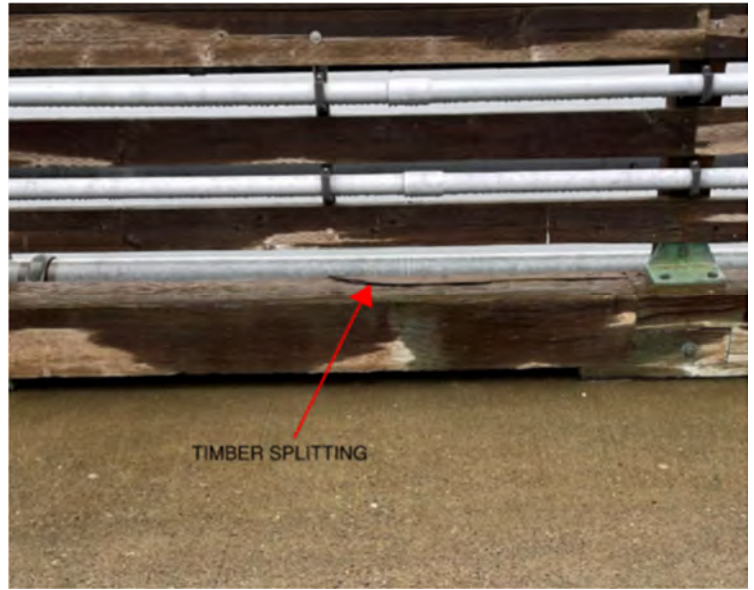
Photo 80: Timber curbing splitting on trestle

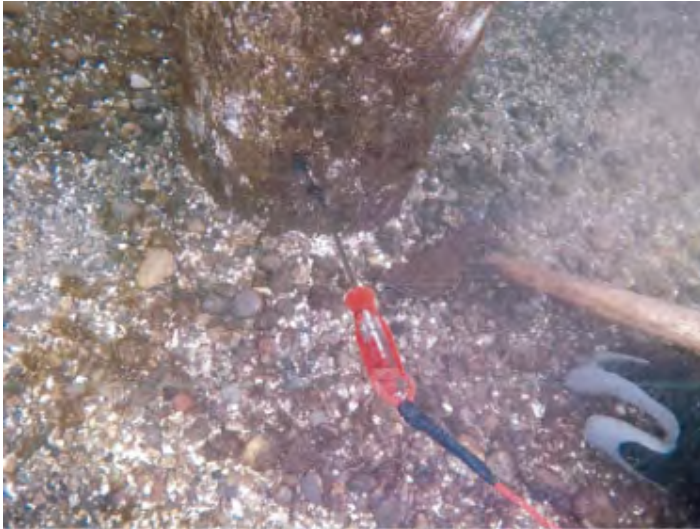
Photo 81: Pile 2C Marine borer entry

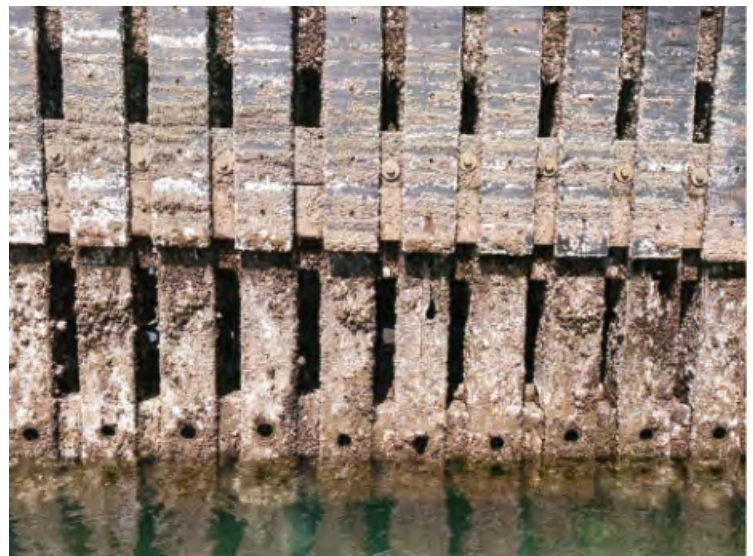
Photo 88: Right wingwall with rot below UHMW sheets

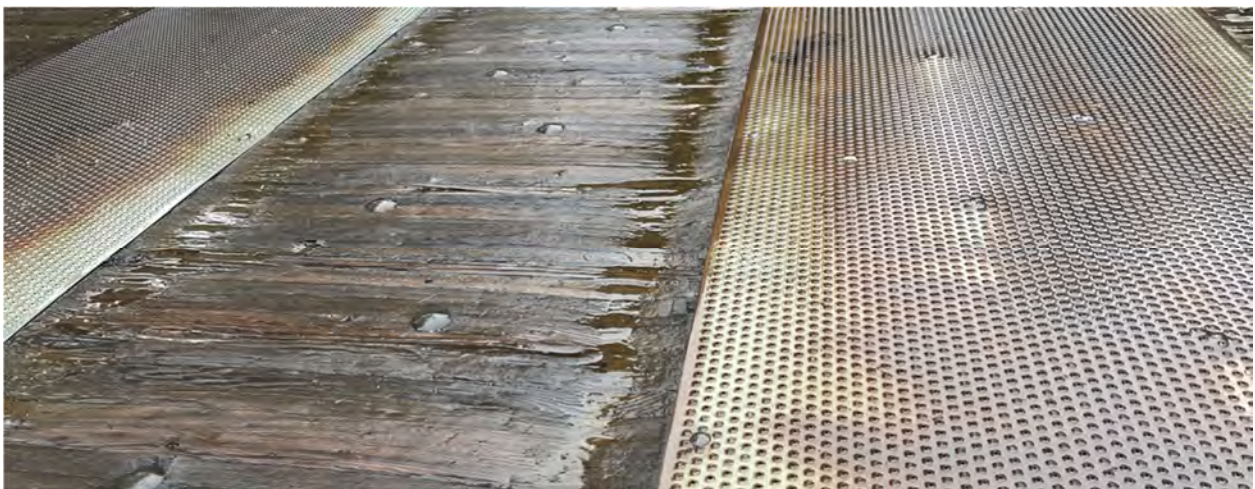
Photo 103: Timber deck is rutting

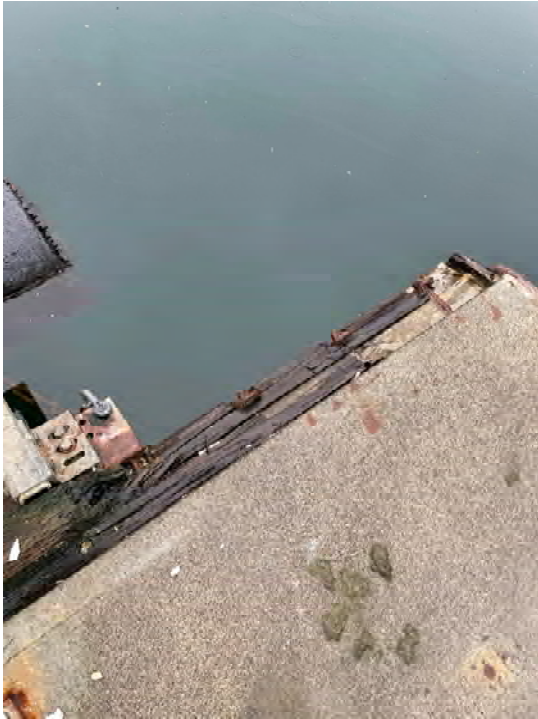
Photo 108: Near Spud Pile A, timber waler is broken and corroding fasteners

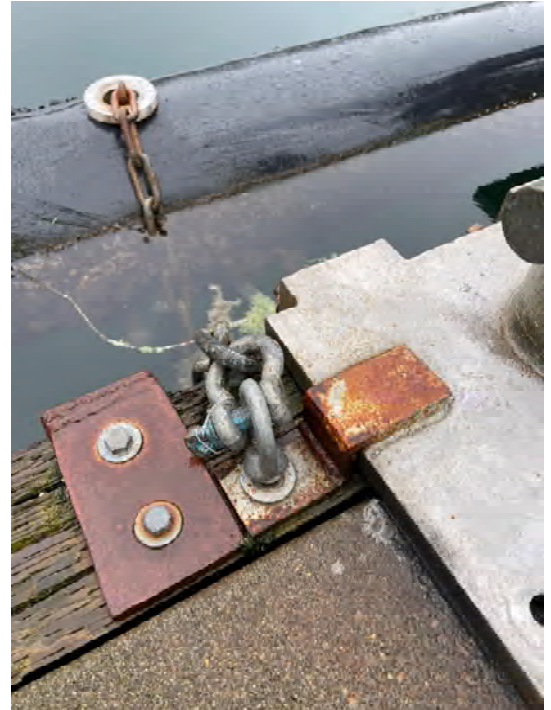
Photo 109: Eyebolts securing log fenders are bent

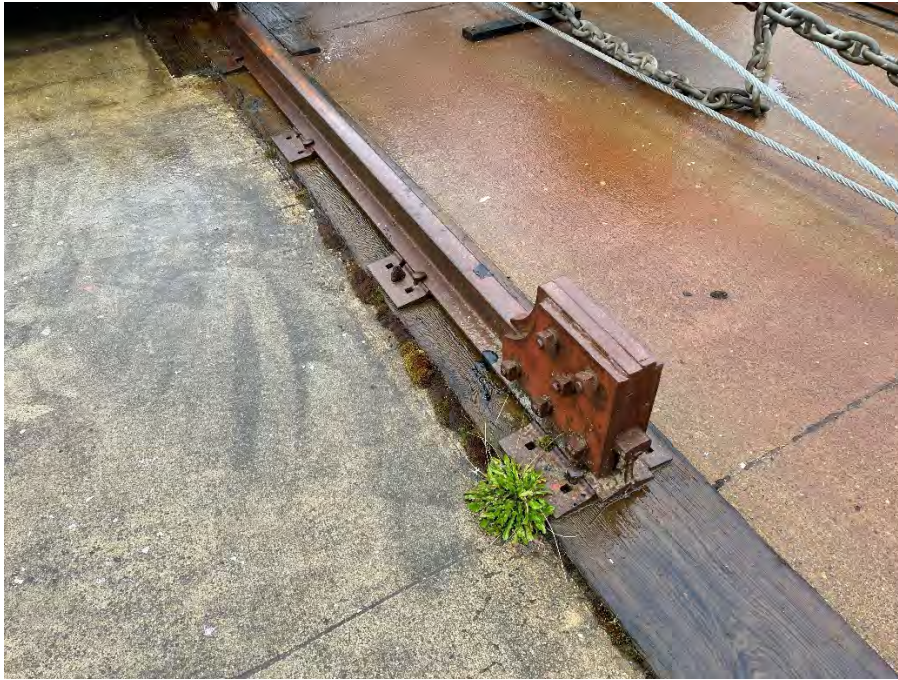
[Photo 126](#): Surface corrosion on rail North of bulkhead

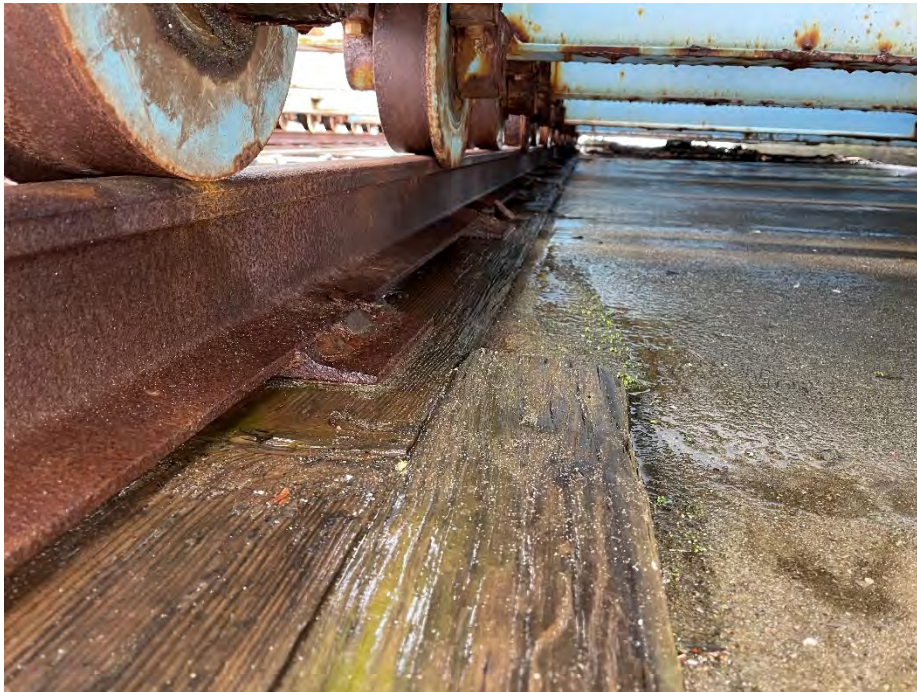
[Photo 127](#): Rail pitting and surface corrosion North of bulkhead

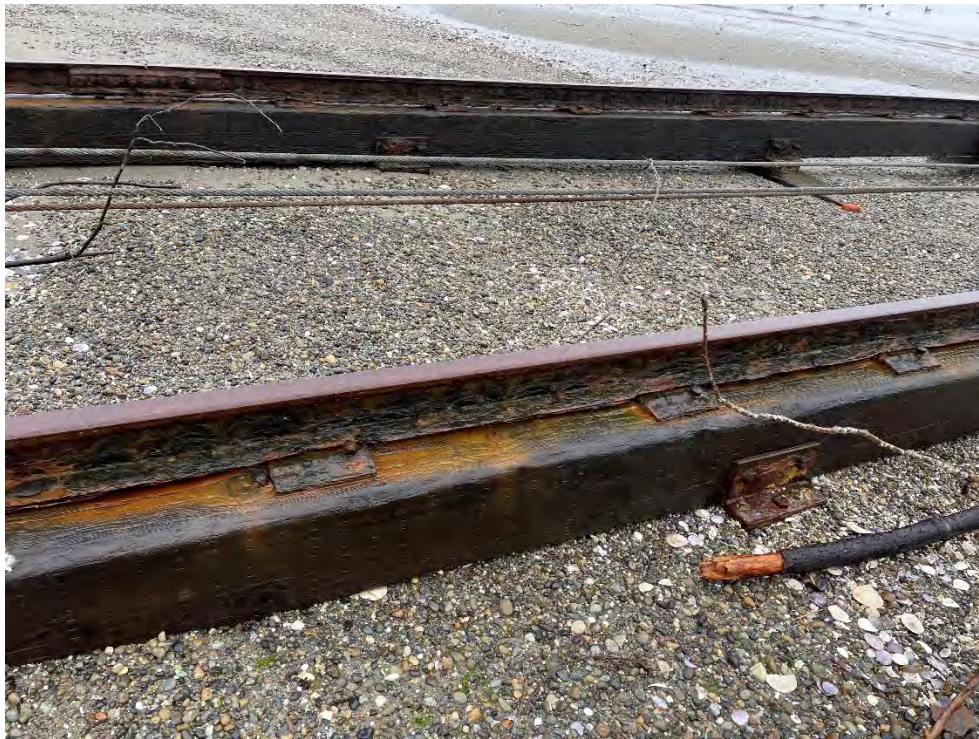
Marine Railway Dry Dock Pile Caps						
Grid Line	Condition Rating	Priority Rating	Condition	Impact on the capacity/serviceability	Photo	Total Rating
1-4	C2	P3	Buried in soil	Not visible for an assessment due to conditions.	130	5
5	C2	P3	Partially buried in soil	Not visible for an assessment due to conditions.	137	5

Photo 137: Heavy surface corrosion on rails and rail clips

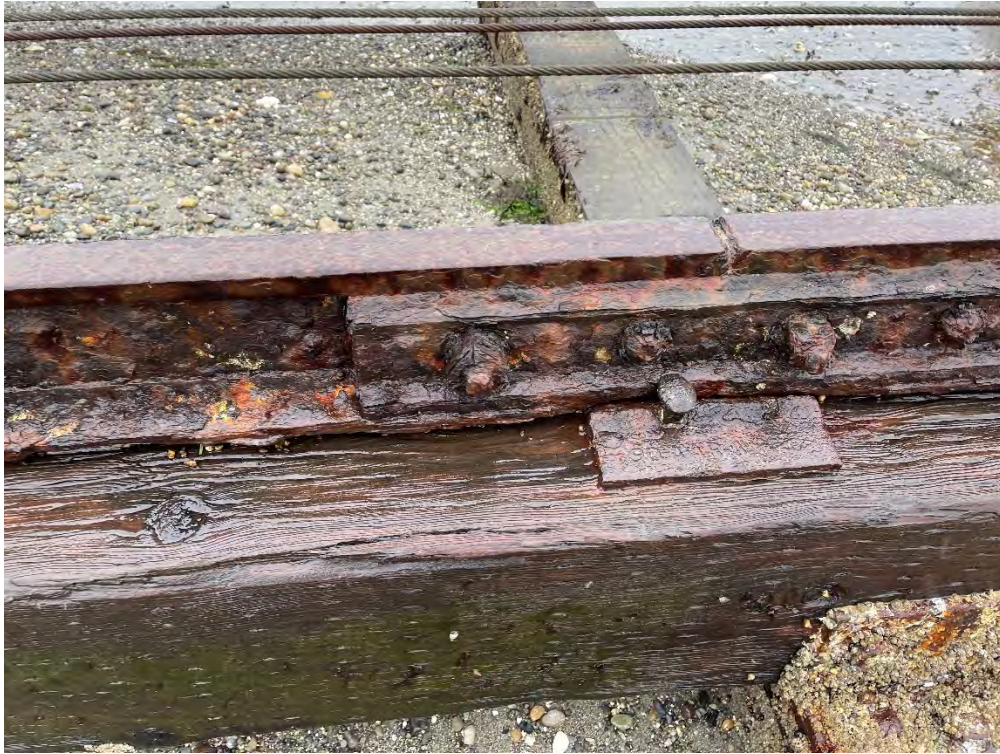
Photo 138: Rail splice plate with heavy surface corrosion
