# McNeil Island Repair and Replacement Options 10182200022

Prepared by KPFF Consulting Engineers  
Draft Repair and Replacement Options  
June 30, 2022

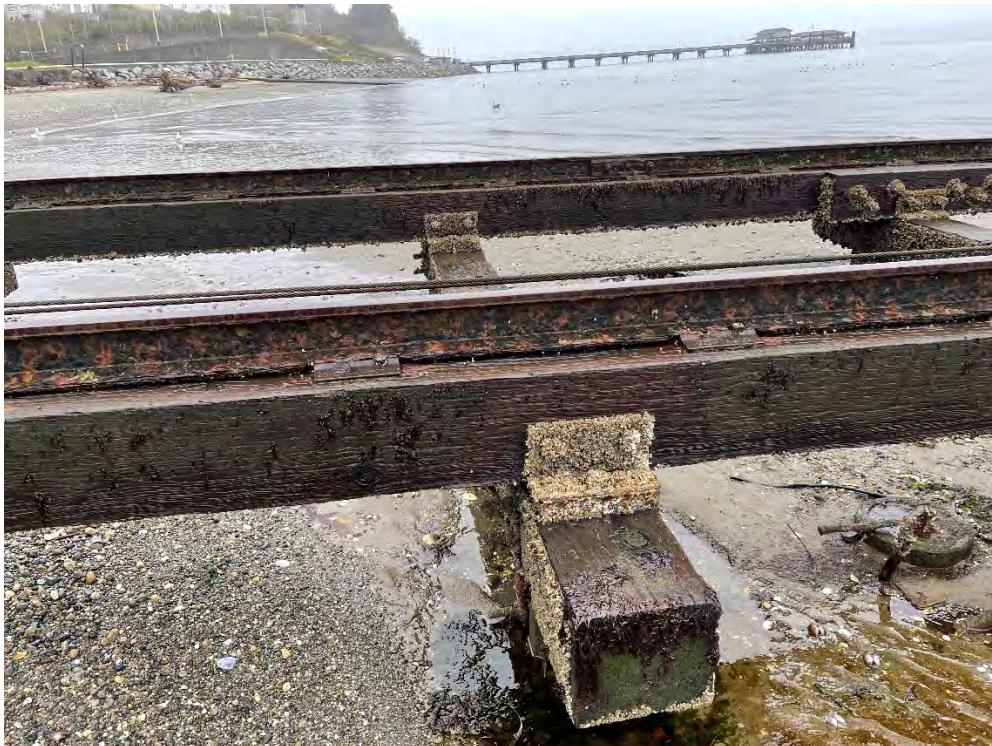
Photo 139: 10<sup>th</sup> pile cap from bulkhead

10	C2	P3	Heavy marine growth, green moss algae, early stages of soft rot, and heavily corroded connection brackets	This member requires action and has a high potential to lose its structural integrity if it gets any worse.	139	5

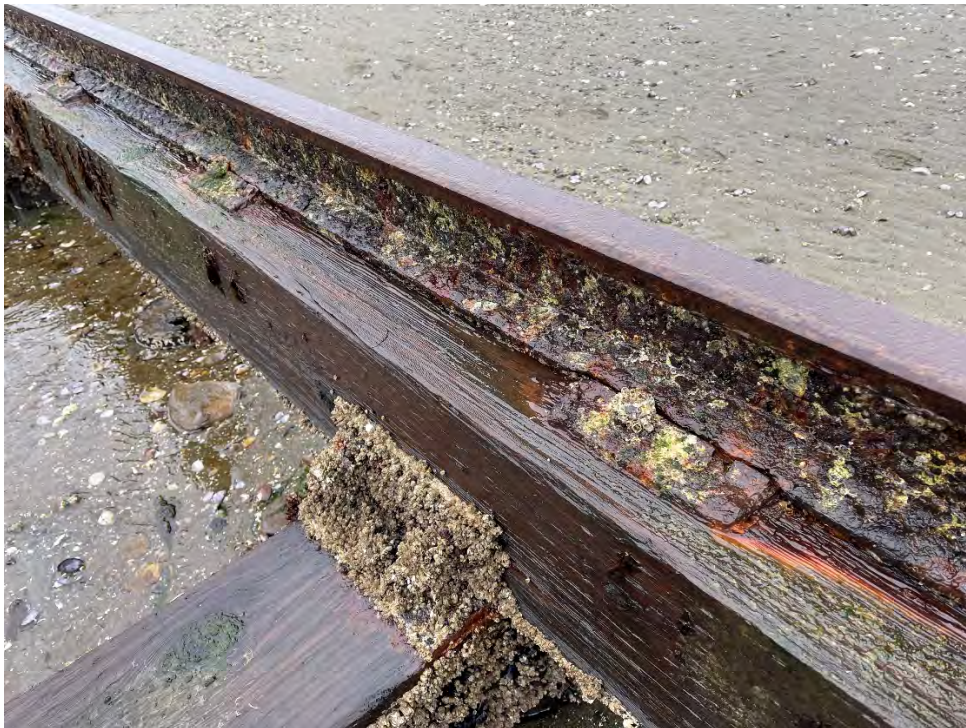
Photo 141: Heavy surface corrosion on rail and pile cap connection bracket

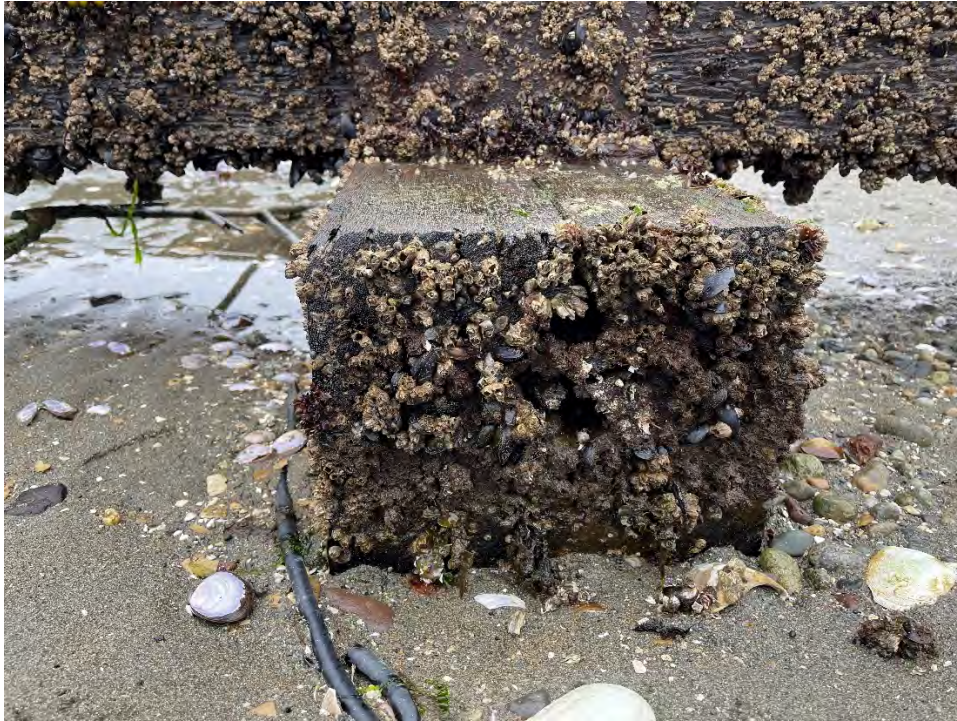
Photo 142: 15<sup>th</sup> pile cap with early stages of hollowing

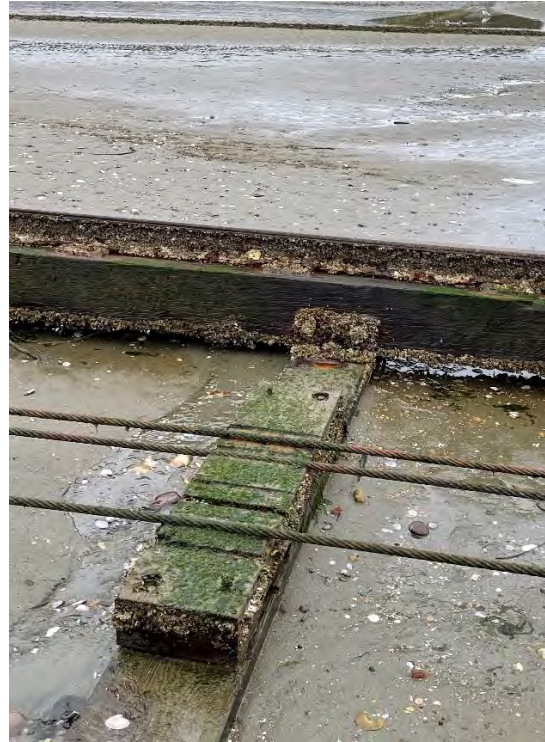
Photo 147: Wire rope wearing on pile cap rub beam

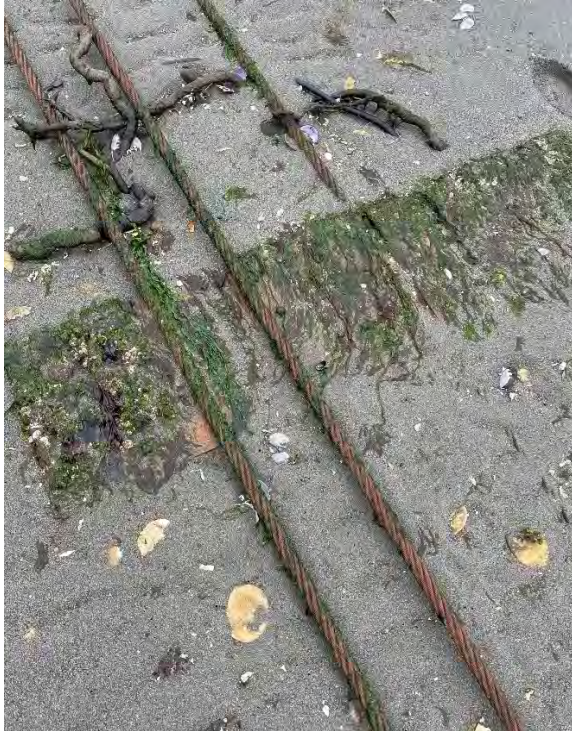
Photo 148: Wire rope wearing on pile cap rub beam

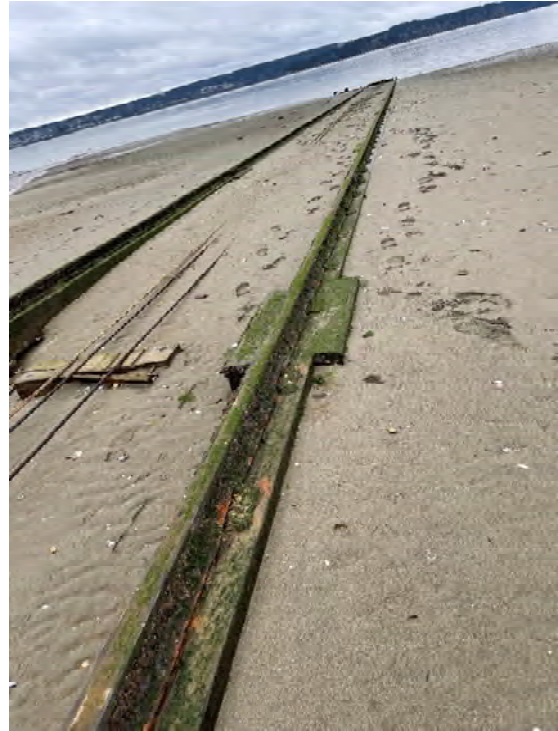
Photo 149: Buried piles and pile caps toward Southern portion of system
