Washington State
Department of Transportation
Bridge Preservation Dive Team

UNDERWATER INSPECTION REPORT FOR
STEILACOOM MOORING FLOAT

BRIDGE NO. DOC-2

STRUCTURE ID 00200437

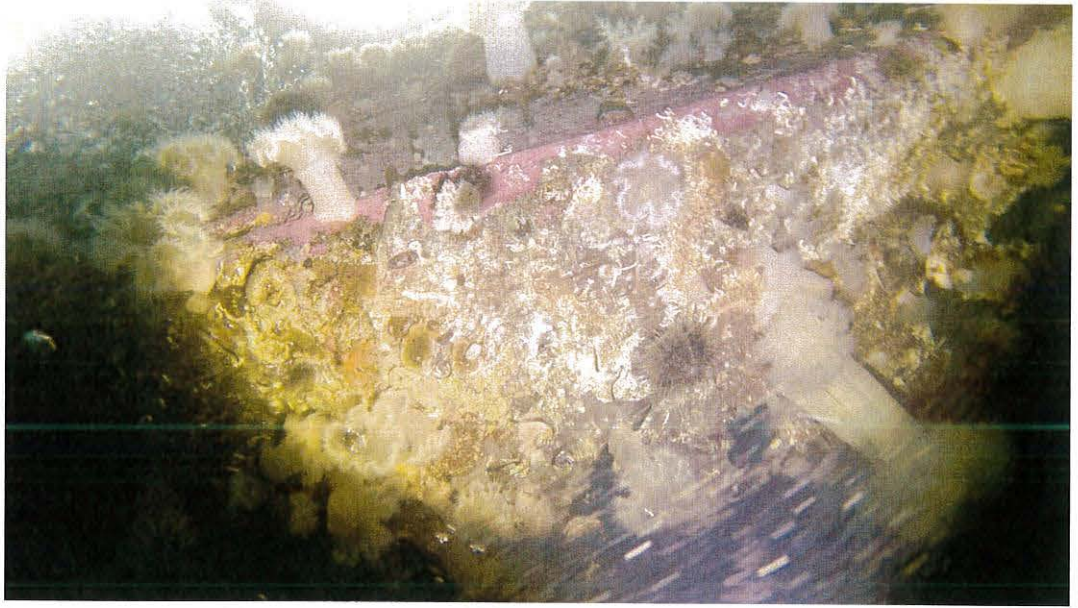
UW-5

The concrete pontoon surface below the waterline is typically about 80% covered in marine growth up to 1-ft. thick. Spot cleaning of growth revealed no defects (photo UW-5).

Heavy marine growth on concrete pontoon.

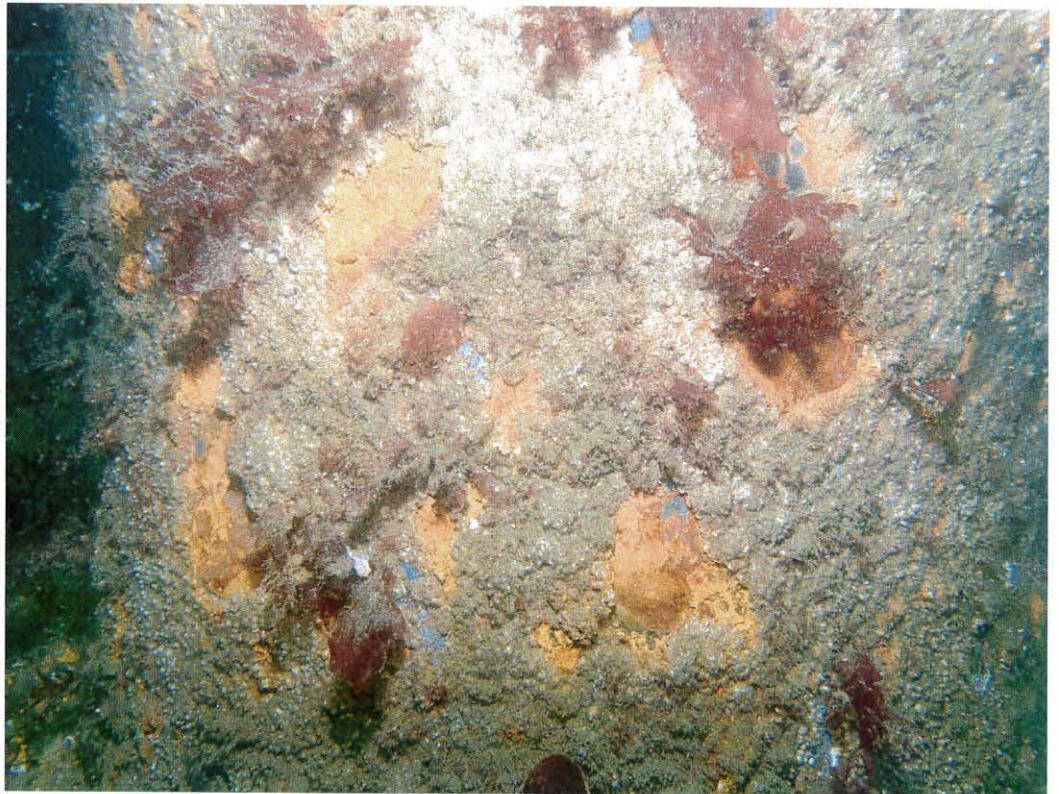
UW-3

Typical coating failure/rust blooming on spud piles (SP1A shown).

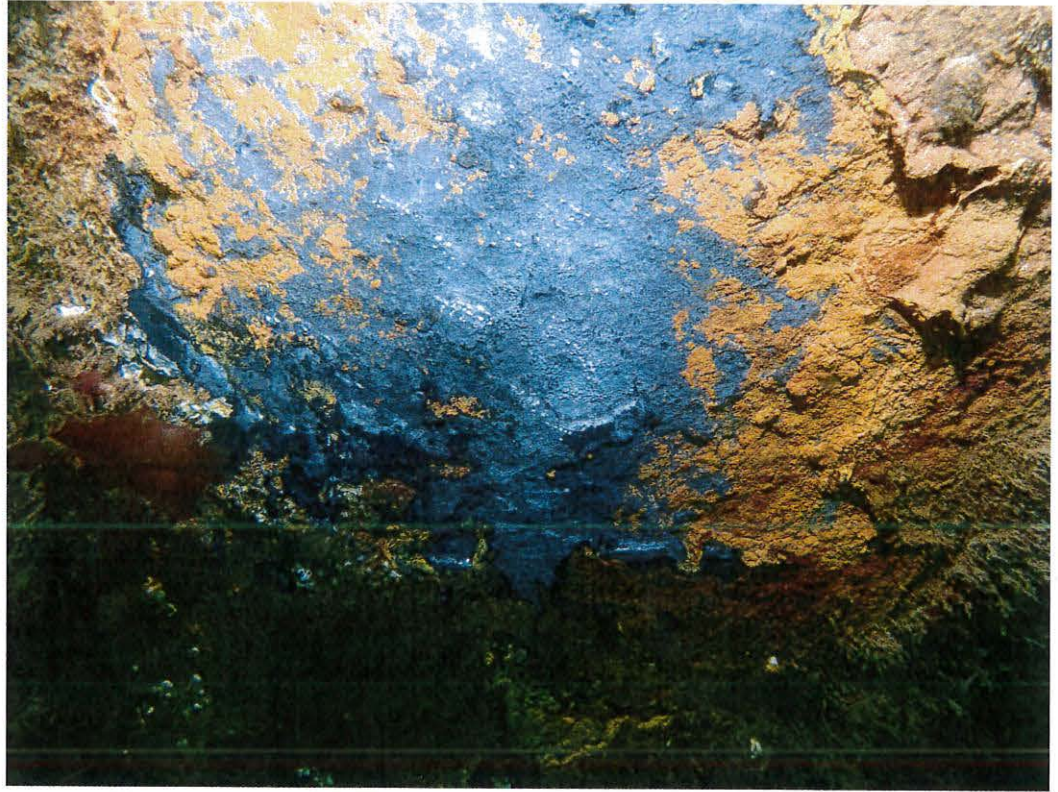
UW-4

More advanced corrosion and section loss on steel spud pile. SP3B thickness reading 0.300"

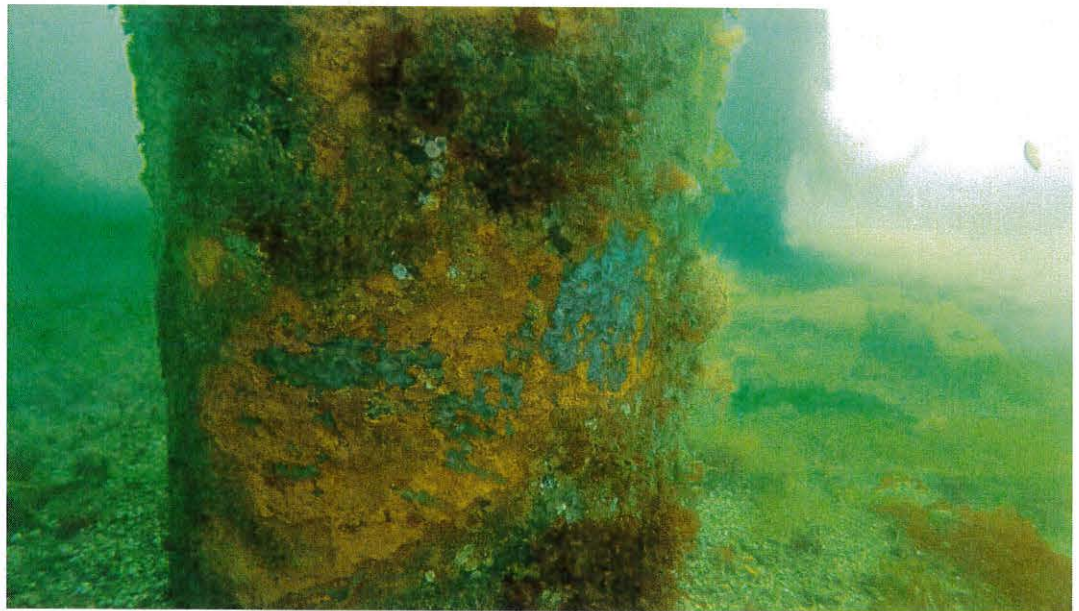
UW-7

SP4 Pile B has 50% coating failure from MDL to MDL +3.

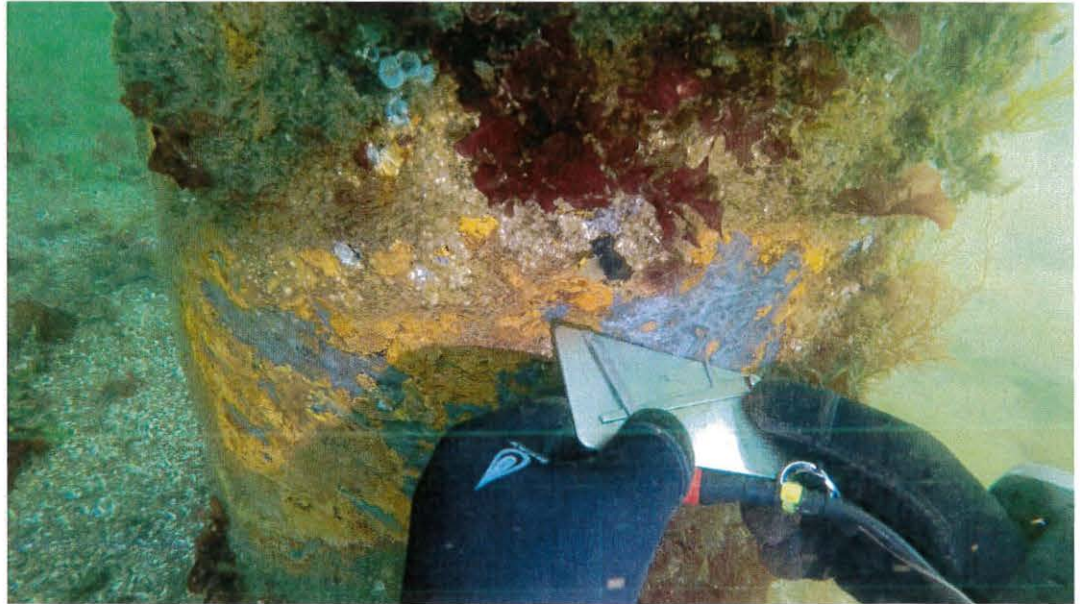
UW-8

SP4 Pile B has deep pitting at MDL +2.

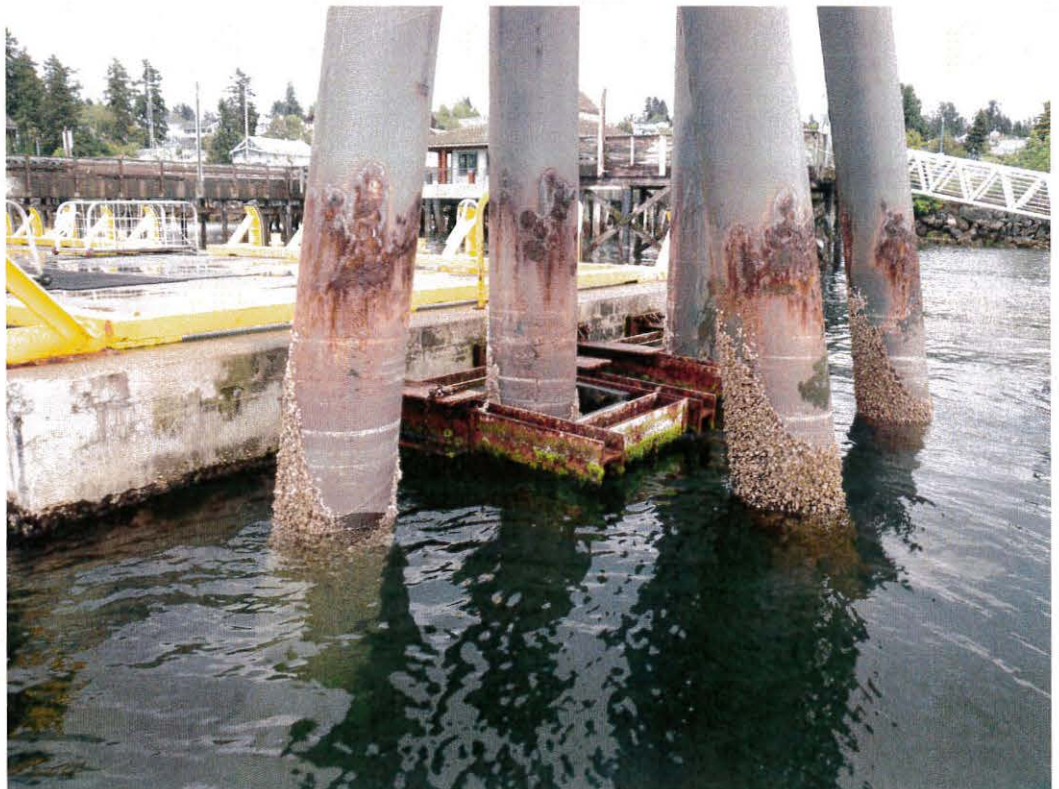
SI-20

Steel Spud piles have lost protective coat in the intertidal zone.

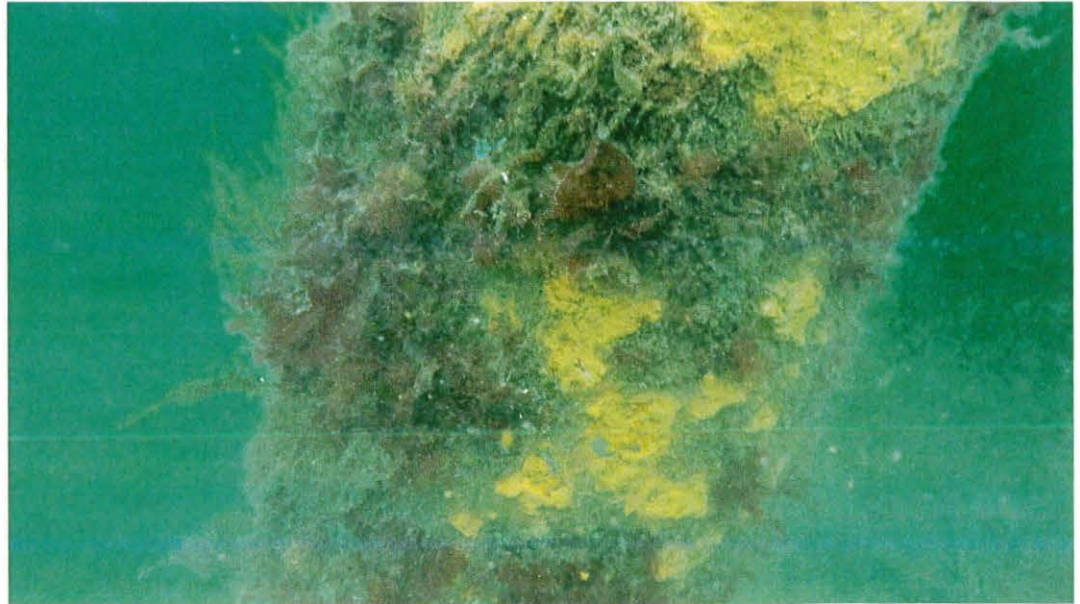
UW-6

Typical coating failure and corrosion
occurring on spud piling underwater
(approx. 50% failure shown).

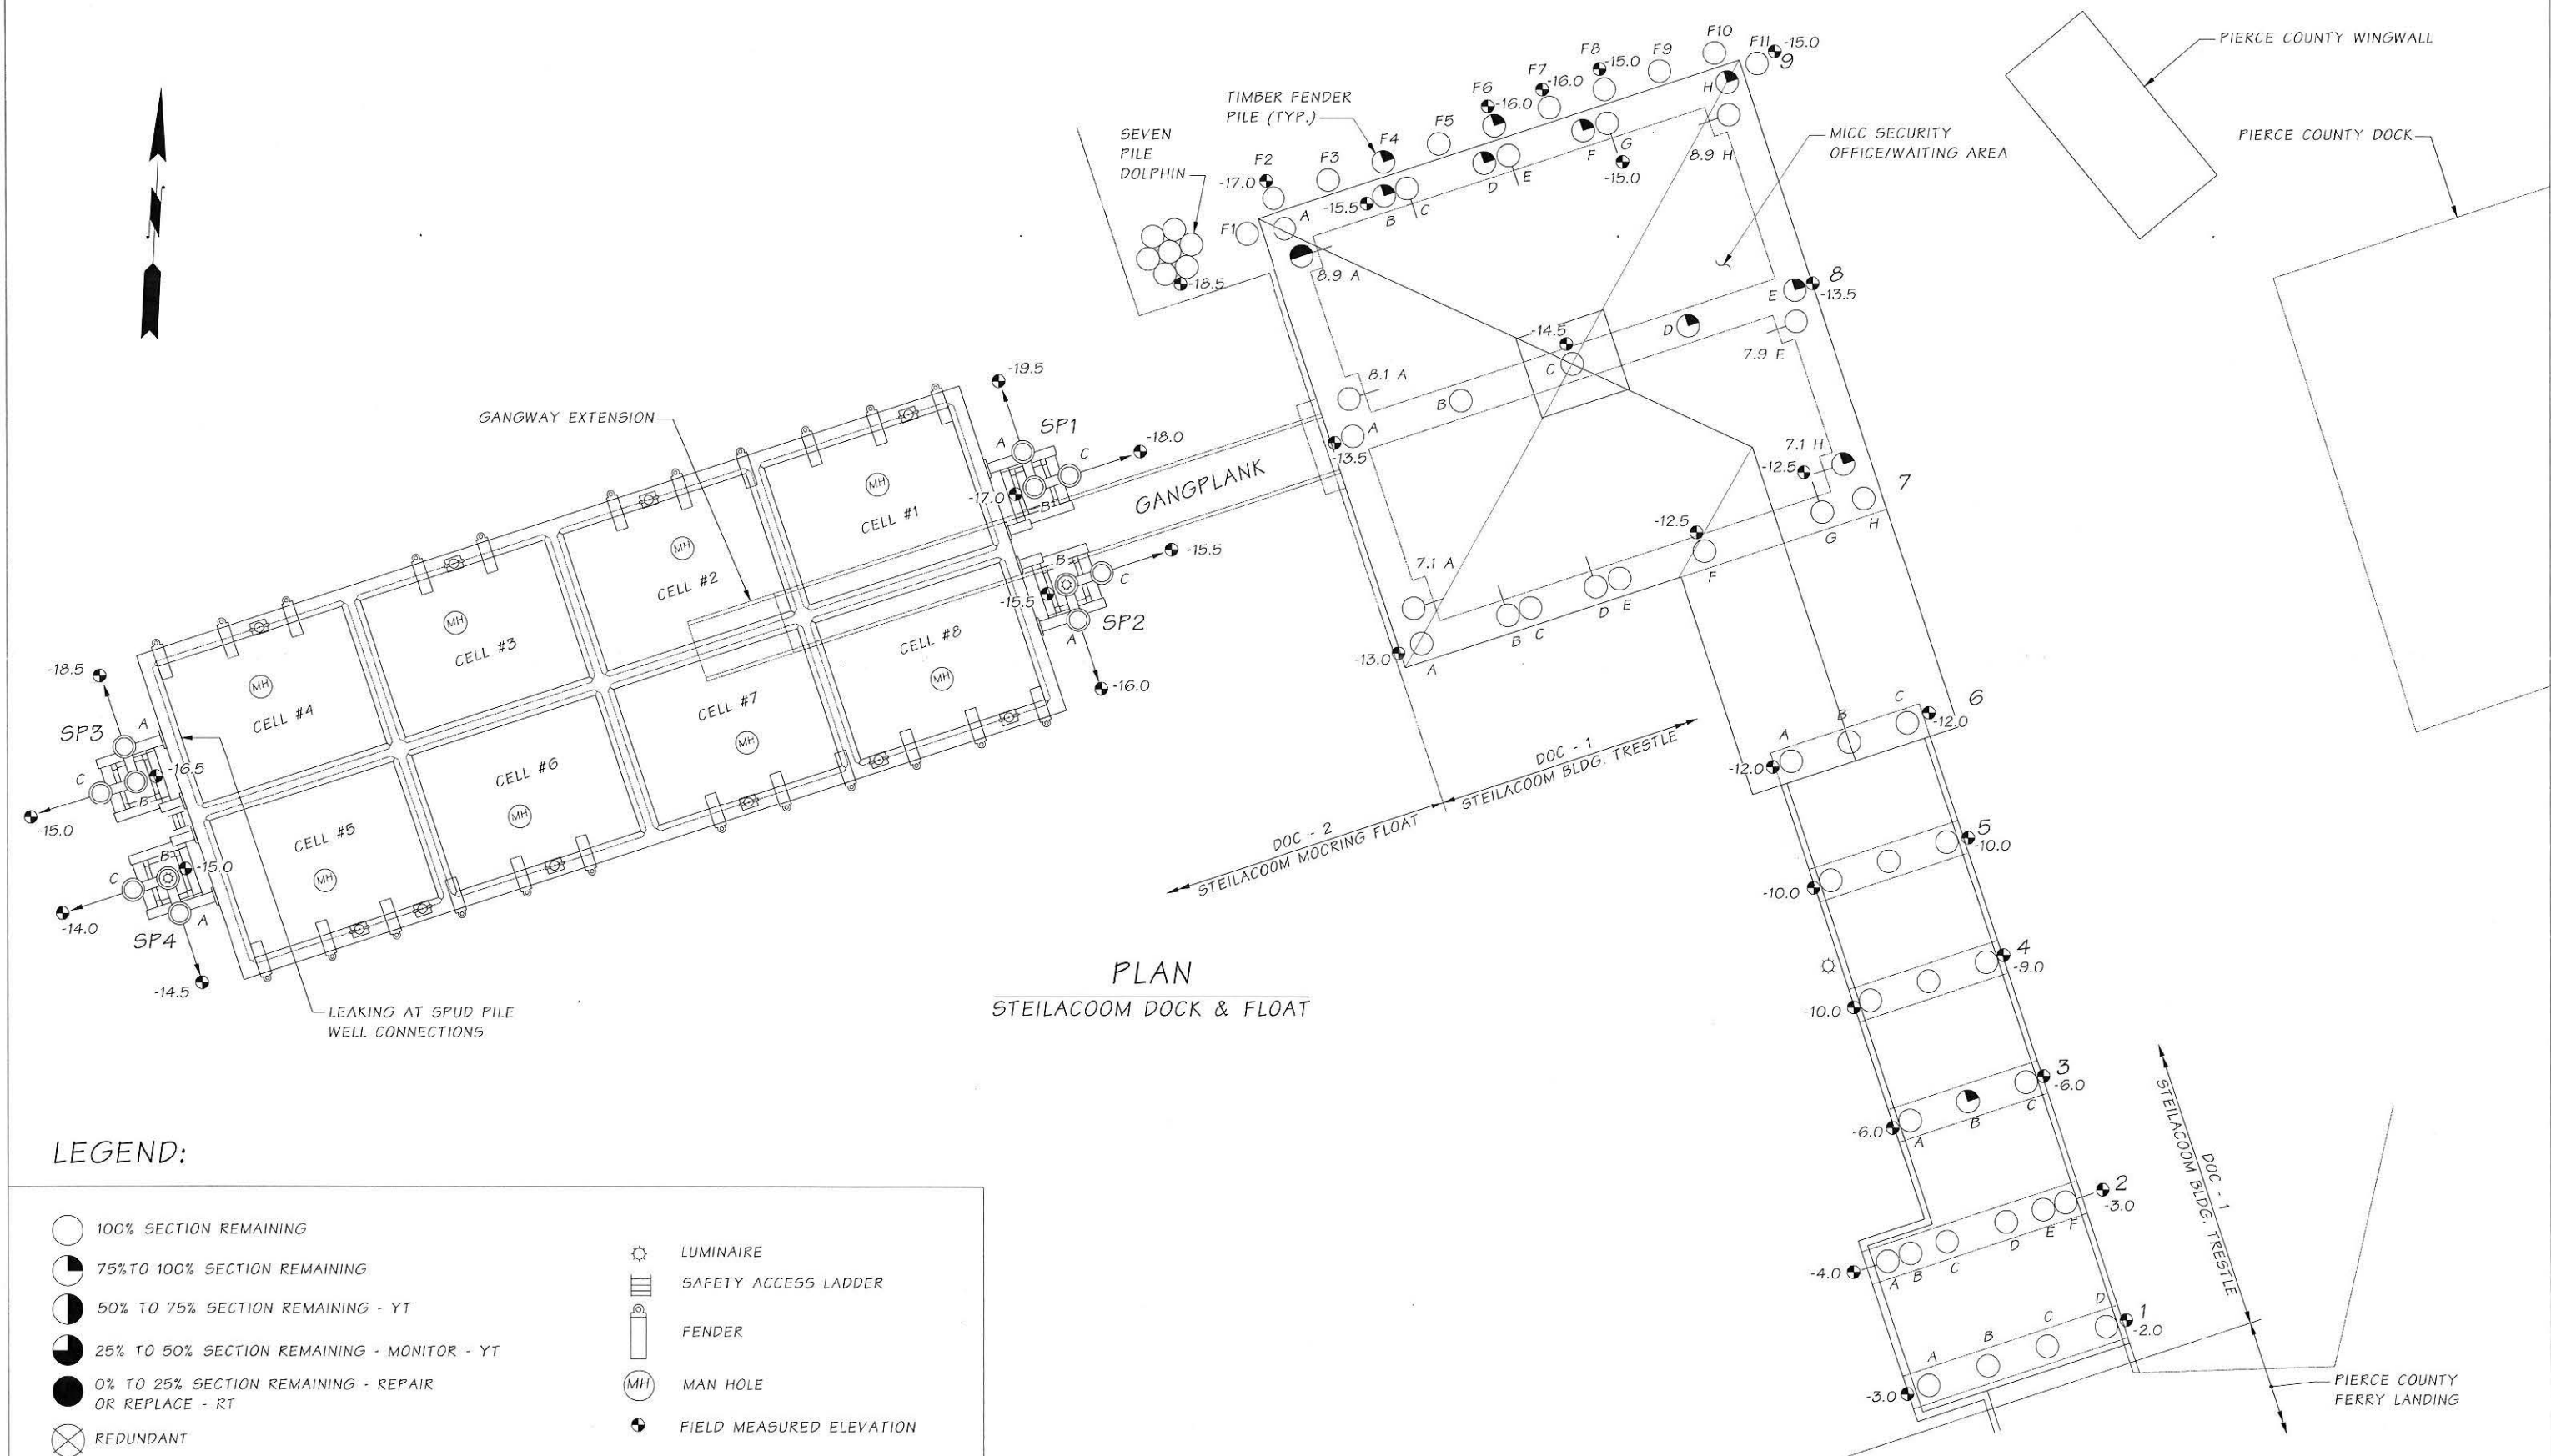
LAYOUT

Underwater Routine		4/26/2021	Lead: JRWH		Co: LAW				
		4/26/2021	Lead: LAW		Co: ABK				
Pile Location		Condition/Damage						Inspection Type	
Bent	Pile	Pile Type	MDL EI.	Defect Location	Details/Remarks		Routine/UW	Date	
PILE INSPECTION DATA - Float Spud Pile Groups									
SP1	A	Steel	-19.5		25% coating failure/loss. Thickness readings 0.455"/0.300" See Photo #UW-3 (typical coating failure/loss).		UW	4/26/2021	
	B	Steel	-17		50% coating failure/loss. Thickness readings 0.445"/0.315"		UW	4/26/2021	
	C	Steel	-18	MDL+3	50% coating failure/loss. Thickness readings 0.465"/0.340" (2021)		UW	4/26/2021	
SP2	A	Steel	-16		25% coating failure/loss. Thickness reading 0.250" in small corroded area. Good area reading 0.485"		UW	4/26/2021	
	B	Steel	-15.5		25% coating failure/loss. Up to 50% area adhesion failure. Thickness readings 0.470"/0.415"		UW	4/26/2021	
				MDL+16	Up to 0.125" pitting in the dent in the pile.

C	Steel	-15.5	MDL+1	25% coating failure/loss. Up to 50% area adhesion failure. Thickness reading 0.450"/0.255" (2021).		UW	4/26/2021	
					25% coating failure/loss. 50% area adhesion failure.				
SP3	A	Steel	-18.5	MDL+1	Thickness reading 0.470"/0.350" (2021).		UW	4/26/2021	
	B	Steel	-16.5		50% coating failure. Thickness reading 0.300" in pitted area. Photo #UW-4.		UW	4/26/2021	
	C	Steel	-15		10% coating failure. Up to 50% adhesion failure. Thickness readings 0.470" (good)/0.370" (in pitted area).		UW	4/26/2021	
	A	Steel	-14.5		25% coating failure/loss. Up to 75% area adhesion failure.		UW	4/26/2021	
SP4				MDL +1	Thickness readings 0.410"/0.300" (2021)				
	B	Steel	-15		25% coating failure/loss.				
				MDL to +3	50% coating failure.				
				MDL +2	Thickness readings 0.480"/0.290" (2021).		UW	4/26/2021	
	C	Steel	-14		25% coating failure/loss. 0.390"/0.250" (in small pitted area).		UW	4/26/2021	
Counts	Steel =	12
