BRIDGE INSPECTION REPORT

Br. No. DOC-3

Br. Name MCNEIL IS. MOORING FLOAT

- 9 The WSDOT Bridge Preservation Dive Team performed an underwater inspection of the subject facility on April 27, 2021. Sixteen steel pipe piles and the concrete floating pontoon exterior were inspected below water by diving.

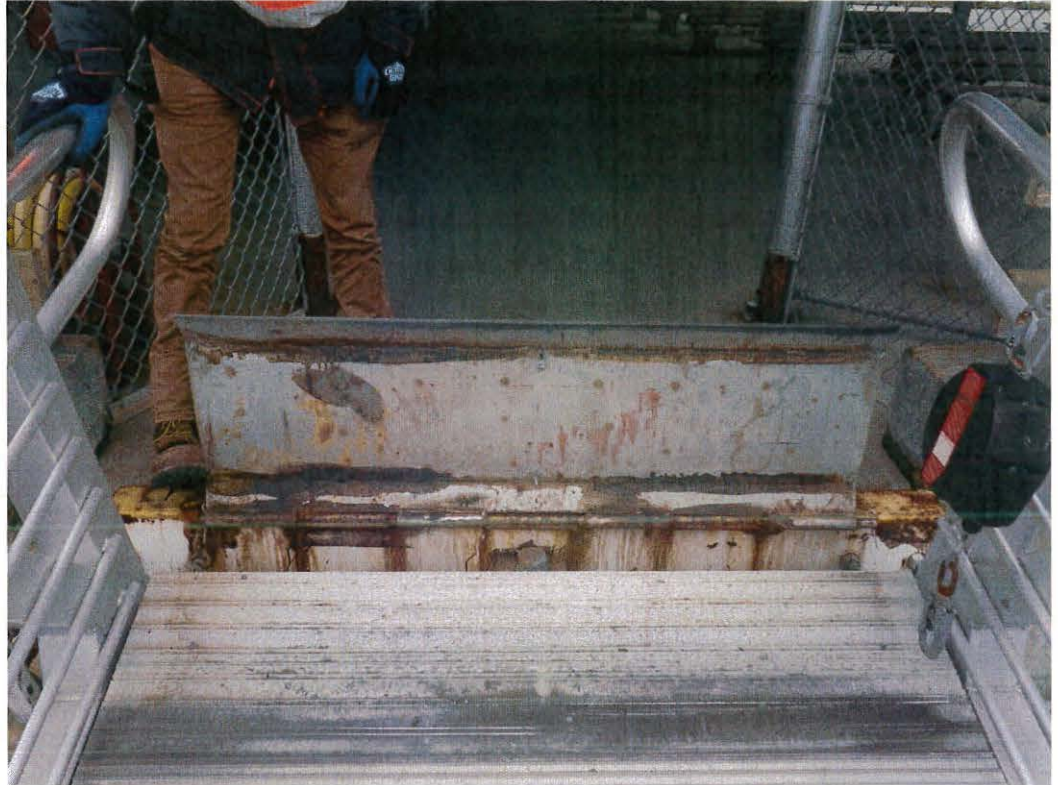
SI-21

The gangplank connection to the fixed dock consists of a structural tube that has sliding bearings and a center pin connection (photo #21). The center pin connection is a 1-1/4" diameter bolt connected through an upper and lower plate. Fixed Pin Bearing was replaced in 2016.

Top end gangplank center pin connection is under upper landing plate.

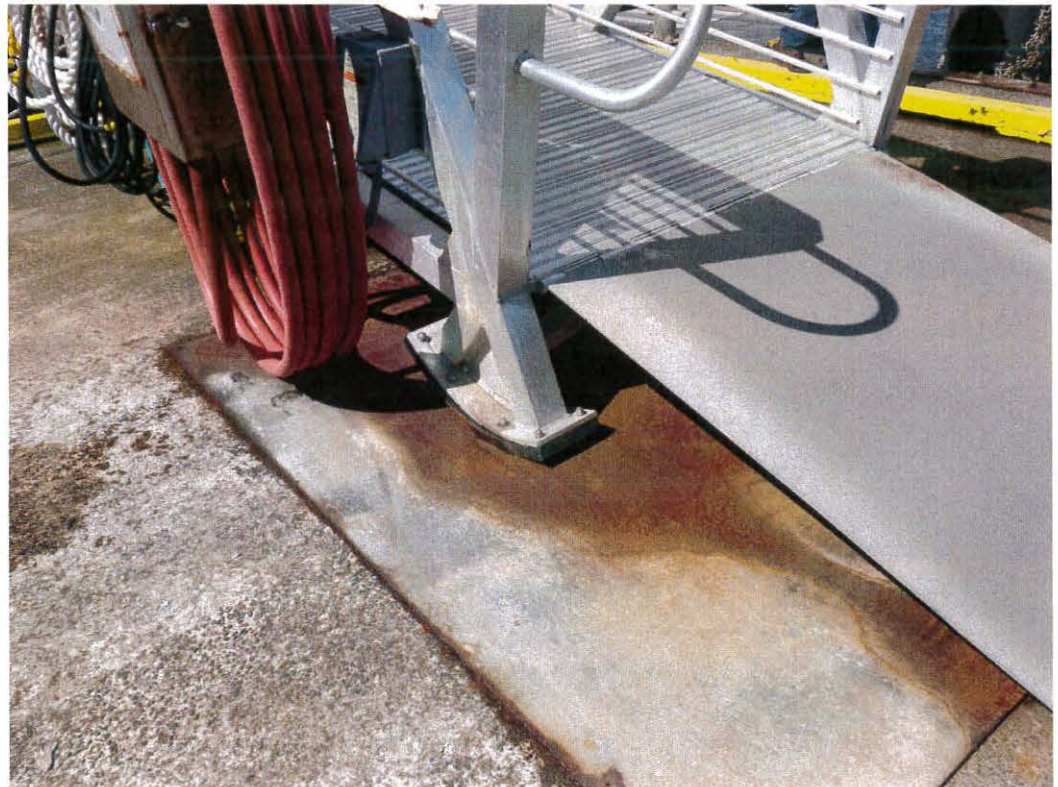
SI-6

Two slider bearings under the floater side of the gangplank (photo #6).

Gangplank sliding bearings.

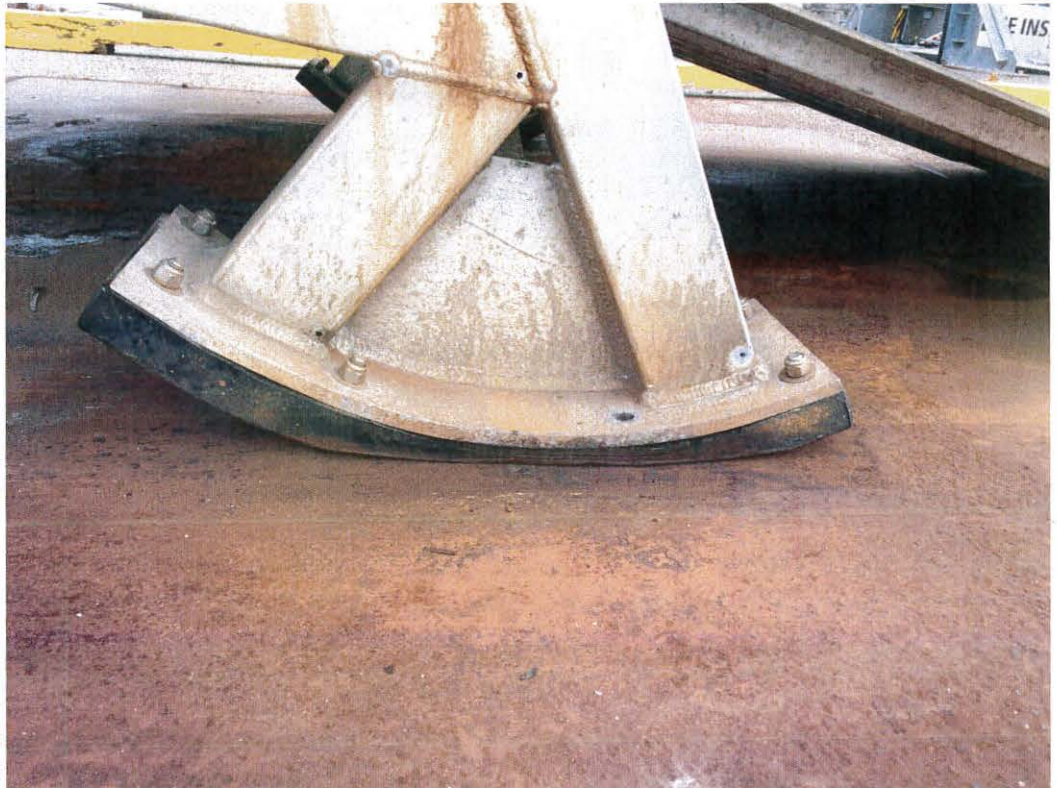
SI-36

Bearings are wearing - 1/2" on the right side, 3/4" on the left. (photos #36 and #37)

Gangplank sliding bearing is warn to 1/2" on the right side.

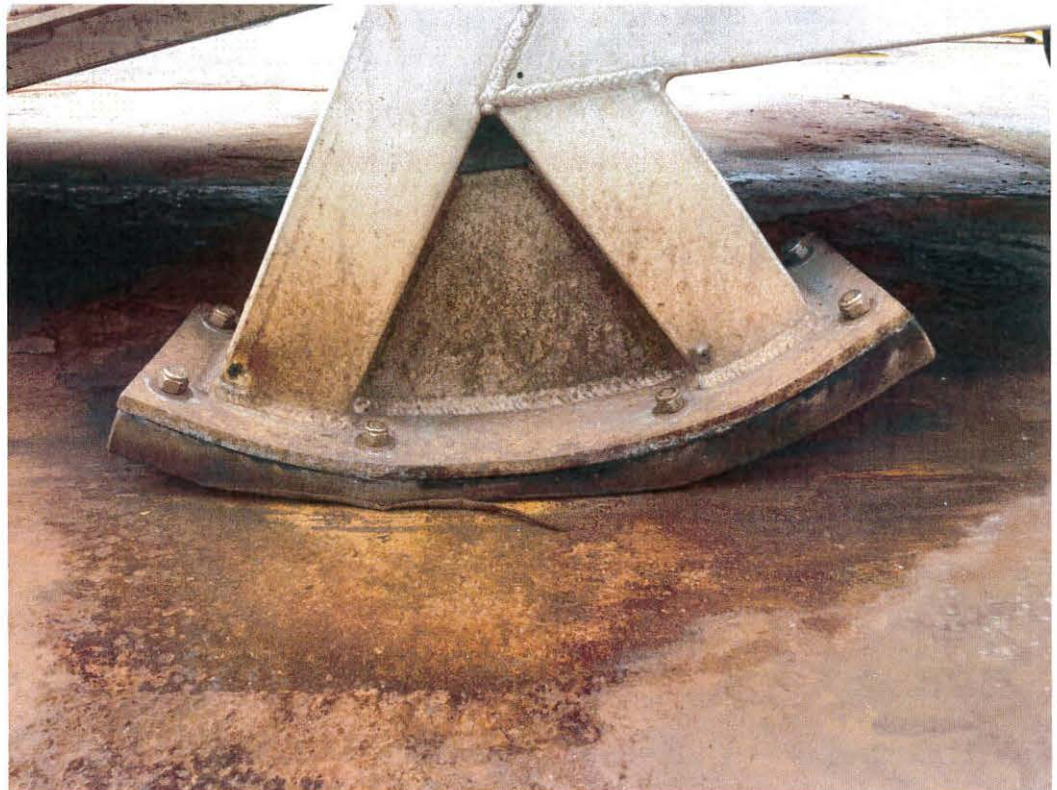
SI-37

Gangplank sliding bearing is warn to 3/4" on the left side.

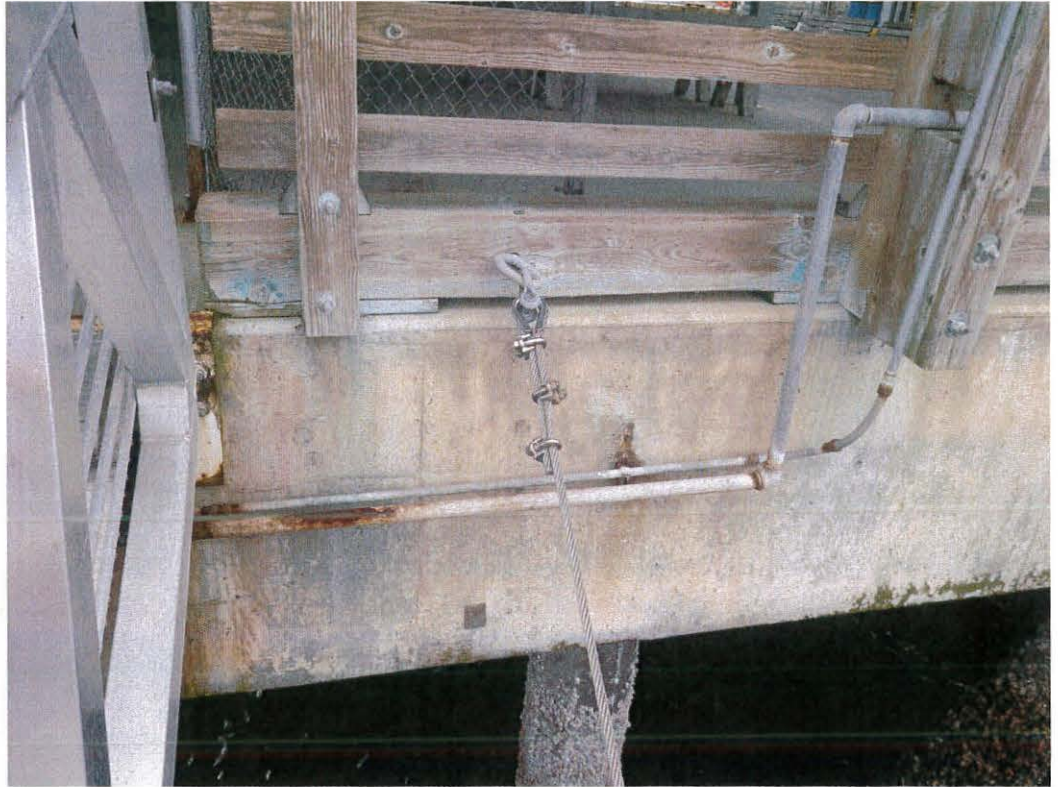
Cables tied to the fixed trestle installed to keep gangplank square.

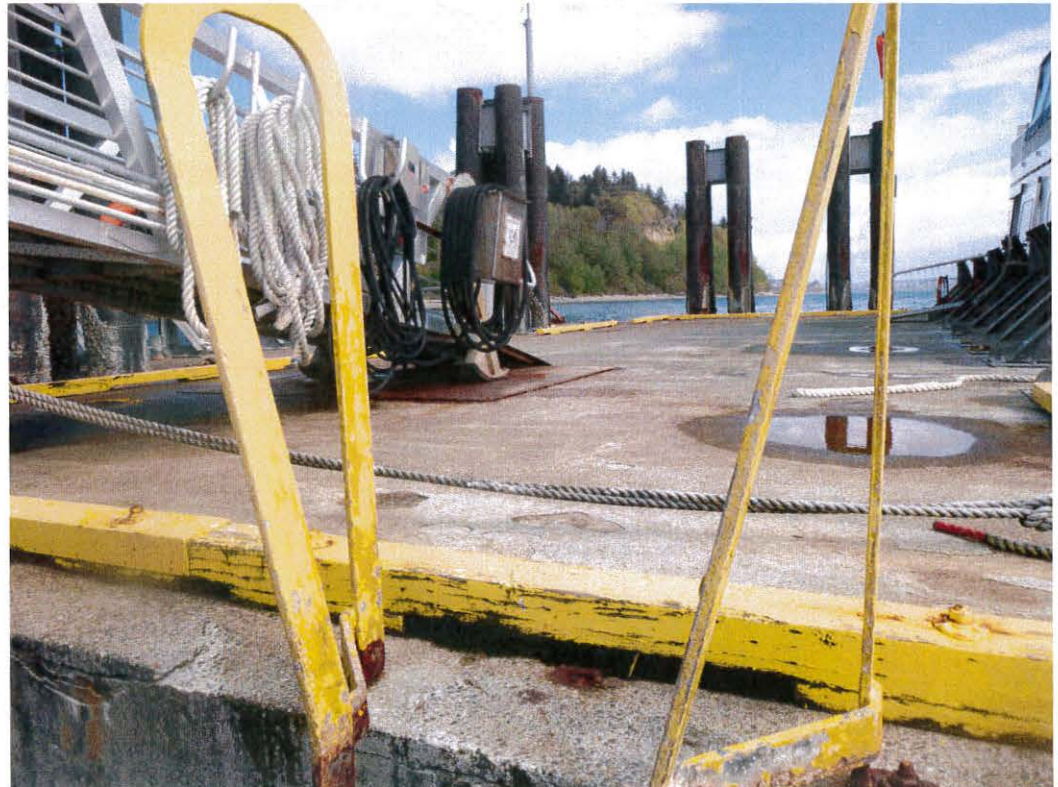
SI-31

Additional rope attached to gangplank to prevent it from working towards shore.

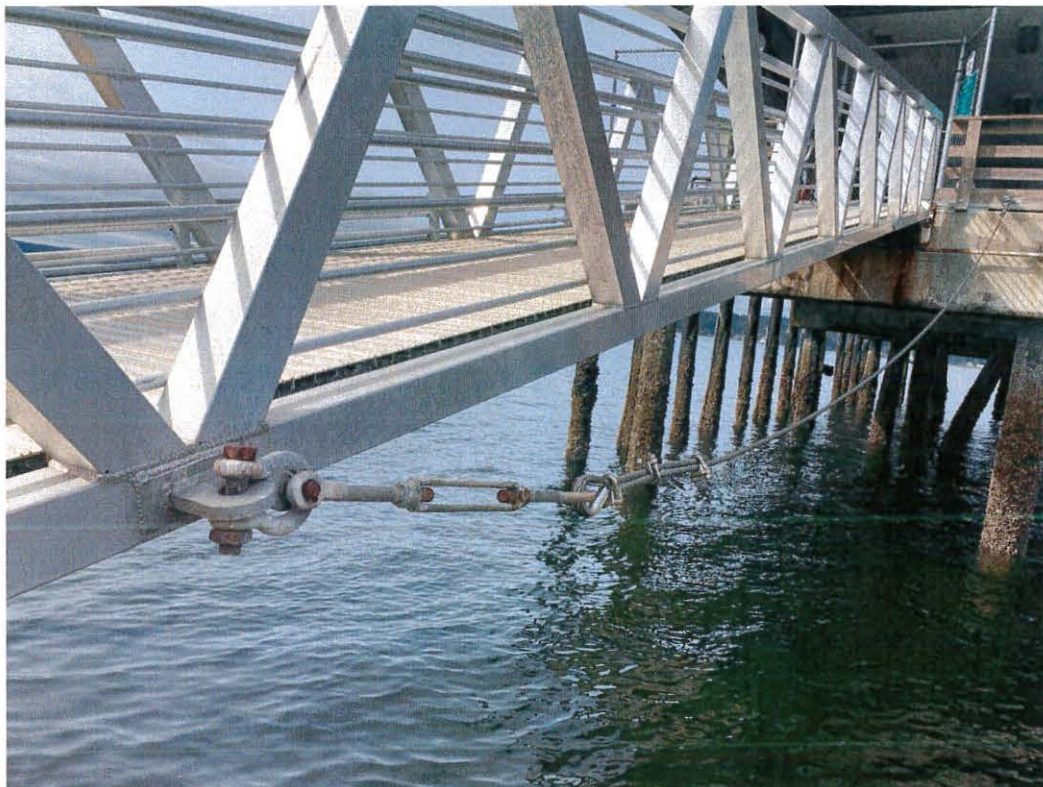
Left side tie back cable attachment is cracked along the bottom of the gangplank (photos #40 and #41).

Tie back cable attachment on the left side of the gangplank has a cracked weld. See Photo #41.

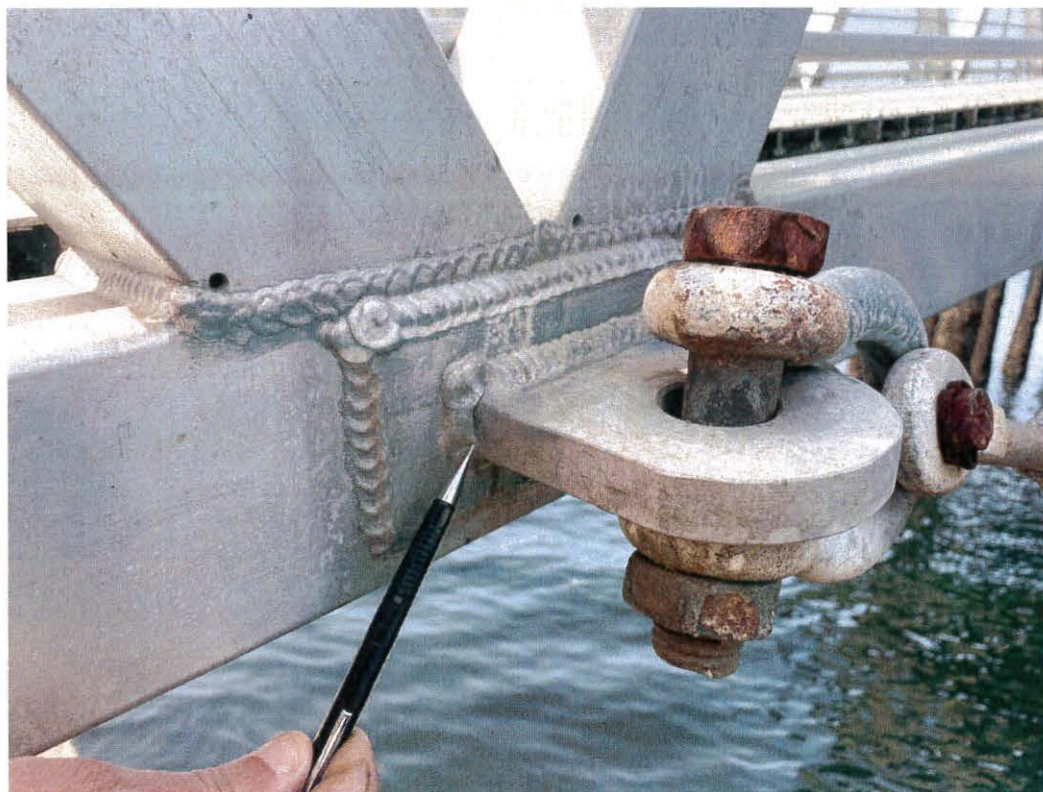
SI-41

Close up of crack in tie back cable attachment on the left side of the gangplank.

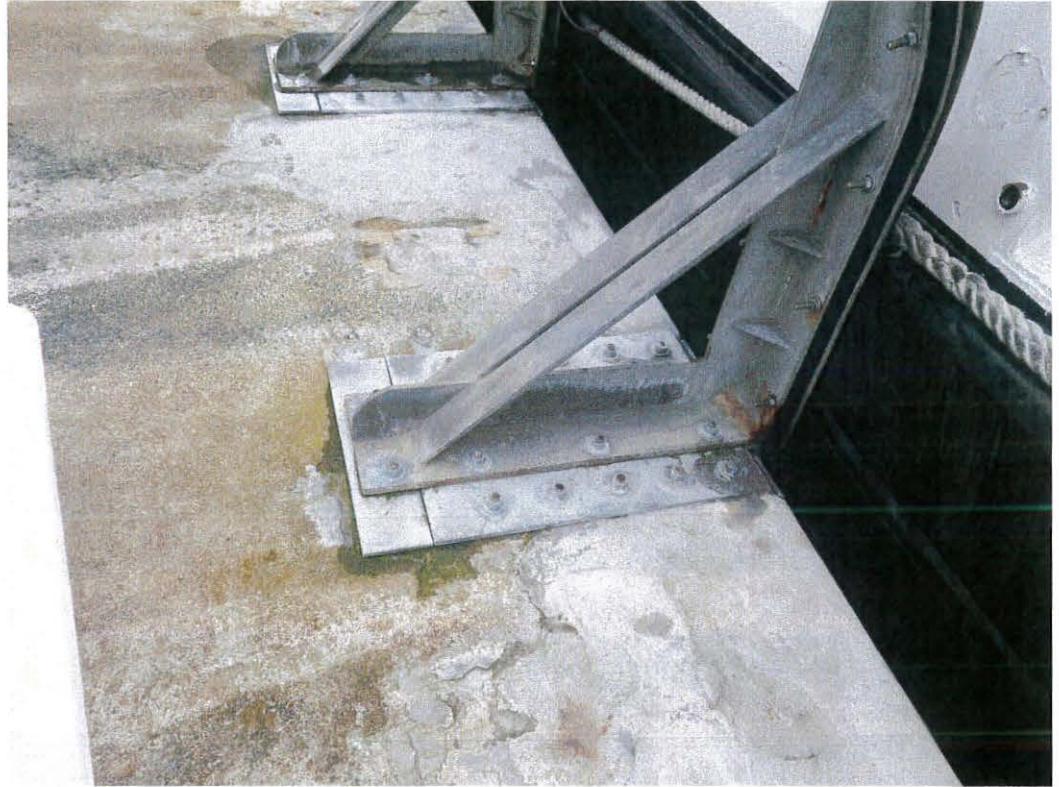
Boat fender bumpers are in fair condition, many have had repairs (photo #24).

Most of the fender brackets have been repaired or replaced.

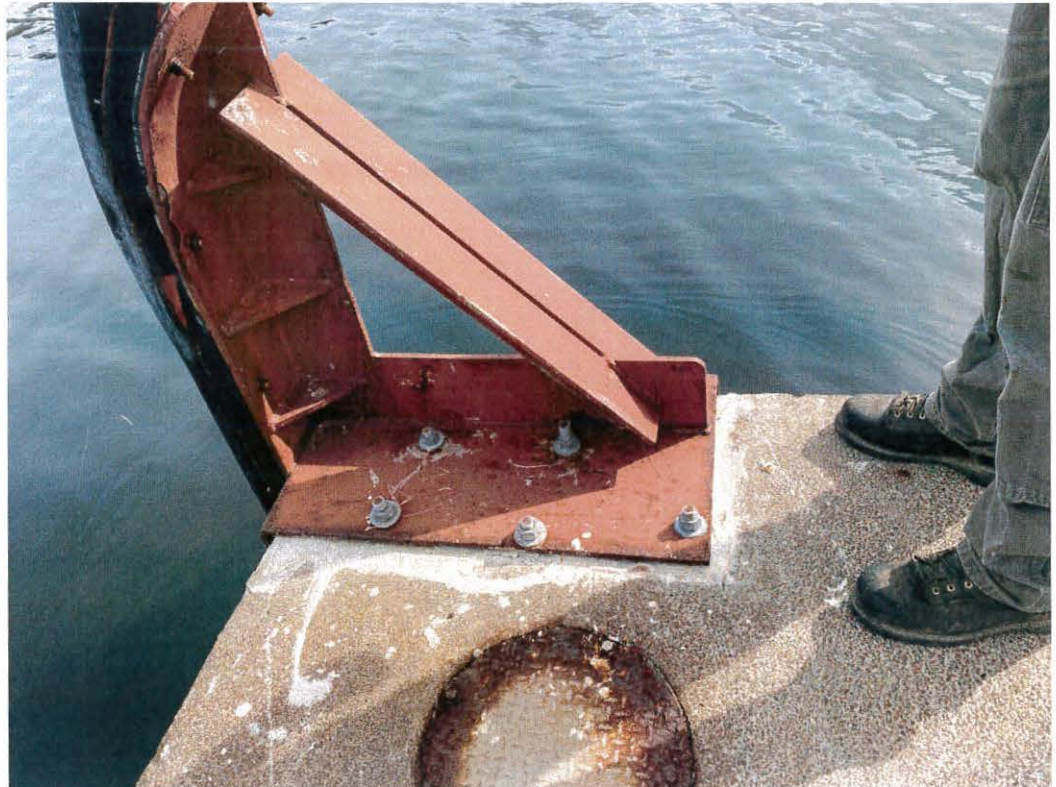
SI-35

The right flanker fender bracket at the right shore side corner had been repaired with new bolts added (photos #35, #29 & #30).

Right flanker pontoon fender bracket at the right shore side corner has been repaired. Archive photo next inspection.

REPAIR #10004 VERIFIED 2021.

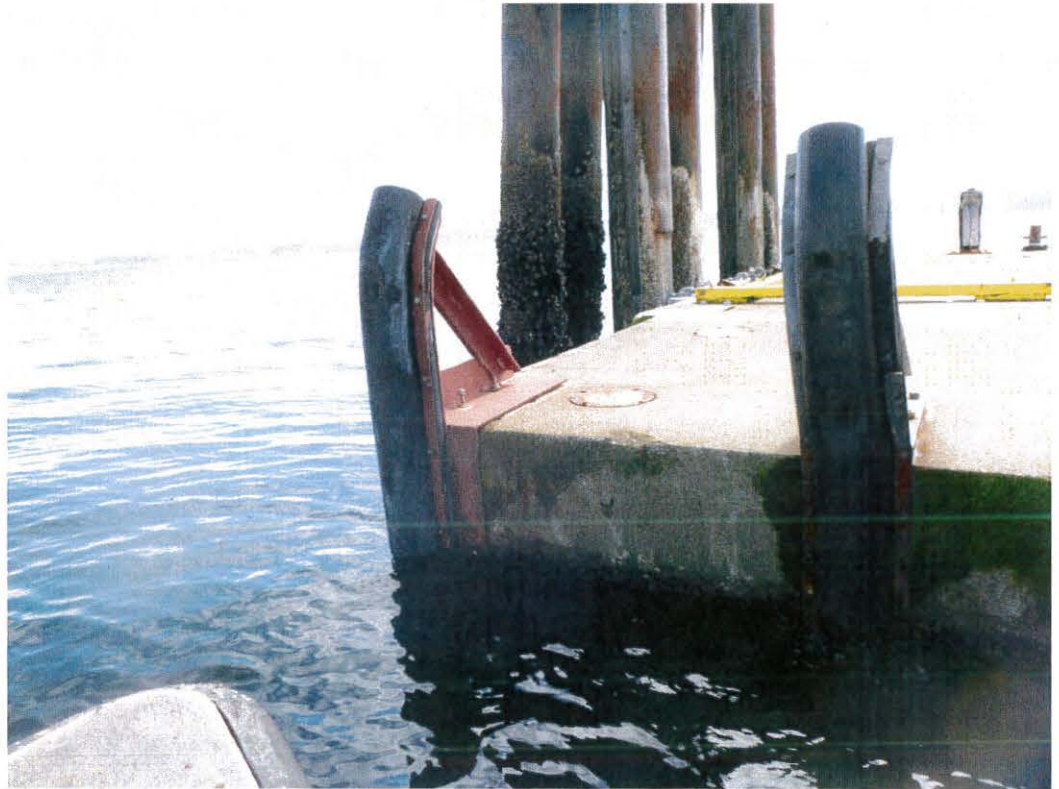
Pre-repair photo. See Photo #35. Right flanker pontoon fender bracket at the right shore side corner has pulled out hold down bolts. Archive next inspection.

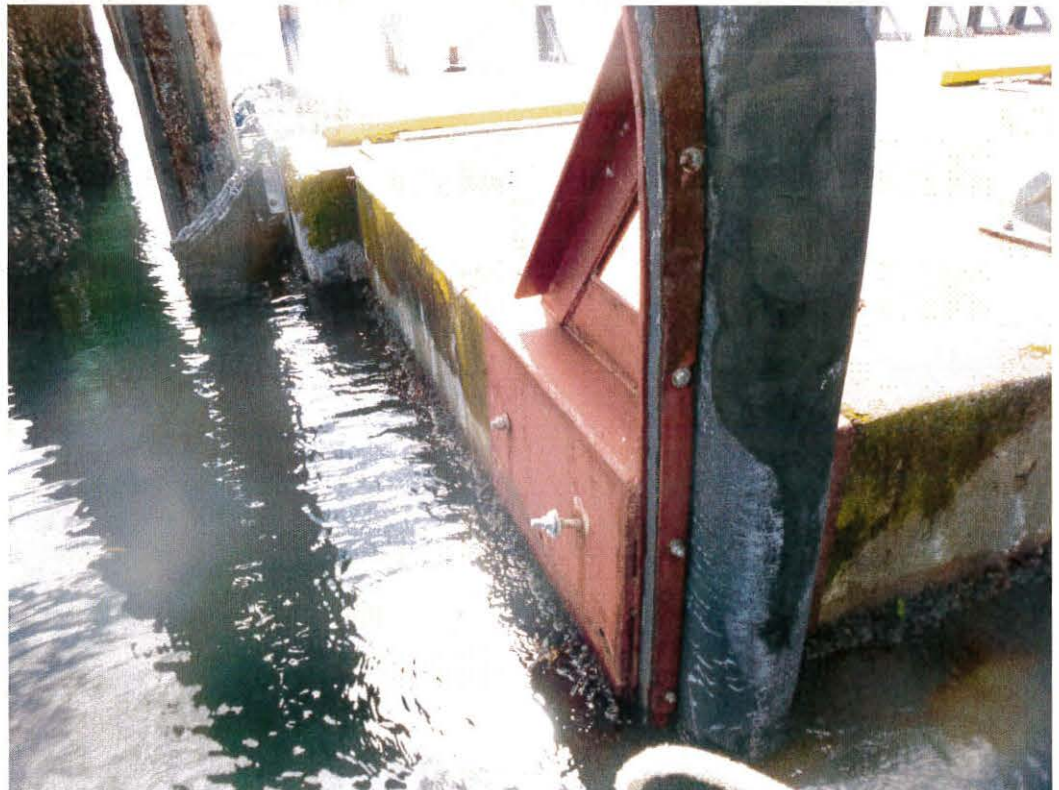
SI-30

Pre-repair photo. See Photo #35. Right flanker pontoon fender bracket at the right shore side corner has pulled out hold down bolts. Archive next inspection.

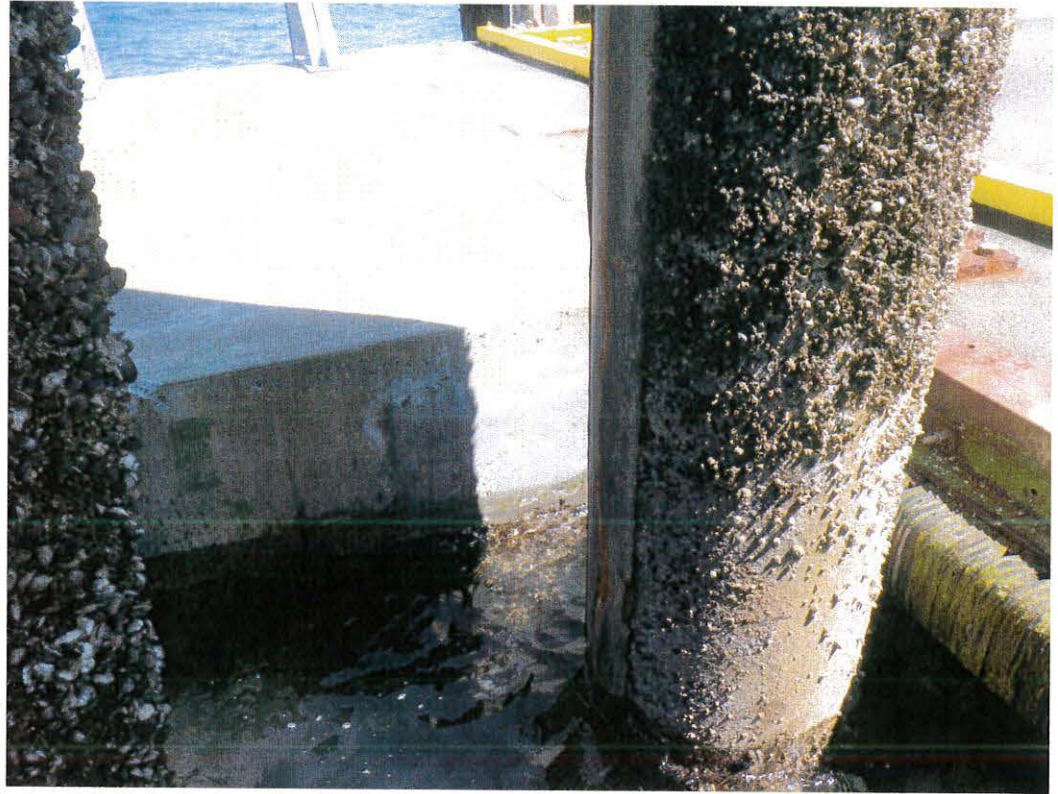
The left flanker pontoon patched spall in the right exterior wall (CS2 condition) (photo #26).

Left flanker pontoon has an old repair.

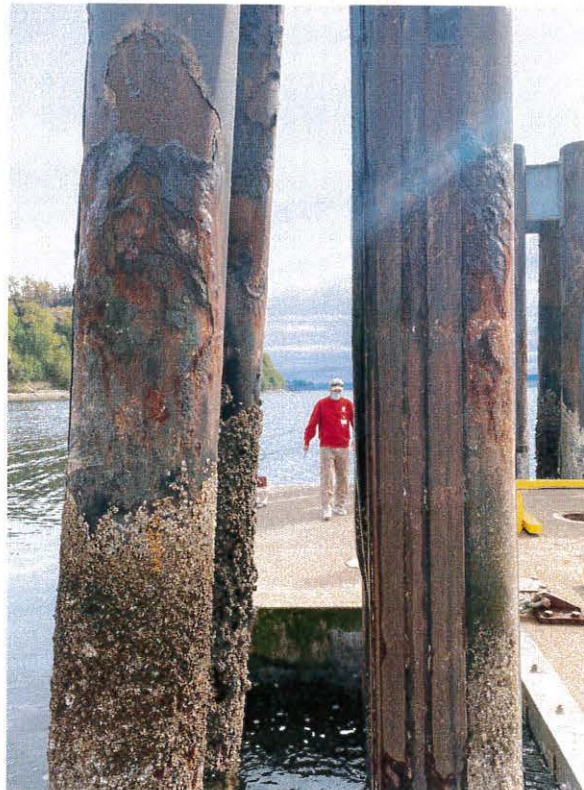
SI-34

Pile SP1-A has had plates welded on to prevent wear to the pile from the chain. (photo #34).

Pile SP1-A has had plates welded on to prevent wear to the pile from the chain.

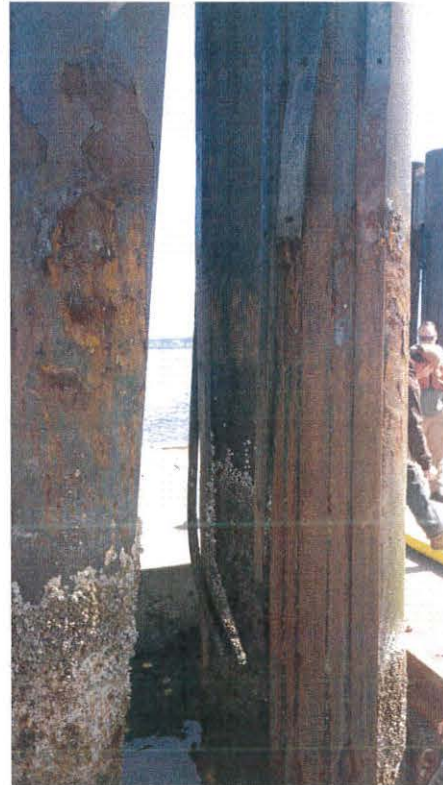
Spud pile group SP2 has failing UHMW protection with steel backer plates remaining, typical for spud piles (photo #17).

Spud pile group SP2 has failing UHMW protection with steel backer plates remaining, typical for spud piles.

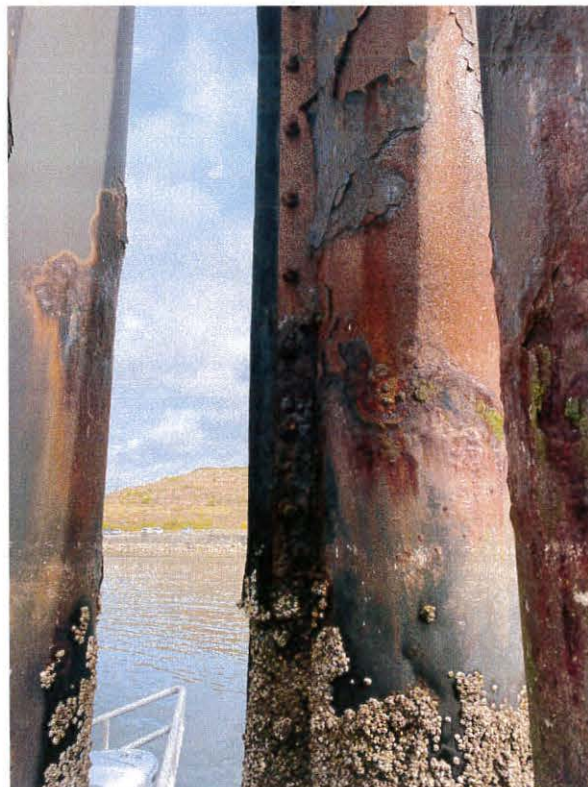
SI-33

Spud pile SP2-C has heavy rusting and section loss at the high side of the tidal zone (photo #33).

Spud pile SP2-C has heavy rusting and section loss at the high side of the tidal zone.

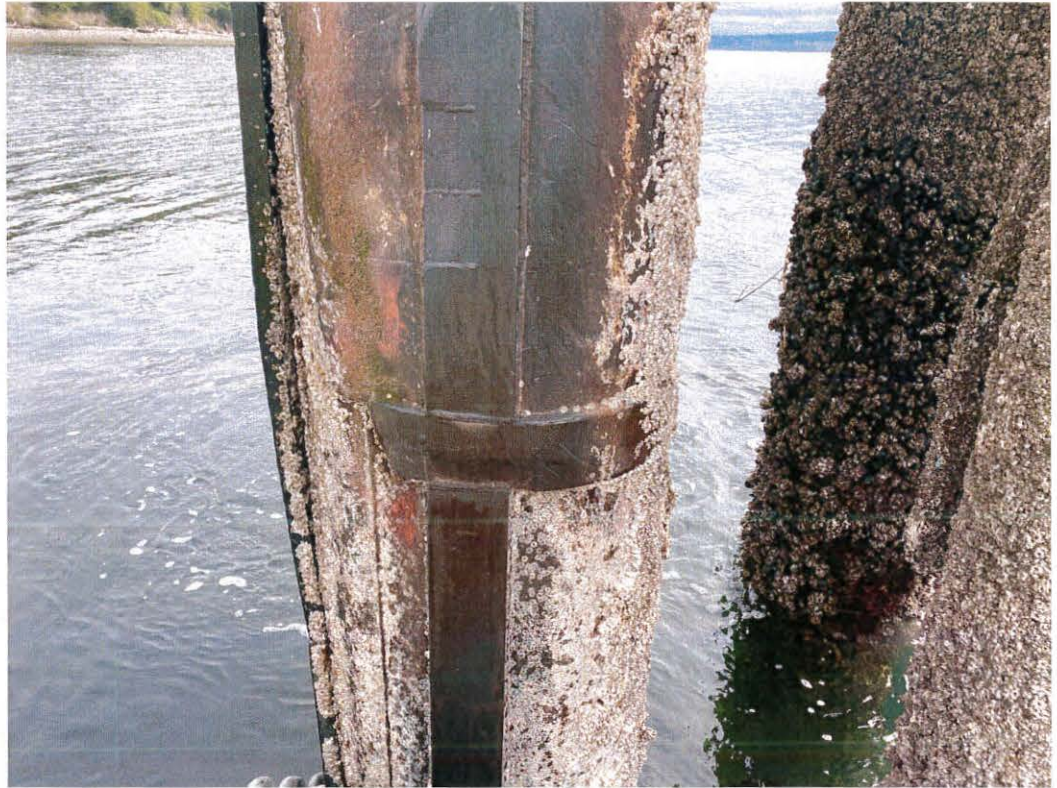
Spud pile SP3-D has been repaired several feet below the high water mark (CS2) (Photo #32 and #27). REPAIR #10005 VERIFIED 2021.

Spud Pile SP3-D has been repaired. See photo #27 for pre-repair photo. Archive next inspection.

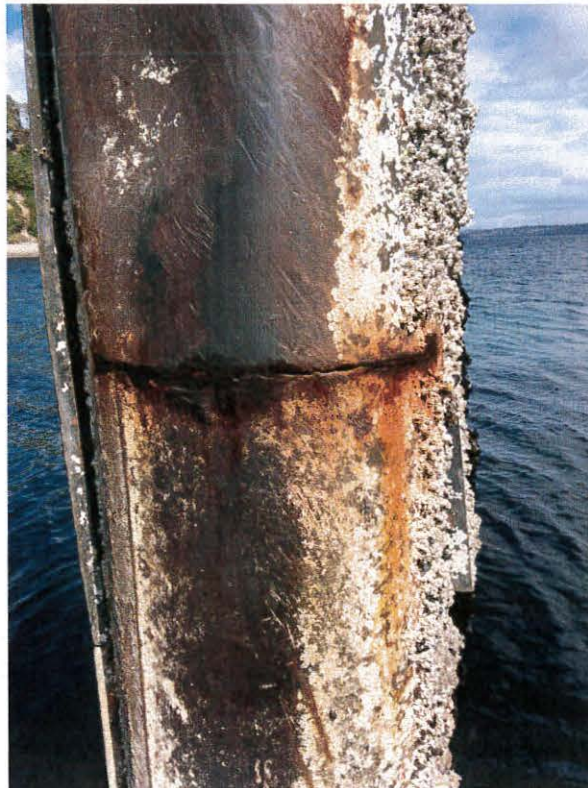
SI-27

Pre - repair: Spud Pile SP3-D is cracked at a butt splice. Archive next inspection

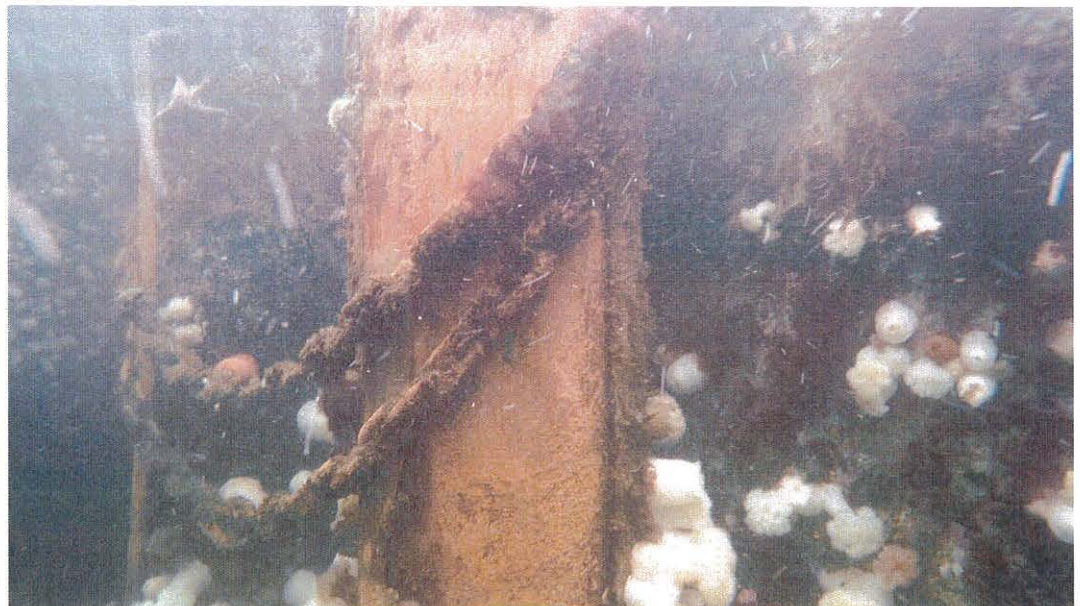
UW-5

Keeper chains fret directly on spud piles in the lower ITZ, causing holes in some locations.

Repair recommendations include repairing or replacing spud piles that have holes in them (REPAIR #10007) which are susceptible to failing during extreme weather events. Recommend retaining the 48-month frequency for underwater inspections. REPAIR #10005 VERIFIED in 2021.

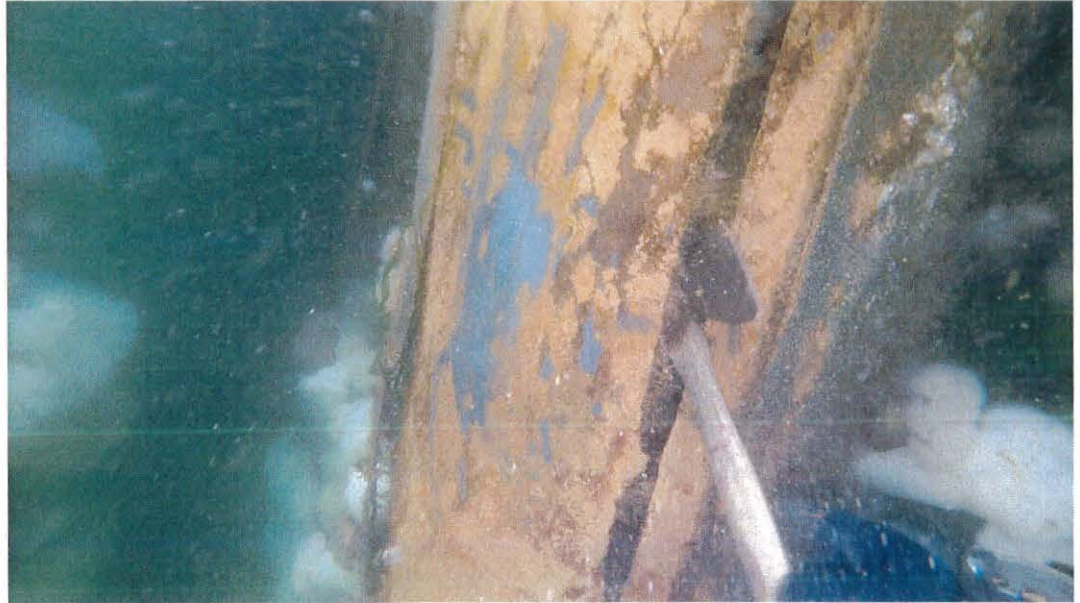
Spud Pile SP1-A holed thru from keeper chain fretting.

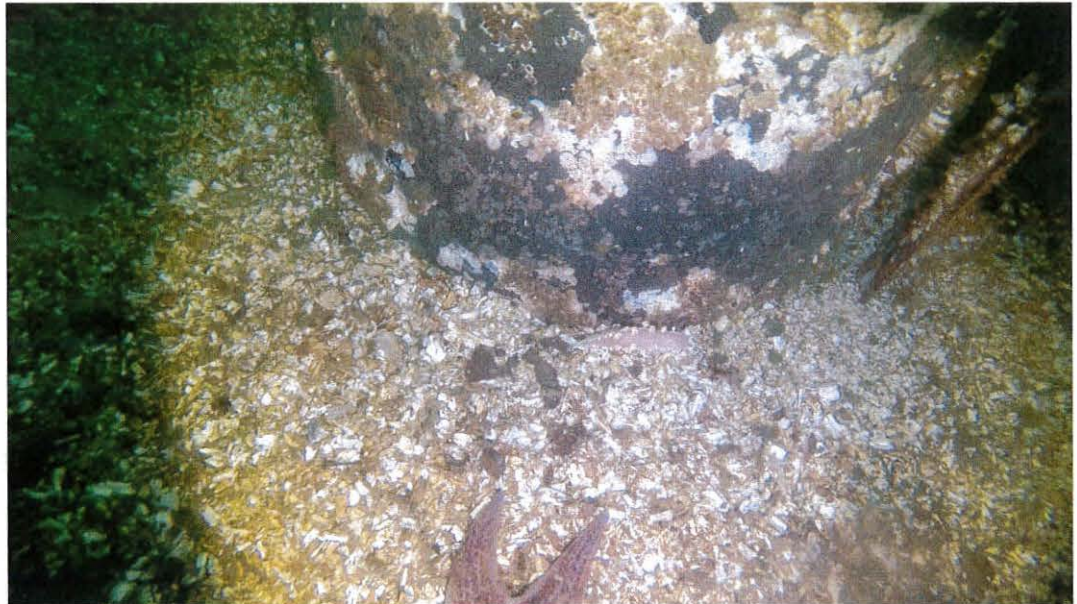
UW-9

Most spud piles have good coating below the ITZ. Pile SP1-B shown near mudline (MDL).

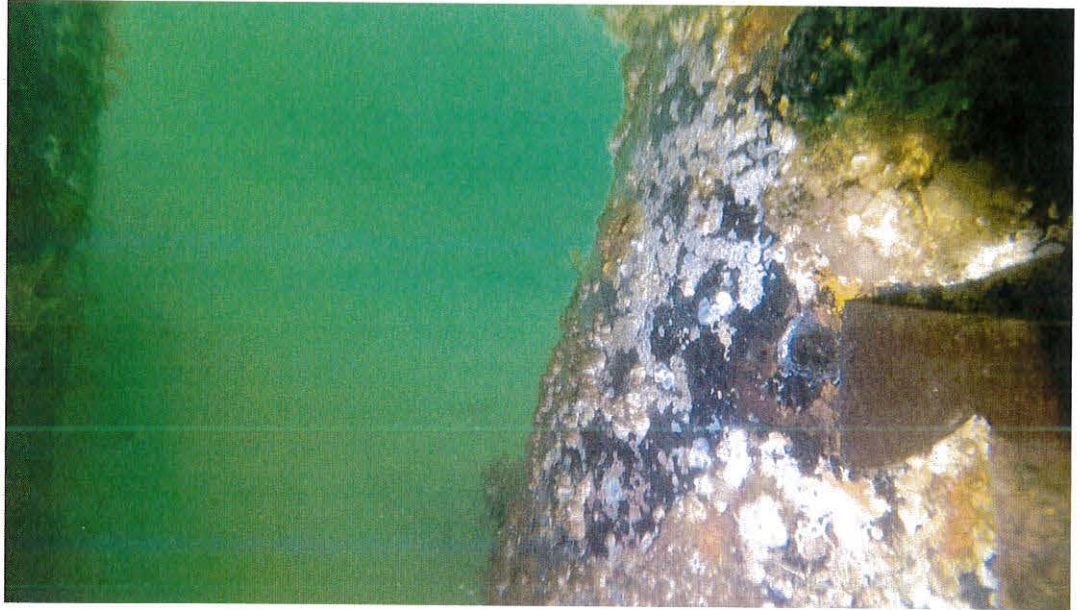
Localized deep pitting in Pile SP1-C;
typical of other piles in localized areas.

C	Steel	CS3	MDL+2 MDL+3 ITZ	Thickness = 0.485" (2017) 1" dia. localized pit @1:00; 0.41" deep. Thickness = 0.480"(2021) in adjacent good area. Typical of other areas of localized deep pitting (Photo #UW-10). 5%-10% area general coating loss/failure.	UW	4/27/2021
	D	Steel	CS4	MDL MDL+1 MDL+2 ITZ	3"(h) x 5"(w) hole thru pile @4:00 (Photo #UW-11). Thickness = 0.490" (2021) in adjacent good area. 3/4" dia. pits up to 0.25" deep in Level II cleaned area @4:00 Thickness 0.490" (2013). 5%-10% area general coating loss/failure.	UW	4/27/2021
SP2	A	Steel	CS3	MDL+1 MDL to MDL+1.5 ITZ	Thickness = 0.495" (2021) 18"(h) x 9"(w) area of coating failure with pitting up to 3/8" deep @2:30 Up to 50% coating failure and heavy corrosion from chain fretting (Photo #UW-12). Thickness readings were 0.130" & 0.270" in fretted area (2021).	UW	4/27/2021
	B	Steel	CS3	MDL+1 ITZ	Thickness = 0.480" (2021) 10% area general coating loss/failure. Pontoon chains are fretting on pile and causing heavy corrosion and section loss. Thickness readings were 0.300" & 0.340" in fretted area from 6:00-9:00 (2021)	UW	4/27/2021

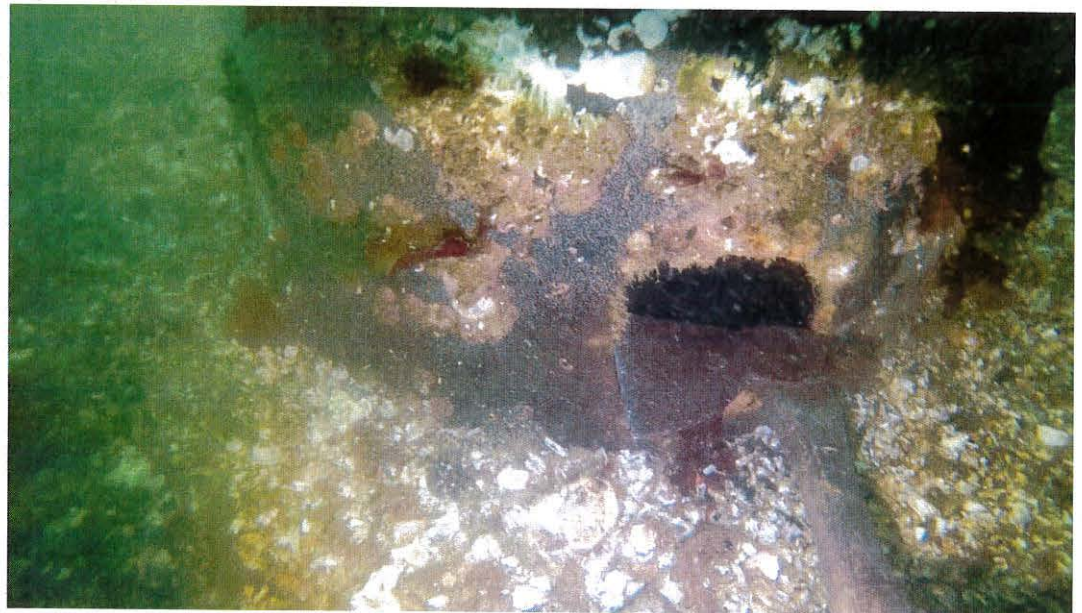
UW-11

Spud Pile SP1-D holed thru near
mudline.

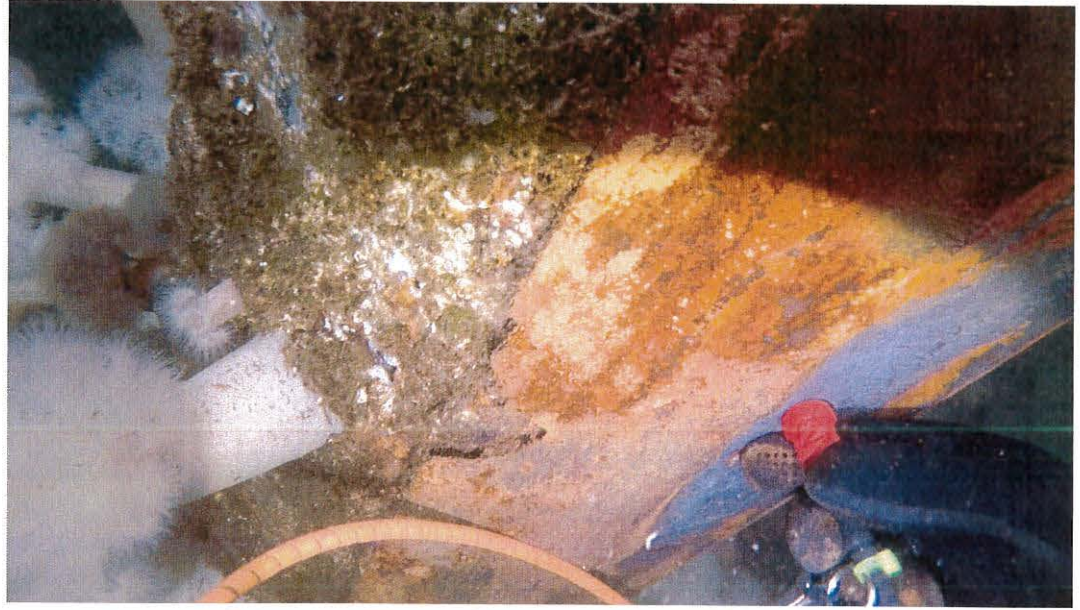
Heavy corrosion and section loss in SP2-A from chain fretting. Only about 1/8" section remaining in this location.

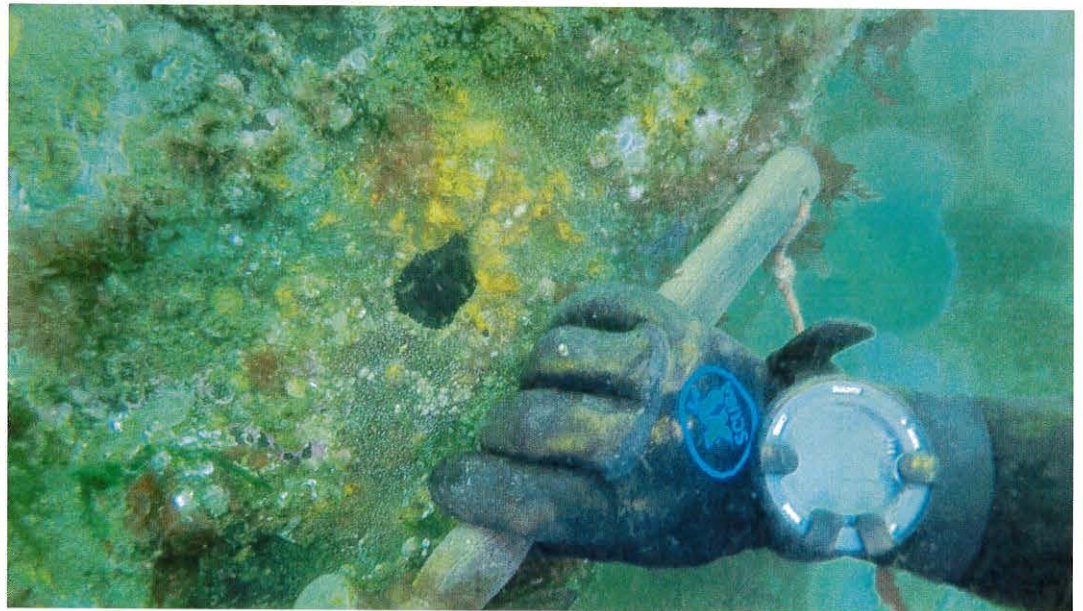
UW-13

Spud Pile SP3-B holed thru at MDL+4

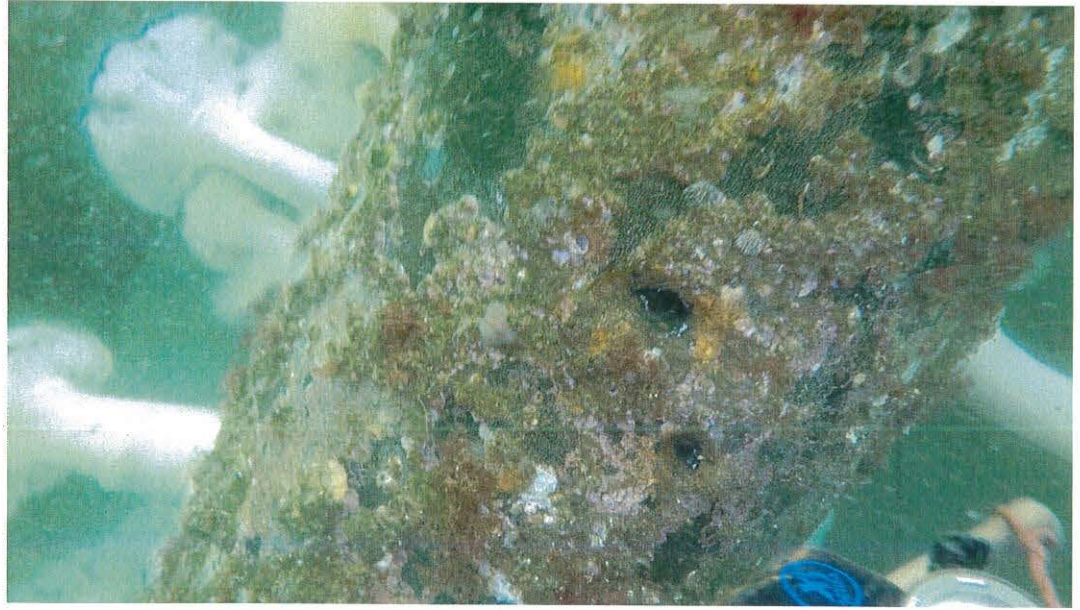
Spud Pile SP3-C deeper pits holed thru at MDL+4

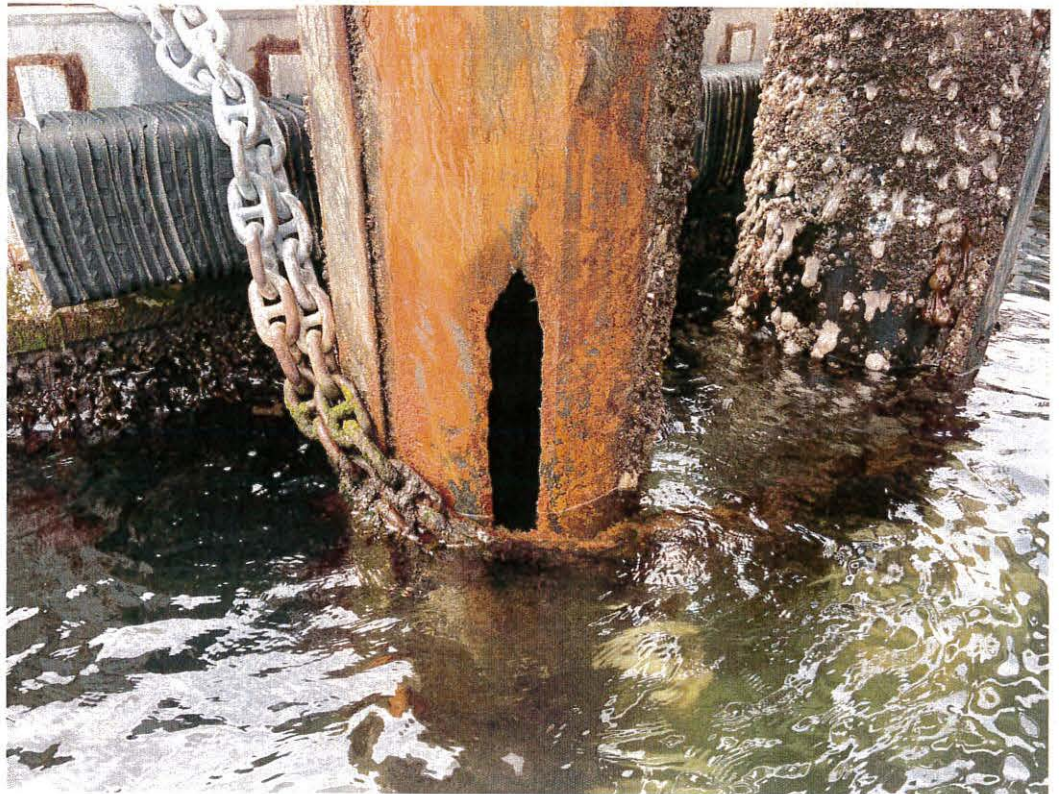
UW-15

Spud Pile SP4-A holed thru in the ITZ from chain fretting.

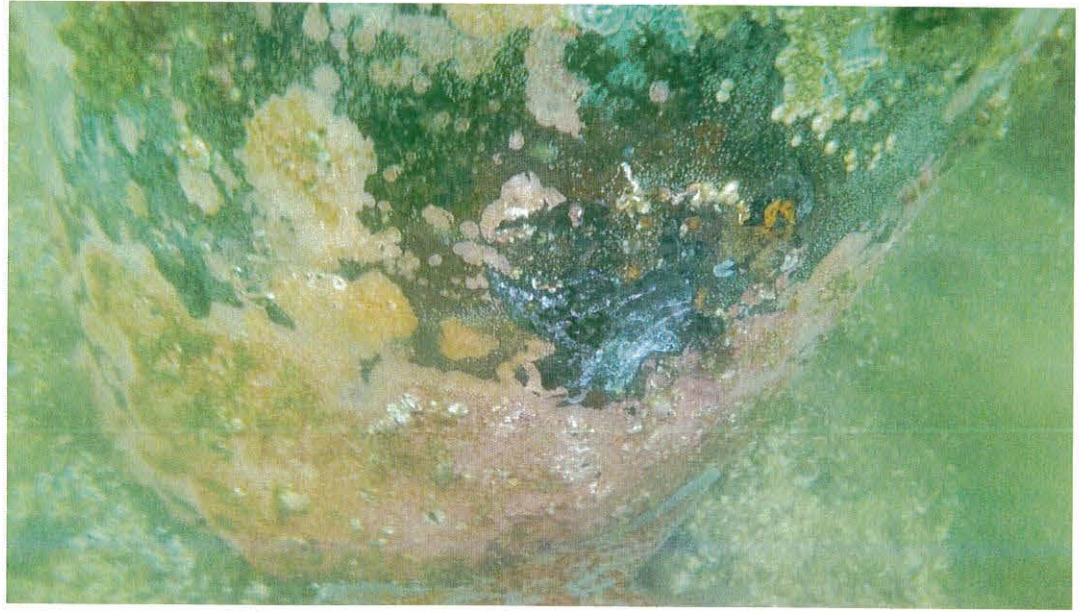
Localized deep pitting near MDL in Spud Pile SP4-B.

D	Steel	CS4	MDL+1 ITZ	Thickness = 0.495" (2017); 0.490" (2021). Approx. 20% area coating failure near mudline. 10% area general coating loss/failure. 3'(h) x 6"(w) area of corrosion and section loss due to chain fretting. Thickness = 0.300"(2021). Horizontal crack across butt weld several feet below high water mark (Photo #27; REPAIR #10005)	UW 4/27/2021
SP4	A	Steel	CS4	MDL+1 MDL+3 to +5 MDL+16 to +19.5 ITZ	Thickness = 0.470"(2017); 0.460"(2021). Corr. band w/ concentrated localized pitting. Hole 3.5'(h) x 4"(w) @10:00 centered in larger corrosion band (Photo #UW-15). 10% area general coating loss/failure. Pontoon chains are fretting on pile.	UW 4/27/2021
	B	Steel	CS3	MDL MDL+1 ITZ	Photo #UW-7 shows typical coating condition near mudline. Thickness = 0.515"(2021) in good coating area. Localized pits up to 0.280" deep around 9:00 (Photo #UW-16) 5%-10% area general coating loss/failure.	UW 4/27/2021

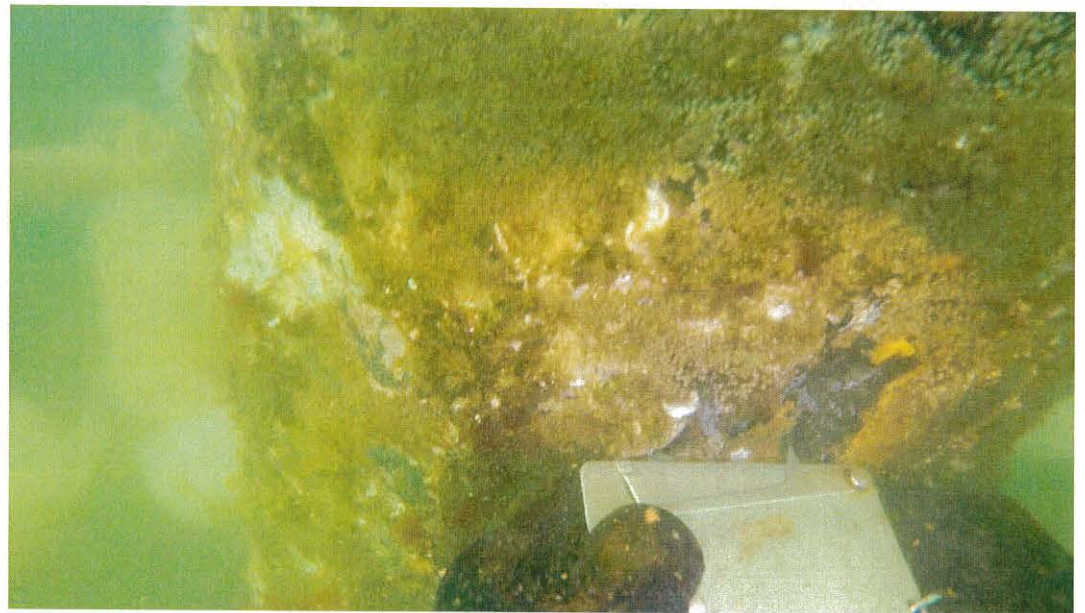
UW-17

Spud Pile SP4-C deep pits mid-height.

C	Steel	CS3	MDL MDL+5 ITZ	Thickness 0.515"/0.260" (good/bad)(2013). Deeper pitting up to 0.350" deep (Photo #UW-17). Thickness = 0.505" in adjacent good area (2021). 5%-10% area general coating loss/failure.	UW 4/27/2021
	D	Steel	CS3	MDL+1 MDL+5 to +6 ITZ	Thickness = 0.510" (2021). Corr. band w/ concentrated localized pitting. 5%-10% area general coating loss/failure. UHMW/Steel stand-offs mainly intact and protecting pile from chain fretting.	UW 4/27/2021
