BRIDGE INSPECTION REPORT

Br. No. DOC-3

Br. Name MCNEIL IS. MOORING FLOAT

- 9 The WSDOT Bridge Preservation Dive Team performed an underwater inspection of the subject facility on April 27, 2021. Sixteen steel pipe piles and the concrete floating pontoon exterior were inspected below water by diving.

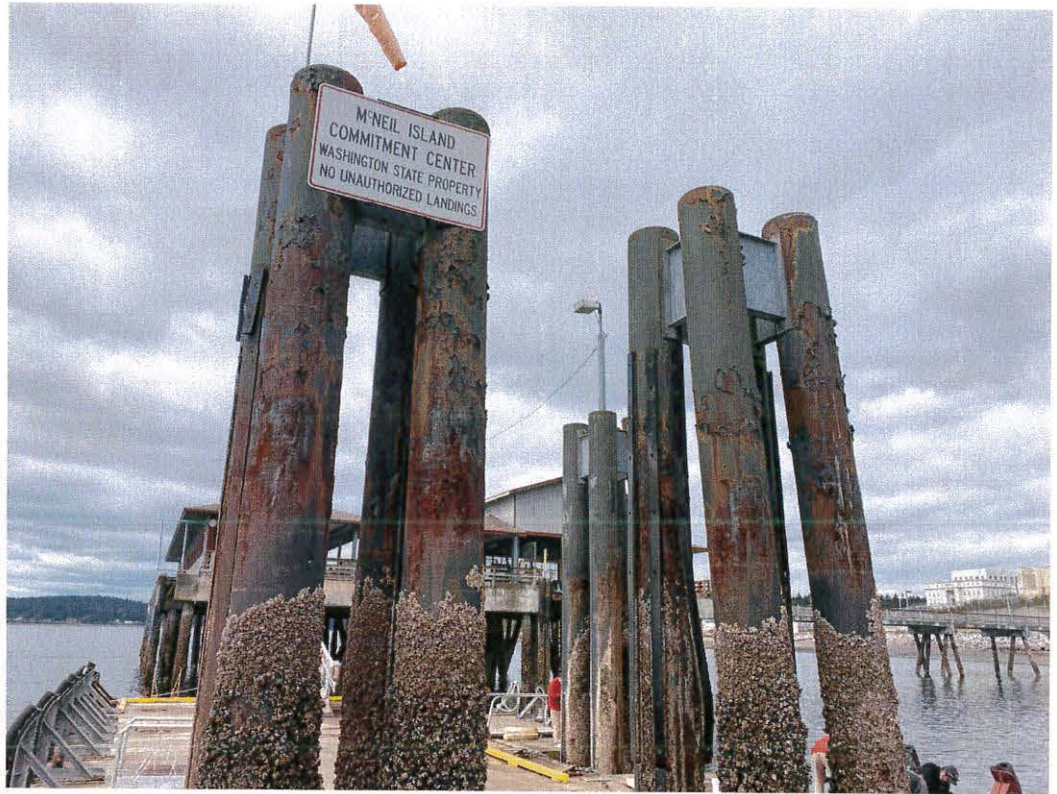
The spud piles have rust blooms in the intertidal zone (photo #39).

Spud pile paint has many rust blooms.

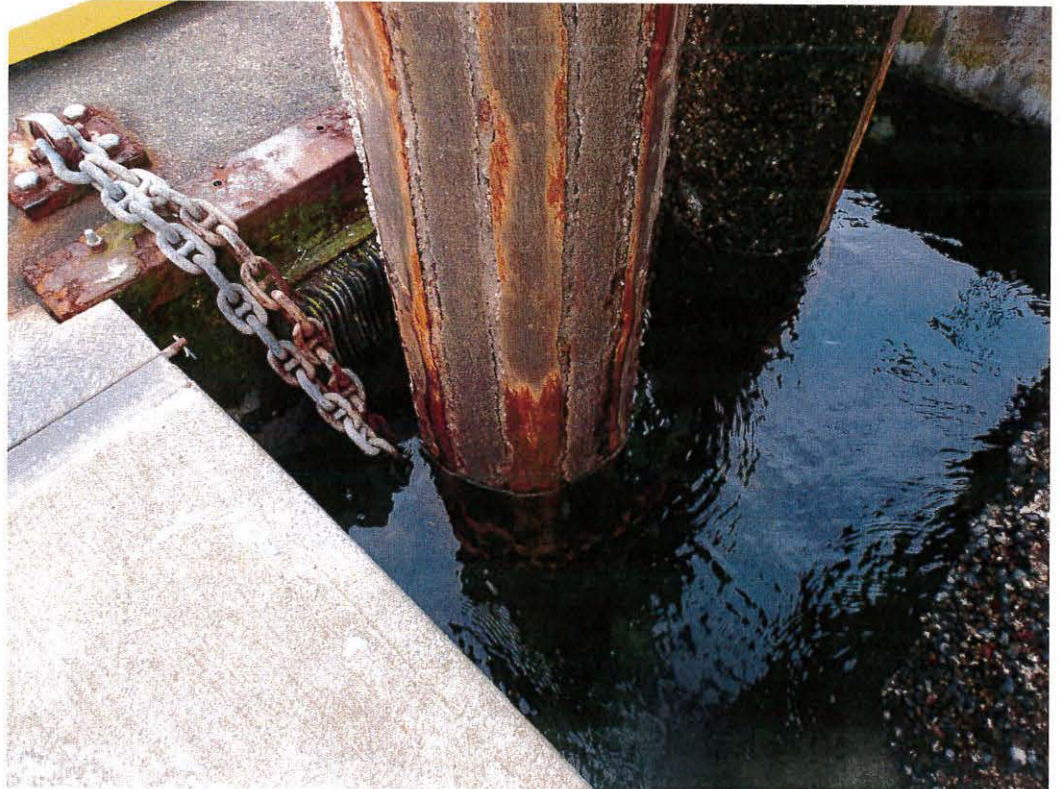
UW-3

The spud pile coating is largely failed in the intertidal zone (ITZ) mainly from pontoon positioning chains rubbing directly on the piles (photo #UW-3). Underwater coating condition below the ITZ is largely intact with only about 5%-10% of the pile surface area showing corrosion on most piling (photo #UW-7).

Typical spud pile condition in the upper intertidal zone (ITZ)

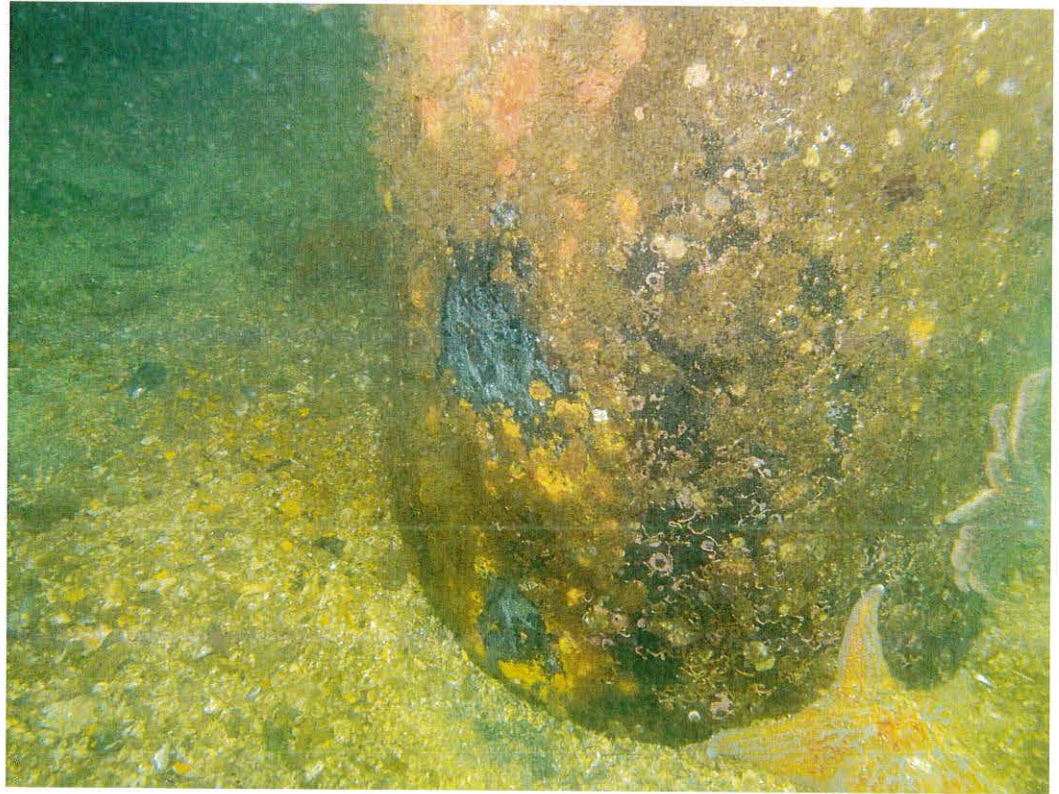
5%-10% coating failure with rusting.
SP4-B shown; typical of other piles.
