**SimplexGrinnell #458 & JCI
9520 10th Avenue South, Suite 100
Seattle, WA 98108
RE: Western State Hospital; Lakewood, WA
318,000 Gallon Bolted STP
August 3, 2018
Ms. Melissa Fraser
Systems Integrity Representative
(206) 291-1439
Job No. 318298-A**

STANDPIPE INSPECTION REPORT

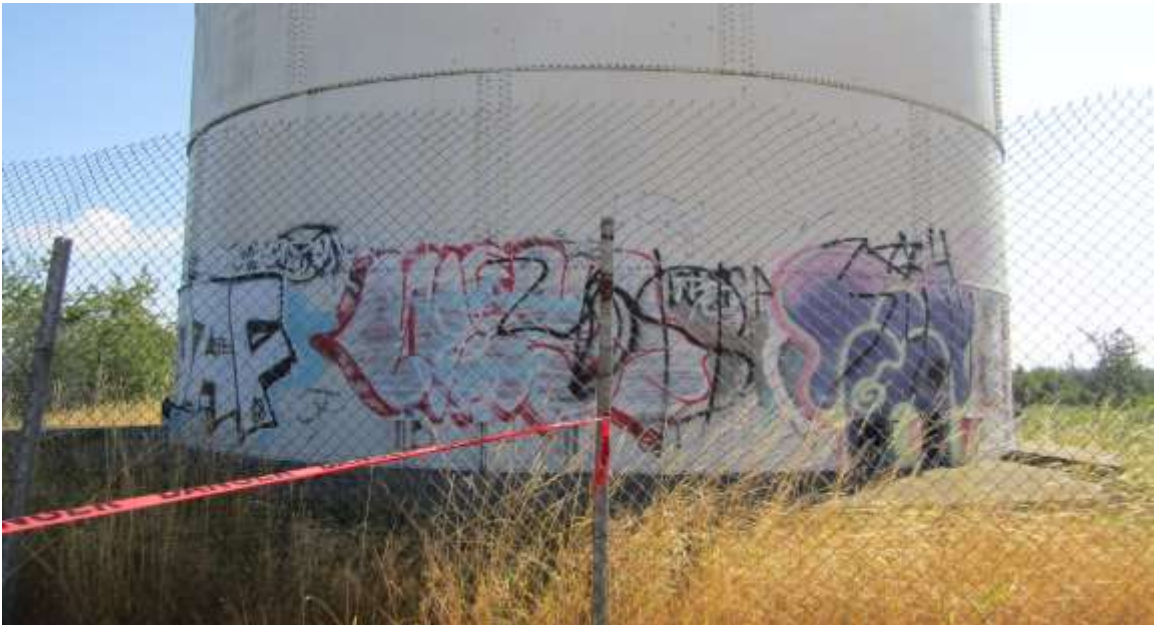
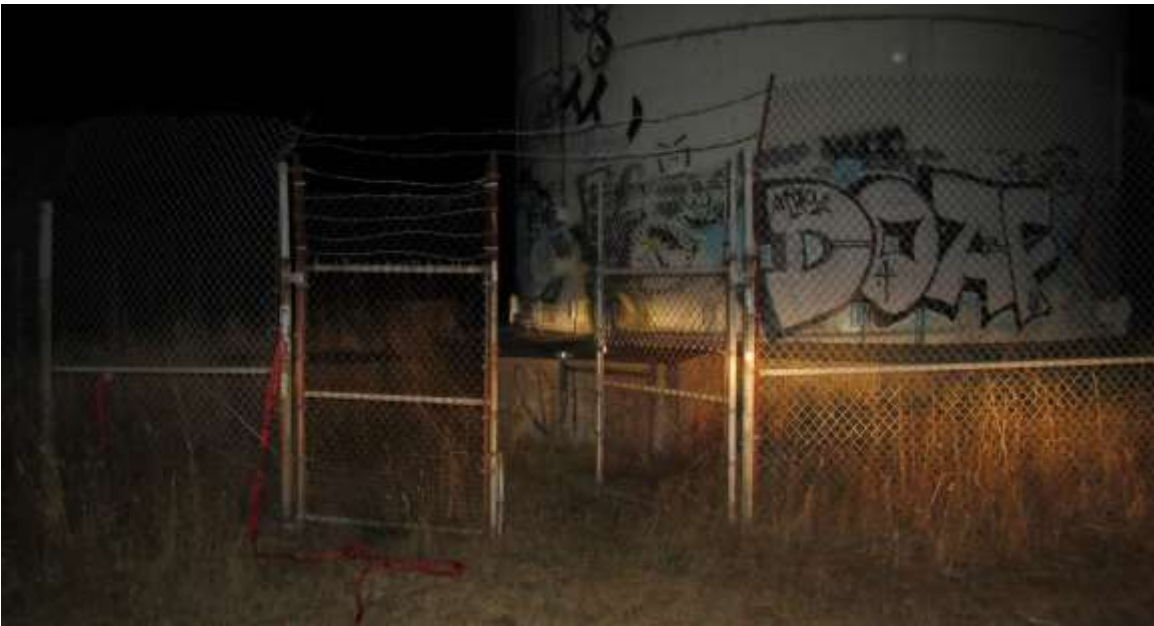
Photos show the tank is secured with fencing. There is no signage on the fence. We recommend posting a **No Trespassing** sign.

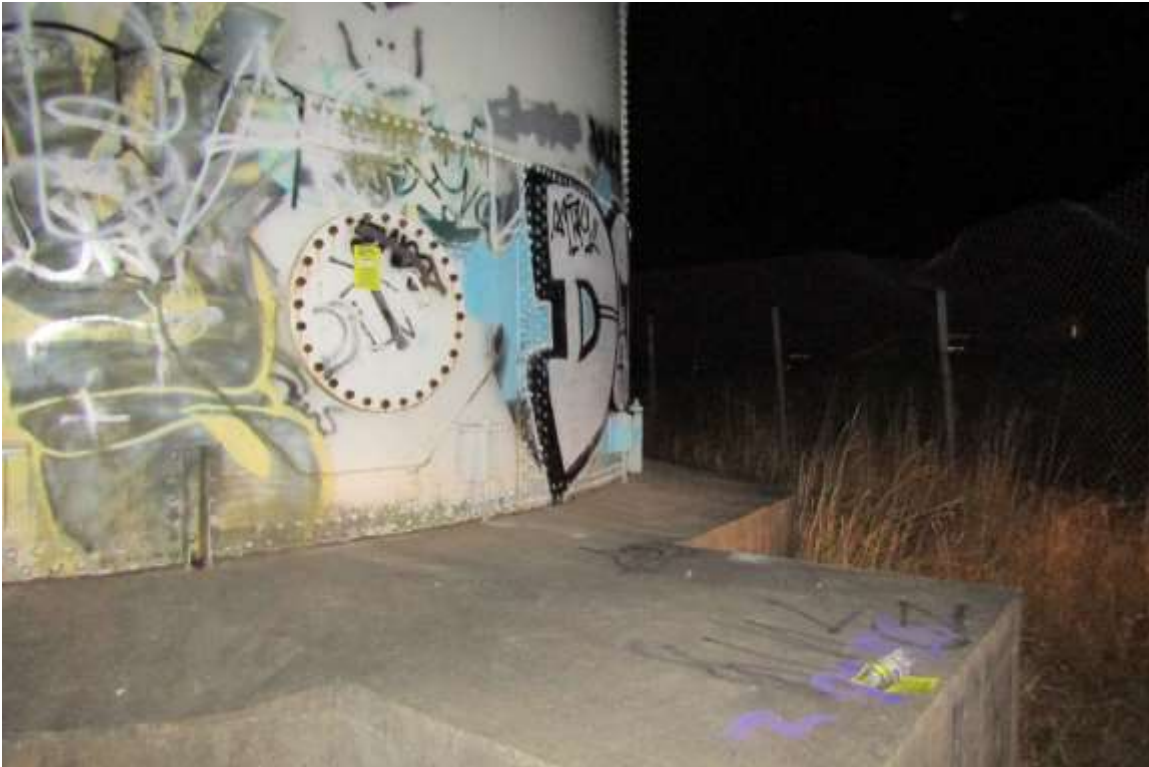
Photo shows the foundation, which is in compliance with [AWWA D103-09; 13.5.1: Height above ground](#) and appears to be in good condition.

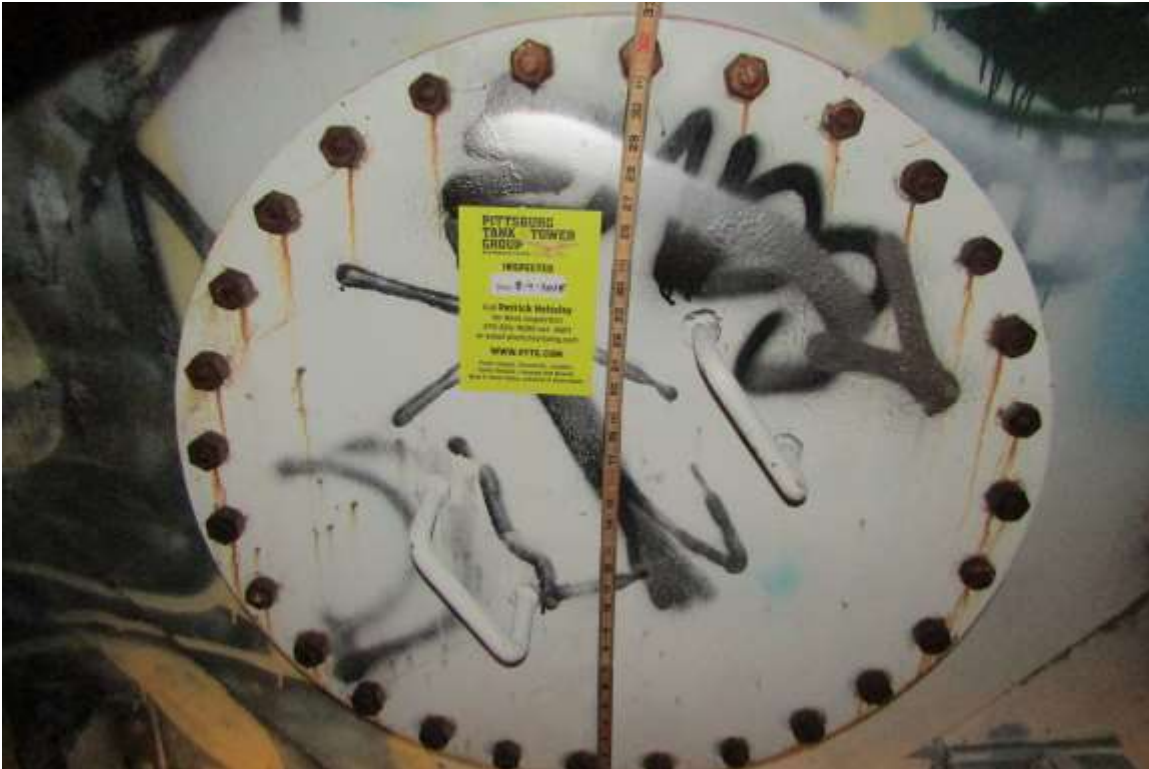
Photo shows the condition of the 24" primary shell manway. **NFPA 22-2018; 14.7.2.1.1** states, "The design of the manholes for steel tanks shall be in accordance with ...and **AWWA D103** for bolted steel tanks." The primary manway requires the following to be in compliance with **NFPA 22-2018; 14.7.2.1.1, AWWA D103-09; 7.1: Shell Manholes** and **OSHA 1910.146(c)(2) Confined spaces**.

We recommend:

- Install a davit arm on primary shell manway
- Install a 30" secondary shell manway 180° from primary manway
- Post **Confined Space Entry** signs
- Install maintenance free galvanized steel bolts

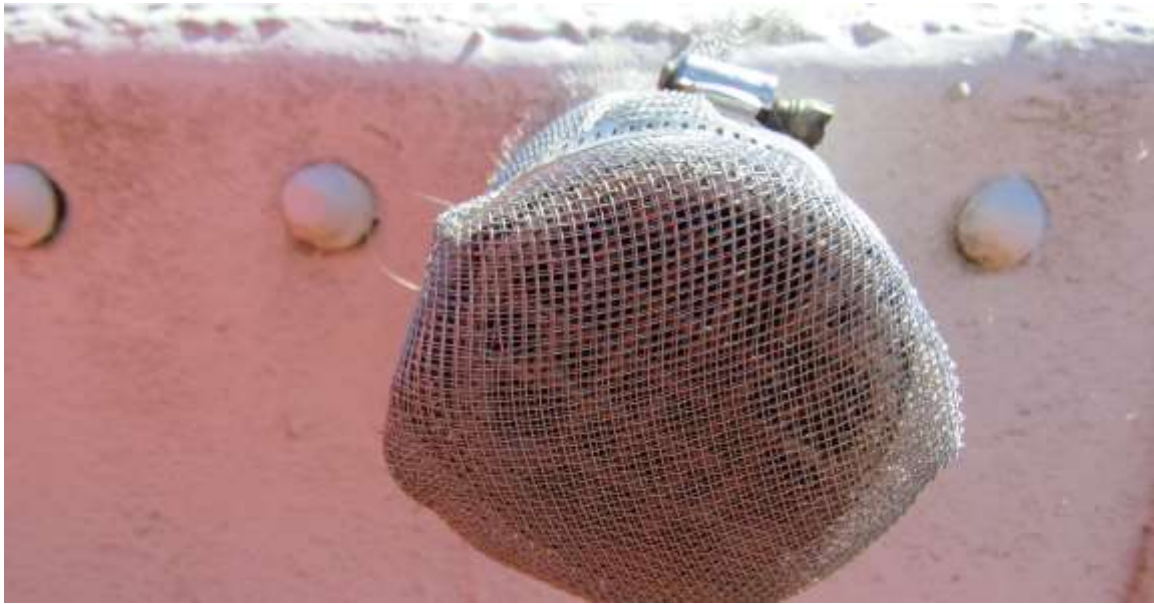
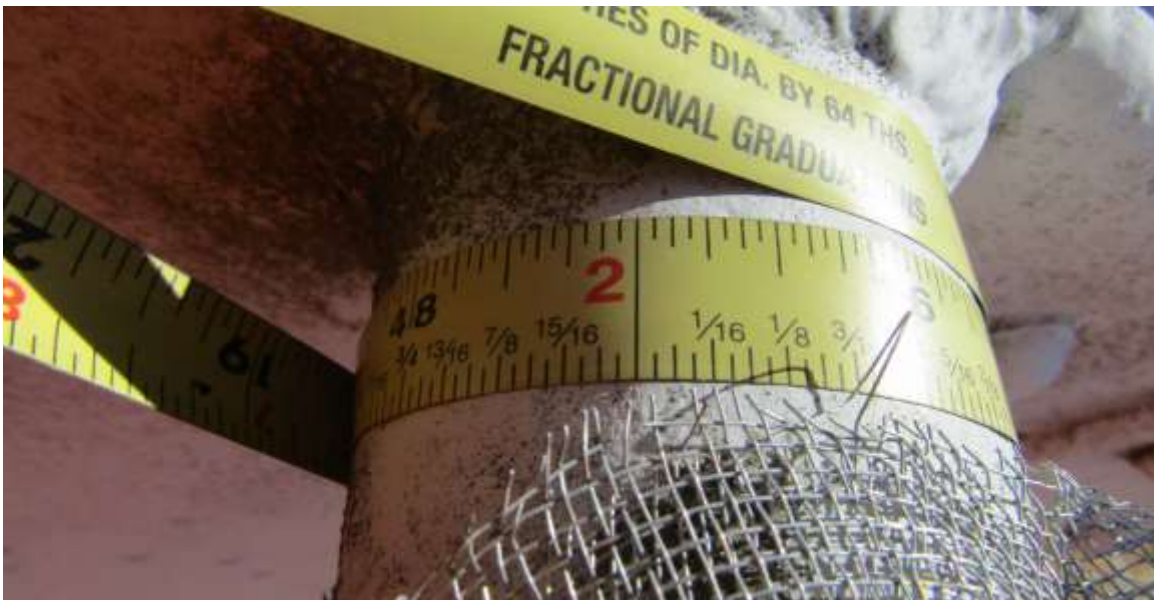
Photos shows the condition of the 2" stub overflow pipe. **NFPA 22-2018; 14.6.3.2** states, "The pipe shall be extended with a slight downward pitch to discharge beyond the tank or balcony and away from the ladders and shall be adequately supported." We recommend extending the overflow down the exterior to grade with same size pipe, complete with standoffs every 10' on center, an elbow at the base fitted with a flapper valve and screen to prevent the ingress of contaminants into the water supply, and a splash pad to direct the water away from the tank foundation. Splash pad to be installed by owner.

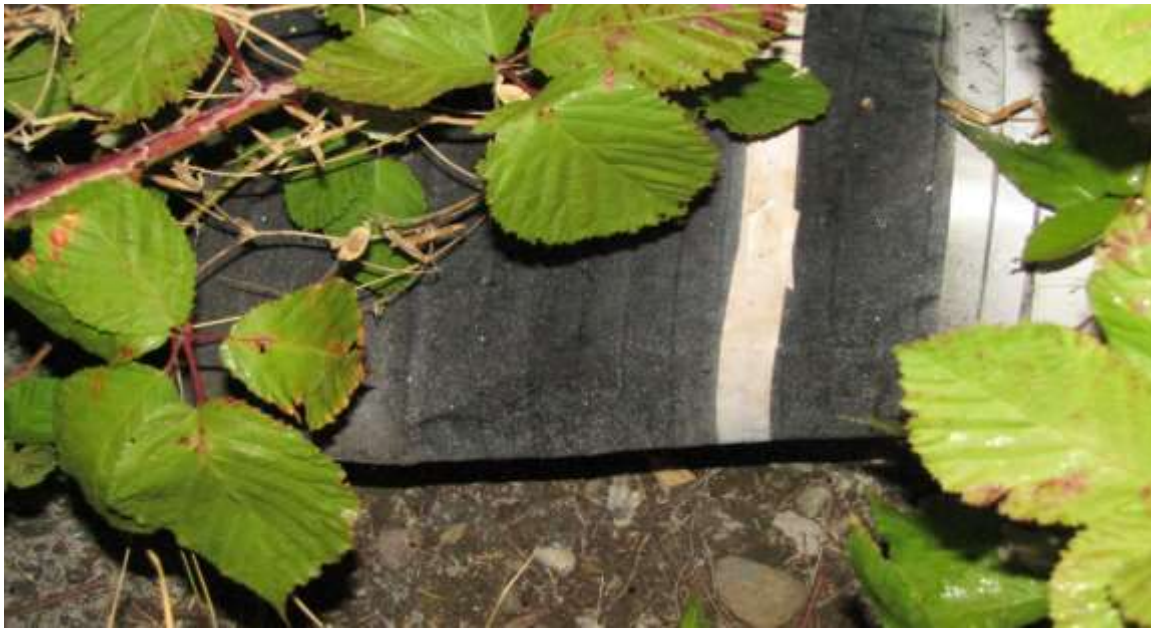
Photos show the 8" overflow pipe system, which is equipped with a flapper valve as required by [AWWA D103-09; 7.3: Overflow](#).

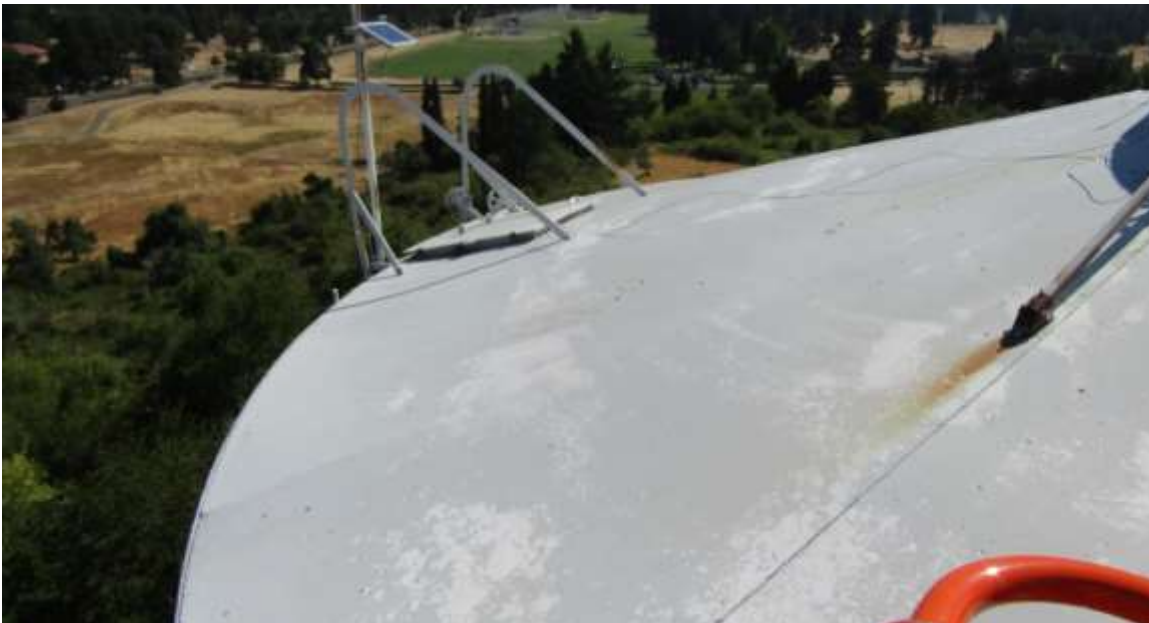
Photos show the tank roof edge is not equipped with a required handrail system for fall protection. **OSHA 1910.28(b)(1)(i)** states, "...the employer must ensure that each employee on a walking-working surface with an unprotected side or edge that is 4 feet (1.2 m) or more above a lower level is protected from falling by one or more of the following: **1910.28(b)(1)(i)(A) Guardrail systems.**" We recommend installing an **OSHA** compliant 42" high handrail system around the circumference of the tank roof, complete with intermediate rail, toeboard and a swing gate at the junction of the shell-to-roof access ladder and tank roof.

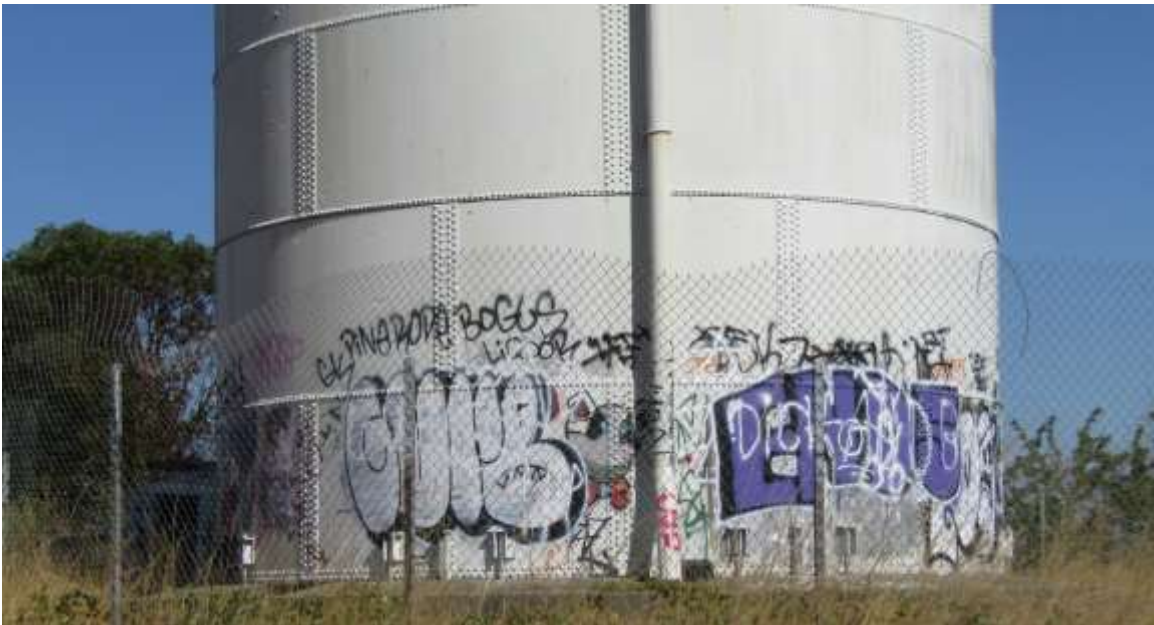
Photos show the tank exterior coating system. We recommend pressure washing the tank exterior with biodegradable detergent injection (minimum 1,500 psi at 1.5 gpm), spot prime and apply one (1) full coat of epoxy mastic, followed by a top coat of polyurethane.

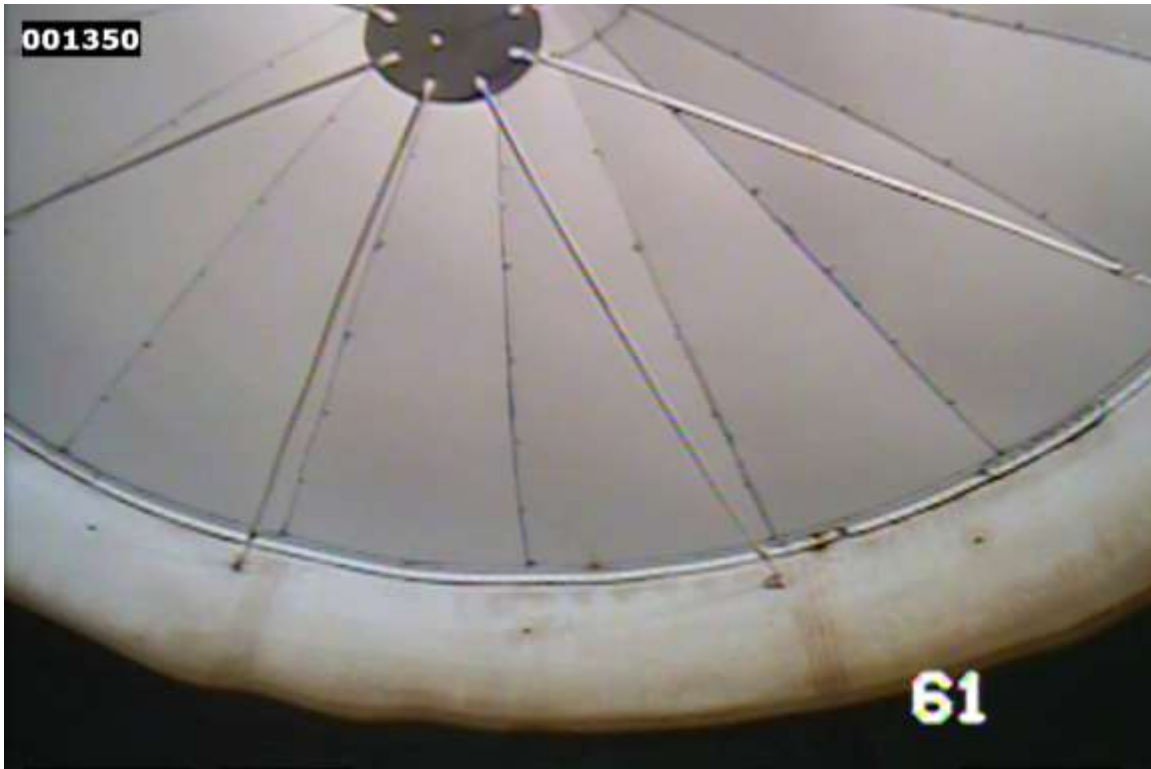
Photo shows the interior roof, which appears to be in good condition.

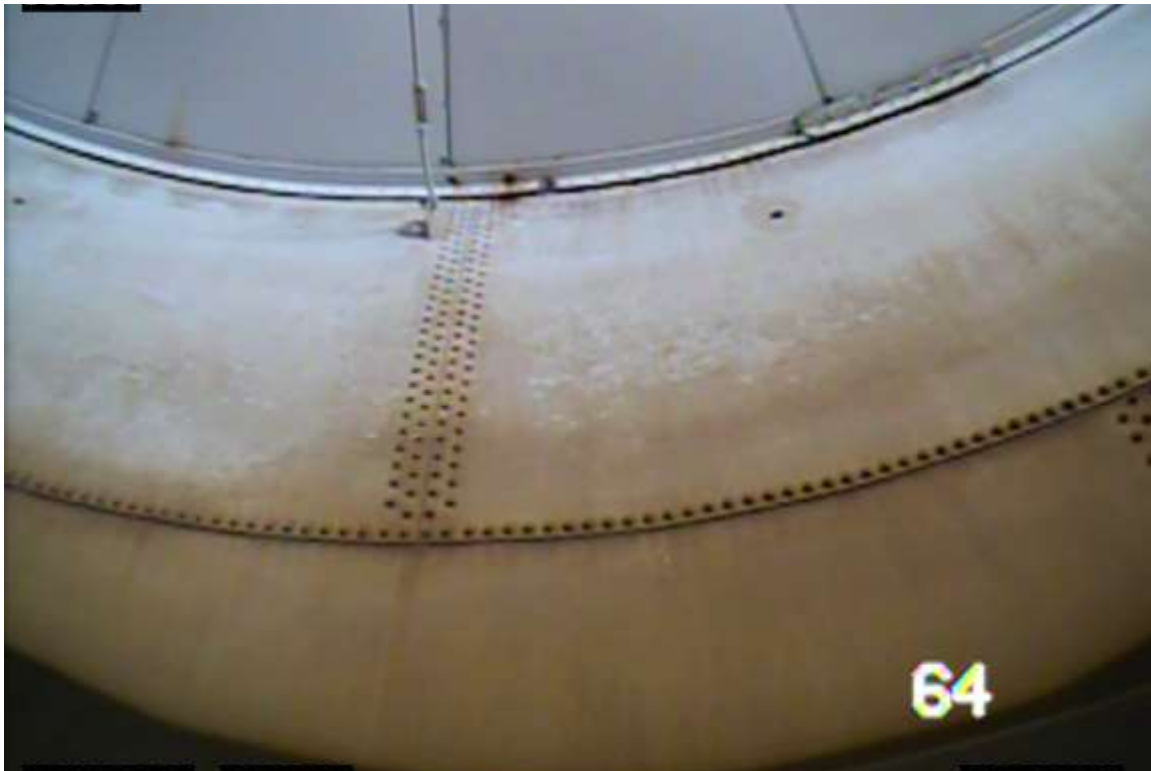
Photo shows the interior roof-to-rim angle connection, which appears to be in good condition.

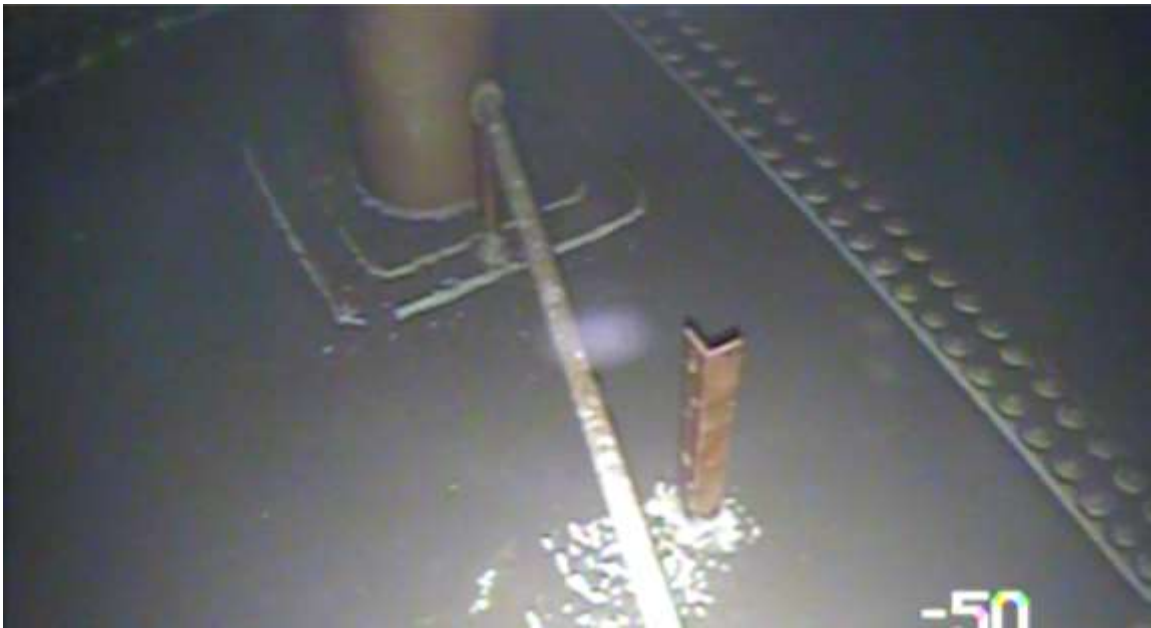
Photos show sediment and debris in the tank interior prior to the performance of the tank clean out.

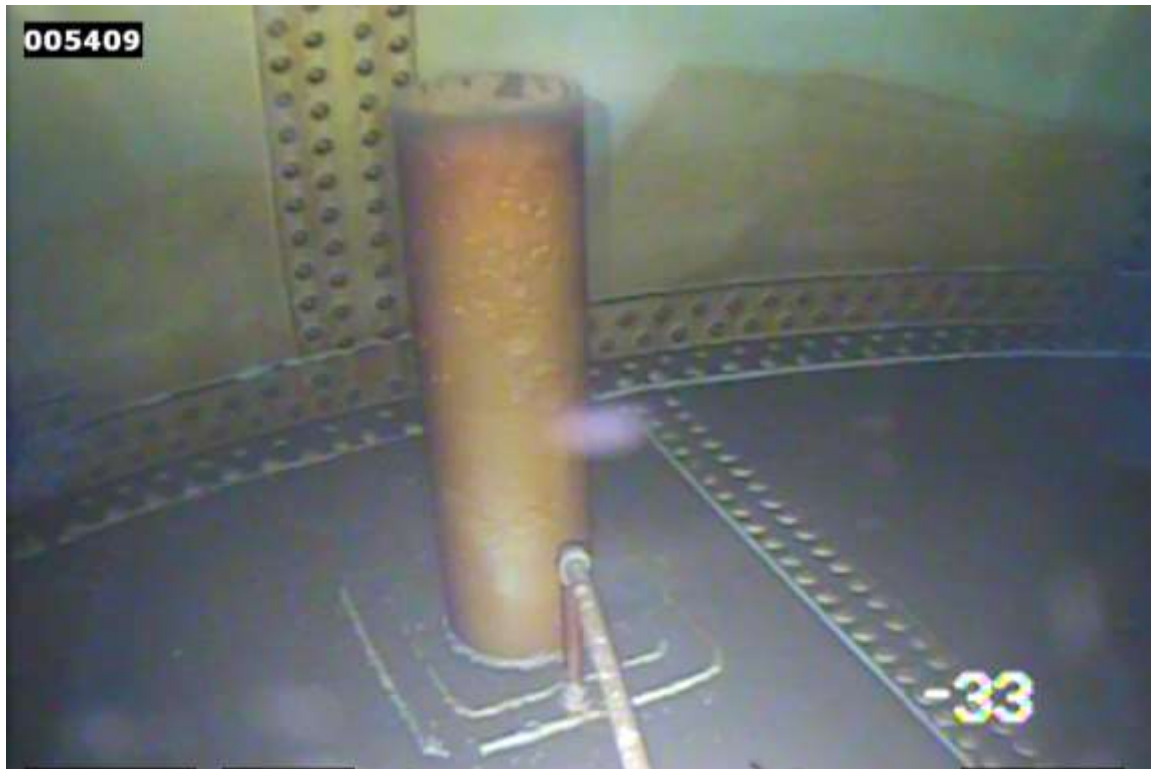
Photo shows a suction pipe on the interior of the tank. **NFPA 22-2018; 14.2.13.1** states, “ The discharge outlet for every suction tank shall be equipped with an anti-vortex plate assembly.” We recommend installing a properly sized anti-vortex plate on the suction pipe to prevent formation of a vortex.

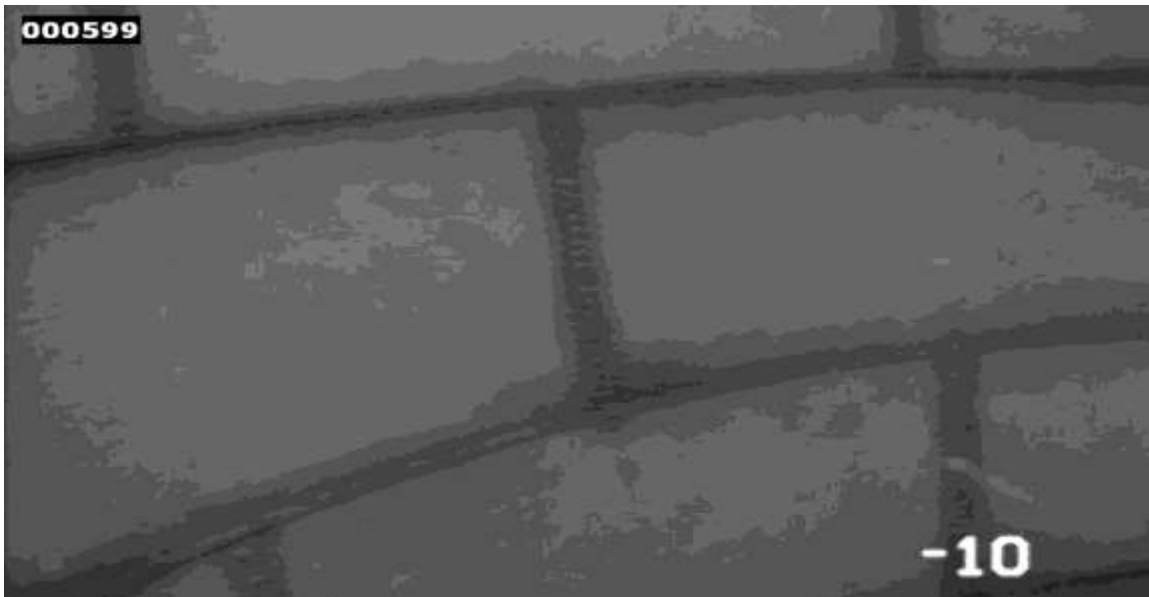
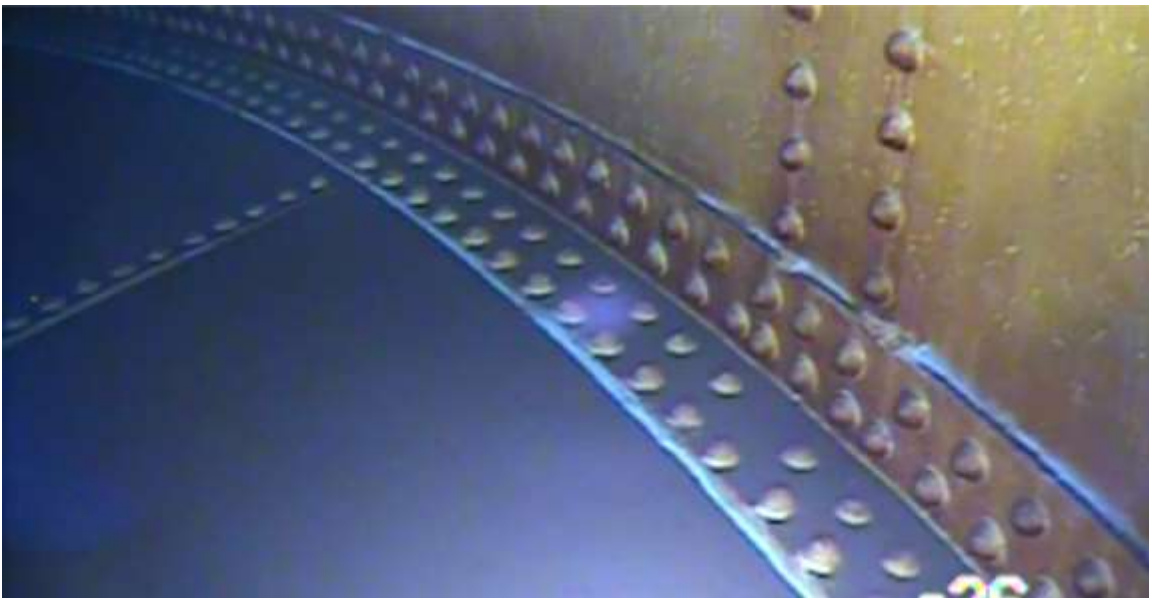
Photos show the tank interior bolt seams. We recommend cleaning the interior seams, then as needed applying a high solids CIM 1000 Trowel grade rubberized coating to all horizontal and vertical seams on the tank interior shell, floor and around the circumference of the shell-to-floor connection. This coating allows up to 350% elongation due to contraction and expansion caused by thermal shifts as well as filling and draining of the tank. All seams will be dry prior to application for proper adhesion. CIM is a flexible coating that also responds to potential leaks. This product is applied thicker than most coatings at up to 30 mils resulting in longer life.
