Roof SURVEY REPORT

Limited Roof Survey and Leak Investigation

Rainier School Building 2010

Buckley, Washington

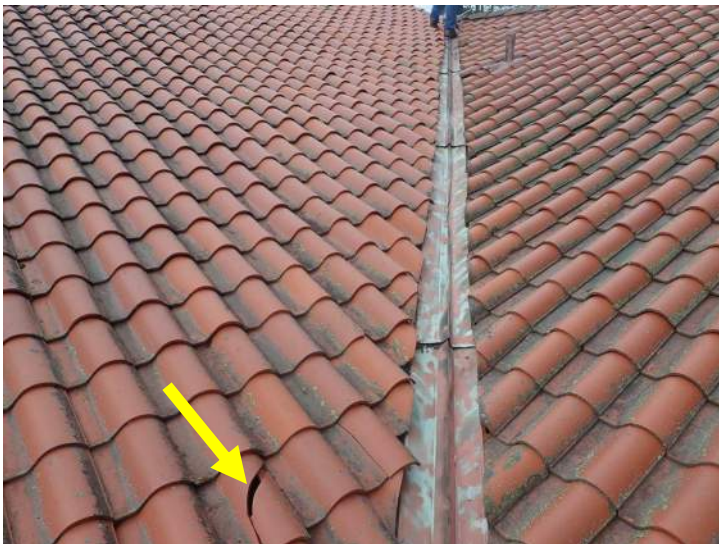
Photo No. 11 - Observations at Typical Valley

The copper valley flashing liner is in poor condition at this time. The center rib has been creased and pressed down flat in several locations and should be replaced with a new sheet metal valley as part of a reroofing project. Several cracked, and/or displaced roofing tiles were also identified along the valleys and field of the roof areas.

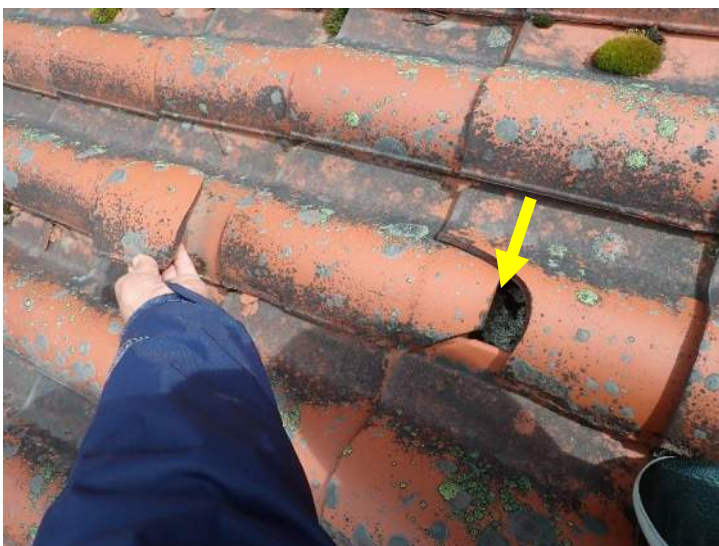
Photo No. 12 - Example of Cracked and Broken Roof Tiles Observed in Field of the Roof Areas

Close-up of typical cracked clay roofing tiles observed at the subject roof areas. The photo shows the exposed 1-ply underlayment beneath the tiles leading to the potential of water intrusion. UV exposure accelerates the aging of the underlayment, causing deterioration and potential failure of the underlayment.

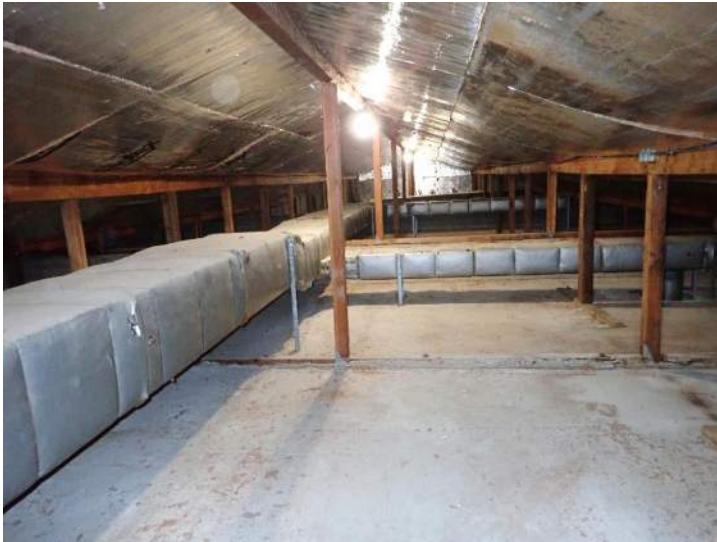
**Photo No. 13 - Building 2010 Attic
Photo in West Roof Area**

Area separation walls within the attic break the overall space into three separate attic sections. This photo depicts existing attic conditions within the west side of the subject roof area looking west. Foil-faced polyisocyanurate insulation is mechanically-attached to the underside of the tongue-and-groove wood roof decking.

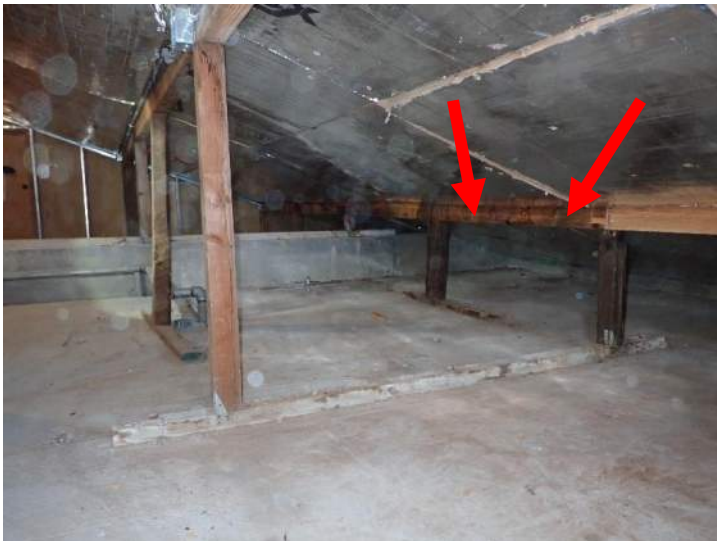
**Photo No. 14 - Building 2010 Attic
Photo in Center Roof Area**

Depicts conditions at the west section of the attic near the area separation wall within the center attic area. The arrows show evidence of water staining on the wood beams. The insulation inhibits identification of leak sources and acts to trap rain water against the wood decking, causing further damage and decay to wood framing components.

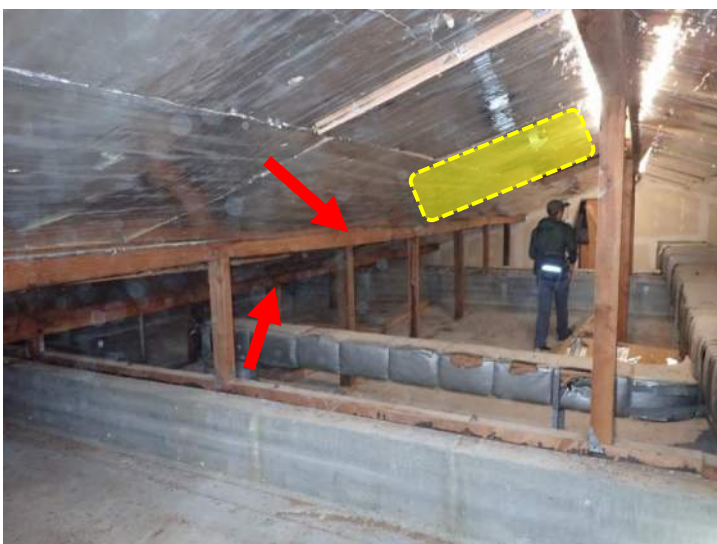
**Photo No. 15 - Building 2010 Attic
Photo in West Roof Area**

The 2x6 T&G wood decking runs parallel with the roof slope and is supported along the ridge line, two intermediate beams that extend the length of the attic and along the downslope eave edge. The two arrows identify the two intermediate beams that have been framed at approximate 10'-3" spacing intervals. The general test opening area is also shown.

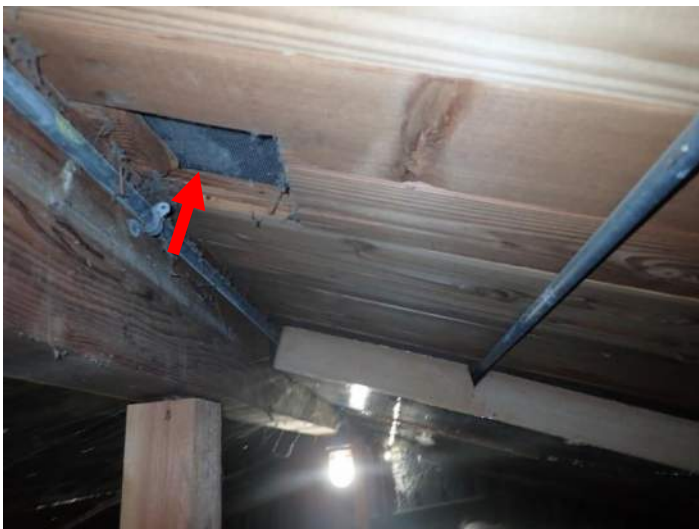
Photo No. 18 - Attic view at Ridge Vent Location

The arrow depicts the cut-out of the wood decking at the location of the small ridge vent that was blocked by the insulation. The wood at the vent appears to be in good, dry condition. Evidence of water intrusion and staining was observed downslope. The following photos depict those conditions.

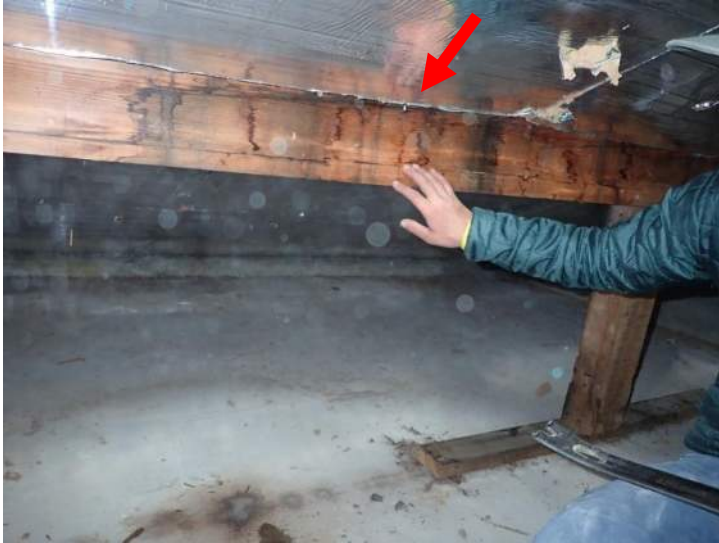
Photo No. 19 - Systemic Water Staining at Attic Wood Beams

Downslope of the ridge vent at the beam located closest to the eave, extensive evidence of water intrusion was observed. As we worked to remove the insulation, water that had been trapped against the wood decking by the 4-inch insulation panels actively dripped onto the concrete below.

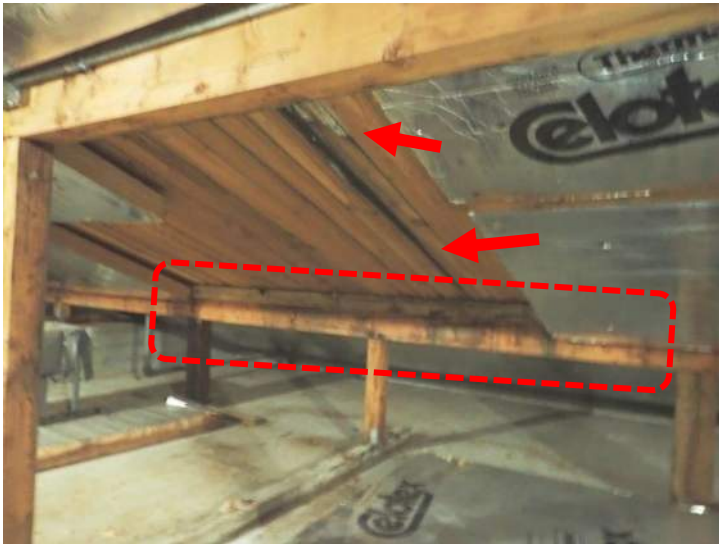
Photo No. 20 - Water Staining at Attic Structural Members

With insulation panels removed, this photo shows water staining running down the roof decking. The arrow at the top of the photo shows an area of biological growth on the wood surface. Water staining was observed along most of the length of the downslope wood beam indicating systemic water intrusion.

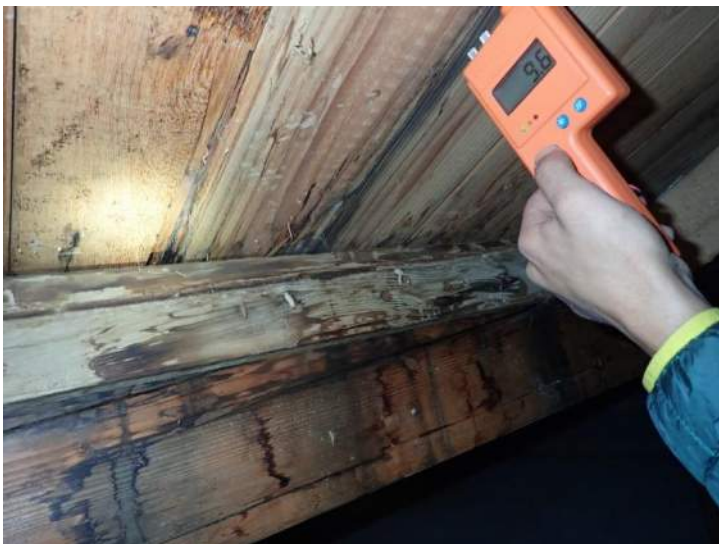
Photo No. 21 - Moisture Meter Readings at Roof Deck

Photo of water staining on the T&G wood decking and 4x10 wood beam. Water staining was observed throughout the attic. The photo shows a Delmhorst BD-2100 Moisture Meter used to measure moisture content of the wood. This photo shows a reading 9.6%, during an unusually on-going dry spring season, while others measured approx. 20%, which is considered significantly elevated and will promote further fungal growth and wood decay.

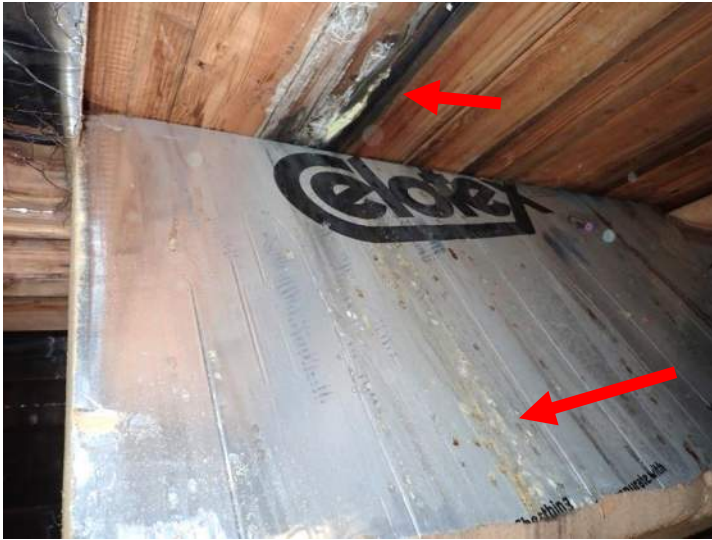
Photo No. 22 - Water Staining and Biological Growth Trapped by Insulation

As other insulation panels upslope where removed, the water staining continued. The white colored substance appeared to be biological growth (i.e. mold). Water staining on the top-surface of the insulation against the wood decking, showed signs of staining on the foil-facer.

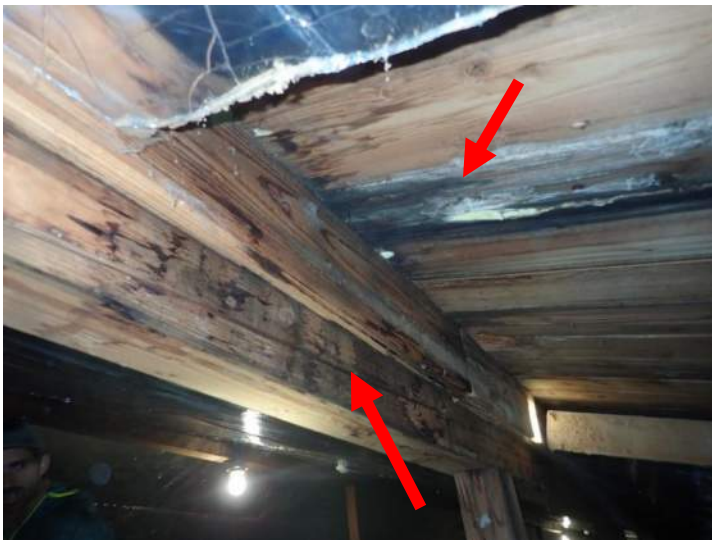
Photo No. 23 - Water Staining and Biological Growth on Wood Structure

Closer photo of water staining and biological growth which had been in contact with the intermediate beam closest to the ridge.

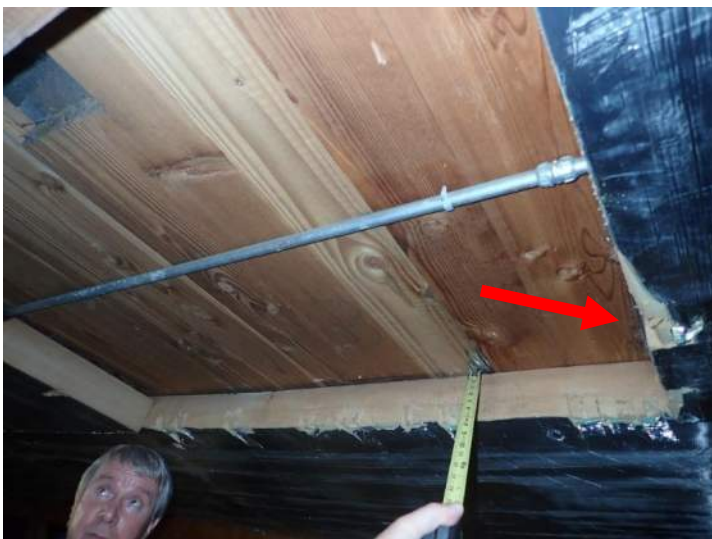
Photo No. 24 - Attic Conditions Downslope from Ridge Vent

The water staining shown in previous photos continued to extend upslope and appeared to originate near the point of the arrow. For reference, the cutout for the ridge vent is shown in the upper left corner.

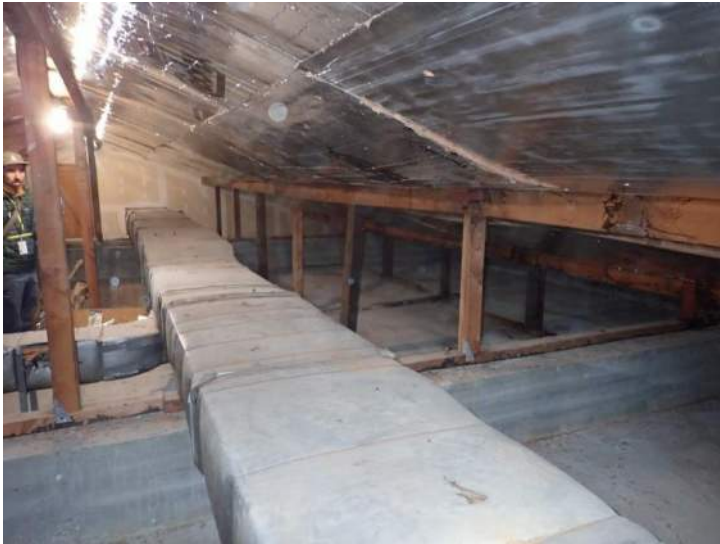
Photo No. 28 - Attic View within West Section of Roof

Photo looking east within the west attic area. The photo shows several areas of water staining along the supporting posts and beams.

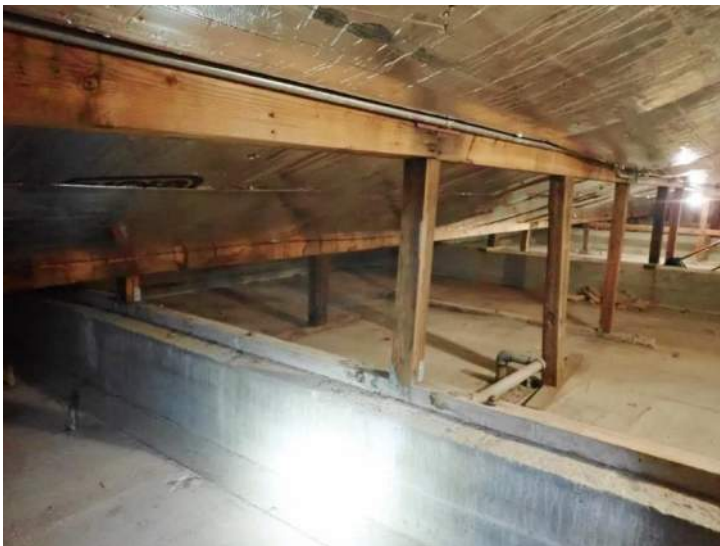
Photo No. 29 - Attic View within Central Section of Roof

Photo near the stair access of the central area in the attic. Again, several areas of water staining on beams were observed.

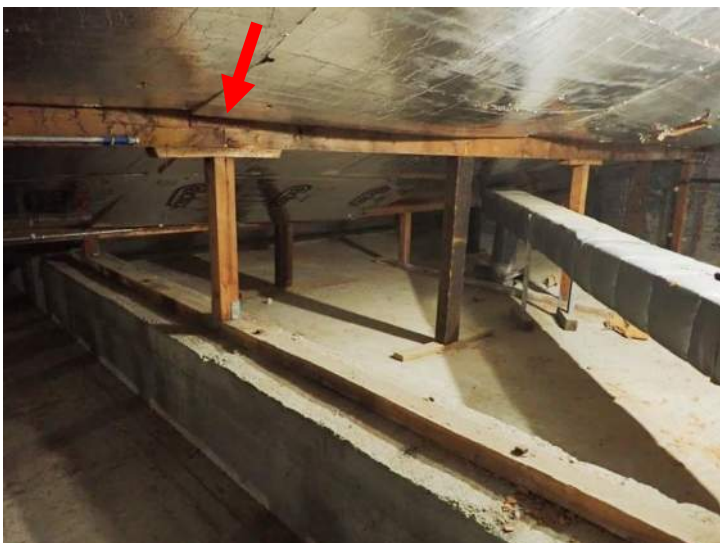
Photo No. 30 - Attic View within East Section of Roof

Depicts evidence of water staining near the east gable end of the east attic area. Please refer to Site Visit Report prepared by Harbor Consulting Engineer's regarding structural components.

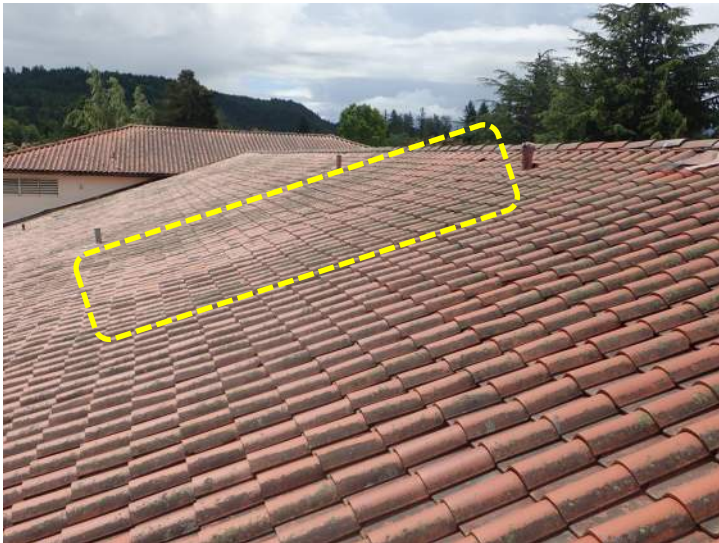
Photo No. 32 - Area of Visual Sagging of Roof Components at Center Wing of Building

During our survey we also observed an area of deflected/sagging roof-related components at the center roof area adjacent the valley on the east side of the roof areas. Several large electrical conduits are located below the area and attached to the underside of the roof decking. This area is an area of critical concern and is recommended to be repaired immediately.

View of area of concern as photographed from the valley. A large section of the clay tile roofing appears to be sagging. This area was not part of our initial survey area; however, we recommend additional survey effort take place along with potential emergency repairs to address the noted issues.

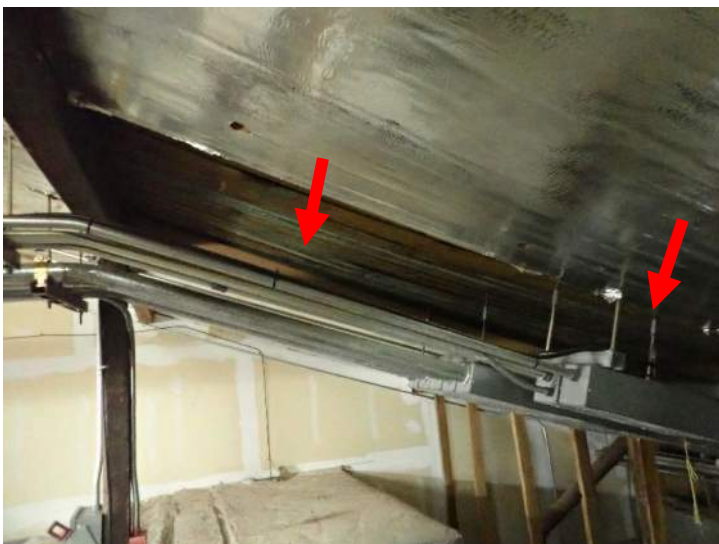
Photo No. 33 - Attic View Below Area of Concern

At the interior of the area of concern, where deflected/sagging roof-related components were visually observed, several electrical conduits and mechanical services were located and supported by the roof decking. This is an area of critical concern and is recommended to be repaired and corrected immediately.

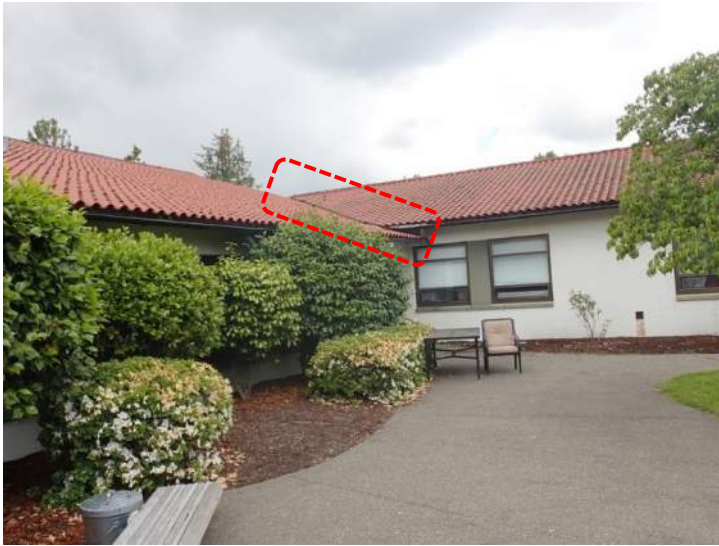
Photo No. 34 - Valley at East Side of Roof Survey Area

Water intrusion was also identified to be problematic at the two valley locations observed during the survey. The valley shown in this photo is located in the courtyard space between the north and center roof sections on the eastern side of the building. The valley flashing was in poor condition and evidence of water intrusion within the attic was prevalent.

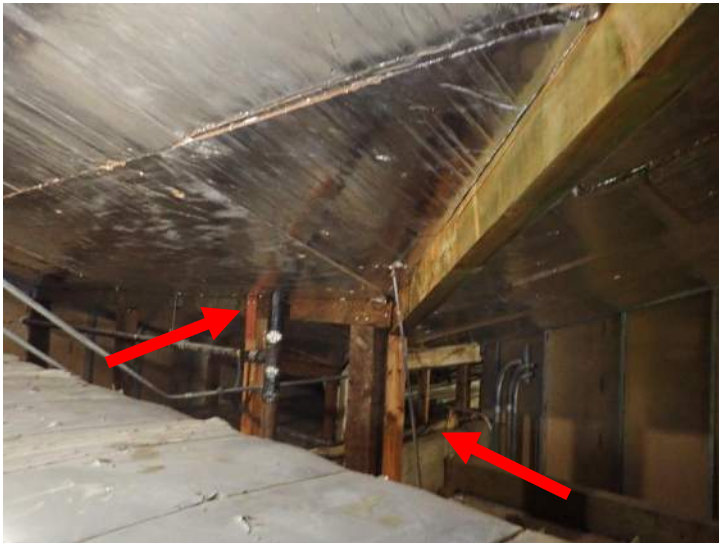
Photo No. 35 - Evidence of Water-Staining at Valleys

Systemic observations of water intrusion were noted along both of the valley's that intersect the north wing roof area. Select wood framing members may also need to be replaced due to water-damage and decay at the valley locations. Evidence of staining on the concrete floor was also evident.

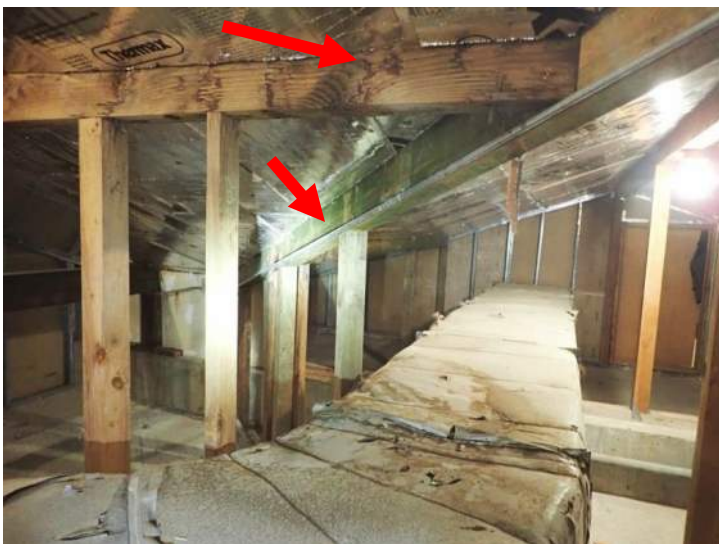
Photo No. 36 - Evidence of Water-Staining at Valleys

The west side valley also showed evidence of water intrusion. On other campus buildings, the existing valleys have been problematic with on-going water intrusion issues. Redesign and retrofit of the valleys and flashing systems is recommended.

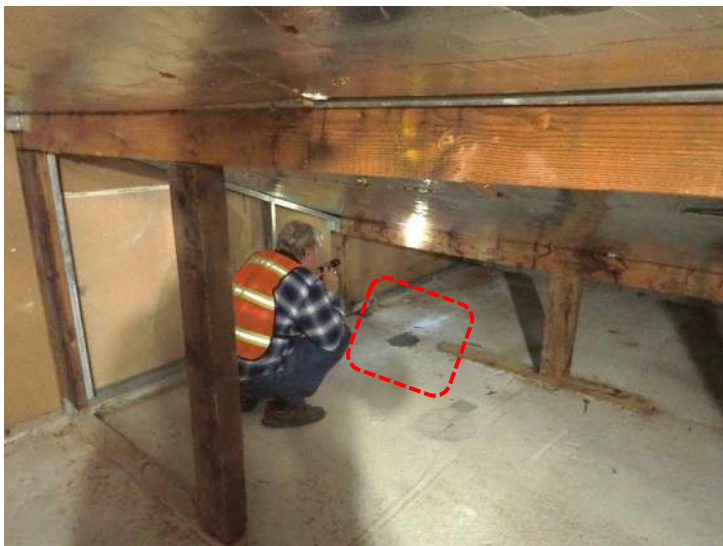
**Photo No. 37 - Rain-water leaks
Following Brief Storm During Survey**

Following a brief, but heavy rainfall during our survey, rain water was observed dripping from the roof at a minimum of three locations observed during a cursory walk through. This is example is located in the central roof area towards the west of the stairs.

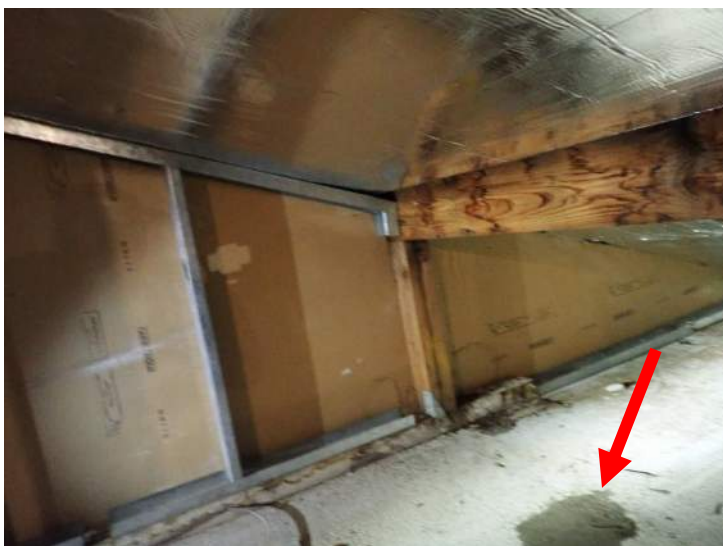
**Photo No. 38 - Rain-water leaks
Following Brief Storm During Survey**

Closer view of rain water collecting on the concrete attic floor following the rain storm.

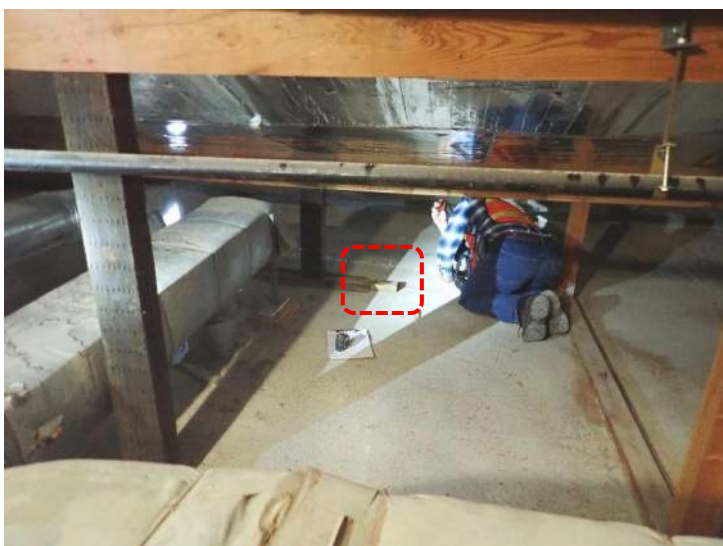
**Photo No. 39 - Rain-water leaks
Following Brief Storm During Survey**

Rain water was also observed dripping from the 4x10 wood beam in the east attic area and dripping on the 2x4 wood sill plate below.

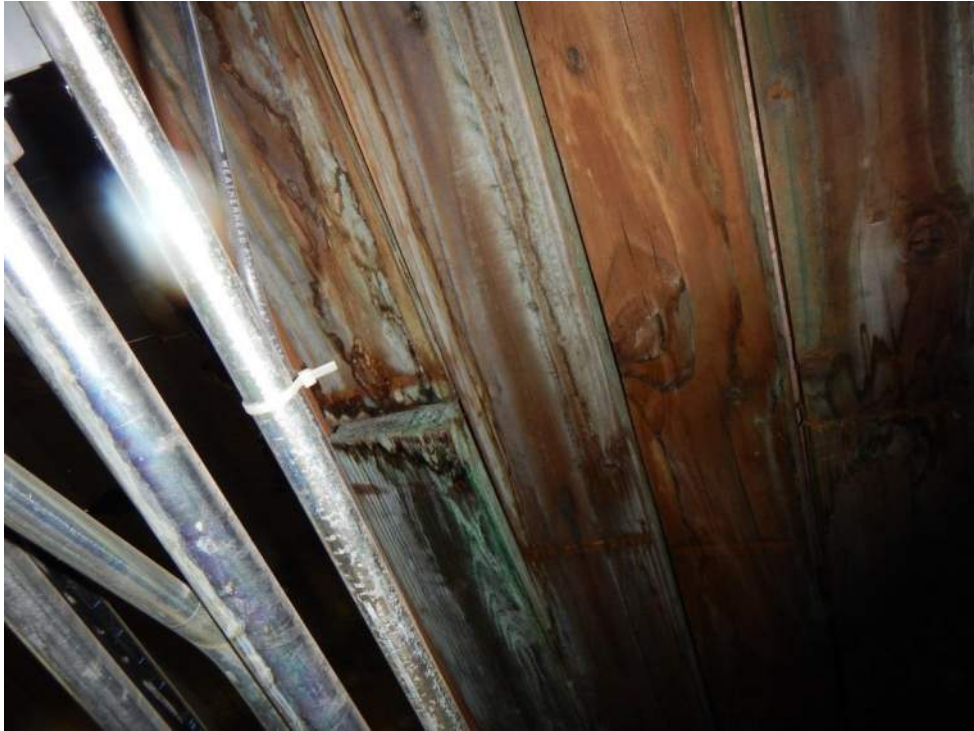
Photograph # 7: Example for water seepage staining on soffit of decking.

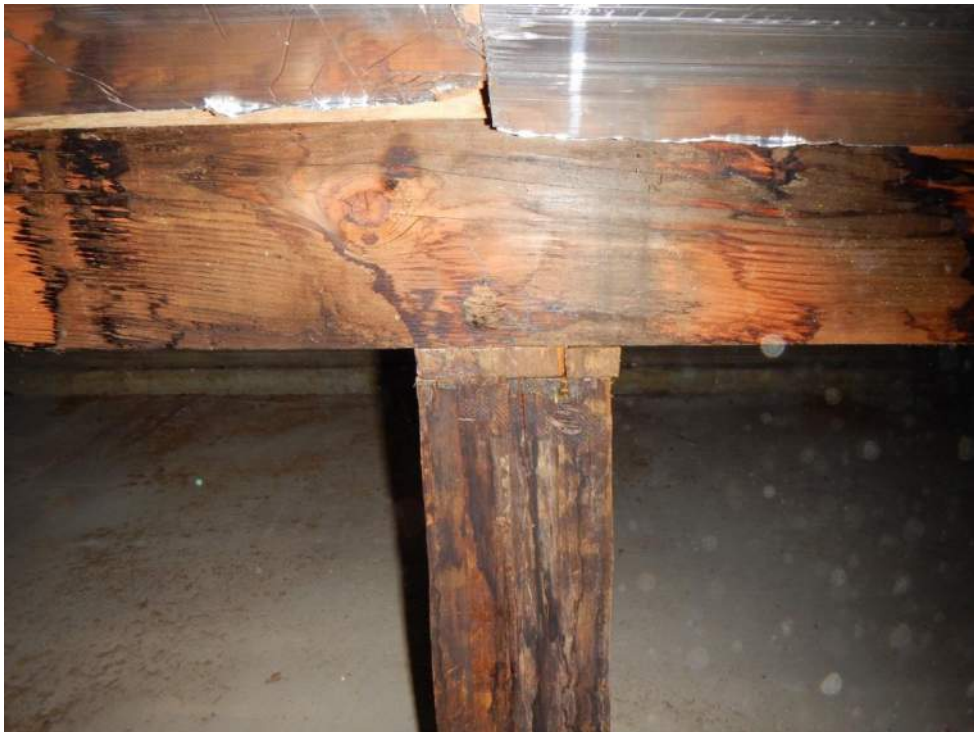
Photograph # 8: Example of water seepage staining on beam and post.

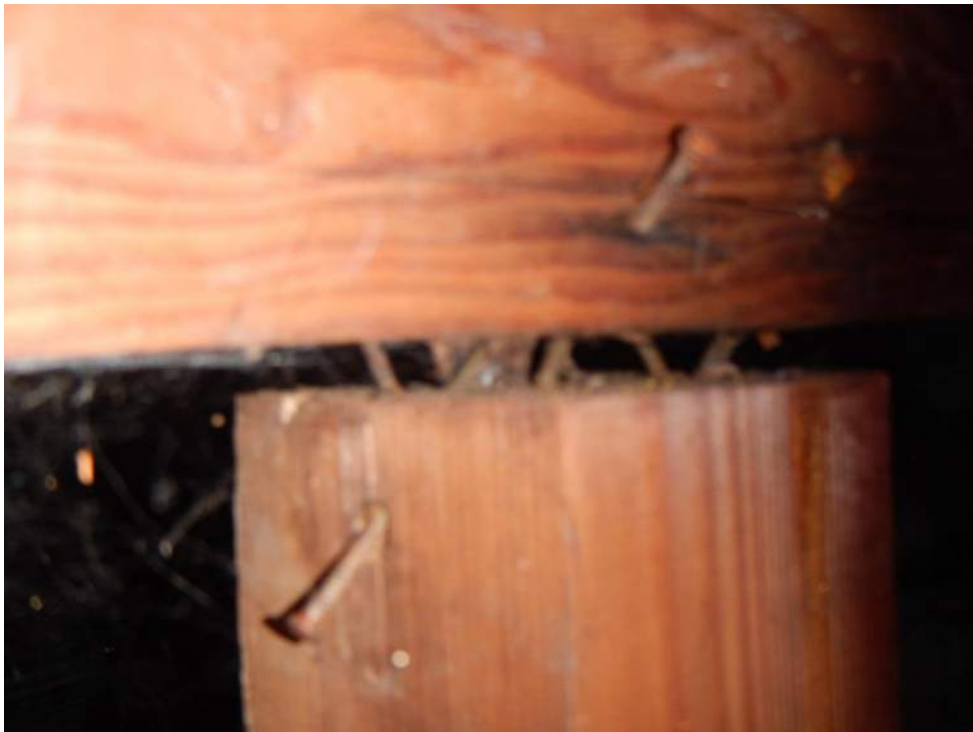
Photograph # 10: Ridge beam not in contact with support post.

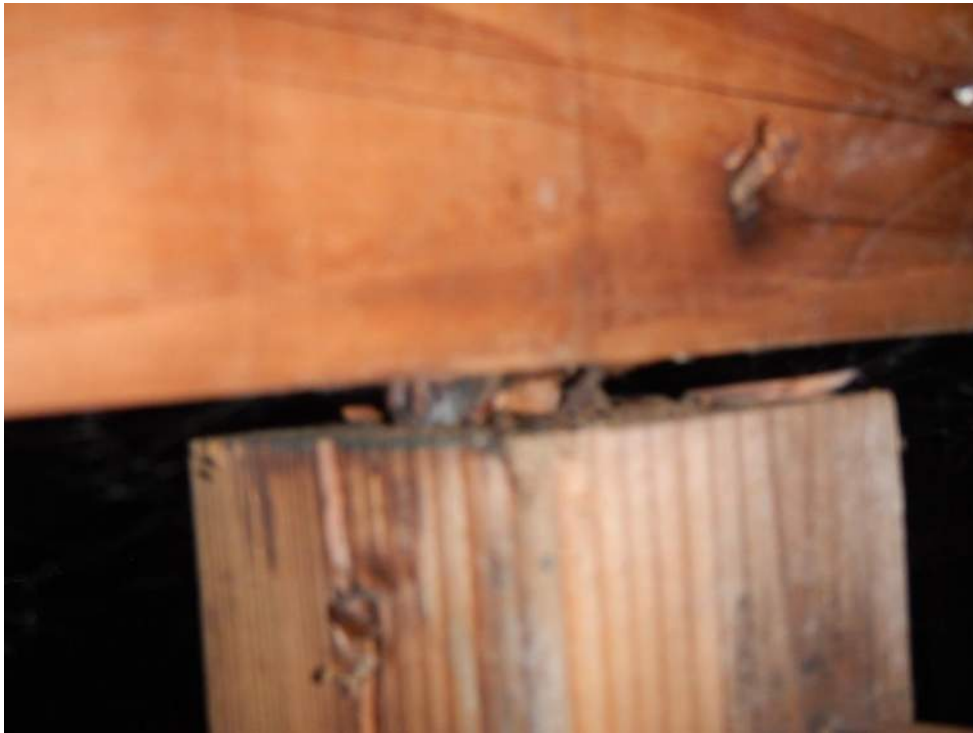
Photograph # 11: Ridge beam not in contact with support post.

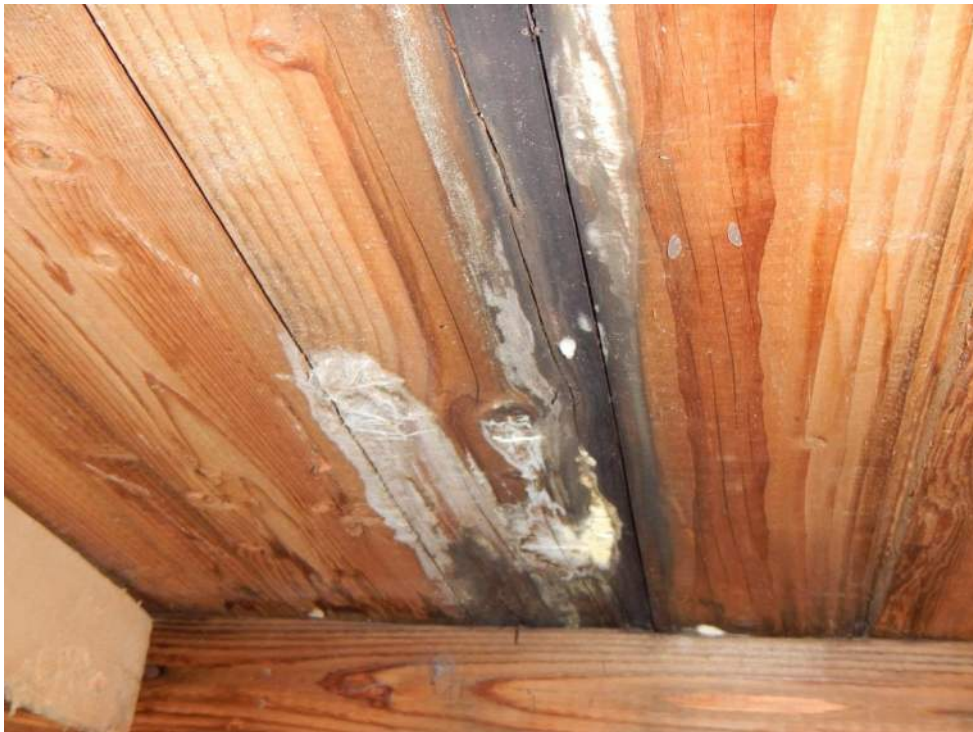
Photograph # 12: Example of timber roof deck decay at soffit.

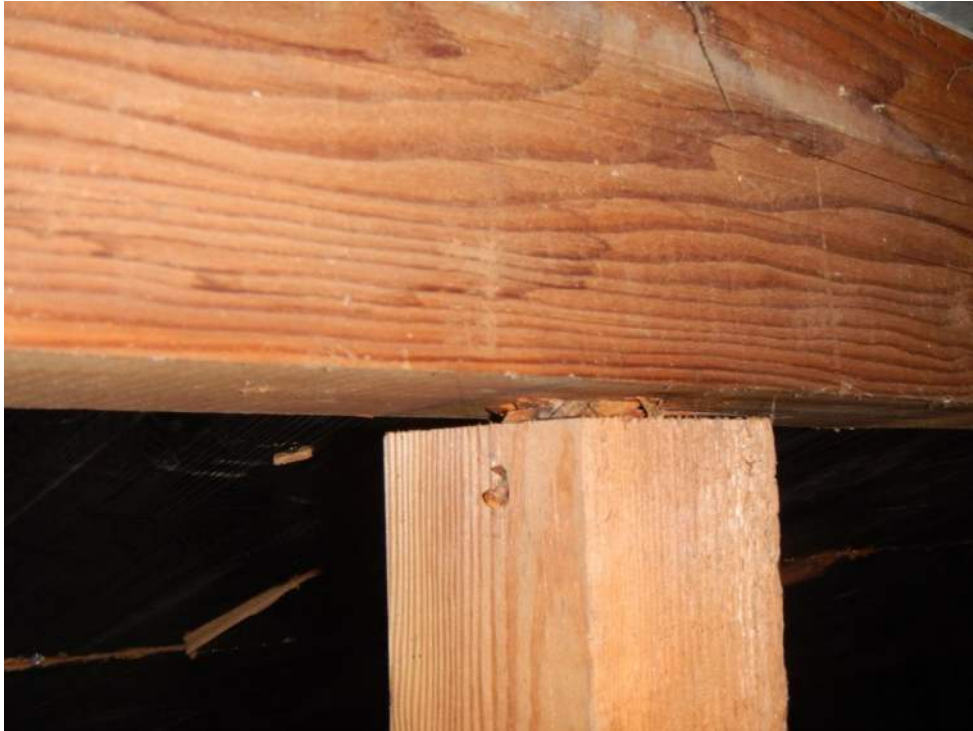
Photograph # 13: Ridge beam not in contact with support post.

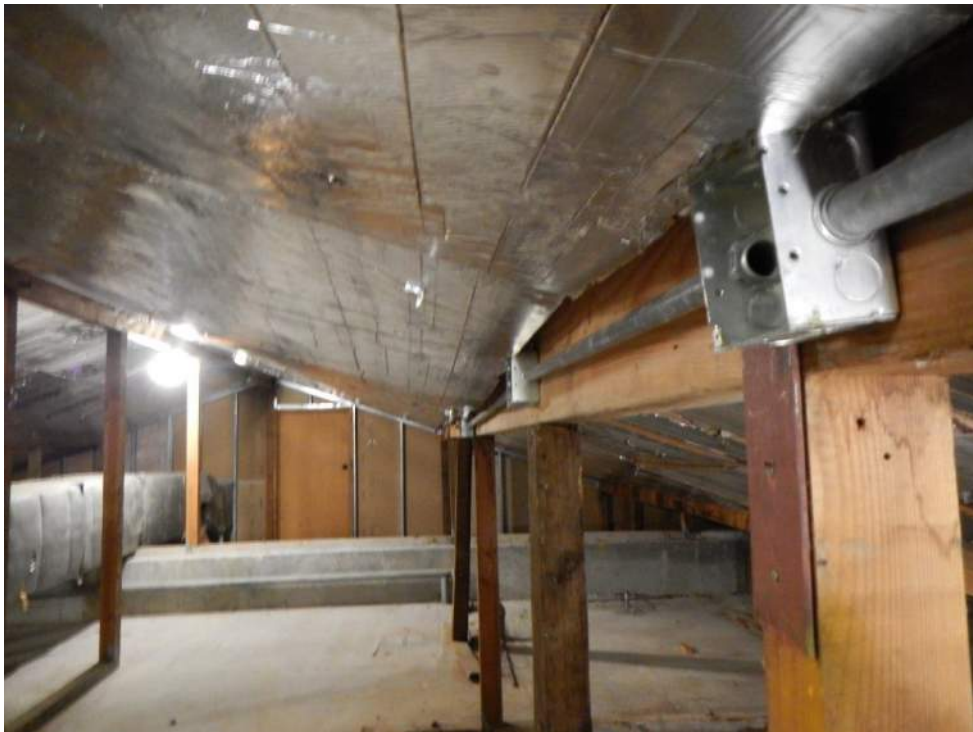
Photograph # 14: View of attic framing with rigid insulation (note non-plumb posts)

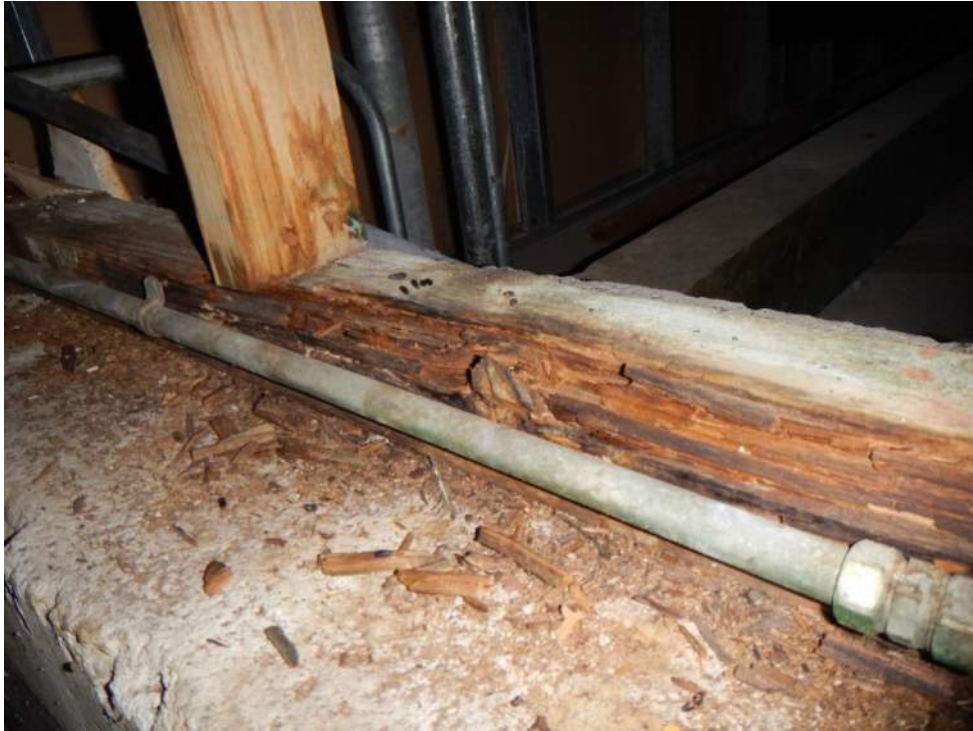
Photograph # 15: Deteriorated wood sill plate below valley on upturned concrete beam.

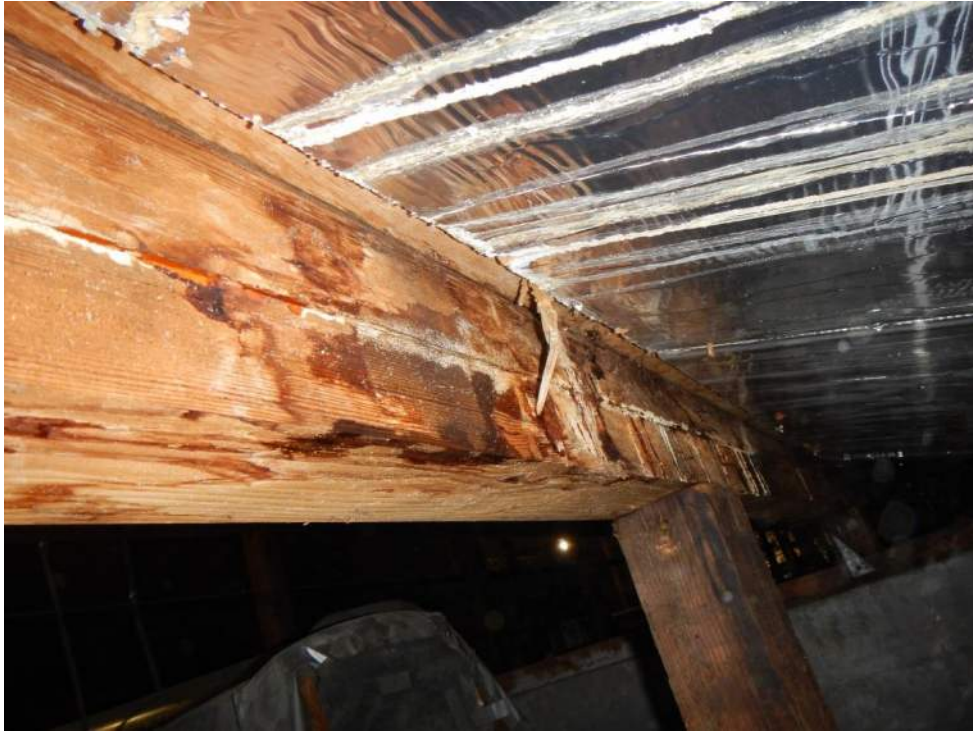
Photograph # 17: Example of seepage staining on soffit of roof decking and support beams.
