**LIFE SAFETY ASSESSMENT
WESTERN STATE HOSPITAL
LAKEWOOD, WASHINGTON 98498**

**Prepared For
WASHINGTON DEPARTMENT OF SOCIAL
AND HEALTH SERVICES (DSHS)
1115 Washington St. SE
Olympia, WA 98504**

June 01, 2018

**JH Project #: 1SSD18011.000
RPA Contract #: 29431**

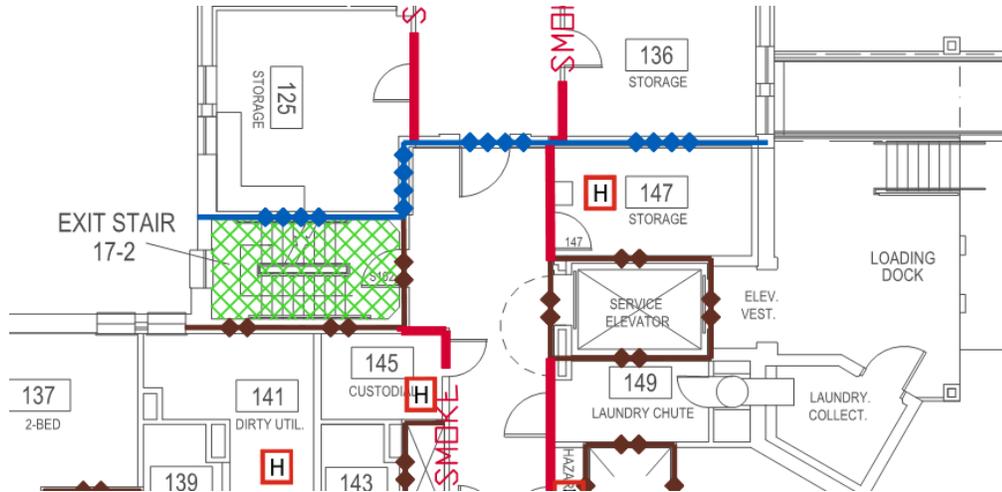
Figure 2: Snip from First Floor Bldg 9 to Bldg 17

On the large inter-connected buildings: specifically, in between Buildings 28 and 29 and between Buildings 9, 17, 18, 19 and 20, a 4-hour fire barrier is listed on the existing life safety plans to separate each building. See Figure 2 below as an example (the navy-blue line type with 4 diamonds).

We suspect this is an attempt to meet the requirements of the 2015 IBC in terms of allowable area by introducing a catch-all wall type that separates buildings into smaller floor areas that meet the IBC allowable area tables. In the case of the example above (Building 9), there are 3-hour fire doors and a cast-in-place concrete wall at each floor that appears thick enough to meet a 4-hour rating. However, the walls have been cast in between floors and this wall does not provide the structural independence required of a true fire wall. In other cases (such as at Building 28 to 29) the doors in this location are only 20 minute-rated and the wall is a combination of cast in place and framed wall, not meeting a 4-hour separation.

The risk being run by continuing to call these walls 4-hour fire walls is that they will continue to incur comments, both in terms of the actual rating and the continuity requirements for fire walls which is not possible given existing construction.

When establishing type of construction for existing buildings, the better practice is to classify a building by what it can be based on applicable codes as opposed to what the building looks like based on observed construction. Due to the type of construction listed for most buildings as Type II, (see further in this report regarding Building 28) we recommend that these fire walls be re-designated to 2-hour fire/smoke barriers in order to meet the occupancy separation requirements of the LSC and better represent what these walls are actually accomplishing.
