**LIFE SAFETY ASSESSMENT
WESTERN STATE HOSPITAL
LAKEWOOD, WASHINGTON 98498**

**Prepared For
WASHINGTON DEPARTMENT OF SOCIAL
AND HEALTH SERVICES (DSHS)
1115 Washington St. SE
Olympia, WA 98504**

June 01, 2018

**JH Project #: 1SSD18011.000
RPA Contract #: 29431**

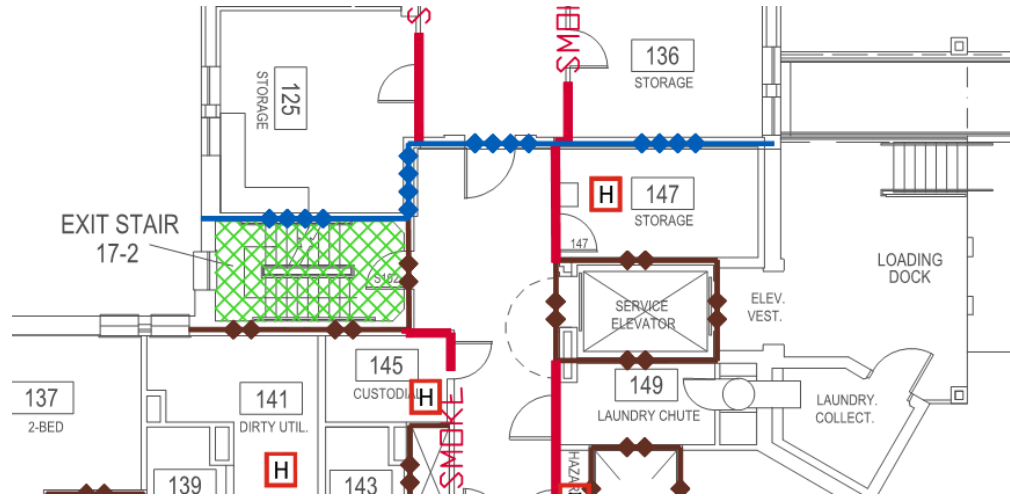
Figure 2: Snip from First Floor Bldg 9 to Bldg 17

On the large inter-connected buildings: specifically, in between Buildings 28 and 29 and between Buildings 9, 17, 18, 19 and 20, a 4-hour fire barrier is listed on the existing life safety plans to separate each building. See Figure 2 below as an example (the navy-blue line type with 4 diamonds).

We suspect this is an attempt to meet the requirements of the 2015 IBC in terms of allowable area by introducing a catch-all wall type that separates buildings into smaller floor areas that meet the IBC allowable area tables. In the case of the example above (Building 9), there are 3-hour fire doors and a cast-in-place concrete wall at each floor that appears thick enough to meet a 4-hour rating. However, the walls have been cast in between floors and this wall does not provide the structural independence required of a true fire wall. In other cases (such as at Building 28 to 29) the doors in this location are only 20 minute-rated and the wall is a combination of cast in place and framed wall, not meeting a 4-hour separation.

The risk being run by continuing to call these walls 4-hour fire walls is that they will continue to incur comments, both in terms of the actual rating and the continuity requirements for fire walls which is not possible given existing construction.

When establishing type of construction for existing buildings, the better practice is to classify a building by what it can be based on applicable codes as opposed to what the building looks like based on observed construction. Due to the type of construction listed for most buildings as Type II, (see further in this report regarding Building 28) we recommend that these fire walls be re-designated to 2-hour fire/smoke barriers in order to meet the occupancy separation requirements of the LSC and better represent what these walls are actually accomplishing.

The justification is that the LSC does not limit the allowable area of buildings, only the allowable height, per Table 19.1.6.1. Since these building are all existing, they should not be required to meet the most current edition of IBC or its allowable area tables. However, in light of attempting to provide some form of separation, the IEBC (International Existing Building Code) Section 10.12.5.1.1 allows existing buildings to have fire walls constructed as fire barriers to meet the intent of building area separation. Since these buildings are being considered as Type II via the LSC, a 2-hour fire wall, or fire barrier in this case is allowed. We recommend the additional designation of smoke barrier to ensure that existing smoke compartment boundaries are not being violated.
