DSHS RAINIER SCHOOL

WA STATE PROJECT NUMBER: 2024-429 K (8)

EXECUTIVE SUMMARY

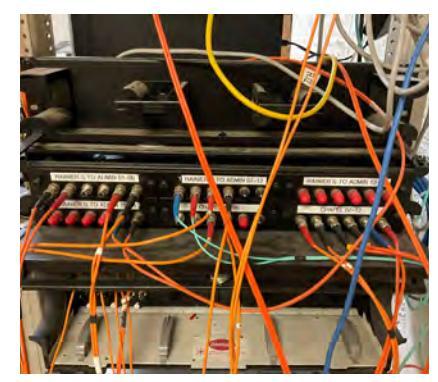
The only intra-building backbone cabling resides within the Administration Building. Each telecom room within Administration is connected to the Main Equipment Room through twisted-pair copper backbone. The intra-building twisted-pair copper backbone is extremely limited in bandwidth and data speeds, is not readily available, and should be replaced with standards compliant OM4 or single-mode optical fiber backbone cabling.

Existing Intrabuilding Fiber Backbone.

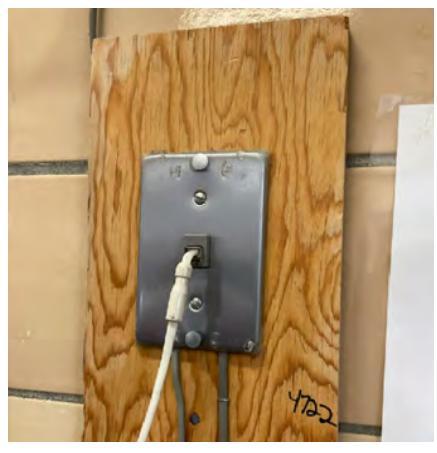
A review of the horizontal voice cabling infrastructure found it to be inadequate to serve the current and future needs of Rainier School. The horizontal cabling consists of twisted-pair copper cabling, which is terminated on 110-blocks on each building. These 110-blocks serve as cable termination points, allowing interconnection of on-premises wiring within a structured cabling system. From the 110-blocks, the cabling is patched to a Category 3 backbone cable that routes back to the Administration Building.

Category 3 cabling does not meet TIA-1179 standards for horizontal cabling. It is recommended that all Category 3 cabling be removed, and the voice network be collapsed onto a converged network infrastructure utilizing standards compliant cabling.

Existing Voice Outlet.

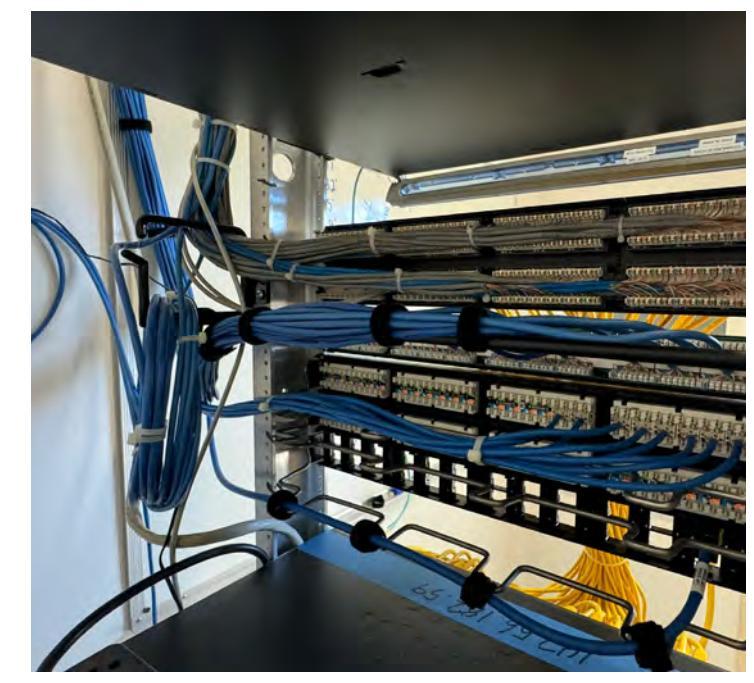
The existing Category 5e infrastructure is not adequate to meet the current and future needs of Rainier School nor does it comply with TIA standards for infrastructure in healthcare facilities. It is recommended that the existing cabling infrastructure be replaced with a new Category 6A cabling infrastructure and that additional data ports be added throughout the facility to provide employees with an adequate quantity of network port connections to support required device connections. New cabling infrastructure installation requires cabling to be secured and outlet boxes to be fitted with the appropriate faceplates to protect the cabling.

Existing Horizontal Cabling Patching.

Meeting TIA-1179 standards will require the entire channel to be Category 6A certified. Meeting this standard will require all new patch panels, modular jacks, and wall outlets comprising a replacement of the entire infrastructure. Existing Category 5 and 5e patch panels will be removed in favor of the Category 6A infrastructure. See Sequencing and Recommendations for sequencing of the project to minimize down time while the infrastructure is replaced.

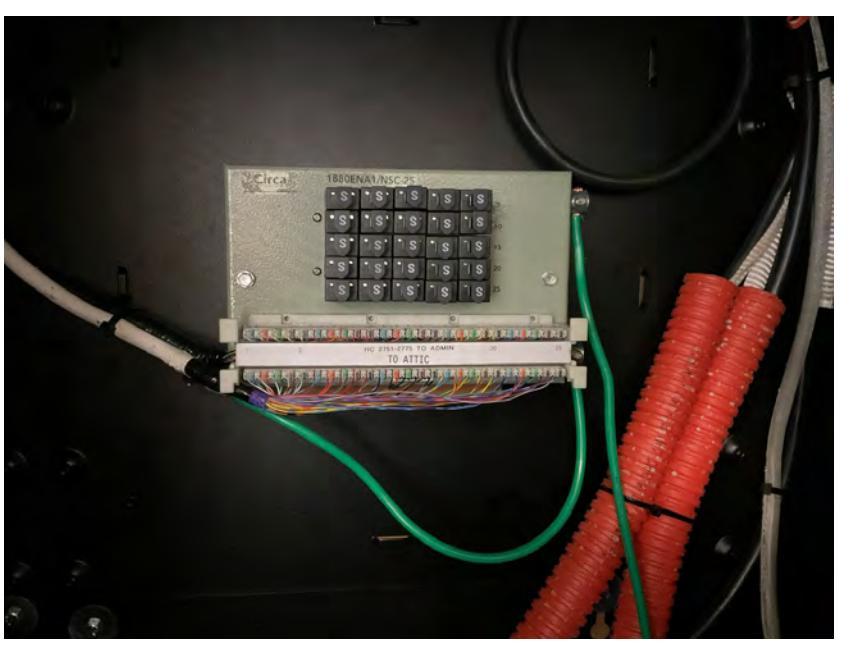
Existing Building Entrance Protection.

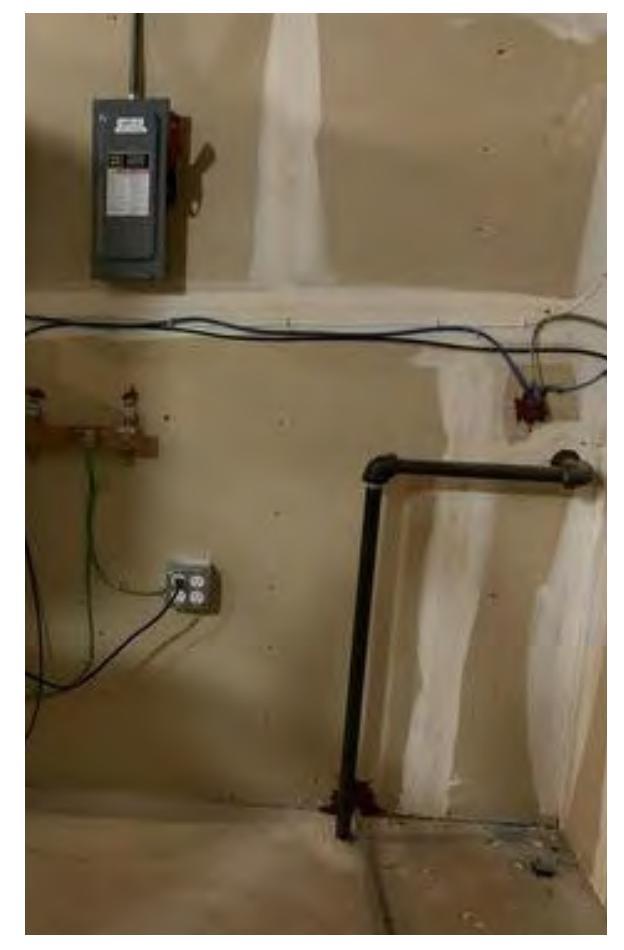
The telecommunications space is in the attic. There is no dedicated telecommunications room. The TR space contains a wall mounted vertical rack. The wall mounted rack includes a patch panel, network switch, and a UPS. The vertical rack was grounded to a telecommunications grounding busbar. There is no dedicated cooling for temperature and humidity control.

- » No dedicated telecommunications room.
- » Horizontal Cabling infrastructure does not meet minimum standards per TIA-1179.
- » Backbone Cabling Infrastructure does not meet minimum standards per TIA-1179.
- » Minimal cable support, leading to cables being draped or placed directly on equipment.
- » No grounding busbar for the telecommunications equipment.
- » No dedicated cooling system to maintain temperature of equipment.
- » Electrical infrastructure does not meet minimum requirements per standards.

Existing Grounding.

- » Provide a dedicated telecommunications room.
- » Upgrade existing port locations to Category 6A.
- » Provide labels for all new cabling and existing cables to remain.
- » Add additional Category 6A 8P8C RJ45 ports to meet standards.
- » Provide new 12-strand single-mode and 12-strand OM4 multimode optical fiber backbone from the Administration Building (Building 1).
- » Add Telecommunications Grounding Busbar.
- » Add ladder tray and cable management as needed.
- » Add a dedicated cooling system.
- » Add power circuits and receptacles as needed.
- » Control access to authorized individuals.

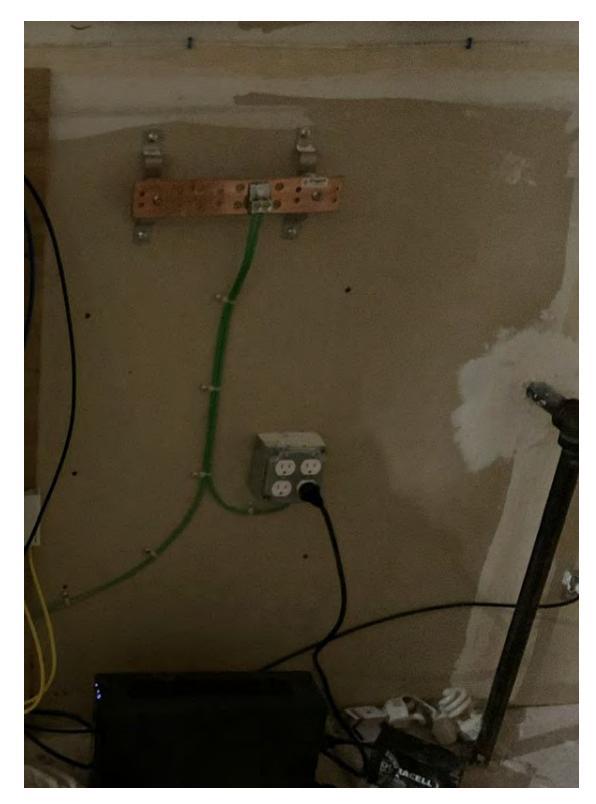
Existing Grounding.

- » Provide a dedicated telecommunications room.
- » Upgrade existing port locations to Category 6A.
- » Provide labels for all new cabling and existing cables to remain.
- » Add additional Category 6A 8P8C RJ45 ports to meet standards.
- » Provide new 12-strand single-mode and 12-strand OM4 multimode optical fiber backbone from the Administration Building (Building 1).
- » Add Telecommunications Grounding Busbar.
- » Add ladder tray and cable management as needed.
- » Add a dedicated cooling system.
- » Add power circuits and receptacles as needed.
- » Control access to authorized individuals.

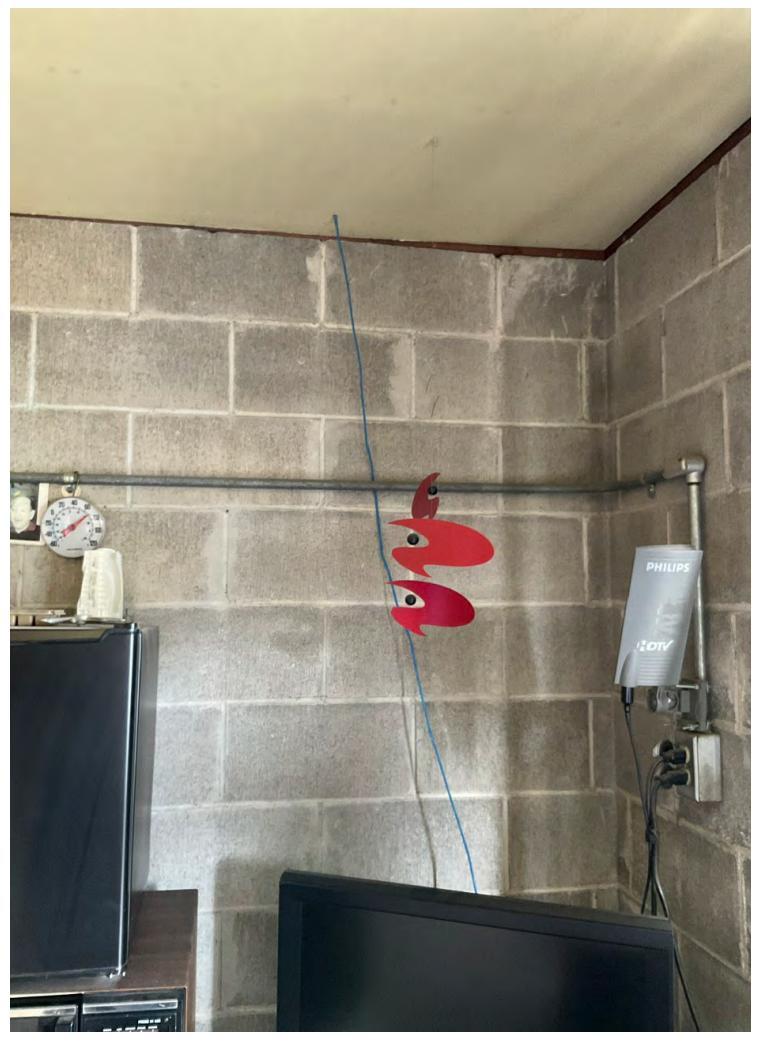
The gasoline station's office building is served by (1) Category 5e cable from the Maintenance Storage Building (Building 28) to support a single workstation in the office. Neither a telecommunications grounding busbar nor dedicated cooling were observed. There is no dedicated telecommunications space.

Existing Category 5e Cable.
