# **TRANSITIONAL CARE CENTER OF SEATTLE**

**WA STATE PROJECT NUMBER: 2024-429 O (12)**

## EXECUTIVE SUMMARY

Telecommunications Infrastructure Assessment Recommendations  
Transitional Care Center of Seattle

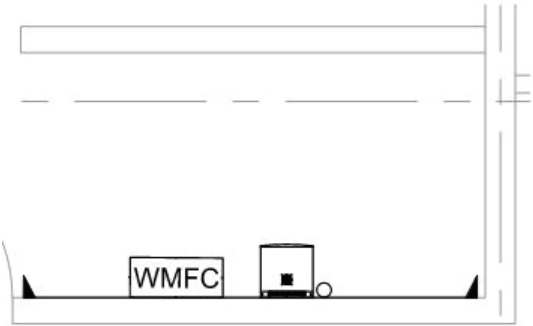
ER-B03B Floor Plan

- » Horizontal Cabling infrastructure does not meet minimum standards per TIA-1179.
- » Backbone Cabling Infrastructure does not meet minimum standards per TIA-1179.
- » No overhead ladder tray for cable support, leading to cables being draped or placed directly on equipment.
- » No grounding busbar for the telecommunications equipment.
- » Electrical infrastructure does not meet minimum requirements per standards.
- » Uncontrolled access to space with no identity verification.
- » No dedicated cooling equipment.
- » No rack space for expansion.

- » Upgrade existing port locations to Category 6A.
- » Add additional Category 6A 8P8C RJ45 ports to meet standards.
- » Provide new 12-strand OS2 single-mode and 12-strand OM4 multi-mode optical fiber backbone to TR-129, TR-229, and TR-329.
- » Add ladder tray and cable management as needed.
- » Add Telecommunications Grounding Busbar.
- » Add power circuits and receptacles as needed.
- » Add dedicated cooling system.
- » Control access to authorized individuals.
- » Replace wall-mounted enclosure with new two-post equipment rack to house telecom equipment

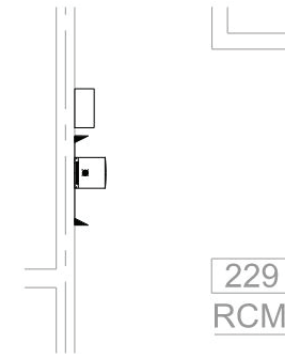
TR-229 Floor Plan

The Telecommunications Room 229 for Transitional Care Center of Seattle is on the second floor. One wall contains a wall-mounted enclosure and coax cabinet for CATV. The telecom rack contains a 48-port Category 6 patch panel. The room is served only by Category 5e cabling from the Main Equipment Room in the basement.

There is currently no space for expansion on the rack, but there is space in the room for additional floor standing racks. There is also no grounding bus bar in the room. The room does not contain cooling or humidity control. There are a few convenience receptacles, but no dedicated equipment receptacles. UPS power is available to provide clean, uninterrupted power for the equipment. While the room can be locked, in practice, it is often left open because it is also used as an employee's workspace, allowing access to anyone walking by.

- » Upgrade existing port locations to Category 6A.
- » Add additional Category 6A 8P8C RJ45 ports to meet standards.
- » Provide new 12-strand OS2 single-mode and 12-strand OM4 multi-mode optical fiber backbone to MER-B03B.
- » Add ladder tray and cable management as needed.
- » Add Telecommunications Grounding Busbar.
- » Add power circuits and receptacles as needed.
- » Add dedicated cooling system.
- » Control access to authorized individuals.
- » Relocate the employee workspace to allow room to be a dedicated telecom space.
- » Replace wall-mounted enclosure with new two-post equipment rack to house telecom equipment

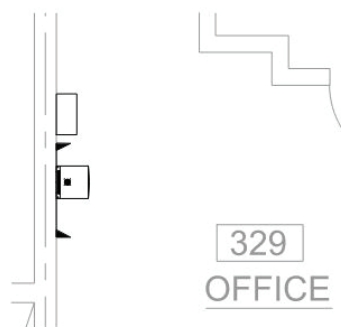
TR-329 Floor Plan

Telecommunications Room 329 is on the second floor. One wall contains a wall-mounted enclosure and coax cabinet for CATV. The telecom rack contains a 48-port Category 6 patch panel. The room is served only by Category 5e cabling to basement Main Equipment Room.

There is currently no space for expansion on the rack, but there is space in the room for additional floor standing racks. There is also no grounding bus bar in the room. The room does not contain cooling or humidity control. There are a few convenience receptacles, but no dedicated equipment receptacles. UPS power is available to provide clean, uninterrupted power for the equipment. While the room can be locked, in practice, it is often left open because it is also used as an employee's workspace, allowing access to anyone walking by.

***To meet industry standards, it is recommended to upgrade the existing backbone and horizontal cabling to OM4/OS2 and Category 6A. Additional Category 6A data ports are required to meet standards. It is also recommended to provide a telecommunications grounding busbar to create a consistent potential across all components. The wall-mounted enclosure should be replaced with a floor standing rack to allow more rack space for future growth. The employee should be moved to a new space to create a dedicated telecommunications room. Dedicated cooling, ladder rack, cable management, and dedicated equipment receptacles are required to meet standards. The addition of card-based access control is recommended to control access and track access to the space.***

- » Upgrade existing port locations to Category 6A.
- » Add additional Category 6A 8P8C RJ45 ports to meet standards.
- » Provide new 12-strand OS2 single-mode and 12-strand OM4 multi-mode optical fiber backbone to MER-B03B.
- » Add ladder tray and cable management as needed.
- » Add Telecommunications Grounding Busbar.
- » Add power circuits and receptacles as needed.
- » Add ductless split-system cooling unit.
- » Control access to authorized individuals.
- » Relocate the employee workspace to allow room to be a dedicated telecom space

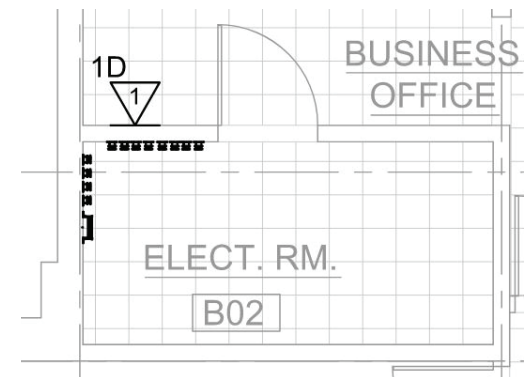
*Cross-Connect B02 Floor Plan*

Cross-connect room B02 is on the basement level. The room contains the unused analog phone cabling, as well as the new Panasonic PBX for the current phone system. The space is only 75 sq ft and is also being shared with electrical equipment. Two walls contain multiple 66 and 110-blocks for voice cross connection.

- » Abandon the closet and route all future cabling to ER-B03B.
- » Relocate the current phone headend to ER-B03B.
