DSHS  
**WESTERN STATE  
HOSPITAL**

**WA STATE PROJECT NUMBER: 2024-429 B (2)**

## EXECUTIVE SUMMARY

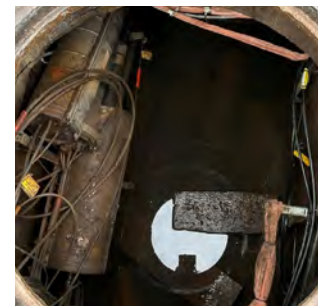
*Existing Fiber and Copper Splices.*

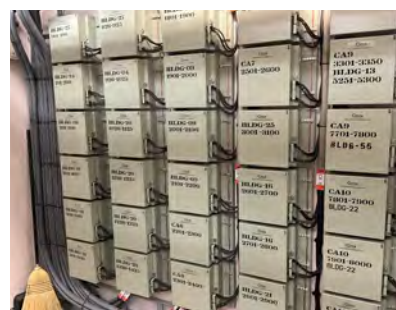
Category 3 twisted pair copper backbone cabling is utilized throughout the campus which originates from the MER. The cabling is then patched through 110 blocks to the outlet cabling coming from the workstation. The voice network should be collapsed to a single converged IP based network, and the existing Category 3 cabling should be demolished to align with current standards.

*Existing Category 3 Backbone Cabling.*

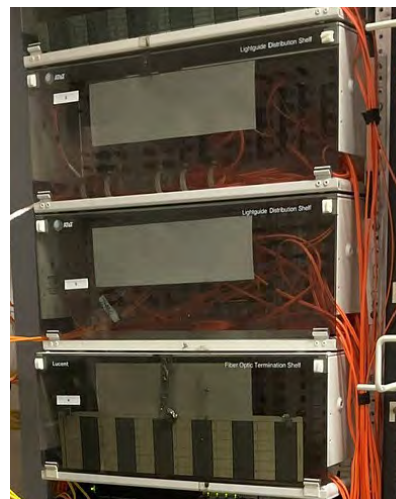
*Existing Fiber Patching.*

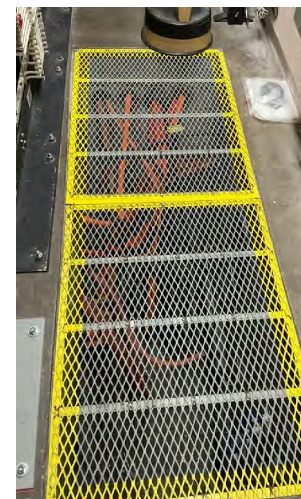
*Existing Backbone Cabling  
In Bldg 18 Tunnel.*

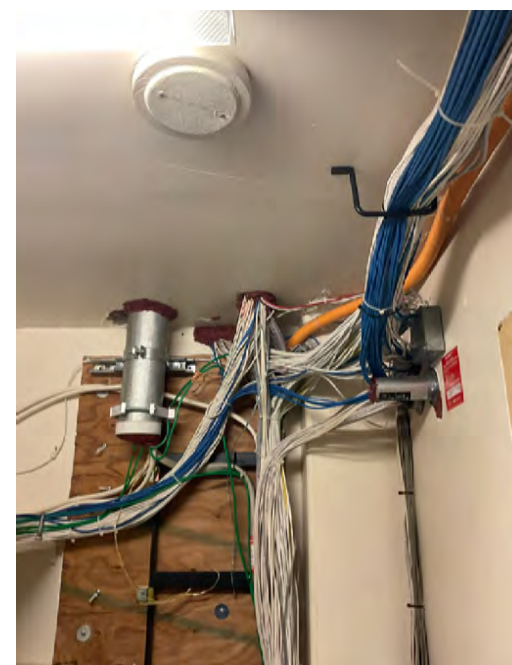
*Existing Horizontal Cabling (2)*

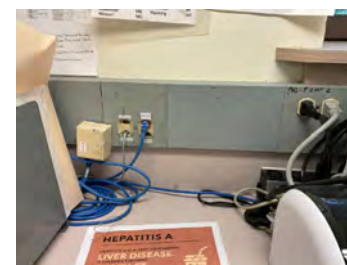
*Existing Telecom Outlets.*

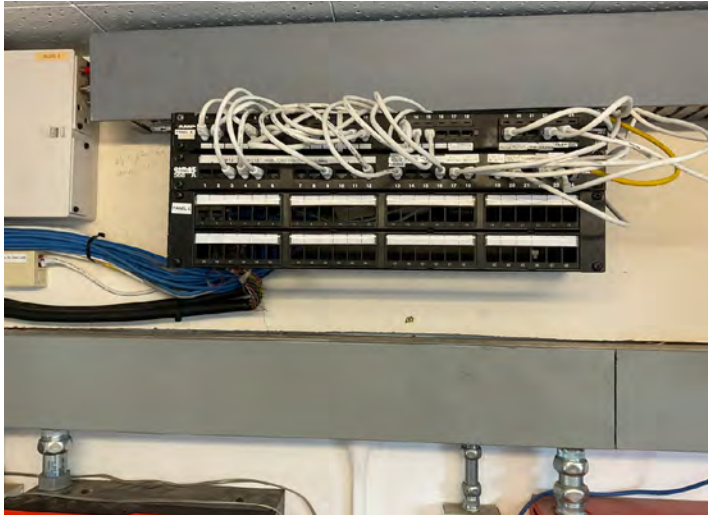
*The existing telecommunications space is not standards compliant. It is recommended to create a new, dedicated telecommunications room. The existing backbone and horizontal cabling do not meet current TIA standards for healthcare facilities. To meet industry standards, it is recommended to provide a new, dedicated telecommunications room with standards compliant backbone and horizontal cabling. Additional Category 6A data ports should be provided as required to meet standards. Dedicated cooling, rack space, cable management, and proper grounding. The addition of card-based access control is recommended to control and track access to the space.*

*Existing Data & Voice Patching.*

- » Provide a new dedicated telecommunications room.
- » Add ladder tray and cable management as needed.
- » Upgrade existing port locations to Category 6A.
- » Add additional Category 6A 8P8C RJ45 ports to meet standards.
- » Provide labels for all new cabling and existing cables to remain.
- » Provide new 12-strand single-mode and 12-strand OM4 multi-mode optical fiber backbone from Maintenance Shops (Building 3).
- » Add power circuits and receptacles as needed.
- » Provide a properly sized UPS.
- » Add Telecommunications Grounding Busbar.
- » Add dedicated cooling system.
- » Control access to authorized individuals.

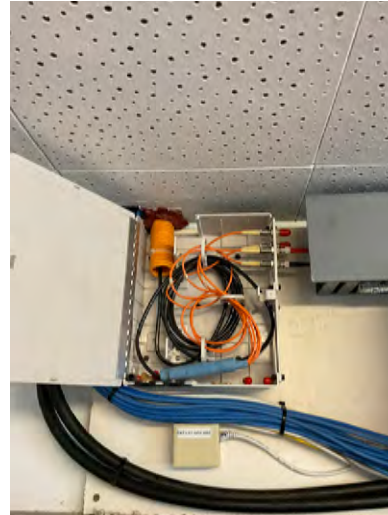
*Existing Fiber Cabinet.*

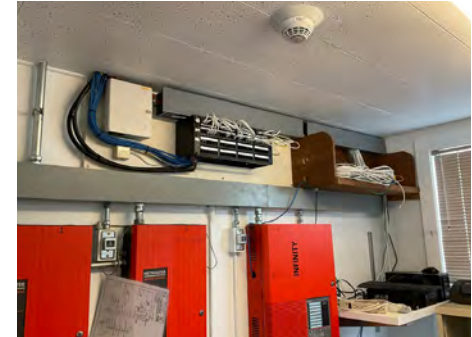
*Existing Telecom Equipment.*

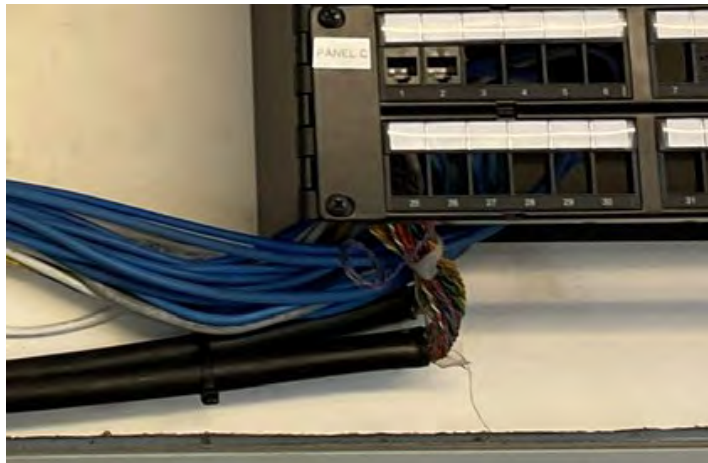
*Existing Horizontal Cabling.*

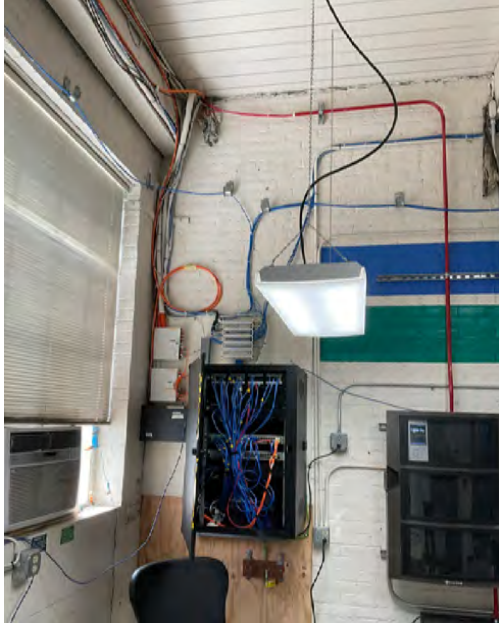
*The existing telecommunications space is not standards compliant. However, due to the small size of the building, the limited telecommunications infrastructure, and the lack of other more suitable spaces, it is recommended to maintain the space as the telecommunications enclosure. The existing backbone and horizontal cabling do not meet current TIA standards for healthcare facilities. To meet industry standards, it is recommended to upgrade the existing backbone and horizontal cabling. Additional Category 6A data ports should be provided as required to meet standards. Dedicated cooling and cable management are required to meet standards. The addition of card-based access control is recommended to control and track access to the space.*

*Existing Telecom Enclosure.*

- » Upgrade existing port locations to Category 6A.
- » Add additional Category 6A 8P8C RJ45 ports to meet standards.
- » Provide labels for all new cabling and existing cables to remain.
- » Provide new 12-strand single-mode and 12-strand OM4 multi-mode optical fiber backbone from MER in Administration (Building 18).
- » Add cable management as needed.
- » Add dedicated cooling system.
- » Control access to authorized individuals.

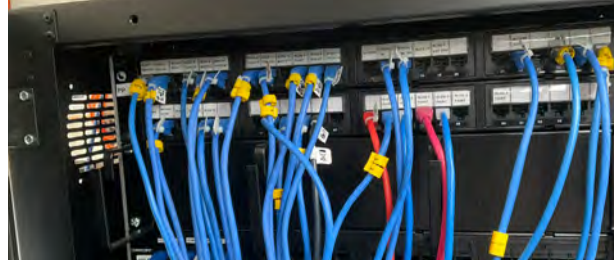
*Existing Data Patching.*

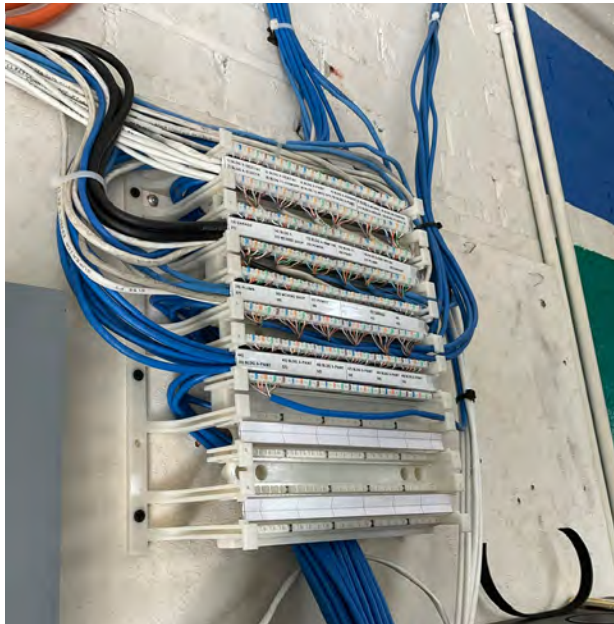
*Existing Voice Patching.*

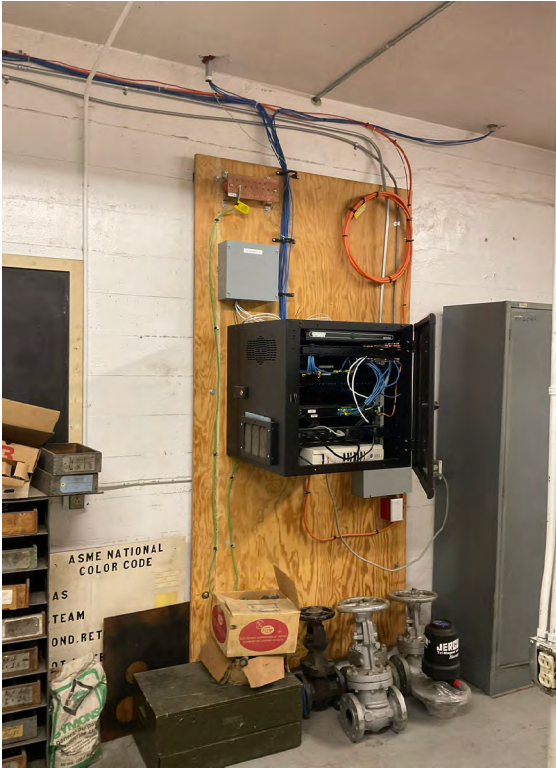
***The existing telecommunications space is not standards compliant. However, due to the small size of the building, the lack of other more suitable spaces, and the limited telecommunications infrastructure, it is recommended to maintain the space as the telecommunications enclosure. The existing backbone and horizontal cabling do not meet current TIA standards for healthcare facilities. To meet industry standards, it is recommended to upgrade the existing backbone and horizontal cabling. Additional Category 6A data ports should be provided as required to meet standards. Dedicated cooling, cable management, and proper grounding are required to meet standards. The addition of card-based access control is recommended to control and track access to the space.***

Existing Telecom Enclosure.

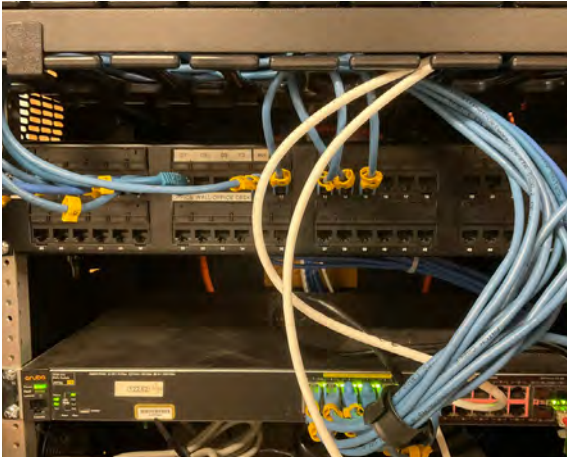
Existing Data Patching.

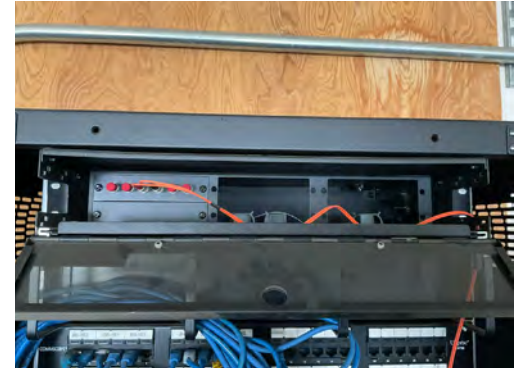
*Existing Fiber Patching.*

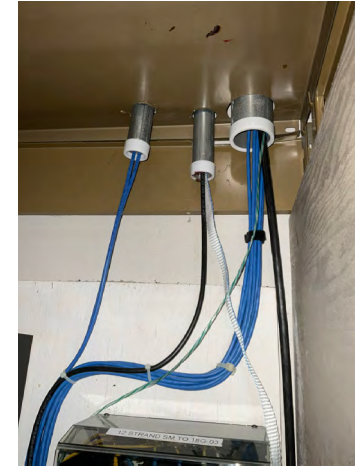
*Existing Grounding.*

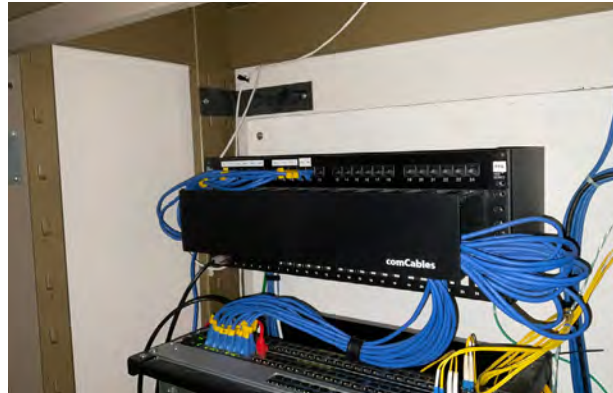
*Existing Horizontal Cabling.*

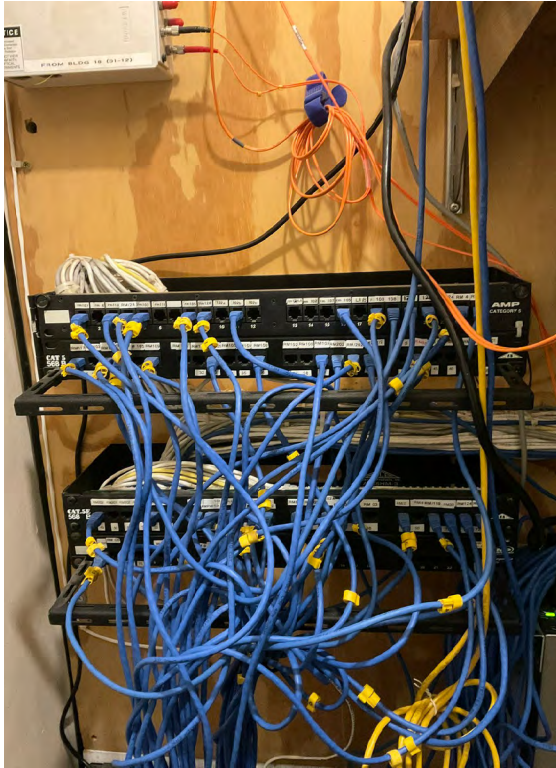
TELECOMMUNICATIONS ROOM – TR-113

*The existing telecommunications space is not standards compliant. It is recommended to provide a dedicated telecommunications room. The existing horizontal cabling and the existing multi-mode optical fiber backbone do not meet current TIA standards for healthcare facilities. To meet industry standards, it is recommended to upgrade the existing multi-mode optical fiber backbone and horizontal cabling. Additional Category 6A data ports should be provided as required to meet standards. Telecommunications racks, dedicated cooling, ladder rack, cable management, and dedicated equipment receptacles are required to meet standards. The addition of card-based access control is recommended to control and track access to the space.*

Existing Data Patching.

- » Provide new dedicated telecommunications room.
- » Upgrade existing port locations to Category 6A.
- » Add additional Category 6A 8P8C RJ45 ports to meet standards.
- » Provide new 12-strand single-mode and 12-strand OM4 multi-mode optical fiber backbone from MER in Administration (Building 18).
- » Provide labels for all new cabling and existing cables to remain.
- » Add cable management as needed.
- » Add dedicated cooling system.
- » Control access to authorized individuals.

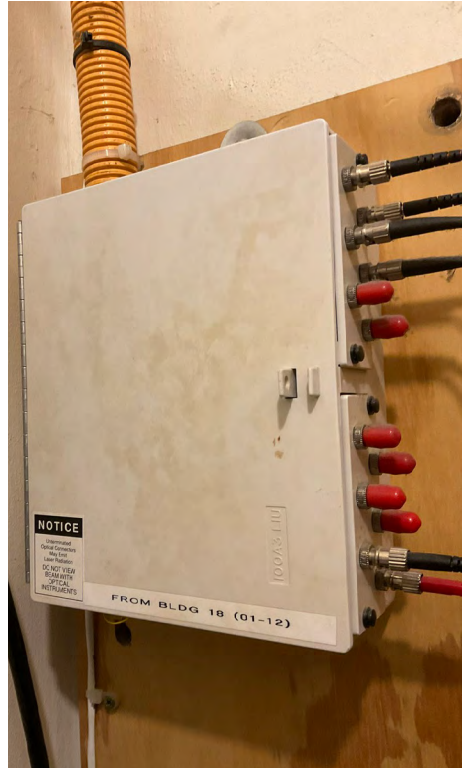
Existing Fiber Cabinet.

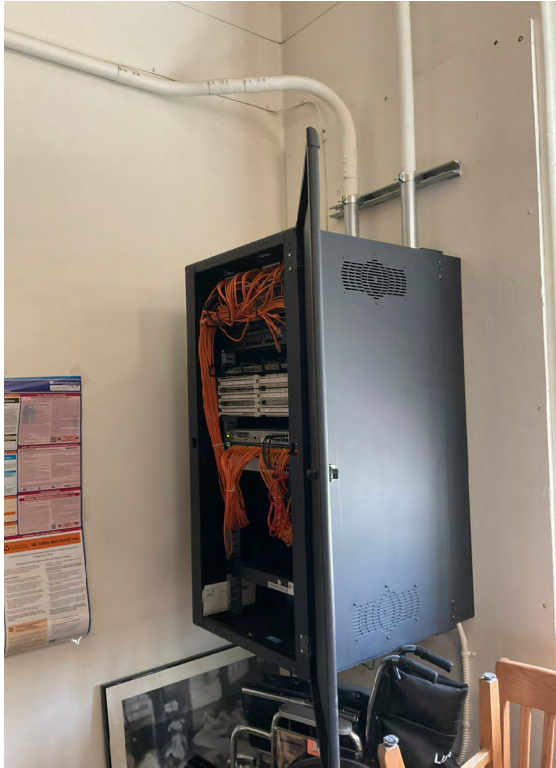
TELECOMMUNICATIONS ENCLOSURE – TE-208

*Existing Telecom Enclosure.*

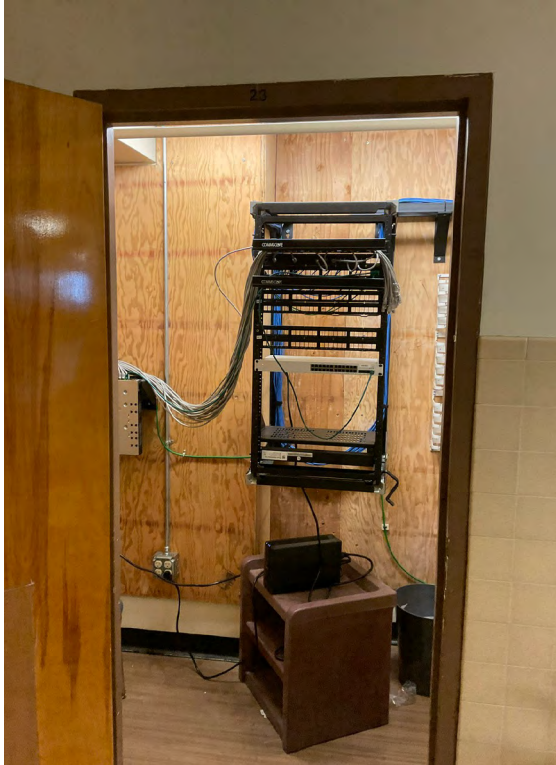
TELECOMMUNICATIONS ROOM – TR-003

- » Horizontal Cabling infrastructure does not meet minimum standards per TIA-1179.
- » Backbone Cabling Infrastructure does not meet minimum standards per TIA-1179.
- » Electrical infrastructure does not meet minimum requirements per standards.
- » No dedicated cooling system to maintain temperature of equipment.
- » Minimal labeling of existing cabling.
- » Uncontrolled access to space with no identity verification.

*Existing Telecom Rack.*

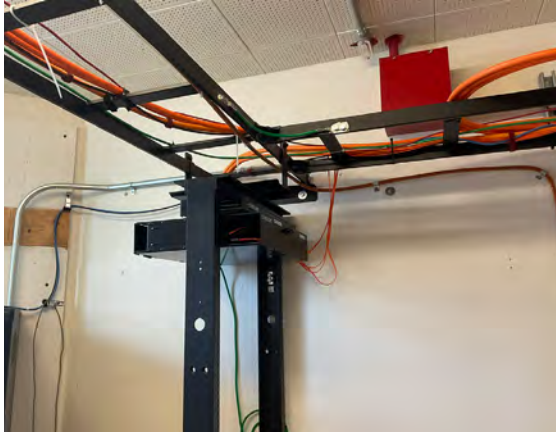
TELECOMMUNICATIONS ROOM – TR-015

- » Horizontal Cabling infrastructure does not meet minimum standards per TIA-1179.
- » Backbone Cabling Infrastructure does not meet minimum standards per TIA-1179.
- » Electrical infrastructure does not meet minimum requirements per standards.
- » No grounding busbar for the telecommunications equipment.
- » No dedicated cooling system to maintain temperature of equipment.
- » Minimal labeling of existing cabling.
- » Uncontrolled access to space with no identity verification.

*Existing Ladder Tray.*

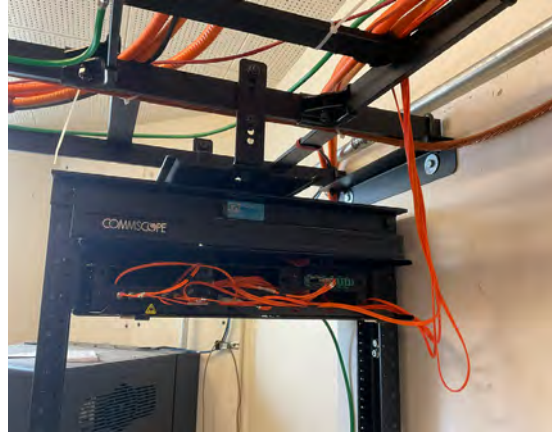
*Existing Telecom Rack.*

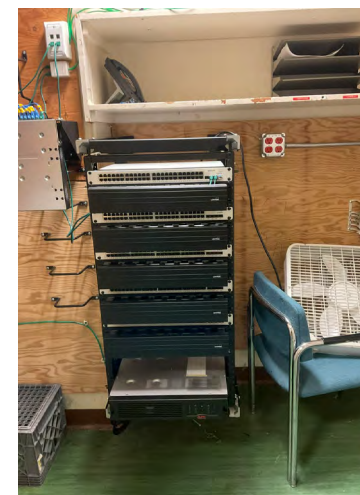
*Existing Telecom Rack.*

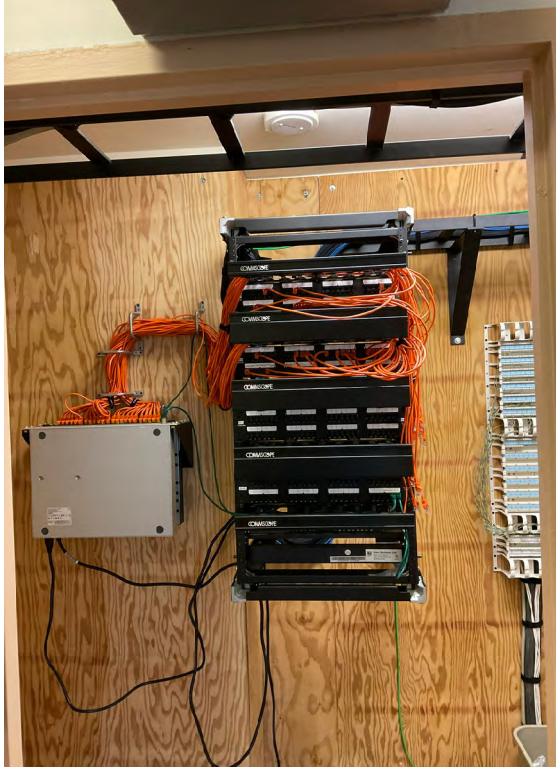
TELECOMMUNICATIONS ROOM – TR-229

- » Horizontal Cabling infrastructure does not meet minimum standards per TIA-1179.
- » Backbone Cabling Infrastructure does not meet minimum standards per TIA-1179.
- » Electrical infrastructure does not meet minimum requirements per standards.
- » No dedicated cooling system to maintain temperature of equipment.
- » Minimal labeling of existing cabling.
- » Uncontrolled access to space with no identity verification.

*Existing Telecom Rack.*

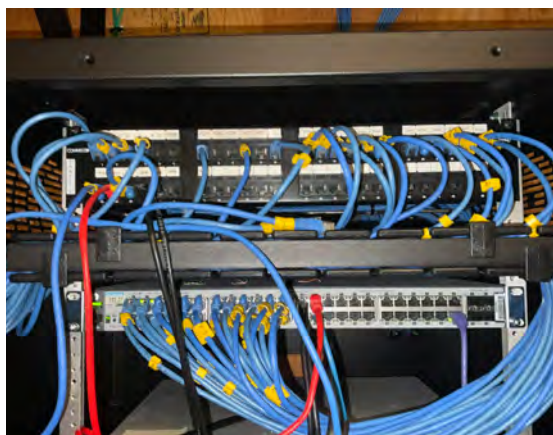
# TELECOMMUNICATIONS ROOM – TR-116

*Existing Data Patching.*

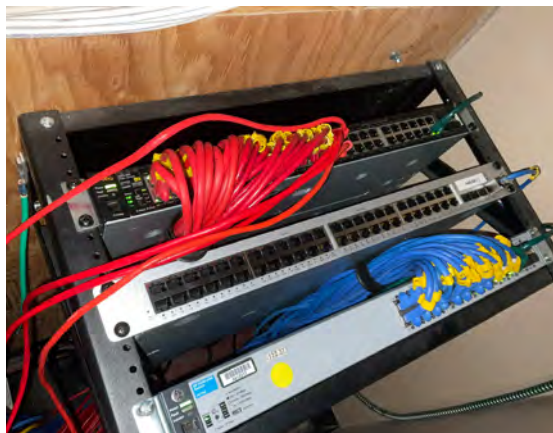
# TELECOMMUNICATIONS ROOM – TR-232

Existing Telecom Rack.

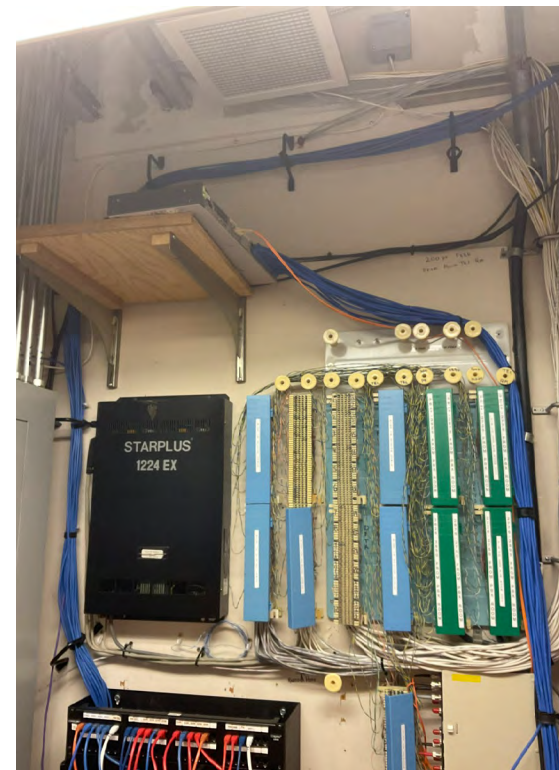
Existing Voice Patching.

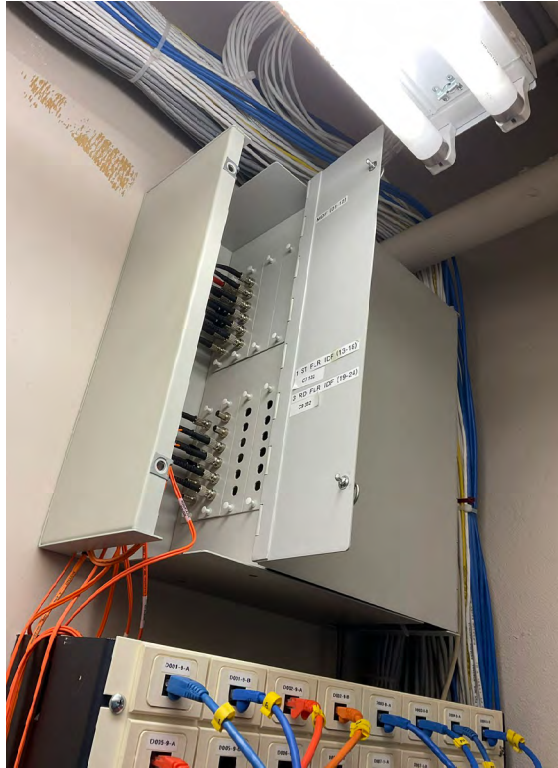
Existing Fiber Cabinet.

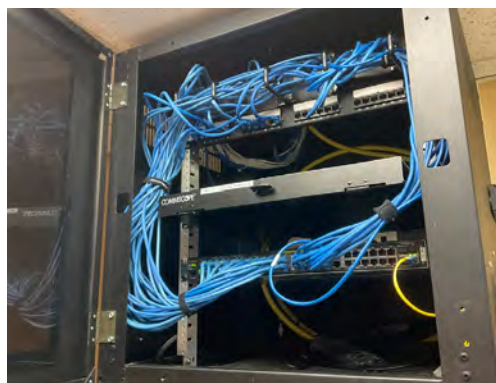
The telecommunications room is a wall mounted enclosure in the Kitchenette. Connectivity is provided by a 12-strand single-mode optical fiber backbone cable. The space consists of a wall mounted rack with a rack mount fiber cabinet, patch panel, network switch, and cable management. The horizontal cabling is Category 5e. Neither a telecommunications grounding busbar nor dedicated cooling were observed in the space. No UPS was observed.

Existing Telecom Enclosure.

- » Provide a new dedicated telecommunications room.
- » Upgrade existing port locations to Category 6A.
- » Add additional Category 6A 8P8C RJ45 ports to meet standards.
- » Provide labels for all new cabling and existing cables to remain.
- » Provide new 12-strand single-mode and 12-strand OM4 multi-mode optical fiber backbone from MER in Administration (Building 18).
- » Add Telecommunications Grounding Busbar.
- » Add power circuits and receptacles as needed.
- » Provide a properly sized UPS.
- » Add dedicated cooling system.
- » Control access to authorized individuals.

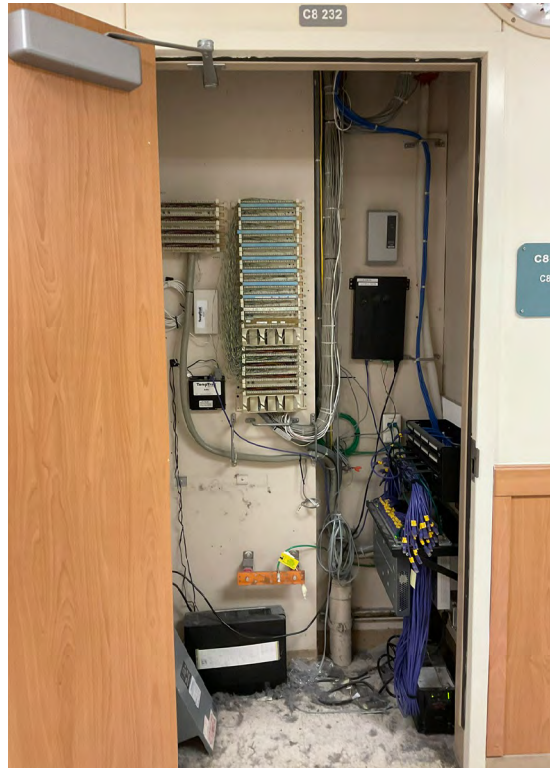
Existing Telecom Room.

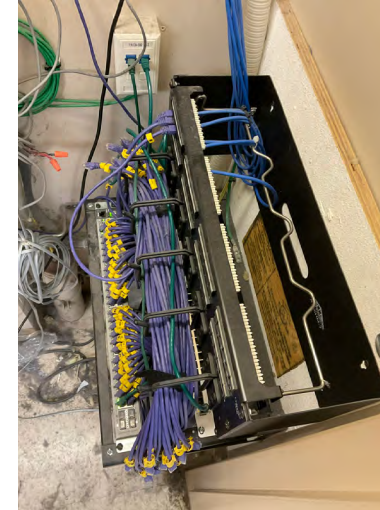
Existing Data Patching.

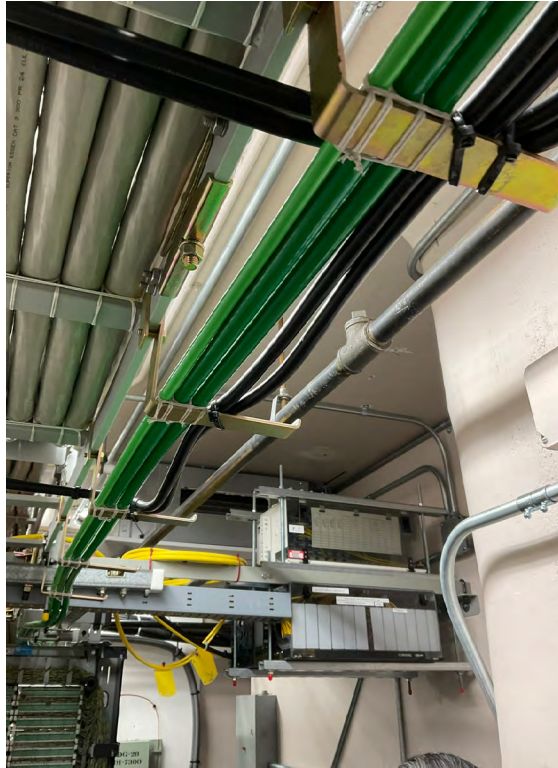
Existing Cable Supports.

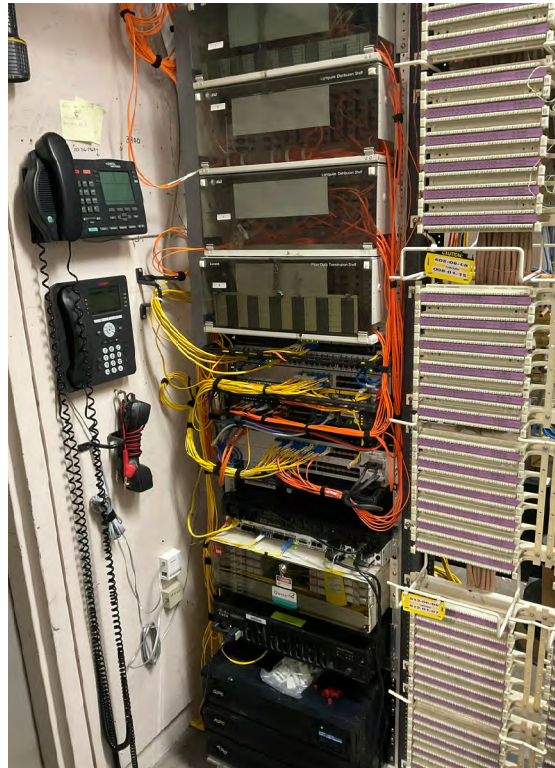
Existing Telecom Racks.

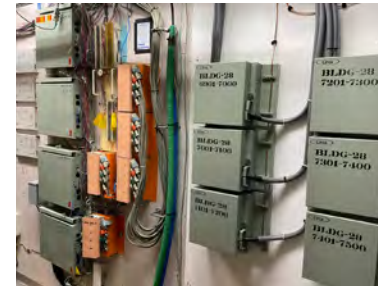
Existing Entrance Protections.

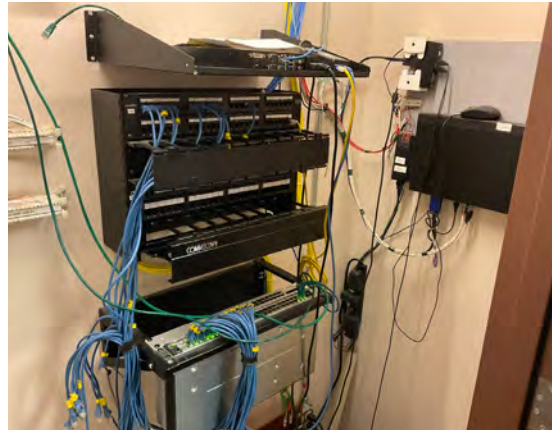
*Existing Telecom Rack.*

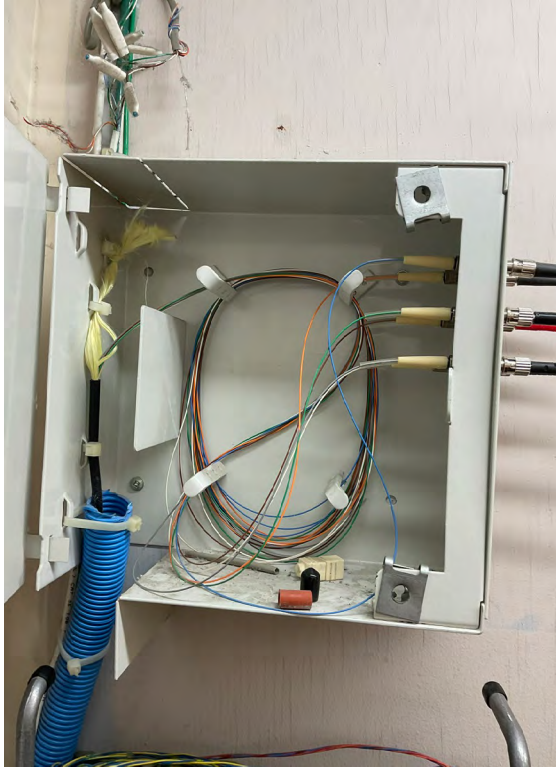
*Existing Fiber Patching.*

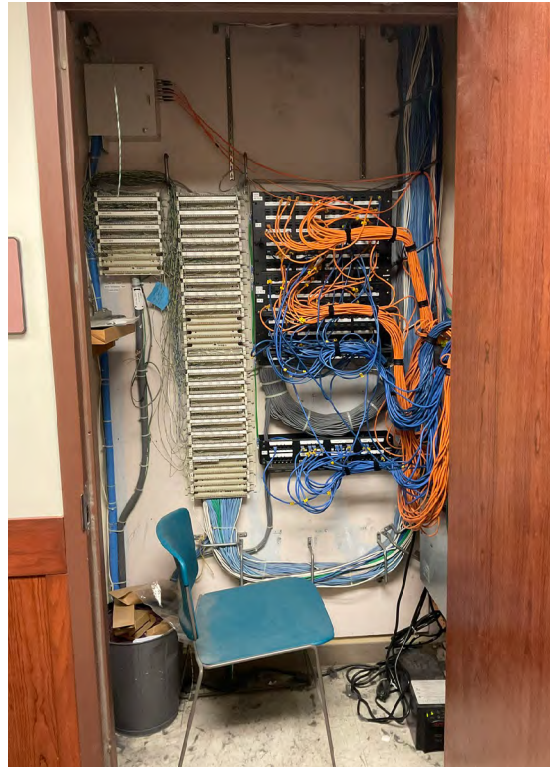
*Existing Telecom Room.*

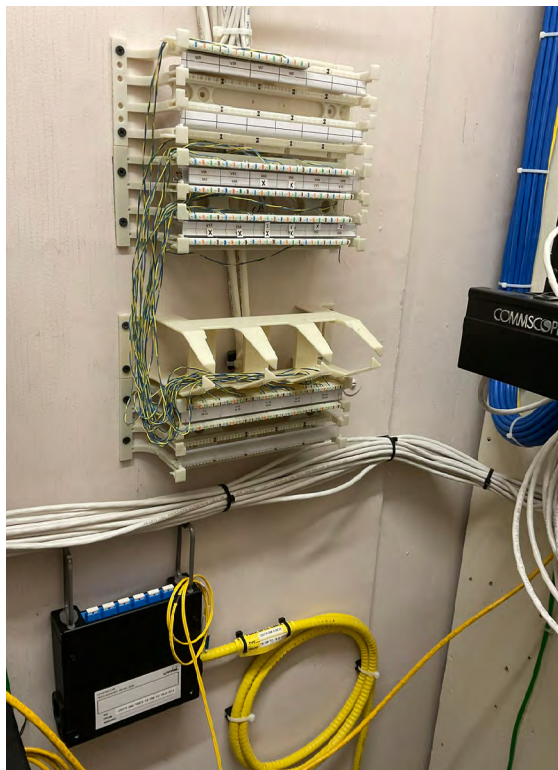
## TELECOMMUNICATIONS ROOM – TR-107

***The existing telecommunications space is not standards compliant. The existing backbone and horizontal cabling does not technically meet current TIA standards for healthcare facilities. To meet industry standards, it is recommended to upgrade the existing backbone and horizontal cabling. Additional Category 6A data ports should be provided as required to meet standards. Dedicated cooling, cable management, proper grounding, and dedicated equipment receptacles are required to meet standards. The addition of card-based access control is recommended to control and track access to the space.***

*Existing Fiber and Voice Patching.*

- » Provide a new dedicated telecommunications room.
- » Upgrade existing port locations to Category 6A.
- » Add additional Category 6A 8P8C RJ45 ports to meet standards.
- » Provide labels for all new cabling and existing cables to remain.
- » Provide new 12-strand single-mode and 12-strand OM4 multi-mode optical fiber backbone from MER in Administration (Building 18).
- » Add Telecommunications Grounding Busbar.
- » Add power circuits and receptacles as needed.
- » Provide a properly sized UPS.
- » Add dedicated cooling system.
- » Control access to authorized individuals.

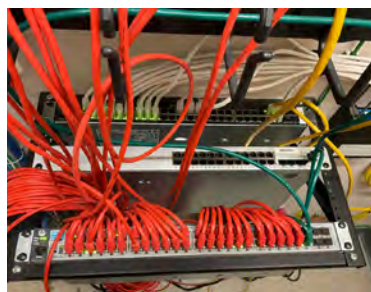
*Existing Telecom Rack.*

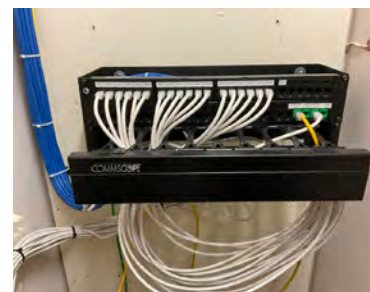
*Existing Data Patching.*

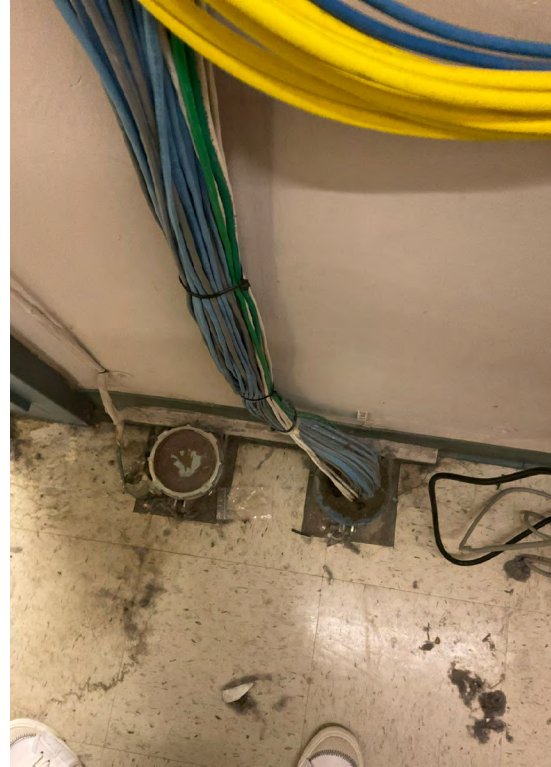
*Existing Horizontal Cabling.*

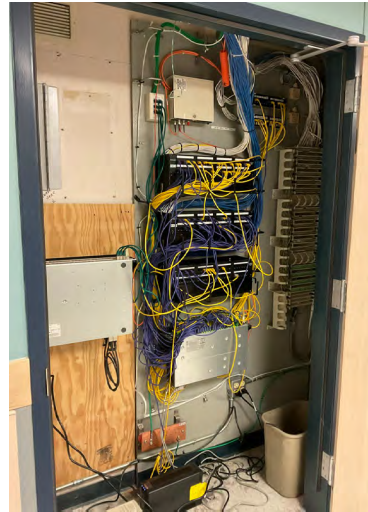
*Existing Telecom Room.*

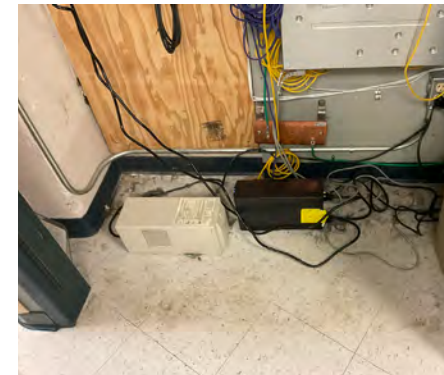
*Existing Grounding and UPS.*

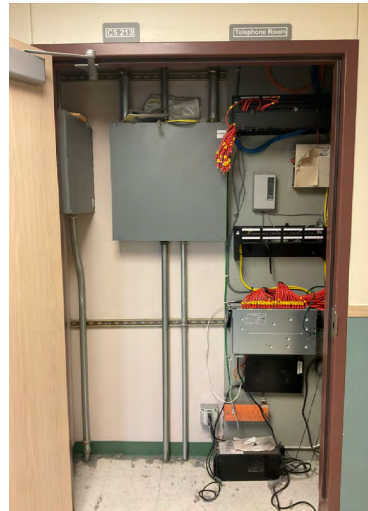
*Existing Telecom Room.*

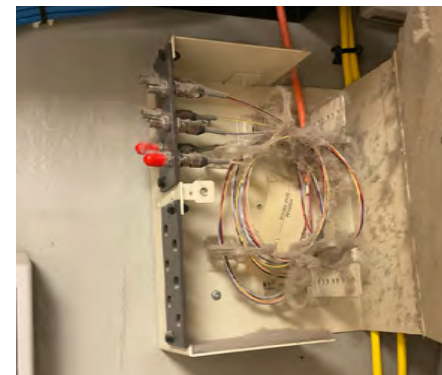
*Existing Unused Fiber.*

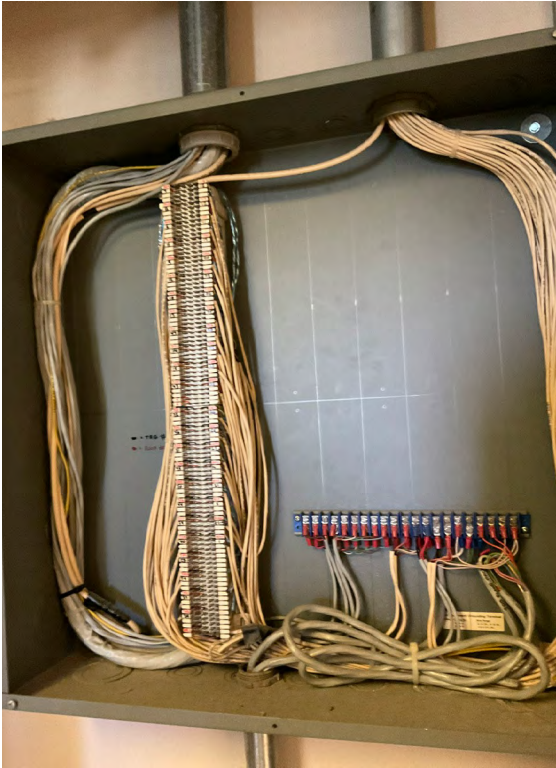
TELECOMMUNICATIONS ROOM – TR-311

*The existing telecommunications space is not standards compliant. The existing backbone and horizontal cabling does not technically meet current TIA standards for healthcare facilities. To meet industry standards, it is recommended to upgrade the existing backbone and horizontal cabling. Additional Category 6A data ports should be provided as required to meet standards. Dedicated cooling, cable management, and dedicated equipment receptacles are required to meet standards. The addition of card-based access control is recommended to control and track access to the space.*

Existing Voice Patching.

- » Provide a new dedicated telecommunications room.
- » Upgrade existing port locations to Category 6A.
- » Add additional Category 6A 8P8C RJ45 ports to meet standards.
- » Provide labels for all new cabling and existing cables to remain.
- » Provide new 12-strand single-mode and 12-strand OM4 multi-mode optical fiber backbone from MER in Administration (Building 18).
- » Add Telecommunications Grounding Busbar.
- » Add power circuits and receptacles as needed.
- » Provide a properly sized UPS.
- » Add dedicated cooling system.
- » Control access to authorized individuals.

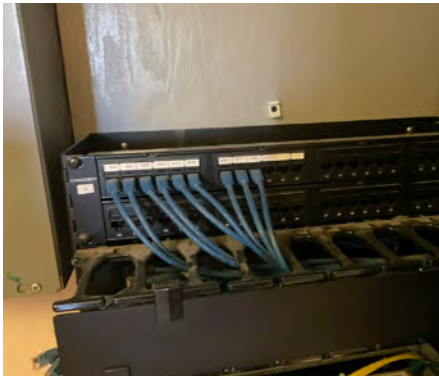
Existing Data Patching.

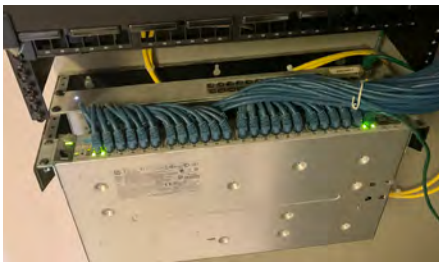
Existing Wall Mounted Bracket.

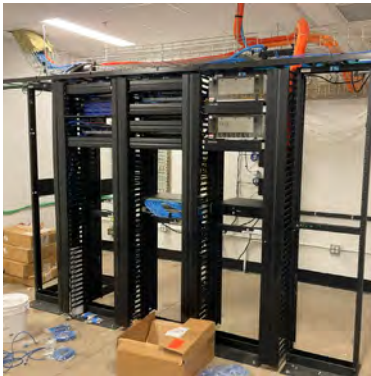
Existing Telecom Racks.

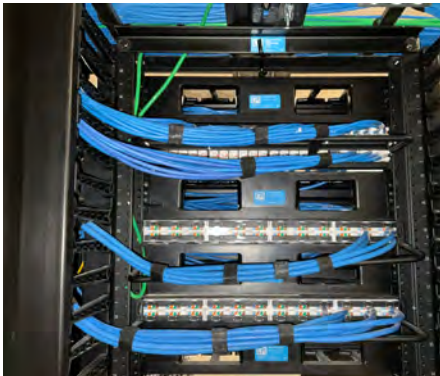
Existing Category 6A Cabling.

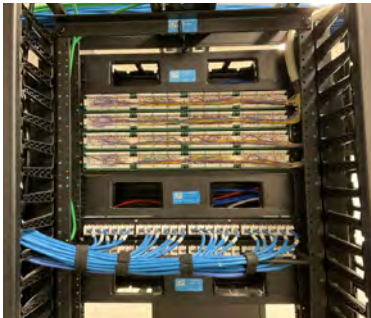
Existing Voice and Data Patching.

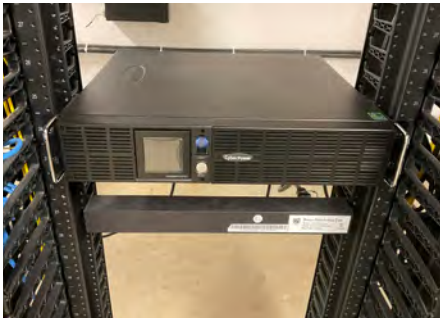
Existing Nonfunctioning UPS.

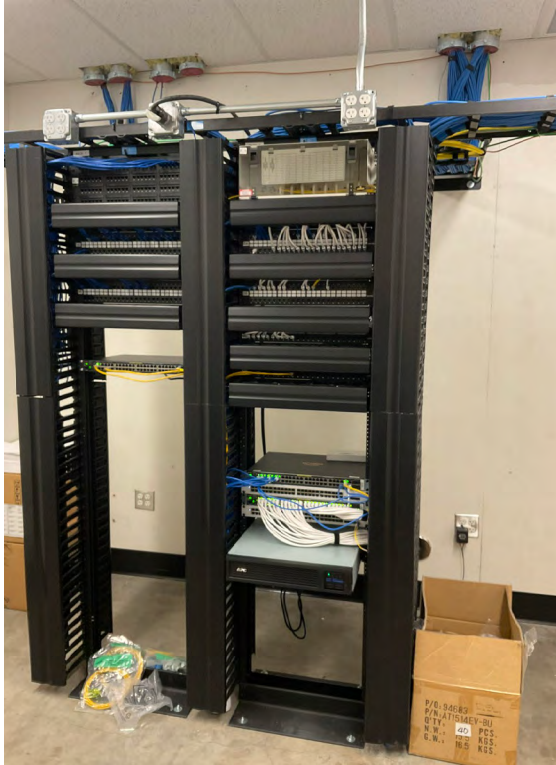
## TELECOMMUNICATIONS ROOM – TR-105

*The existing backbone cabling does not technically meet current TIA standards for healthcare facilities. To meet industry standards, it is recommended to upgrade the existing backbone. Additional Category 6A data ports should be provided as required to meet standards. The existing patching equipment should also be upgraded to meet standards. The addition of card-based access control is recommended to control and track access to the space.*

*Existing Telecom Racks.*

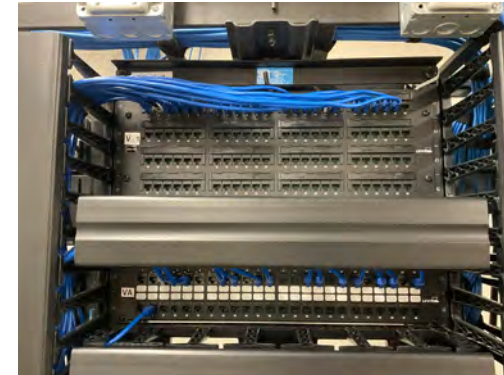
*Existing Category 5e Patch Panels.*

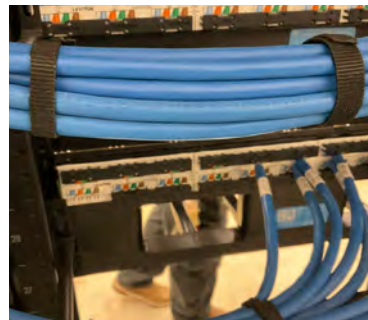
*Existing Category 6A Cabling.*

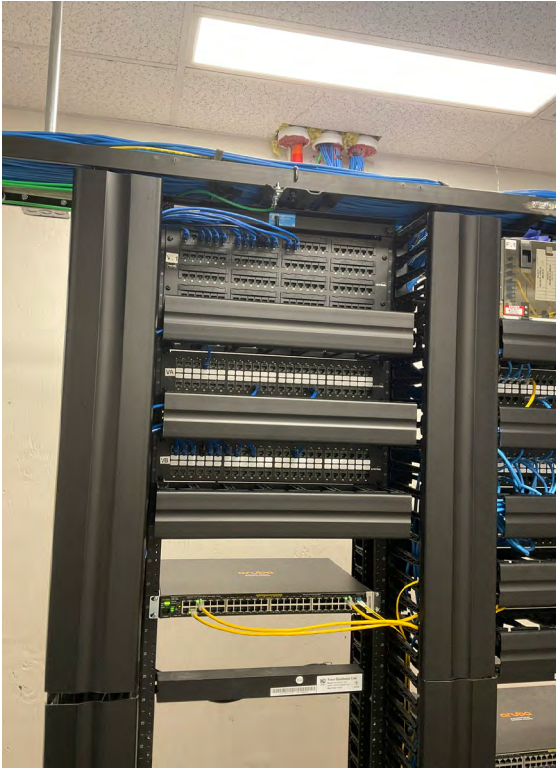
TELECOMMUNICATIONS ROOM – TR-209

*The existing backbone cabling does not technically meet current TIA standards for healthcare facilities. To meet industry standards, it is recommended to upgrade the existing backbone. Additional Category 6A data ports should be provided as required to meet standards. The existing patching equipment should also be upgraded to meet standards. The addition of card-based access control is recommended to control and track access to the space.*

Existing Telecom Rack.

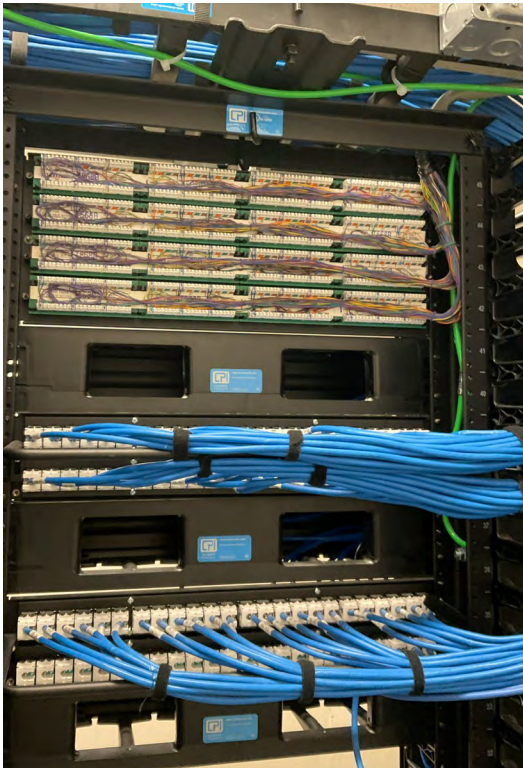
Existing Voice Patching.

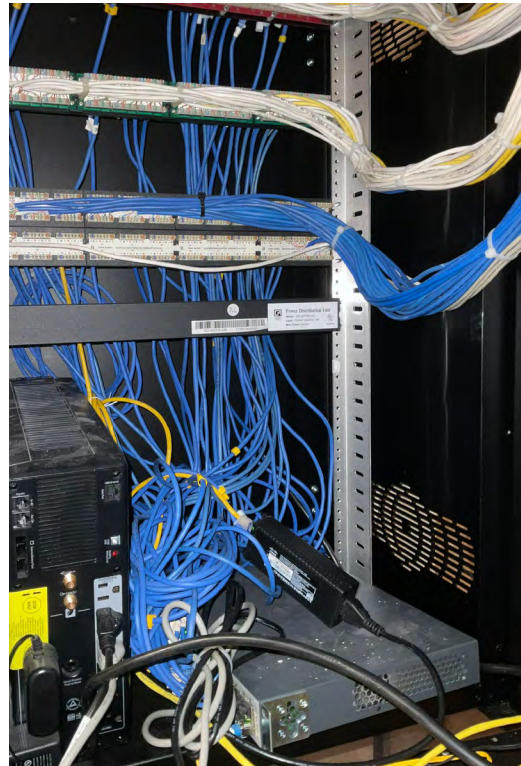
TELECOMMUNICATIONS ROOM – TR-105

*Existing Voice and Data Patching.*

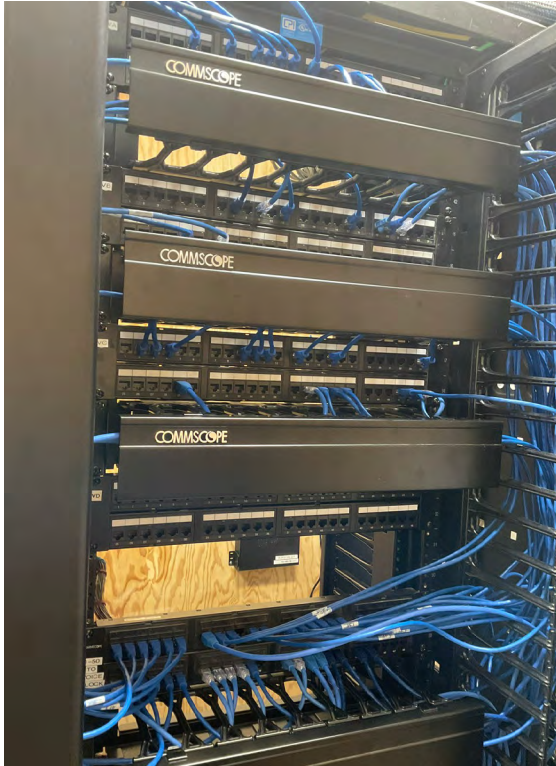
TELECOMMUNICATIONS ROOM – TR-164

Telecommunications Room TR-164 is in the west wing of the building. The telecommunications space contains three two-post equipment racks with multiple patch panels. There is space available in the existing racks for expansion. Network connectivity is provided by a 12-strand single-mode optical fiber cable from telecommunications room TR-105 that terminates in a rack mount fiber cabinet. Voice connectivity is provided by a 100-pair Category 3 twisted-pair cable. The horizontal cabling is Category 5e and Category 3 for voice infrastructure. There is a UPS mounted in the rack. A telecommunications grounding busbar was observed. There was no dedicated cooling observed in the space.

*Existing Telecom Rack.*

***The existing backbone and horizontal cabling do not technically meet current TIA standards for healthcare facilities. To meet industry standards, it is recommended to upgrade the existing backbone and horizontal cabling. Additional Category 6A data ports should be provided as required to meet standards. Dedicated cooling, cable management, and dedicated equipment receptacles are required to meet standards. The addition of card-based access control is recommended to control and track access to the space.***

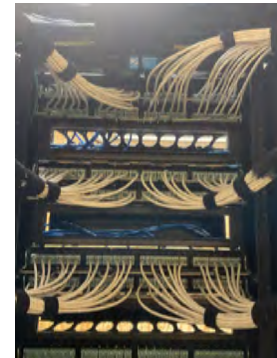
*Existing Category 5e Cabling.*

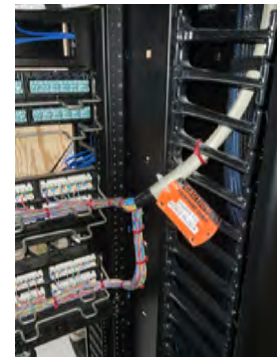
*Existing Voice Patching (2).*

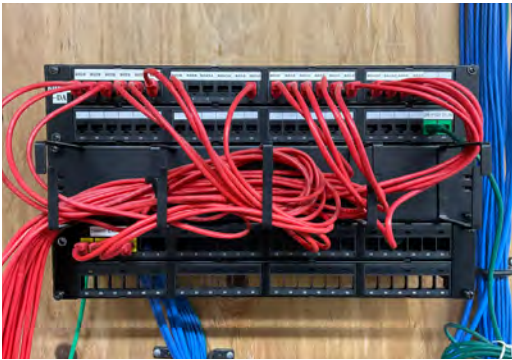
TELECOMMUNICATIONS ROOM – TR-A020

Existing Data Patching.

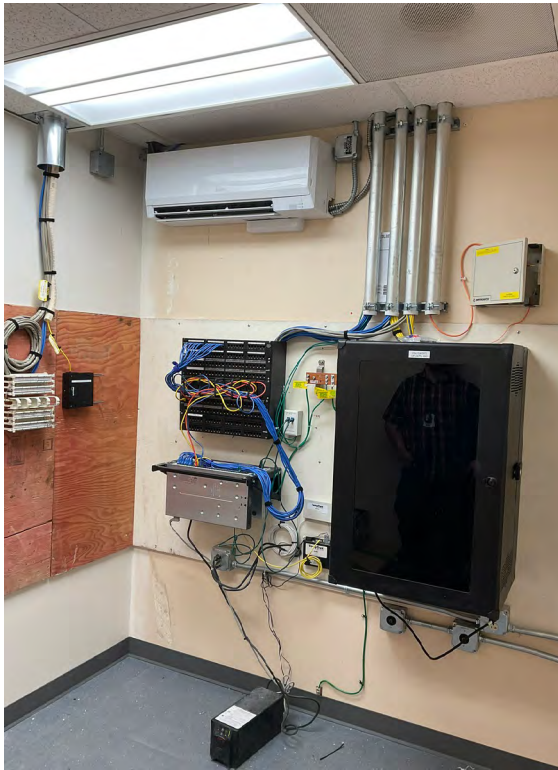
TELECOMMUNICATIONS ROOM – TR-D070

Existing Telecom Equipment.

*The existing backbone and horizontal cabling do not meet current TIA standards for healthcare facilities. To meet industry standards, it is recommended to upgrade the existing backbone and horizontal cabling. Additional Category 6A data ports should be provided as required to meet standards. Dedicated cooling is required to meet standards. The addition of card-based access control is recommended to control and track access to the space.*

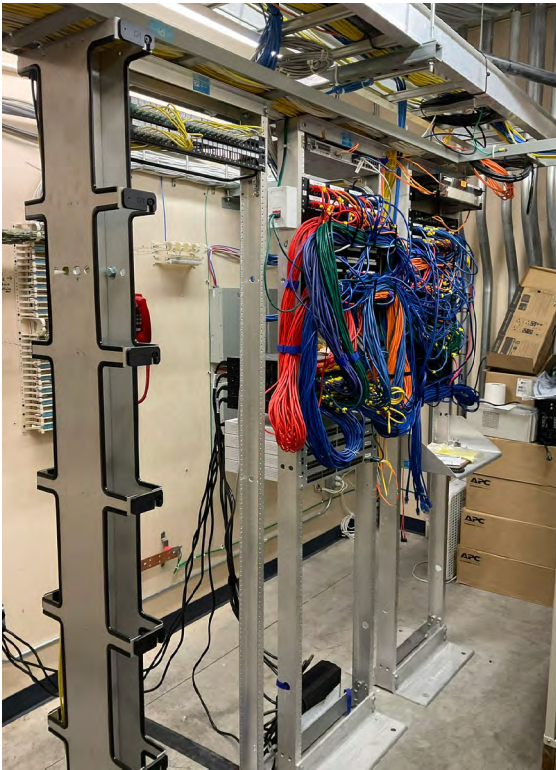
TELECOMMUNICATIONS ROOM – TR-F101

Existing Telecom Rack.

*The existing backbone and horizontal cabling do not meet current TIA standards for healthcare facilities. To meet industry standards, it is recommended to upgrade the existing backbone and horizontal cabling. Additional Category 6A data ports should be provided as required to meet standards. Dedicated cooling is required to meet standards. The addition of card-based access control is recommended to control and track access to the space.*

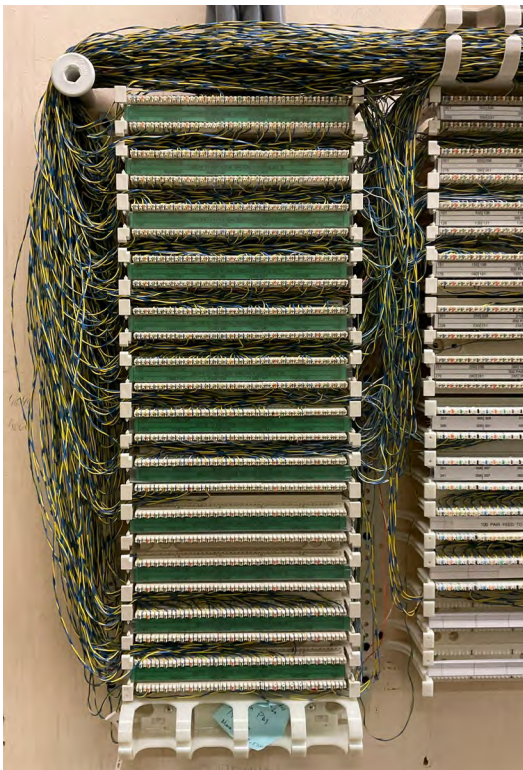
Existing Voice Patching.

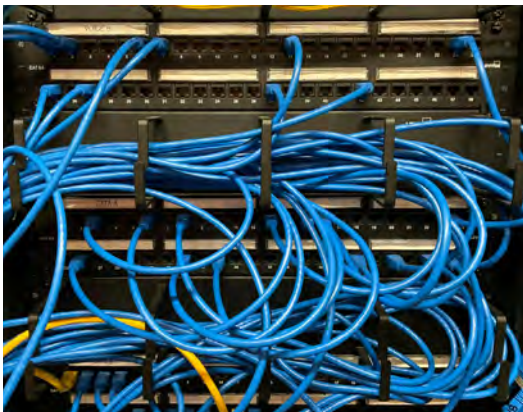
TELECOMMUNICATIONS ROOM – TR-G102

Existing Data Patching.

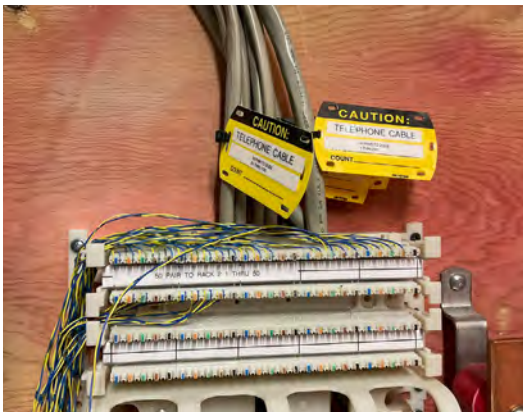
Existing Voice Patching.

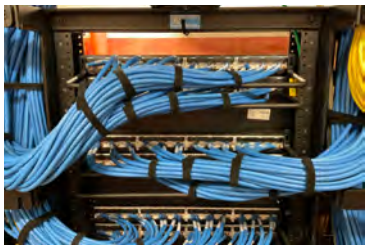
Existing Category 6A Cabling.
