DSHS  
**WESTERN STATE  
HOSPITAL**

**WA STATE PROJECT NUMBER: 2024-429 B (2)**

## EXECUTIVE SUMMARY

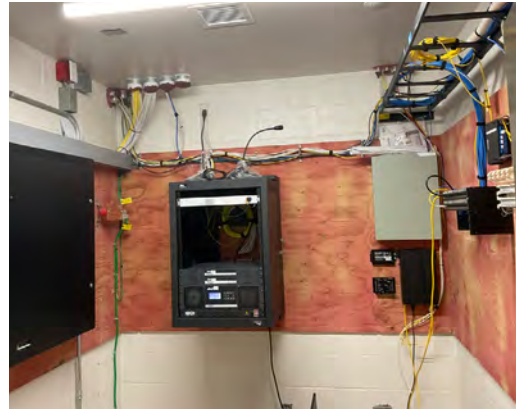
TELECOMMUNICATIONS ROOM – TR-G111

Existing Telecom Room.

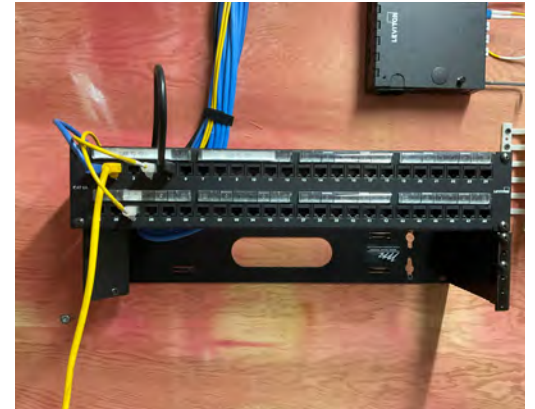
Existing Data Patching.

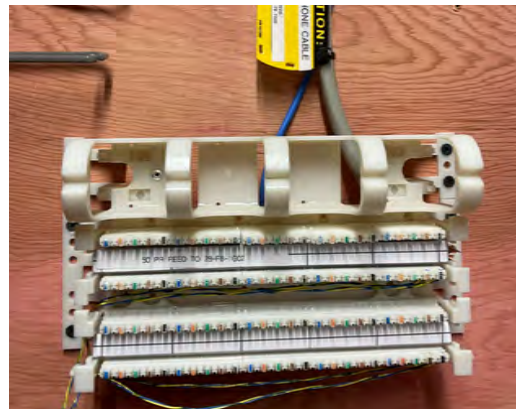
Existing Voice Patching.

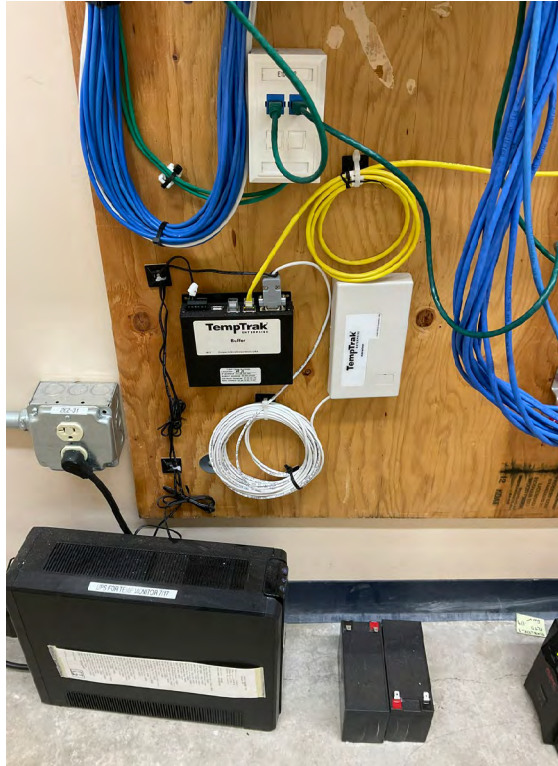
TELECOMMUNICATIONS ROOM – TR-E201

Existing Wall-Mounted Equipment.

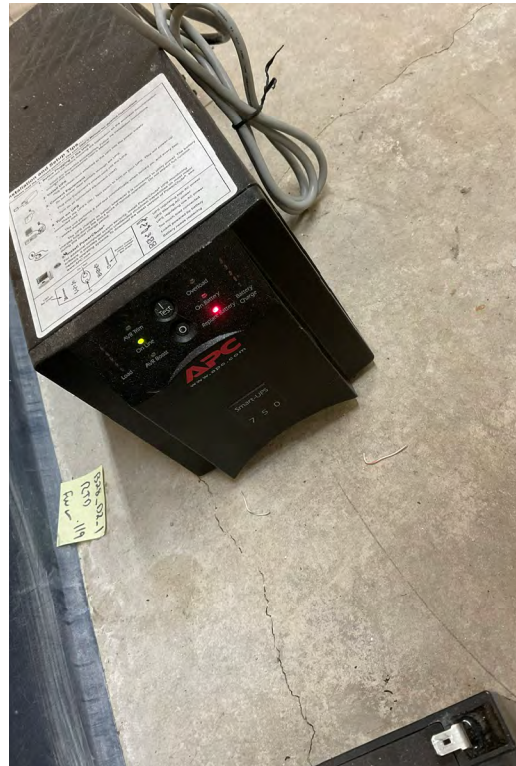
Existing Failing UPS.

*The existing backbone and horizontal cabling do not meet current TIA standards for healthcare facilities. To meet industry standards, it is recommended to upgrade the existing backbone and horizontal cabling. Additional Category 6A data ports should be provided as required to meet standards. Dedicated cooling is required to meet standards. The addition of card-based access control is recommended to control and track access to the space.*

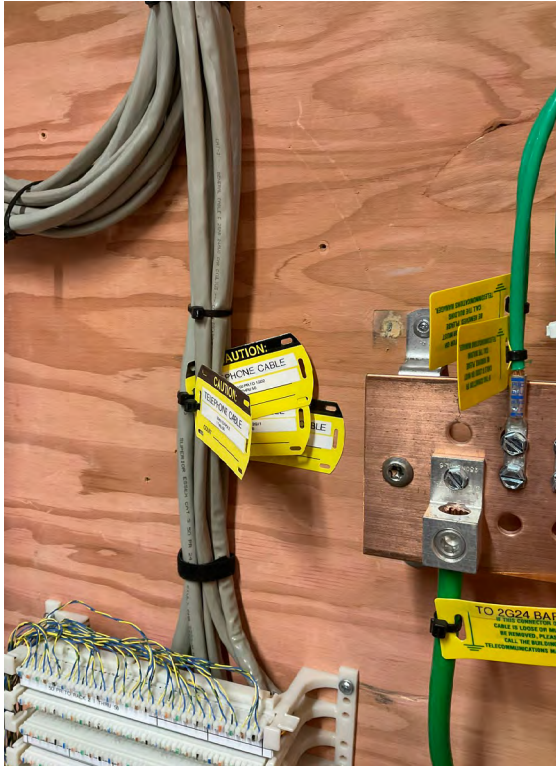
## TELECOMMUNICATIONS ROOM – TR-G202

*Existing Voice Patching.*

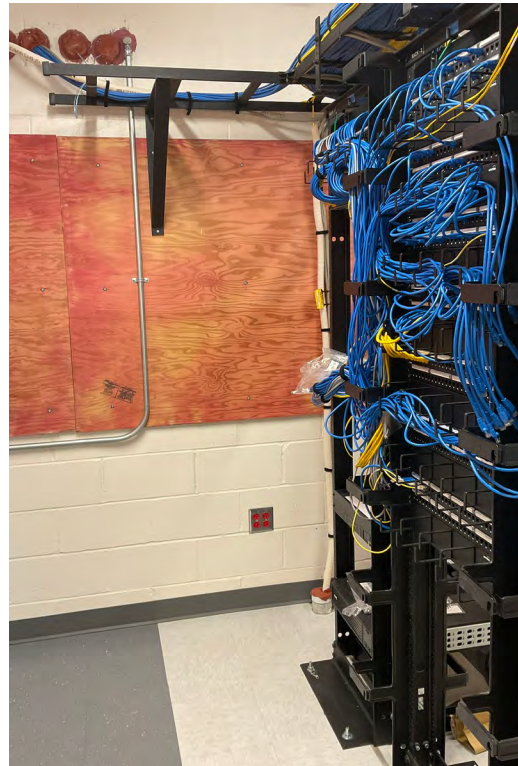
*Existing Telecom Racks.*

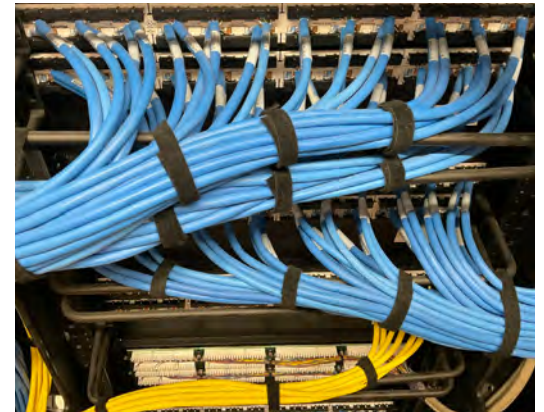
*Existing Data Patching.*

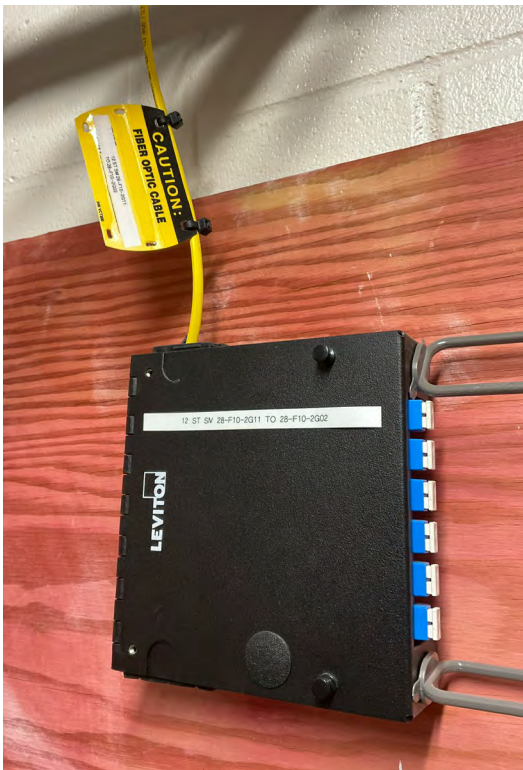
Existing Unused Fiber Cabinet.

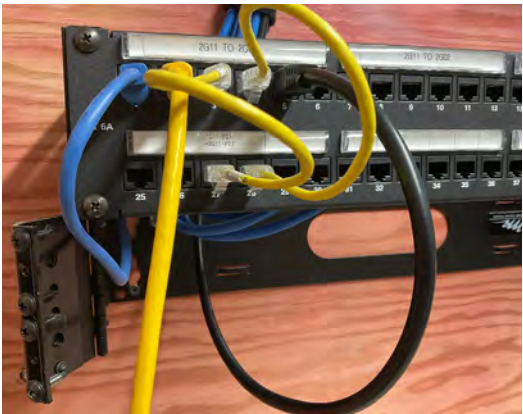
Existing Data Patching.

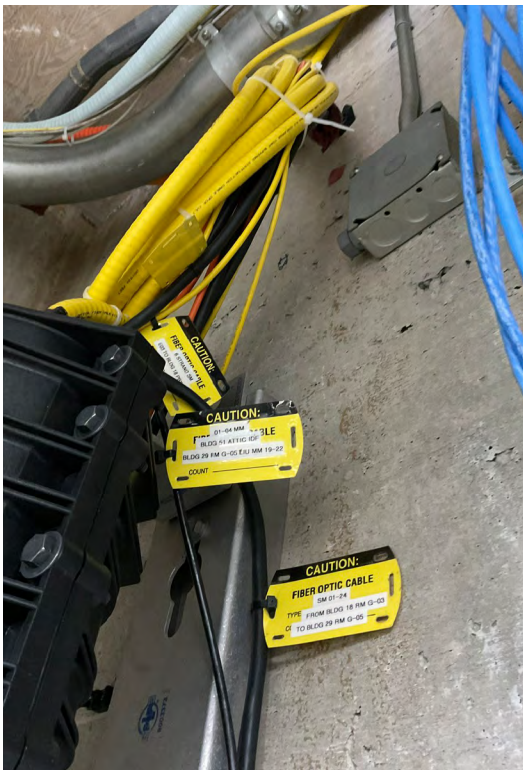
Existing Fiber Cabling.

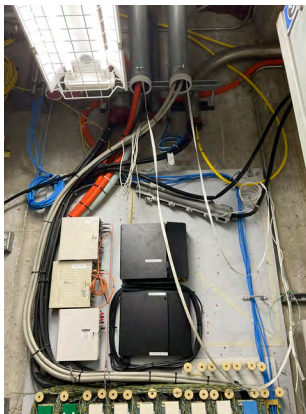
Existing Fiber Cabinets.

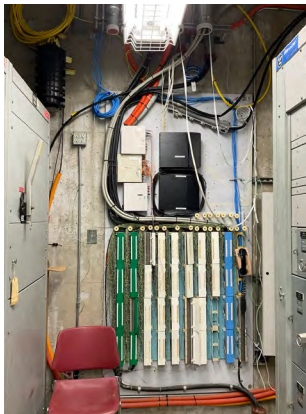
***The telecommunications space does not meet current TIA standards. The telecommunications equipment should be relocated to a dedicated telecom space. Existing backbone cabling do not meet current TIA standards for healthcare facilities. To meet industry standards, it is recommended to upgrade the existing backbone. Dedicated cooling, and dedicated equipment and convenience receptacles are required to meet standards. The addition of card-based access control is recommended to control and track access to the space.***

Existing Telecom Room.

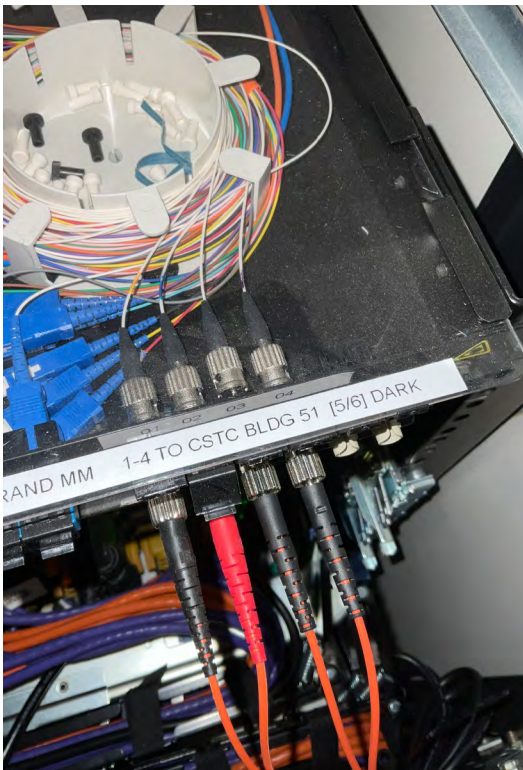
Existing Fiber Cabinet.

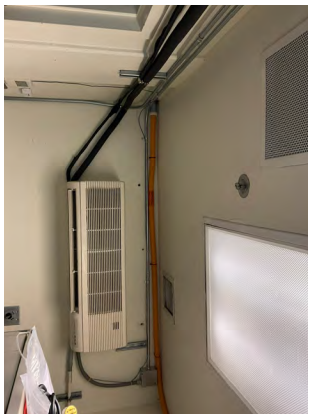
Existing Cooling Unit.

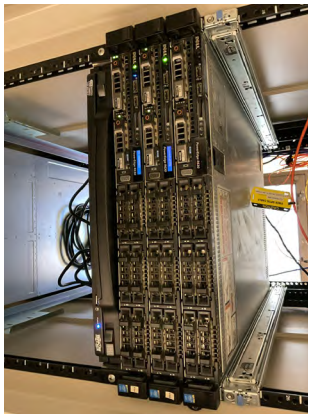
Existing Server Equipment.

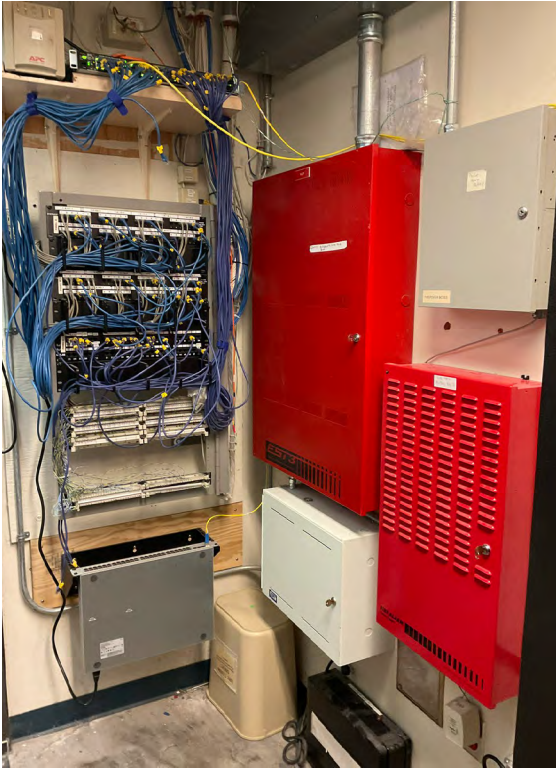
TELECOMMUNICATIONS ROOM – TR-A112

Existing Telecom Room.

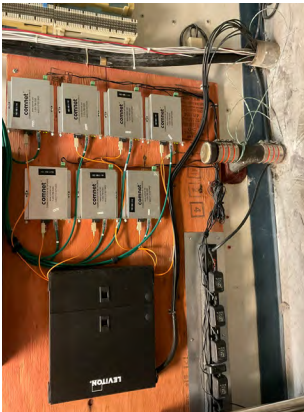
Existing Media Converters.

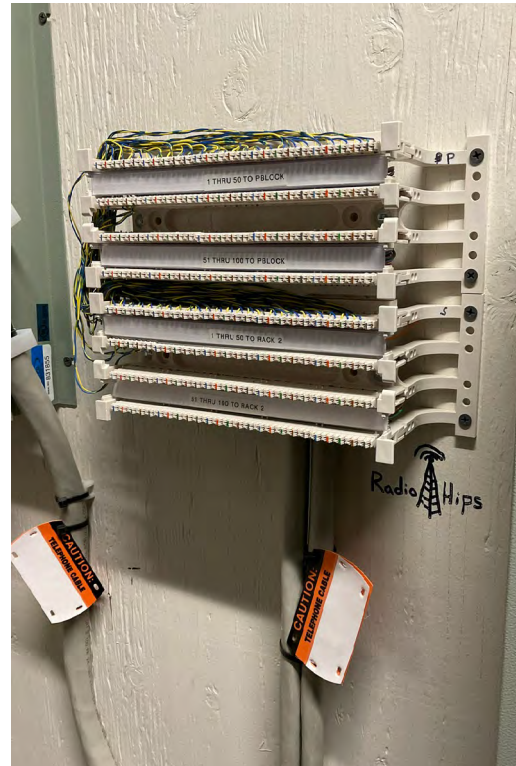
*Existing Voice Patching.*

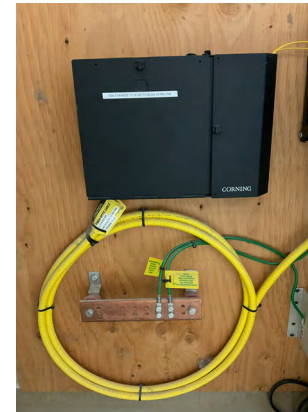
Existing Grounding and OFC.

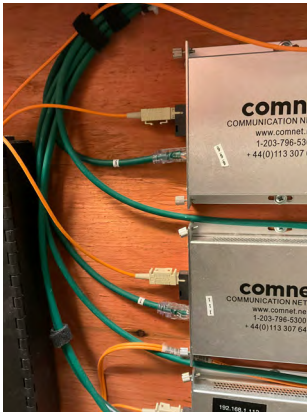
Existing Media Converters.

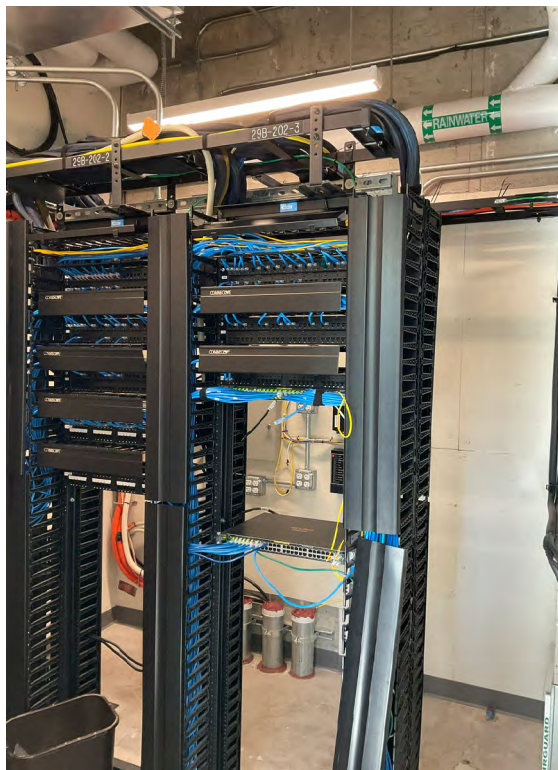
## TELECOMMUNICATIONS ROOM – TR-B202

Telecommunications Room TR-B202 is a dedicated telecommunications room on the second floor. It includes three two-post equipment racks with patch panels, ethernet switches, and a UPS. Connectivity is provided by a 12-strand OM3 multi-mode optical fiber backbone cable and a 100-pair twisted-pair copper cable from TR-003. There is also a 24-strand single-mode optical fiber backbone cable from TR-B102. Existing horizontal cabling is Category 6A for data and voice cabling. There is a rack mounted UPS. A telecommunications grounding busbar was observed. There was no dedicated cooling observed in the space.

*Existing Telecom Racks.*

*The existing backbone and horizontal cabling do not meet current TIA standards for healthcare facilities. To meet industry standards, it is recommended to upgrade the existing backbone. Additional Category 6A data ports should be provided as required to meet standards. Dedicated cooling is required to meet standards. The addition of card-based access control is recommended to control and track access to the space.*

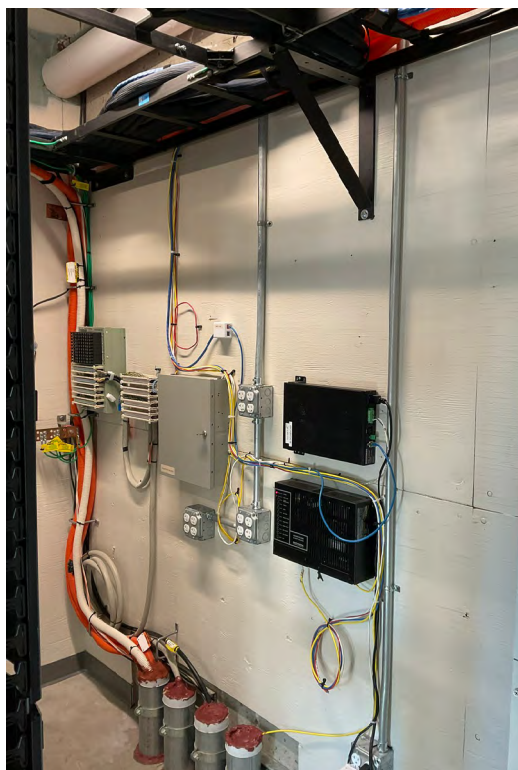
*Existing Wall-Mounted Equipment.*

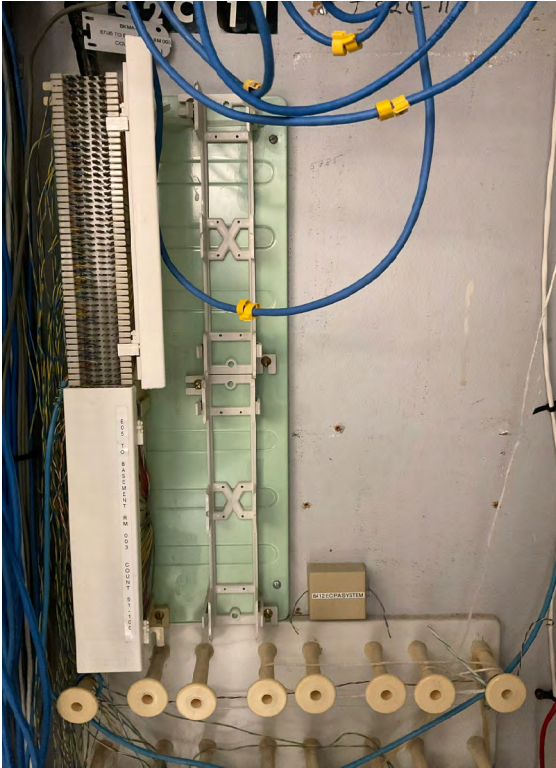
TELECOMMUNICATIONS ROOM – TR-C206

Telecommunications Room TR-C206 is a small electrical closet on the second floor. The telecommunications space is too small to meet current standards. It contains multiple patch panels, 66-blocks, and switches mounted on the wall. Connectivity is provided by Category 5e cables for network backbone and a 100-pair twisted-pair Category 3 cable for voice backbone. Existing horizontal cabling is Category 5e for data and Category 3 for voice cabling. There is a tower UPS on the floor. A telecommunications grounding busbar was observed. There was no dedicated cooling observed in the space.

Existing Voice Patching.

***The existing telecommunications space is not standards compliant. The existing backbone and horizontal cabling does not technically meet current TIA standards for healthcare facilities. To meet industry standards, it is recommended to upgrade the existing backbone and horizontal cabling. Additional Category 6A data ports should be provided as required to meet standards. Dedicated cooling, cable management, and dedicated equipment receptacles are required to meet standards. The addition of card-based access control is recommended to control and track access to the space.***

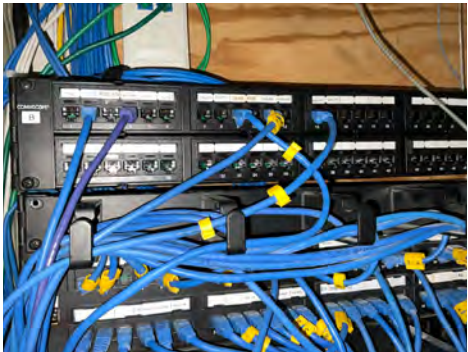
Existing Data Patching.

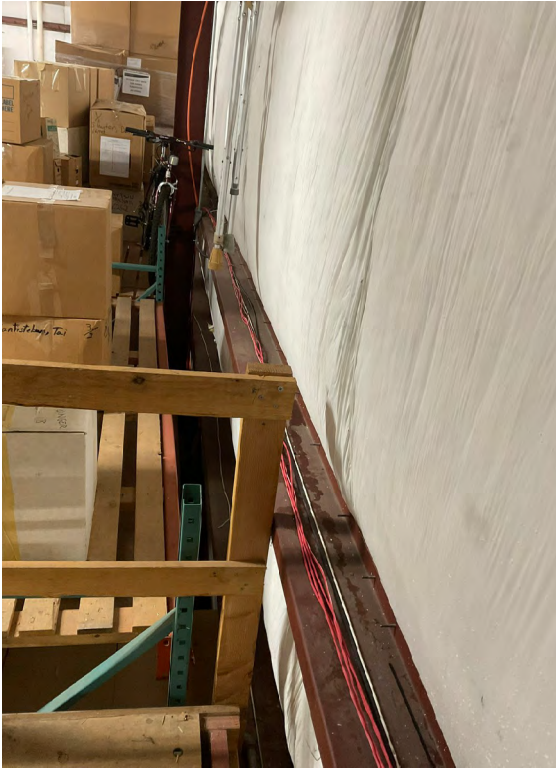
TELECOMMUNICATIONS ROOM – TR-INVENTORY CONTROL

The telecommunications room is a storage space on the ground floor. It contains a patch panel and 110-block mounted on the wall. Connectivity is provided by a 4-strand OM1 multi-mode optical fiber backbone cable and a 25-pair twisted-pair copper cable from the Maintenance Office (Building 1). Existing horizontal cabling is Category 5e for data and Category 3 for voice cabling. There is no UPS power available. Neither a telecommunications grounding busbar no dedicated cooling was observed in the space.

Existing Cable Routing.

*The existing telecommunications space is not standards compliant. It is recommended to create a new, dedicated telecommunications room. The existing backbone and horizontal cabling do not meet current TIA standards for healthcare facilities. To meet industry standards, it is recommended to provide a new, dedicated telecommunications room with standards compliant backbone and horizontal cabling. Additional Category 6A data ports should be provided as required to meet standards. Dedicated cooling, rack space, and cable management should be provided. The addition of card-based access control is recommended to control and track access to the space.*

- » Provide a new dedicated telecommunications room.
- » Add ladder tray and cable management as needed.
- » Upgrade existing port locations to Category 6A.
- » Add additional Category 6A 8P8C RJ45 ports to meet standards.
- » Provide labels for all new cabling and existing cables to remain.
- » Provide new 12-strand single-mode and 12-strand OM4 multi-mode optical fiber backbone from Maintenance Shops (Building 1).
- » Add power circuits and receptacles as needed.
- » Provide a properly sized UPS.
- » Add Telecommunications Grounding Busbar.
- » Add dedicated cooling system.
- » Control access to authorized individuals.

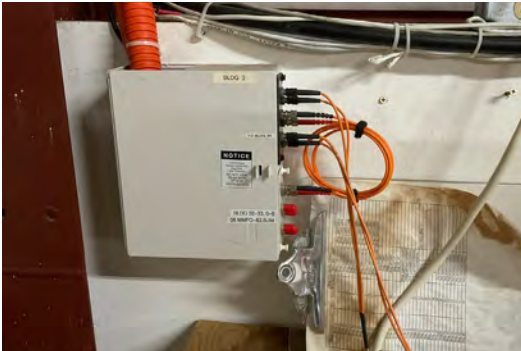
Existing Fiber Cabinet.

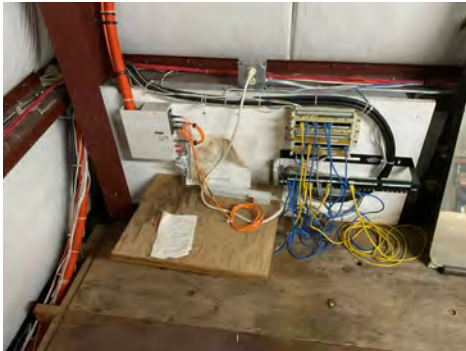
Existing Telecom Equipment.

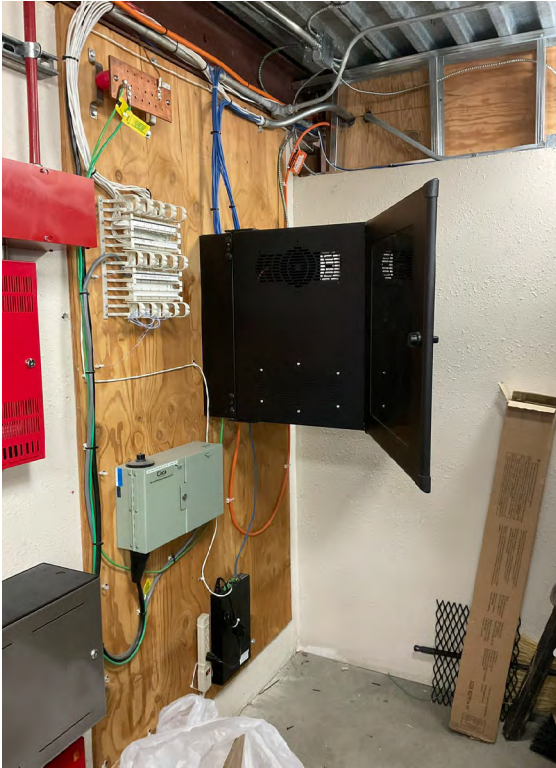
TELECOMMUNICATIONS ROOM – TR-MAINTENANCE WAREHOUSE

Existing Telecom Equipment.

***The existing backbone and horizontal cabling do not meet current TIA standards for healthcare facilities. To meet industry standards, it is recommended to upgrade the existing backbone. Additional Category 6A data ports should be provided as required to meet standards. Dedicated cooling is required to meet standards. The addition of card-based access control is recommended to control and track access to the space.***

- » Add ladder tray and cable management as needed.
- » Upgrade existing port locations to Category 6A.
- » Add additional Category 6A 8P8C RJ45 ports to meet standards.
- » Provide labels for all new cabling and existing cables to remain.
- » Provide new 12-strand single-mode and 12-strand OM4 multi-mode optical fiber backbone from Maintenance Shops (Building 32).
- » Provide a properly sized UPS.
- » Add Telecommunications Grounding Busbar.
- » Add dedicated cooling system.
- » Control access to authorized individuals.

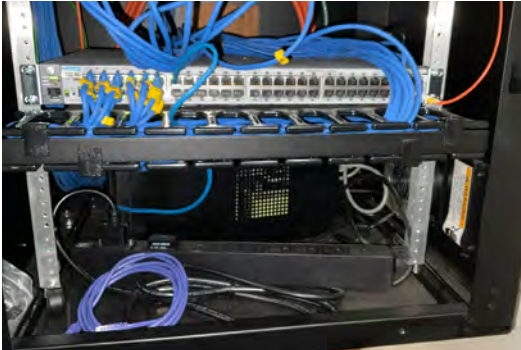
Existing Telecom Cabinet.

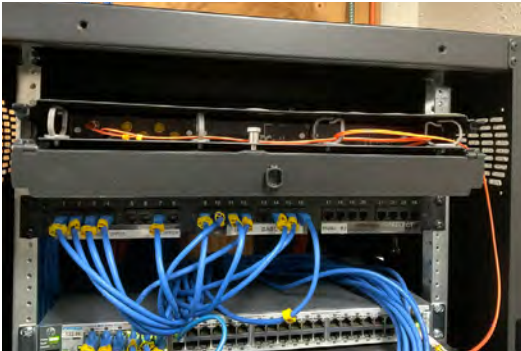
Existing Fiber Patching.

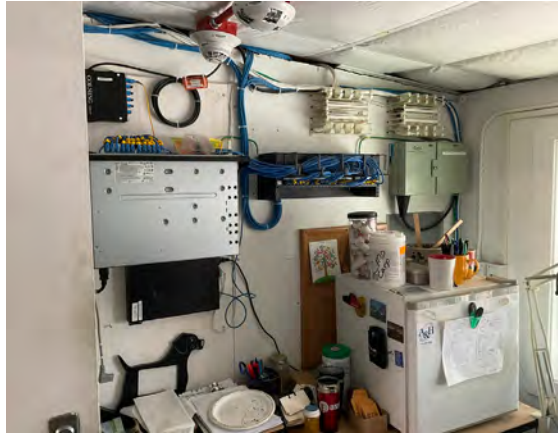
# TELECOMMUNICATIONS ROOM – TR-CARPENTER SHOP

Existing Telecom Room.

*The existing telecommunications space is not standards compliant. It is recommended to create a new, dedicated telecommunications room. The existing backbone and horizontal cabling do not meet current TIA standards for healthcare facilities. To meet industry standards, it is recommended to provide a new, dedicated telecommunications room with standards compliant backbone and horizontal cabling. Additional Category 6A data ports should be provided as required to meet standards. Dedicated cooling, rack space, and cable management should be provided. The addition of card-based access control is recommended to control and track access to the space.*

- » Add ladder tray and cable management as needed.
- » Upgrade existing port locations to Category 6A.
- » Add additional Category 6A 8P8C RJ45 ports to meet standards.
- » Provide labels for all new cabling and existing cables to remain.
- » Provide new 12-strand single-mode and 12-strand OM4 multi-mode optical fiber backbone from Maintenance Shops (Building 32).
- » Add power circuits and receptacles as needed.
- » Provide a properly sized UPS.
- » Add Telecommunications Grounding Busbar.
- » Add dedicated cooling system.
- » Control access to authorized individuals.

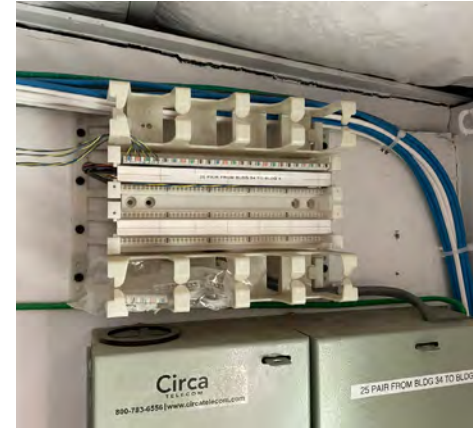
Existing Voice Patching.

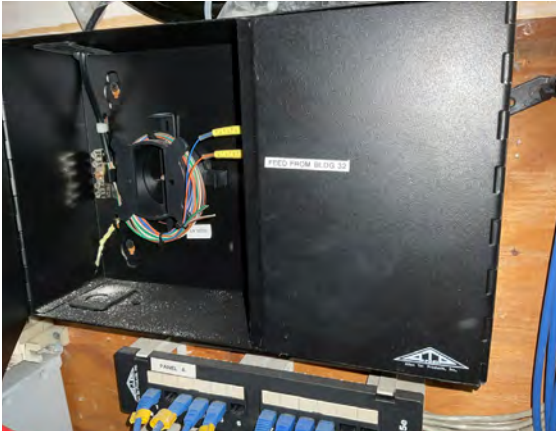
TELECOMMUNICATIONS ROOM – TR-WAREHOUSE

Existing Cut Fiber.

***The existing backbone and horizontal cabling do not meet current TIA standards for healthcare facilities. To meet industry standards, it is recommended to upgrade the existing backbone. Additional Category 6A data ports should be provided as required to meet standards. Dedicated cooling is required to meet standards. The addition of card-based access control is recommended to control and track access to the space.***

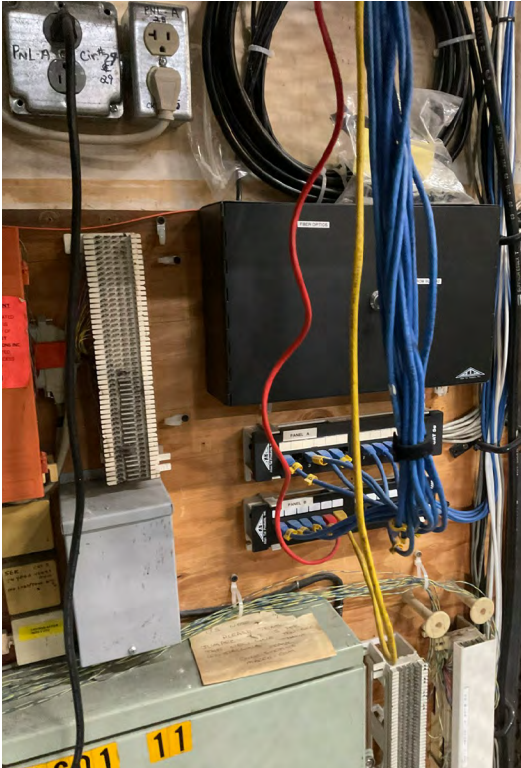
Existing Data Patching.

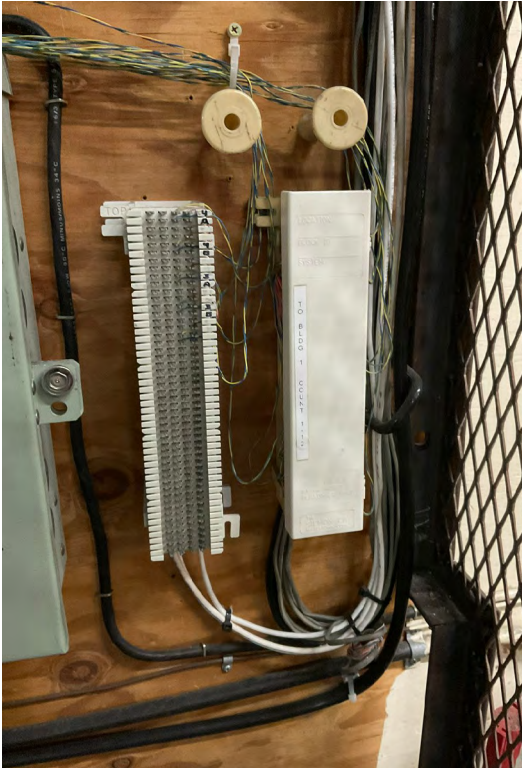
Existing Voice Patching.
