Washington State
Department of Transportation
Bridge Preservation Dive Team

UNDERWATER INSPECTION REPORT FOR
STEILACOOM MOORING FLOAT

BRIDGE NO. DOC-2

STRUCTURE ID 00200437

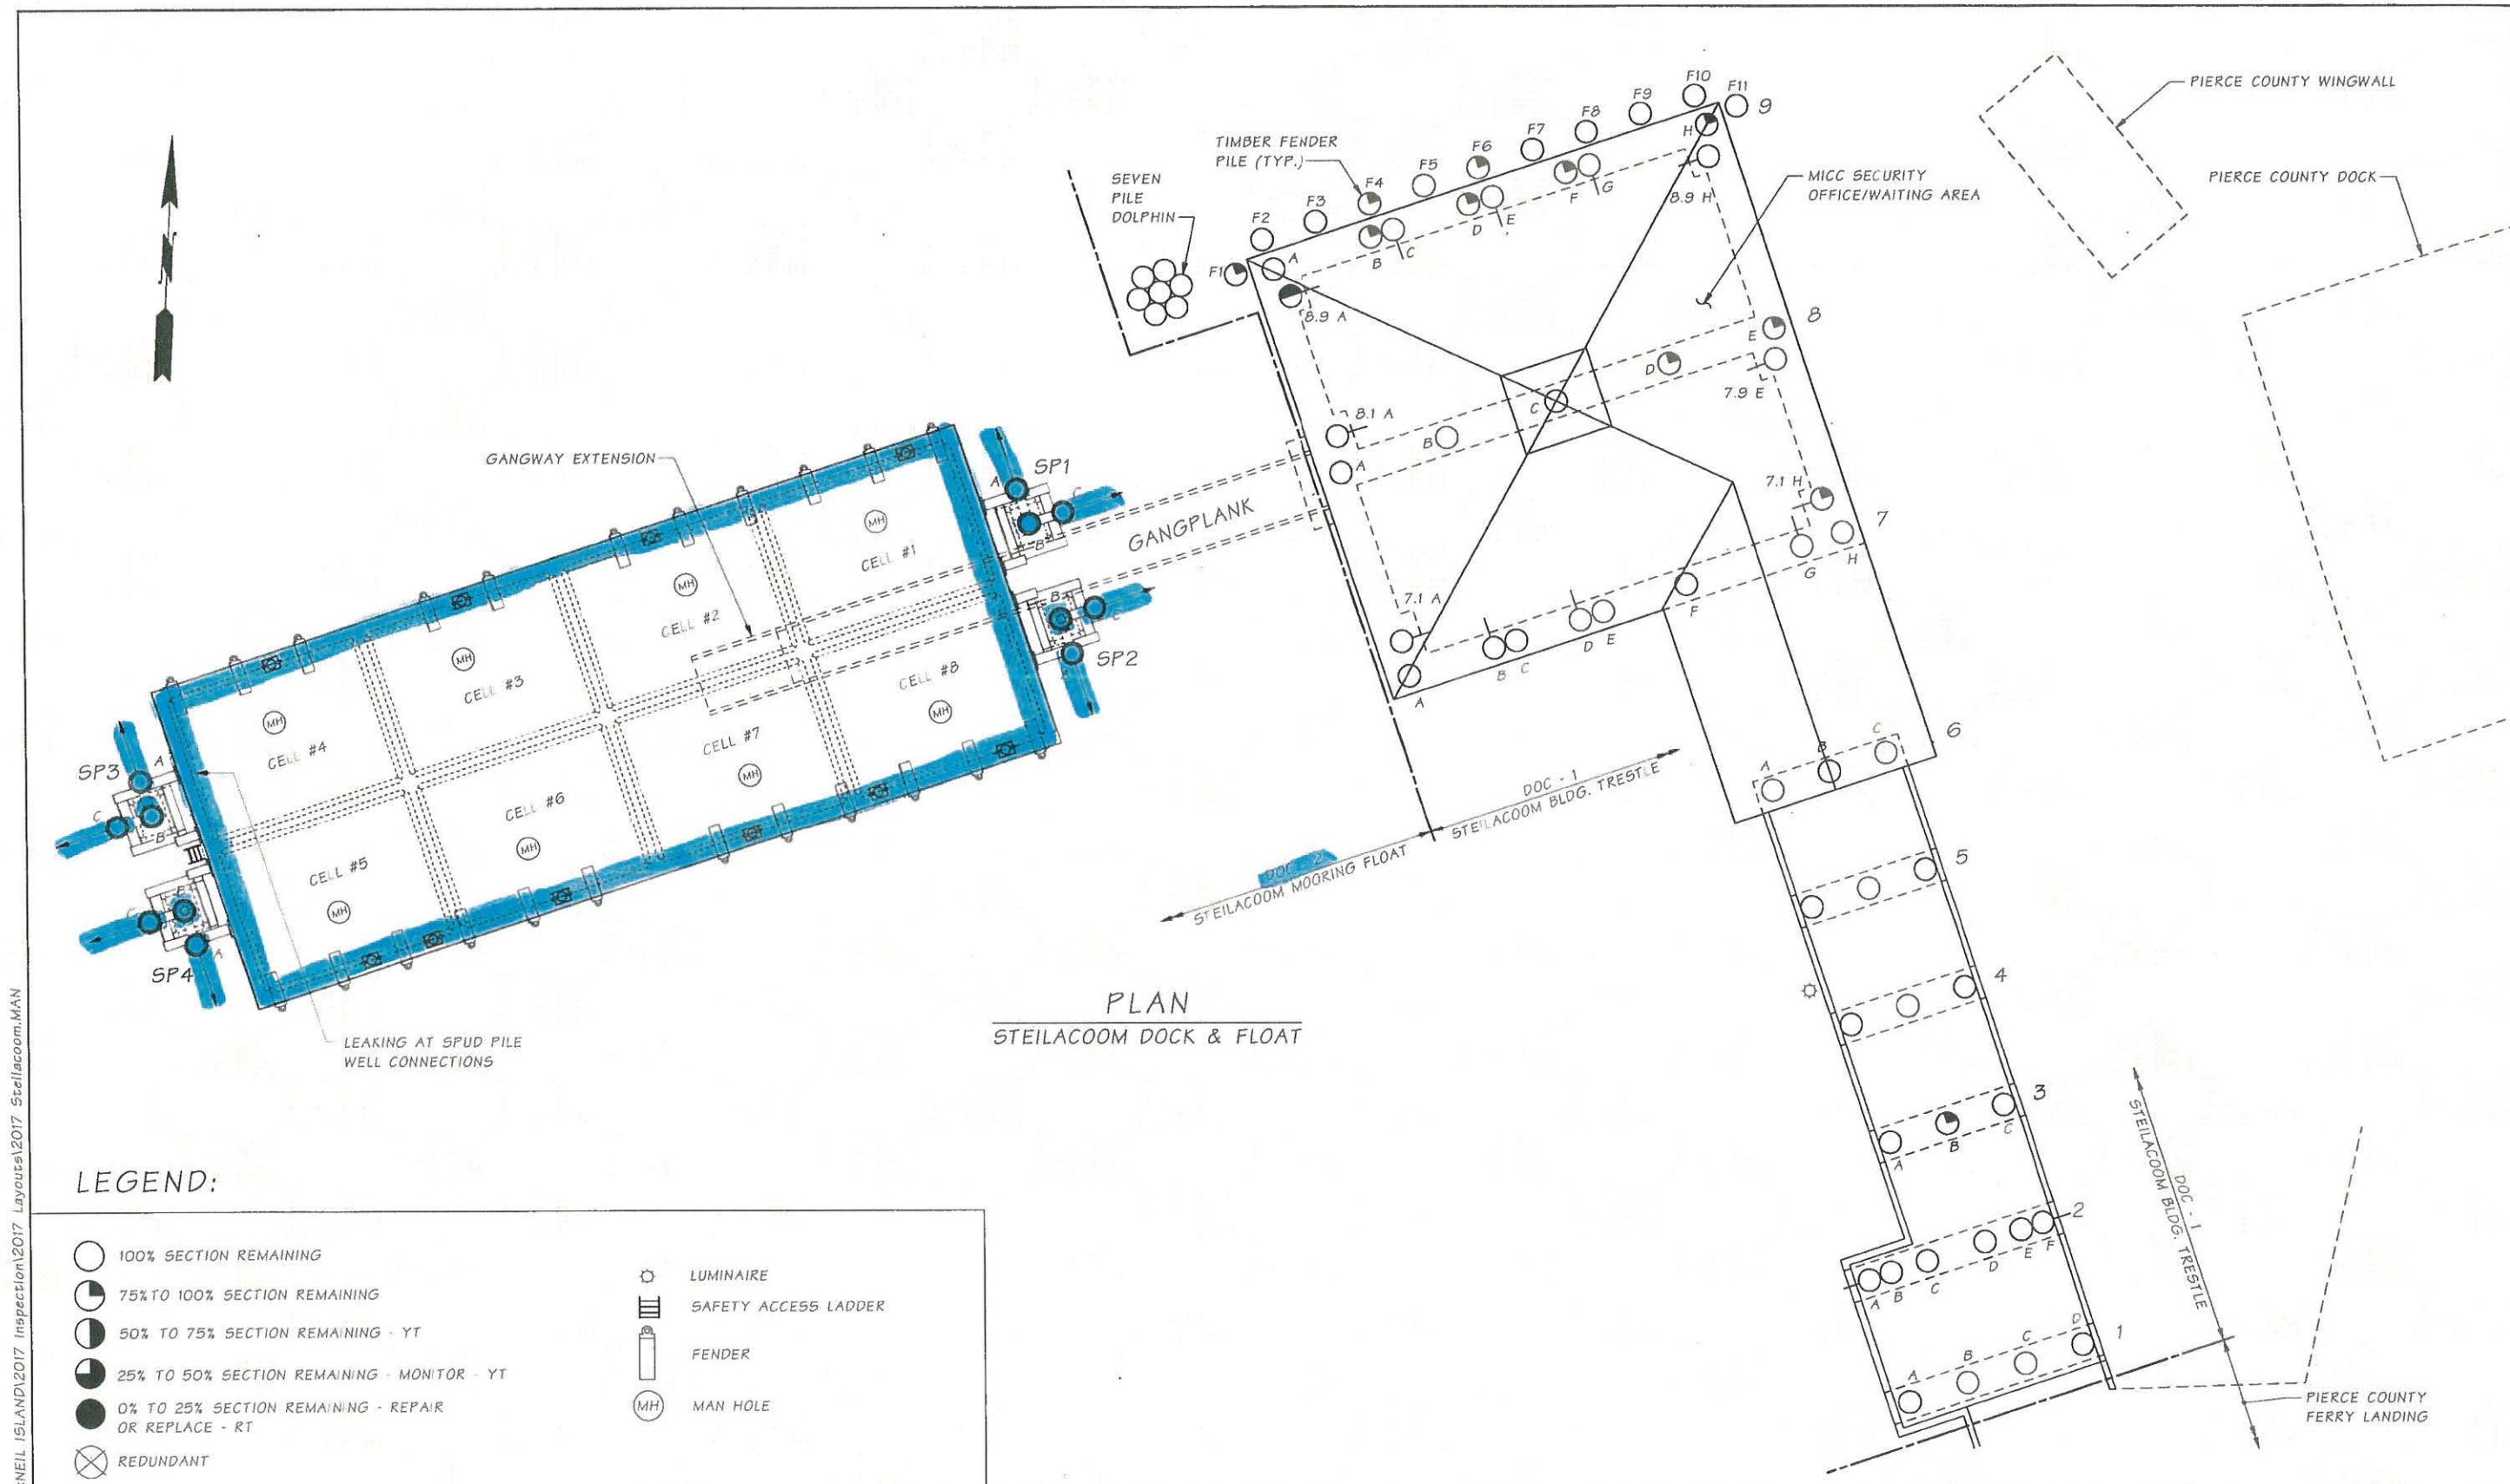
PLAN
STEILACOOM DOCK & FLOAT

8701 FERRY CONCRETE FLOATING PONTOON:
INTERIOR:
All eight cells of the mooring float were entered during the 2017 inspection (see layout sheet for cell numbering) (photos #7 & #8).
The cell at the spud pile well connection on the west side, cell #4, showed some signs of leaking at the interior connection plates (photo #9) (CS4). Marty Rankin informed us in 2013 that cell #5 is pumped regularly. DOC employees told the inspectors in 2017 and 2019 that all cells are pumped regularly. The pumping depths should be tracked, REPAIRS #10001 and #10007.
Cell #4 has a broken hold down bolt stuck in the base tab and Cell #5 has a broken hold down tab (photos #11 and #12). REPAIR #10003.
Cell #5 spud pile well connections have rust and some section loss (photo #13).
Cell #8 also has spud pile well connection plates on the interior. These plates are slightly undersized resulting in the bolts not having a solid anchor base (photo #14).
