Roof SURVEY REPORT

Limited Roof Survey and Leak Investigation

Rainier School Building 2010

Buckley, Washington

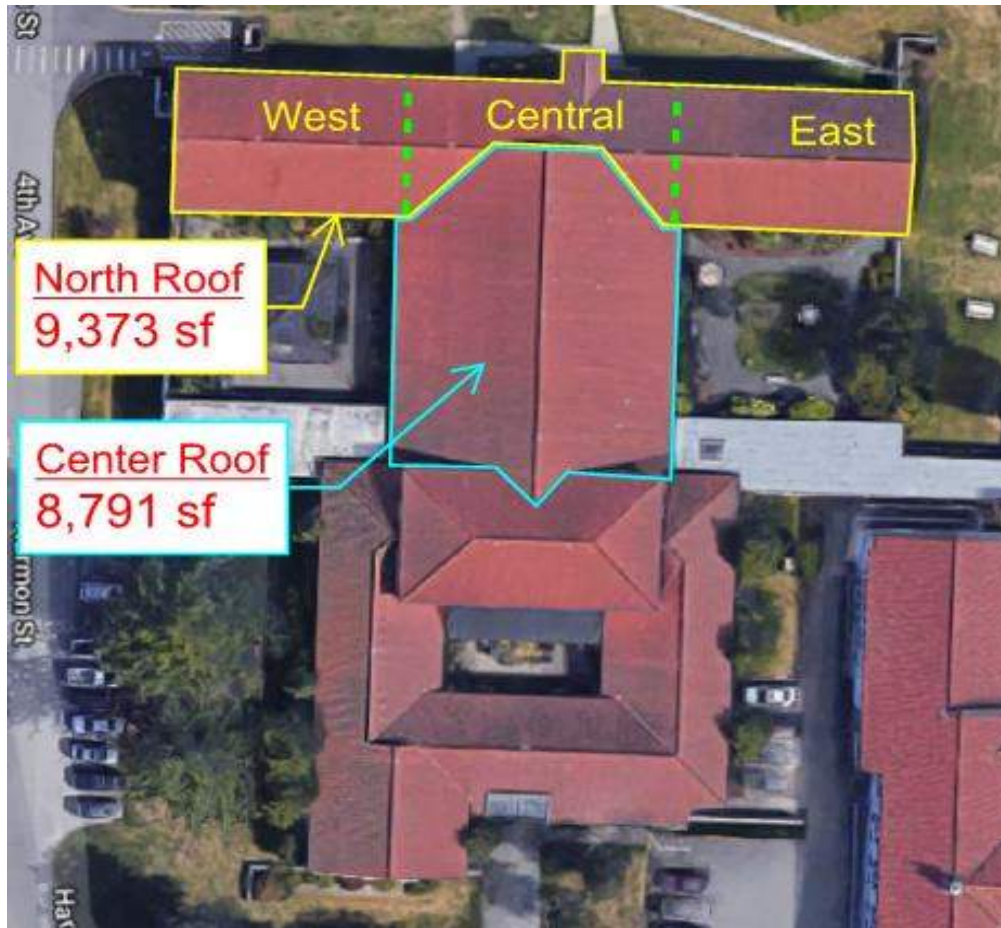
Photo No. 6 - Depicts an overview of the roof areas at the 2010 Building. The yellow outlined roof area at the north end of the building represents the requested area of roof to be included in the roof survey. The north end (yellow) roof area, as the focus of our survey, measures approximately 9,373 square feet. The roof area outlined in blue represents the additional roof area recommended to be included into a reroofing project as a result of visual deficiencies observed as part of our preliminary roof survey. The additional roof area, outlined in blue, measures approx. 8,791 square feet.

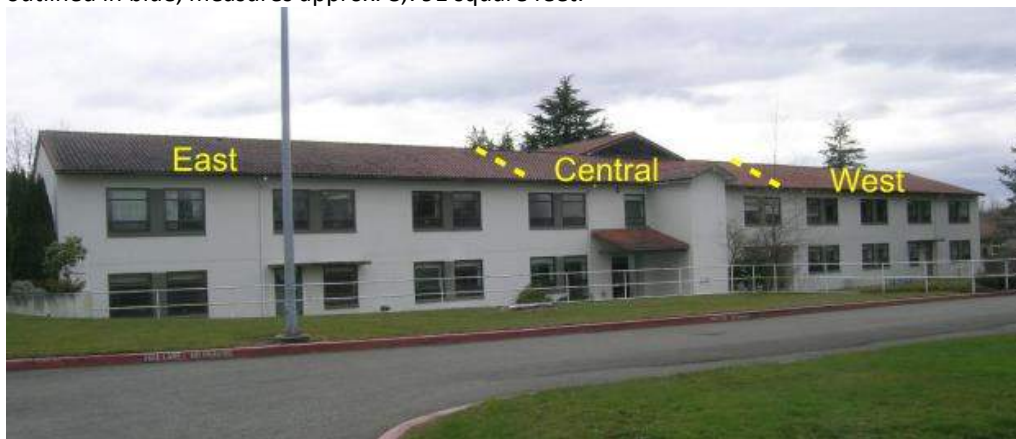
Photo No. 7 - View of the north-facing gable end roof area at the 2010 Building that was the primary focus of our roofing survey. Area separation walls built within the attic break the space into sections identified here as East, central, and West, as indicated in this photo.

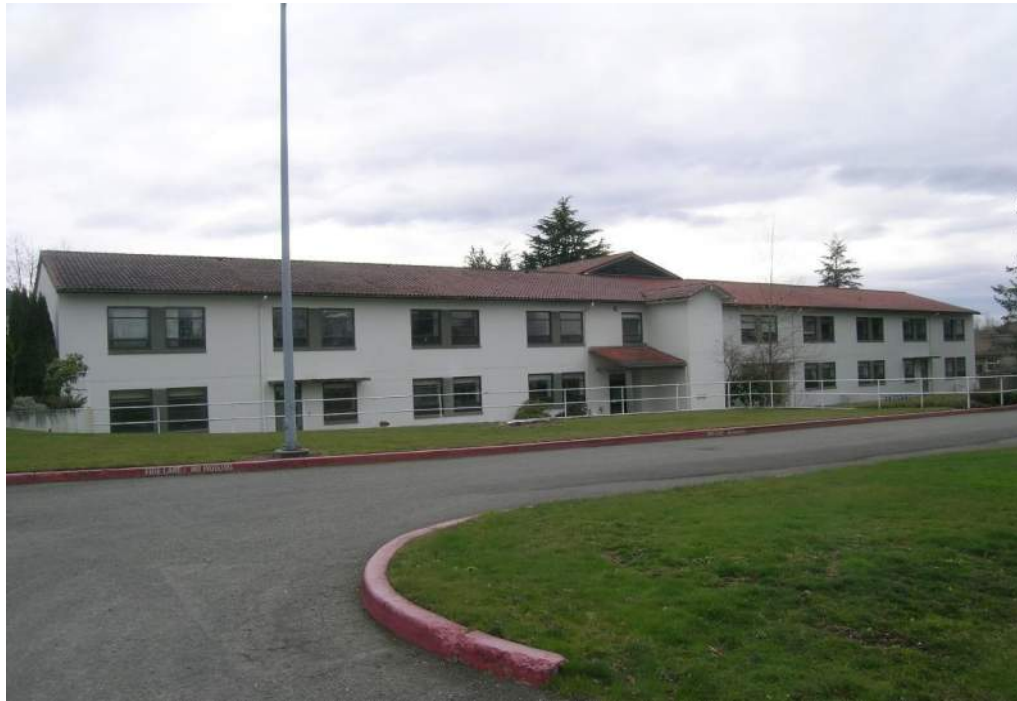
Photo No. 8 - View of the north-facing gable roof area at the 2010 Building that was the primary focus of our roofing survey.

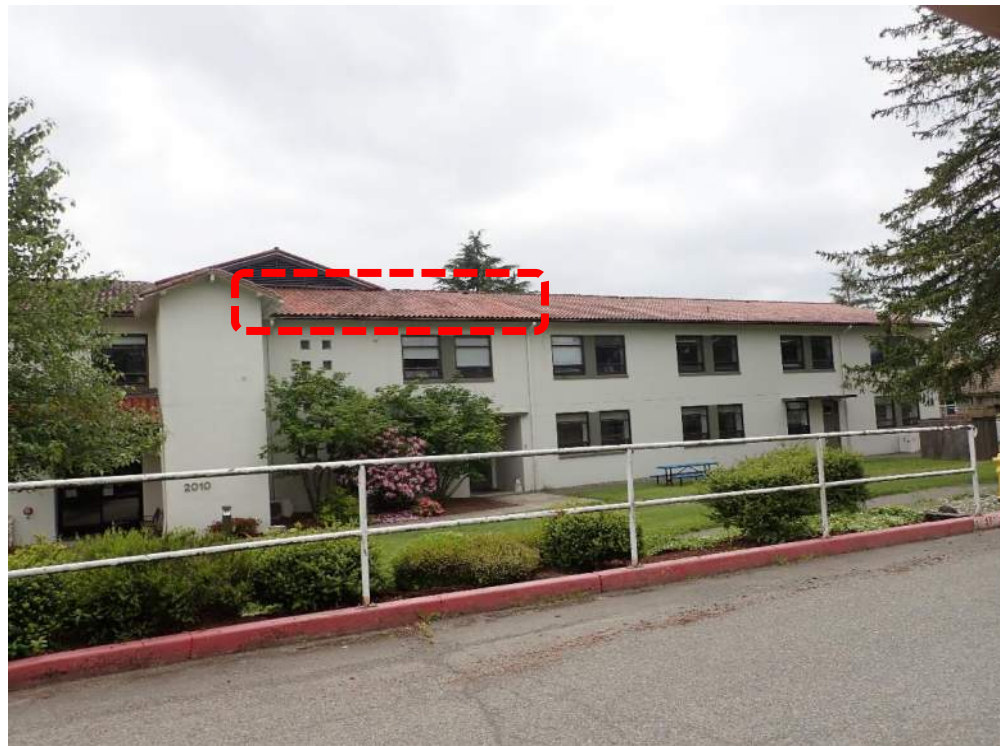
Photo No. 9 - View of the north-facing gable end roof area at the 2010 Building showing the west end of the roof area. It was reported that a portion of the roof area, shown by the red hatched line identified area, was previously repaired to address water-intrusions and water-damaged T&G roof decking.

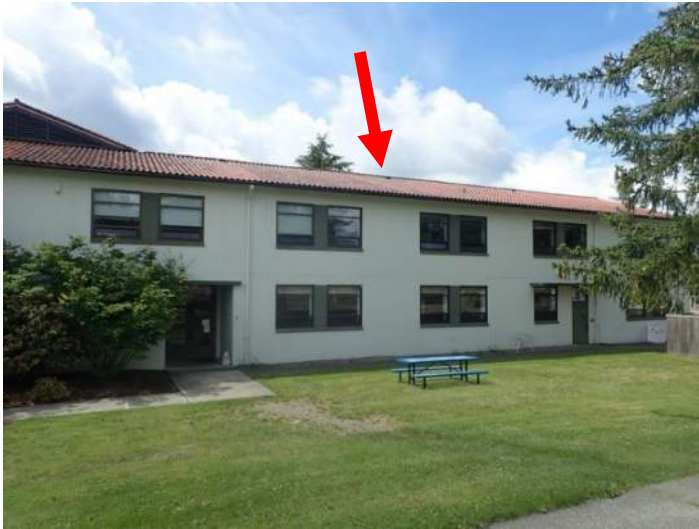
Photo No. 16 - Building 2010 North End Roof Area

As part of our roof survey, we removed select areas of interior insulation under the roof deck to observe conditions at the wood decking. The arrow depicts the general location of the testing and survey area at the west side area of the attic. The arrow points to a ridge vent that is shown in photos below.

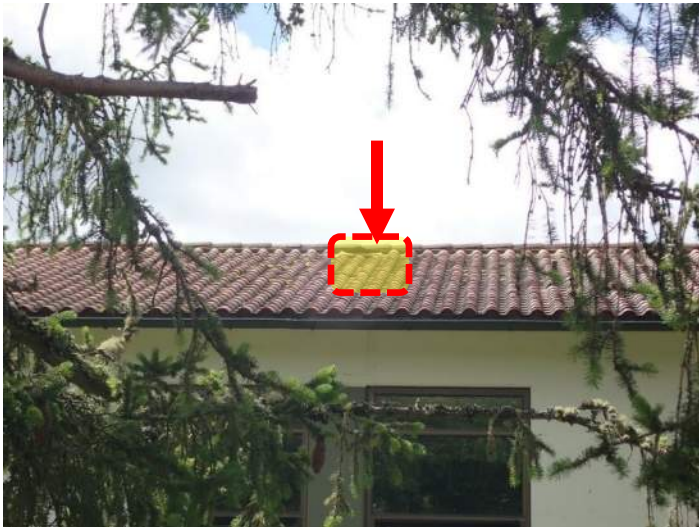
Photo No. 17 - North End Roof Area and Ridge Vent at Test Area

Closer photo of ridge vent location and general area where observations of the wood decking were documented from within the attic space.

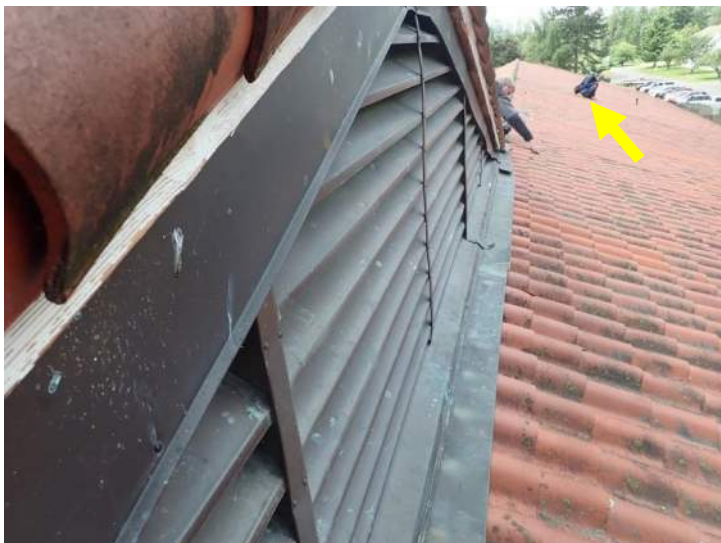
Photo No. 25 - North-facing gable end roof looking west

View of the north-facing side of the gable roof looking west. The arrow shows the approx. location of the test area shown in previous photos.

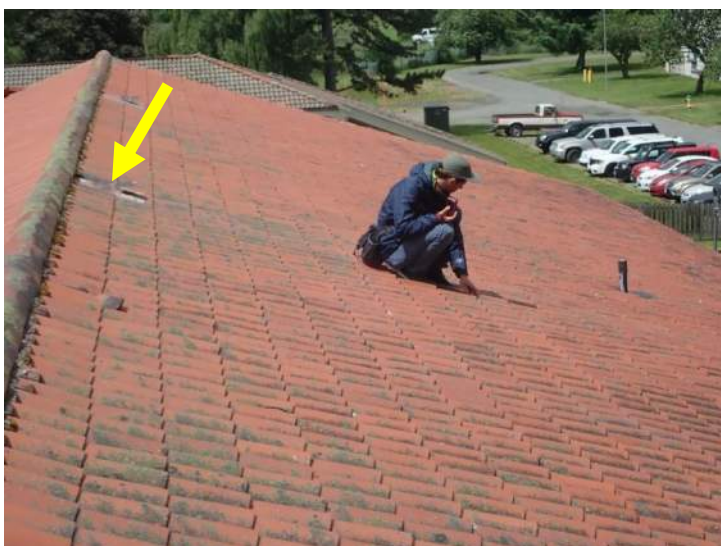
Photo No. 26 - North-facing gable end roof near test area

Closer photo showing location of the ridge vent location and BET&R roofing technician conducting roof level observations.

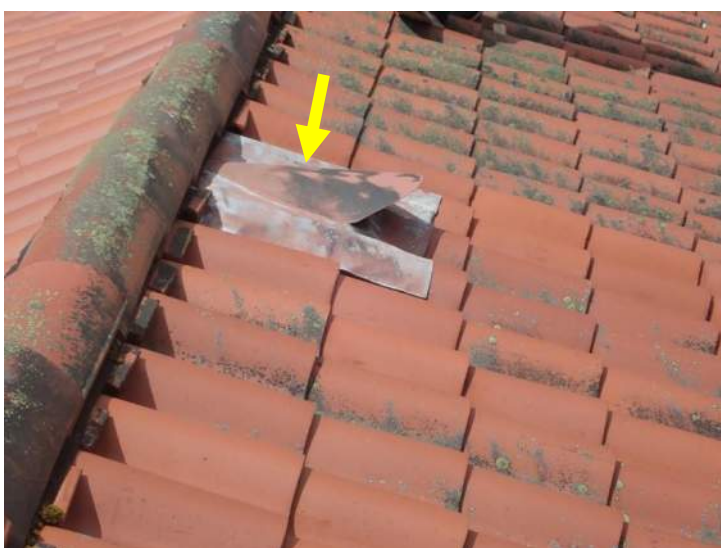
Photo No. 27 - Example gable vent at north end roof area

At the ridge vent, the openings were protected with a sheet metal flashing hood. As a general note, the small ridge vents do not appear to be effective for providing adequate roof ventilation, particularly as the rigid insulation fully blocks the vent opening. It also appeared that no downslope eave intake vents were provided.

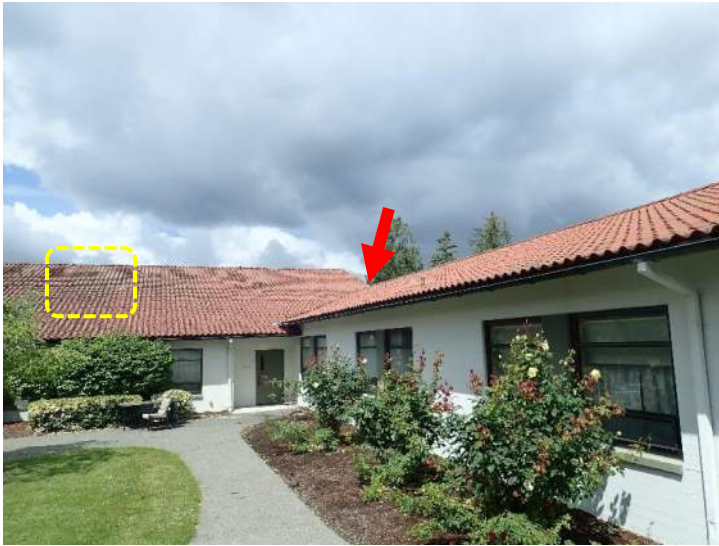
During our survey we also observed an area of deflected/sagging roof-related components at the center roof area adjacent the valley on the east side of the roof areas. Several large electrical conduits are located below the area and attached to the underside of the roof decking. This area is an area of critical concern and is recommended to be repaired immediately.

Photo No. 31 - East Courtyard showing Valley at Area of Concern

Following our initial interior observations, we accessed the roof from the central courtyard on the east side of the building, going up the valley identified by the arrow. The yellow box identifies an area of concern at the adjacent roof area where visual signs of sagging of roof components were observed.

The layout of the 2010 Building allows for reroofing to be planned out, prioritized, and conducted in phases as budgets become available. For an initial phase it is recommended that the north-side gable roof, along with the adjacent north-south oriented roof area, extending perpendicular to the subject roof area, both be included in the first phase of reroofing. Please Note: The two valleys where the roof areas intersect appear to be particular systemic zones of water intrusion and are in poor condition including extensive wood decay. Select areas of the adjacent north-south extending roof area also showed visual evidence of deflection/sagging of the roof system and existing affected wood roof decking, and is recommended to be further evaluated and included in a reroofing project. It appears there are water-damaged and decayed roof decking that needs to be replaced in order to maintain the integrity of the building. Although the observed deflection/sagging this subject roof area described was outside of your requested primary roof survey area, the area in question requires further in-depth evaluation and is recommended to be invasively investigated, evaluated, and repaired soon as a potential emergency repair scenario. A number of large electrical conduits were attached to the underside of the roof decking at this general location, and further degradation of the roof system may lead to partial roof collapse and potential disruption to critical services and functions of the building.

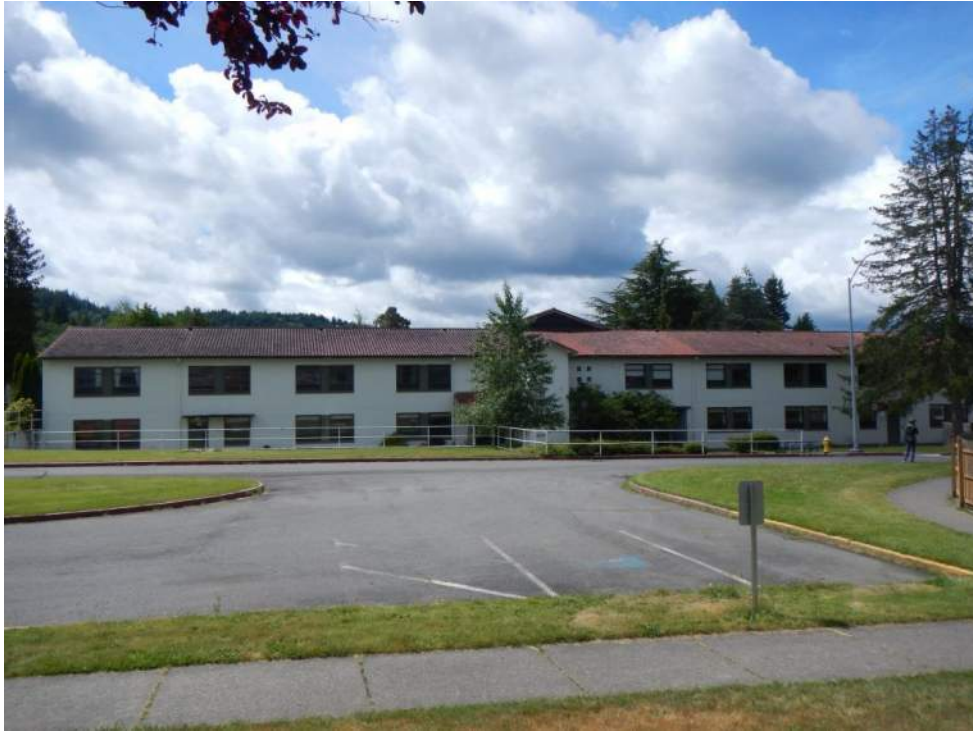
Photograph # 1: Overall view of building north elevation.

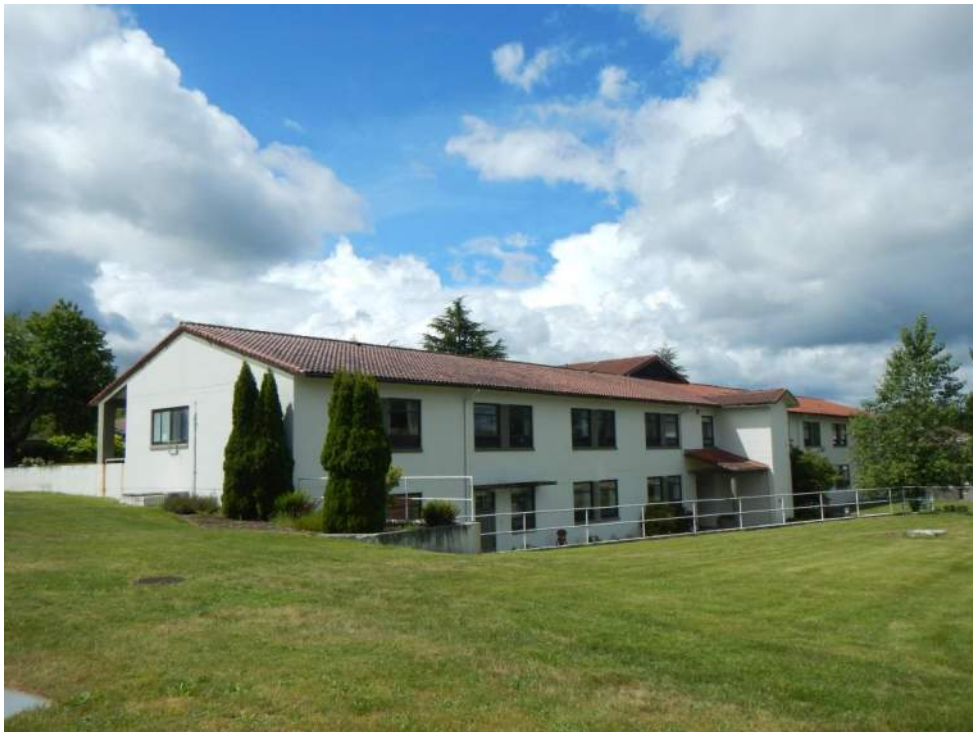
Photograph # 2: View of north-east corner of north elevation.

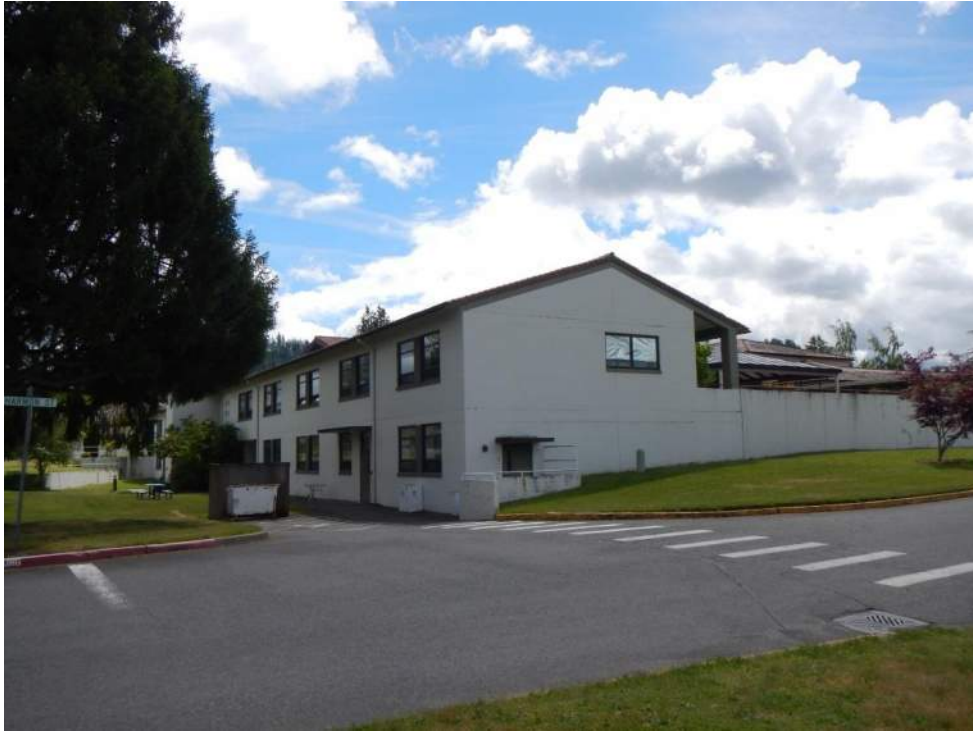
Photograph # 3: View of north-west corner of north elevation.

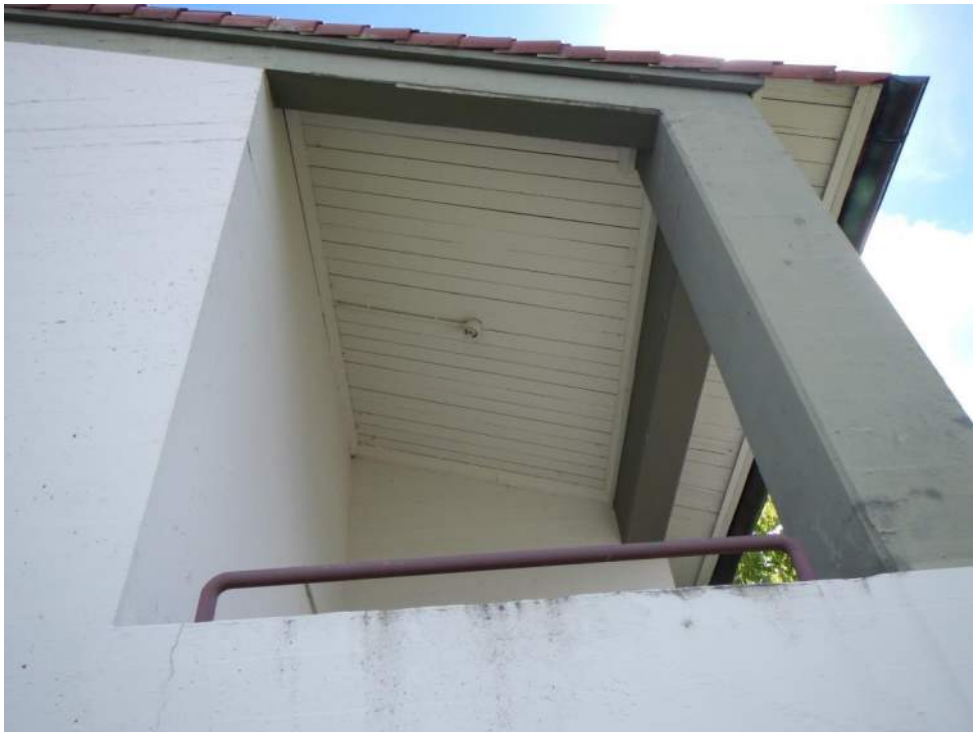
3. View of the north-west corner of the building. *See photograph # 3.*
4. Roof decking exposed at corner porch recesses. *See photograph # 4.*
5. View of the west half of the northern section of roof just in front of the gable end vent. *See photograph # 5.*

Photograph # 4: Exposed roof decking at corner porch recesses.

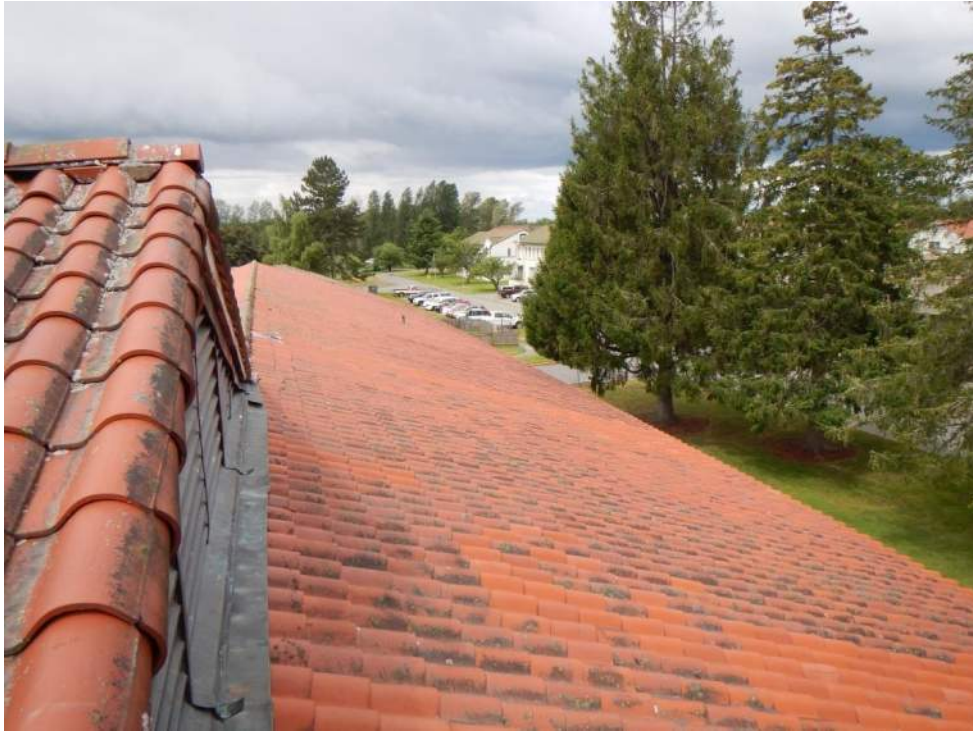
Photograph # 5: View of west roof section of north elevation.

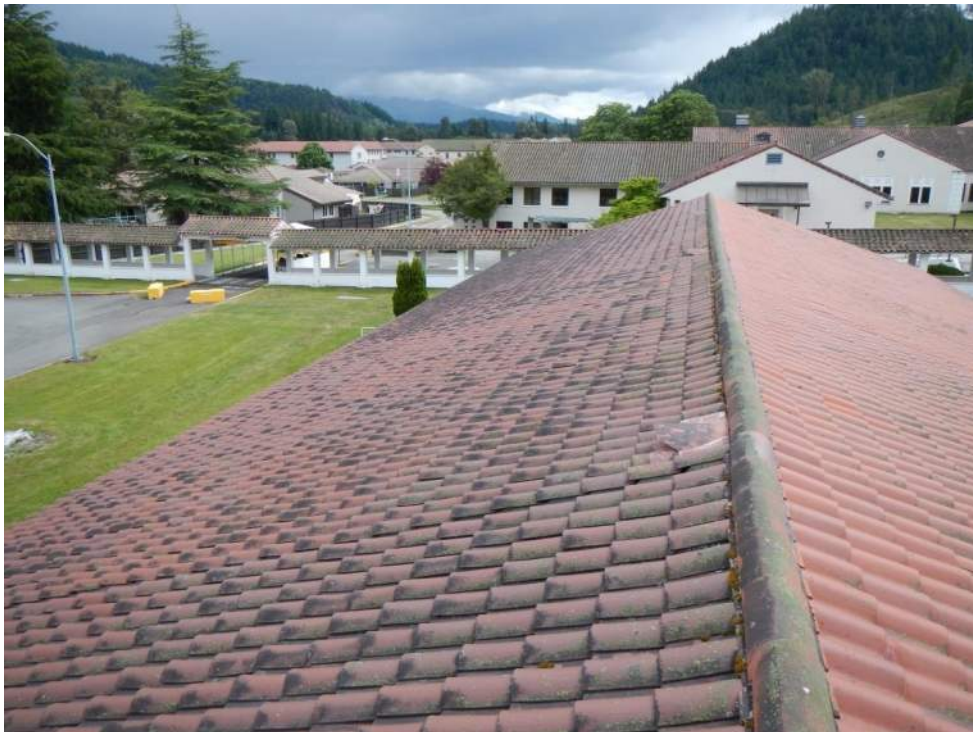
Photograph # 6: View of east roof section of north elevation.

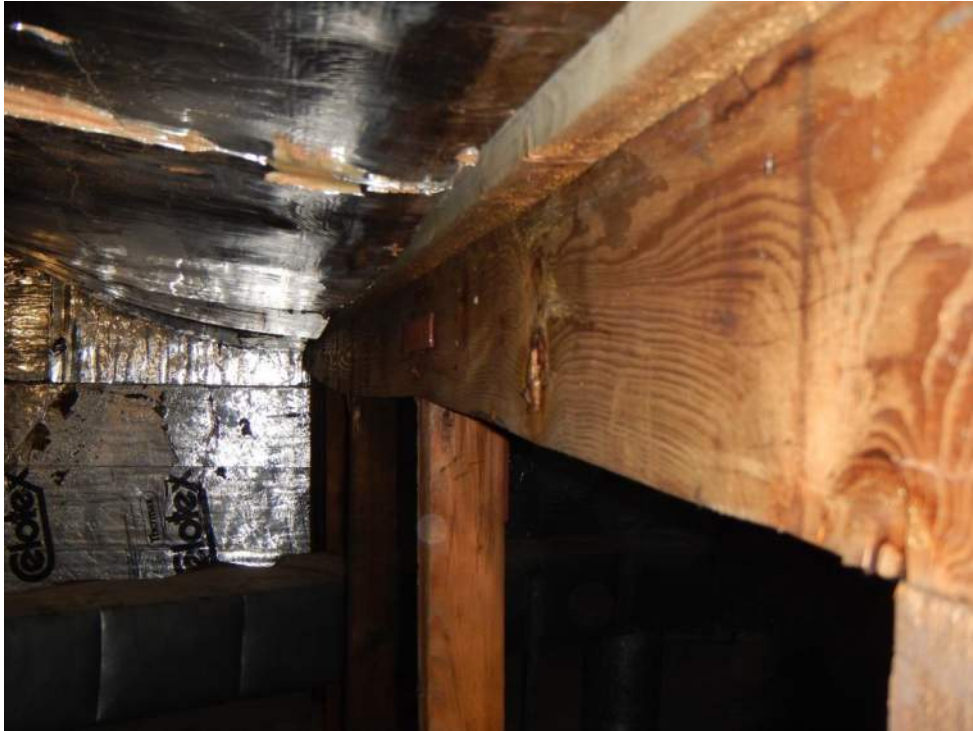
8. Example of water seepage staining noted on the beam and post supporting the roof. *See photograph # 8.*
9. Typical rigid insulation installed below the roof decking with beam and post. *See photograph # 9.*

Photograph # 9: Rigid insulation at decking soffit abutting beams and posts.

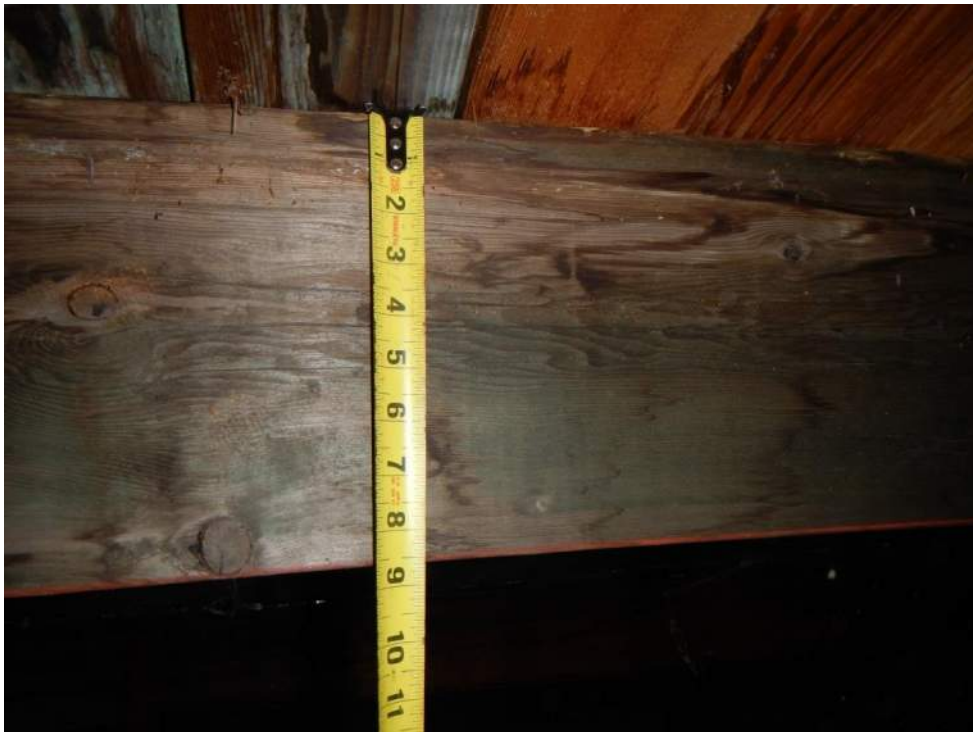
15. Decayed and deteriorated sill plate below the western valley of the central roof chamber.
See photograph # 15.
16. Example of plumb installation of 4X10 beams shaped at the top to receive roof decking.
See photograph # 16.

Photograph # 16: Example of plumb shaped 4X roof support beam.

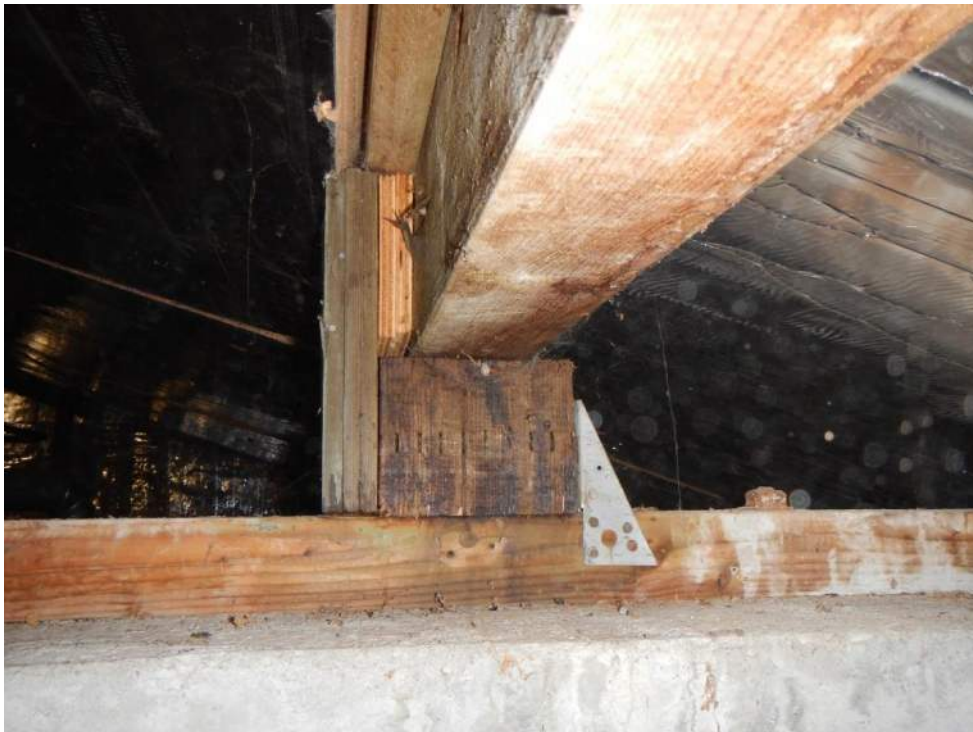
17. Example of roof seepage staining noted at the western attic chamber. *See photograph # 17.*
18. Example of short post repair at upturned concrete beam in the western attic chamber.
See photograph # 18.

Photograph # 18: Repair of short timber post on upturned concrete beam.

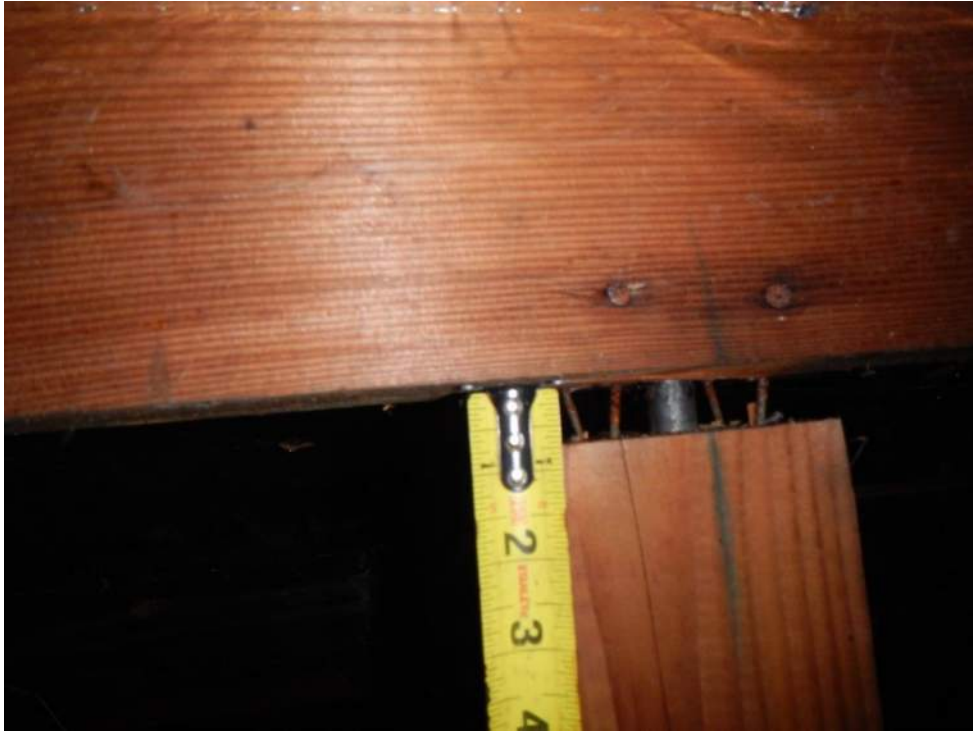
19. High separation of ridge beam from supporting post found in the western attic chamber.
See photograph # 19.
20. The attic roof vents were covered by post-original construction installed rigid insulation panels. No attic ventilation was noted in the northern attic section.

Photograph # 19: High beam separation from post of 3/4 inch.

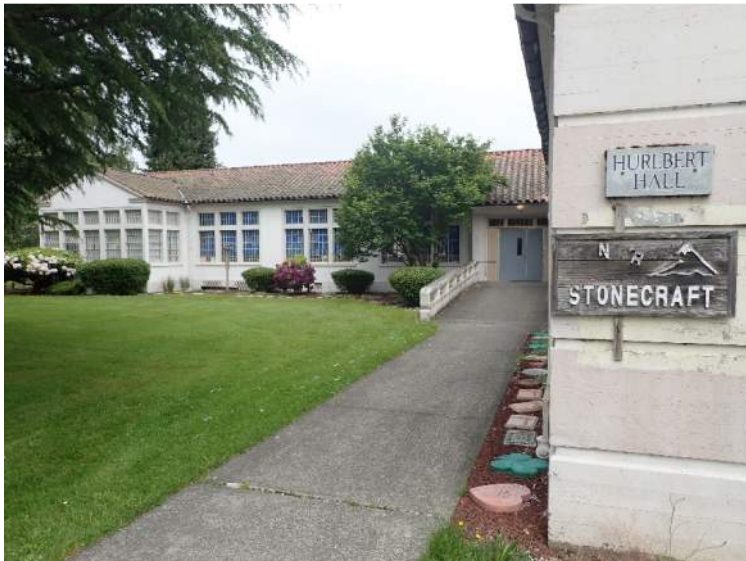
Photo No. 1 - Hurlbert Hall

View of the main south-facing entry and elevation of Hurlbert Hall.

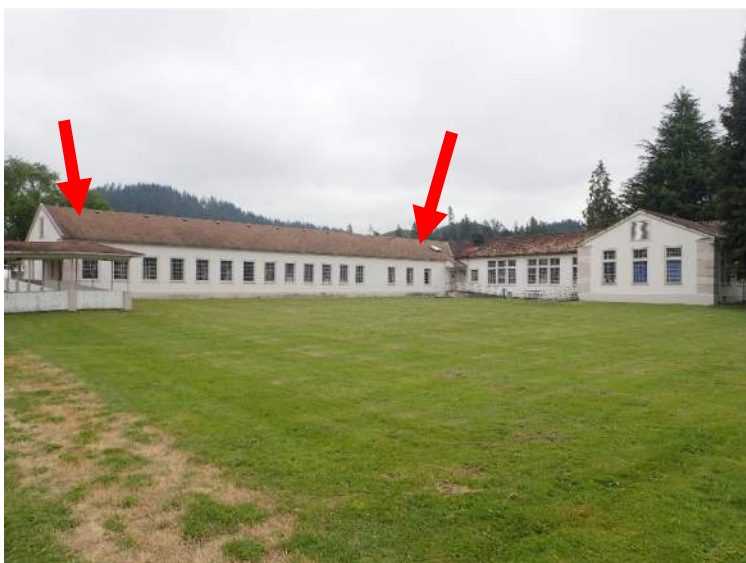
Photo No. 2 - Hurlbert Hall

Photo of Hurlbert Hall looking southeast from the backside of the building. The arrows identify the north gable end wing of the building that has been reroofed with asphalt shingles during previous repair projects. Reroofing is recommended to preserve this architecturally significant building for the Rainier School campus.

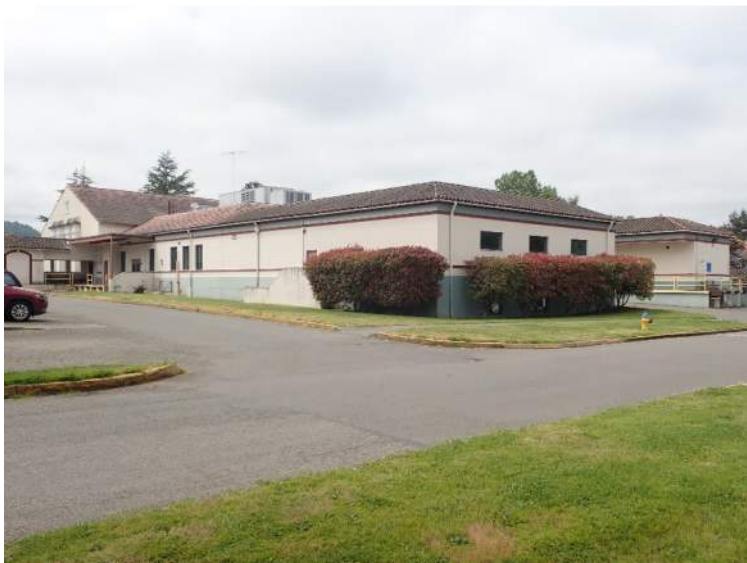
Photo No. 3 - Main Kitchen Building

Overview from the north showing the perimeter steep-slope mansard style roof areas with pan-and-cover clay tiles with the low-slope roof areas located near the center of the building.

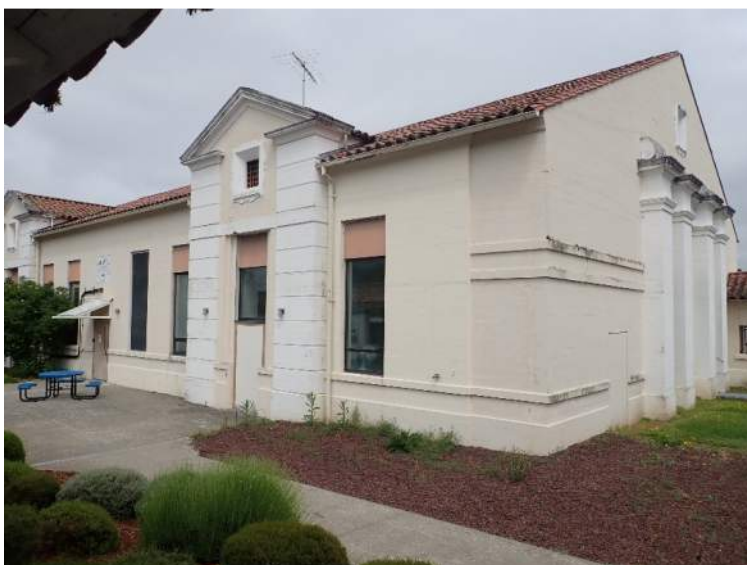
Photo No. 4 - Main Kitchen Building

Photo of the south side of the building where the café is located. The ornate concrete exterior walls are roofed with a steep-slope pan-and-cover clay roofing tile system, similar to other buildings.

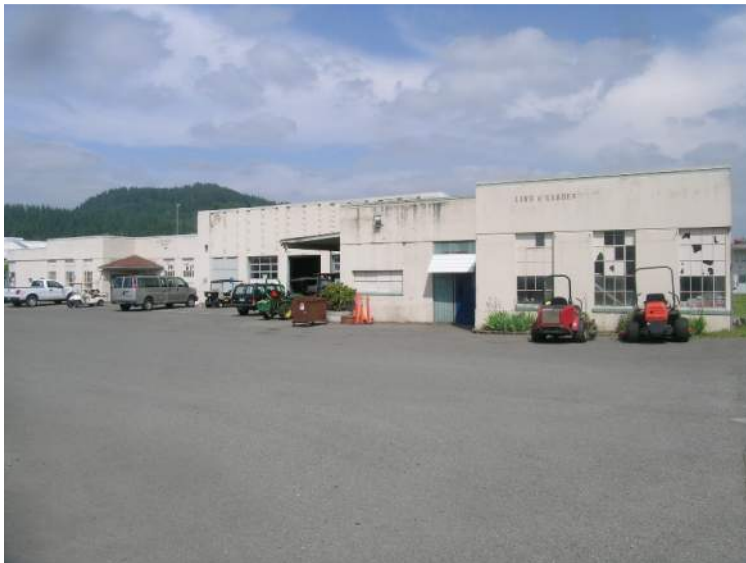
Photo No. 5 - Maintenance Building

Similar to the older, original campus buildings, the Maintenance Building is a largely composed of concrete. The existing low-slope roof membrane is reportedly an aged single-ply Hypalon roofing membrane. Rain water leaks have been reported at numerous areas and it is our opinion that due to the age, existing membrane condition, and reports of water intrusion, it is prudent to consider roof replacement with a new multiple-ply roofing membrane system. This Project Team has successfully designed, specified, and administered the construction phase and installation, in conjunction with qualified roofing contractors, with a new low-slope multiple-ply SBS-modified asphalt roofing membrane system. Replacement of the aged single-ply Hypalon roof membranes should be prioritized as high importance.

Overview looking east towards the Maintenance Building.

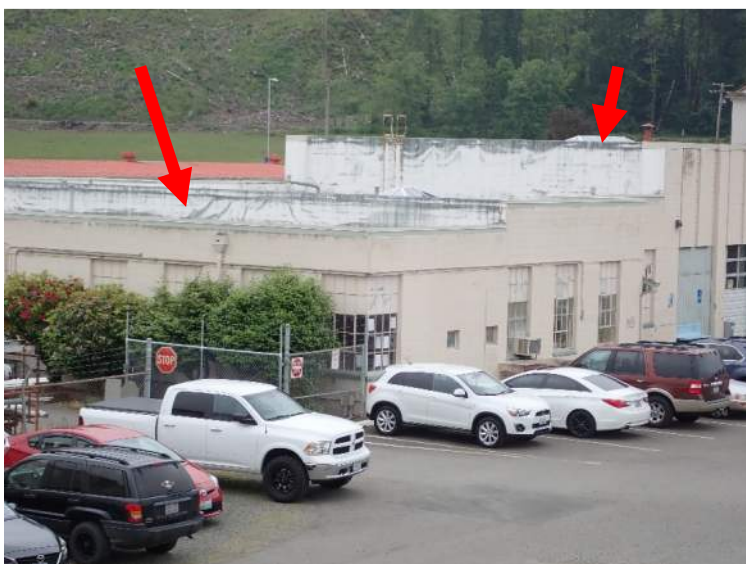
Photo No. 6 - Maintenance Building

Photo depicting the series of low-slope roof areas needing replacement prior to failure of the existing roof membrane system. The building currently experiences rain water intrusion leaks at several locations.

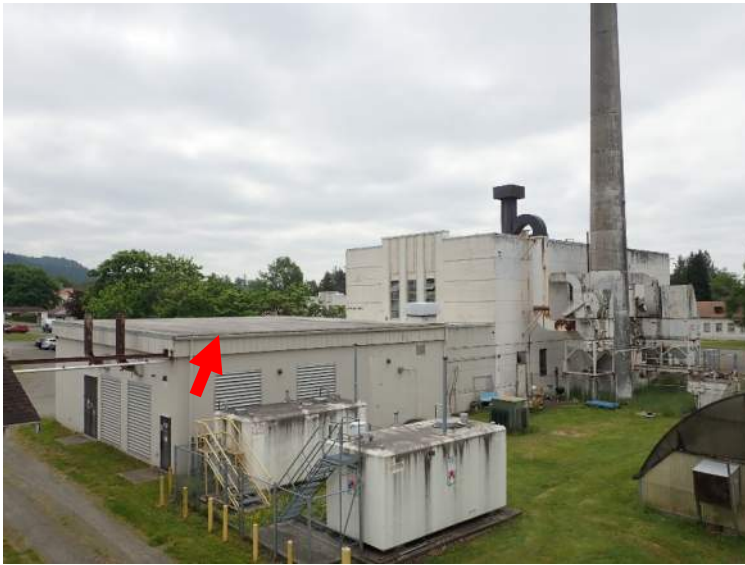
Photo No. 7 - Power House Building

The Power House also consists of a single-ply Hypalon roofing membrane at the various roof levels of the building. Although we have not closely surveyed the roof areas, it is evident from a distance that the existing roof membrane has deteriorated and is in need of replacement. Providing power to the campus, this building serves a critical function for the entire facility.

Overview from the P-43 Building looking southwest towards the Power House. The low-slope single-ply Hypalon membrane was extended and rolled over the perimeter edge of the identified roof area. Visual evidence, even from this distance, showed that the existing membrane is aged, has deteriorated, and is recommended for replacement, as the membrane has reached the end of its useful service life.

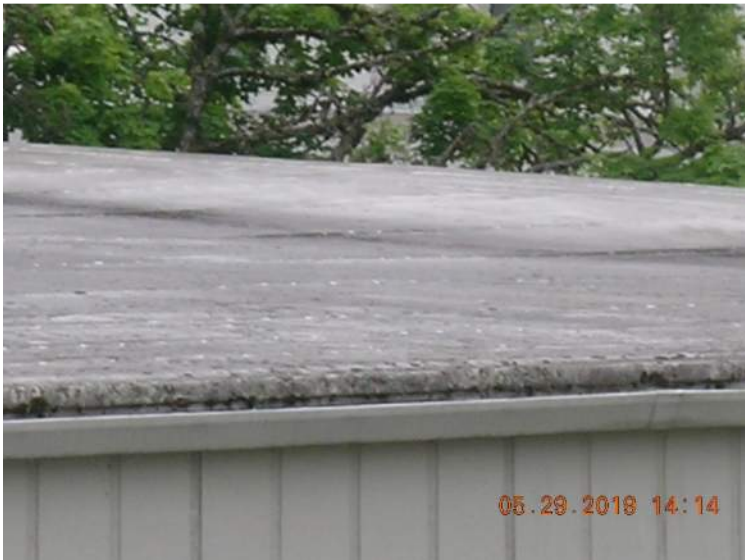
Photo No. 8 - Power House Building Low-Slope Roof

Close-up view of the existing single-ply Hypalon membrane at the east end roof area, identified above. Areas of ponding are evident and the edge of the membrane shows signs of deterioration and is recommended for replacement.

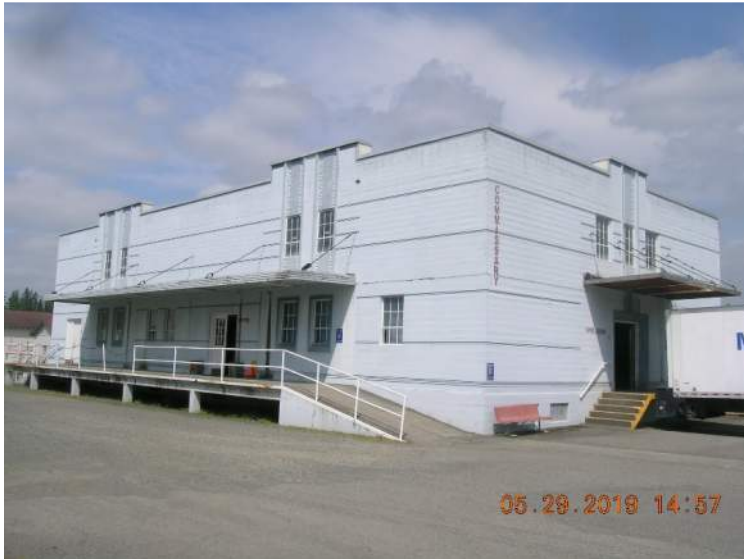
Photo No. 9 - Commissary Building

Overview showing the south and west elevations of the Commissary Building. The concrete-farmed exterior of the building is part of the original campus buildings.

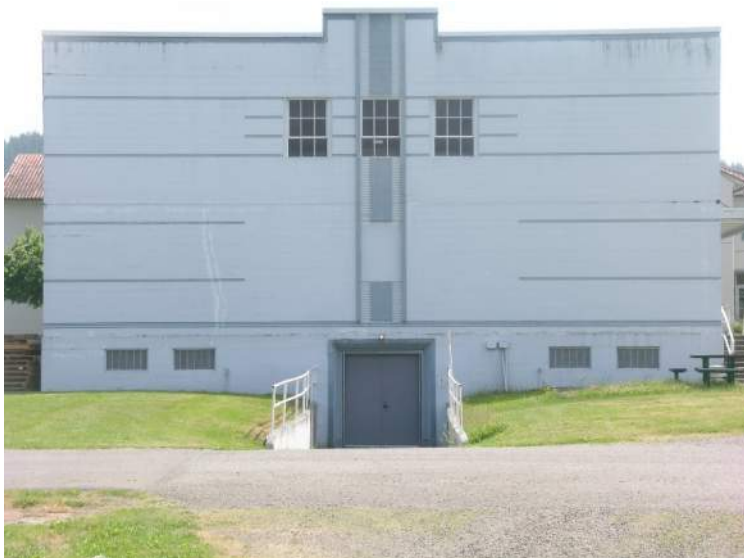
Photo No. 10 - Commissary Building

Photo depicting the north elevation of the Commissary Building.

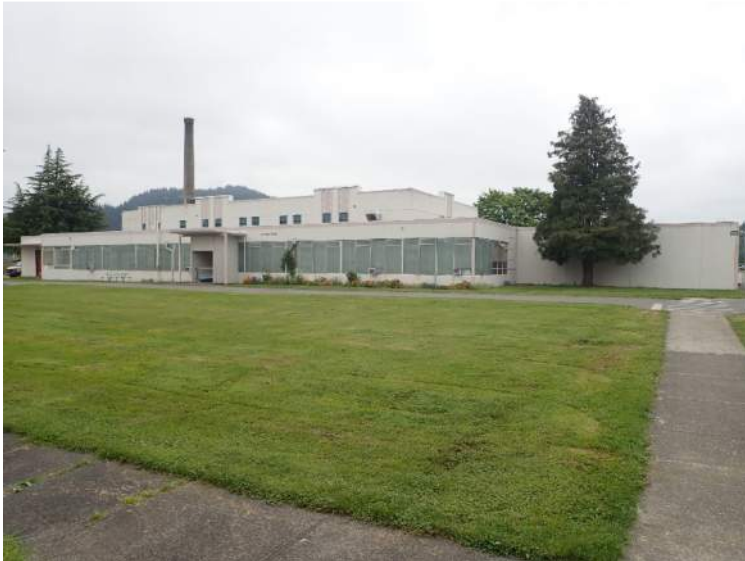
Photo No. 11 - Laundry Building

Overview showing the original two-story Laundry Building near the center and later one-story addition that surrounds the original building.

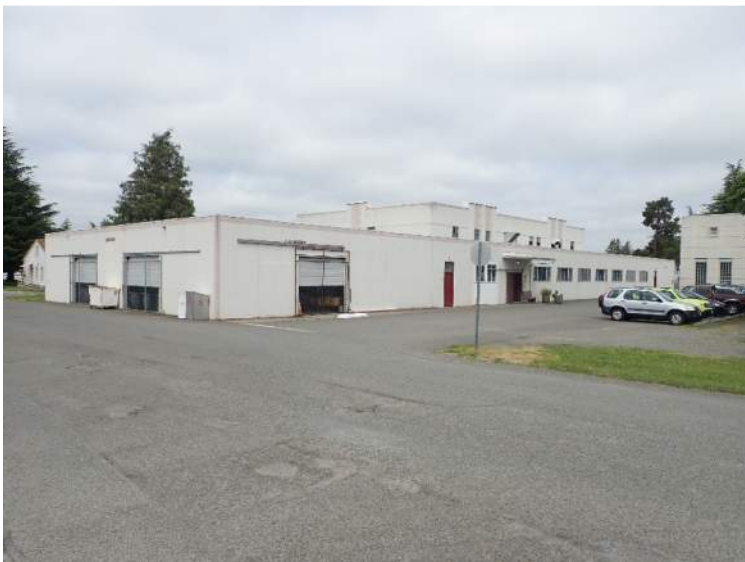
Photo No. 12 - Laundry Building

Photo looking northwest towards the Laundry Building. The later single-story addition that surrounds the original building appears to have been constructed of tilt-up concrete wall panels and low-slope roof areas.

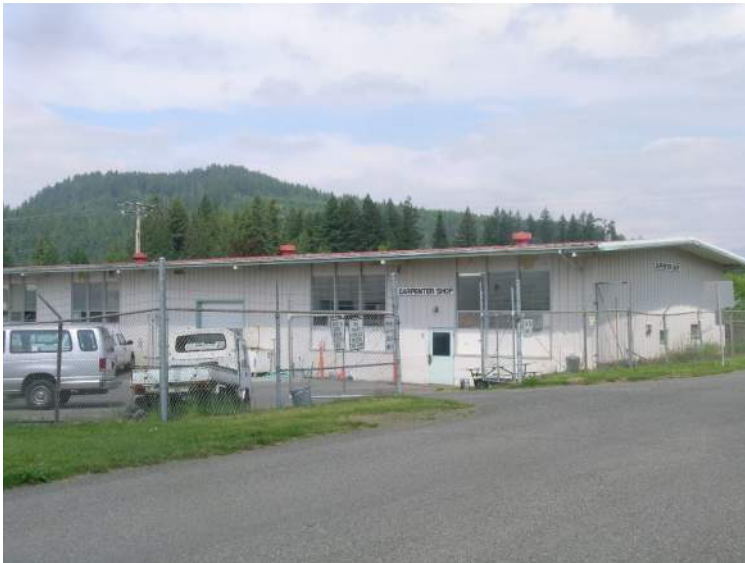
Photo No. 13 - Carpentry Shop

The Carpentry Shop is currently roofed with a low-slope sheet metal panel standing seam roof system. Numerous interior leaks have been reported and are recommended to be addressed. Additional survey is needed to better understand the source or water intrusion to assist with proper design and specification of roofing related repairs.

Overview depicting the existing Carpentry Shop at Rainier School showing the low-slope roof profile at the gable end.

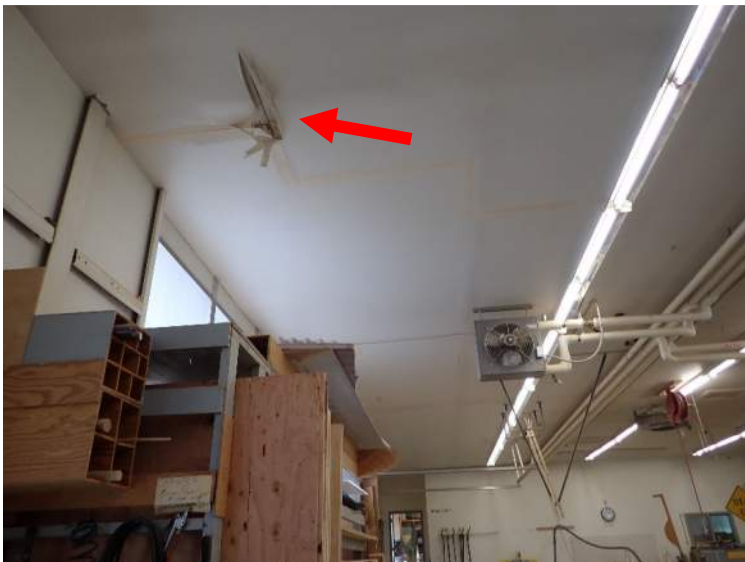
Photo No. 14 - Carpentry Shop Interior

Several interior leak locations were reported. This photo shows interior ceiling damage due to ongoing water intrusion.

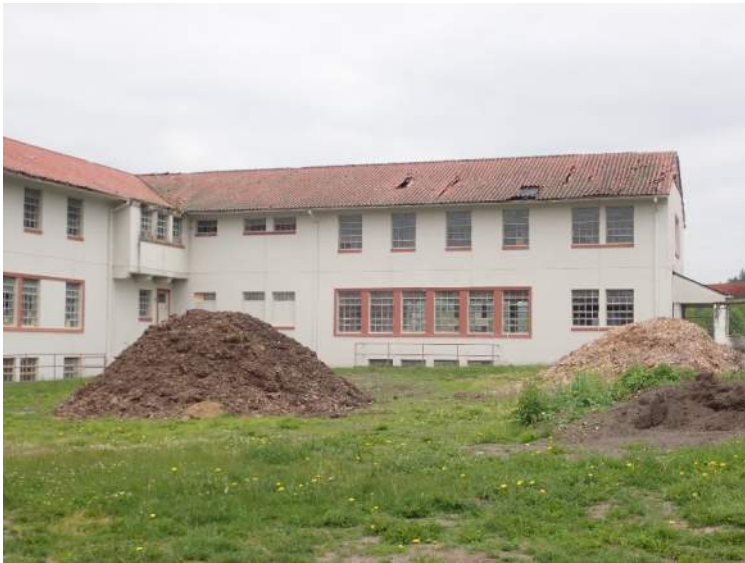
Photo No. 15 - Adler Hall and other Residence Buildings

Photo depicting extensive roof damage at Adler Hall. Reroofing and replacement of damaged roof structure members is recommended for this building and the other buildings that create a four-building quad. While roof replacement work may be extensive, the high-quality construction of the main building structure is worth protecting on our opinion.

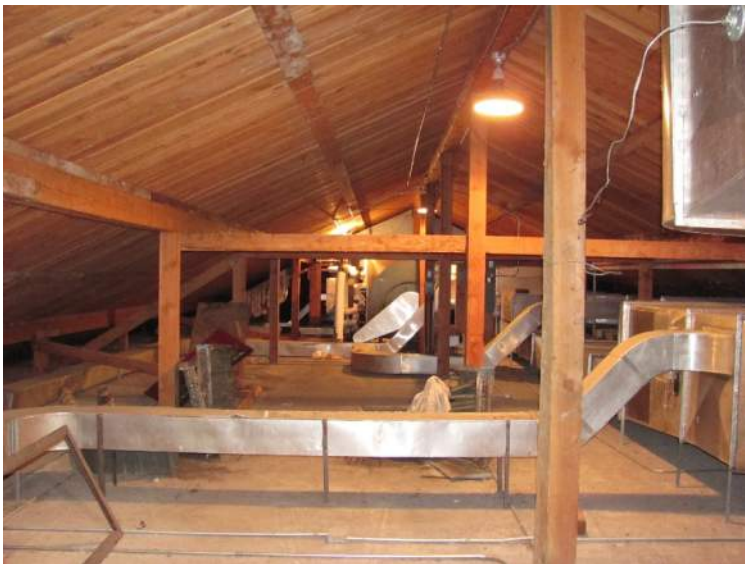
Photo No. 16 - Adler Hall and other Residence Buildings

Photo provided by the State of Washington from the attic spaces within these residential buildings. Note that the tongue-and-groove roof decking runs parallel with the slope of the roof. It is likely that much of the damage and decay is isolated to the roof decking and the primary, large-dimension wood framed structural support members remain largely intact and serviceable for reroofing.

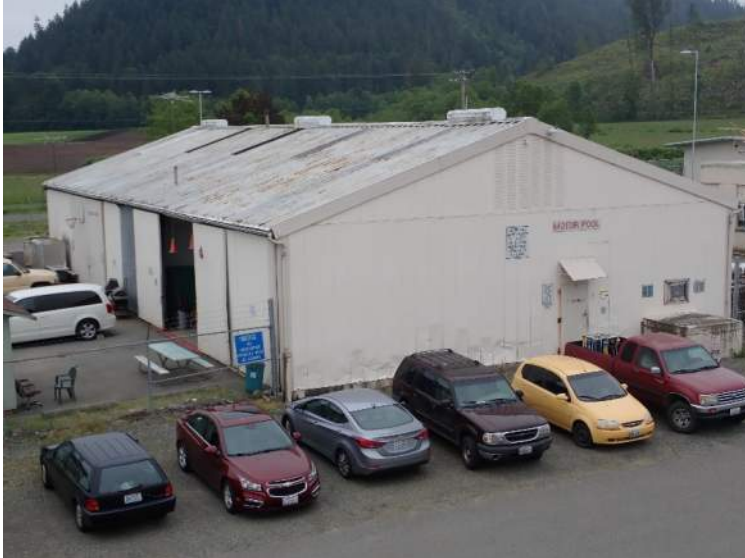
Photo No. 17 - Motor Pool Building

The Motor Pool, similar to the original roof system of the recently reroofed P-43 Maintenance Building, consists of sheet metal panel roofing system. Water intrusion leaks have been reported and should be addressed as budget allows for the campus.

Photo from the P-43 Building looking east towards the Motor Pool Building.
