Roof SURVEY REPORT

Limited Roof Survey and Leak Investigation

Rainier School Building 2010

Buckley, Washington

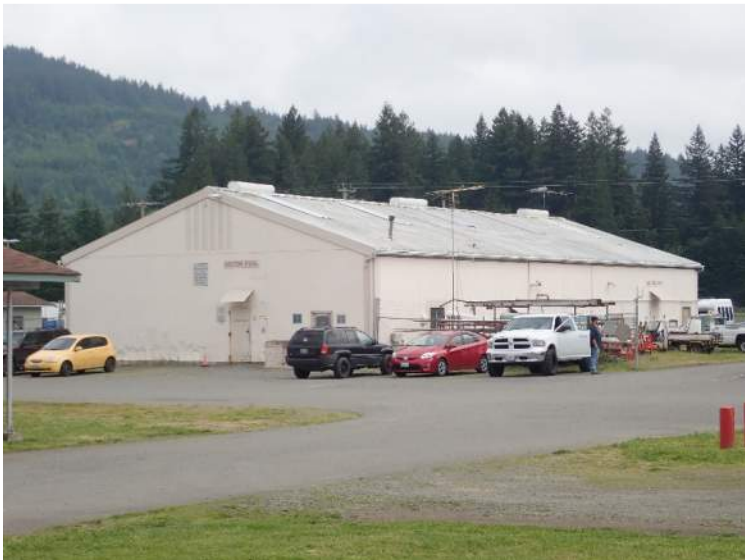
Photo No. 18 - Motor Pool Building

View showing the west and south elevations to the Motor Pool Building.
