2020 Supplemental Capital Budget Request

Limited Roof Survey and Leak Investigation

Rainier School Building 2010

DATE OF REPORT	Friday, June 28, 2019	PROJECT:	Rainier School – Building 2010 Limited Roof Survey and Report
TO	Dean Heglund, DSHS Project Manager	CC:	Scott Ward, Rainier School
CLIENT	State of Washington DSHS		Pat Bockelman, Rainier School
TEL	360-902-8158		Sean Yates, Rainier School
E-MAIL	hegluda@dshs.wa.gov		Nat Stiles, Rainier School
FROM	Scott Vlotho BET&R Architect		Darren Johnston, Harbor Engineers
SUBJECT	RAINIER SCHOOL – BUILDING 2010 LIMITED ROOF SURVEY PRELIMINARY OBSERVATIONS, FINDINGS, AND RECOMMENDATIONS

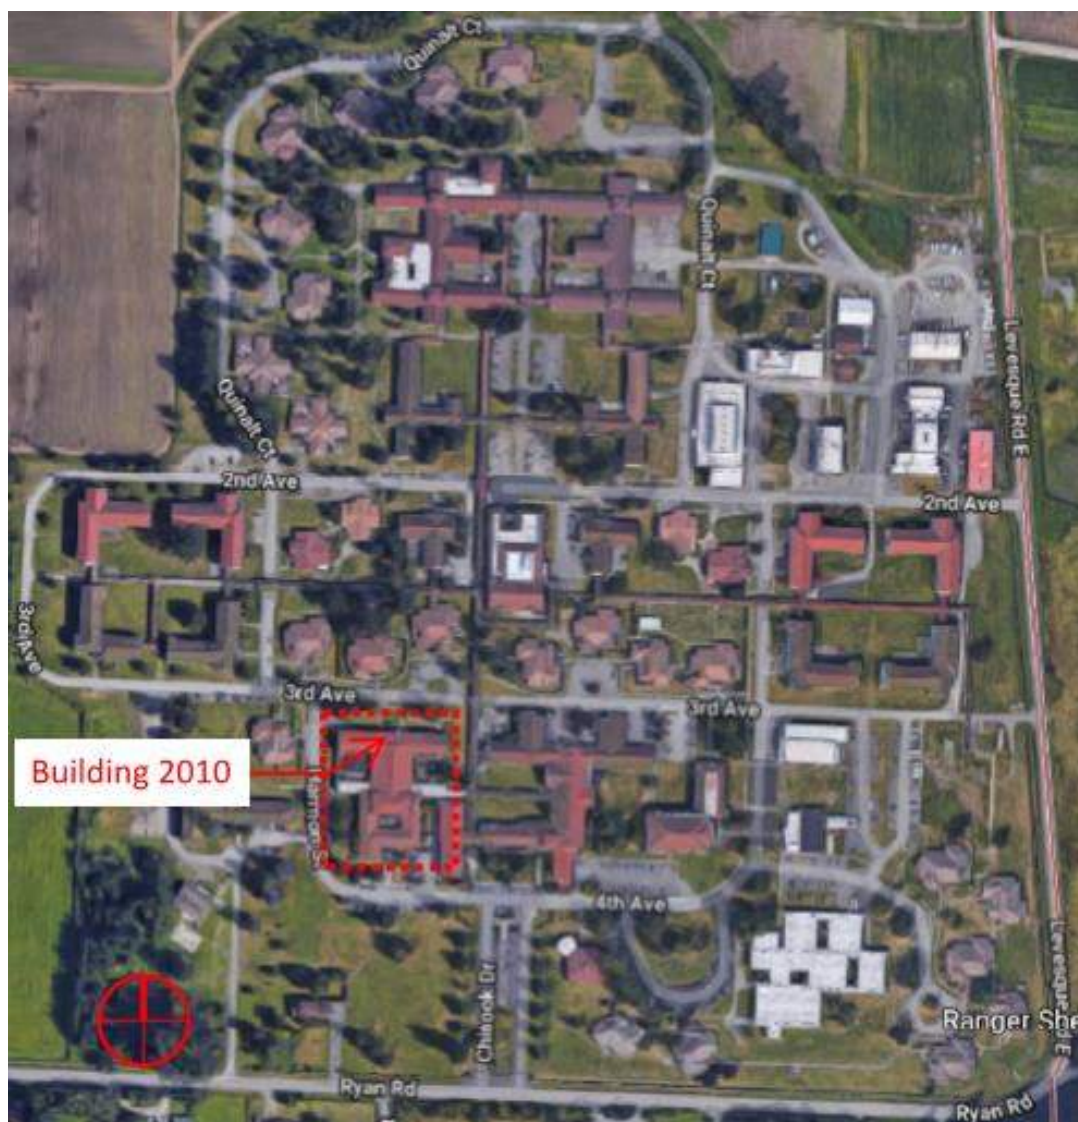
Figure 1 -- In this overview map, the red dashed rectangle highlights the location of the 2010 Building on the Rainier School campus. This survey focused on the north side gable roof, shown by the arrow.

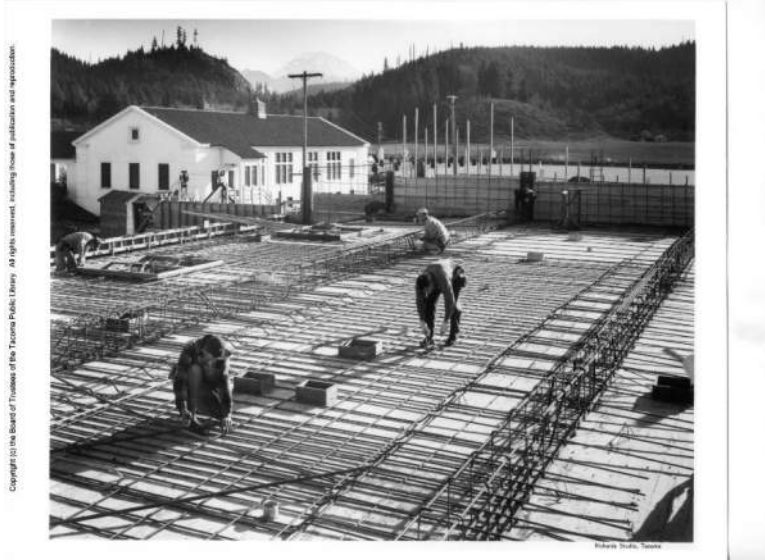
Photo No. 3 - Building 2010 Construction Photo

Photo depicts construction of the 2010 building. Note the main Administration Building in the background.

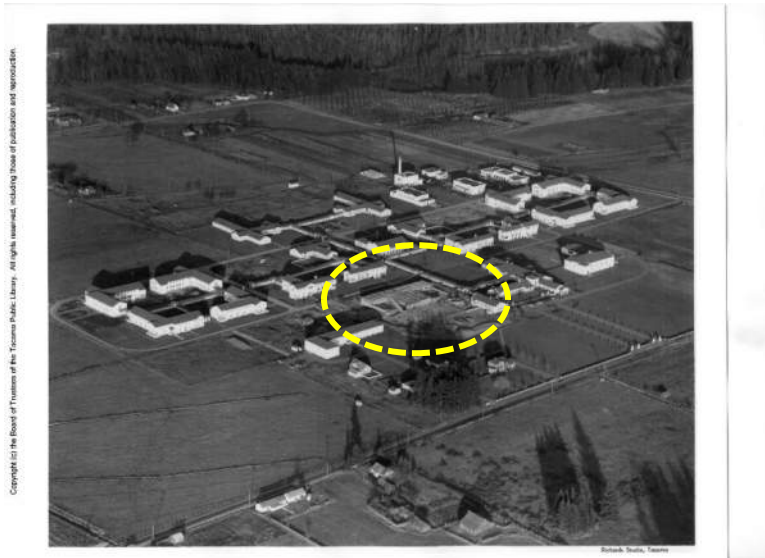
Photo No. 4 - Building 2010 Construction Photo

Aerial photograph of the Rainier School site during construction of Building 2010, identified with the yellow circle. No date was provided on the photo; however, other documents appear to indicate construction was underway in 1953.

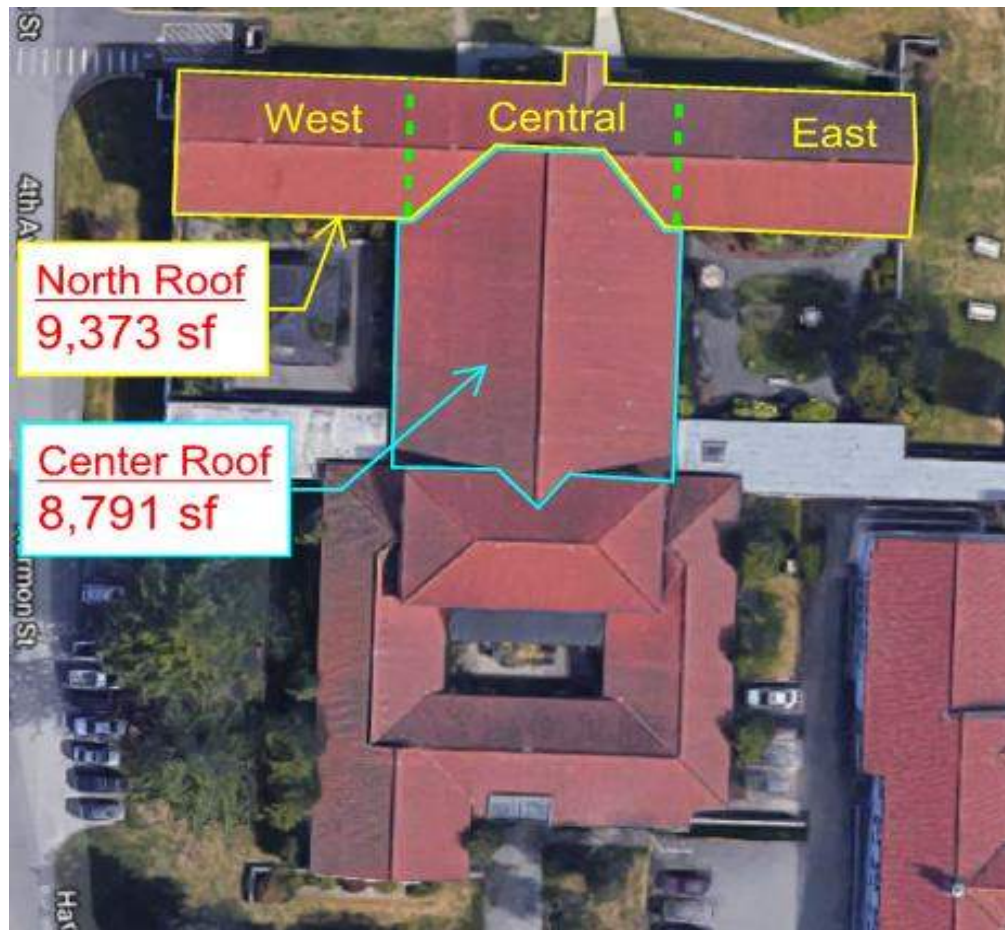
Photo No. 6 - Depicts an overview of the roof areas at the 2010 Building. The yellow outlined roof area at the north end of the building represents the requested area of roof to be included in the roof survey. The north end (yellow) roof area, as the focus of our survey, measures approximately 9,373 square feet. The roof area outlined in blue represents the additional roof area recommended to be included into a reroofing project as a result of visual deficiencies observed as part of our preliminary roof survey. The additional roof area, outlined in blue, measures approx. 8,791 square feet.

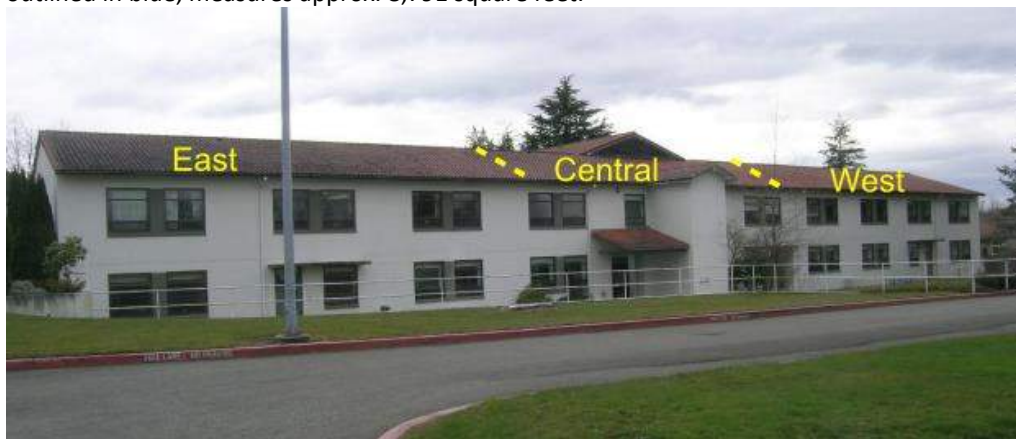
Photo No. 7 - View of the north-facing gable end roof area at the 2010 Building that was the primary focus of our roofing survey. Area separation walls built within the attic break the space into sections identified here as East, central, and West, as indicated in this photo.

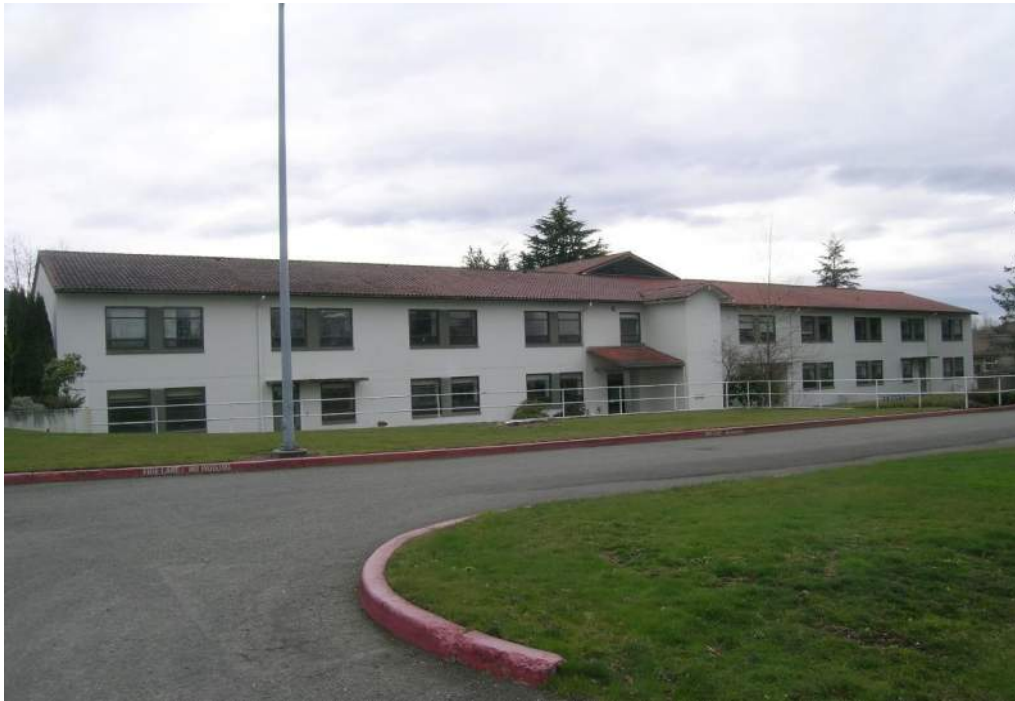
Photo No. 8 - View of the north-facing gable roof area at the 2010 Building that was the primary focus of our roofing survey.

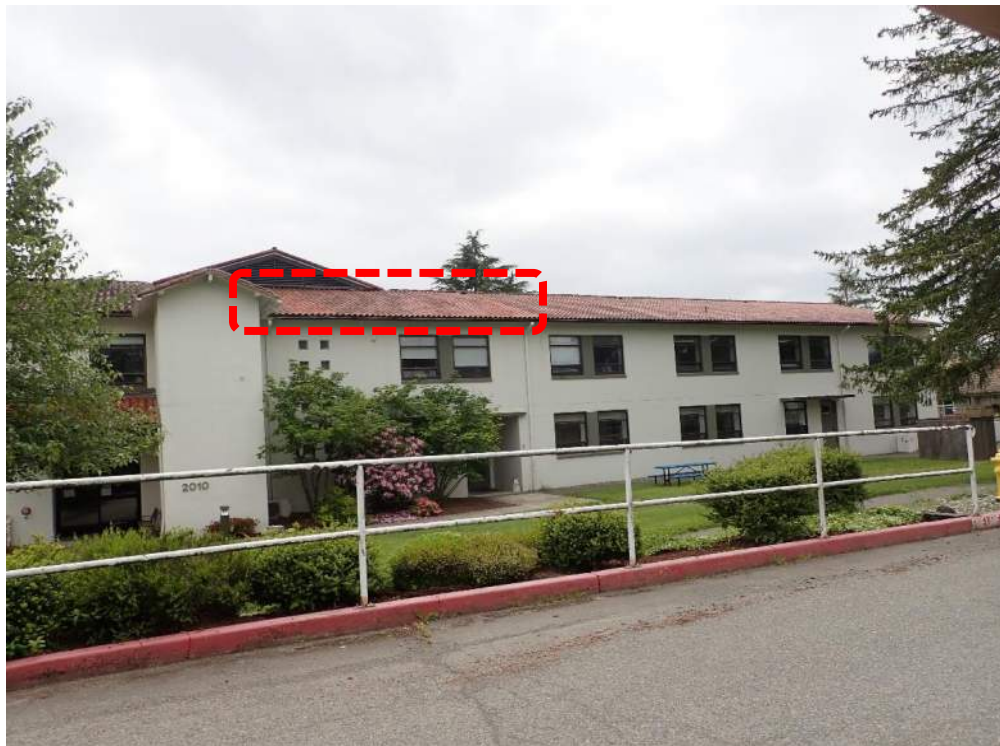
Photo No. 9 - View of the north-facing gable end roof area at the 2010 Building showing the west end of the roof area. It was reported that a portion of the roof area, shown by the red hatched line identified area, was previously repaired to address water-intrusions and water-damaged T&G roof decking.

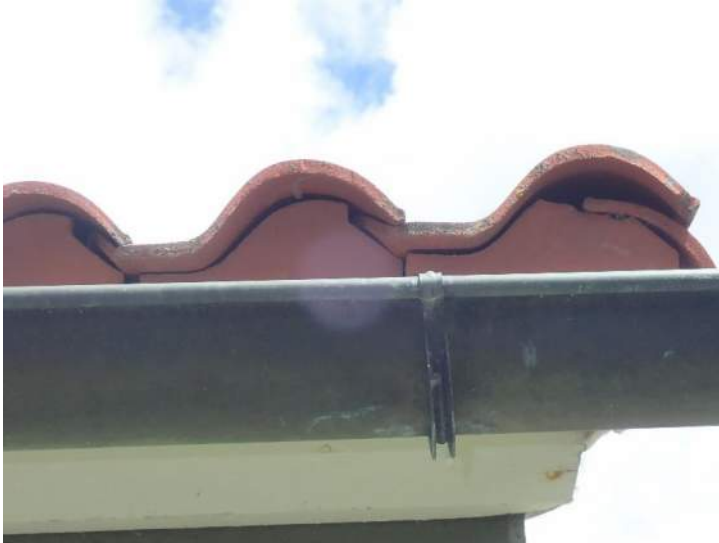
Photo No. 10 - Interlocking Clay Roof Tile Profile

Photo depicting the profile of the existing interlocking S-shaped profile clay tile roofing system installed at the 2010 Building.

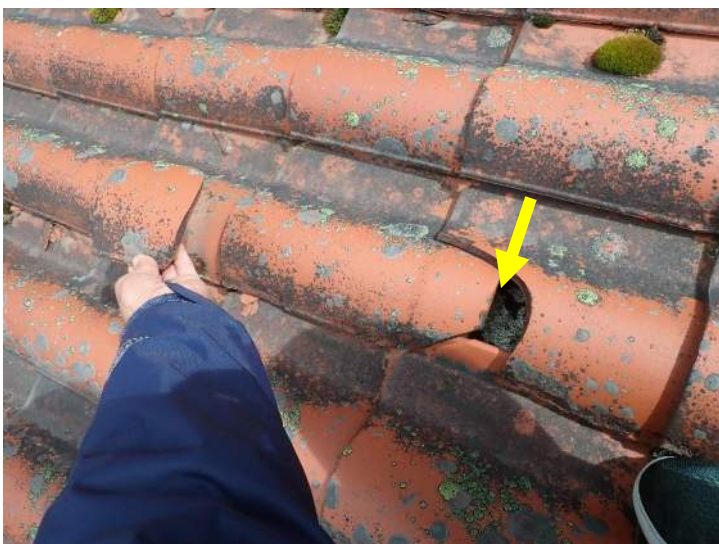
Photo No. 12 - Example of Cracked and Broken Roof Tiles Observed in Field of the Roof Areas

Close-up of typical cracked clay roofing tiles observed at the subject roof areas. The photo shows the exposed 1-ply underlayment beneath the tiles leading to the potential of water intrusion. UV exposure accelerates the aging of the underlayment, causing deterioration and potential failure of the underlayment.

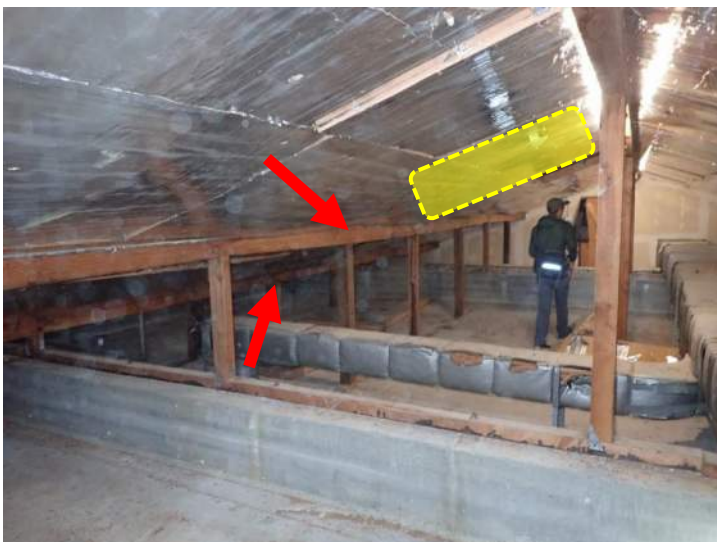
**Photo No. 15 - Building 2010 Attic
Photo in West Roof Area**

The 2x6 T&G wood decking runs parallel with the roof slope and is supported along the ridge line, two intermediate beams that extend the length of the attic and along the downslope eave edge. The two arrows identify the two intermediate beams that have been framed at approximate 10'-3" spacing intervals. The general test opening area is also shown.

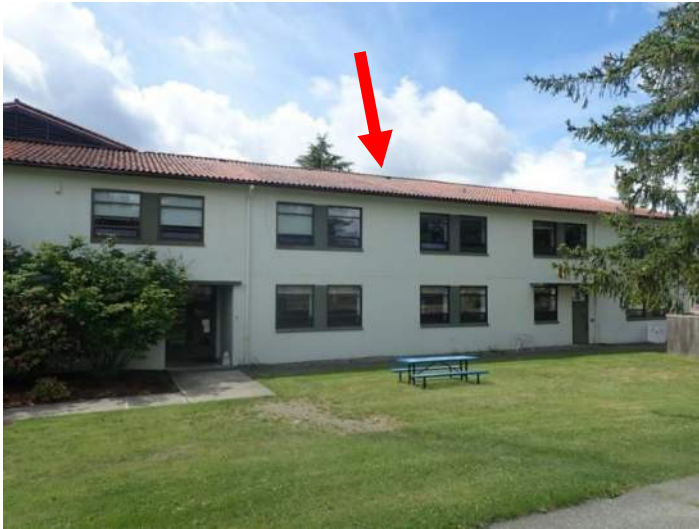
Photo No. 16 - Building 2010 North End Roof Area

As part of our roof survey, we removed select areas of interior insulation under the roof deck to observe conditions at the wood decking. The arrow depicts the general location of the testing and survey area at the west side area of the attic. The arrow points to a ridge vent that is shown in photos below.

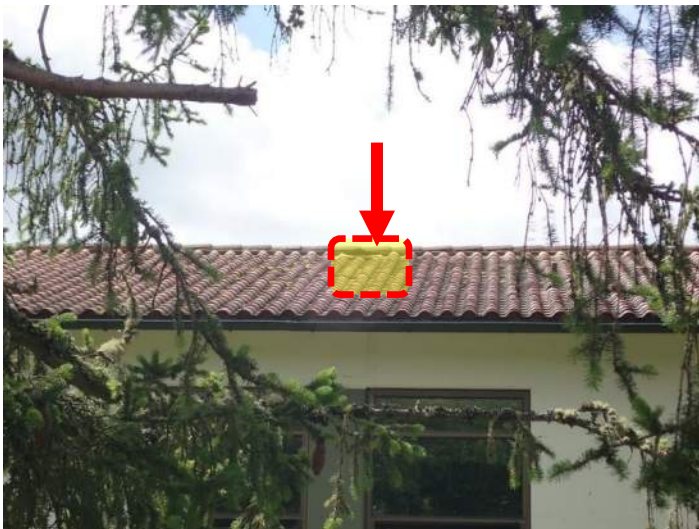
Photo No. 17 - North End Roof Area and Ridge Vent at Test Area

Closer photo of ridge vent location and general area where observations of the wood decking were documented from within the attic space.

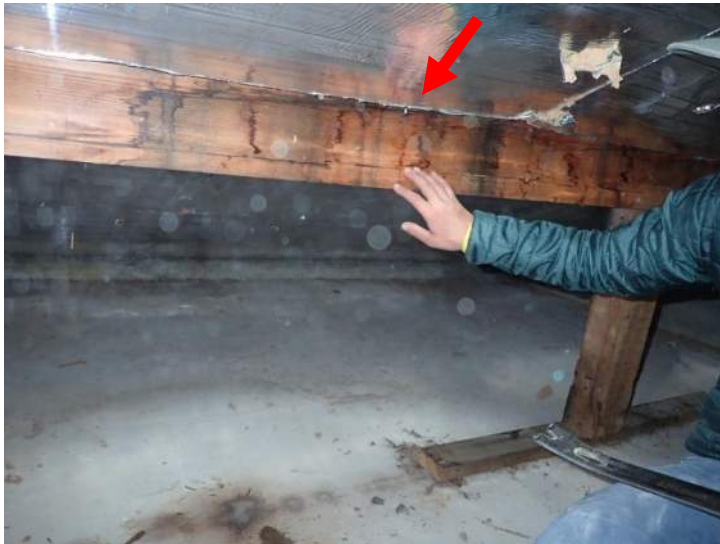
Photo No. 19 - Systemic Water Staining at Attic Wood Beams

Downslope of the ridge vent at the beam located closest to the eave, extensive evidence of water intrusion was observed. As we worked to remove the insulation, water that had been trapped against the wood decking by the 4-inch insulation panels actively dripped onto the concrete below.

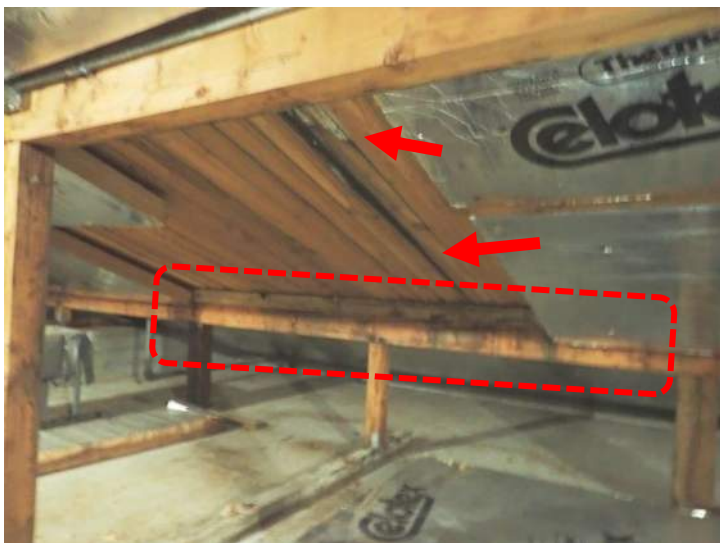
Photo No. 20 - Water Staining at Attic Structural Members

With insulation panels removed, this photo shows water staining running down the roof decking. The arrow at the top of the photo shows an area of biological growth on the wood surface. Water staining was observed along most of the length of the downslope wood beam indicating systemic water intrusion.

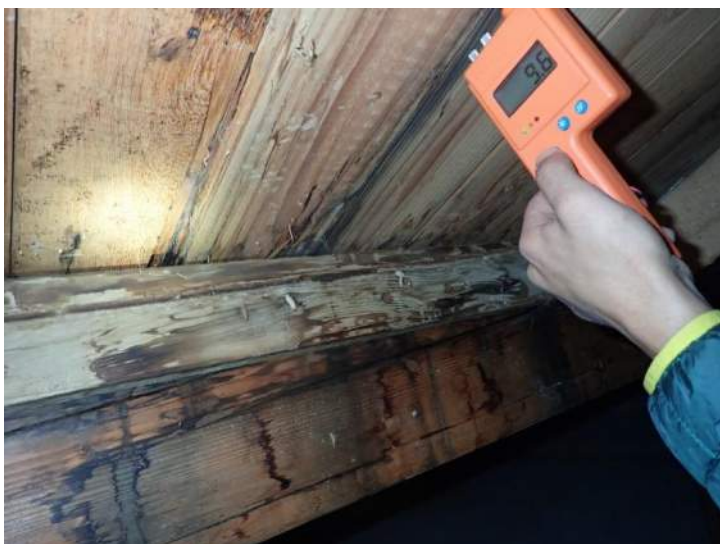
Photo No. 21 - Moisture Meter Readings at Roof Deck

Photo of water staining on the T&G wood decking and 4x10 wood beam. Water staining was observed throughout the attic. The photo shows a Delmhorst BD-2100 Moisture Meter used to measure moisture content of the wood. This photo shows a reading 9.6%, during an unusually on-going dry spring season, while others measured approx. 20%, which is considered significantly elevated and will promote further fungal growth and wood decay.

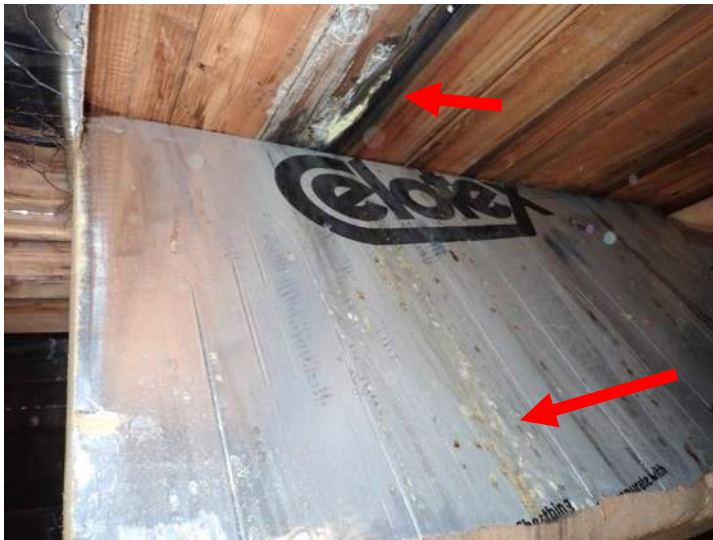
Photo No. 22 - Water Staining and Biological Growth Trapped by Insulation

As other insulation panels upslope where removed, the water staining continued. The white colored substance appeared to be biological growth (i.e. mold). Water staining on the top-surface of the insulation against the wood decking, showed signs of staining on the foil-facer.

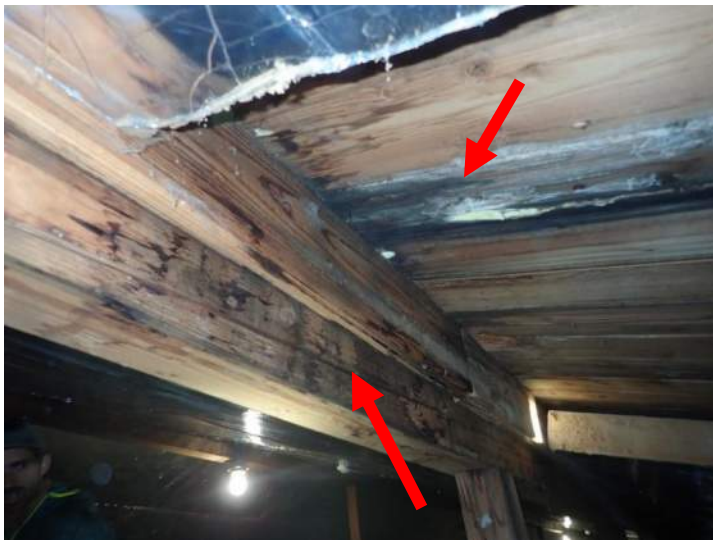
Photo No. 23 - Water Staining and Biological Growth on Wood Structure

Closer photo of water staining and biological growth which had been in contact with the intermediate beam closest to the ridge.

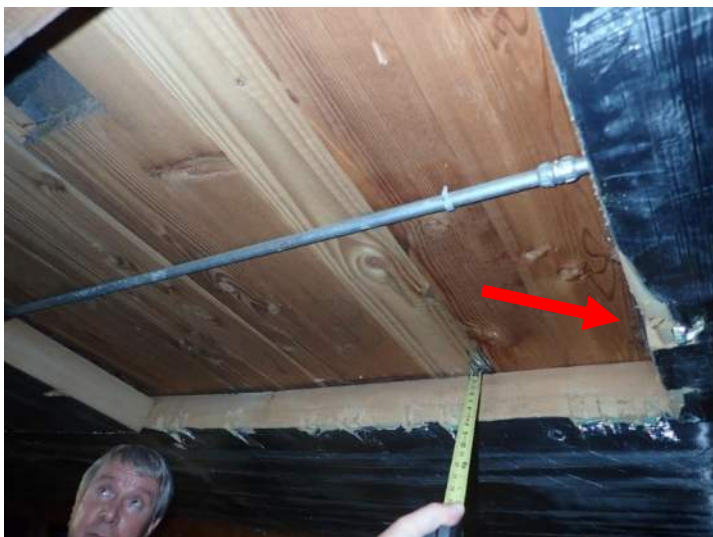
Photo No. 24 - Attic Conditions Downslope from Ridge Vent

The water staining shown in previous photos continued to extend upslope and appeared to originate near the point of the arrow. For reference, the cutout for the ridge vent is shown in the upper left corner.

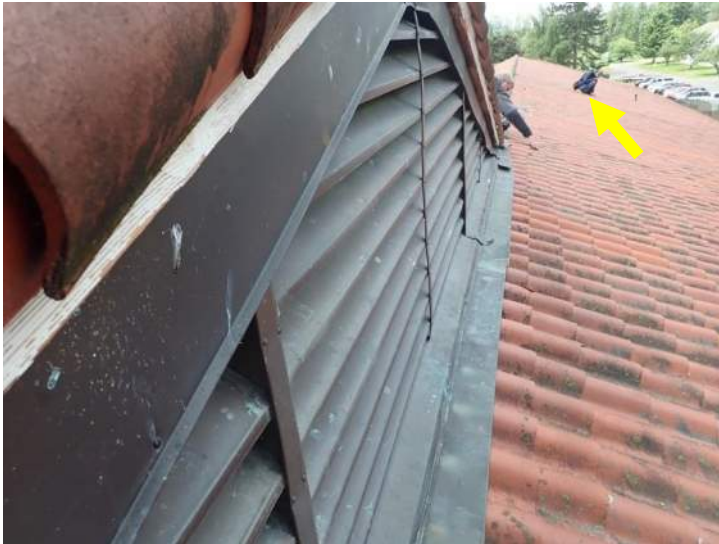
Photo No. 25 - North-facing gable end roof looking west

View of the north-facing side of the gable roof looking west. The arrow shows the approx. location of the test area shown in previous photos.

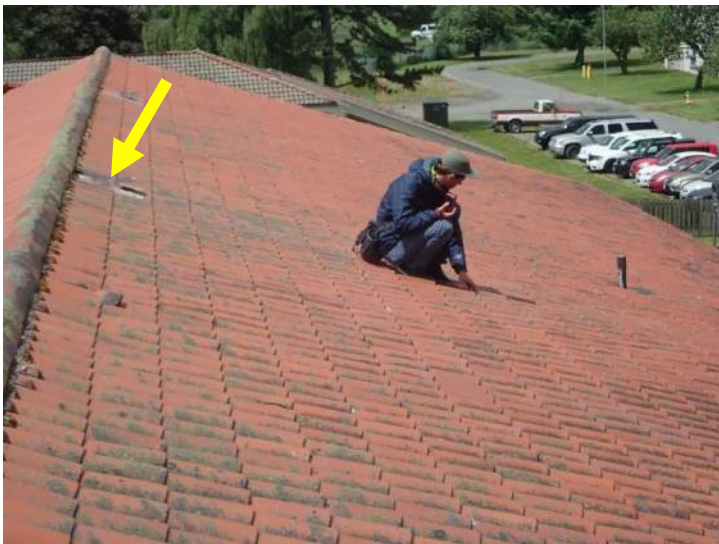
Photo No. 26 - North-facing gable end roof near test area

Closer photo showing location of the ridge vent location and BET&R roofing technician conducting roof level observations.

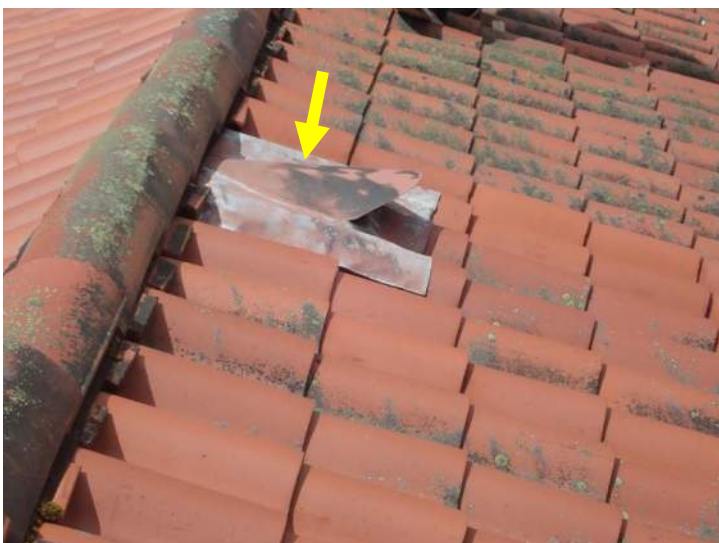
Photo No. 27 - Example gable vent at north end roof area

At the ridge vent, the openings were protected with a sheet metal flashing hood. As a general note, the small ridge vents do not appear to be effective for providing adequate roof ventilation, particularly as the rigid insulation fully blocks the vent opening. It also appeared that no downslope eave intake vents were provided.

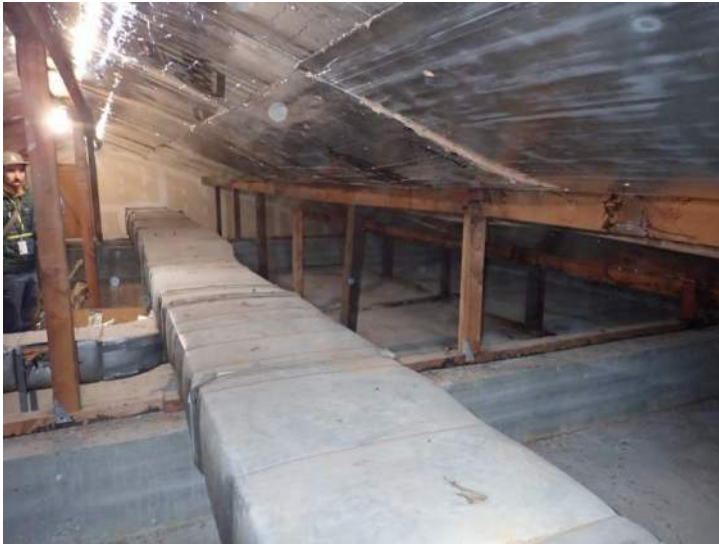
Photo No. 28 - Attic View within West Section of Roof

Photo looking east within the west attic area. The photo shows several areas of water staining along the supporting posts and beams.

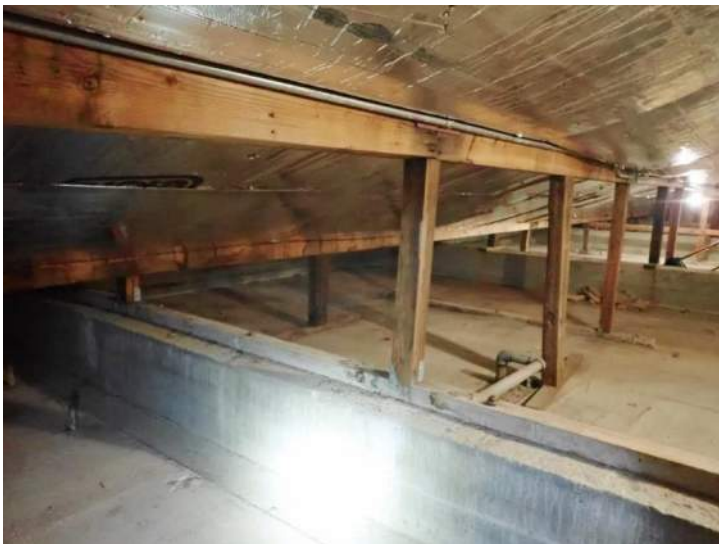
Photo No. 29 - Attic View within Central Section of Roof

Photo near the stair access of the central area in the attic. Again, several areas of water staining on beams were observed.

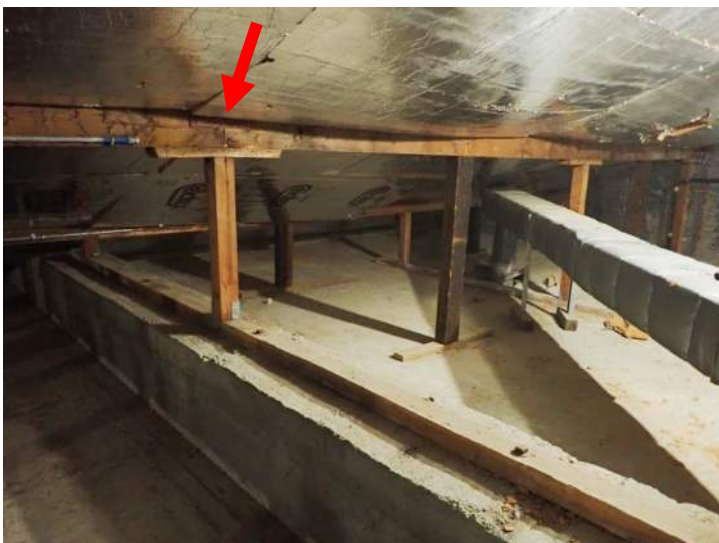
Photo No. 30 - Attic View within East Section of Roof

Depicts evidence of water staining near the east gable end of the east attic area. Please refer to Site Visit Report prepared by Harbor Consulting Engineer's regarding structural components.

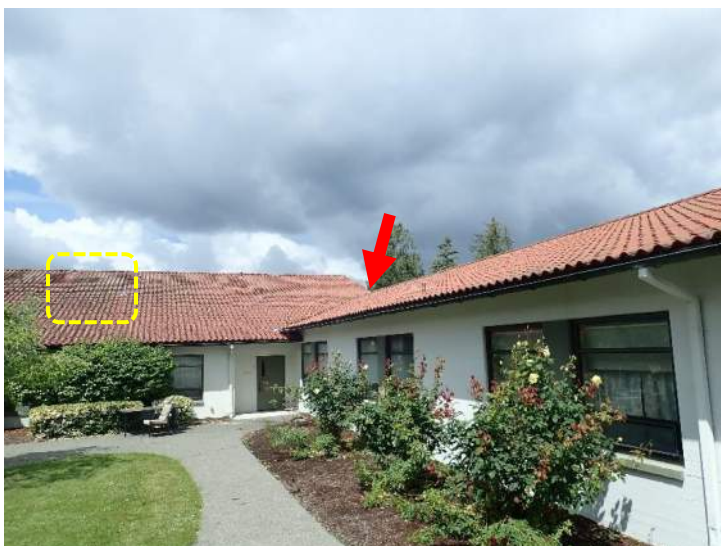
Photo No. 31 - East Courtyard showing Valley at Area of Concern

Following our initial interior observations, we accessed the roof from the central courtyard on the east side of the building, going up the valley identified by the arrow. The yellow box identifies an area of concern at the adjacent roof area where visual signs of sagging of roof components were observed.

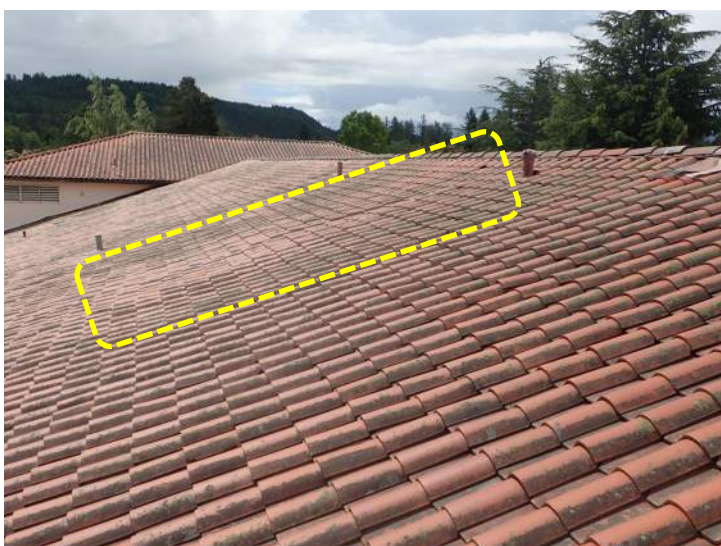
Photo No. 32 - Area of Visual Sagging of Roof Components at Center Wing of Building

View of area of concern as photographed from the valley. A large section of the clay tile roofing appears to be sagging. This area was not part of our initial survey area; however, we recommend additional survey effort take place along with potential emergency repairs to address the noted issues.

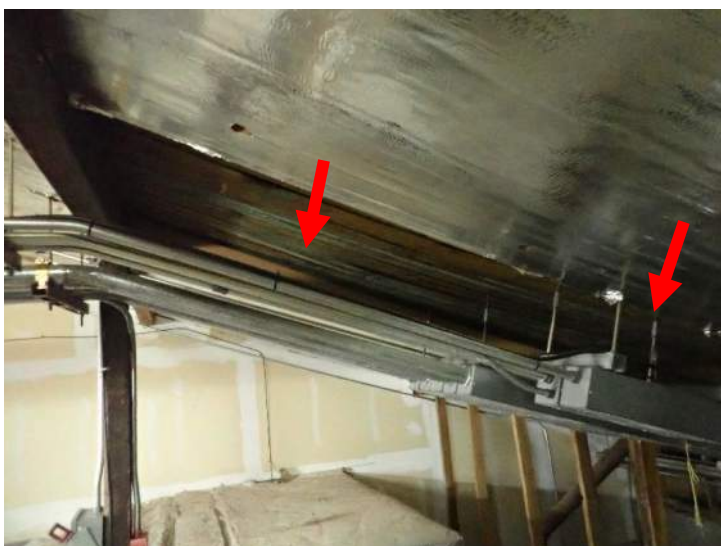
Photo No. 33 - Attic View Below Area of Concern

At the interior of the area of concern, where deflected/sagging roof-related components were visually observed, several electrical conduits and mechanical services were located and supported by the roof decking. This is an area of critical concern and is recommended to be repaired and corrected immediately.

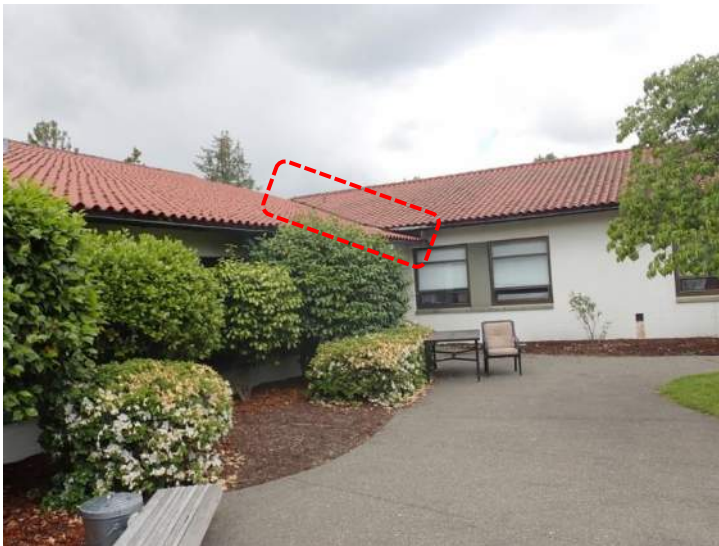
Photo No. 34 - Valley at East Side of Roof Survey Area

Water intrusion was also identified to be problematic at the two valley locations observed during the survey. The valley shown in this photo is located in the courtyard space between the north and center roof sections on the eastern side of the building. The valley flashing was in poor condition and evidence of water intrusion within the attic was prevalent.

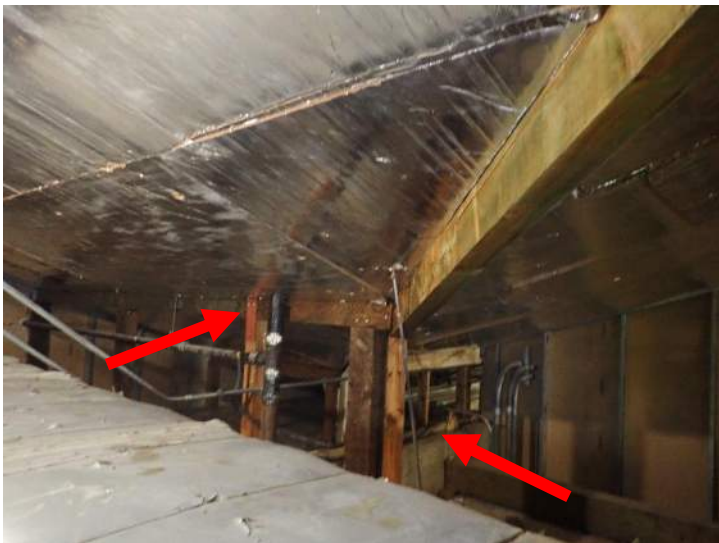
Photo No. 35 - Evidence of Water-Staining at Valleys

Systemic observations of water intrusion were noted along both of the valley's that intersect the north wing roof area. Select wood framing members may also need to be replaced due to water-damage and decay at the valley locations. Evidence of staining on the concrete floor was also evident.

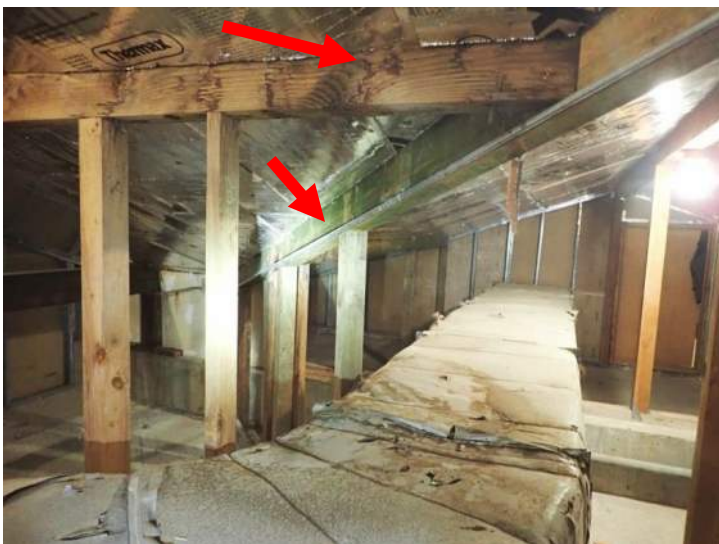
Photo No. 36 - Evidence of Water-Staining at Valleys

The west side valley also showed evidence of water intrusion. On other campus buildings, the existing valleys have been problematic with on-going water intrusion issues. Redesign and retrofit of the valleys and flashing systems is recommended.

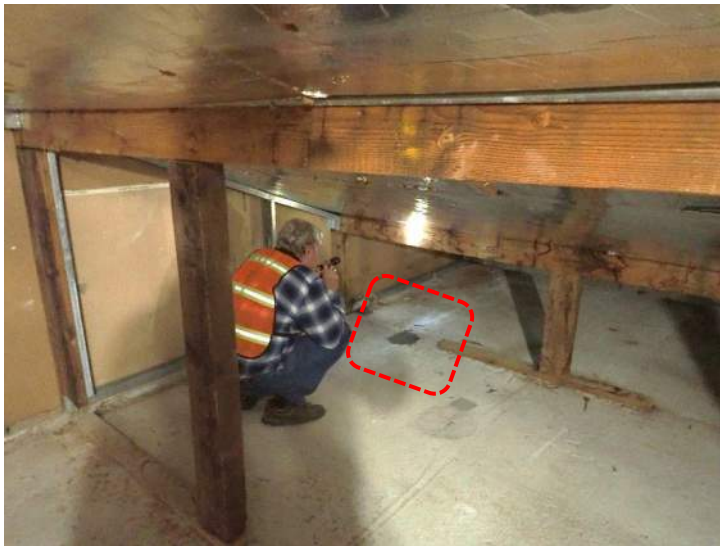
**Photo No. 37 - Rain-water leaks
Following Brief Storm During Survey**

Following a brief, but heavy rainfall during our survey, rain water was observed dripping from the roof at a minimum of three locations observed during a cursory walk through. This is example is located in the central roof area towards the west of the stairs.

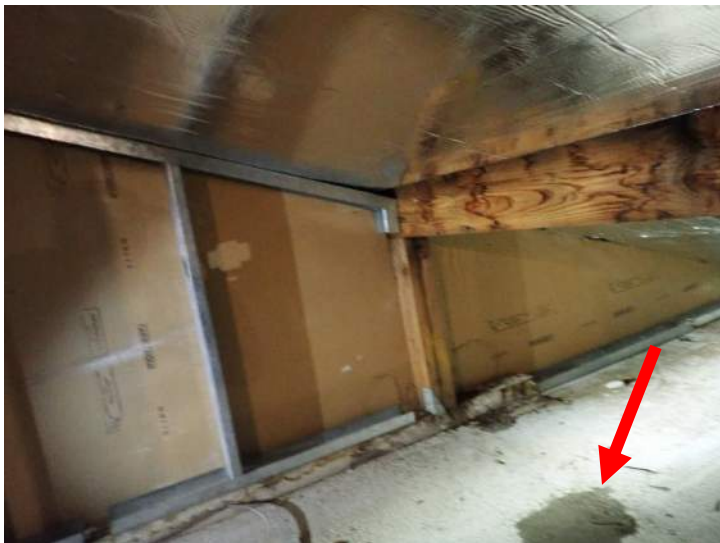
**Photo No. 38 - Rain-water leaks
Following Brief Storm During Survey**

Closer view of rain water collecting on the concrete attic floor following the rain storm.

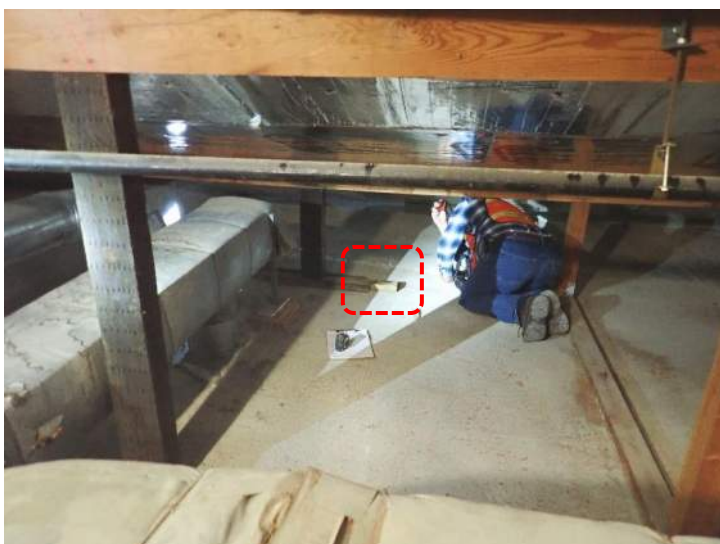
**Photo No. 39 - Rain-water leaks
Following Brief Storm During Survey**

Rain water was also observed dripping from the 4x10 wood beam in the east attic area and dripping on the 2x4 wood sill plate below.

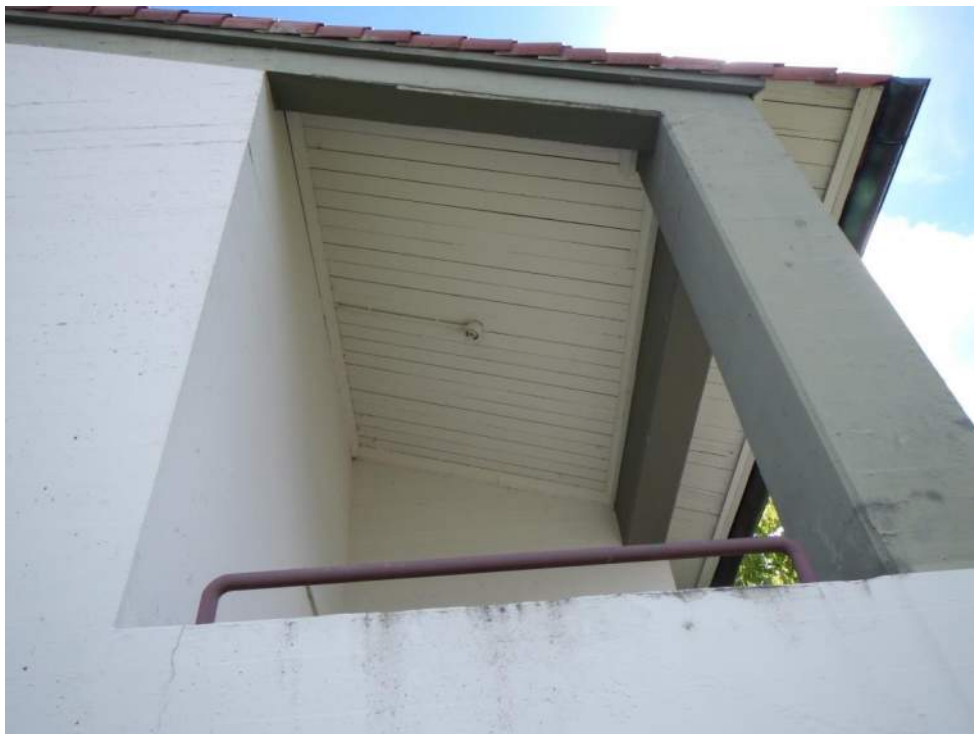
Photograph # 4: Exposed roof decking at corner porch recesses.

3. View of the north-west corner of the building. *See photograph # 3.*
4. Roof decking exposed at corner porch recesses. *See photograph # 4.*
5. View of the west half of the northern section of roof just in front of the gable end vent. *See photograph # 5.*

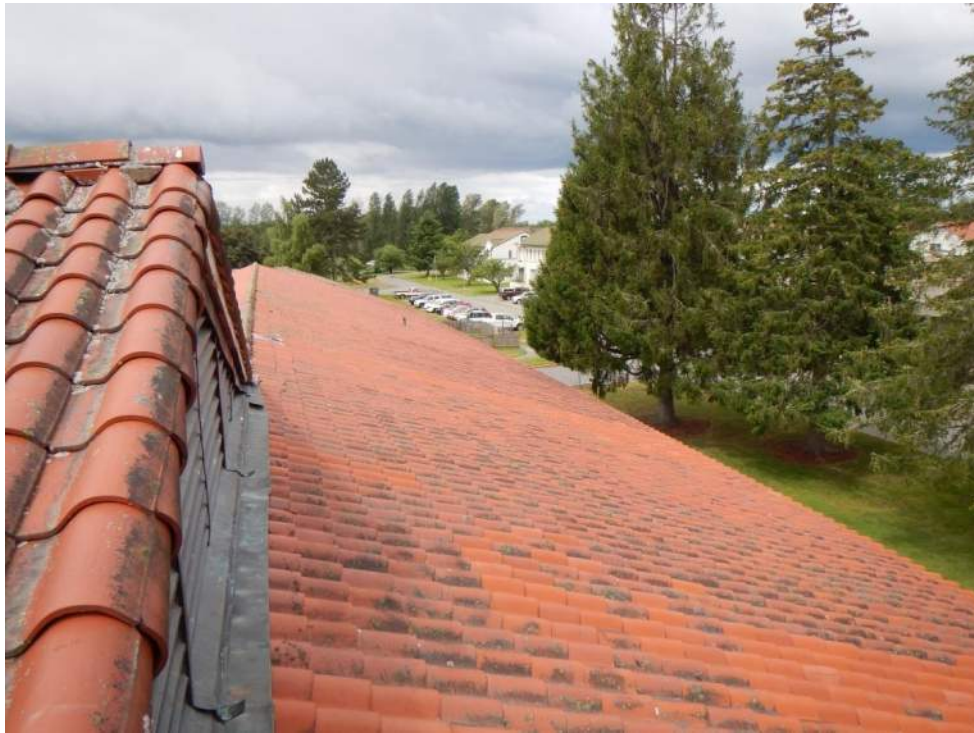
Photograph # 5: View of west roof section of north elevation.

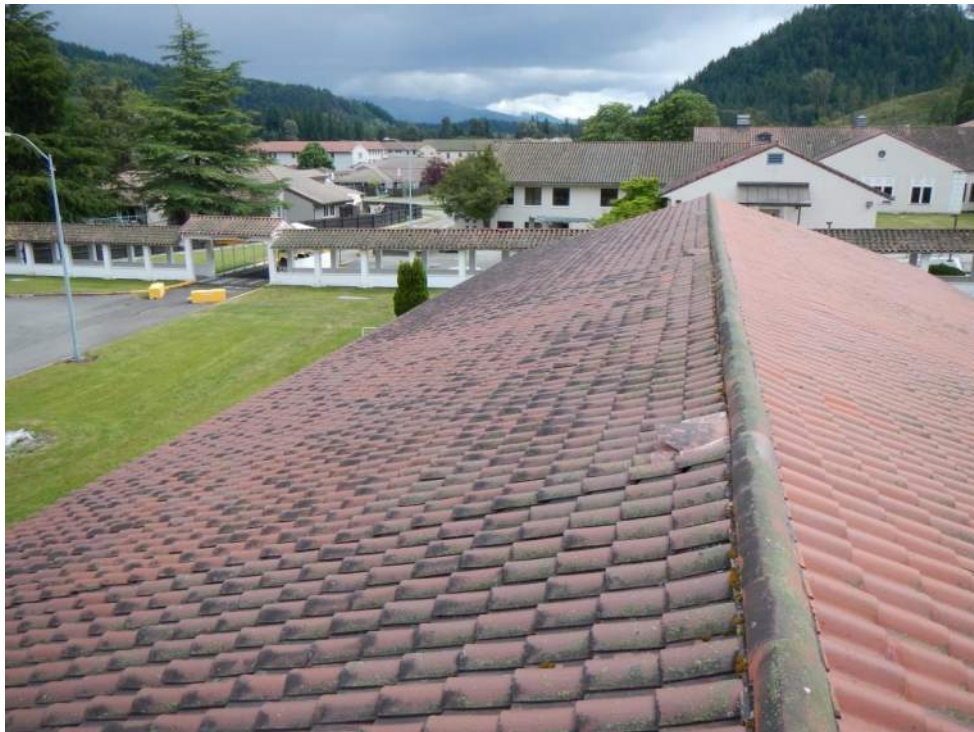
Photograph # 6: View of east roof section of north elevation.

6. View of the east half of the roof just beyond the gable end vent. *See photograph # 6.*
7. Example of water seepage staining noted on the soffit of the timber roof decking. *See photograph # 7.*

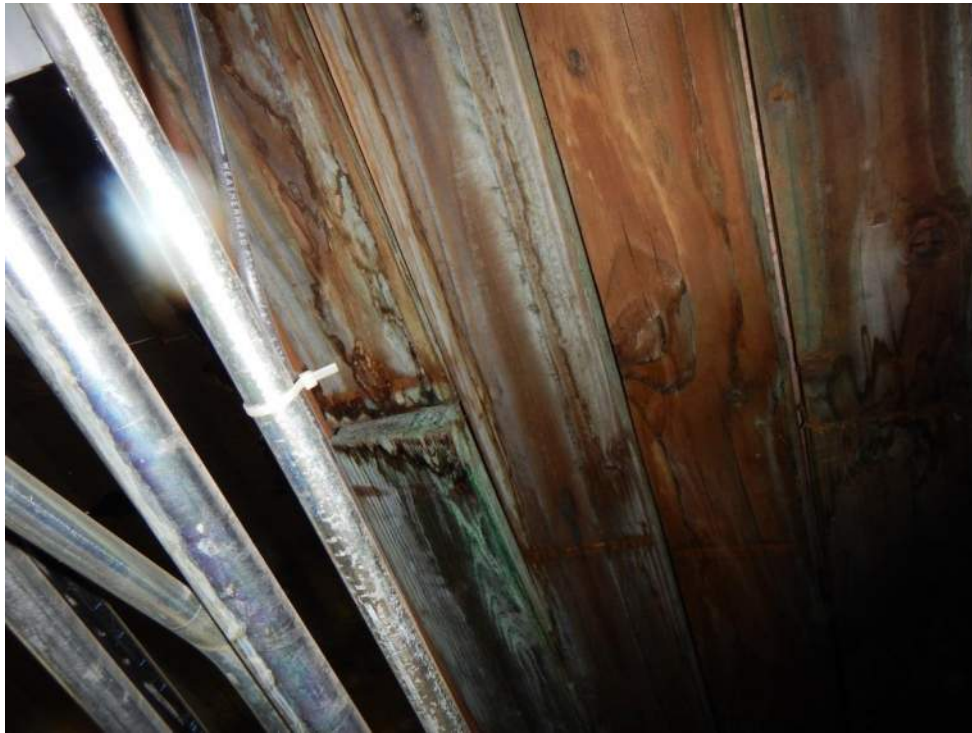
Photograph # 7: Example for water seepage staining on soffit of decking.

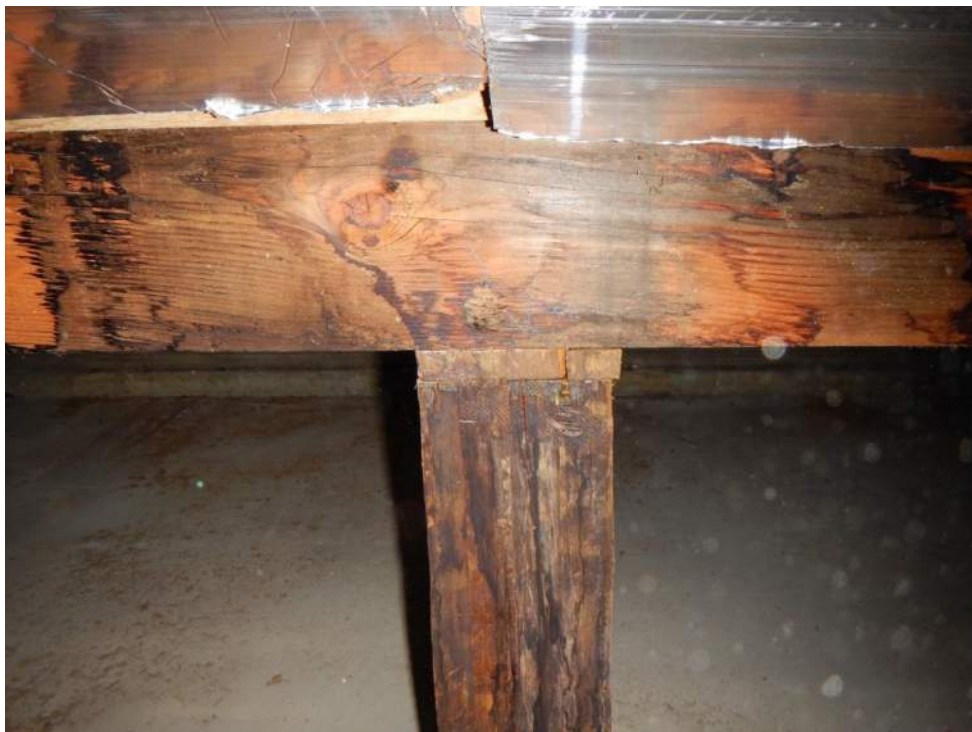
Photograph # 8: Example of water seepage staining on beam and post.

8. Example of water seepage staining noted on the beam and post supporting the roof. *See photograph # 8.*
9. Typical rigid insulation installed below the roof decking with beam and post. *See photograph # 9.*

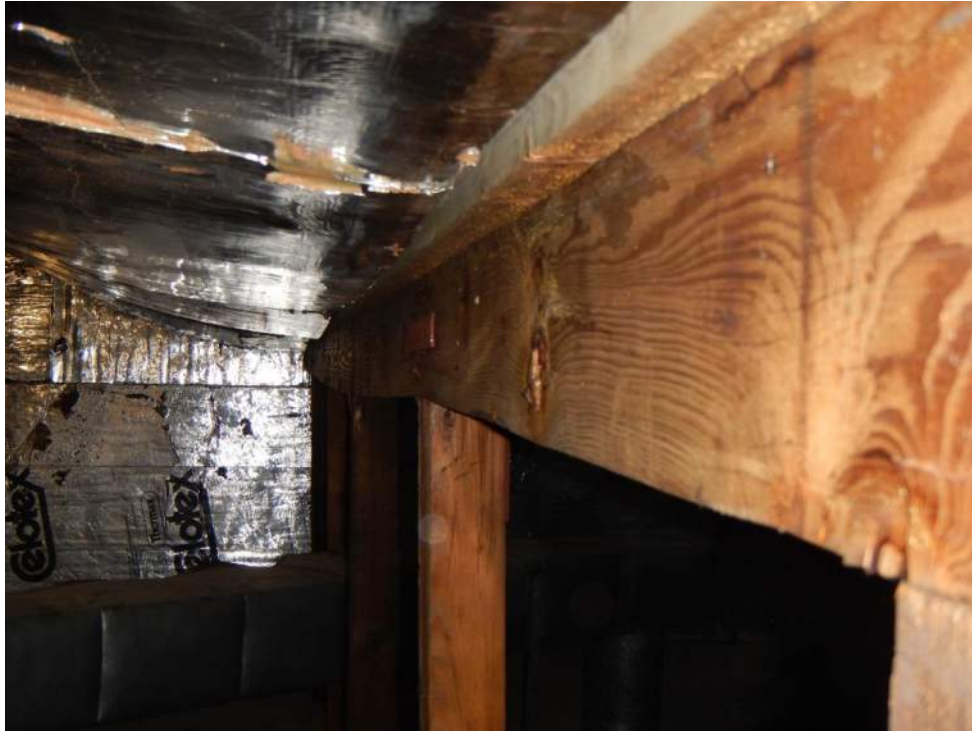
Photograph # 9: Rigid insulation at decking soffit abutting beams and posts.
