2020 Supplemental Capital Budget Request

Limited Roof Survey and Leak Investigation

Rainier School Building 2010

DATE OF REPORT	Friday, June 28, 2019	PROJECT:	Rainier School – Building 2010 Limited Roof Survey and Report
TO	Dean Heglund, DSHS Project Manager	CC:	Scott Ward, Rainier School
CLIENT	State of Washington DSHS		Pat Bockelman, Rainier School
TEL	360-902-8158		Sean Yates, Rainier School
E-MAIL	hegluda@dshs.wa.gov		Nat Stiles, Rainier School
FROM	Scott Vlotho BET&R Architect		Darren Johnston, Harbor Engineers
SUBJECT	RAINIER SCHOOL – BUILDING 2010 LIMITED ROOF SURVEY PRELIMINARY OBSERVATIONS, FINDINGS, AND RECOMMENDATIONS

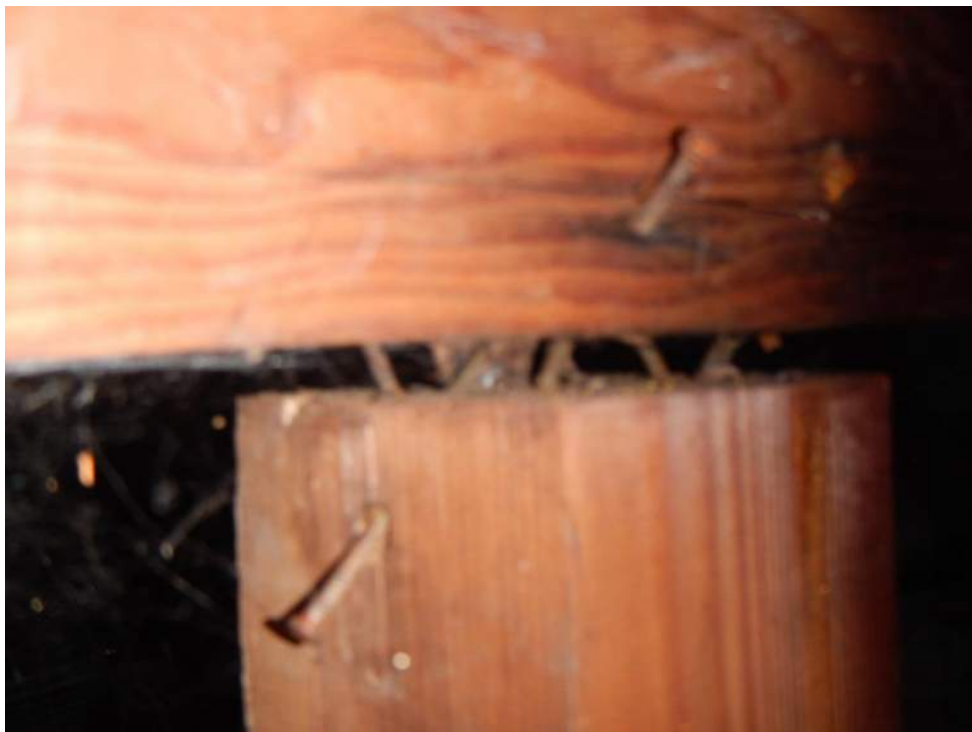
Photograph # 10: Ridge beam not in contact with support post.

10. Timber post not in contact with ridge beam in the western attic chamber. *See photograph # 10.*

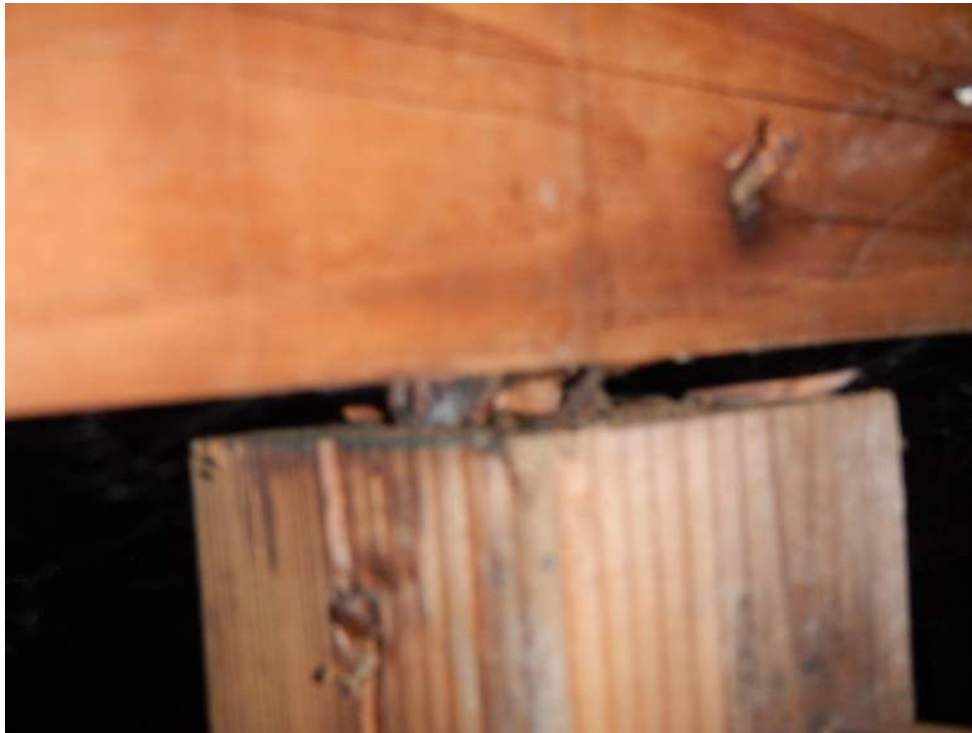
Photograph # 11: Ridge beam not in contact with support post.

11. Timber post not in contact with the ridge beam in the western attic chamber.
See photograph # 11.
12. Fungal decay growth noted at removed insulation panel at the western attic chamber.
See photograph # 12.

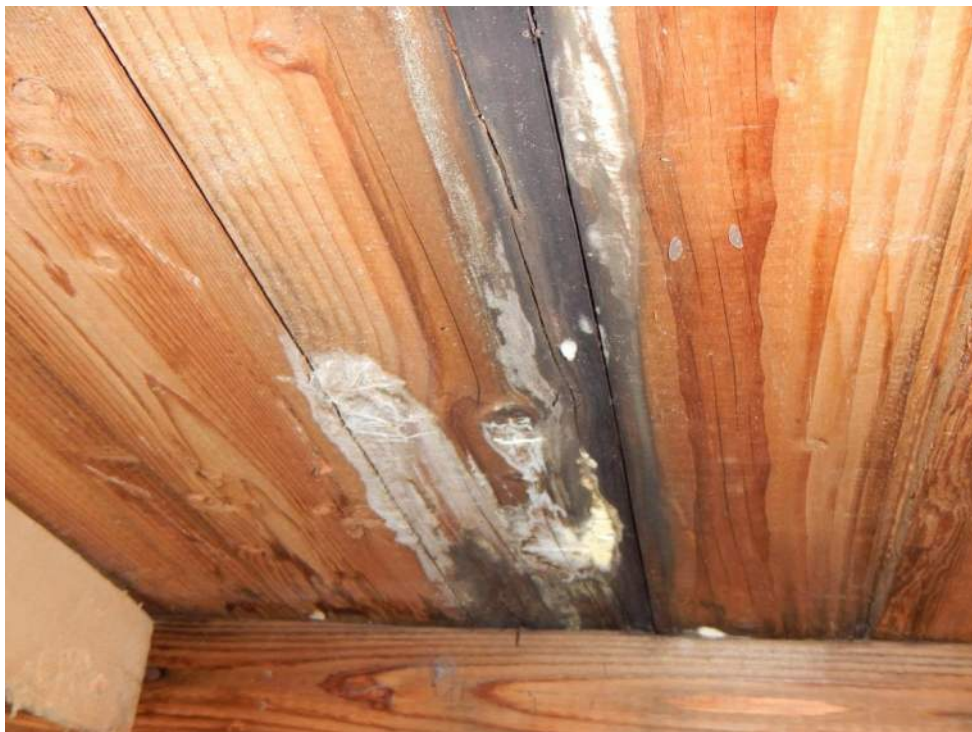
Photograph # 12: Example of timber roof deck decay at soffit.

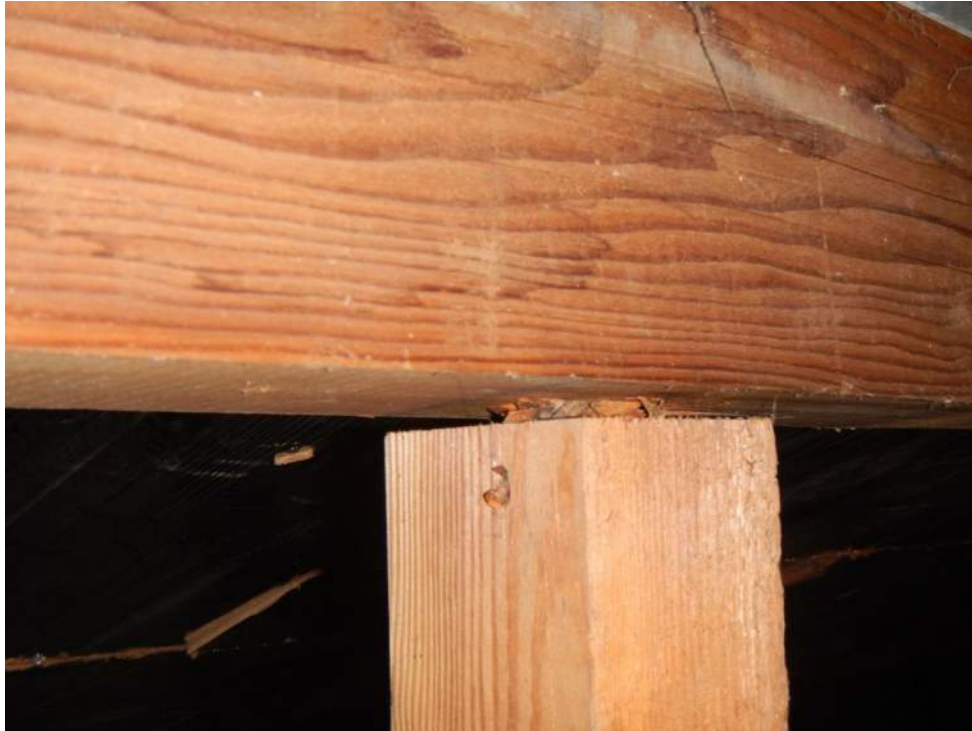
Photograph # 13: Ridge beam not in contact with support post.

13. Timber post not in contact with ridge beam in the western attic chamber. *See photograph # 13.*
14. View of roof and support framing in the central attic chamber note the non-plumb posts and curved beams. *See photograph # 14.*

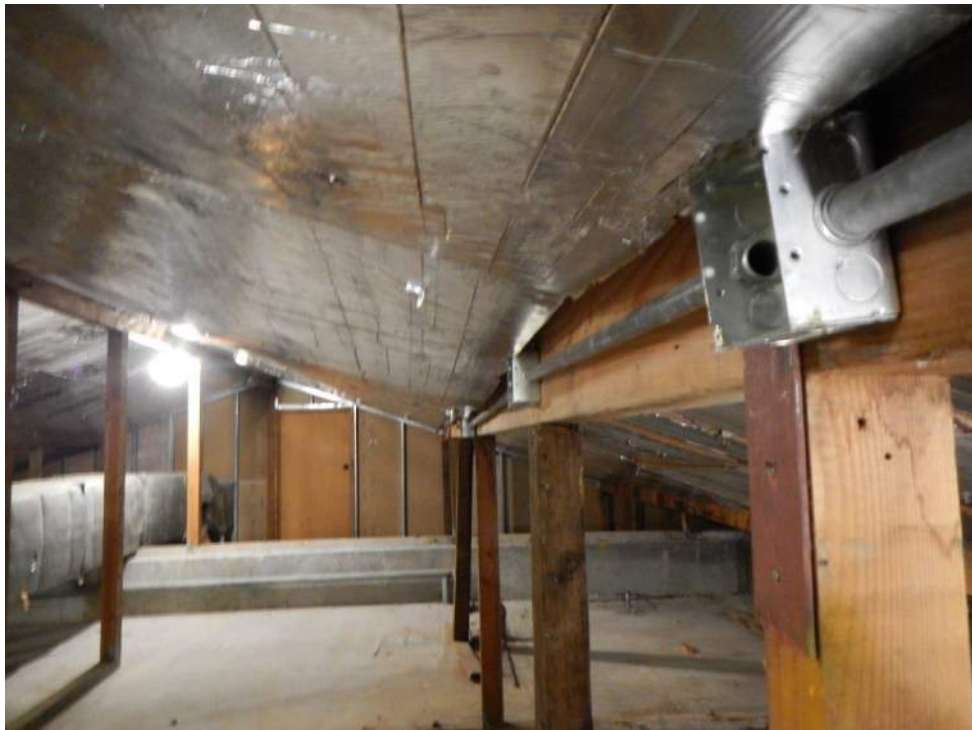
Photograph # 14: View of attic framing with rigid insulation (note non-plumb posts)

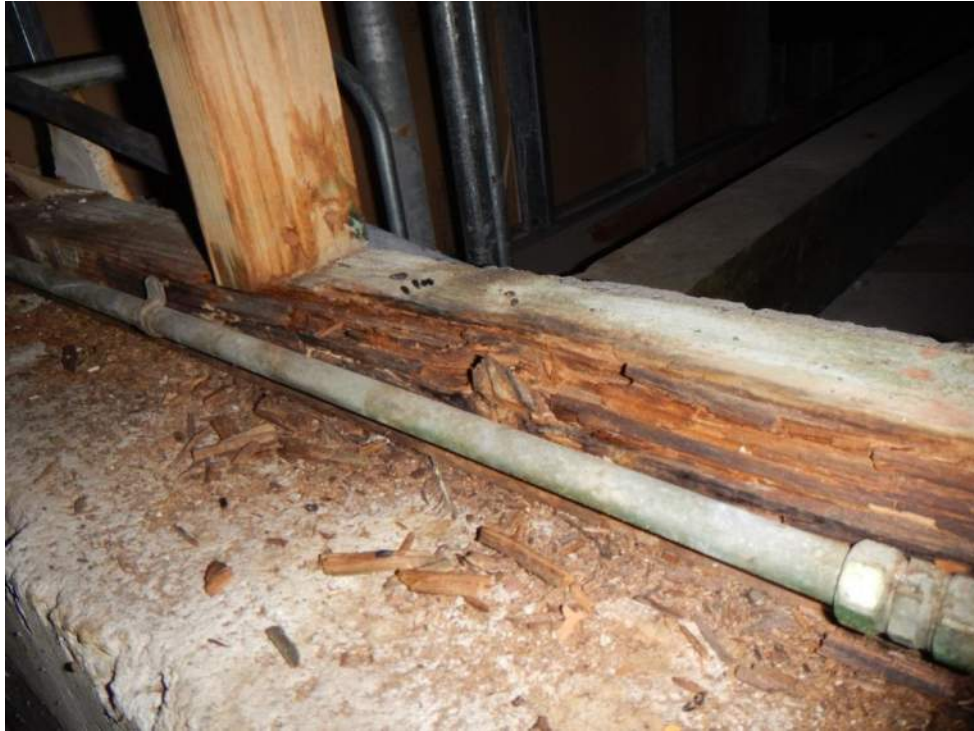
Photograph # 15: Deteriorated wood sill plate below valley on upturned concrete beam.

15. Decayed and deteriorated sill plate below the western valley of the central roof chamber.
See photograph # 15.
16. Example of plumb installation of 4X10 beams shaped at the top to receive roof decking.
See photograph # 16.

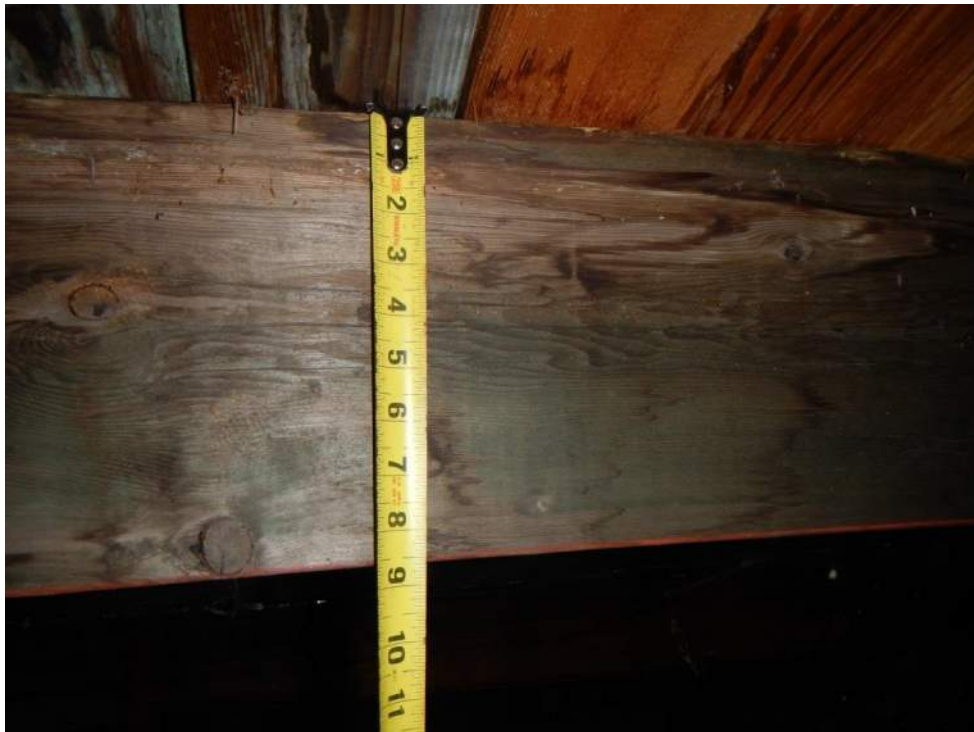
Photograph # 16: Example of plumb shaped 4X roof support beam.

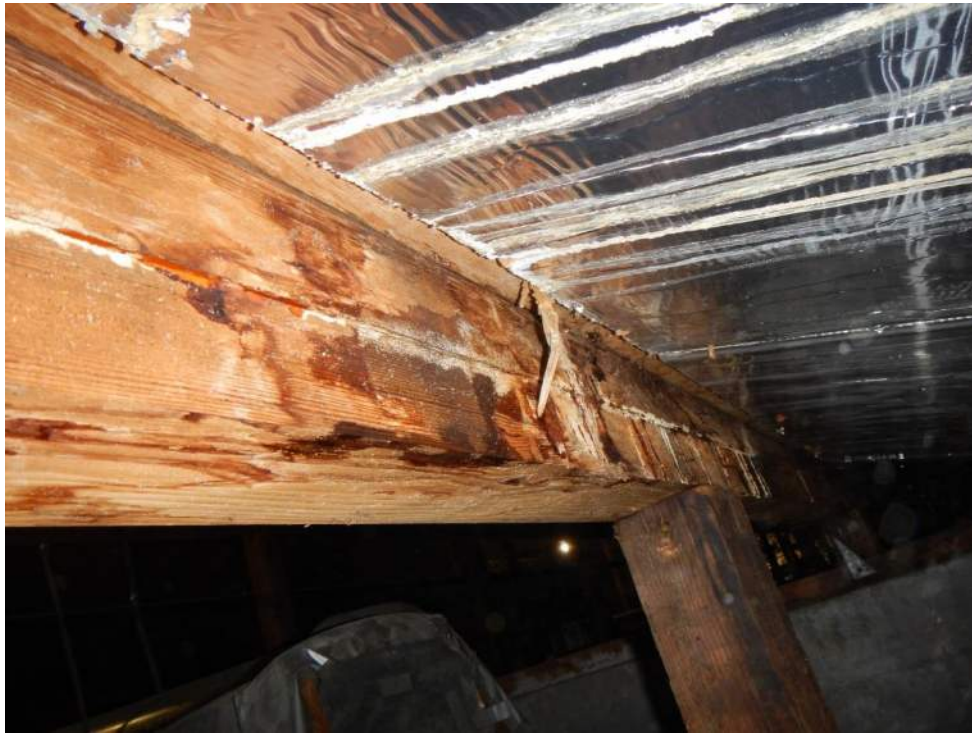
Photograph # 17: Example of seepage staining on soffit of roof decking and support beams.

17. Example of roof seepage staining noted at the western attic chamber. *See photograph # 17.*
18. Example of short post repair at upturned concrete beam in the western attic chamber.
See photograph # 18.

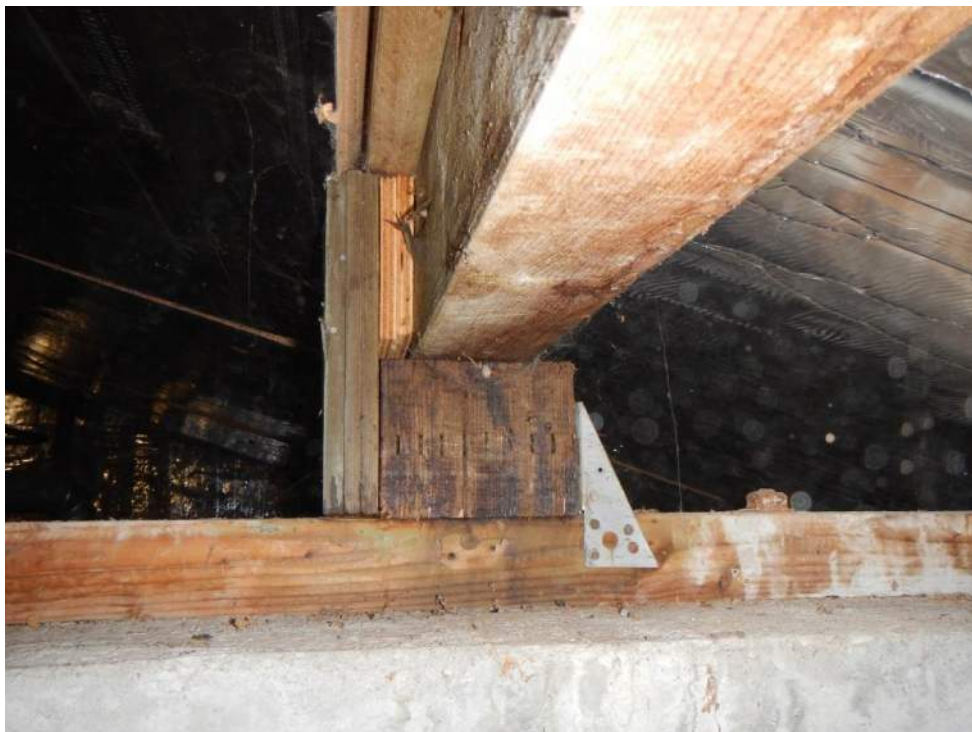
Photograph # 18: Repair of short timber post on upturned concrete beam.

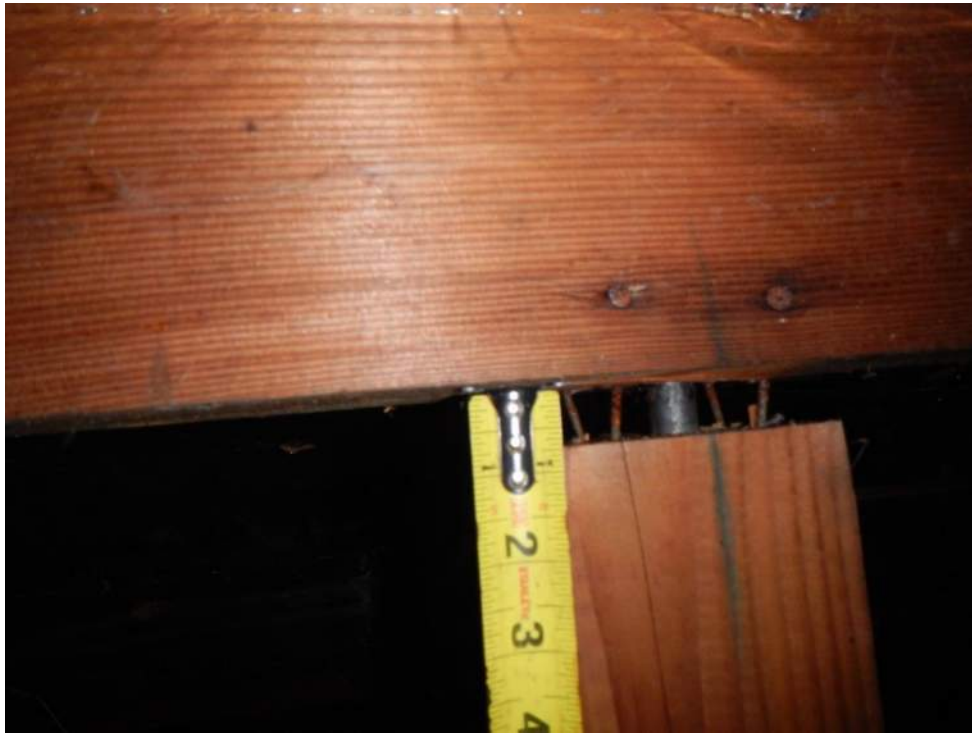
Photograph # 19: High beam separation from post of 3/4 inch.

19. High separation of ridge beam from supporting post found in the western attic chamber.
See photograph # 19.
20. The attic roof vents were covered by post-original construction installed rigid insulation panels.
No attic ventilation was noted in the northern attic section.

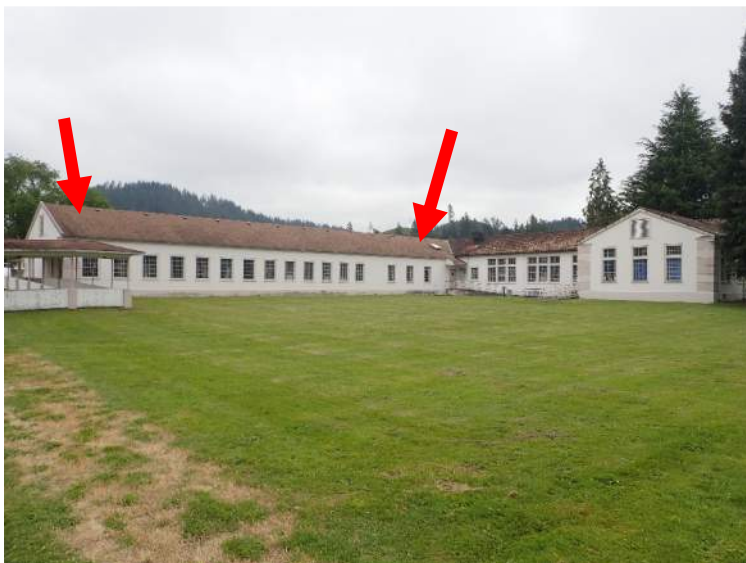
Photo No. 2 - Hurlbert Hall

Photo of Hurlbert Hall looking southeast from the backside of the building. The arrows identify the north gable end wing of the building that has been reroofed with asphalt shingles during previous repair projects. Reroofing is recommended to preserve this architecturally significant building for the Rainier School campus.

Hurlbert Hall is one of the original core campus building at Rainier School. It has been reported that water-intrusion and leaking has been a long-term problem for this building. During previous retrofit attempts, the section of roofing on the north wing of the building had the original pan-and-cover clay roofing tiles removed and replaced with an asphalt shingle roof system. Water intrusion has continued, and it is our opinion that extensive roof repairs and replacement is critically needed to prolong the service life of this significant campus building.

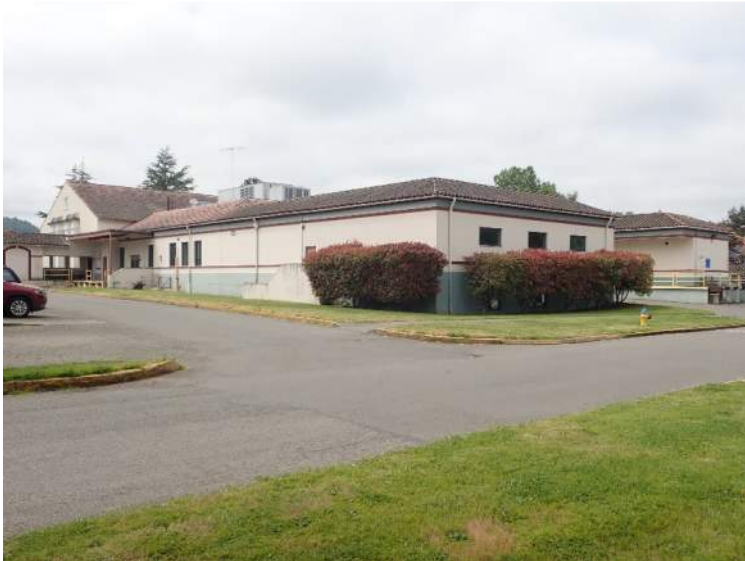
Photo No. 3 - Main Kitchen Building

Overview from the north showing the perimeter steep-slope mansard style roof areas with pan-and-cover clay tiles with the low-slope roof areas located near the center of the building.

The Kitchen Building, located at the center of the campus, provides the main food service functions for the Rainier School campus. The south end of the building consists of a steep-slope pan-and-cover clay tile roof system and the northern half of the building is a mix of steep-slope clay tile roof area at the perimeter, and larger low-slope roof areas at the central roof areas. It was reported that the existing low-slope roof membranes are Hypalon, consistent with those observed at other campus buildings. Persistent water-intrusion has been reported at this building. Providing a leak free and watertight building envelope system is needed for this critical food preparation facility.

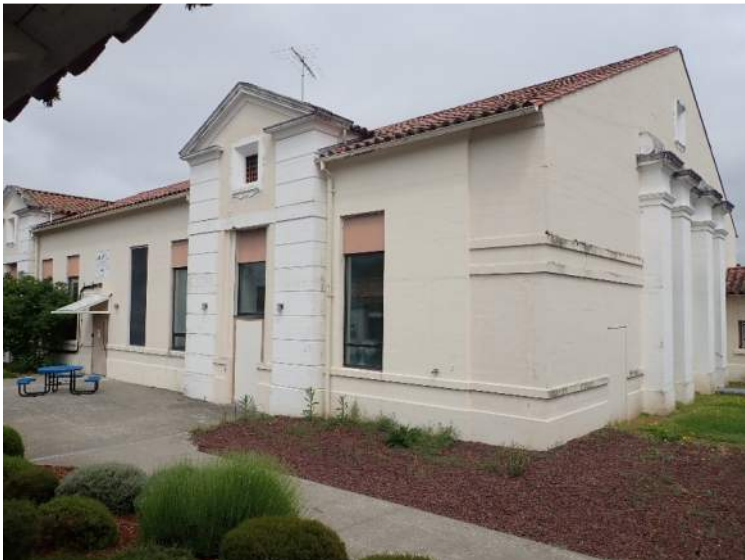
Photo No. 4 - Main Kitchen Building

Photo of the south side of the building where the café is located. The ornate concrete exterior walls are roofed with a steep-slope pan-and-cover clay roofing tile system, similar to other buildings.

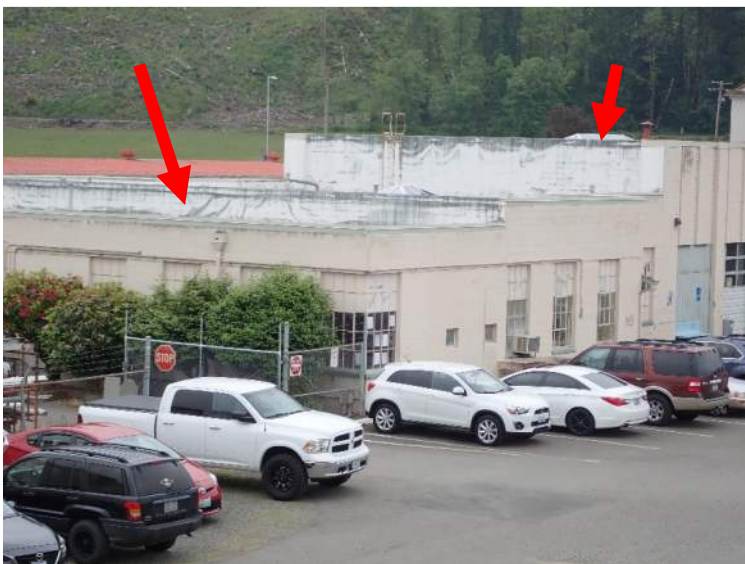
Photo No. 6 - Maintenance Building

Photo depicting the series of low-slope roof areas needing replacement prior to failure of the existing roof membrane system. The building currently experiences rain water intrusion leaks at several locations.

Similar to the older, original campus buildings, the Maintenance Building is a largely composed of concrete. The existing low-slope roof membrane is reportedly an aged single-ply Hypalon roofing membrane. Rain water leaks have been reported at numerous areas and it is our opinion that due to the age, existing membrane condition, and reports of water intrusion, it is prudent to consider roof replacement with a new multiple-ply roofing membrane system. This Project Team has successfully designed, specified, and administered the construction phase and installation, in conjunction with qualified roofing contractors, with a new low-slope multiple-ply SBS-modified asphalt roofing membrane system. Replacement of the aged single-ply Hypalon roof membranes should be prioritized as high importance.

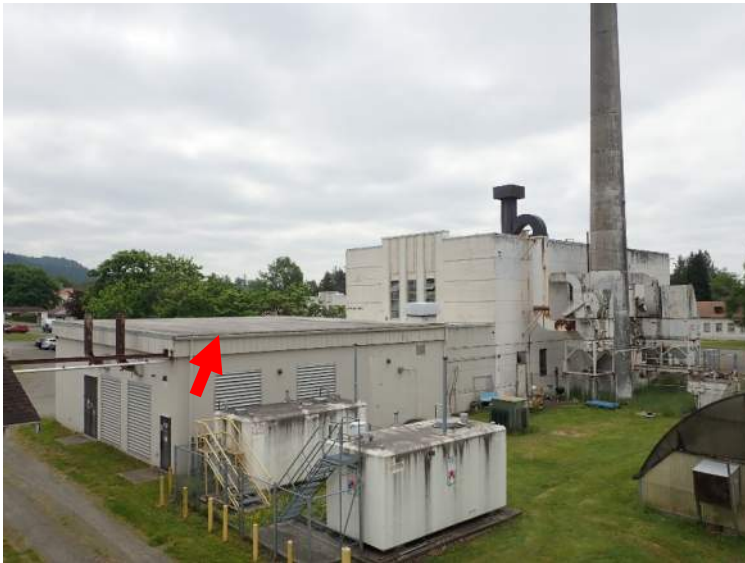
Photo No. 7 - Power House Building

Overview from the P-43 Building looking southwest towards the Power House. The low-slope single-ply Hypalon membrane was extended and rolled over the perimeter edge of the identified roof area. Visual evidence, even from this distance, showed that the existing membrane is aged, has deteriorated, and is recommended for replacement, as the membrane has reached the end of its useful service life.

The Power House also consists of a single-ply Hypalon roofing membrane at the various roof levels of the building. Although we have not closely surveyed the roof areas, it is evident from a distance that the existing roof membrane has deteriorated and is in need of replacement. Providing power to the campus, this building serves a critical function for the entire facility.

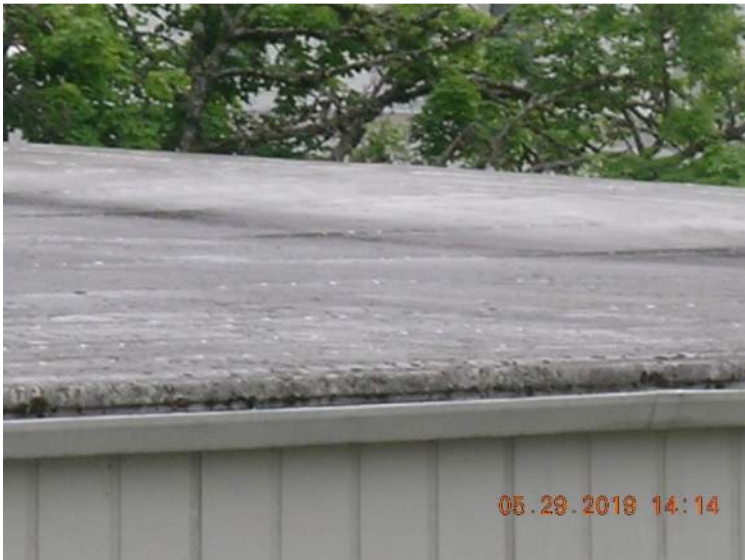
Photo No. 8 - Power House Building Low-Slope Roof

Close-up view of the existing single-ply Hypalon membrane at the east end roof area, identified above. Areas of ponding are evident and the edge of the membrane shows signs of deterioration and is recommended for replacement.

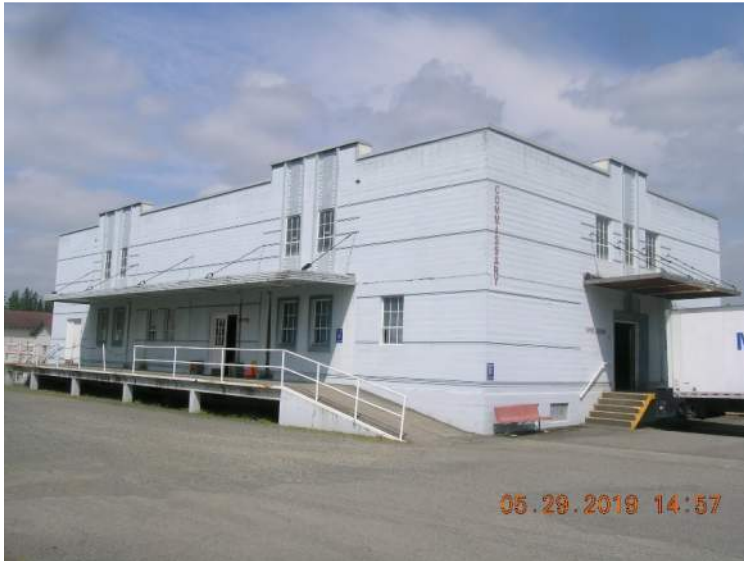
Photo No. 9 - Commissary Building

Overview showing the south and west elevations of the Commissary Building. The concrete-farmed exterior of the building is part of the original campus buildings.

The Commissary Building serves as the primary warehouse and distribution facility for goods and services for the clients of Rainier School. The roof is reported to also consist of a single-ply Hypalon membrane at the upper low-slope roof area. Although the roofing membrane has not been surveyed, we believe that the age and condition of the membrane is likely consistent with other low-slope roof systems on other buildings.

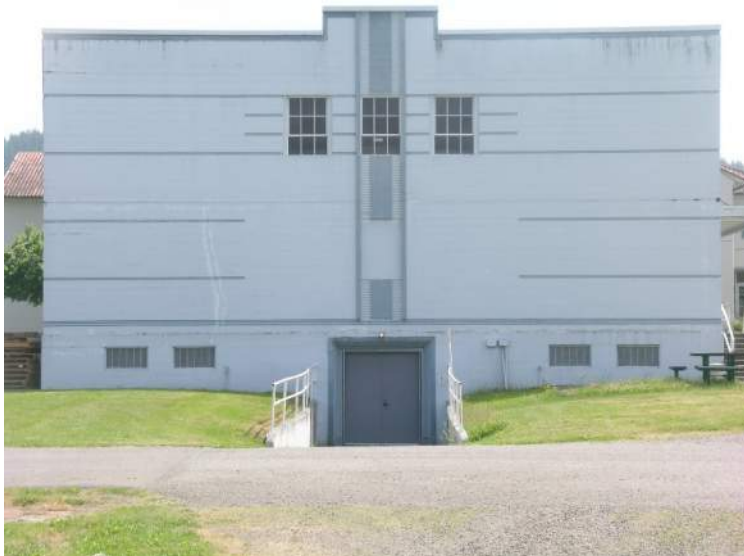
Photo No. 10 - Commissary Building

Photo depicting the north elevation of the Commissary Building.

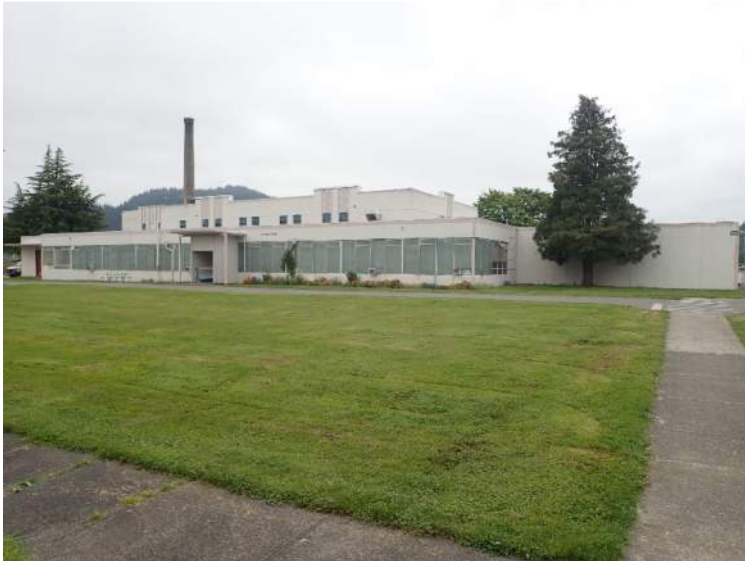
Photo No. 11 - Laundry Building

Overview showing the original two-story Laundry Building near the center and later one-story addition that surrounds the original building.

The Laundry Building consist of the original two-story building, and has been surrounded by a lower one-story addition during a later construction project. It appears that both the lower and upper roof areas consist of a single-ply Hypalon roof membrane. Although the roofing membrane has not been surveyed at this building, we believe that the age and condition of the membrane is likely consistent with other low-slope roof systems on other buildings. It has been reported that the Rainier School Laundry Building provides laundry services for Rainier School along with at least two other state facilities.

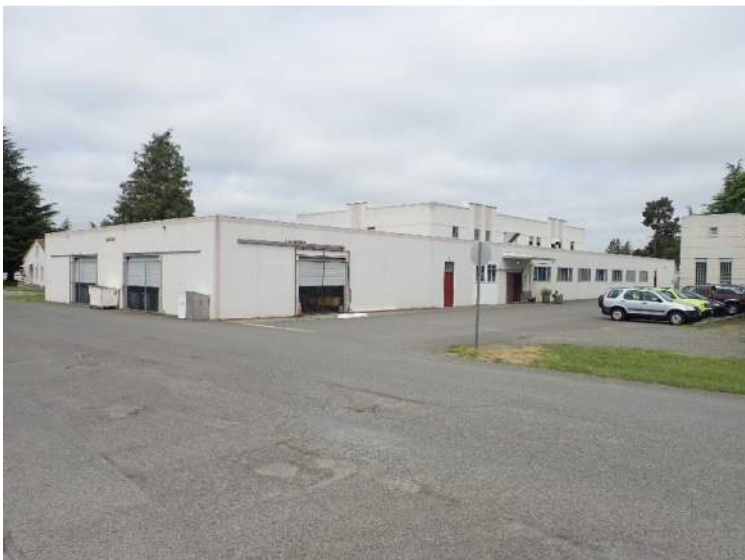
Photo No. 12 - Laundry Building

Photo looking northwest towards the Laundry Building. The later single-story addition that surrounds the original building appears to have been constructed of tilt-up concrete wall panels and low-slope roof areas.

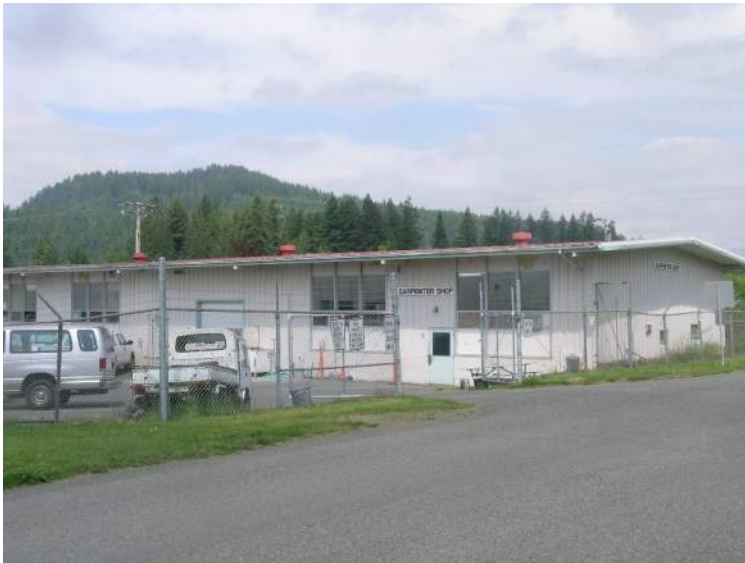
Photo No. 13 - Carpentry Shop

Overview depicting the existing Carpentry Shop at Rainier School showing the low-slope roof profile at the gable end.

The Carpentry Shop is currently roofed with a low-slope sheet metal panel standing seam roof system. Numerous interior leaks have been reported and are recommended to be addressed. Additional survey is needed to better understand the source or water intrusion to assist with proper design and specification of roofing related repairs.

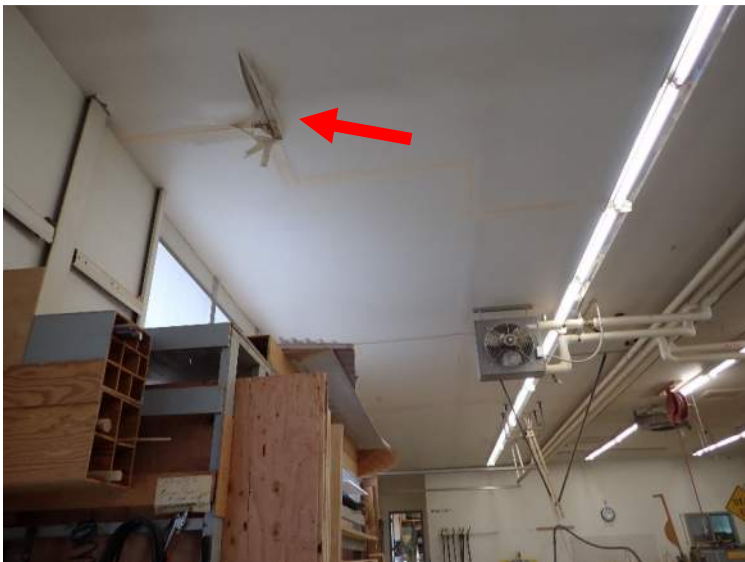
Photo No. 14 - Carpentry Shop Interior

Several interior leak locations were reported. This photo shows interior ceiling damage due to on-going water intrusion.

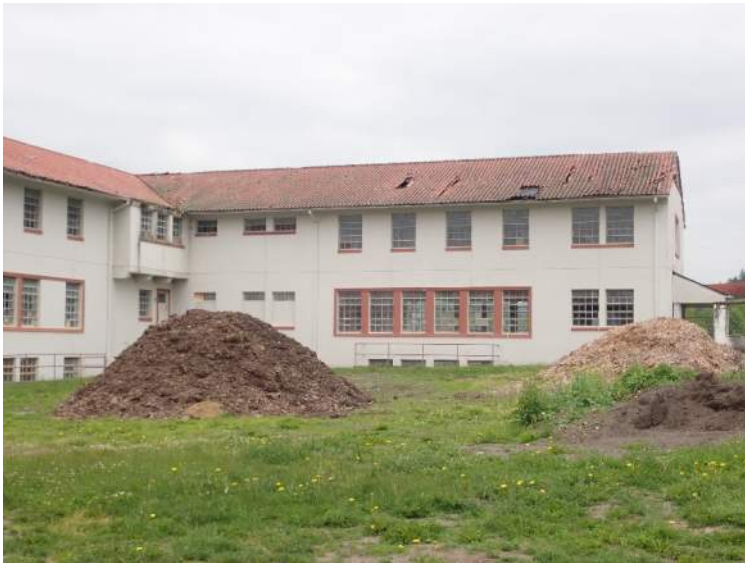
Photo No. 15 - Adler Hall and other Residence Buildings

Photo depicting extensive roof damage at Adler Hall. Reroofing and replacement of damaged roof structure members is recommended for this building and the other buildings that create a four-building quad. While roof replacement work may be extensive, the high-quality construction of the main building structure is worth protecting on our opinion.

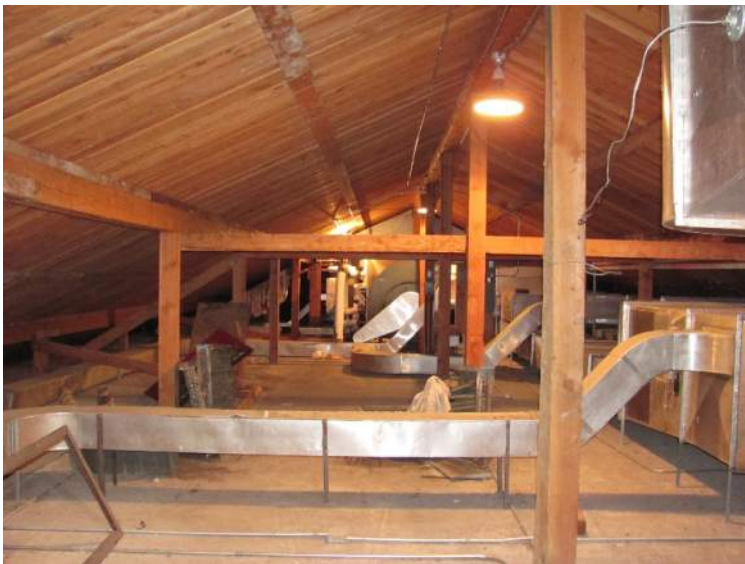
Photo No. 16 - Adler Hall and other Residence Buildings

Photo provided by the State of Washington from the attic spaces within these residential buildings. Note that the tongue-and-groove roof decking runs parallel with the slope of the roof. It is likely that much of the damage and decay is isolated to the roof decking and the primary, large-dimension wood framed structural support members remain largely intact and serviceable for reroofing.

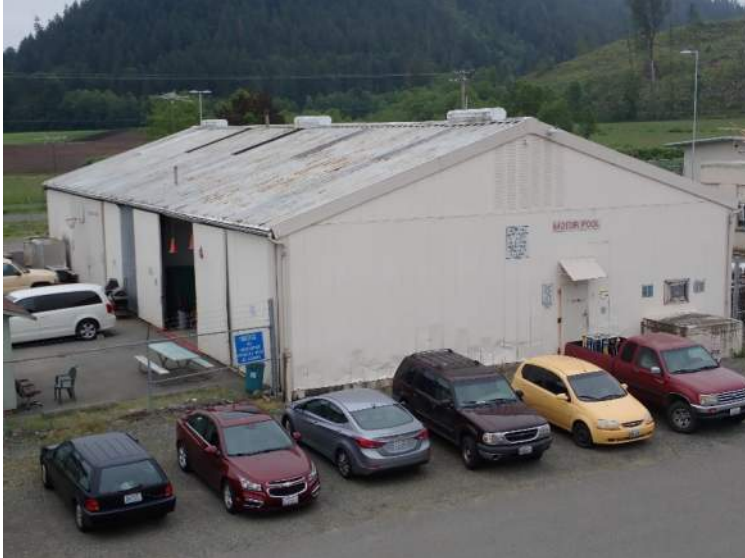
Photo No. 17 - Motor Pool Building

Photo from the P-43 Building looking east towards the Motor Pool Building.

The Motor Pool, similar to the original roof system of the recently reroofed P-43 Maintenance Building, consists of sheet metal panel roofing system. Water intrusion leaks have been reported and should be addressed as budget allows for the campus.

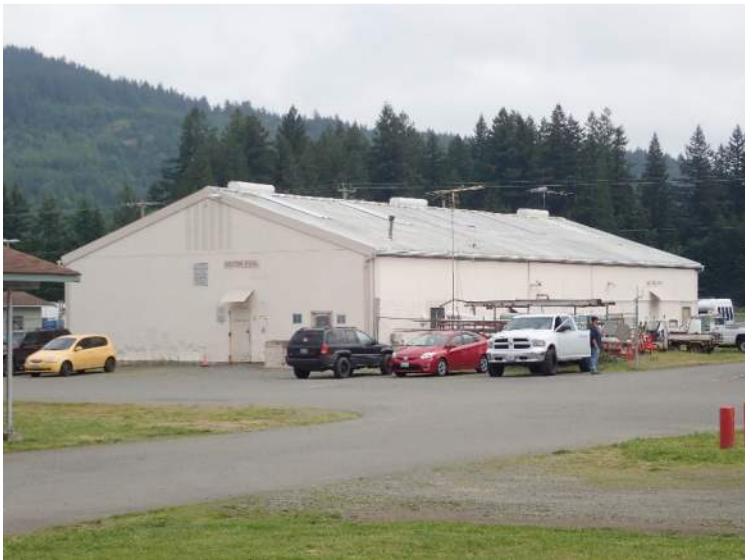
Photo No. 18 - Motor Pool Building

View showing the west and south elevations to the Motor Pool Building.

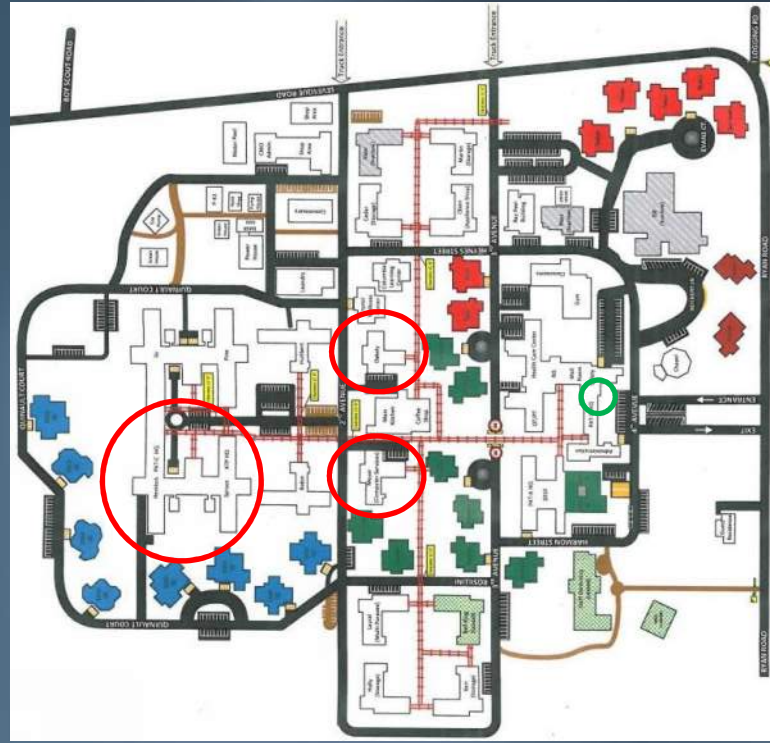
AUDITORIUM BUILDING & ROOF AREA OVERVIEW

Overview showing the general layout of the Rainier School Campus.

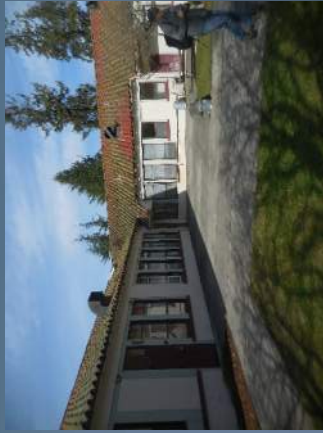
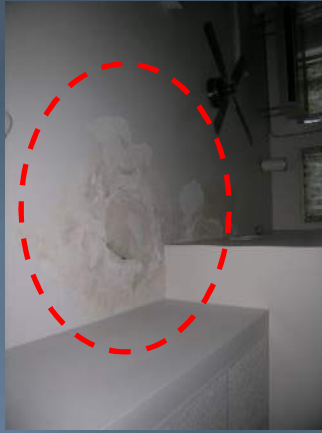
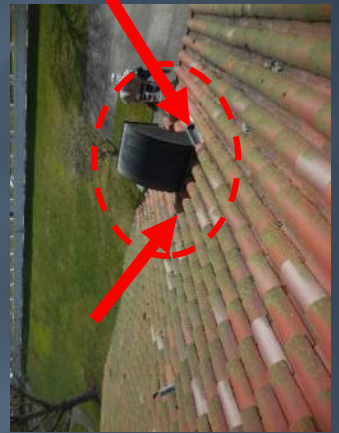
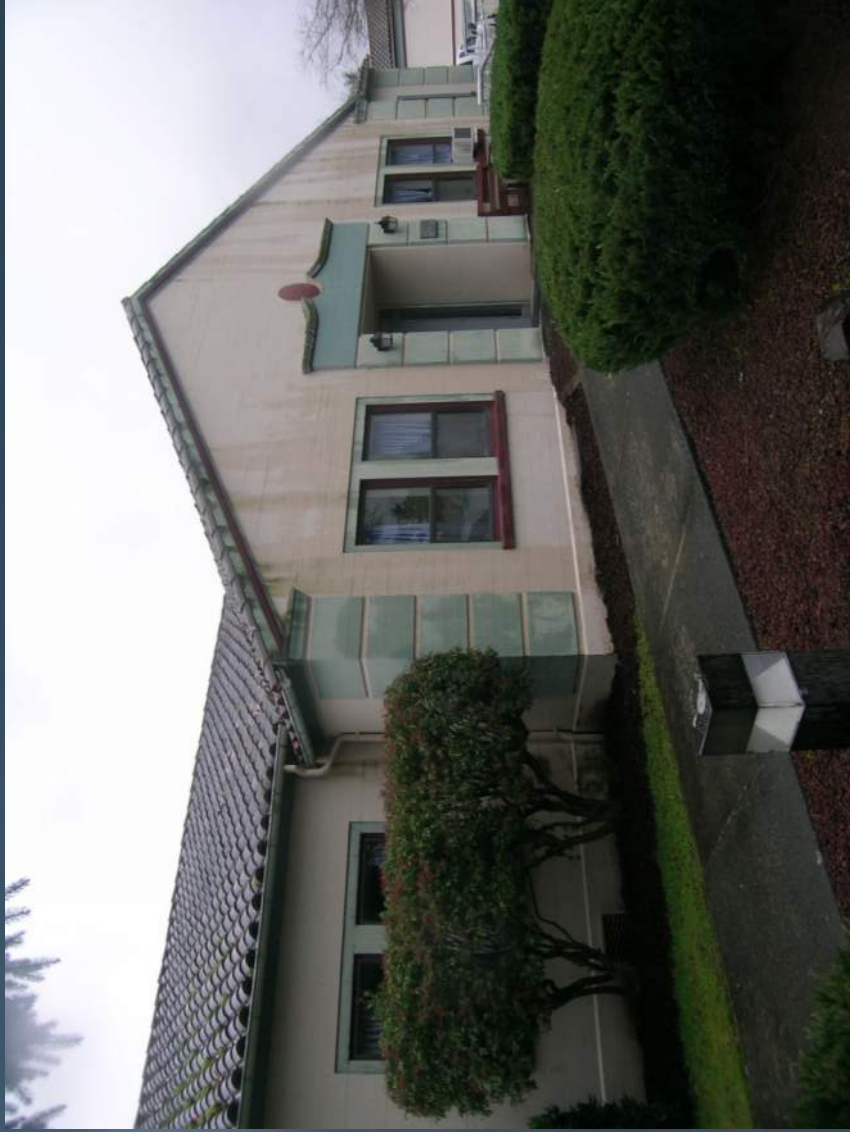
OAKLEY HALL-- OVERVIEW

Overview of Conditions at Oakley Hall
Reports of water intrusion primarily appear to be related to aged valley flashing conditions and defective flashings at select HVAC related penetrations.

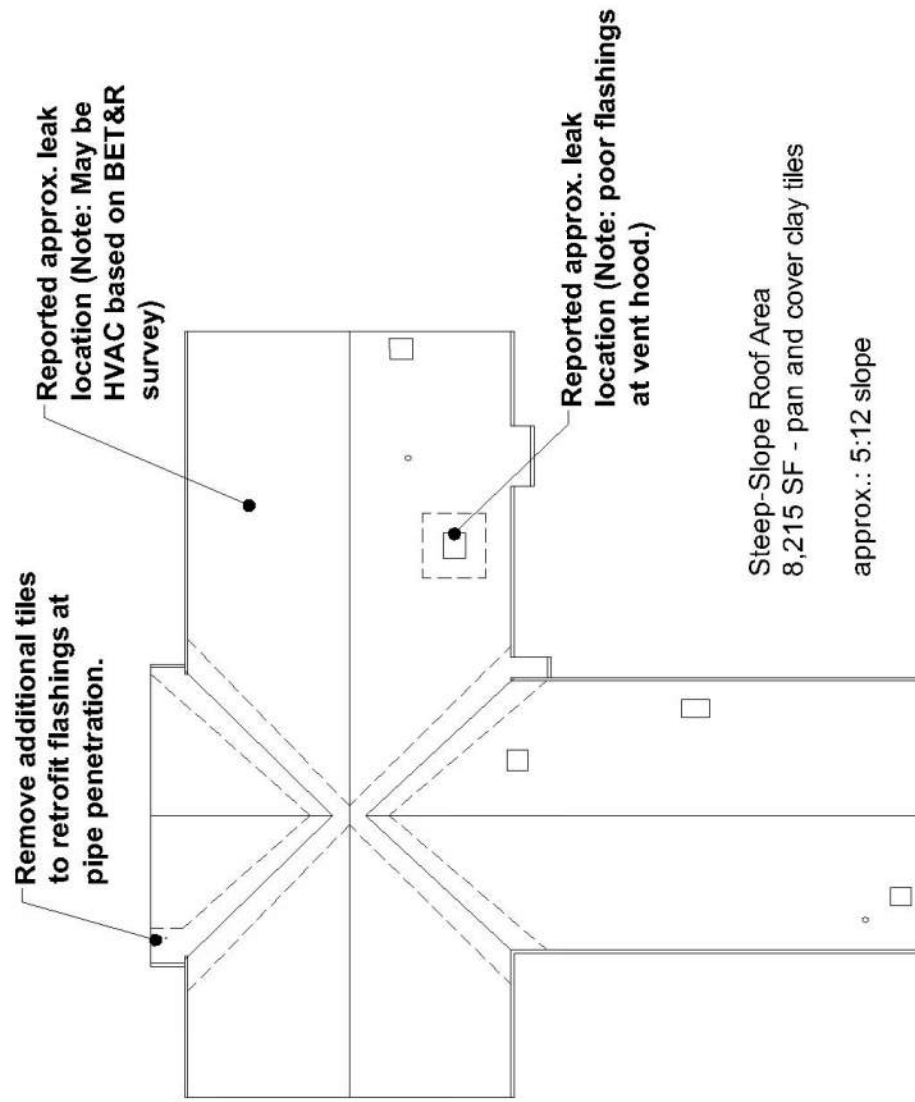
OAKLEY HALL -- ROOF PLAN

1/8" = 1' - 0"

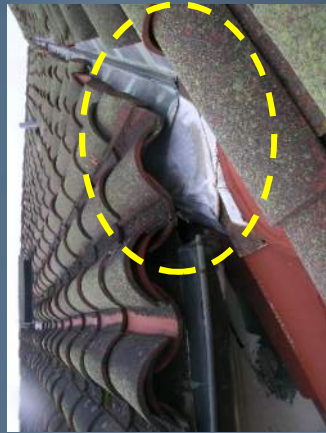
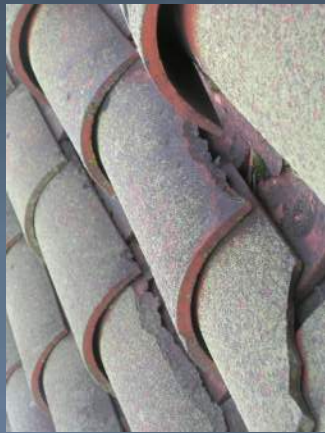
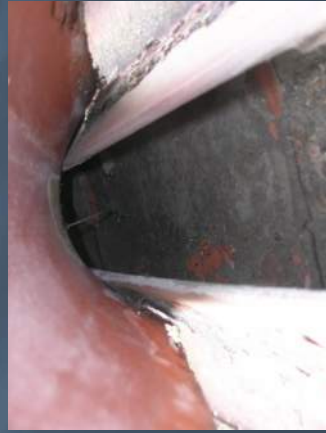
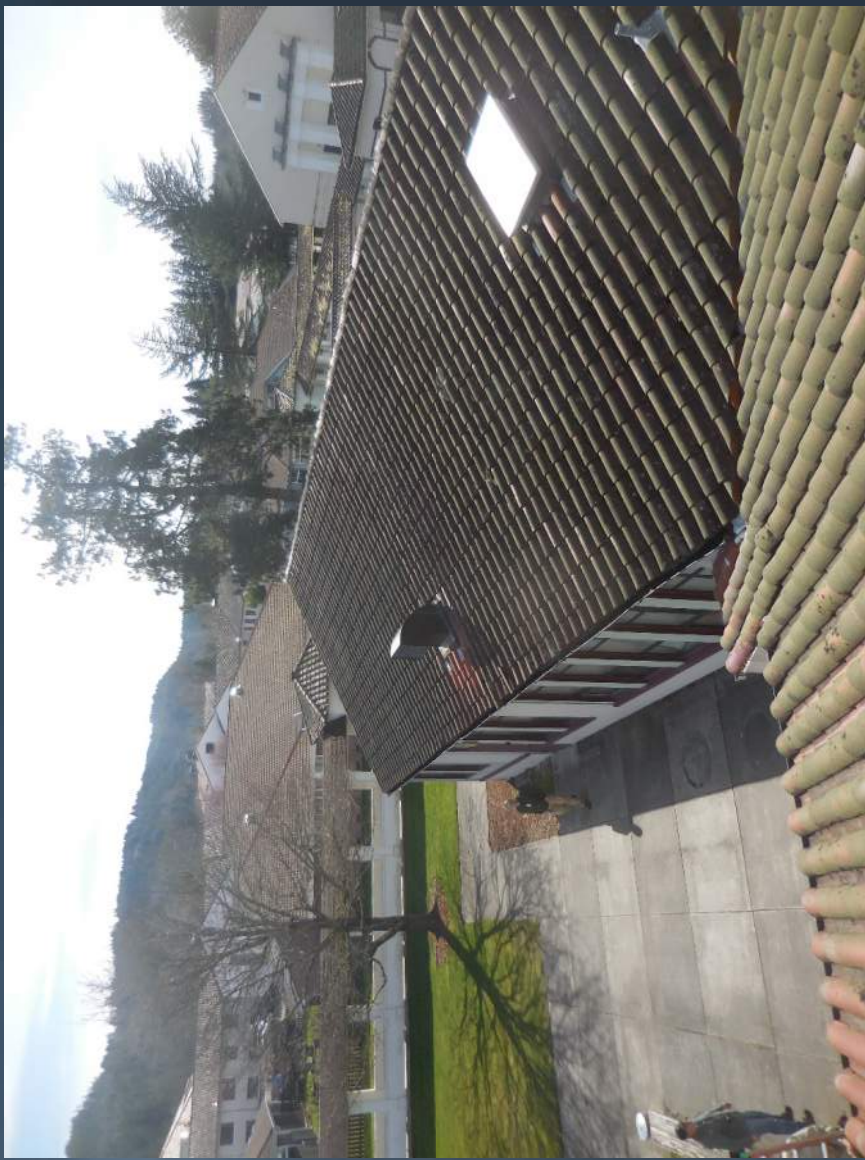
GENERAL ROOF FINDINGS AND CONDITIONS

Overview of Oakley Hall pan-and-cover clay tile roofing and general survey findings.

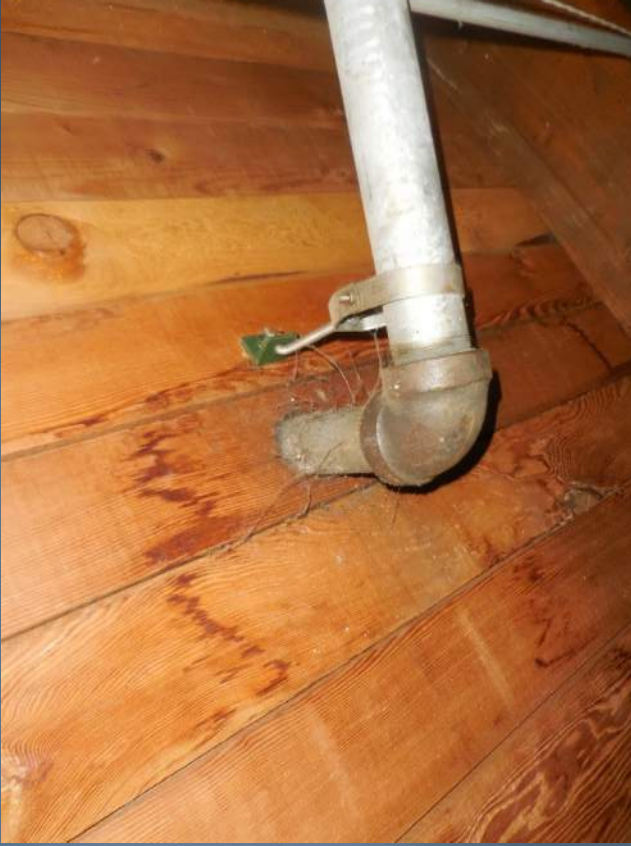
View of water staining on underside of wood car decking from attic space

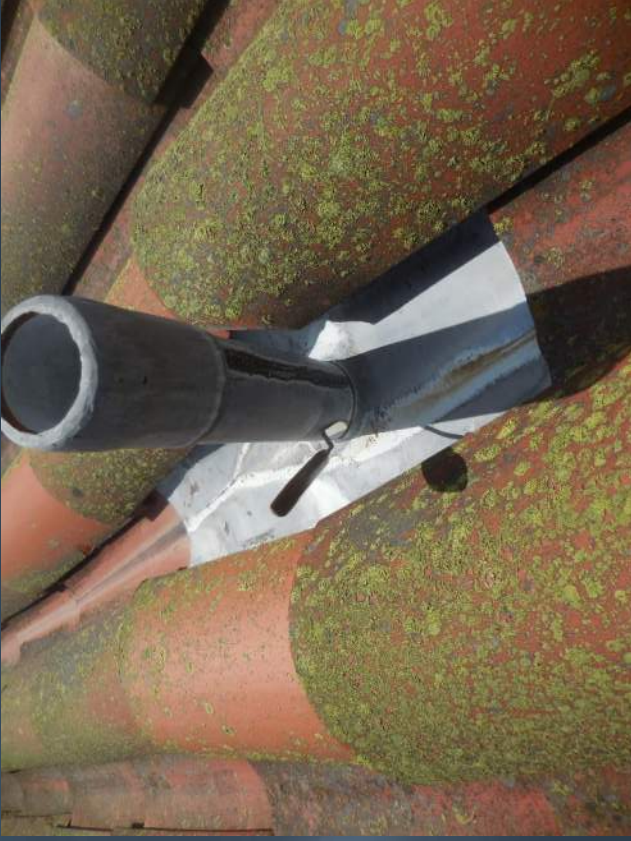
Deficient lead flashing at soil stack pipe penetration

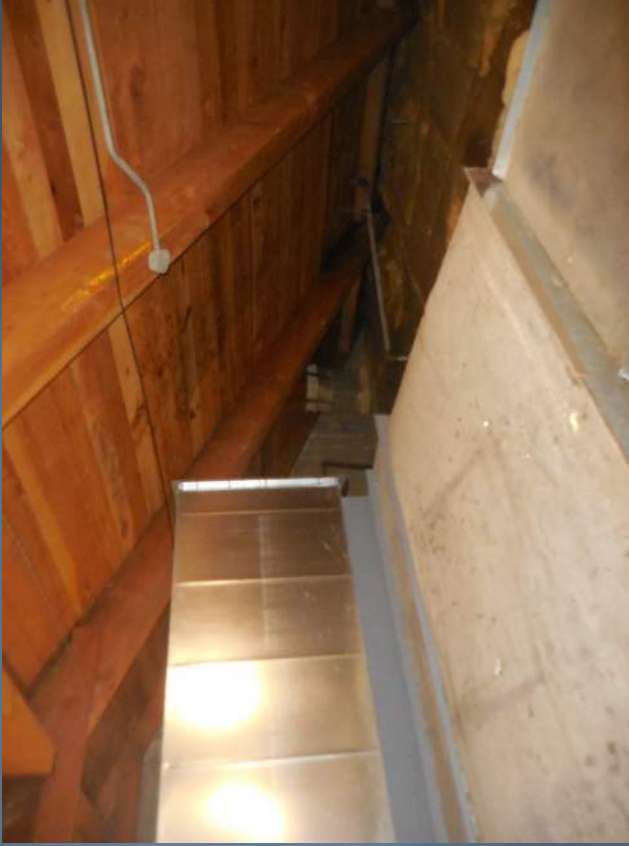
Depicts generally dry and good condition of 2x car decking and wood-framed structure
