2020 Supplemental Capital Budget Request

Limited Roof Survey and Leak Investigation

Rainier School Building 2010

DATE OF REPORT	Friday, June 28, 2019	PROJECT:	Rainier School – Building 2010 Limited Roof Survey and Report
TO	Dean Heglund, DSHS Project Manager	CC:	Scott Ward, Rainier School
CLIENT	State of Washington DSHS		Pat Bockelman, Rainier School
TEL	360-902-8158		Sean Yates, Rainier School
E-MAIL	hegluda@dshs.wa.gov		Nat Stiles, Rainier School
FROM	Scott Vlotho BET&R Architect		Darren Johnston, Harbor Engineers
SUBJECT	RAINIER SCHOOL – BUILDING 2010 LIMITED ROOF SURVEY PRELIMINARY OBSERVATIONS, FINDINGS, AND RECOMMENDATIONS

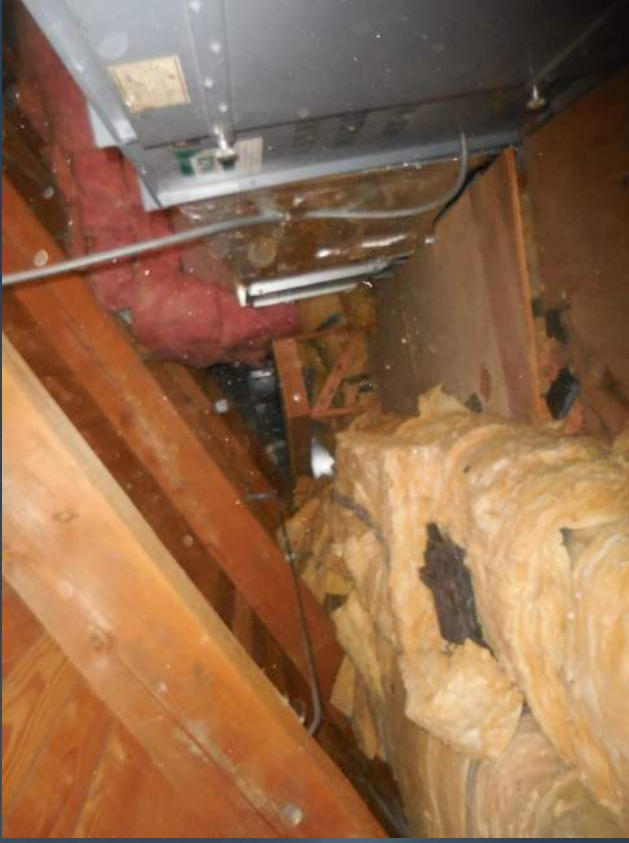
While the roofing structure appears dry, water intrusion as reported in an office below select HVAC units. The leak in office 128 appears to be related to this HVAC unit.

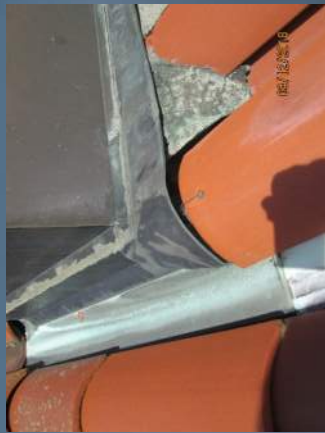
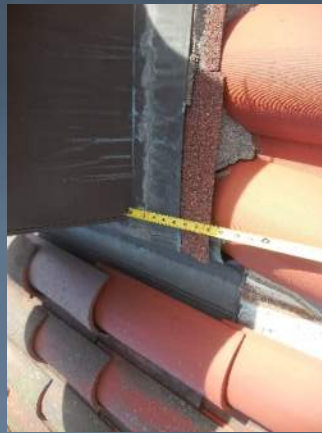
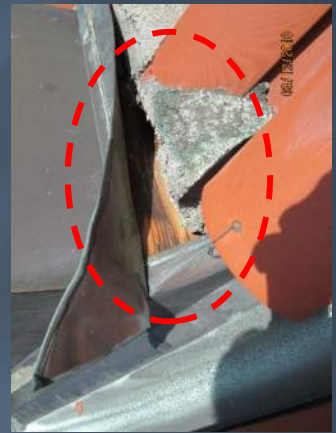
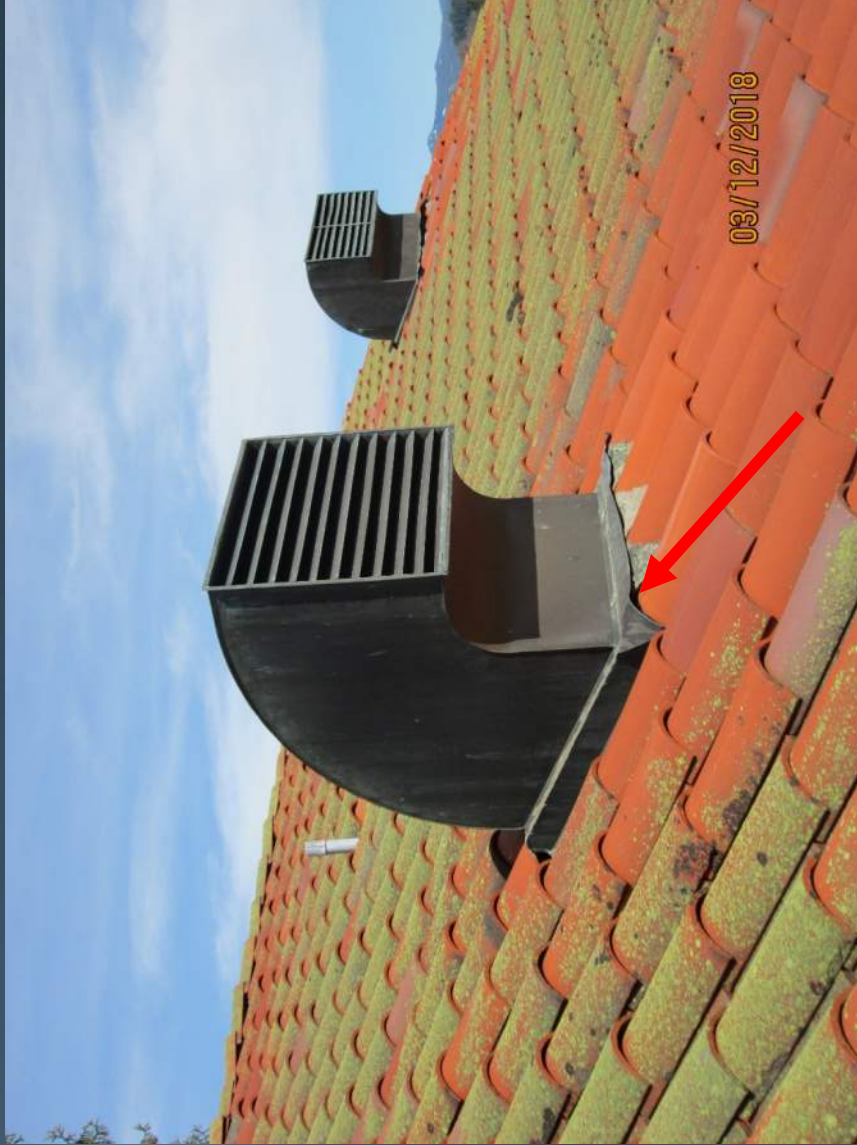
OAKLEY HALL- VENT HOOD FLASHINGS

Photos of conditions at HVAC Hood at related leak location where curb not correctly flashed.

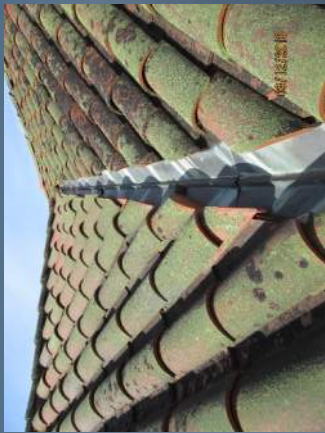
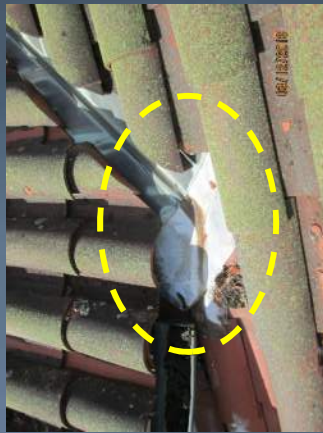
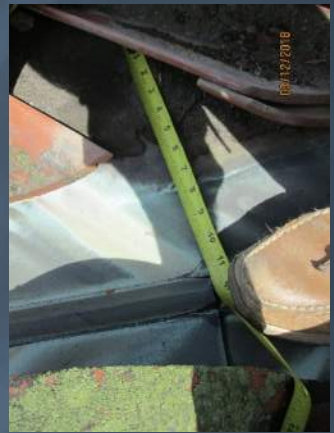
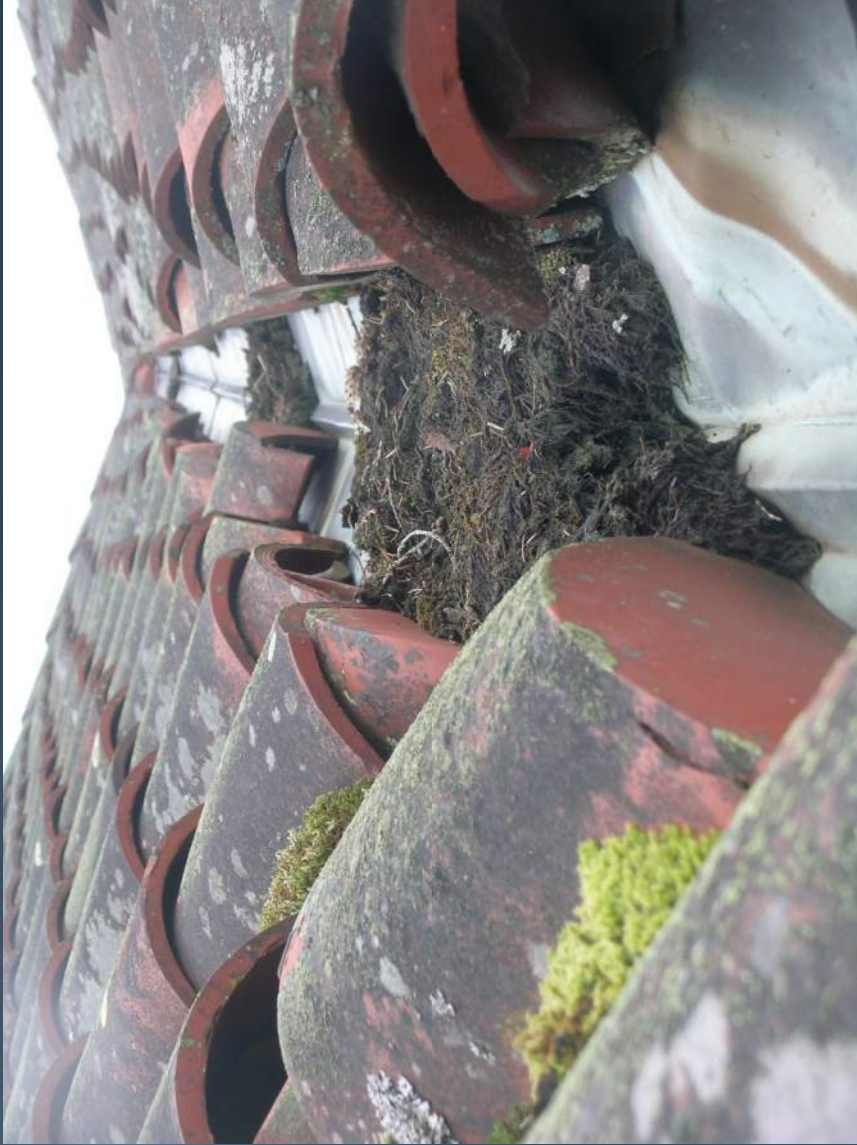
OAKLEY HALL- VALLEY FLASHINGS

Photos of conditions at typical valley

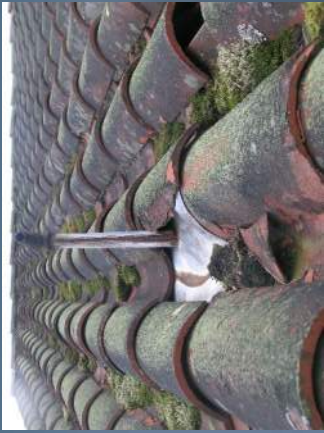
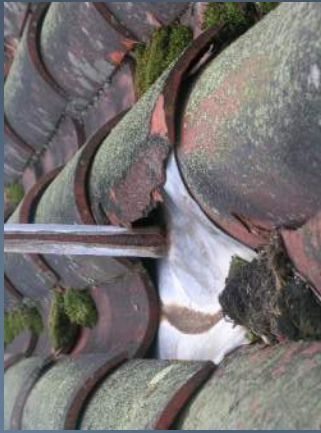
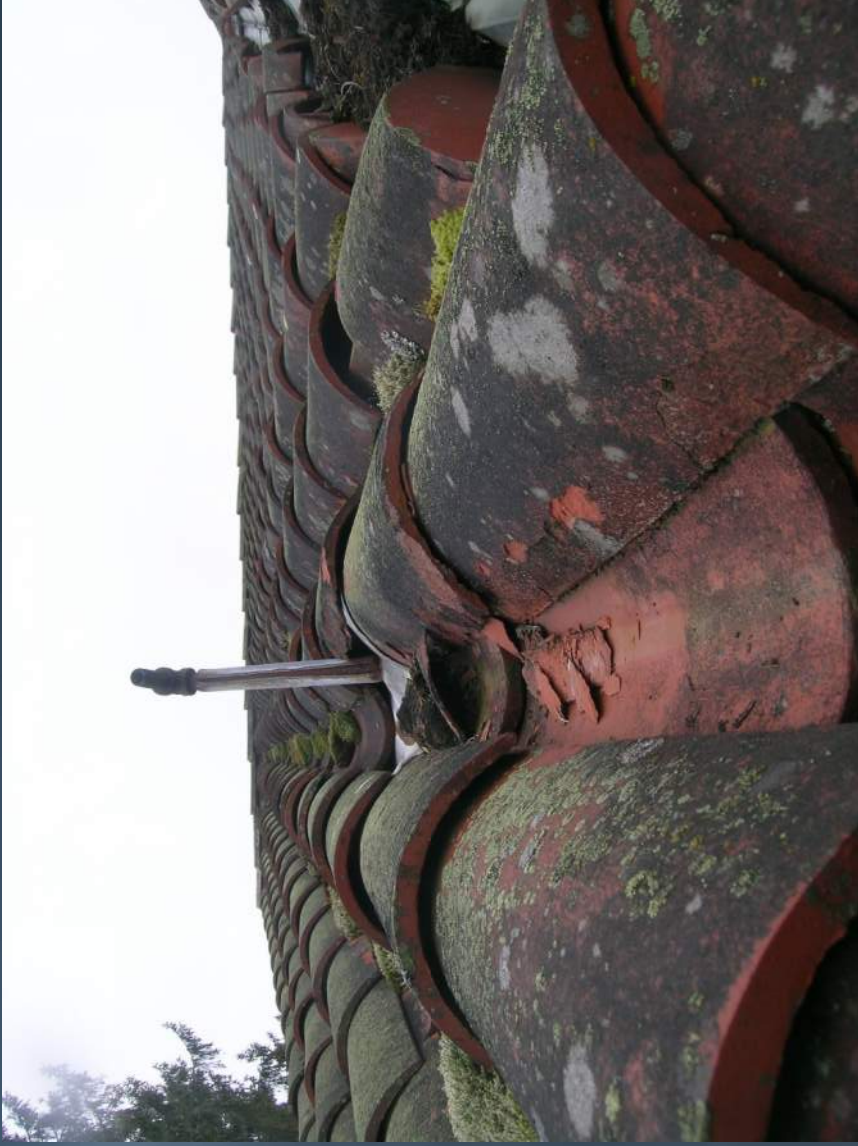
OAKLEY HALL- PIPE PENETRATION FLASHINGS

Photos of conditions at pipe penetration near northwest corner of building

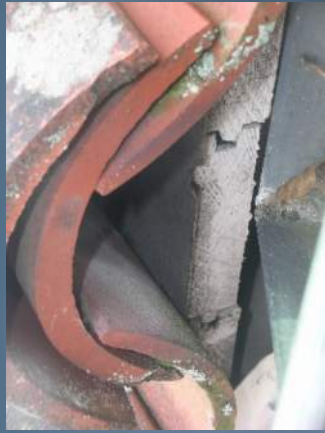
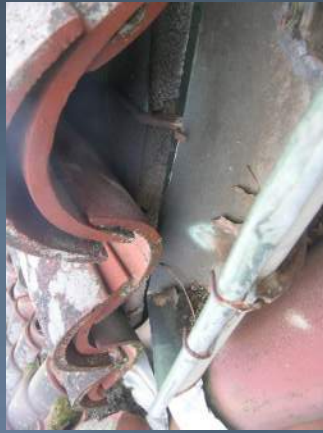
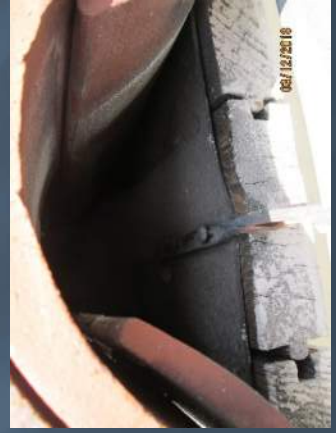
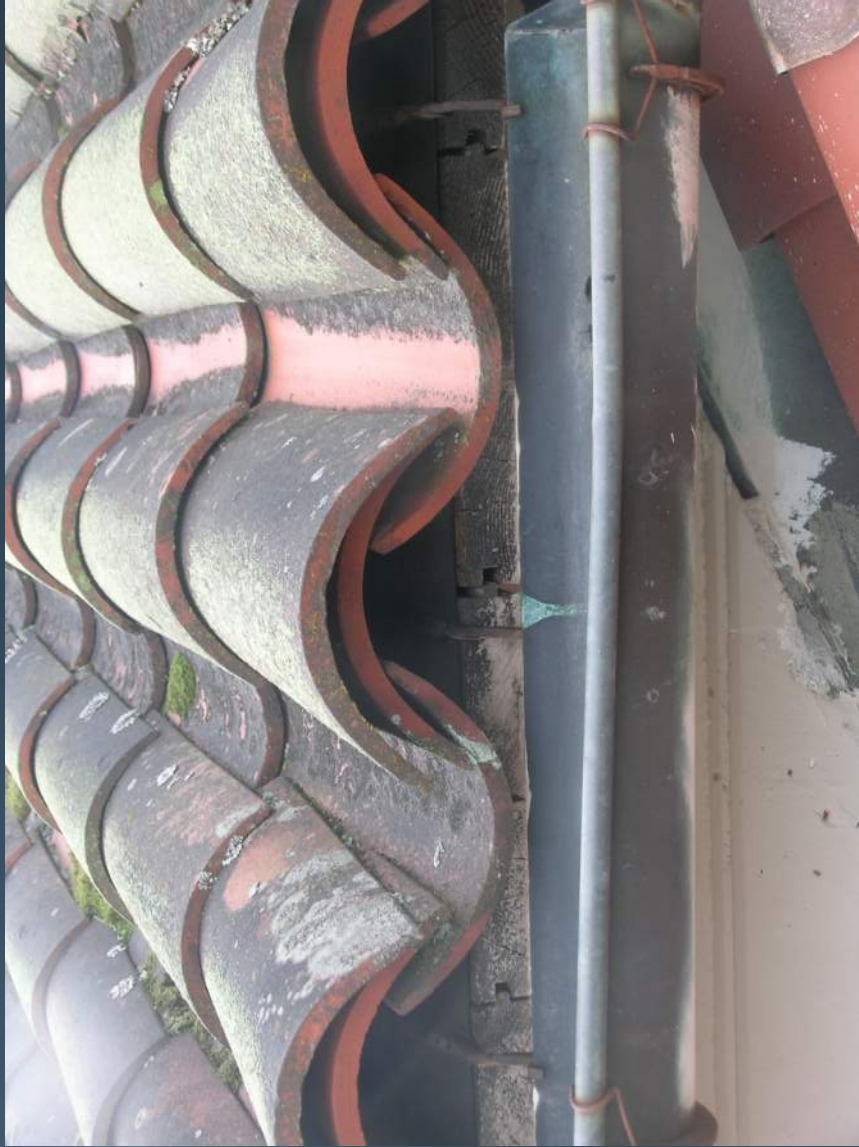
OAKLEY HALL- DOWNSLOPE EAVE EDGE CONDITIONS

Photos of conditions at downslope eave edge flashings.

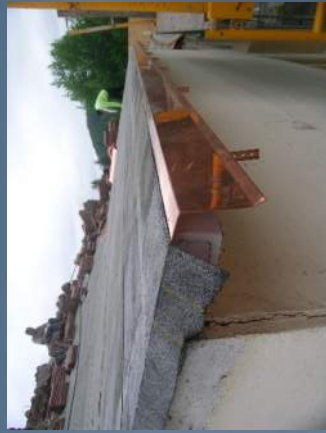
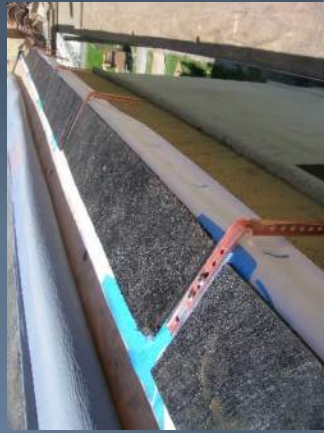
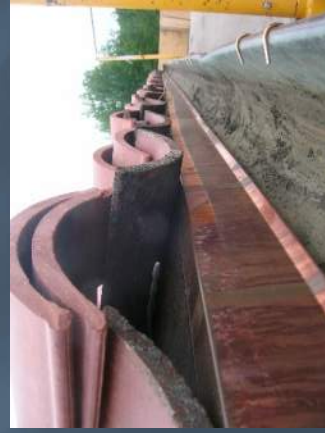
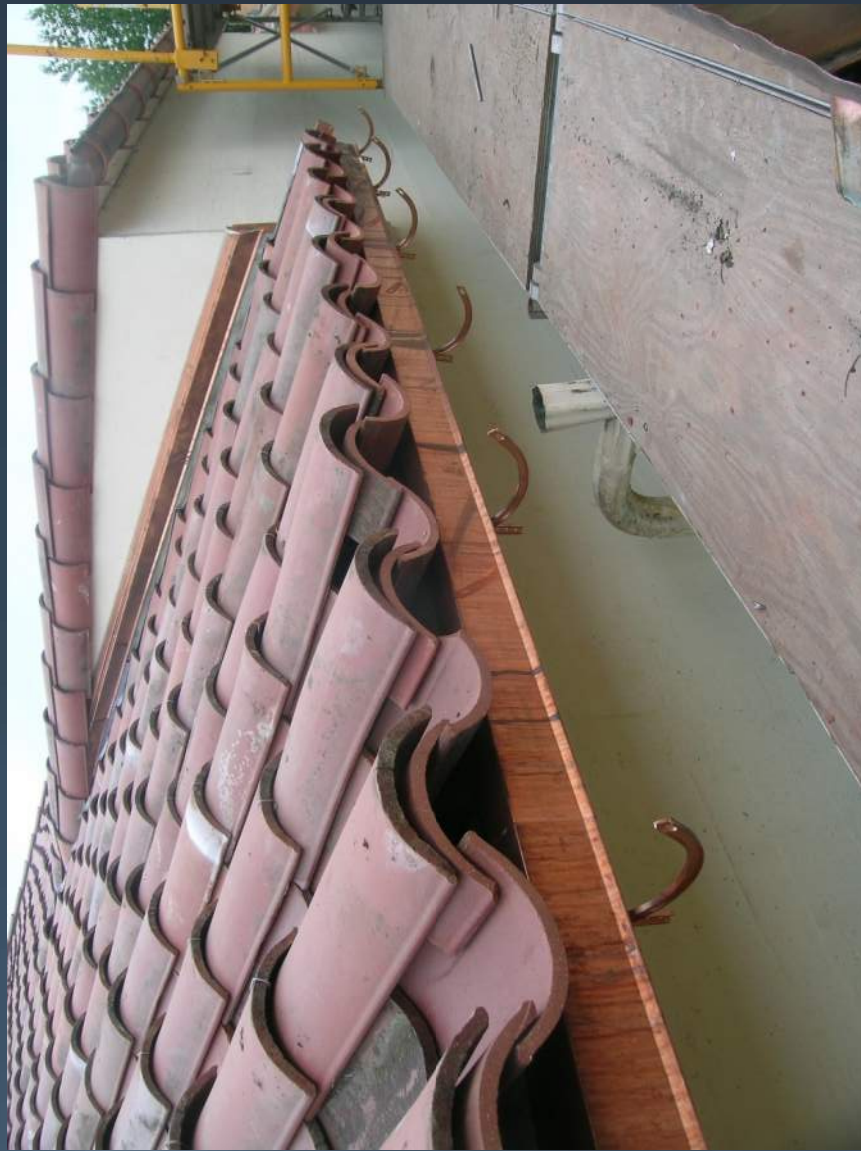
GYMNASIUM REROOFING PROJECT SAMPLE PHOTOS – DOWNSLOPE EAVE EDGE CONDITIONS

Gymnasium/Office Wing downslope eave edge at retrofit copper gutters.

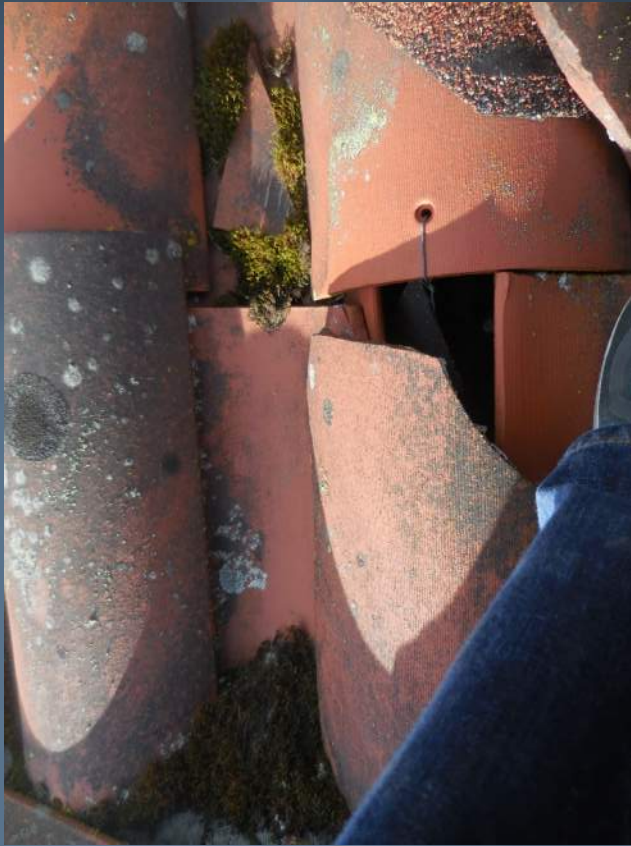
OAKLEY HALL – BROKEN AND DEGRADED TILES

View of broken clay tile needing replacement

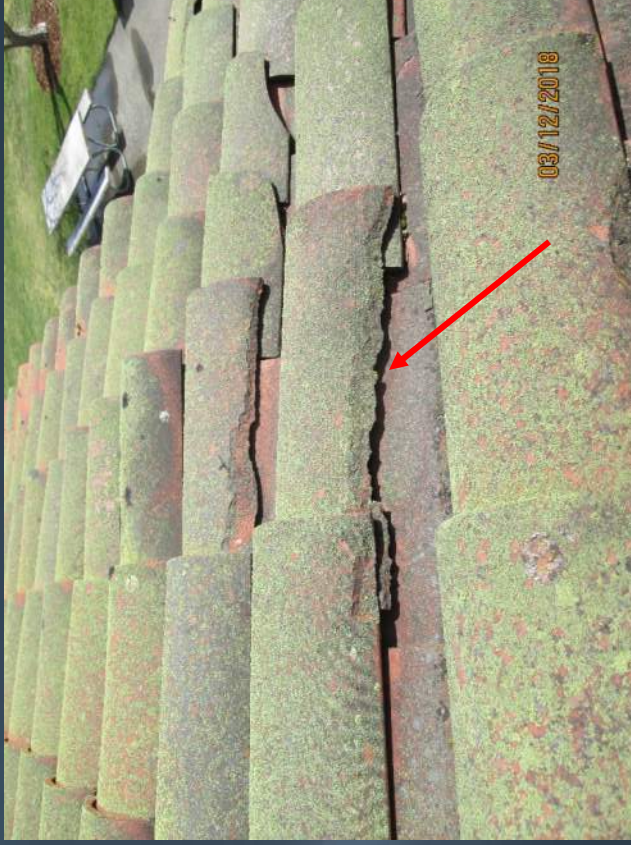
Apparent freeze-thaw damage eroding edges of select clay tiles

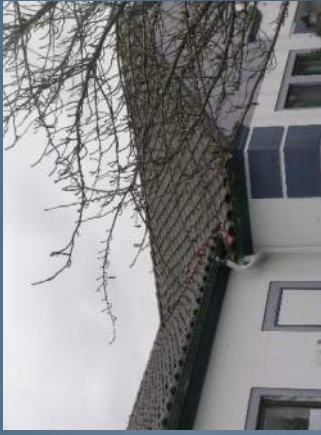
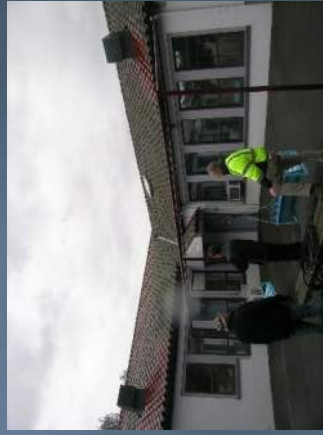
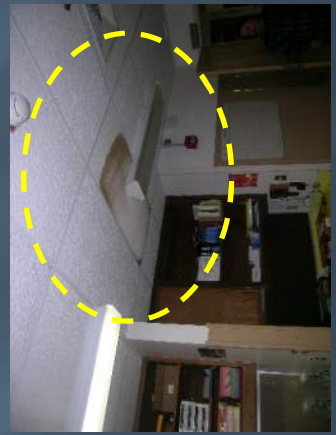
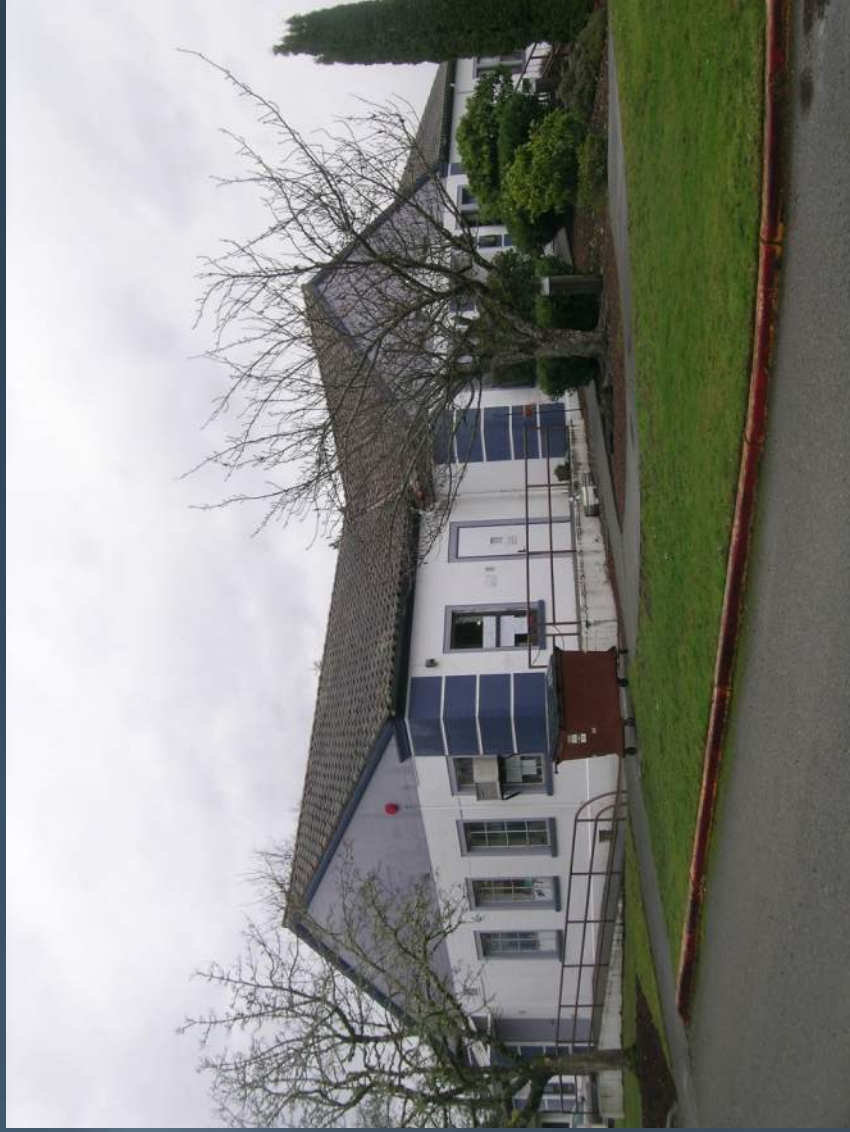
MEYER HALL-- OVERVIEW

Overview of Conditions at Meyer Hall
Reports of water intrusion also appear to be primarily related to valley flashing conditions and flashings at select HVAC units' penetrations.

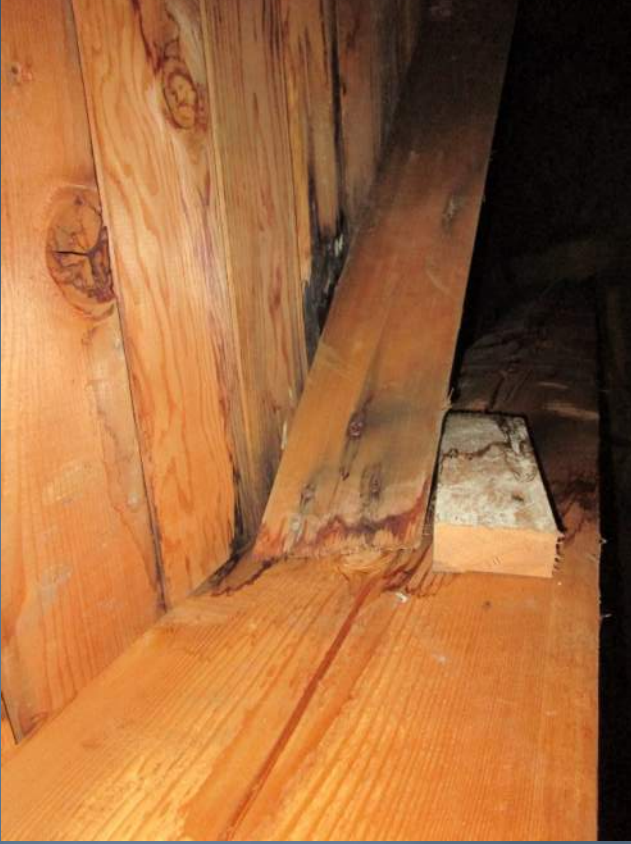
MEYER HALL – WET AND WATER STAINED DECKING NEAR VALLEYS

View of water stained and decayed car decking and adjacent framing members at a valley transition.

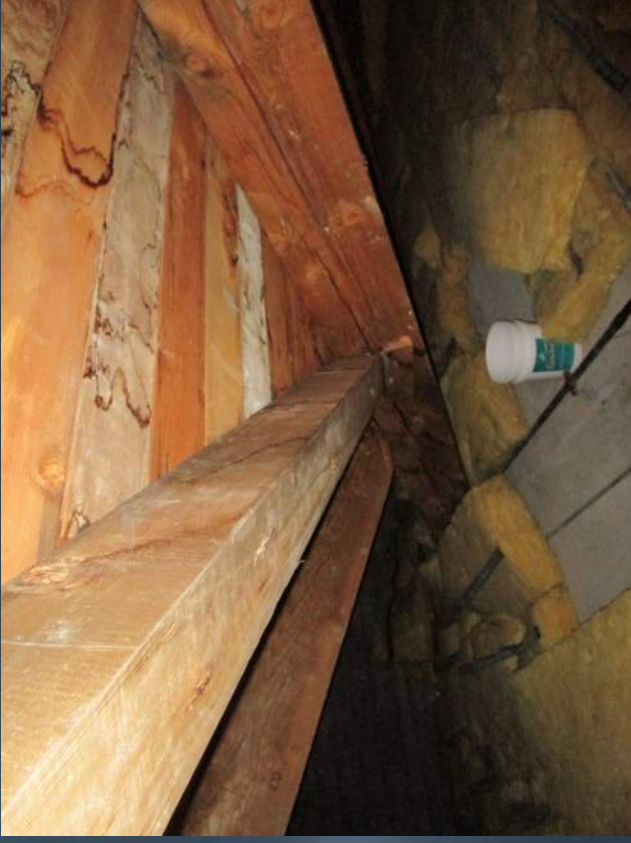
Placement of buckets to collect rain water run-off leaks. Note: insulation has been displaced on concrete ceiling due to previous water intrusion.

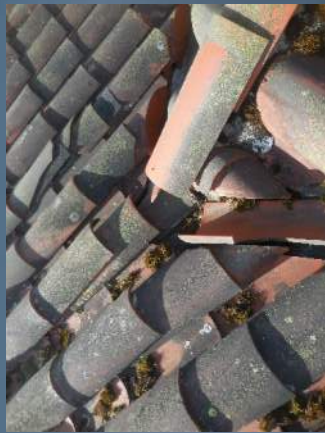
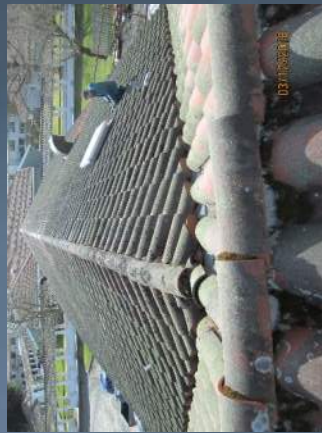
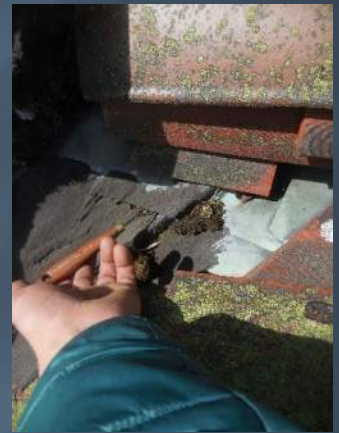
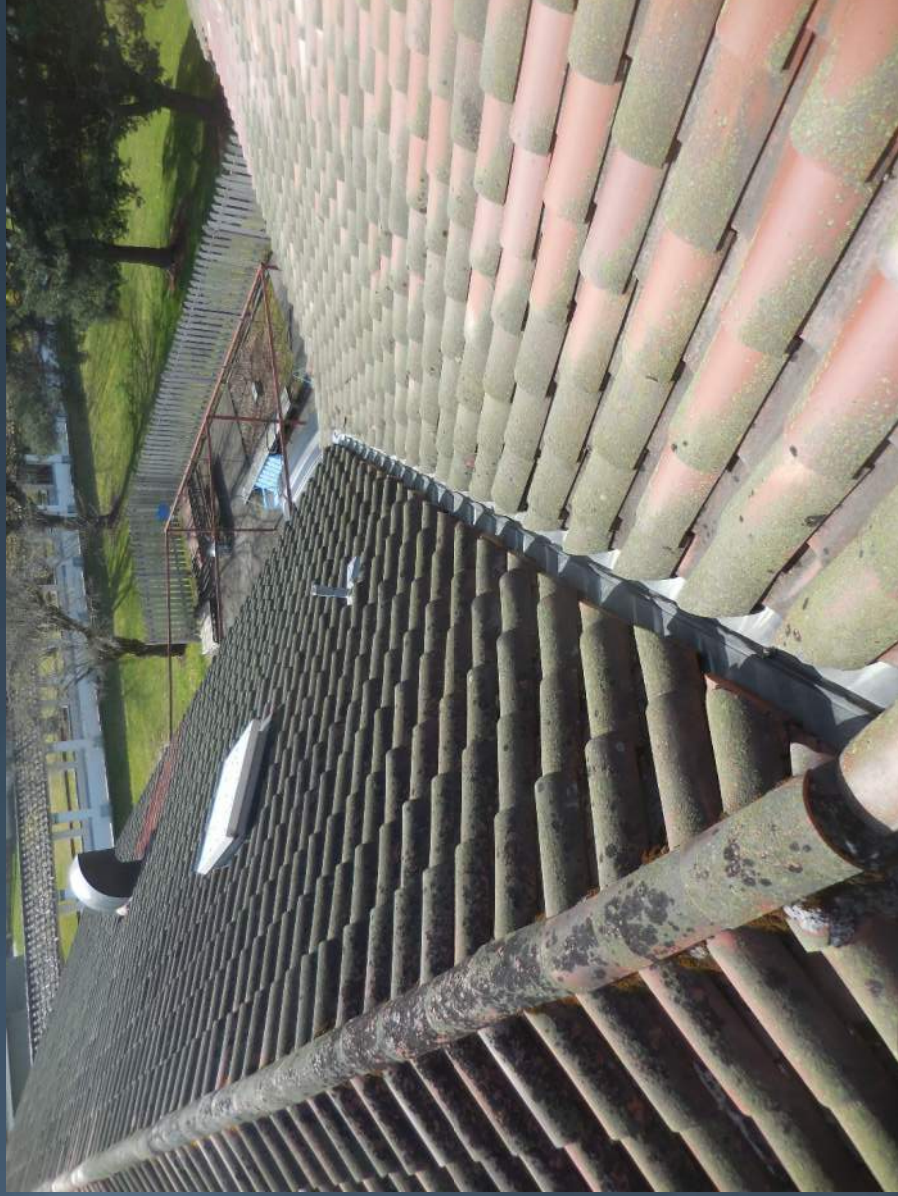
MEYER HALL- ROOFING OVERVIEW

Overview of Roof Level Conditions

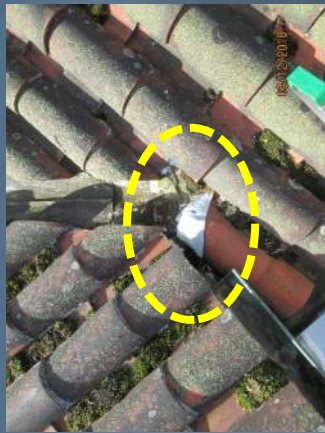
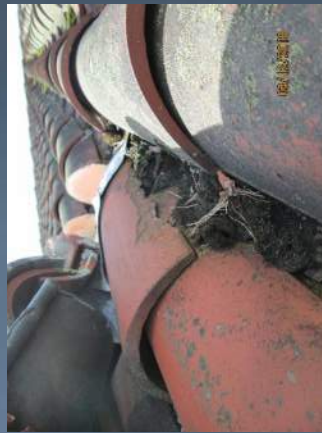
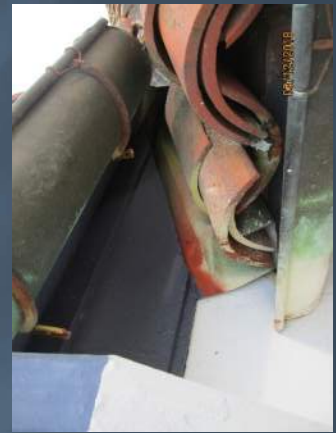
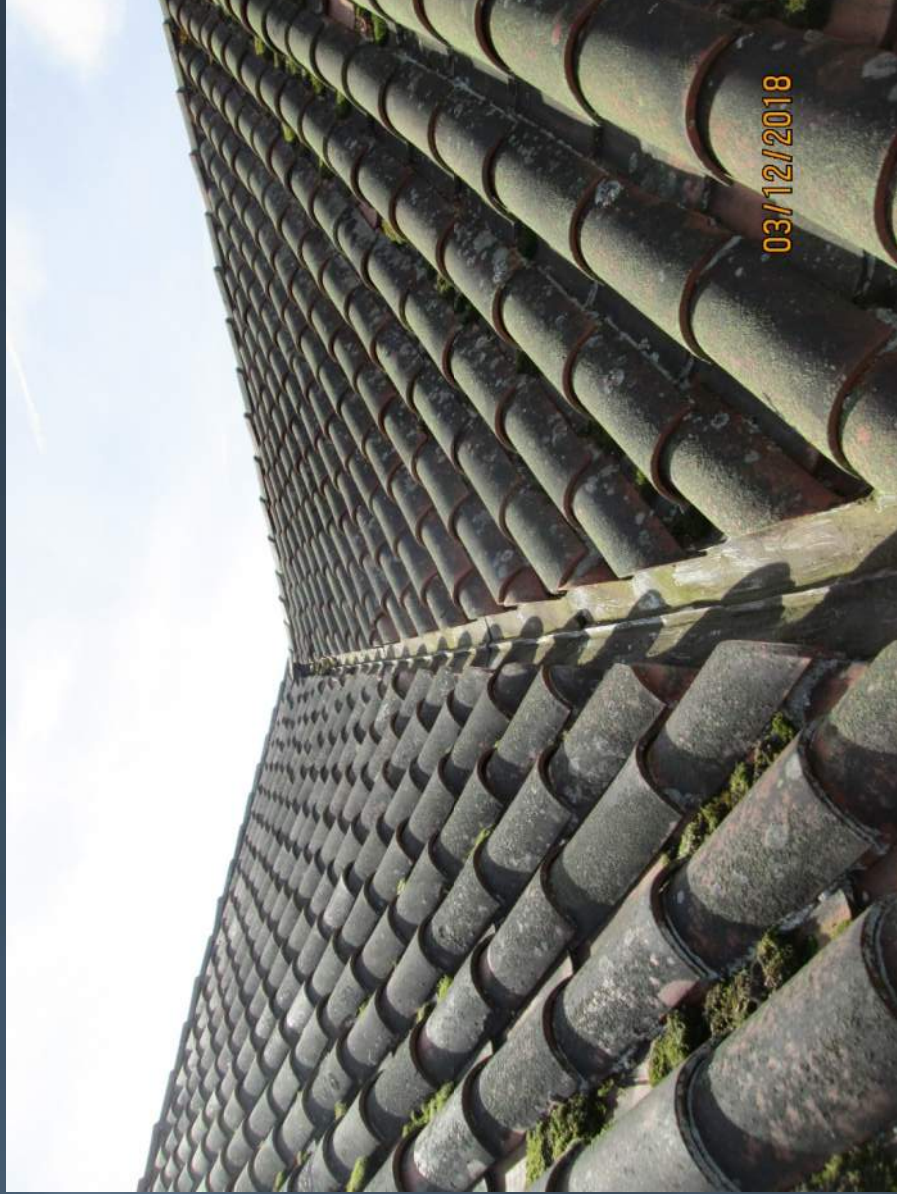
MEYER HALL- VALLEY CONDITIONS

Overview of Roof Level Valley Conditions

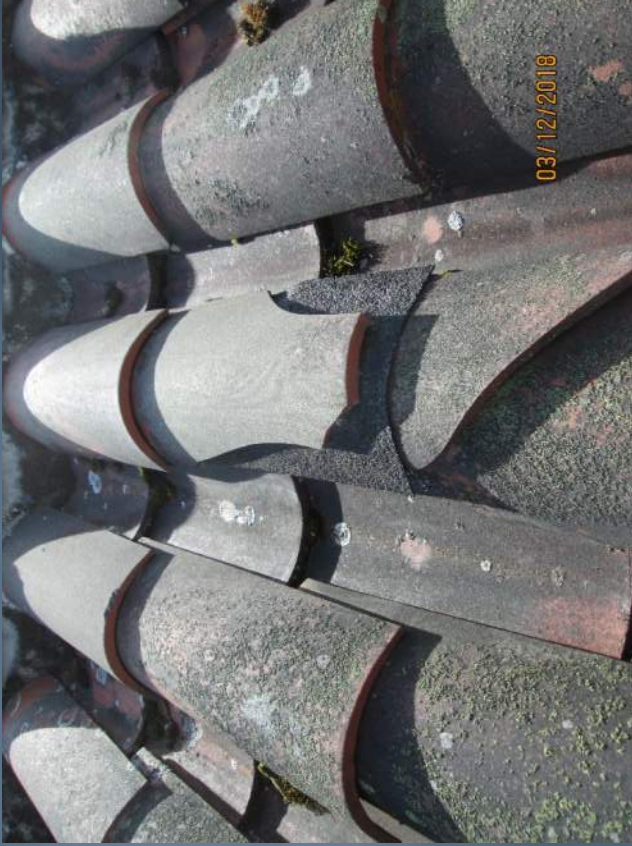
MEYER HALL – BROKEN AND MISPLACED TILES

View of broken clay tile needing replacement

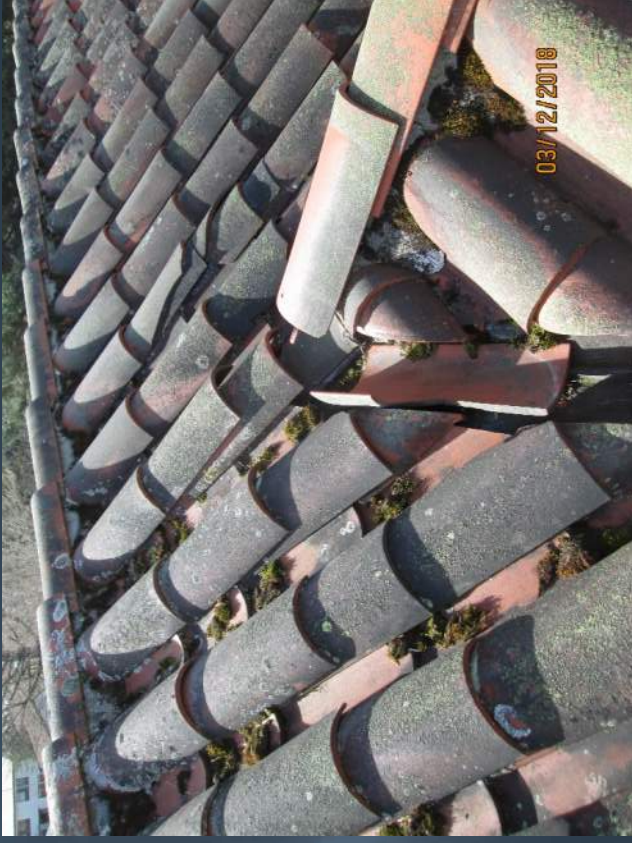
Misplaced tiles at valley-to-ridge transitions.

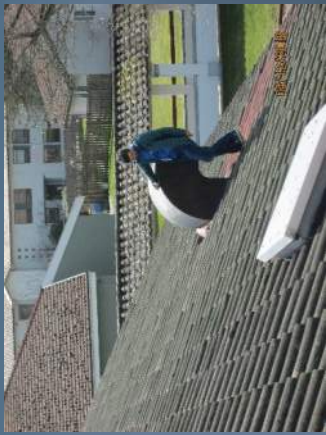
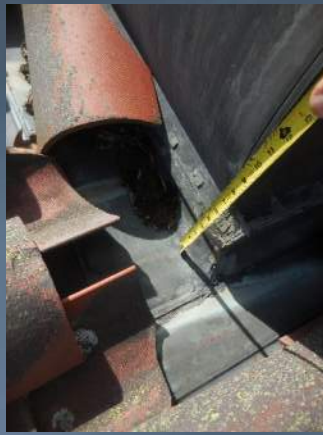
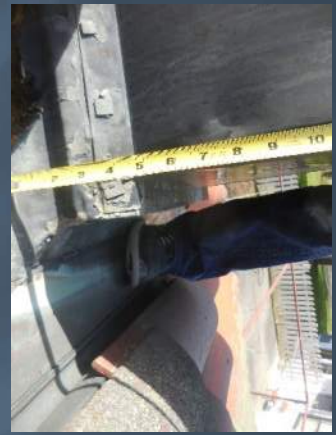
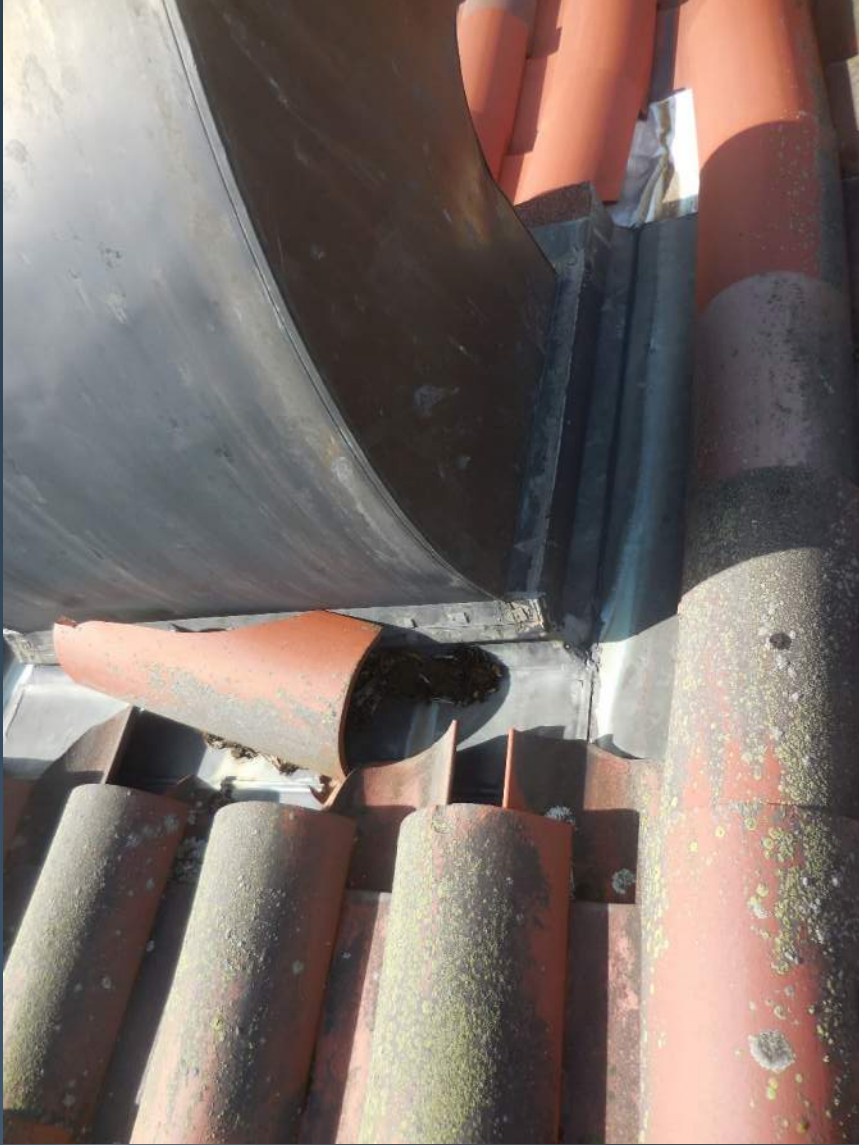
MEYER HALL- VENT HOOD FLASHINGS

Photos of flashing conditions at typical HVAC Hood.

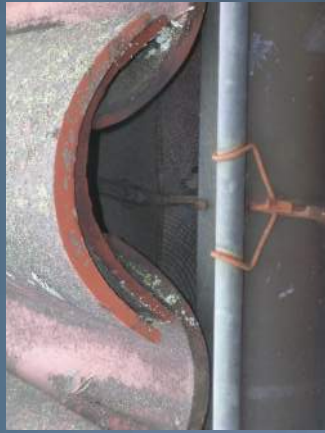
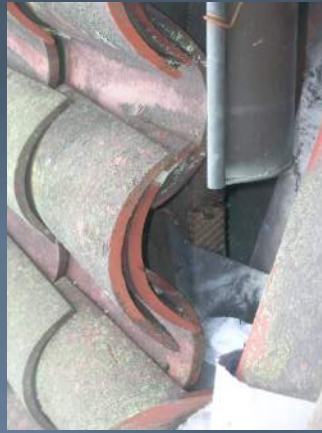
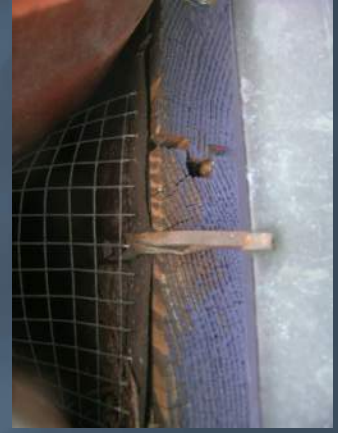
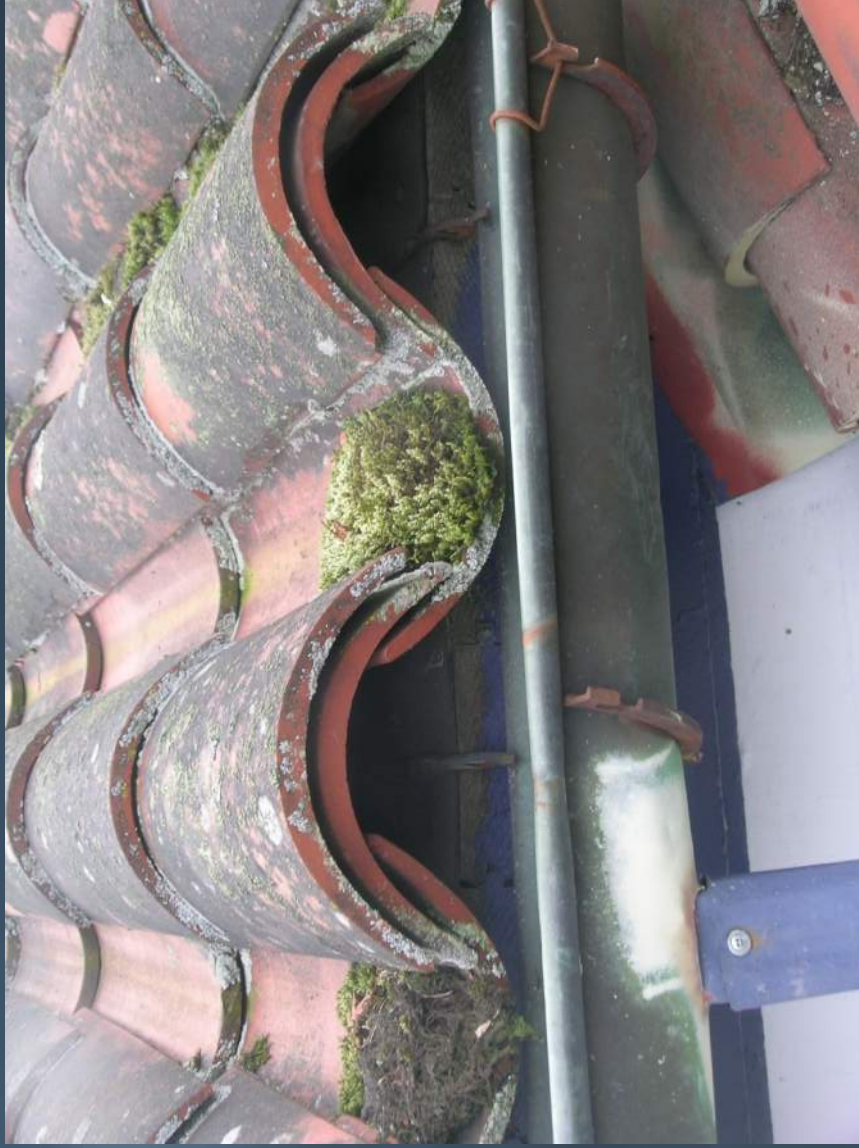
MEYER HALL- DOWNSLOPE EAVE EDGE CONDITIONS

Photos of conditions at downslope eave edge flashings.

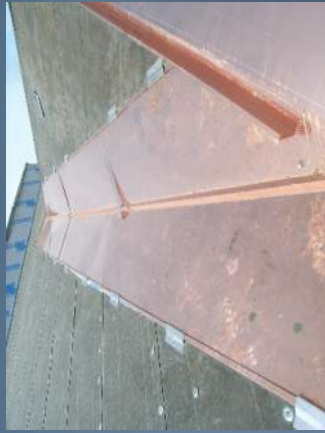
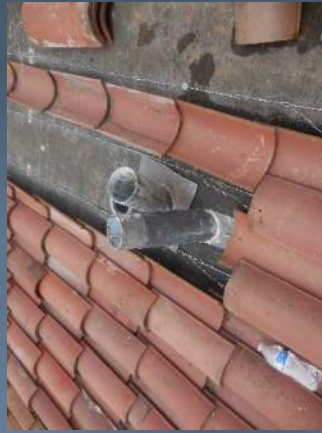
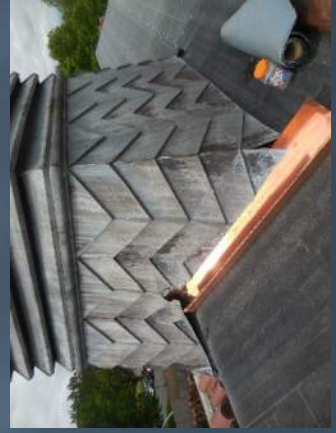
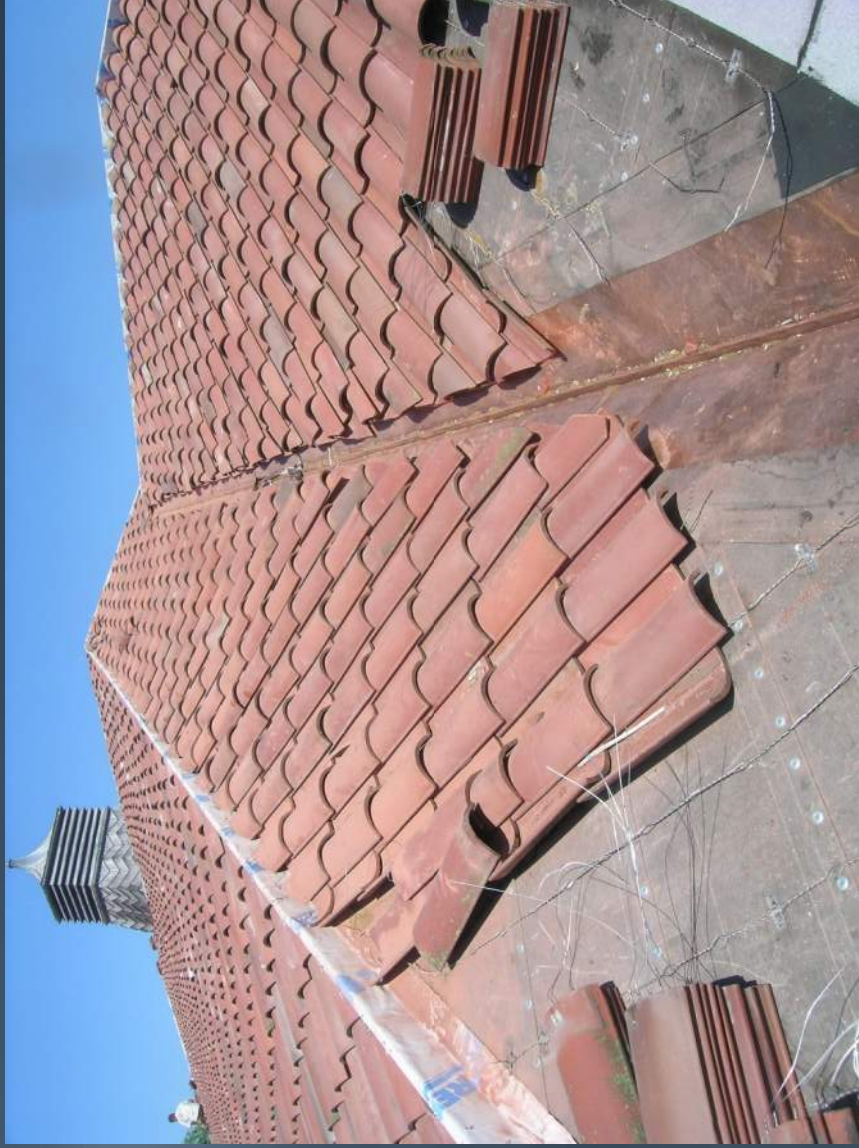
GYMNASIUM REROOFING PROJECT SAMPLE PHOTOS – TYPICAL DETAIL CONDITIONS AT VALLEYS & TRANSITIONS

Gymnasium/Office Wing Reroofing Project Sample
Photos of typical details.

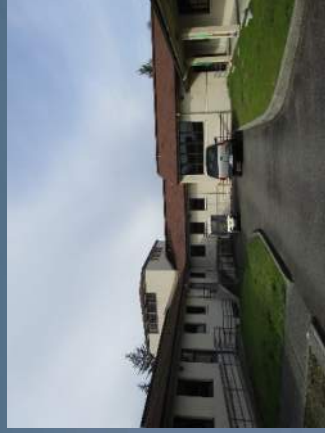
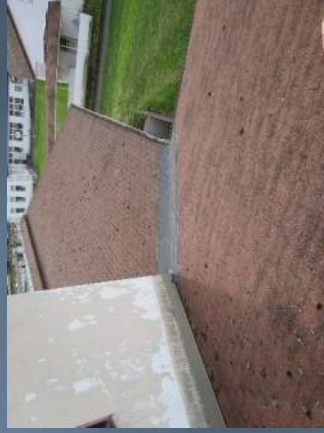
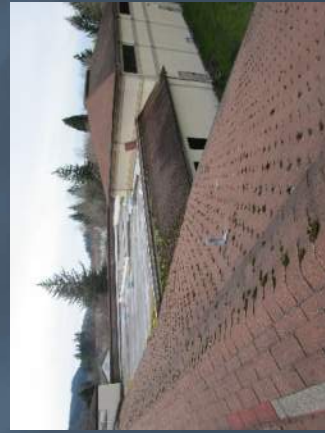
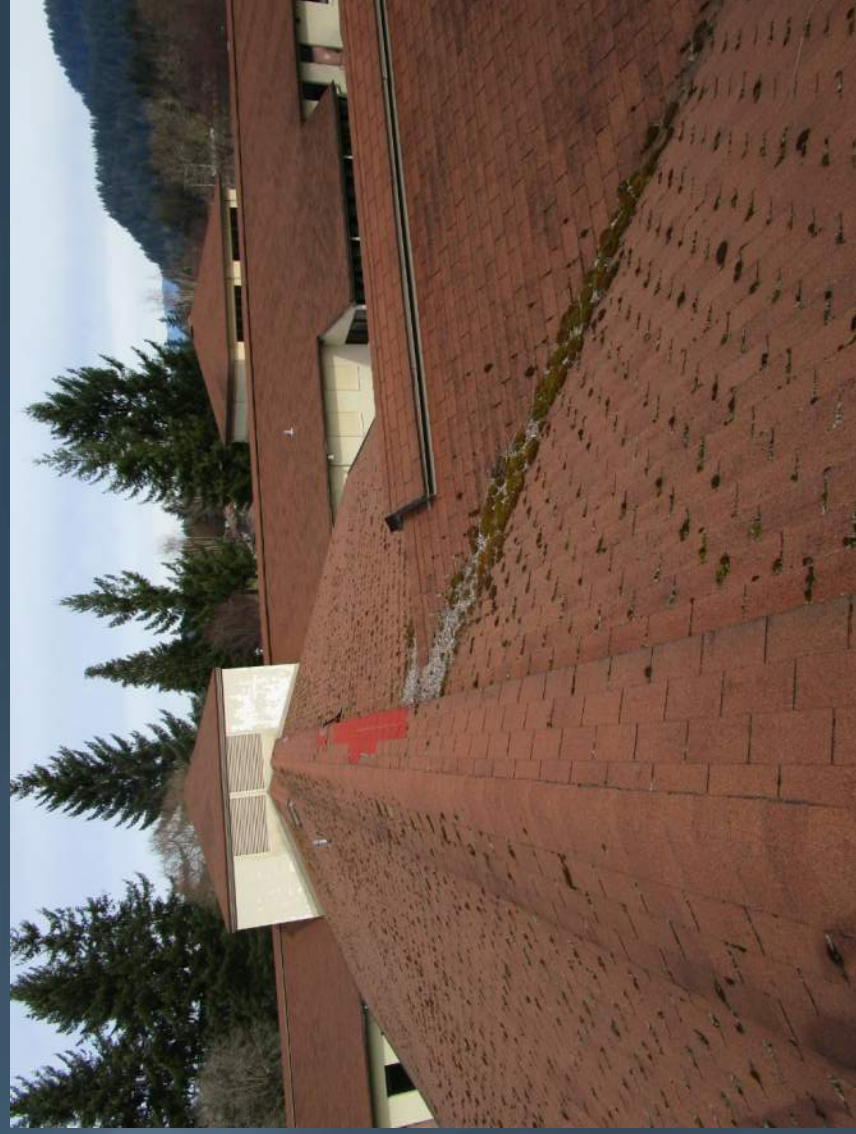
HEMLOCK-SPRUCE- OVERVIEW OF ROOF CONDITIONS

Overview of Conditions at hemlock-Spruce Hall
The existing 3-tab asphalt shingles appear to be approaching 26+ years of service life, are cracking and are generally in need of replacement.

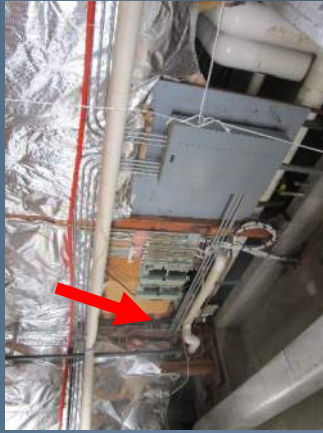
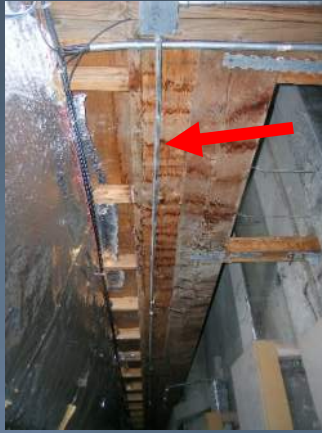
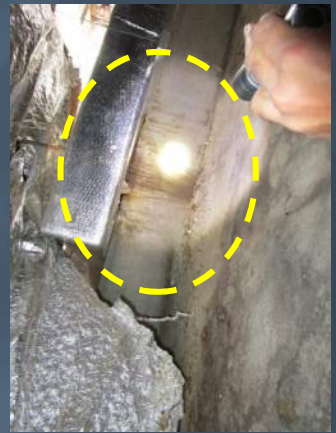
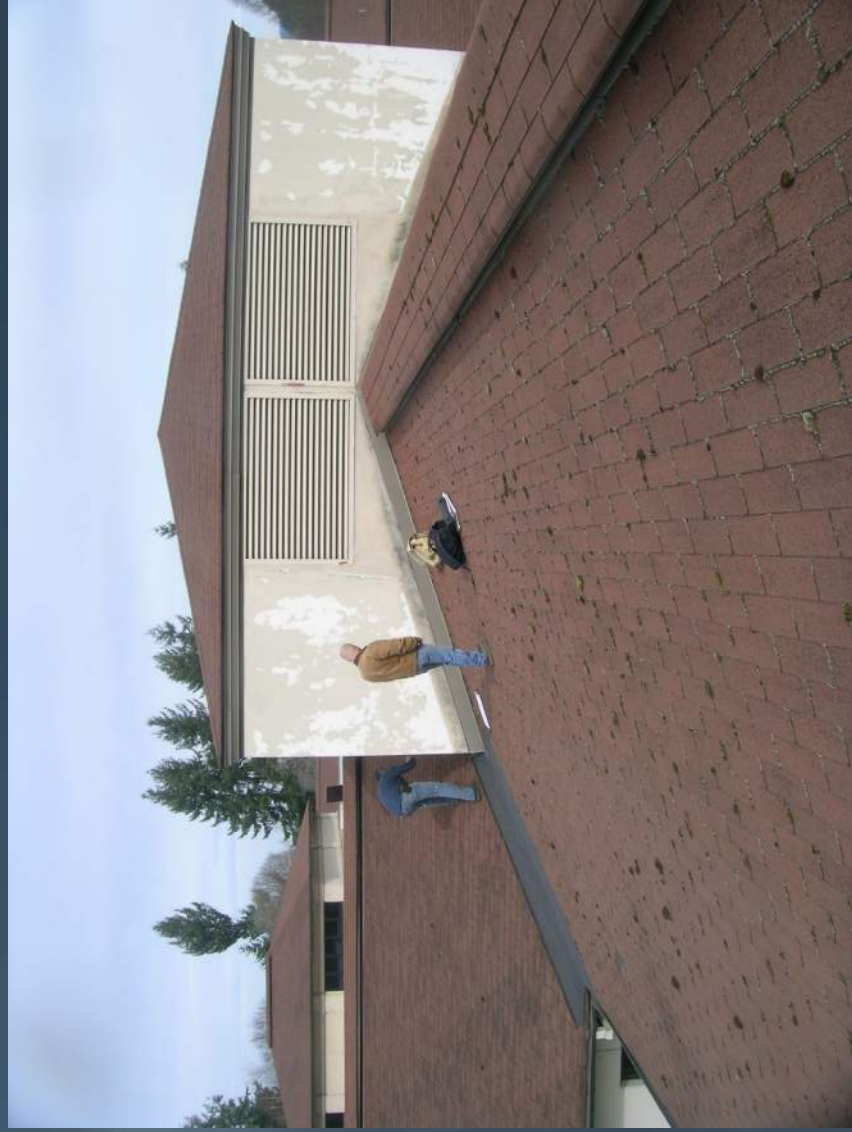
HEMLOCK-SPRUCE- CONDITIONS AT CUPOLAS

General Conditions at Cupolas

Water intrusion appears to be occurring at roof-to-wall transition at areas related to valley flashings.
