2020 Supplemental Capital Budget Request

Limited Roof Survey and Leak Investigation

Rainier School Building 2010

DATE OF REPORT	Friday, June 28, 2019	PROJECT:	Rainier School – Building 2010 Limited Roof Survey and Report
TO	Dean Heglund, DSHS Project Manager	CC:	Scott Ward, Rainier School
CLIENT	State of Washington DSHS		Pat Bockelman, Rainier School
TEL	360-902-8158		Sean Yates, Rainier School
E-MAIL	hegluda@dshs.wa.gov		Nat Stiles, Rainier School
FROM	Scott Vlotho BET&R Architect		Darren Johnston, Harbor Engineers
SUBJECT	RAINIER SCHOOL – BUILDING 2010 LIMITED ROOF SURVEY PRELIMINARY OBSERVATIONS, FINDINGS, AND RECOMMENDATIONS

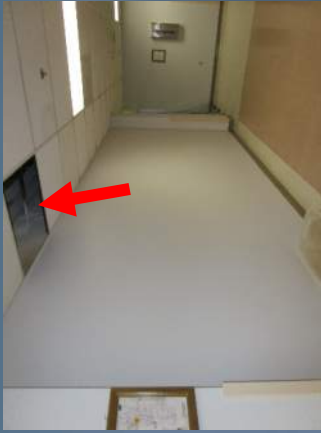
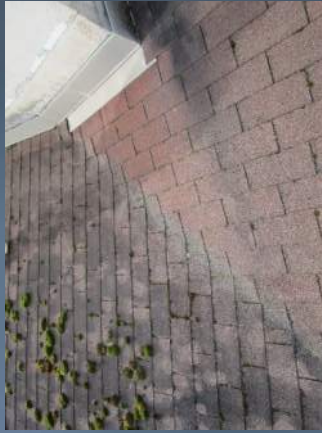
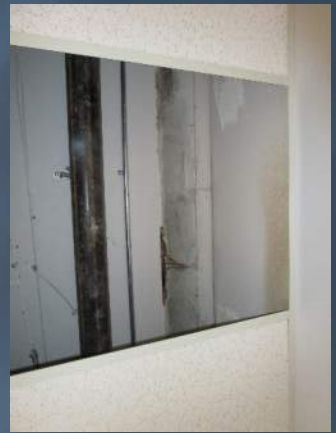
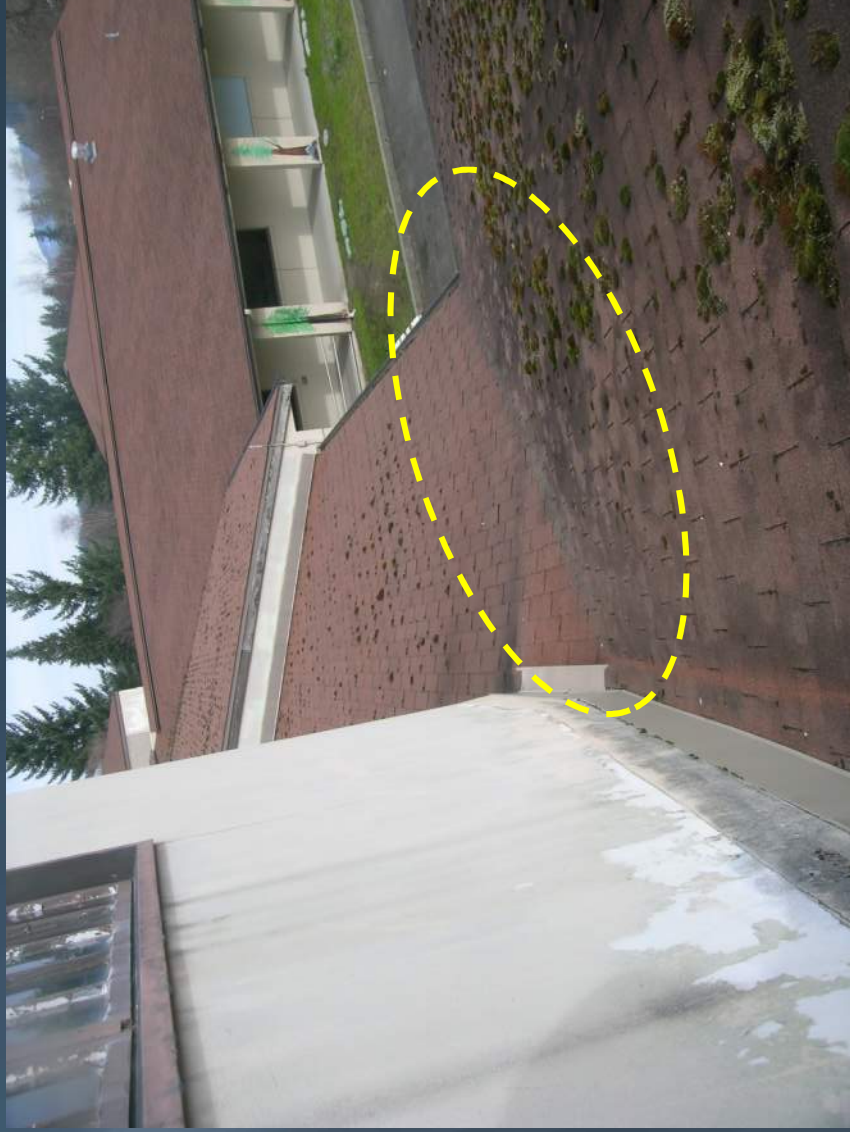
HEMLOCK-SPRUCE- REPORTED LEAK LOCATIONS

Water Intrusion Beneath Woven Valleys
Water intrusion reported in hallway near wood shop appears to be emanating from asphalt shingle woven valley.

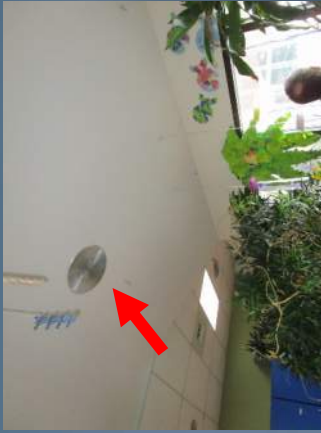
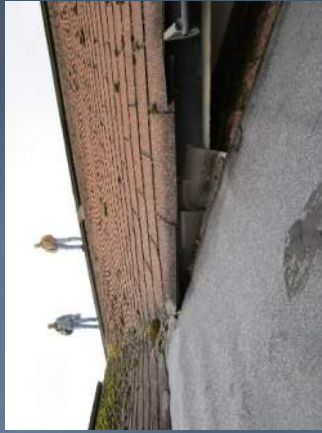
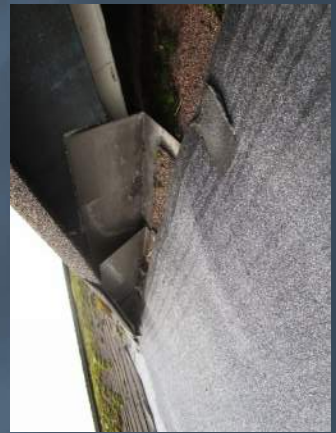
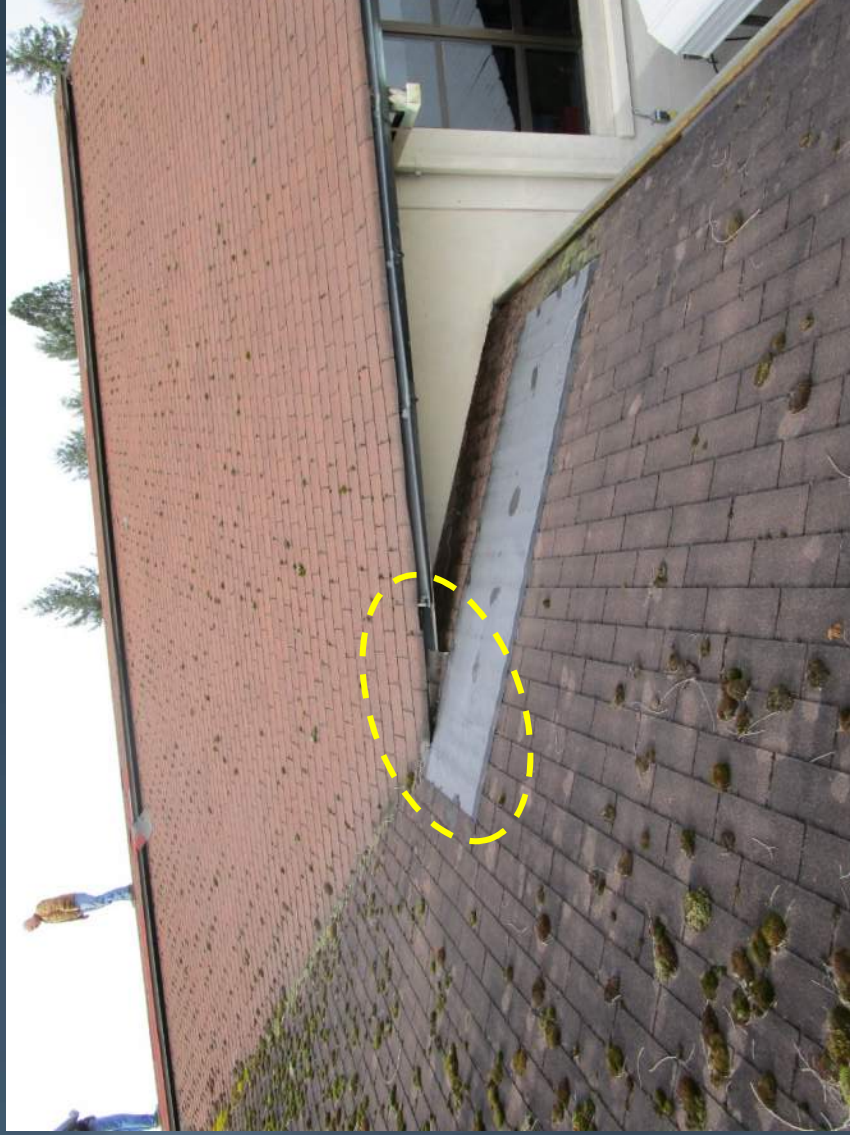
HEMLOCK-SPRUCE- REPORTED LEAK LOCATIONS

Water Intrusion at Valley-to-Roof Transition at Art Room
Water intrusion reported in the Arts Classroom appears to be related to valley-to-intersecting roof transition. ²⁹

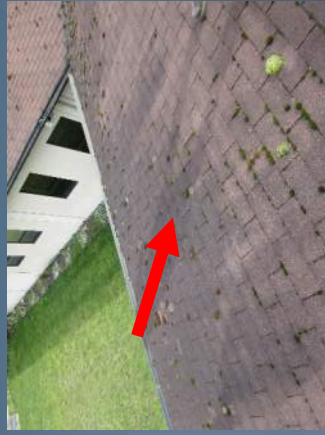
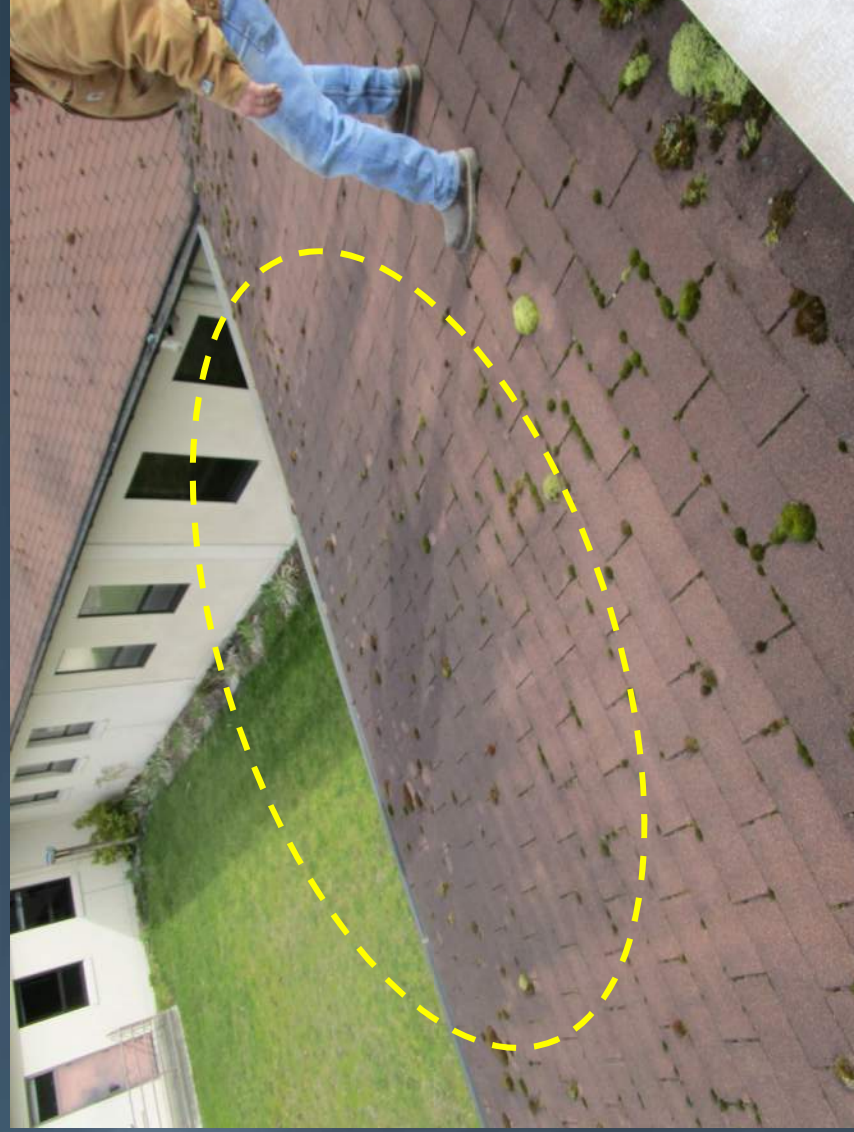
HEMLOCK-SPRUCE- REPORTED DECAYED SHEATHING

Soft, Decayed Sheathing Beneath Shingles
Although no interior leaks have been reported at this area, the sheathing is decayed / degraded and quite soft. Replacement of sheathing is needed.

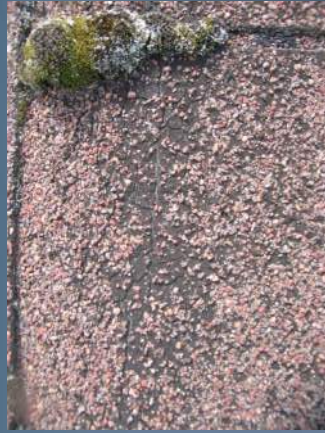
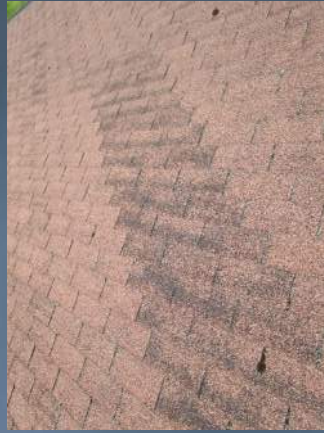
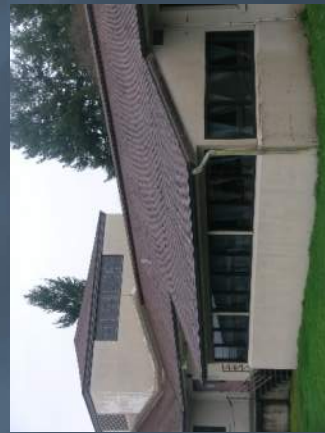
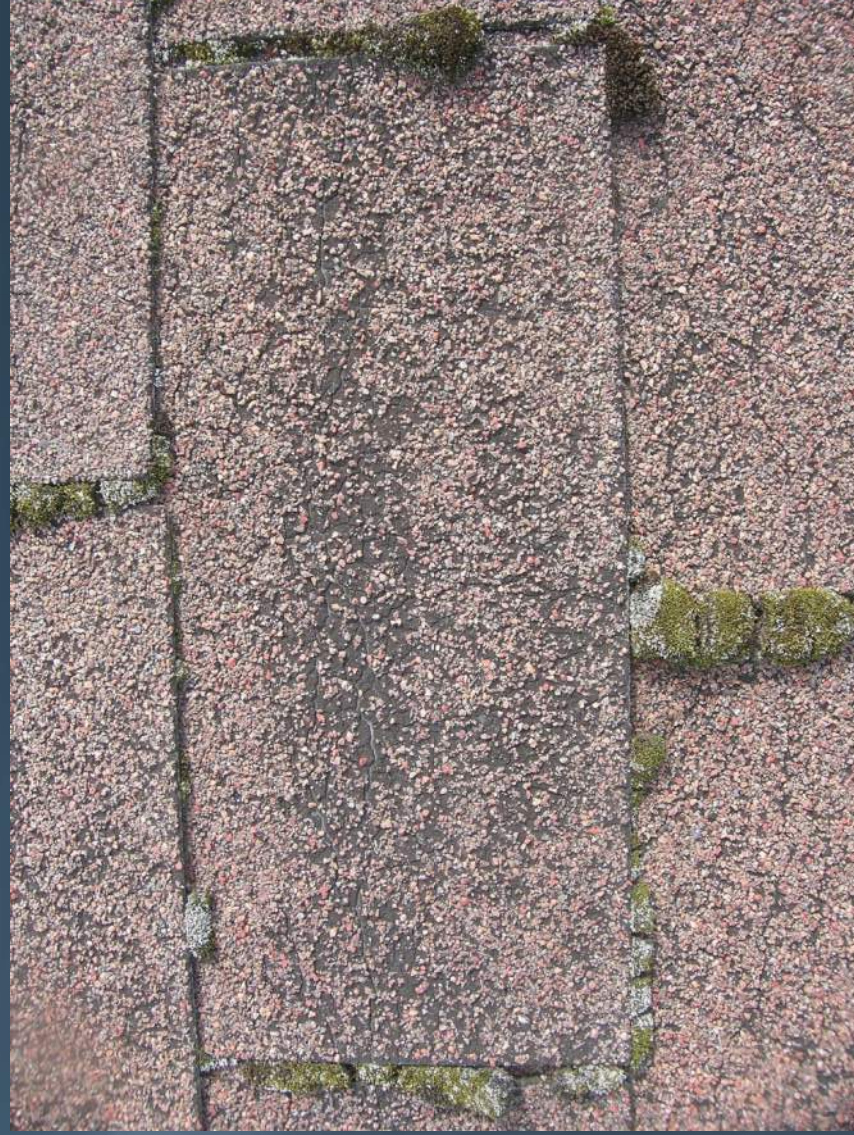
HEMLOCK-SPRUCE- SHINGLE CONDITION

Overall Condition of Existing 3-tab Asphalt Shingles
The existing 3-tab asphalt shingles are generally in poor condition. Extensive granule loss is widespread with reinforcing degrading from long-term exposure.

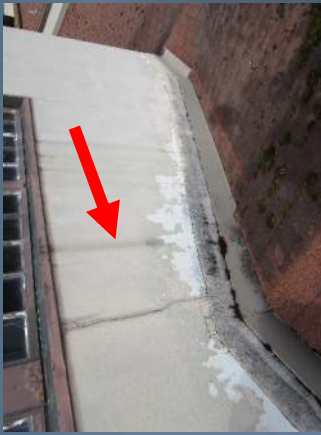
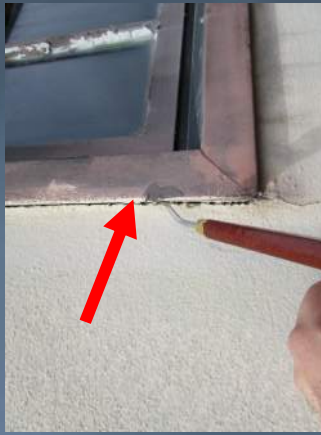
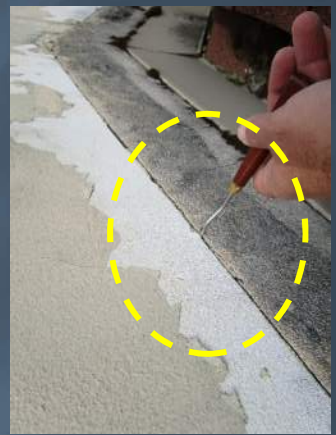
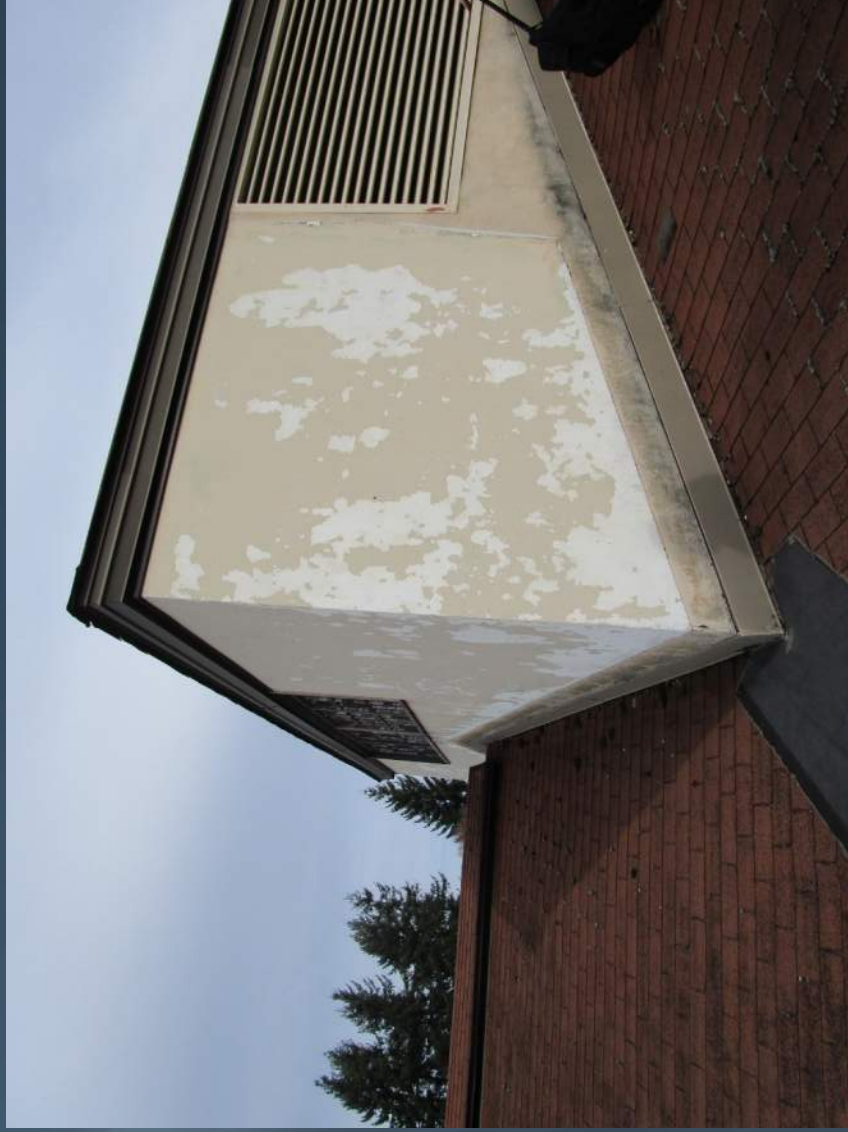
HEMLOCK-SPRUCE- CONDITIONS AT CUPOLA

General Conditions at Cupolas

Water intrusion appears to be occurring at roof-to-wall transition at areas related to valley flashings.

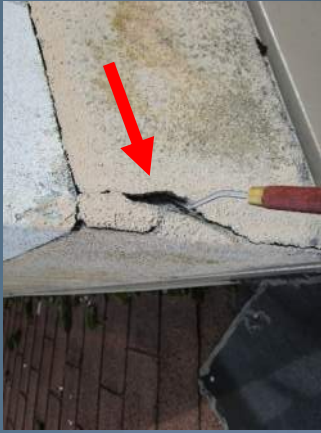
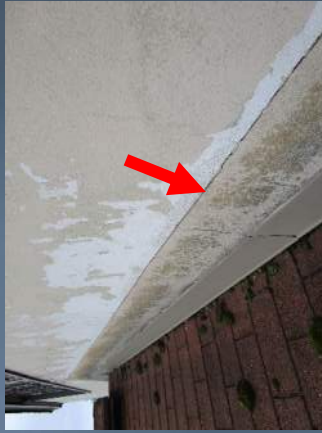
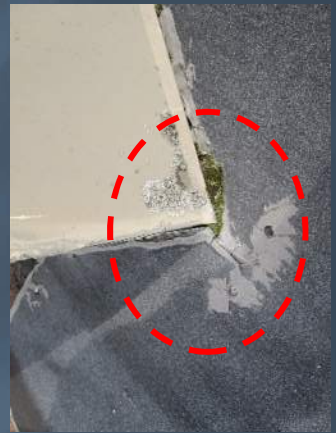
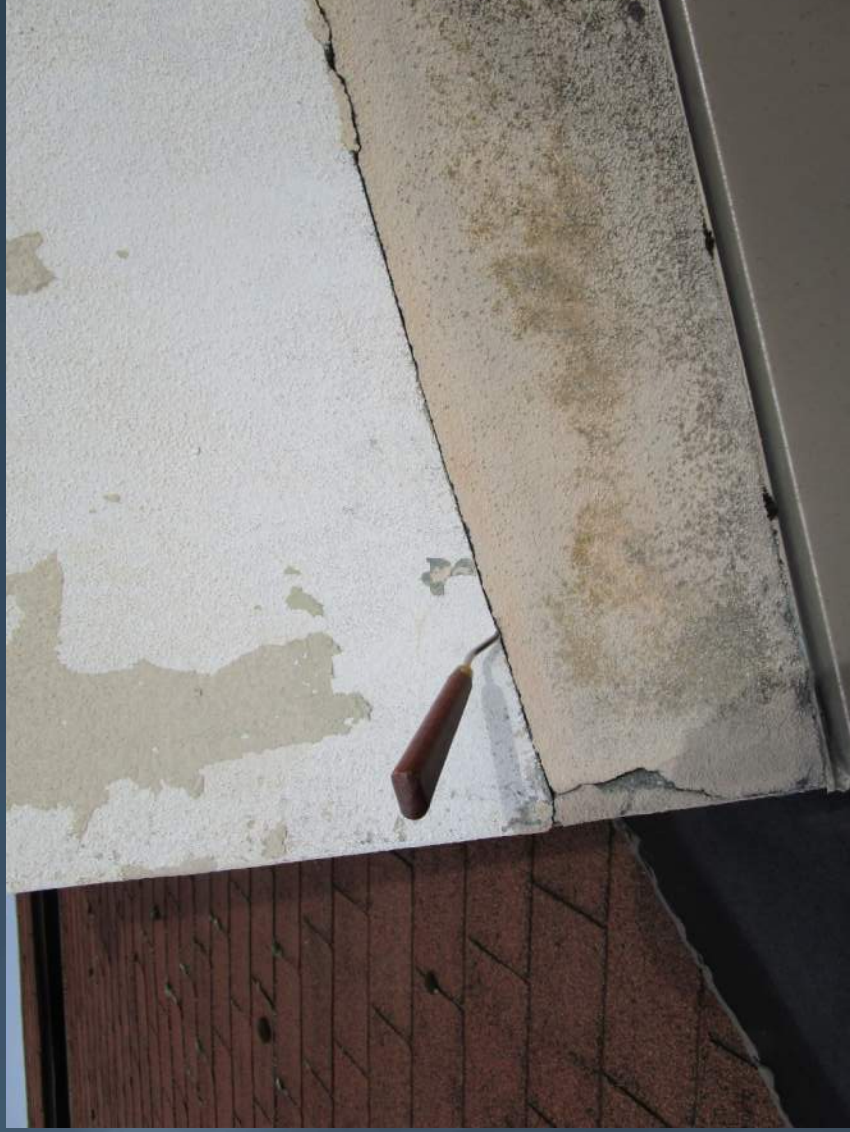
HEMLOCK-SPRUCE- CONDITIONS AT CUPOLA

General Conditions at Cupolas
Stucco repairs and proper integration with weather-resistive barrier are needed as part of the retrofit of roof-to-wall flashing details.

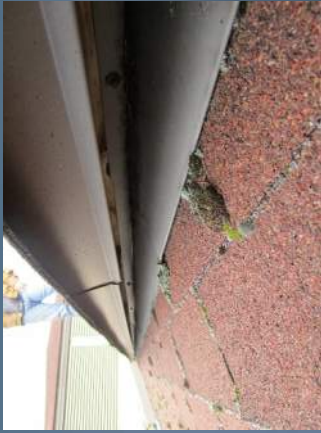
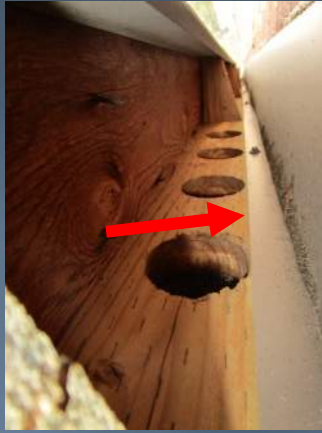
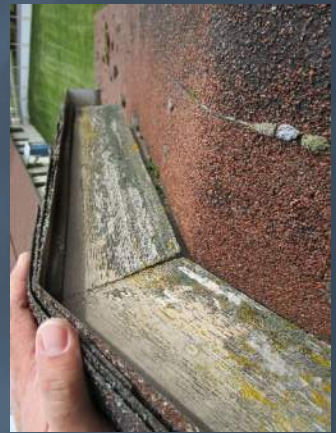
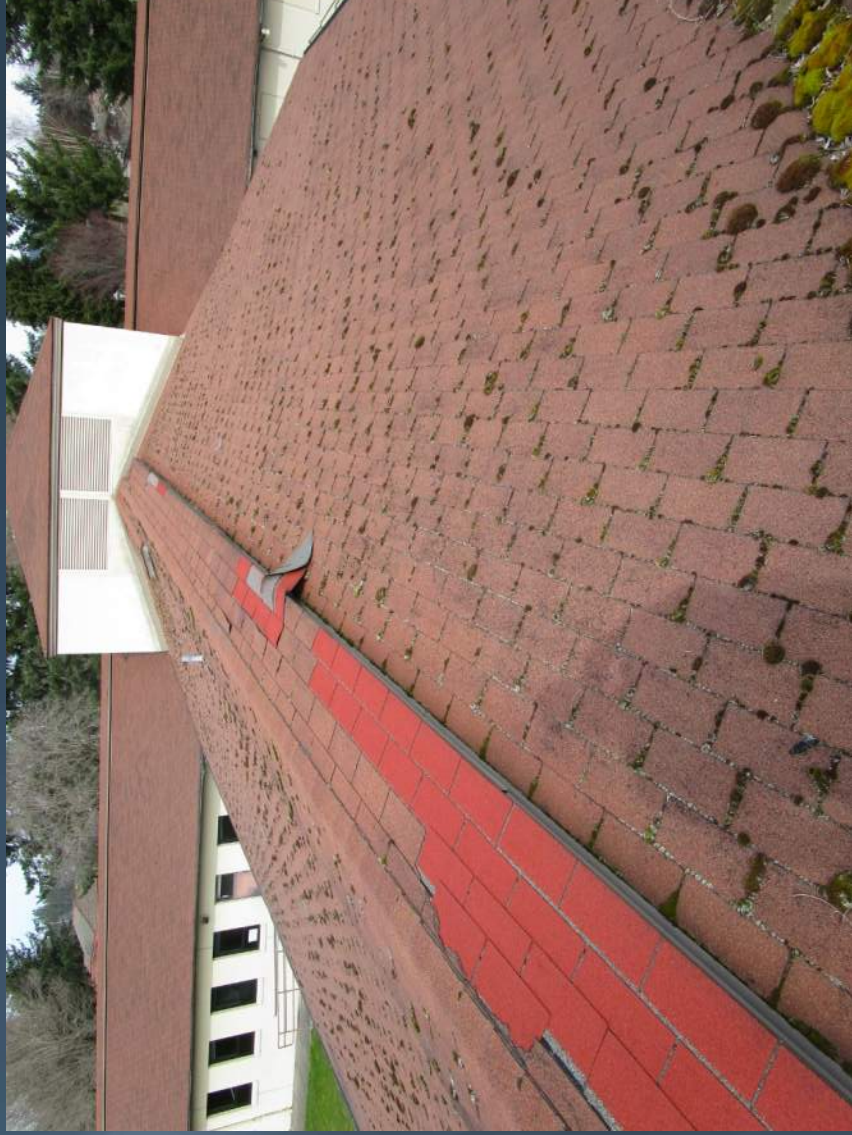
HEMLOCK-SPRUCE- RIDGE VENT OBSERVATIONS

General Conditions at Ridge Vents

Wood-framed ridge vents have experienced shingles being blown off and are susceptible to water intrusion and wind-driven rain.

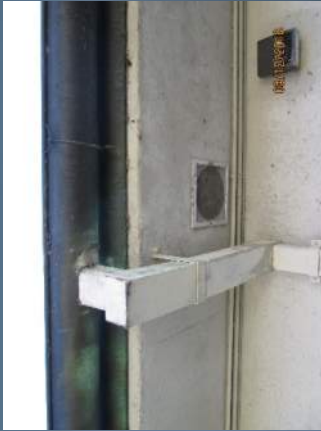
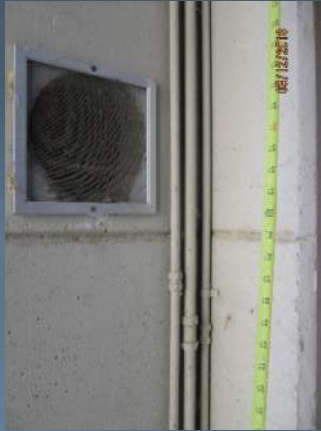
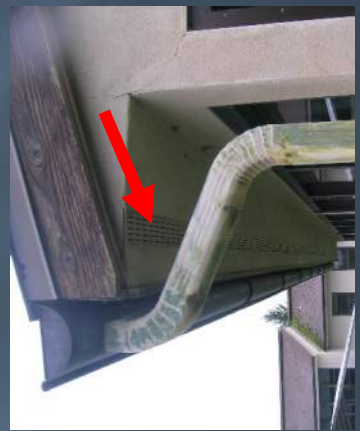
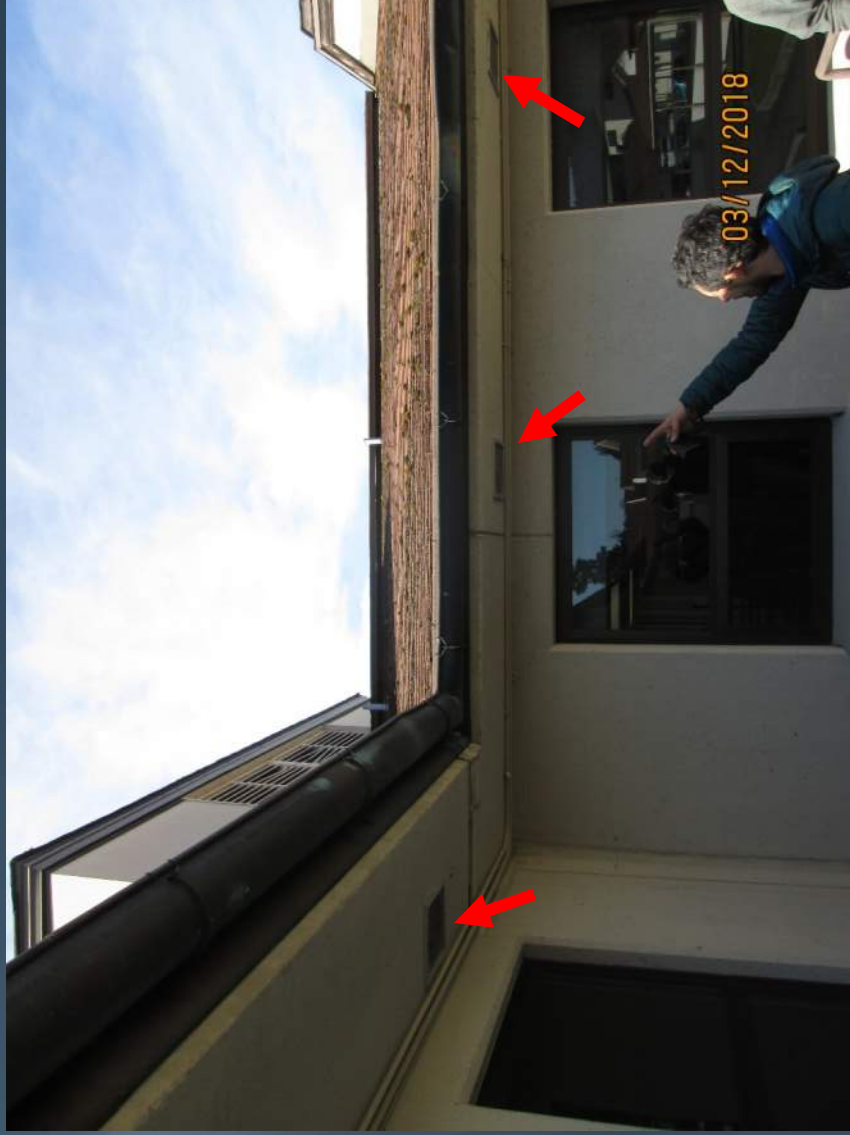
HEMLOCK-SPRUCE- SOFFIT VENT OBSERVATIONS

General Conditions at Soffit Vents

Downslope eave in-take air ventilation provided by intermittent 6" diameter soffit vents at some locations, and strip vents at others.

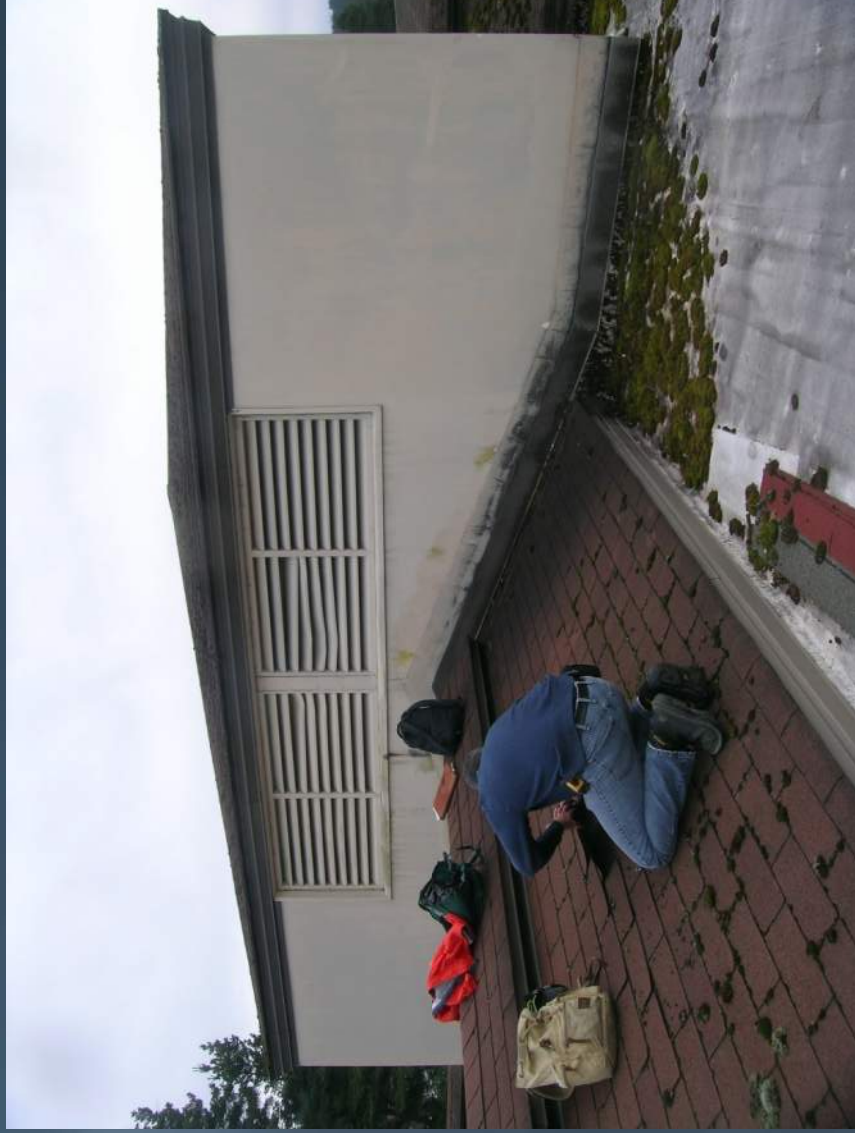
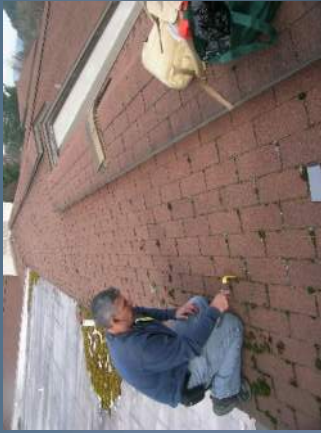
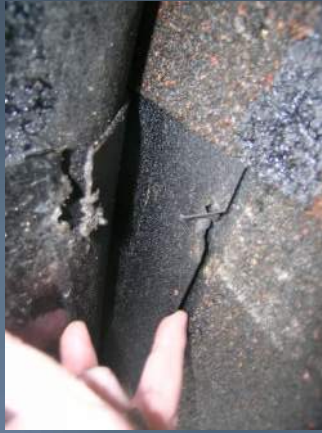
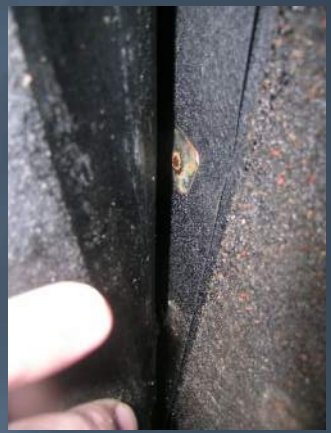
HEMLOCK-SPRUCE- SHINGLE TEST OPENING

Select shingles were carefully removed, which revealed just one layer of No. 15 asphalt-saturated underlayment over plywood sheathing.

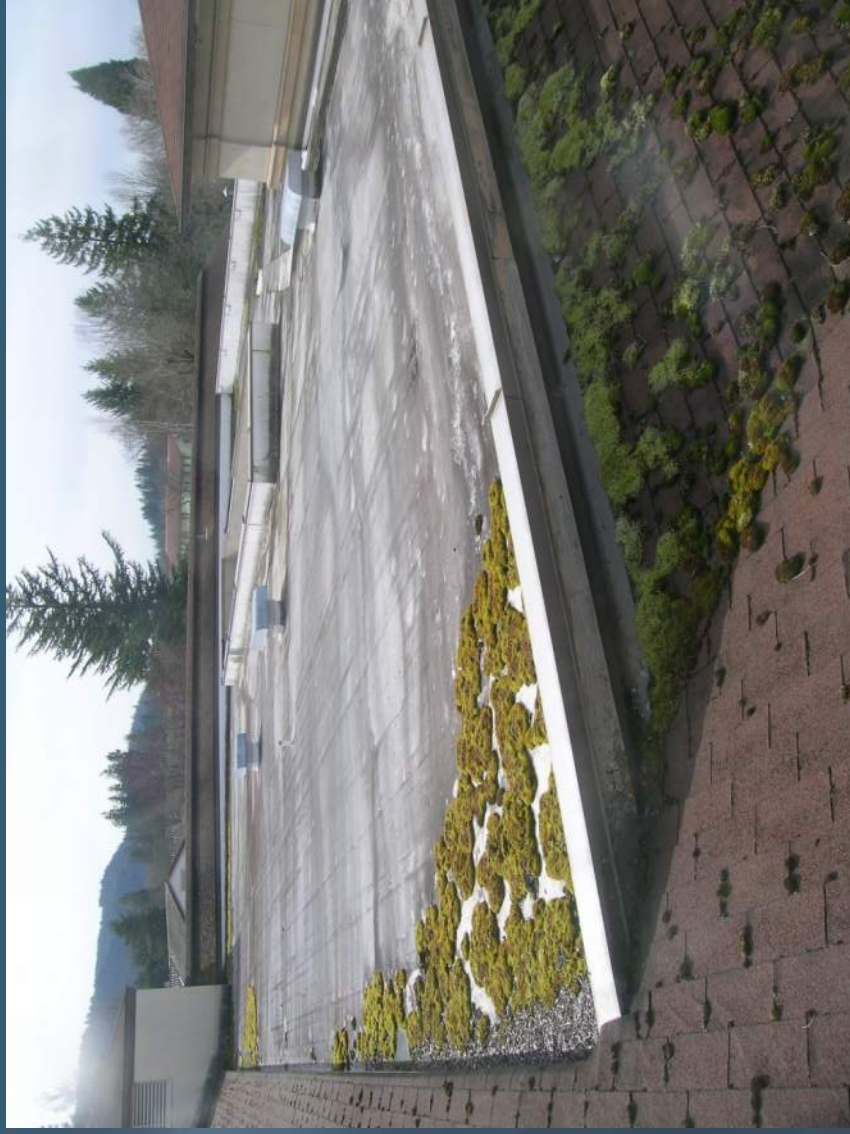
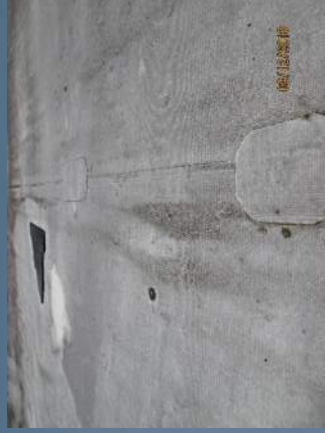
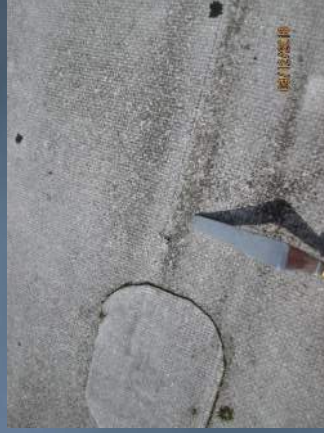
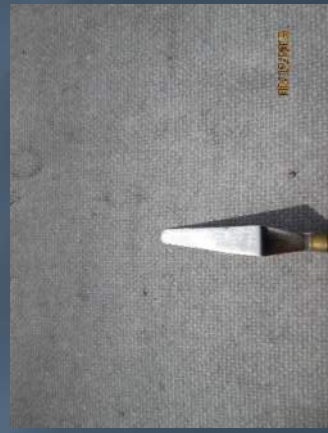
HEMLOCK-SPRUCE- LOW-SLOPE ROOF OBSERVATIONS

Debris needs to be removed from the roof areas. We believe the life of the membrane can be extended with careful cleaning, proper prep, priming, and polyurethane coating application.

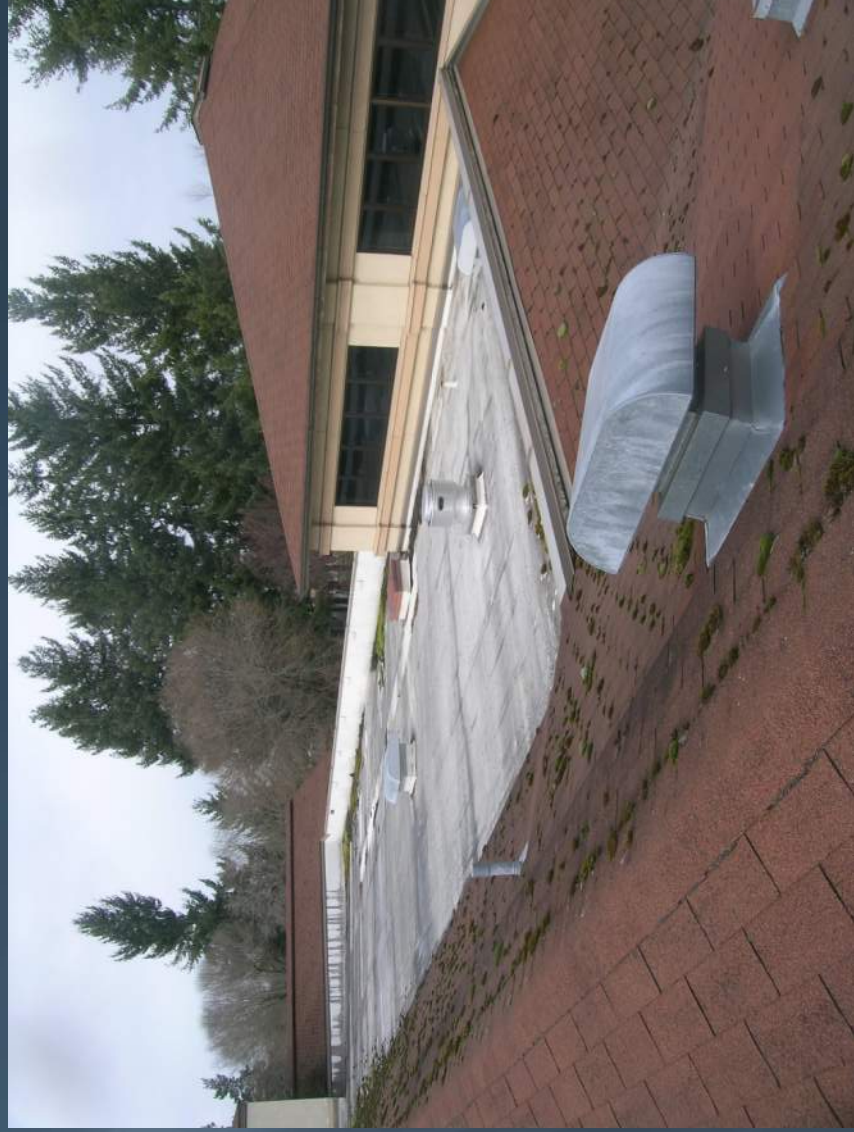
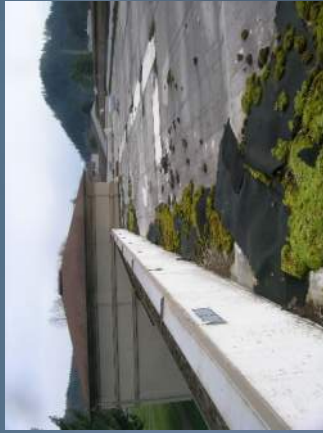
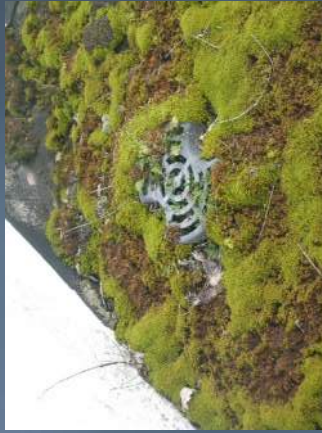
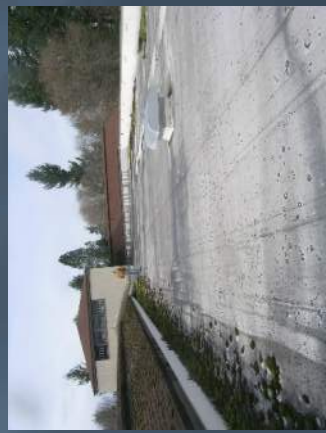
HEMLOCK-SPRUCE- LOW-SLOPE ROOF OBSERVATIONS

Debris needs to be removed from the roof areas. We believe the life of the membrane can be extended with careful cleaning, prep, and coating application.

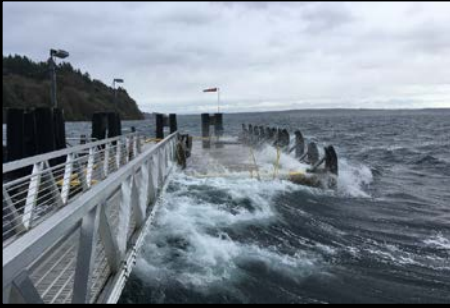
The main dock is subjected to extreme forces during rough seas.

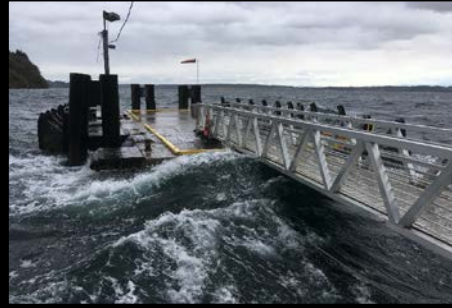
The ramp & dock can be hazardous in rough seas & inclement weather.

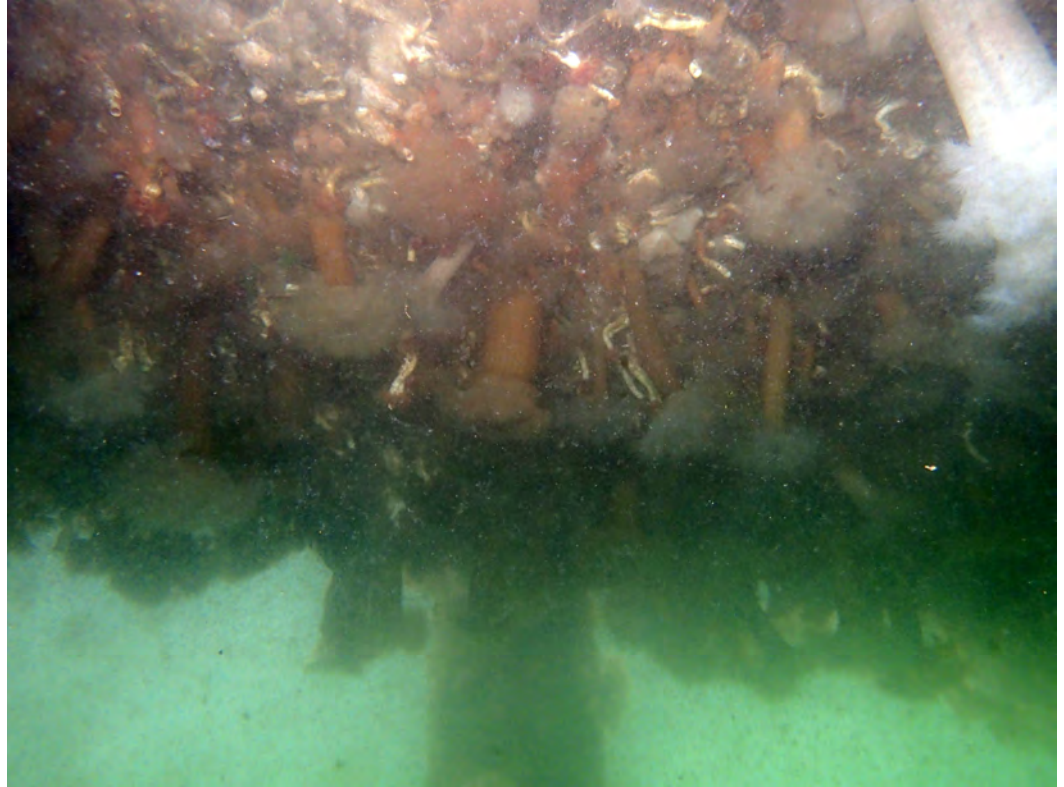
Typical heavy marine growth on floating dock sections.

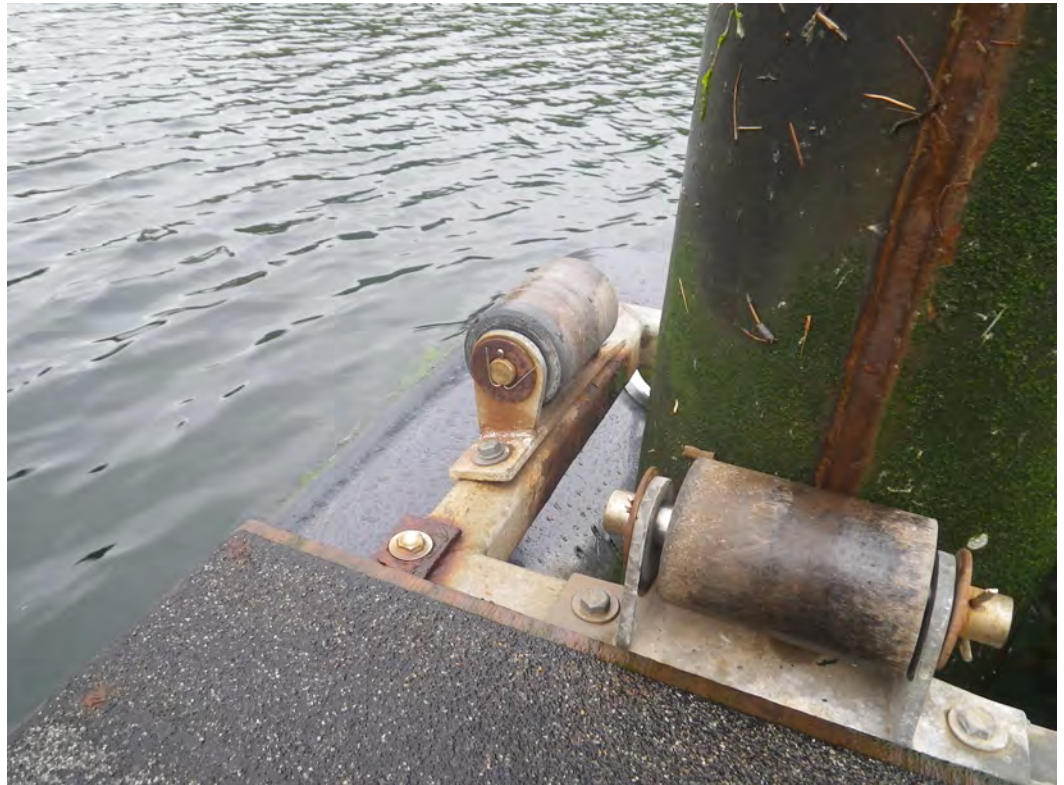
Spud pile rollers are all intact, some are bent from storm events.

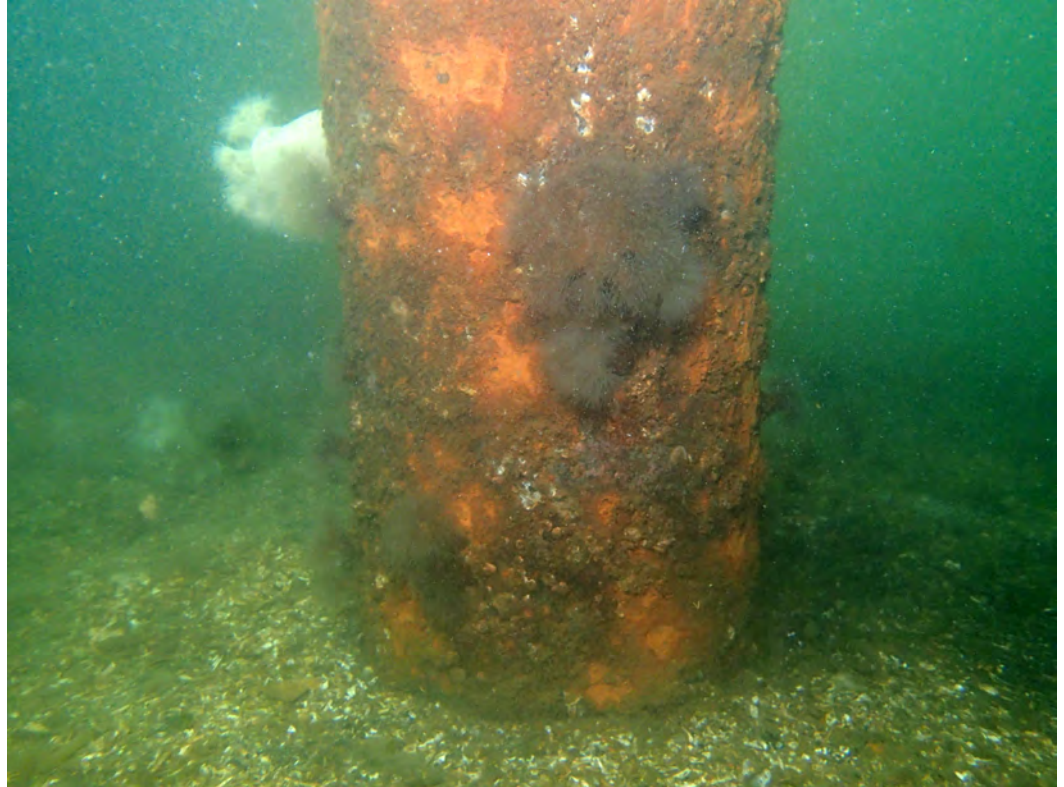
UW-2

8703 Spud Piling & Wells
Photo Type: I - In Depth
Orientation:
Date: 5/23/2013
Repairs:
T-dock Pile S; general coating failure and rusting with section loss. Typical of T-dock piles.

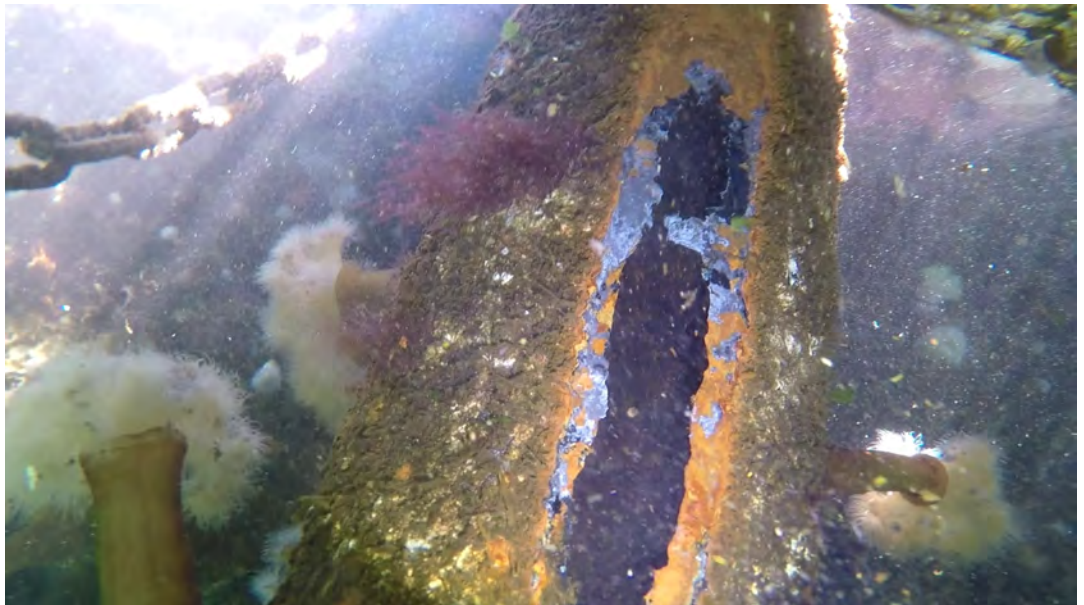
UW-3

8703 Spud Piling & Wells
Photo Type: I - In Depth
Orientation:
Date: 4/27/2017
Repairs:
T-dock, Pile A: 18" H x 4" W hole from mechanical damage.

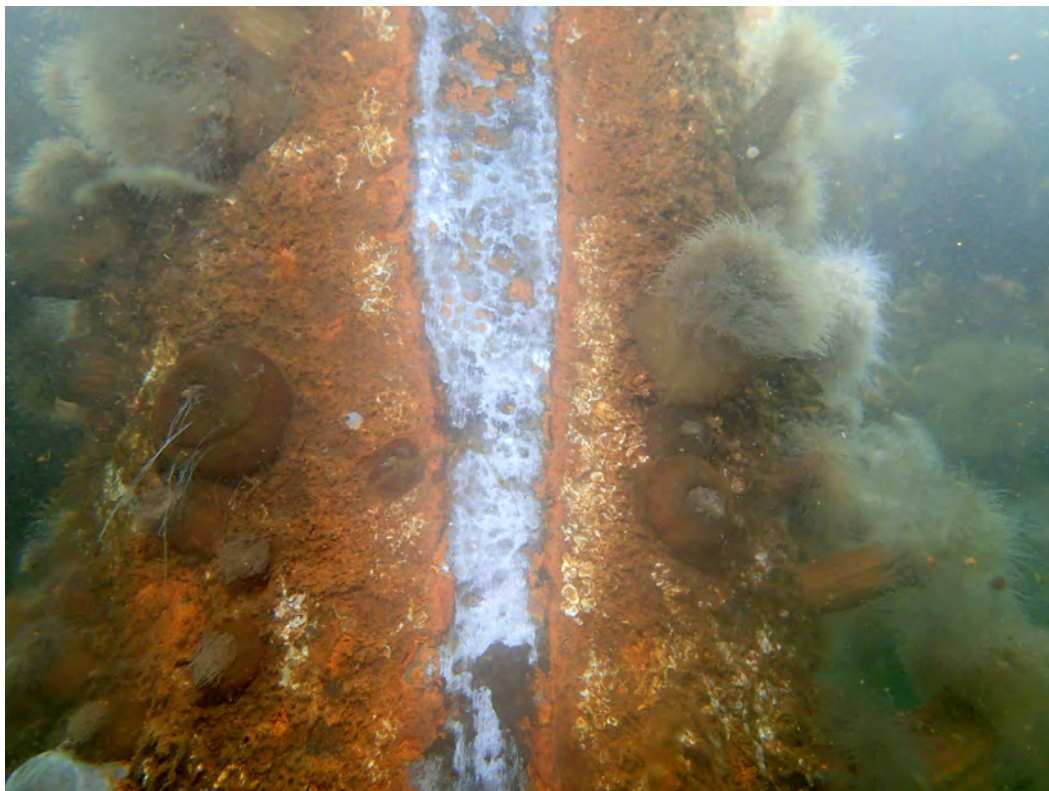
T-dock Pile J; 4" wide mechanical damage (flat spot). 2013 photo; compare to UW-5 for 2017 photo to see progression.

T-dock Pile J: 12" H x 2.5" W hole (was just a flat spot in 2013, see UW-4).

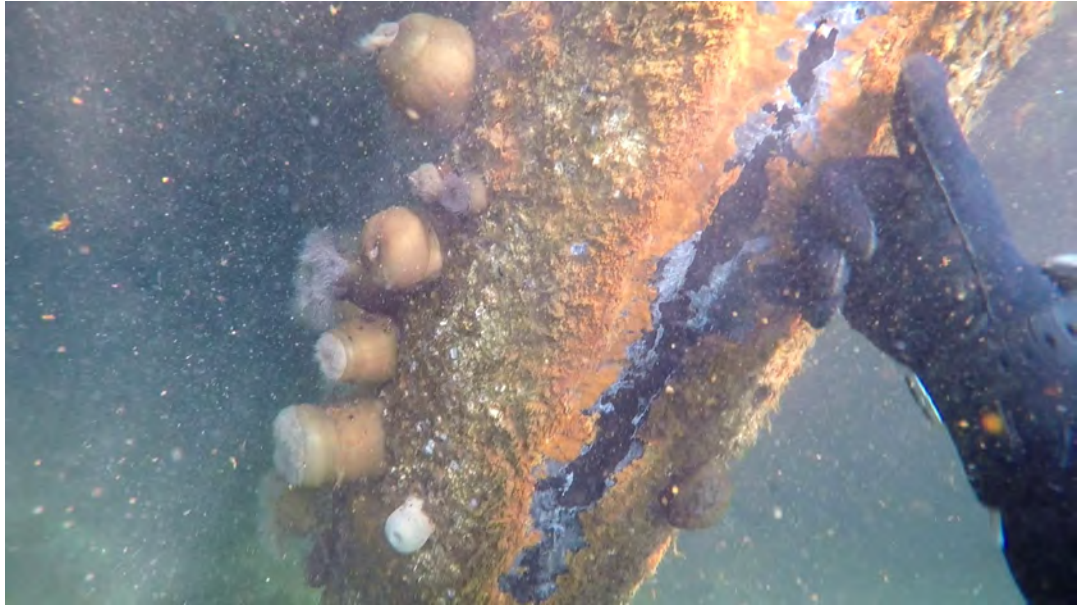
UW-6

8703 Spud Piling & Wells
Photo Type: I - In Depth
Orientation:
Date: 4/27/2017
Repairs:
T-dock Pile O: 18" H x 4" W (up to) hole from mechanical damage.

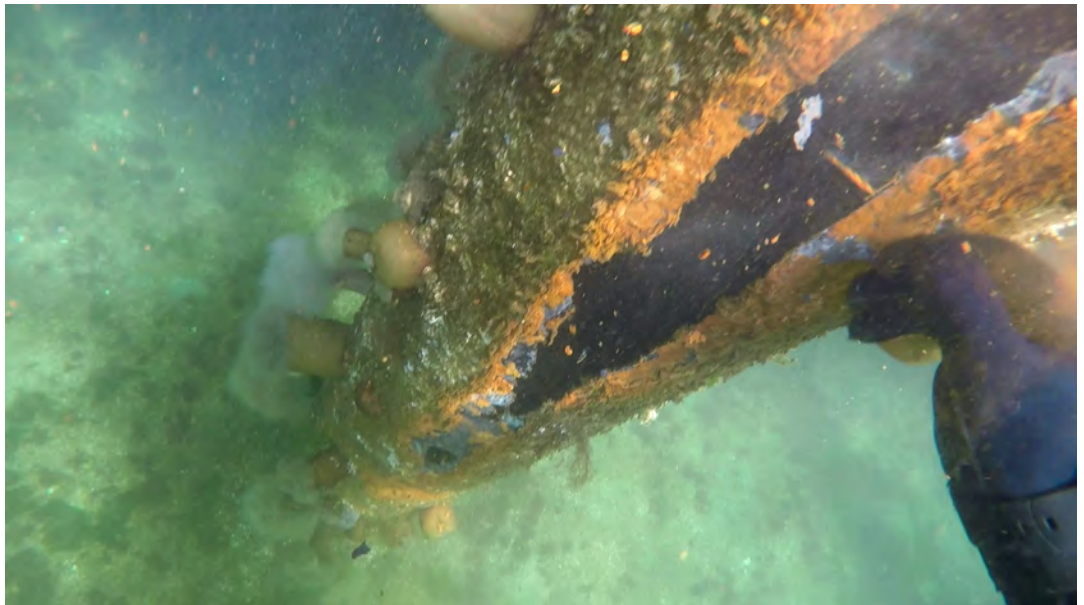
UW-7

8703 Spud Piling & Wells
Photo Type: I - In Depth
Orientation:
Date: 4/27/2017
Repairs:
T-dock Pile P: Large 3-ft. vertical hole from mechanical damage.

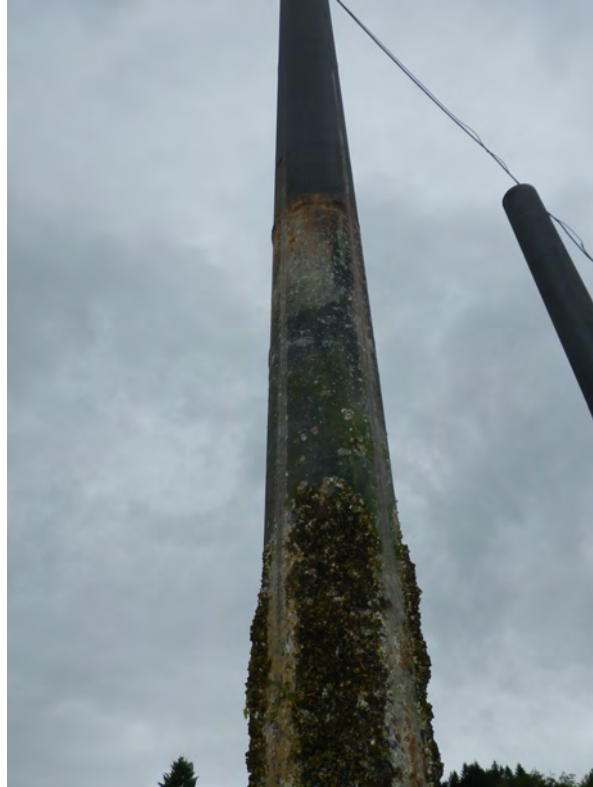
Typical shot of spud piles. Seam rust on welds are breaking through the paint.

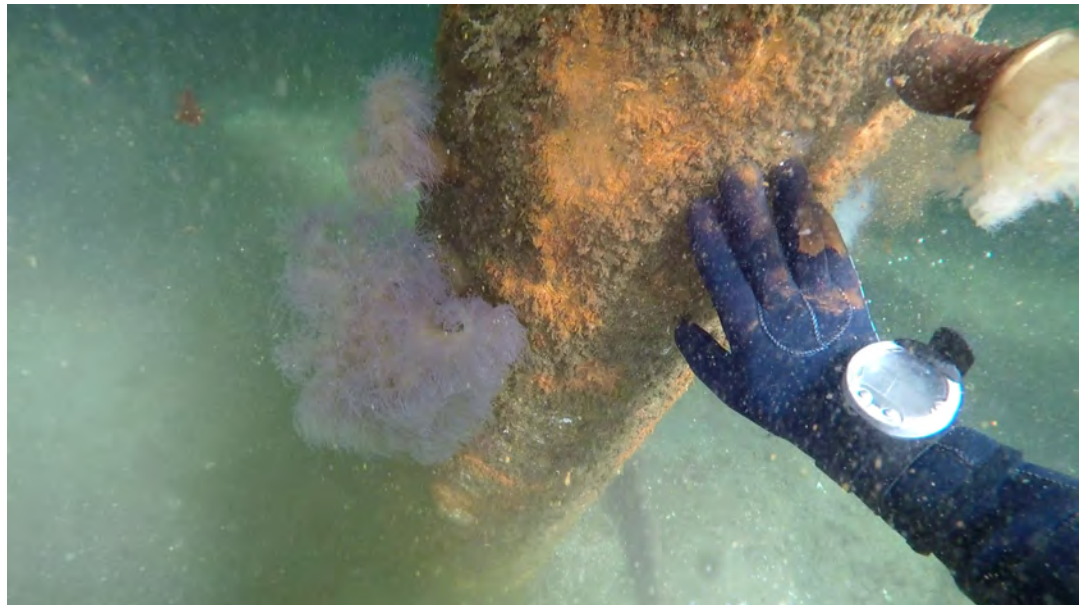
UW-8

Typical pile condition underwater.
Coating has failed over 25%-50% of the surface area on the piles below water.
Example of ~25% exposed metal shown.
