DSHS

OLYMPIC HERITAGE BEHAVIORAL HEALTH

WA STATE PROJECT NUMBER: 2024-429 N (11)

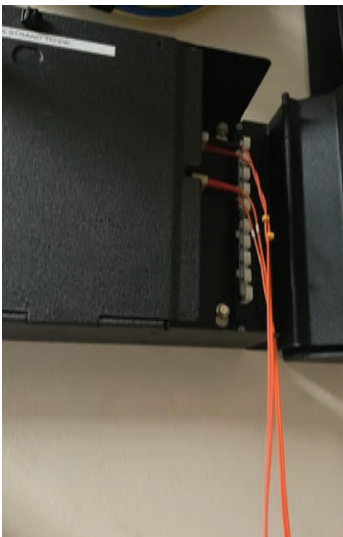
Existing Fiber Cabinet

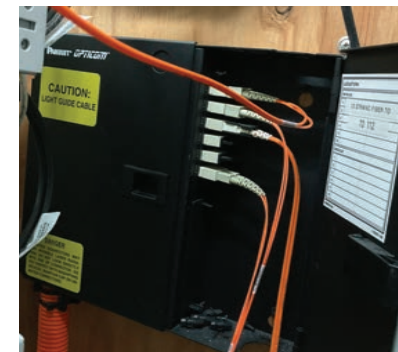
warehouses, and is now rarely manufactured. The limited capabilities of the OM1 fiber and twisted-pair copper backbone limit the new technologies that can be introduced at Olympic Heritage Behavioral Health. To meet TIA and industry standards, the backbone fiber cabling and backbone twisted-pair copper cabling should be upgraded to a minimum of OM4 or to single-mode fiber. It is recommended to provide both as a backbone to meet all possible future needs. Providing 12 strands of OS2 single-mode and 12 strands of OM4 multi-mode optical fiber cable will provide a backbone with enough capacity to handle new technologies while still having the capability to support unforeseen future technologies.

Existing OM1 MM OFC

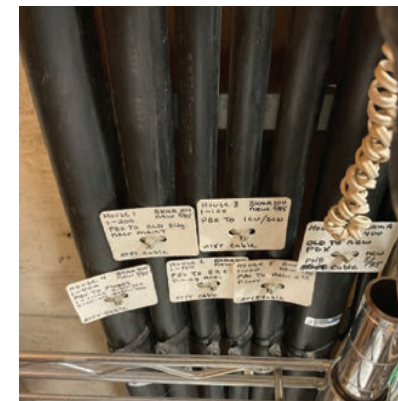
The Category 3 cabling supporting the voice cabling is inadequate to support new technologies being proposed for implementation at Olympic Heritage Behavioral Health. The voice network should be collapsed to a single converged IP based network, and the existing Category 3 cabling should be demolished.

*Existing Twisted-Pair Copper
Backbone Cabling*

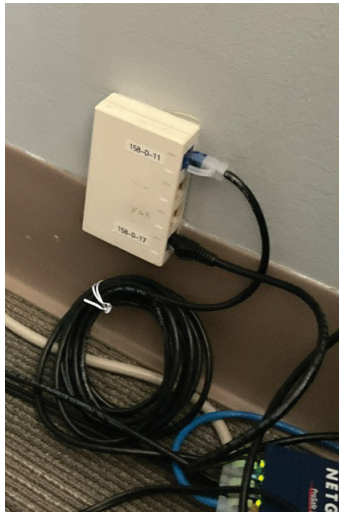
Existing 4-Port Switch

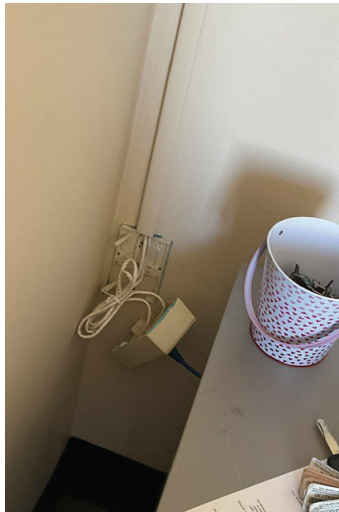
Existing Telecom Outlet Box

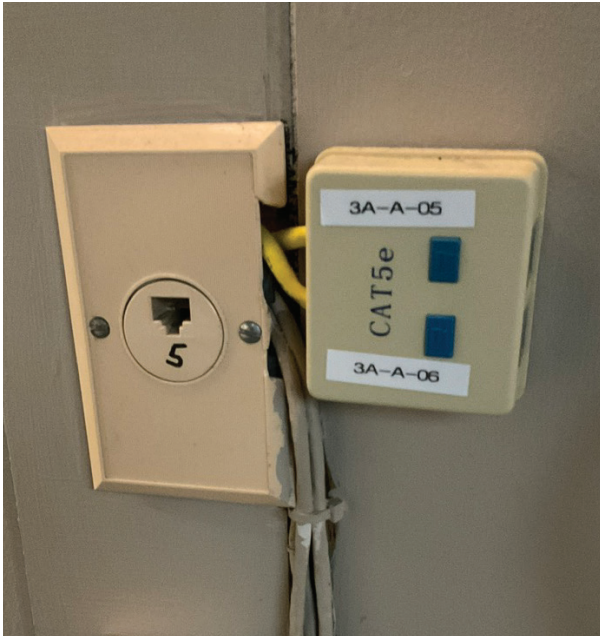
Existing Telecom Outlet

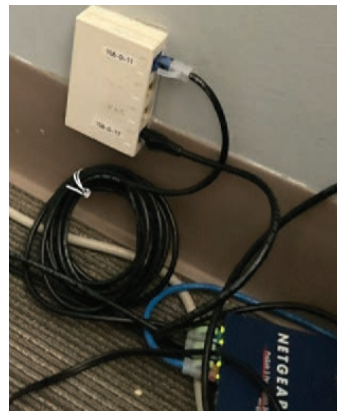
Existing 4-Port Switch

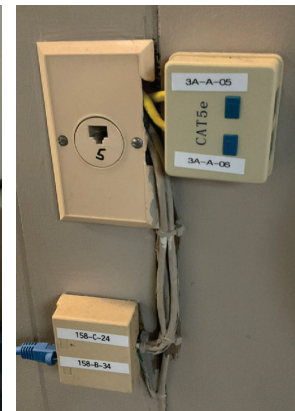
Existing Telecom Outlet

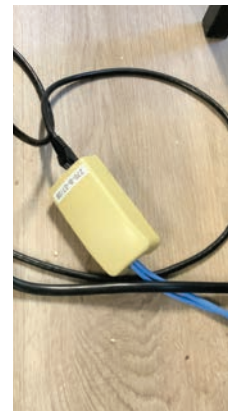
Existing Biscuit Jack On Floor

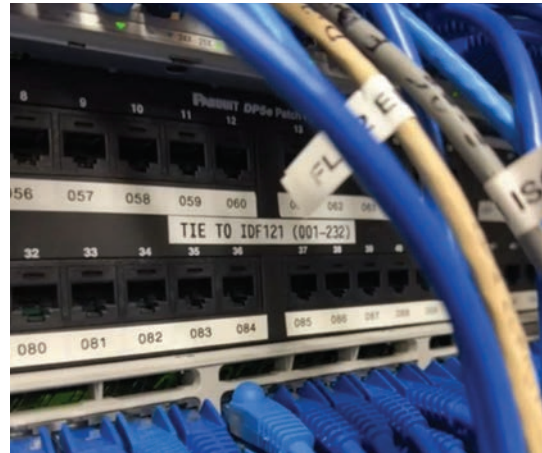
Existing Category 5e Patch Panel

- » Upgrade existing port locations to Category 6A.
- » Add additional Category 6A 8P8C RJ45 ports to meet standards.
- » Provide new 12-strand OS2 single-mode and 12-strand OM4 multi-mode optical fiber backbone to TR-158/S147 and TR-2W/W202.
- » Add ladder tray and cable management as needed.
- » Add Telecommunications Grounding Busbar.
- » Add power circuits and receptacles as needed.
- » Control access to authorized individuals

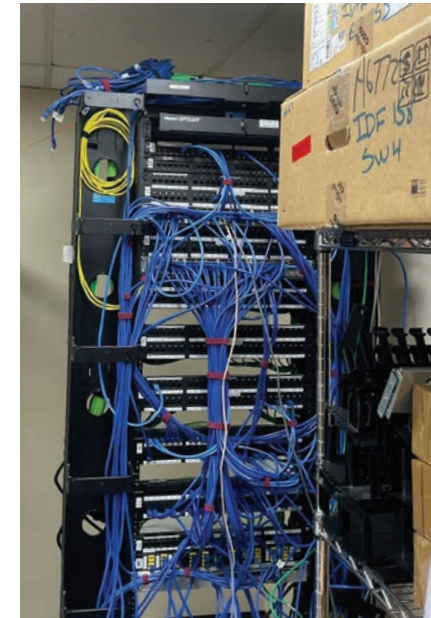
Existing Telecom Rack 2

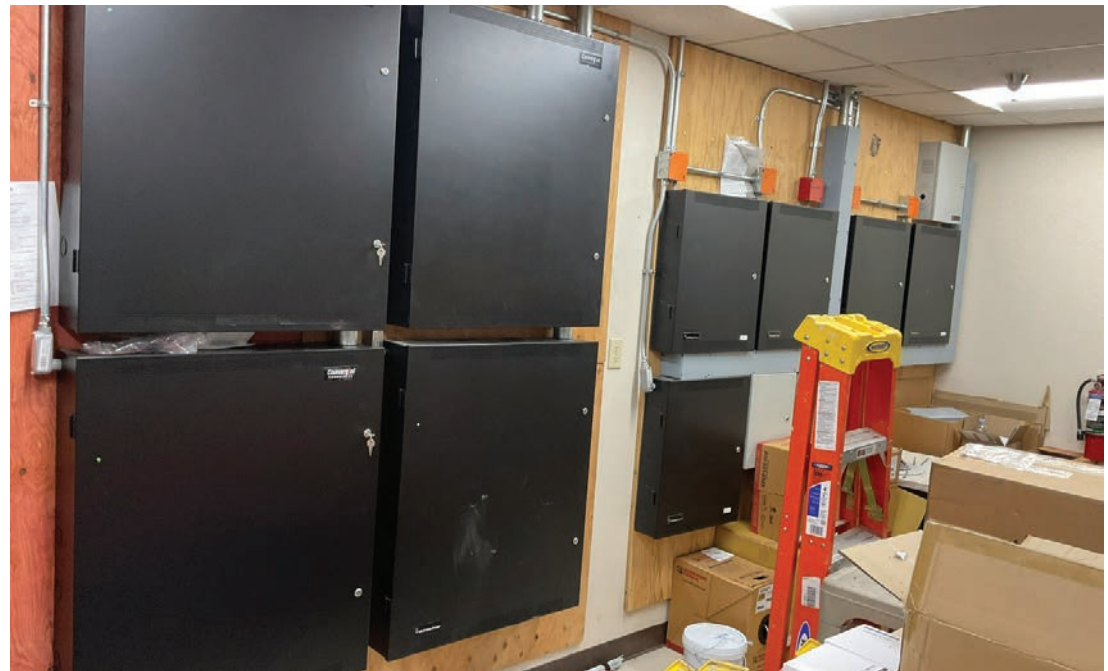
Existing Security Panels

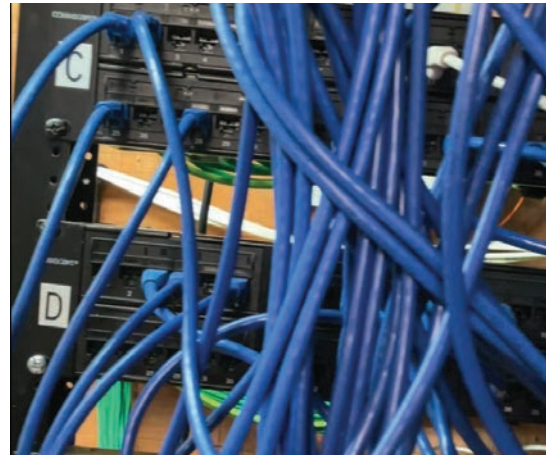
Space for expansion is present in the existing rack, but due to the small size of the closet, there is no room for adding additional racks. There is no telecommunications grounding bus bar present. The space does not contain cooling or humidity control. There are a few convenience receptacles, but no dedicated equipment receptacles. UPS power is available to provide clean, uninterrupted power for the equipment. The room can be locked but there is no other access control on the room.

Existing Data Patching

- » Upgrade existing port locations to Category 6A.
- » Add additional Category 6A 8P8C RJ45 ports to meet standards.
- » Provide new 12-strand OS2 single-mode and 12-strand OM4 multi-mode optical fiber backbone from ER-112/W108, TR-121, and TR-270/S206.
- » Add ladder tray and cable management as needed.
- » Add Telecommunications Grounding Busbar.
- » Add power circuits and receptacles as needed.
- » Add ductless split-system cooling unit.
- » Control access to authorized individuals.
- » Remove unused equipment.

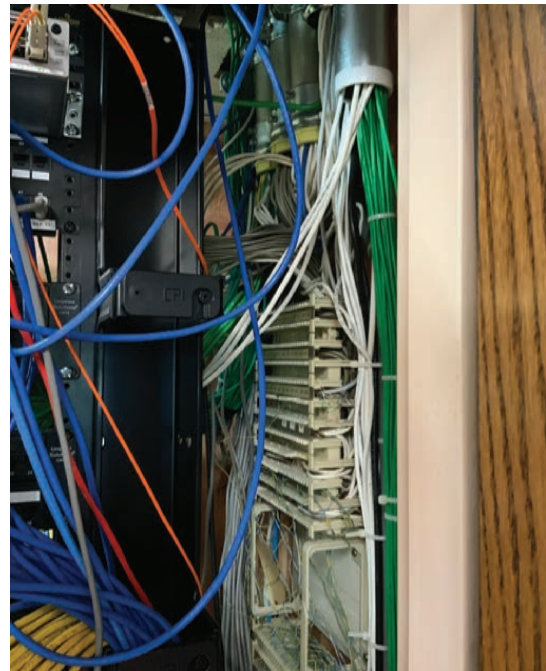
Existing Voice Patching

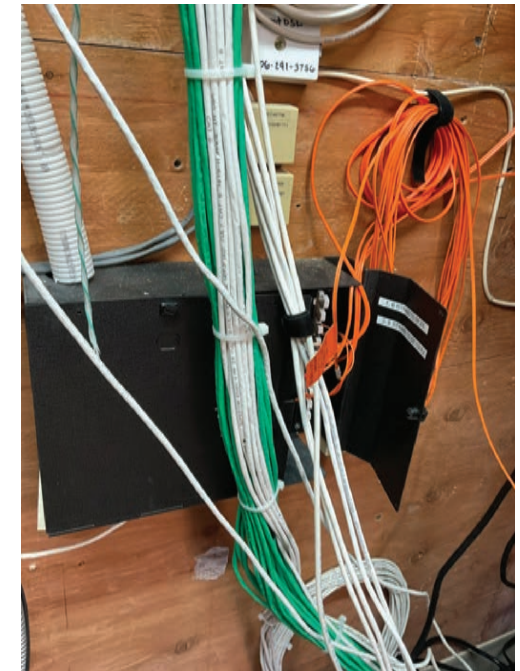
Existing Fiber Patching

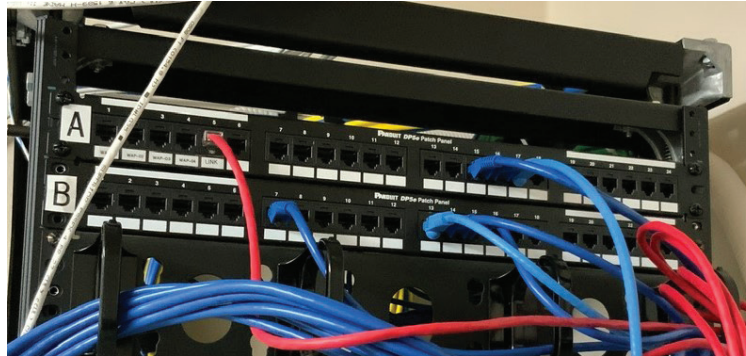
The wall-mounted rack and fiber cabinet are mounted directly above a sink and behind the swing of the door. There is limited space for expansion on the rack, and there is also room for adding additional wall-mounted and floor standing racks. There is no grounding bus bar in the room. The room does not contain cooling or humidity control. There are a few convenience receptacles, but no dedicated equipment receptacles. UPS backed power is not available. The room can be locked but there is no other access control on the room.

Existing Data Patching

To meet industry standards, it is recommended to provide ladder racks for cable support. A new floor-standing rack should be installed to provide better organization and space for future growth. It is also recommended to provide a telecommunications grounding busbar to create a consistent potential across all components. New standards compliant backbone and horizontal cabling are recommended. The addition of card-based access control is recommended to control access and track access to the space. Ductless split-system cooling unit is also recommended to be installed to provide adequate cooling in the room.

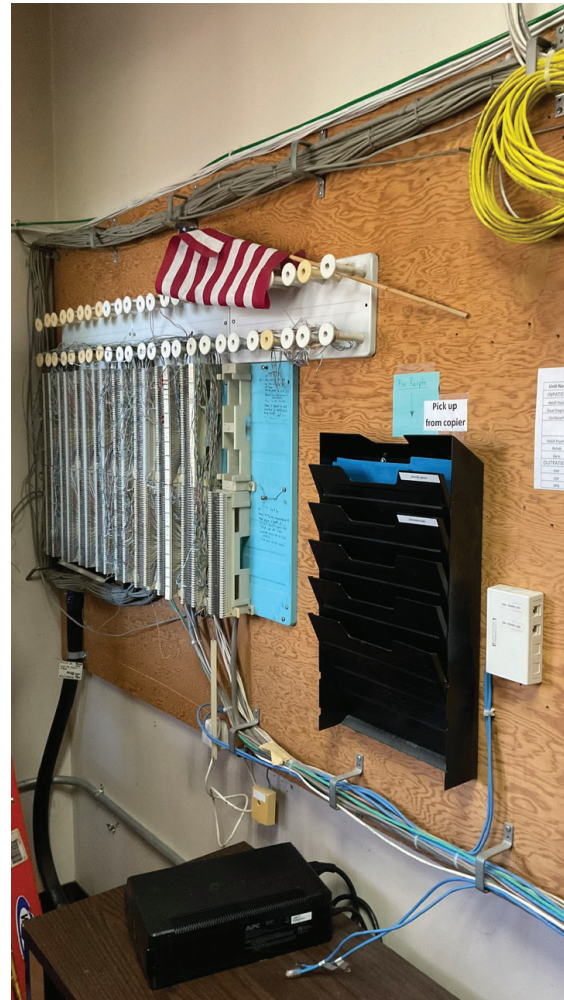
There is limited wall-space for expansion due to all the equipment being mounted on the wall. However, there is space to provide floor-standing equipment racks. There is no grounding bus bar in the room. The room does not contain cooling or humidity control. There are a few convenience receptacles, but no dedicated equipment receptacles. UPS backed power is not available. The room can be locked but there is no other access control on the room.

Existing Voice Patching

- » Upgrade existing port locations to Category 6A.
- » Add additional Category 6A 8P8C RJ45 ports to meet standards.
- » Provide new 12-strand OS2 single-mode and 12-strand OM4 multi-mode optical fiber backbone from TR-2W/W202 and TR-3A/A312.
- » Add ladder tray and cable management as needed.
- » Add Telecommunications Grounding Busbar.
- » Add power circuits and receptacles as needed.
- » Add ductless split-system cooling unit.
- » Control access to authorized individuals.
- » Provide new two-post equipment rack to house telecom equipment.

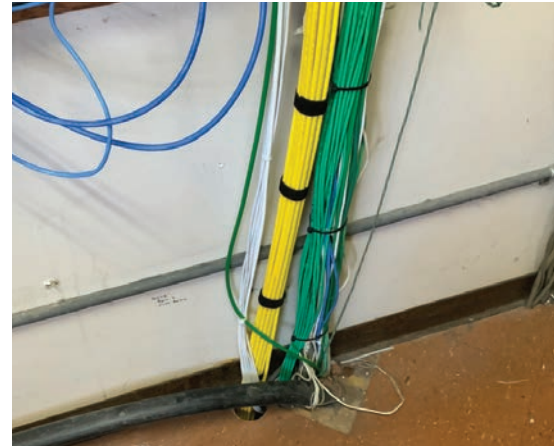
Existing cabling

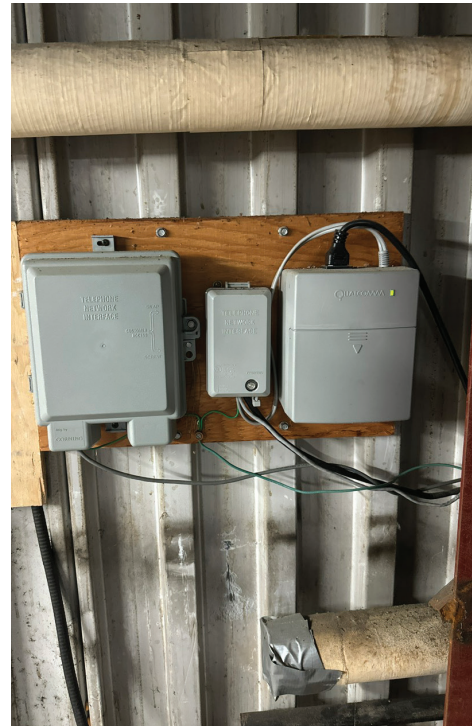
Existing Phone Provider Equipment

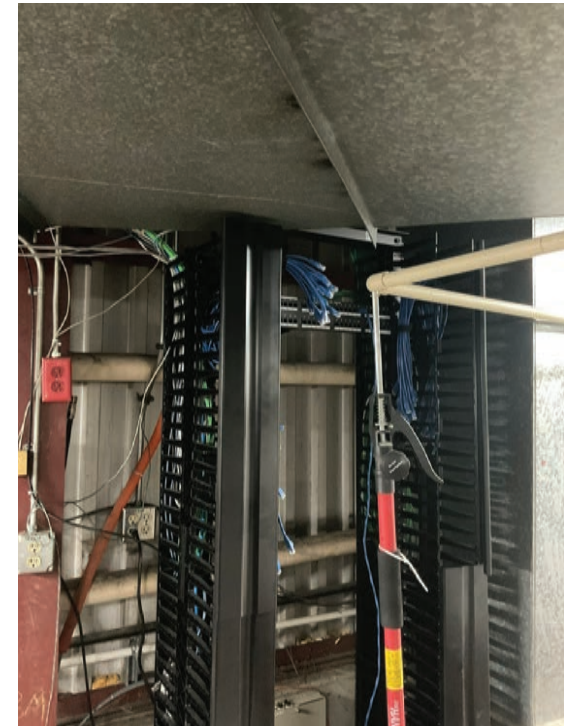
Existing Telecom Rack

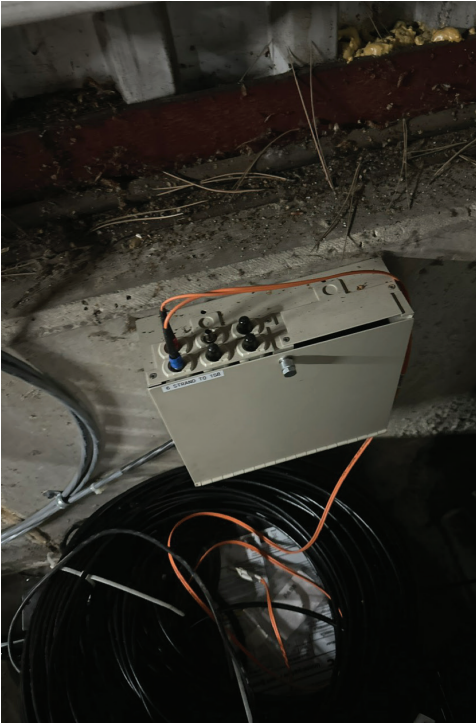
Existing Fiber Cabinet

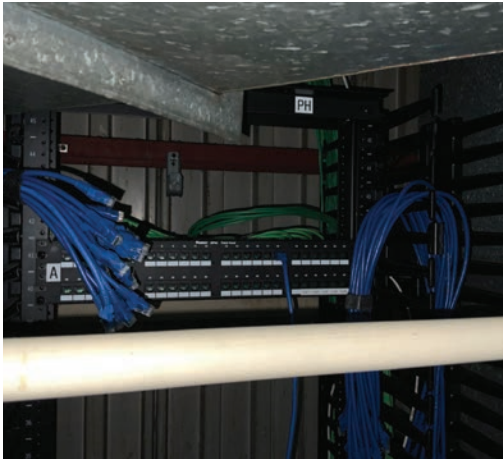
Existing Data Patching

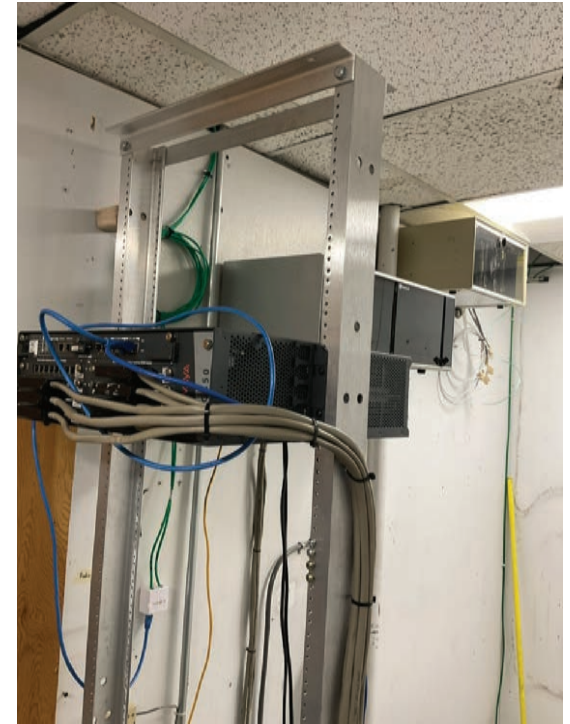
There is currently space for expansion on the rack. A grounding bus bar has been installed in the room, but there is no proper bonding to the telecom equipment. A portable AC unit is being used to provide cooling and humidity control. There are a few convenience receptacles, but no dedicated equipment receptacles. UPS power is available to provide clean, uninterrupted power for the equipment. The room can be locked but there is no other access control on the room.

Existing Telecom Rack

To meet industry standards, it is recommended to provide a ladder rack for cable support. It is also recommended to provide proper bonding of the telecom equipment to create a consistent potential across all components. New standards compliant backbone and horizontal cabling are recommended. The addition of card-based access control is recommended to control access and track access to the space. A ductless split-system cooling unit is also recommended to be installed in place of the portable AC to provide adequate cooling in the room.

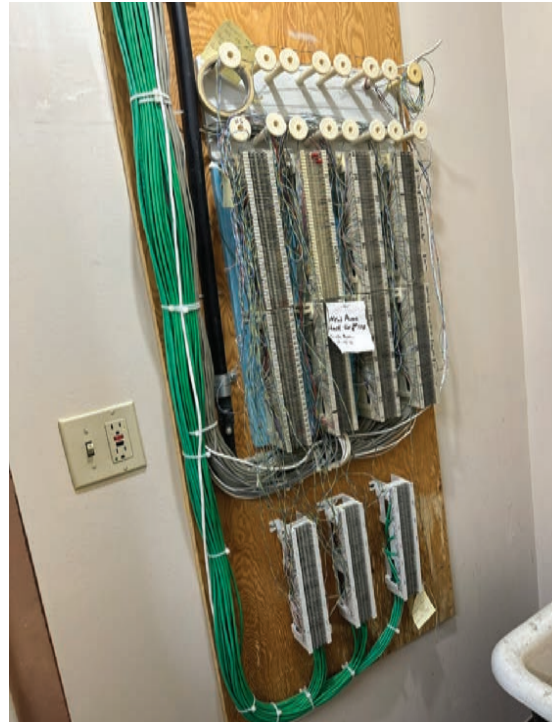
Cross-connect room W114 is located on the west side of the first floor. The room is roughly 16 sq-ft and was formerly a janitor's closet. The room is currently used as a cross-connect point for the existing voice Category 3 cabling. One wall contains multiple 66-blocks for voice cross connection.

Existing Phone Patching

Due to the small size, it is recommended that the room be abandoned with all new cabling being routed to TR-121 or ER-112/W108 on the same floor.

- » Abandon the closet and route all future cabling to TR-121 or ER-112/W108.
- » Remove all unused equipment.

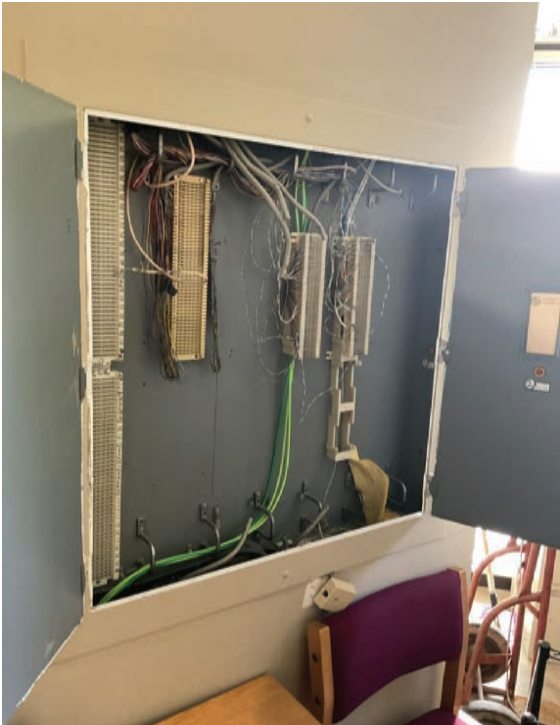
Cross-connect room A209A is located on the second floor. The room is currently used as a lounge and has a cross-connect point for the existing voice Category 3 cabling. One wall contains a panel with multiple 66-blocks for voice cross connection.

Existing Phone Patching

Due to the small size, it is recommended that the room be abandoned with all new cabling being routed to TR-3A on the third floor.

- » Abandon the closet and route all future cabling to TR-3A.
- » Remove all unused equipment.
