EASTERN STATE HOSPITAL

WA STATE PROJECT NUMBER: 2024-429 C (3)

EXECUTIVE SUMMARY

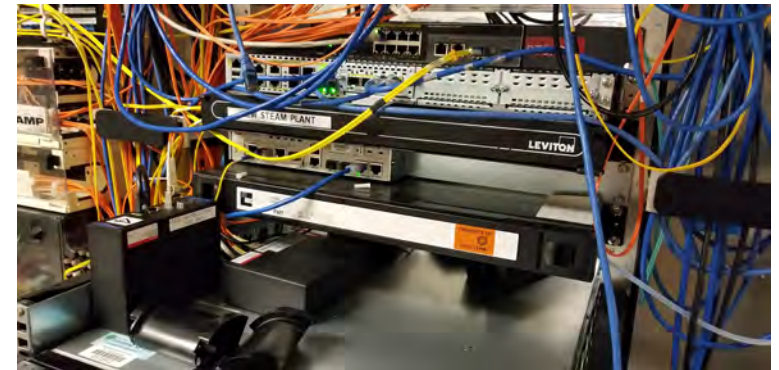
Service Provider Connection

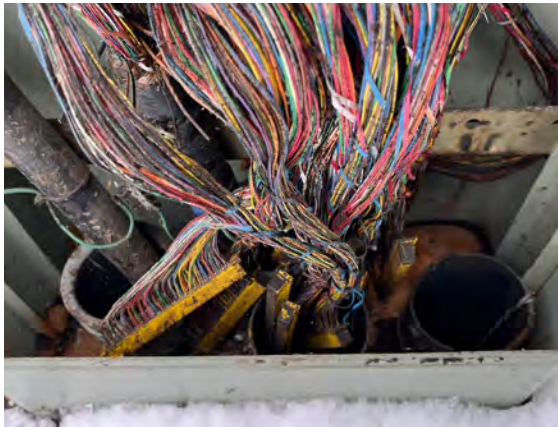
Existing Interbuilding Voice Backbone.

Category 3 twisted-pair copper backbone cabling is utilized throughout the campus which originates from the Admin Building TR-MER. The cabling is then patched to the 110 blocks where the outlet cabling coming from the workstation terminates. The voice network should be collapsed to a single converged IP based network, and the existing Category 3 cabling should be demolished to align with current standards.

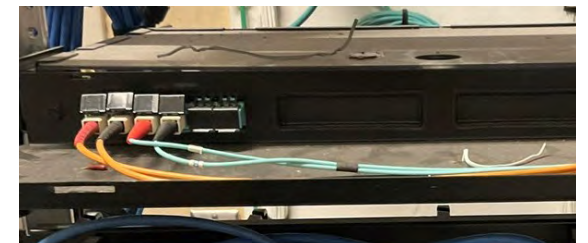
The Eastlake buildings are supported by a mixture of 6-strand, 12 strand, and 24 strand OM1 multi-mode optical fiber cables are provided between the MER and TR rooms within each building. There are locations where the existing fiber is patched with mismatched fiber, typically OM3 and OM1 patched to each other. The two fiber types have different diameters, leading to signal loss from light reflection. To meet TIA standards, the backbone fiber cabling should be upgraded to a minimum of OM4 multi-mode and augmented with the addition of single-mode optical fiber cable. Providing 12-strand OS2 single-mode and 12-strand OM4 multi-mode optical fiber cables will provide an optical fiber backbone that is compliant with current industry standards.

Existing Intrabuilding Backbone Fiber Patching Mismatch.

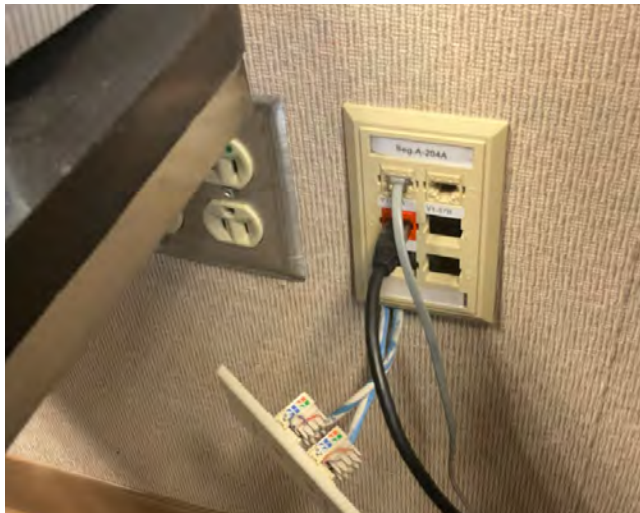
Existing Condition.

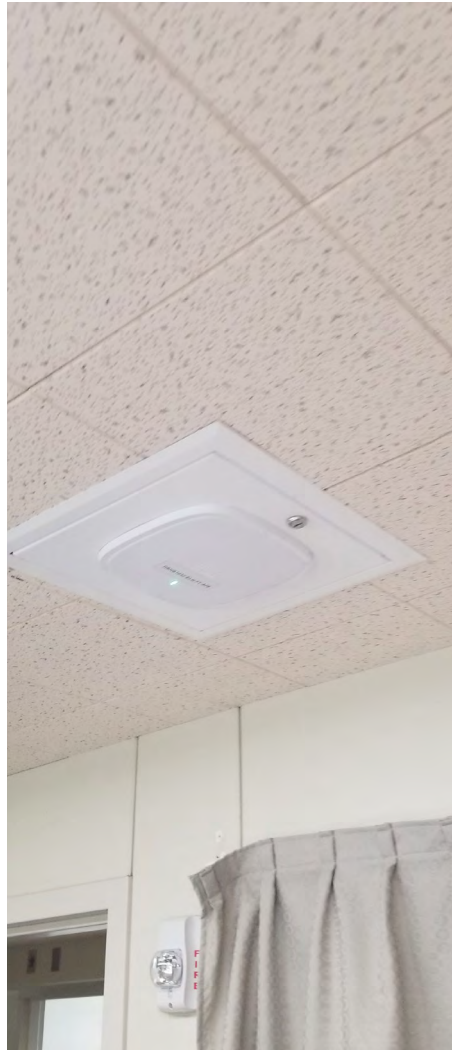
Existing Wireless Access Point.

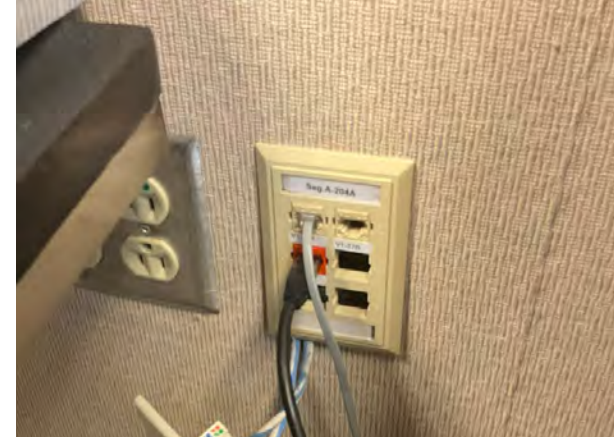
Existing Condition.

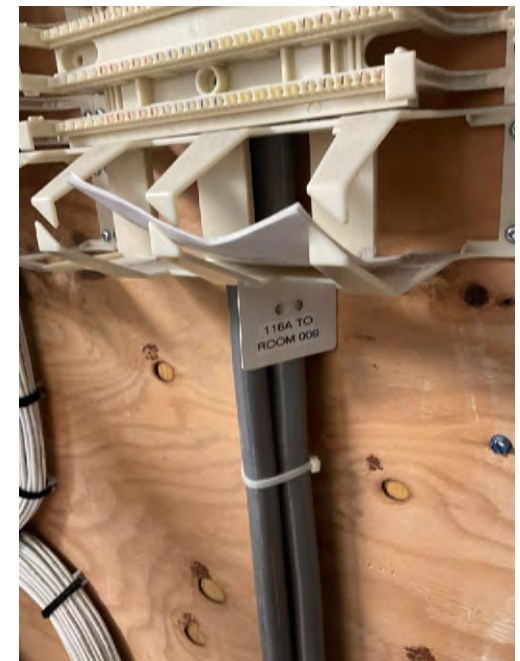
To meet industry standards, it is recommended to upgrade the existing backbone and horizontal cabling. Additional Category 6A data ports are required to meet standards. Dedicated cooling is required to meet standards. The addition of card-based access control is recommended to control access and track access to the space.

Existing Voice Backbone.

- » Upgrade existing port locations to Category 6A.
- » Provide labels for all new cabling and existing cables to remain
- » Add additional Category 6A 8P8C RJ45 ports to meet standards.
- » Provide new 12-strand OS2 single-mode and 12-strand OM4 multi-mode optical fiber backbone from WSH MER in Admin Building.
- » Add cable management as needed.
- » Add ductless split-system cooling unit or connect to building environmental system.
- » Add power circuits and receptacles as needed.
- » Control access to authorized individuals.

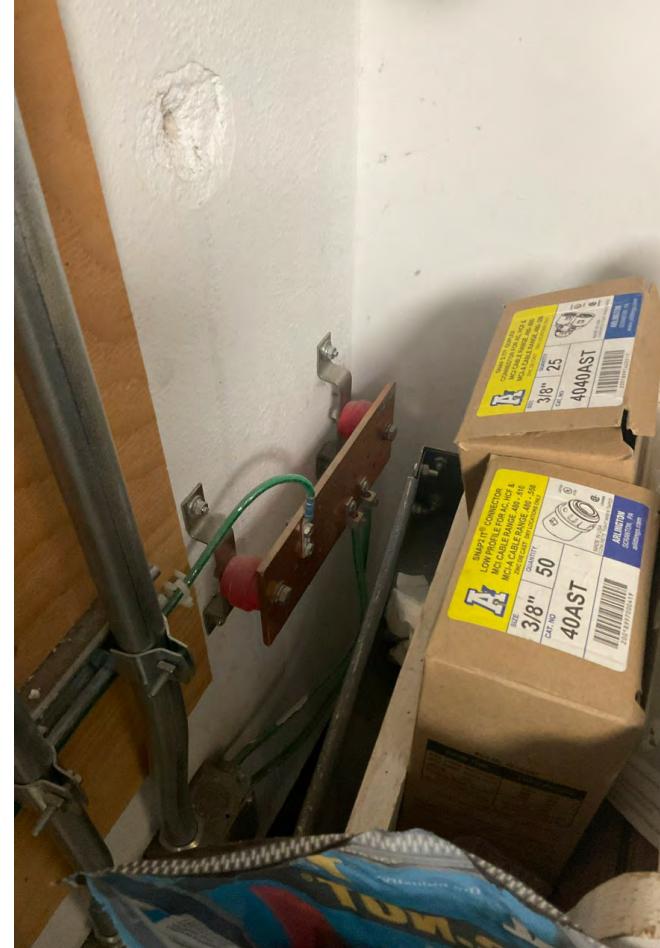
Existing Grounding.

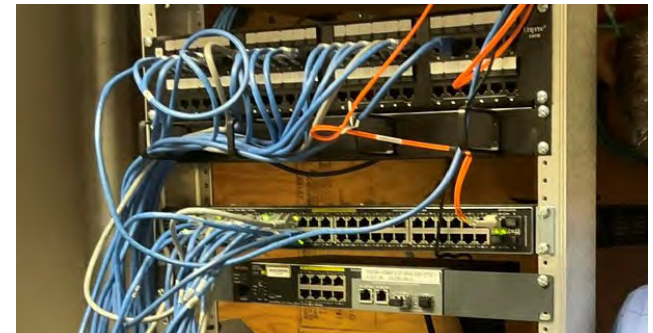
To meet industry standards, it is recommended to upgrade the existing backbone and horizontal cabling. Additional Category 6A data ports are required to meet standards. Dedicated cooling is required to meet standards. The addition of card-based access control is recommended to control access and track access to the space.

Existing Telecom Rack.

- » Upgrade existing port locations to Category 6A.
- » Provide labels for all new cabling and existing cables to remain.
- » Add additional Category 6A 8P8C RJ45 ports to meet standards.
- » Provide new 12-strand OS2 single-mode and 12-strand OM4 multi-mode optical fiber backbone from ESH MER in the Admin Building.
- » Add cable management as needed.
- » Add ductless split-system cooling unit or connect to building environmental system.
- » Add power circuits and receptacles as needed.
- » Control access to authorized individuals.

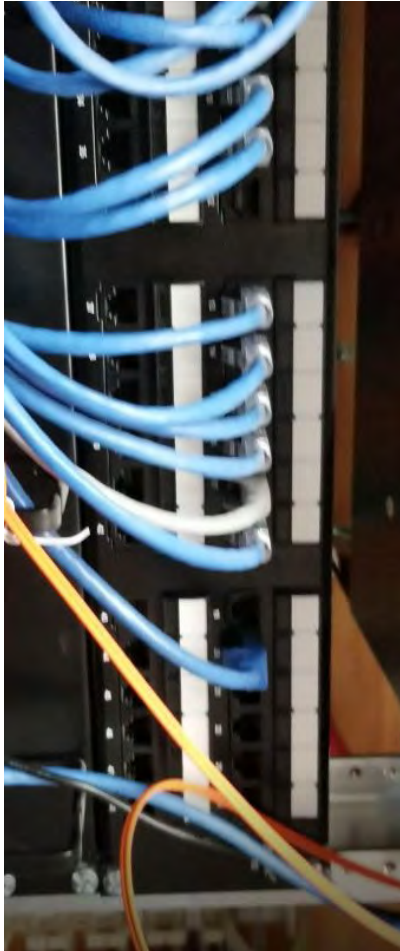
Existing Data Patching.

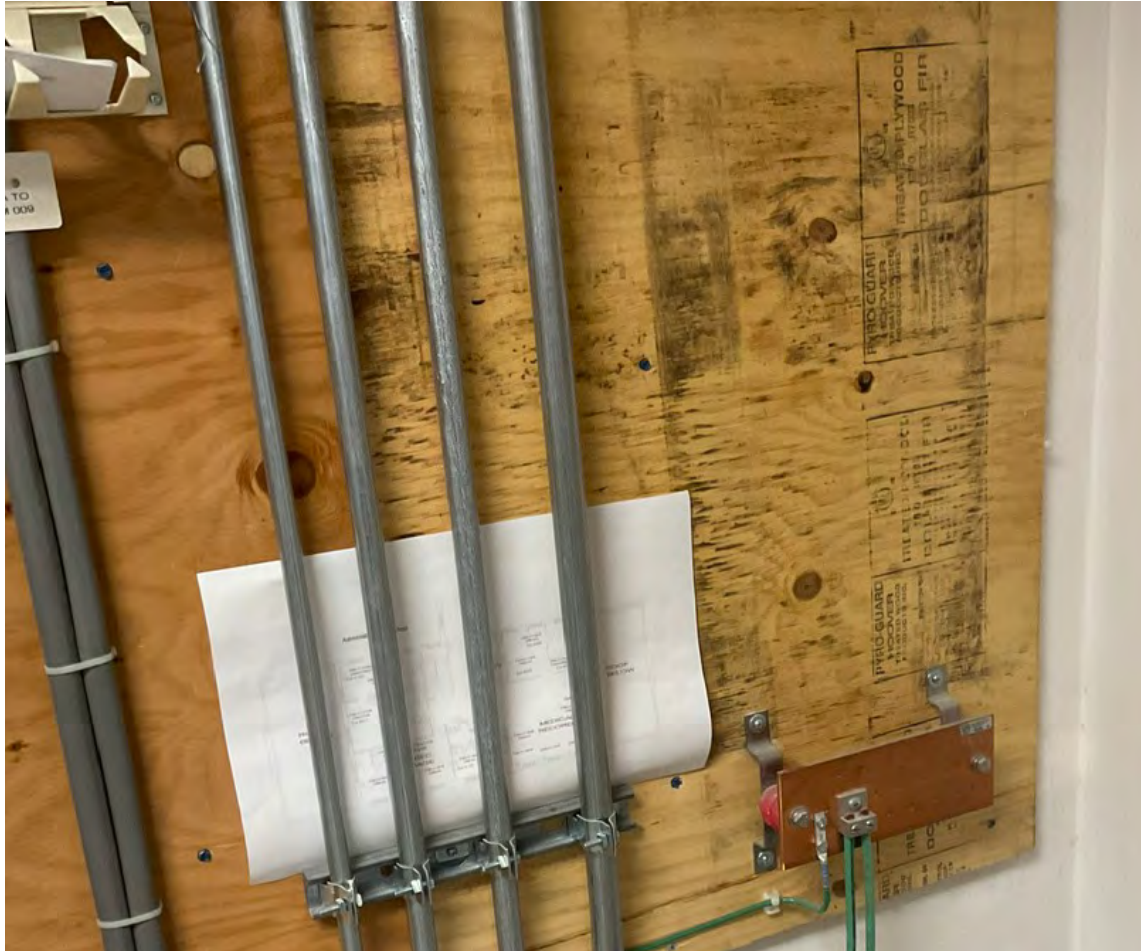
Existing Grounding.

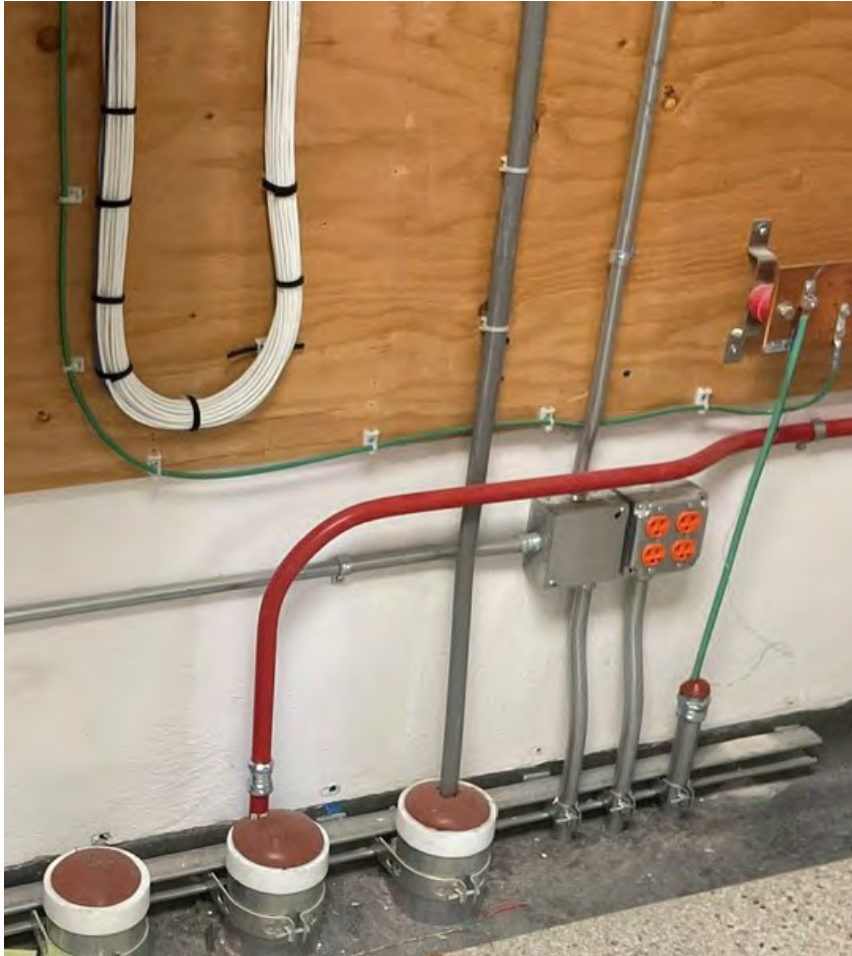
To meet industry standards, it is recommended to upgrade the existing backbone and horizontal cabling to OM4/OS2 and Category 6A. Additional Category 6A data ports are required to meet standards. It is also recommended to provide a telecommunications grounding busbar to create a consistent potential across all components. Dedicated cooling, cable management, and dedicated equipment receptacles are required to meet standards. The addition of card-based access control is recommended to control access and track access to the space.

Existing Grounding.

- » Upgrade existing port locations to Category 6A.
- » Provide labels for all new cabling and existing cables to remain.
- » Add additional Category 6A 8P8C RJ45 ports to meet standards.
- » Provide new 12-strand OS2 single-mode and 12-strand OM4 multi-mode optical fiber backbone from ESH MER in the Admin Building.
- » Add cable management as needed.
- » Add ductless split-system cooling unit or connect to building environmental system.
- » Add power circuits and receptacles as needed.
- » Control access to authorized individuals.

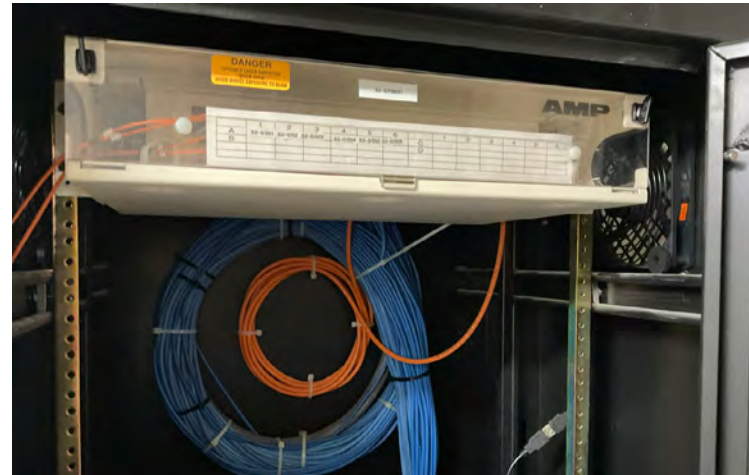
Existing Horizontal Cabling.

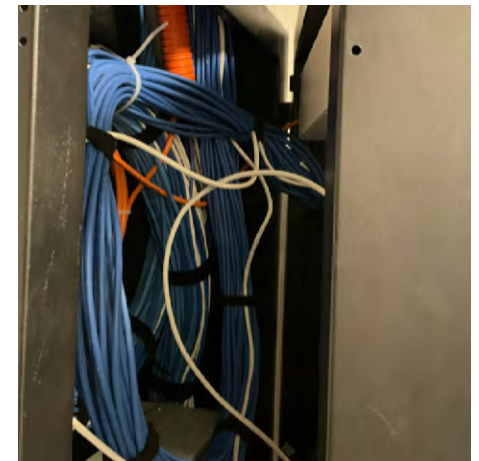
Existing Horizontal Cabling.

- » Upgrade existing port locations to Category 6A.
- » Add additional Category 6A 8P8C RJ45 ports to meet standards.
- » Provide labels for all new cabling and existing cables to remain.
- » Provide new 12-strand OS2 single-mode and 12-strand OM4 multi-mode optical fiber backbone from the MER in the Admin Building basement.
- » Add ladder tray and cable management as needed.
- » Add ductless split-system cooling unit.
- » Add power circuits and receptacles as needed.
- » Control access to authorized individuals.

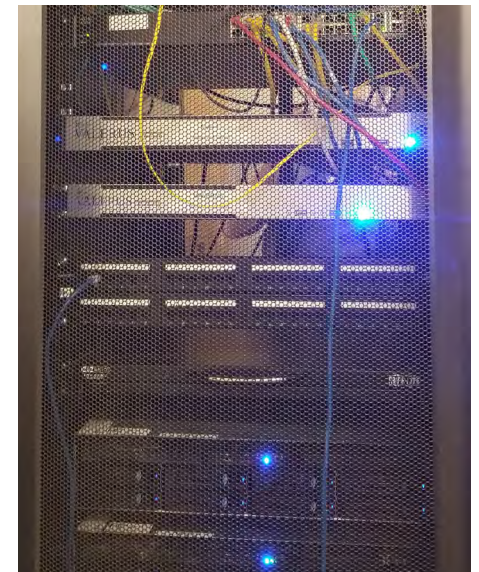
Existing CCTV Rack.

- » Upgrade existing port locations to Category 6A.
- » Provide labels for all new cabling and existing cables to remain.
- » Provide new 12-strand OS2 single-mode and 12-strand OM4 multi-mode optical fiber backbone from the MER in the Admin Building basement.
- » Add ladder tray and cable management as needed.
- » Add ductless split-system cooling unit.
- » Add power circuits and receptacles as needed.
- » Control access to authorized individuals.

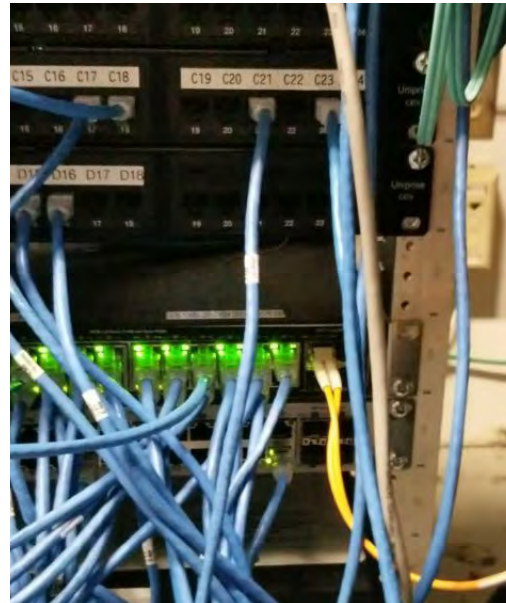
To meet industry standards, it is recommended to upgrade the existing backbone and horizontal cabling to OM4/OS2 and Category 6A. Additional Category 6A data ports are required to meet standards. Dedicated cooling, ladder rack, cable management, and dedicated equipment receptacles are required to meet standards. The addition of card-based access control is recommended to control access and track access to the space.

Existing Data Patching.

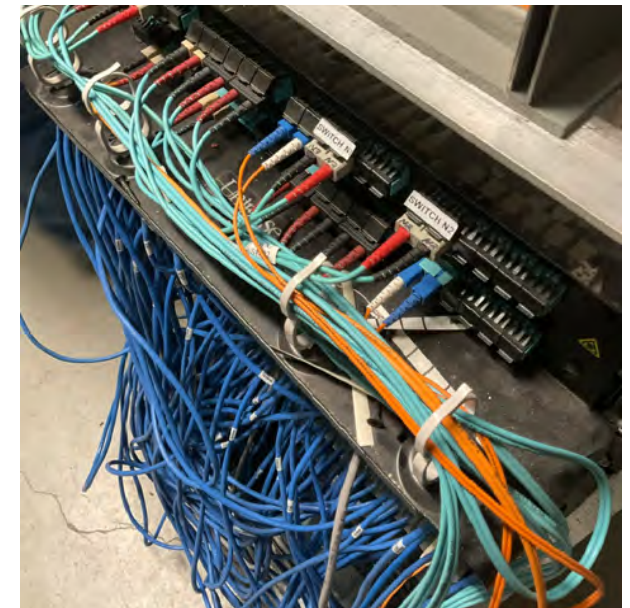
Existing Fiber Cabinet.

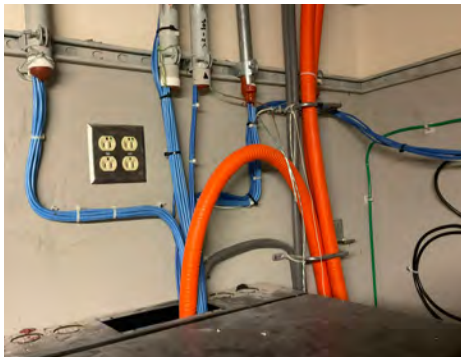
Existing Fiber and Copper Cabling.

- » Upgrade existing port locations to Category 6A.
- » Add additional Category 6A 8P8C RJ45 ports to meet standards.
- » Provide labels for all new cabling and existing cables to remain.
- » Provide new 12-strand OS2 single-mode and 12-strand OM4 multi-mode optical fiber backbone from ESH MER in the Admin Building.
- » Add ladder tray and cable management as needed.
- » Add ductless split-system cooling unit.
- » Add power circuits and receptacles as needed.
- » Control access to authorized individuals.

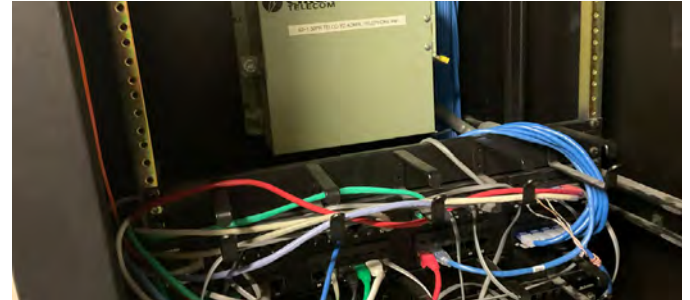
Existing Telecom Enclosure.

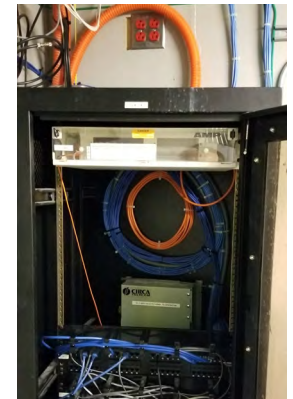
Existing Telecom Enclosure.

- » Upgrade existing port locations to Category 6A.
- » Add additional Category 6A 8P8C RJ45 ports to meet standards.
- » Provide labels for all new cabling and existing cables to remain.
- » Provide new 12-strand OS2 single-mode and 12-strand OM4 multi-mode optical fiber backbone from ESH MER in the Admin Building.
- » Add ladder tray and cable management as needed.
- » Add ductless split-system cooling unit.
- » Add power circuits and receptacles as needed.
- » Control access to authorized individuals.

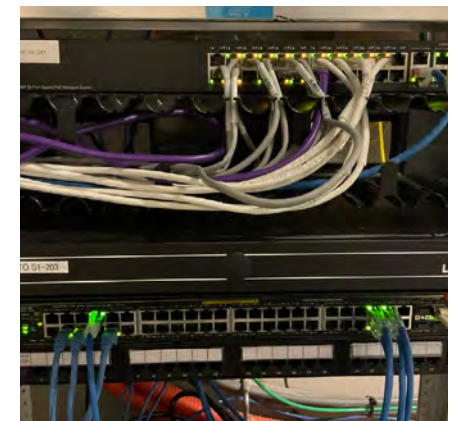
Existing Telecom Rack.

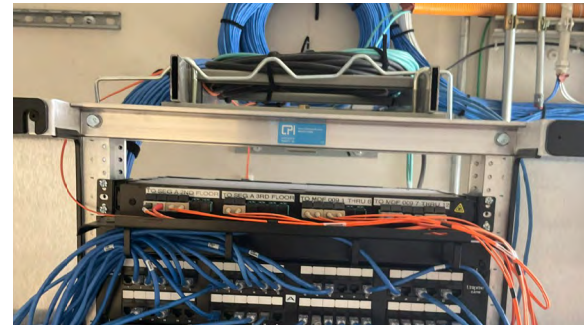
Existing Telecom Rack.

- » Upgrade existing port locations to Category 6A.
- » Add additional Category 6A 8P8C RJ45 ports to meet standards.
- » Provide labels for all new cabling and existing cables to remain.
- » Provide new 12-strand OS2 single-mode and 12-strand OM4 multi-mode optical fiber backbone from ESH MER in the Admin Building.
- » Add ladder tray and cable management as needed.
- » Add ductless split-system cooling unit.
- » Add power circuits and receptacles as needed.
- » Control access to authorized individuals.

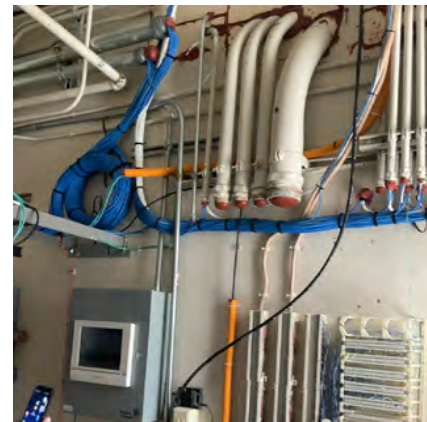
Existing Voice Patching.

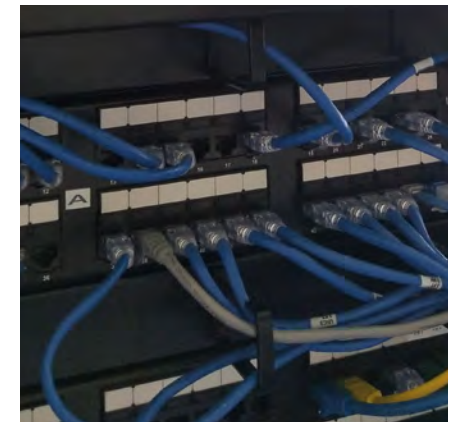
Existing Data Patching.

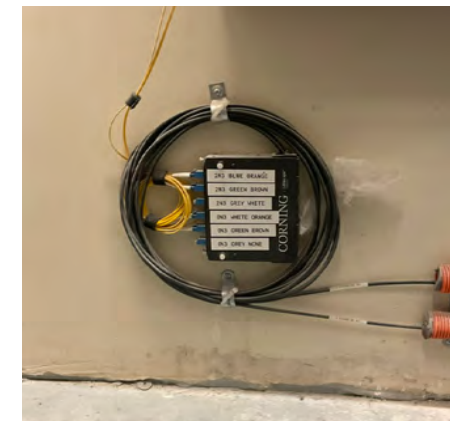
Existing Fire Alarm Fiber.

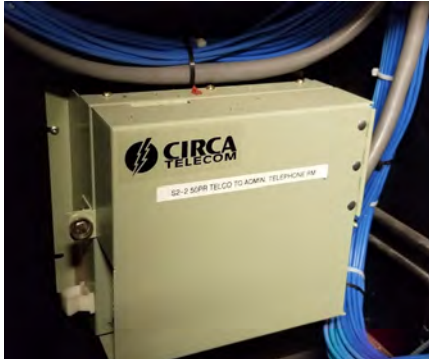
Existing Voice Backbone.

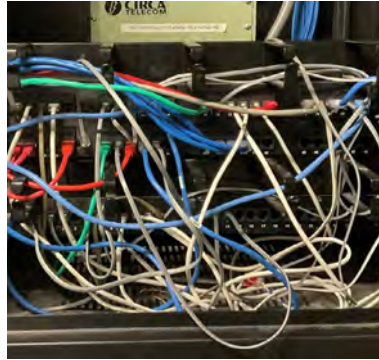
Existing Data Patching.

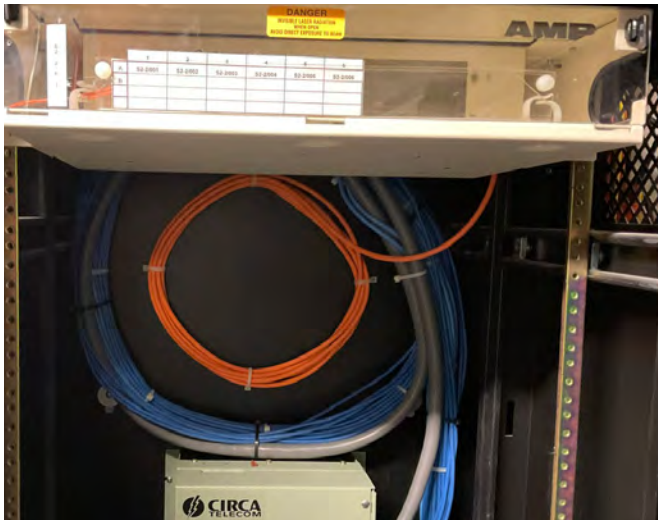
Existing Telecom Enclosure.

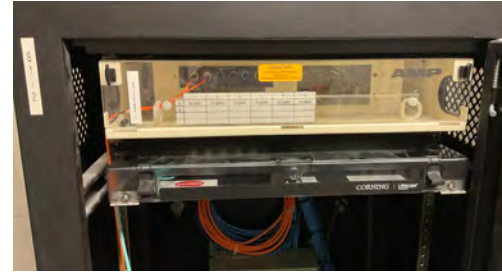
Existing Fiber Patching.

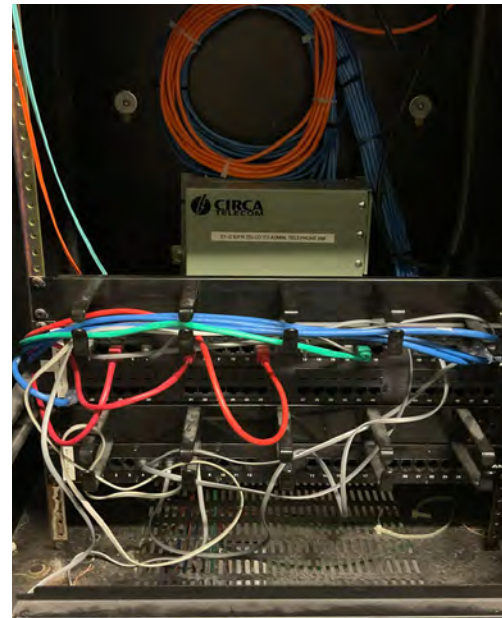
Existing Telecom Enclosure.

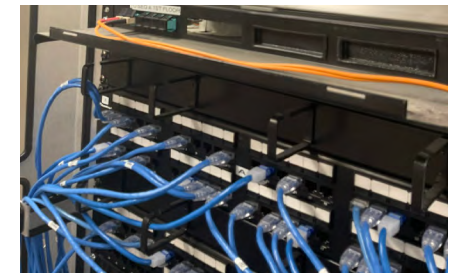
Existing Fiber and Data Patching.

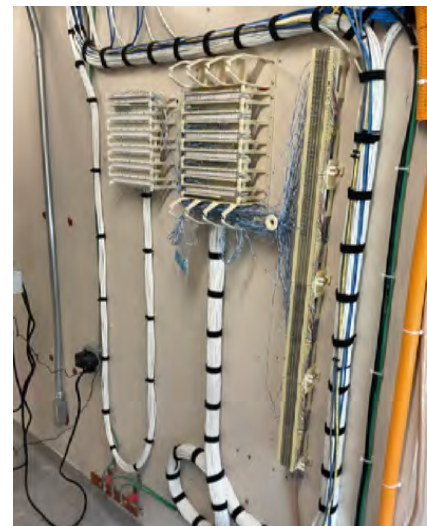
Existing Voice Patching.

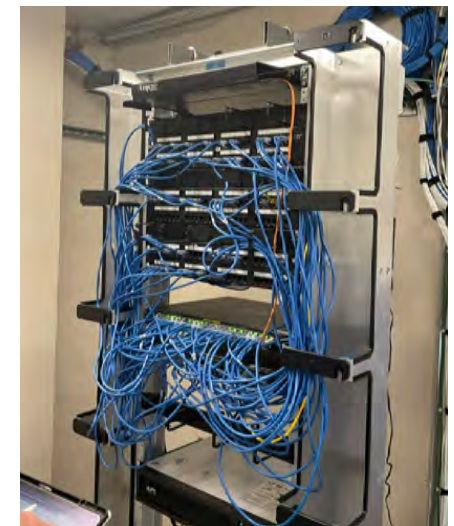
Existing Telecom Rack.

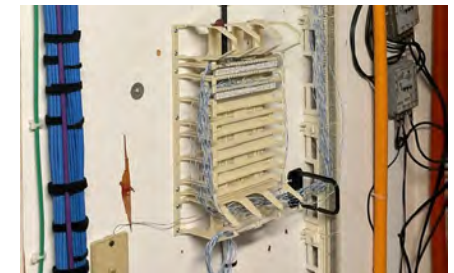
Existing Voice Patching.

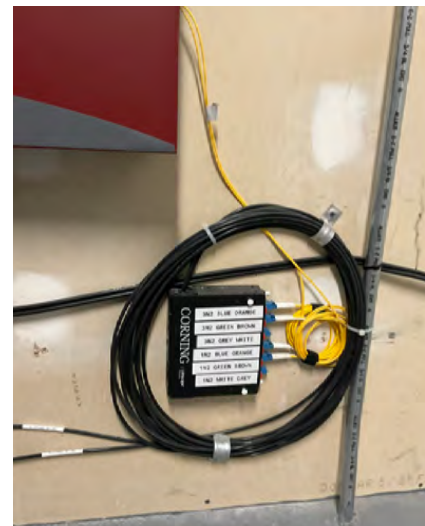
Existing Fire Alarm Fiber.

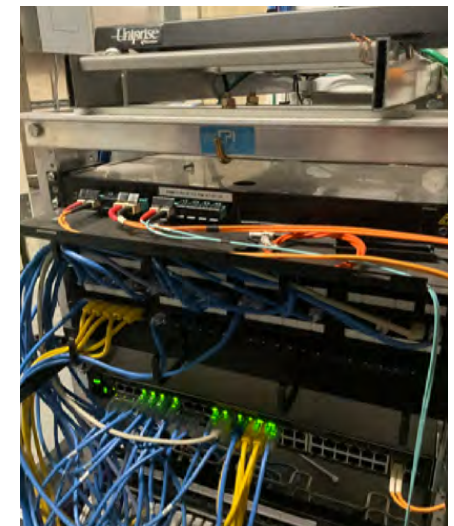
Existing Telecom Rack.

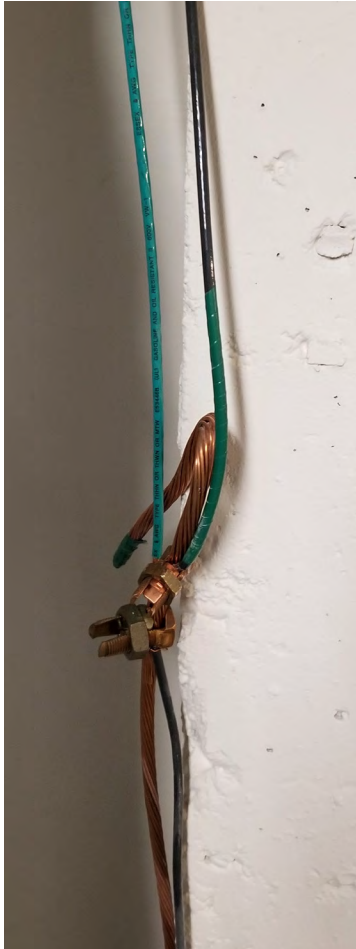
Existing Bonding.

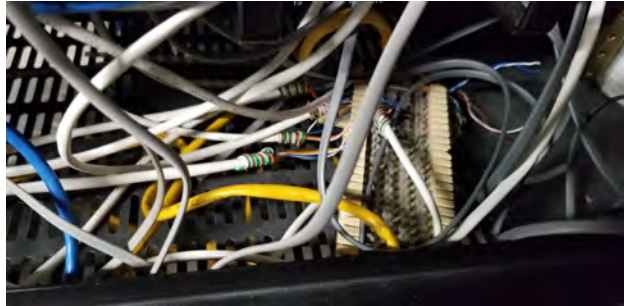
Existing Voice Patching.

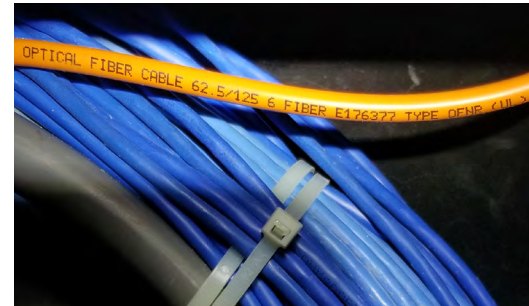
Existing OFC and Category 5e Cabling.

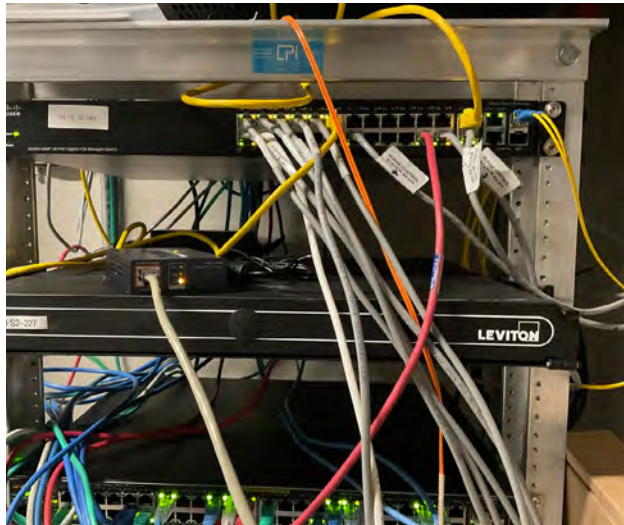
Existing Telecom Rack.

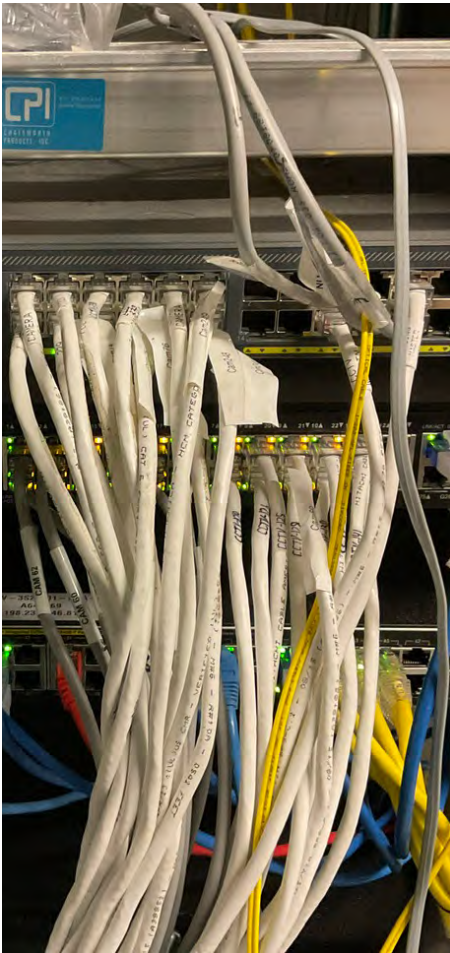
Existing Telecom Rack.

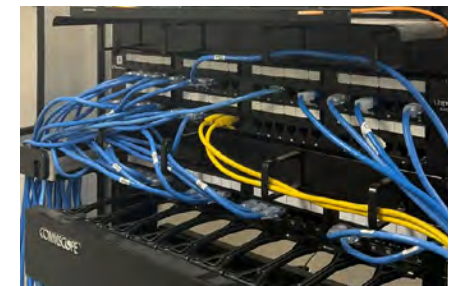
Existing Data Patching.

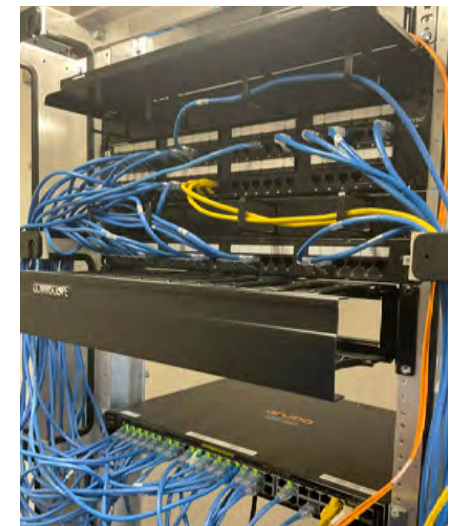
Existing Telecom Rack.

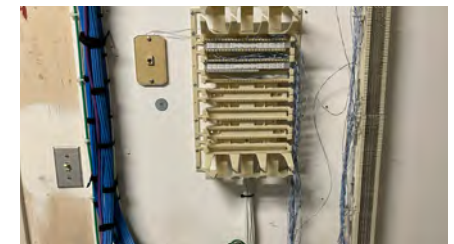
Existing Voice Patching.

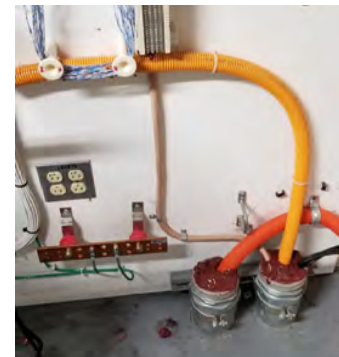
Existing Grounding.

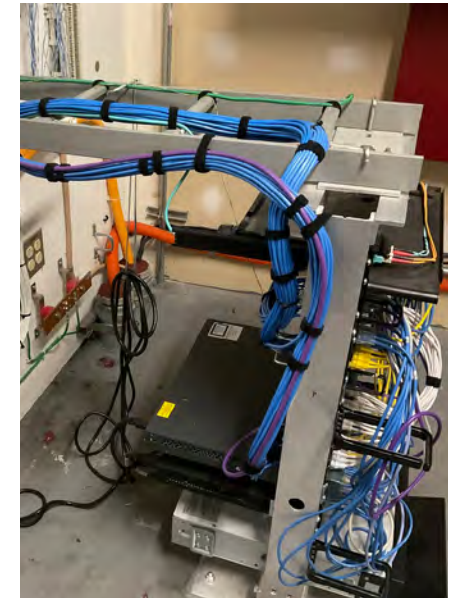
Existing Telecom Rack.

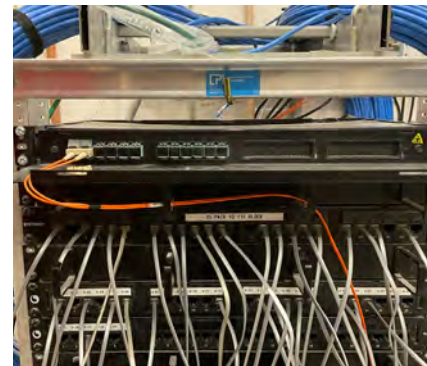
Existing Telecom Rack.

- » Upgrade existing port locations to Category 6A.
- » Add additional Category 6A 8P8C RJ45 ports to meet standards.
- » Provide labels for all new cabling and existing cables to remain.
- » Provide new 12-strand OS2 single-mode and 12-strand OM4 multi-mode optical fiber backbone from ESH MER in the Admin Building.
- » Add ladder tray and cable management as needed.
- » Add ductless split-system cooling unit.
- » Add power circuits and receptacles as needed.

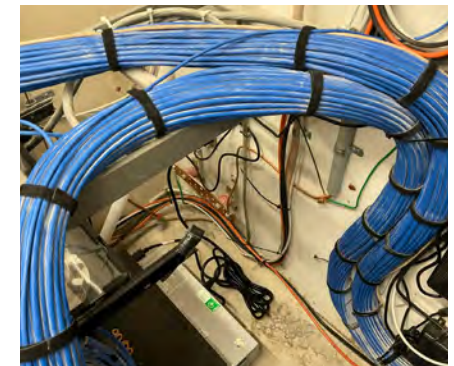
Existing Category 5e Cabling.

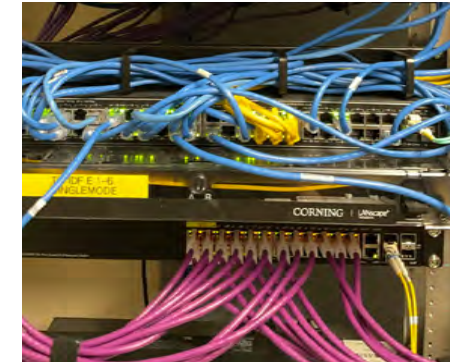
Existing Data Patching.

- » Upgrade existing port locations to Category 6A.
- » Add additional Category 6A 8P8C RJ45 ports to meet standards.
- » Provide labels for all new cabling and existing cables to remain.
- » Provide new 12-strand OS2 single-mode and 12-strand OM4 multi-mode optical fiber backbone from ESH MER in the Admin Building.
- » Add ladder tray and cable management as needed.
- » Add ductless split-system cooling unit.
- » Add power circuits and receptacles as needed.
- » UPS should be replaced with a properly sized UPS to handle the electrical load and duration.

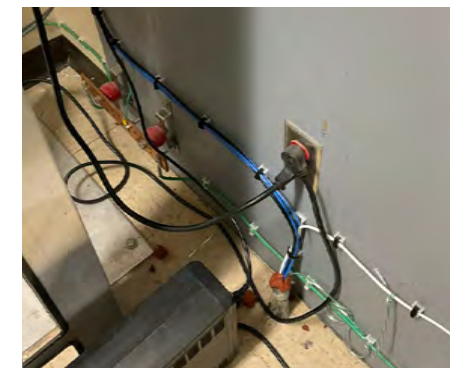
Existing Grounding.

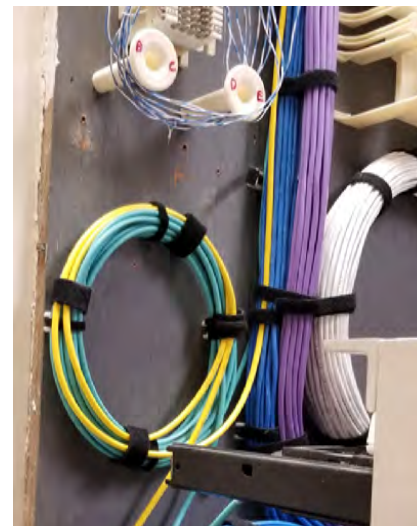
Existing Cabling.

- » Upgrade existing port locations to Category 6A.
- » Add additional Category 6A 8P8C RJ45 ports to meet standards.
- » Provide labels for all new cabling and existing cables to remain.
- » Provide new 12-strand OS2 single-mode and 12-strand OM4 multi-mode optical fiber backbone from ESH MER in the Admin Building.
- » Add ladder tray and cable management as needed.
- » Add ductless split-system cooling unit.
- » Add power circuits and receptacles as needed.
- » UPS should be replaced with a properly sized UPS to handle the electrical load and duration.

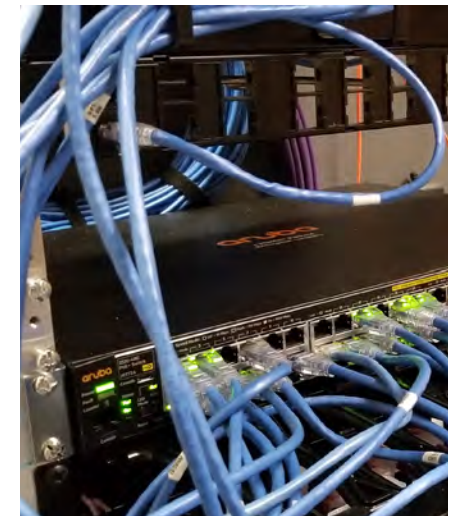
Existing Telecom Rack.

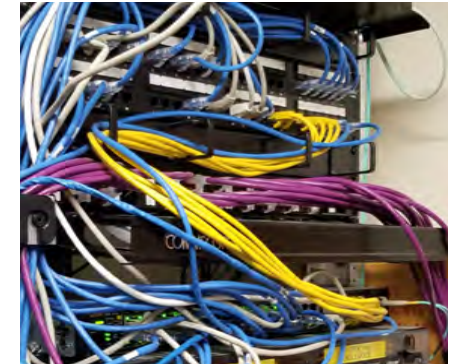
Existing Cabling.

- » Upgrade existing port locations to Category 6A.
- » Add additional Category 6A 8P8C RJ45 ports to meet standards.
- » Provide labels for all new cabling and existing cables to remain.
- » Provide new 12-strand OS2 single-mode and 12-strand OM4 multi-mode optical fiber backbone from ESH MER in the Admin Building.
- » Add ladder tray and cable management as needed.
- » Add ductless split-system cooling unit.
- » Add power circuits and receptacles as needed.
- » UPS should be replaced with a properly sized UPS to properly handle the electrical load and duration.

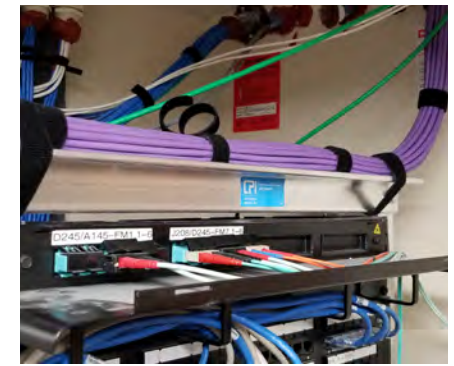
Existing Fiber Cabinet.

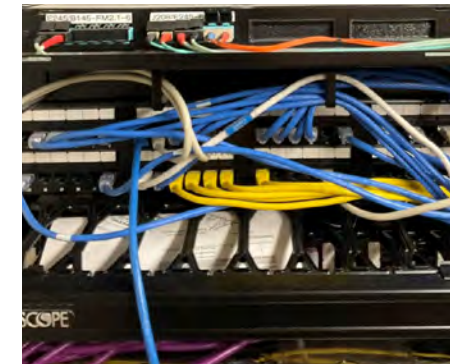
Existing Data Patching.

- » Upgrade existing port locations to Category 6A.
- » Add additional Category 6A 8P8C RJ45 ports to meet standards.
- » Provide labels for all new cabling and existing cables to remain.
- » Provide new 12-strand OS2 single-mode and 12-strand OM4 multi-mode optical fiber backbone from ESH MER in the Admin Building.
- » Add ladder tray and cable management as needed.
- » Add ductless split-system cooling unit.
- » Add power circuits and receptacles as needed.
- » UPS should be replaced with a properly sized UPS to properly handle the electrical load and duration.

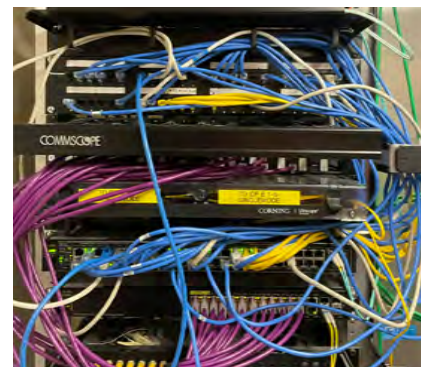
Existing Telecom Rack.

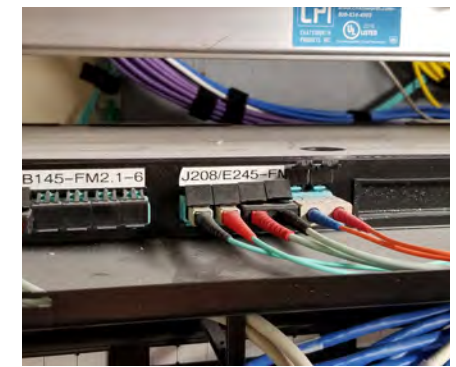
Existing Fiber Patching Mismatch.

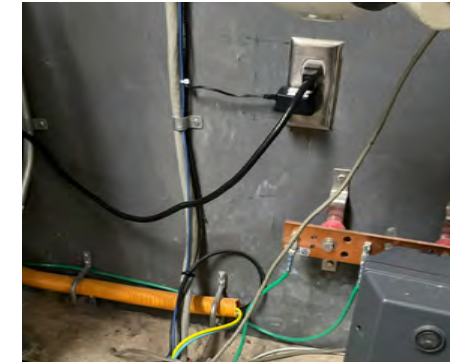
Existing Grounding.

- » Upgrade existing port locations to Category 6A.
- » Add additional Category 6A 8P8C RJ45 ports to meet standards.
- » Provide labels for all new cabling and existing cables to remain.
- » Provide new 12-strand OS2 single-mode and 12-strand OM4 multi-mode optical fiber backbone from ESH MER in the Admin Building.
- » Add ladder tray and cable management as needed.
- » Add ductless split-system cooling unit.
- » Add power circuits and receptacles as needed.
- » UPS should be replaced with a properly sized UPS to properly handle the electrical load and duration.

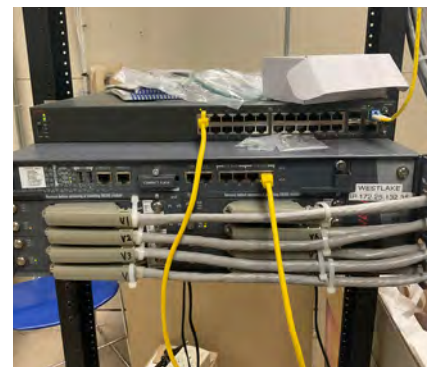
Existing Fiber Cabinets.

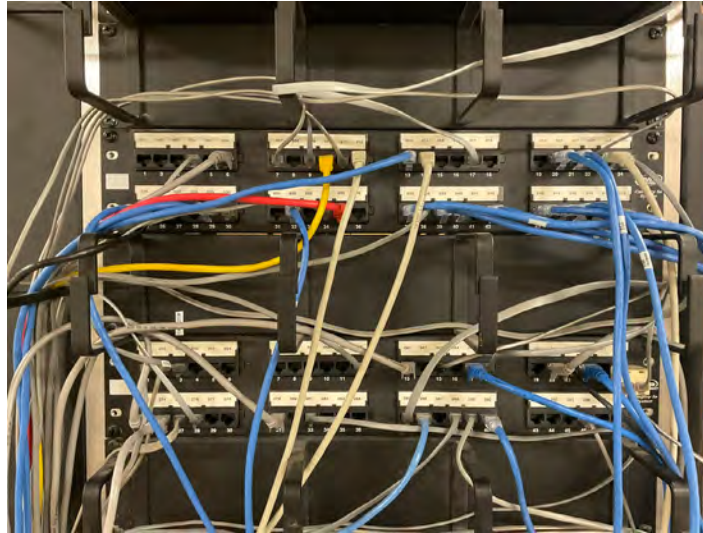
Existing Data and Voice Patching

- » Upgrade existing port locations to Category 6A.
- » Add additional Category 6A 8P8C RJ45 ports to meet standards.
- » Provide labels for all new cabling and existing cables to remain.
- » Provide new 12-strand OS2 single-mode and 12-strand OM4 multi-mode optical fiber backbone from ESH MER in the Admin Building.
- » Add ladder tray and cable management as needed.
- » Add Telecommunications Grounding Busbar if needed.
- » Add ductless split-system cooling unit.
- » Add power circuits and receptacles as needed.
- » UPS should be replaced with a ups sized to properly handle the electrical load and duration.

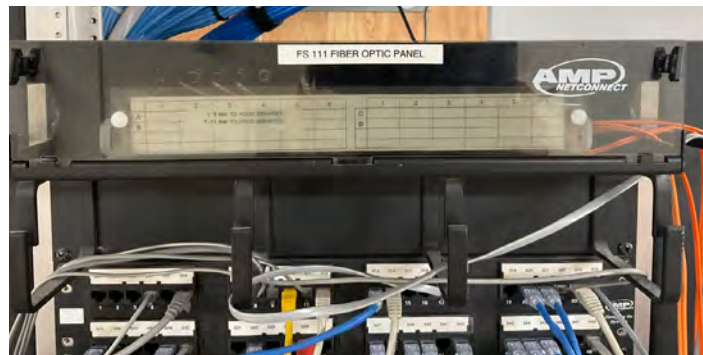
Existing Fiber Cabinet.

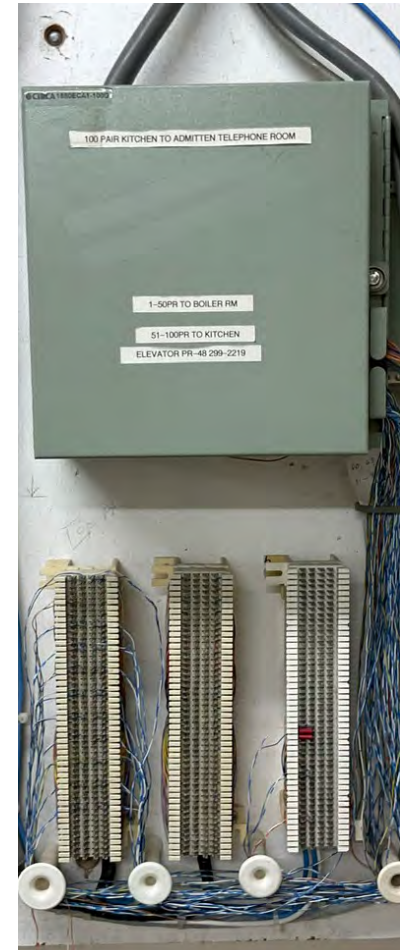
Existing Voice Patching.

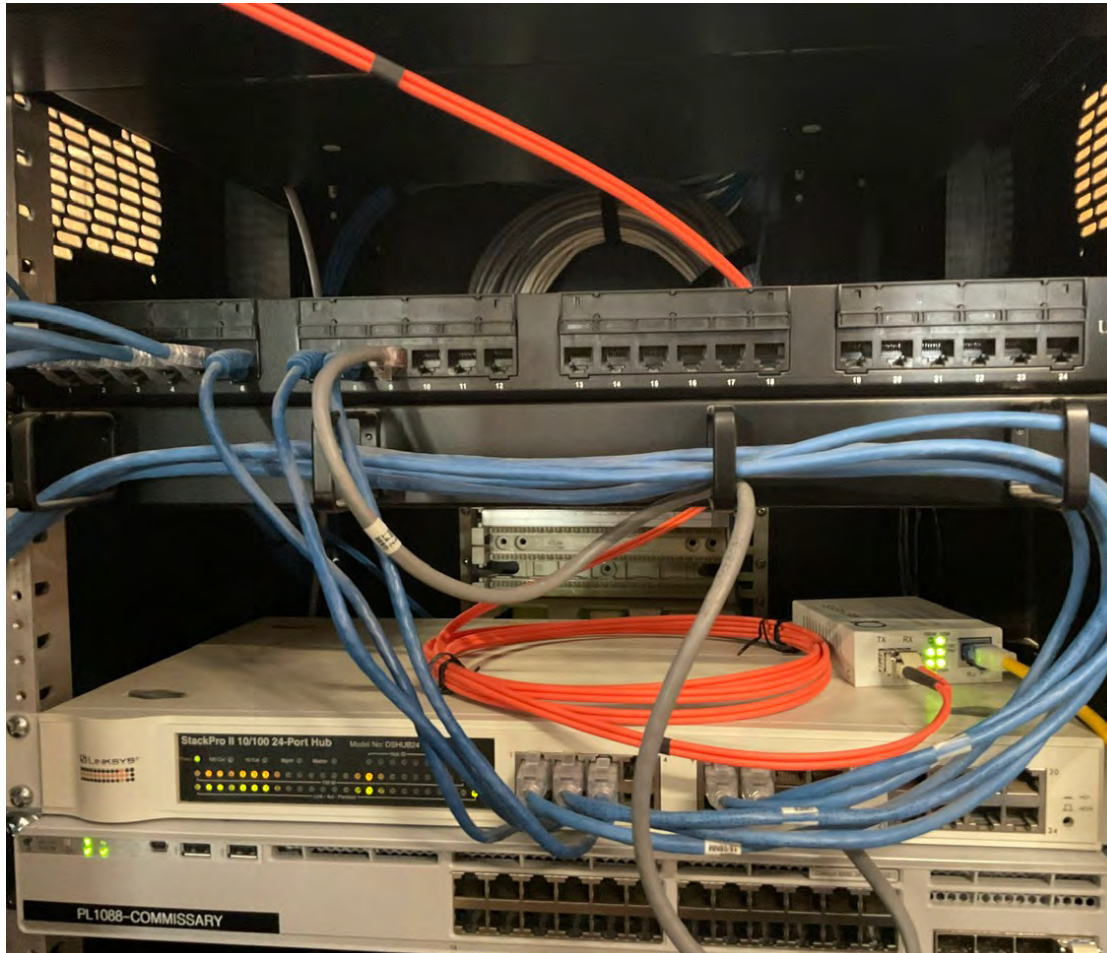
Existing Telecom Enclosure

- » Upgrade existing port locations to Category 6A.
- » Add additional Category 6A 8P8C RJ45 ports to meet standards.
- » Provide labels for all new cabling and existing cables to remain.
- » Provide new 12-strand OS2 single-mode and 12-strand OM4 multi-mode optical fiber backbone from ESH MER in the Admin Building.
- » Add ladder tray and cable management as needed.
- » Add Telecommunications Grounding Busbar if needed.
- » Add ductless split-system cooling unit.
- » Add power circuits and receptacles as needed.
- » UPS should be replaced with a ups sized to properly handle the electrical load and duration.

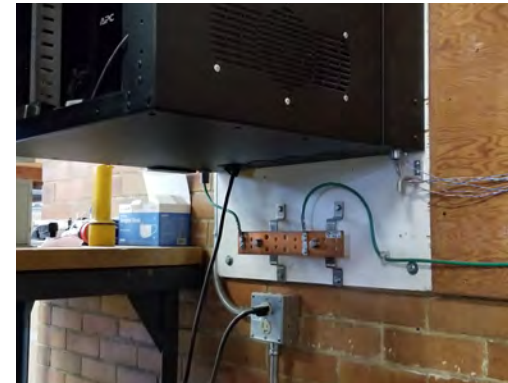
Existing Grounding.

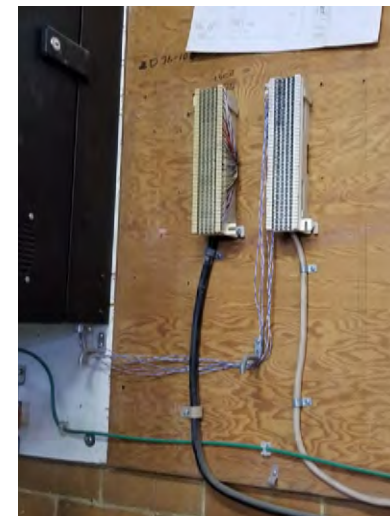
Existing Voice Patching.

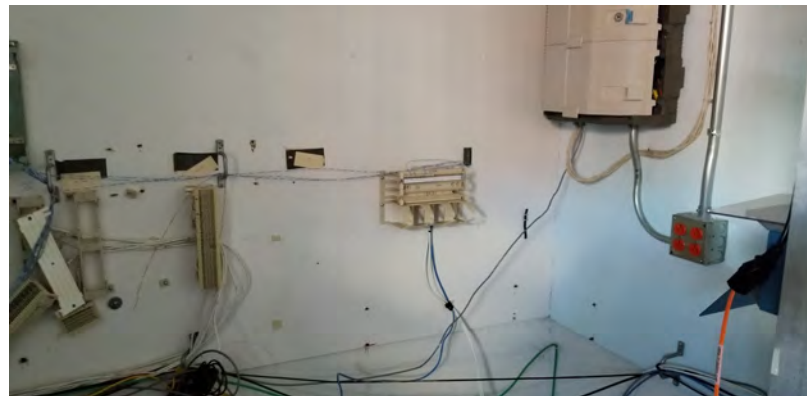
The building is decommissioned and the TR has been mostly demolished.

Existing Voice Patching.

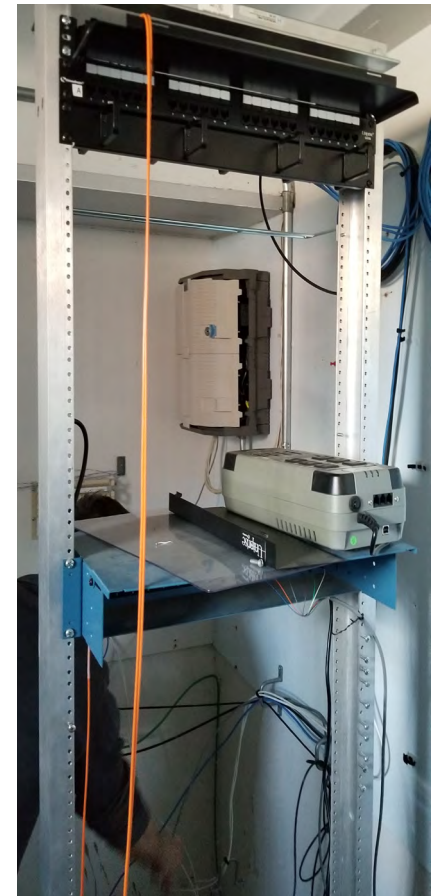
Existing Telecom Rack.

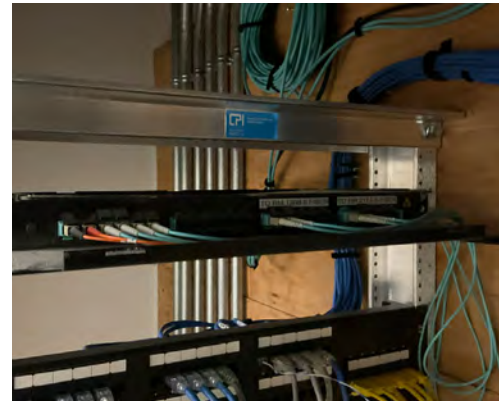
Existing Mismatch Fiber Patching.

- » Upgrade existing port locations to Category 6A.
- » Add additional Category 6A 8P8C RJ45 ports to meet standards.
- » Provide labels for all new cabling and existing cables to remain.
- » Provide new 12-strand OS2 single-mode and 12-strand OM4 multi-mode optical fiber backbone from ESH MER in the Admin Building.
- » Add ladder tray and cable management as needed.
- » Add Telecommunications Grounding Busbar.
- » Add ductless split-system cooling unit.
- » Add power circuits and receptacles as needed.
- » A properly sized UPS should be installed.

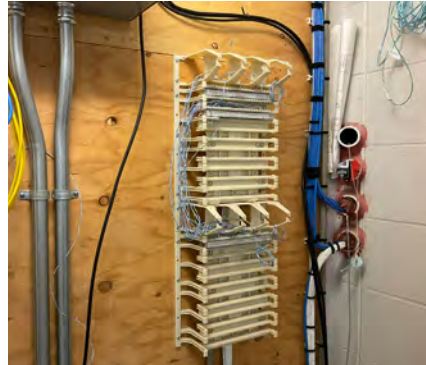
Existing Voice Patching.

- » Upgrade existing port locations to Category 6A.
- » Add additional Category 6A 8P8C RJ45 ports to meet standards.
- » Provide labels for all new cabling and existing cables to remain.
- » Provide new 12-strand OS2 single-mode and 12-strand OM4 multi-mode optical fiber backbone from ESH MER in the Admin Building.
- » Add ladder tray and cable management as needed.
- » Add Telecommunications Grounding Busbar as needed.
- » Add ductless split-system cooling unit.
- » Add power circuits and receptacles as needed.
- » UPS should be replaced with a ups sized to properly handle the electrical load and duration.

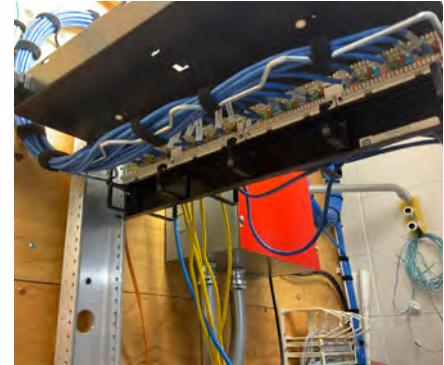
Existing Data Patching.
