EASTERN STATE HOSPITAL

WA STATE PROJECT NUMBER: 2024-429 C (3)

EXECUTIVE SUMMARY

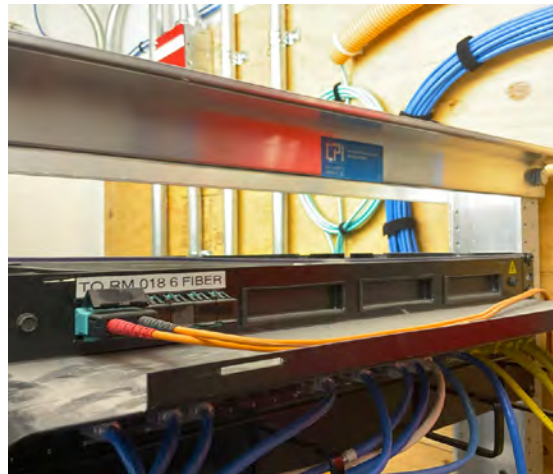
Existing Fiber Cabinet.

- » Upgrade existing port locations to Category 6A.
- » Add additional Category 6A 8P8C RJ45 ports to meet standards.
- » Provide labels for all new cabling and existing cables to remain.
- » Provide new 12-strand OS2 single-mode and 12-strand OM4 multi-mode optical fiber backbone from ESH MER in the Admin Building.
- » Add ladder tray and cable management as needed.
- » Add Telecommunications Grounding Busbar as needed.
- » Add ductless split-system cooling unit.
- » Add power circuits and receptacles as needed.
- » UPS should be replaced with a ups sized to properly handle the electrical load and duration.

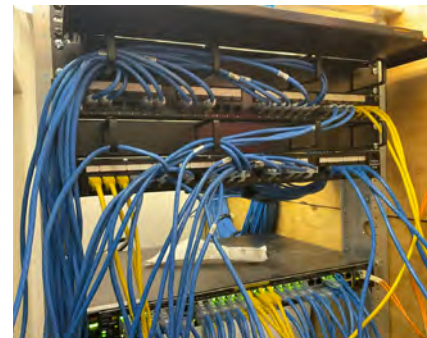
Existing Data Patching.

- » Upgrade existing port locations to Category 6A.
- » Add additional Category 6A 8P8C RJ45 ports to meet standards.
- » Provide labels for all new cabling and existing cables to remain.
- » Provide new 12-strand OS2 single-mode and 12-strand OM4 multi-mode optical fiber backbone from ESH MER in the Admin Building.
- » Add ladder tray and cable management as needed.
- » Add ductless split-system cooling unit.
- » Add power circuits and receptacles as needed.

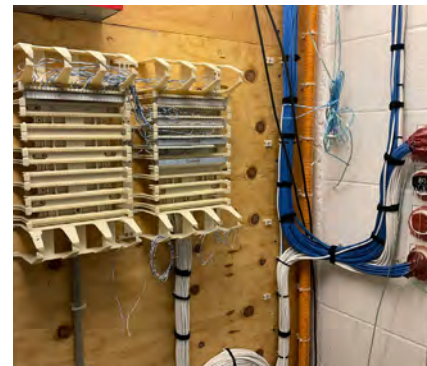
Existing Voice Patching.

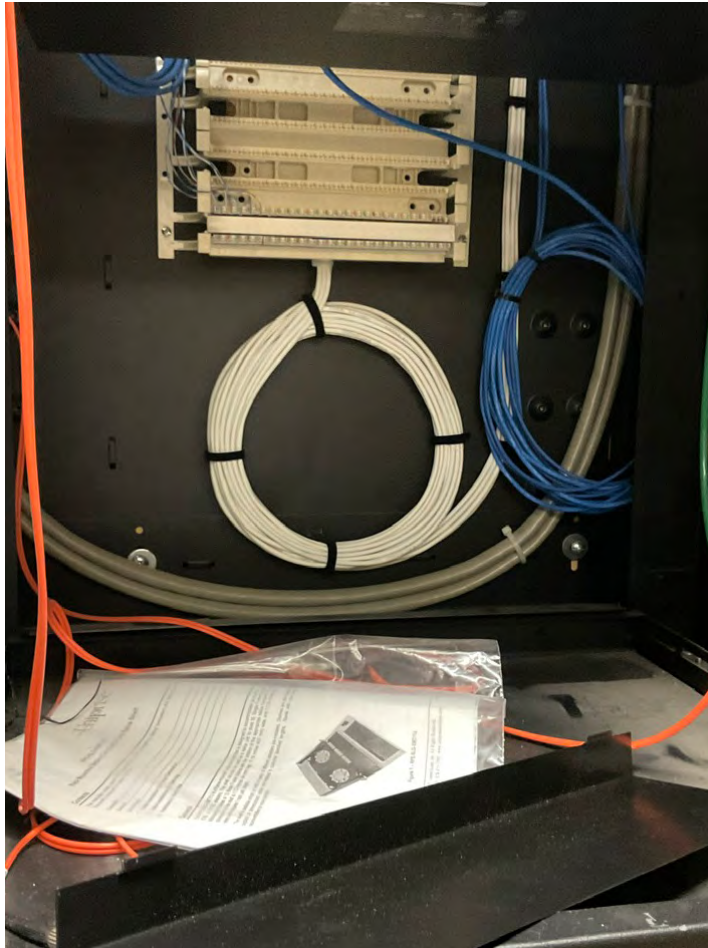
Existing Voice Patching.

- » Upgrade existing port locations to Category 6A.
- » Add additional Category 6A 8P8C RJ45 ports to meet standards.
- » Provide labels for all new cabling and existing cables to remain.
- » Provide new 12-strand OS2 single-mode and 12-strand OM4 multi-mode optical fiber backbone from ESH MER in the Admin Building.
- » Add ladder tray and cable management as needed.
- » Add Telecommunications Grounding Busbar.
- » Add ductless split-system cooling unit.
- » Add power circuits and receptacles as needed.
- » A properly sized UPS should be installed.

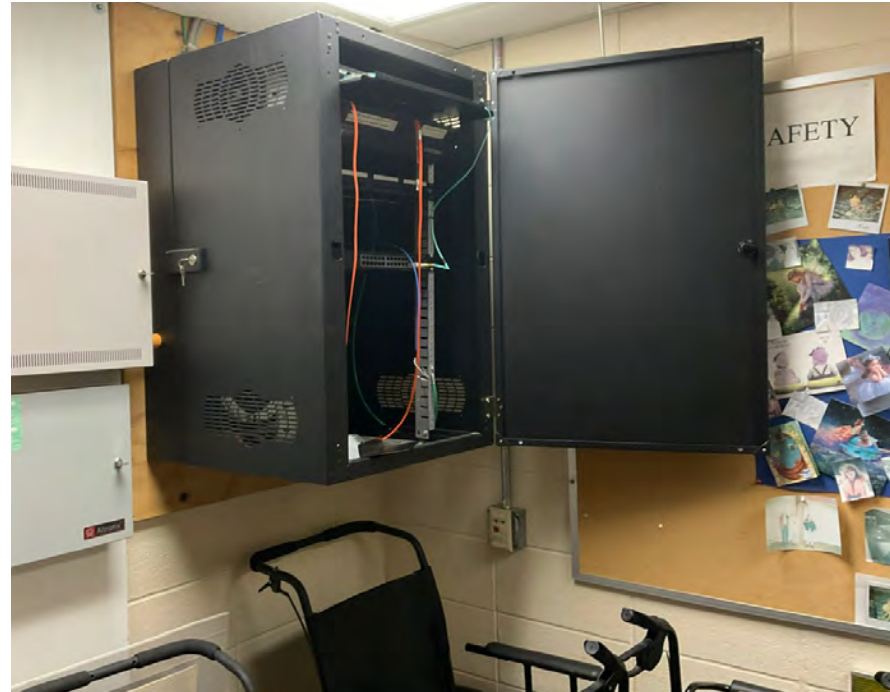
Existing Telecom Enclosure.

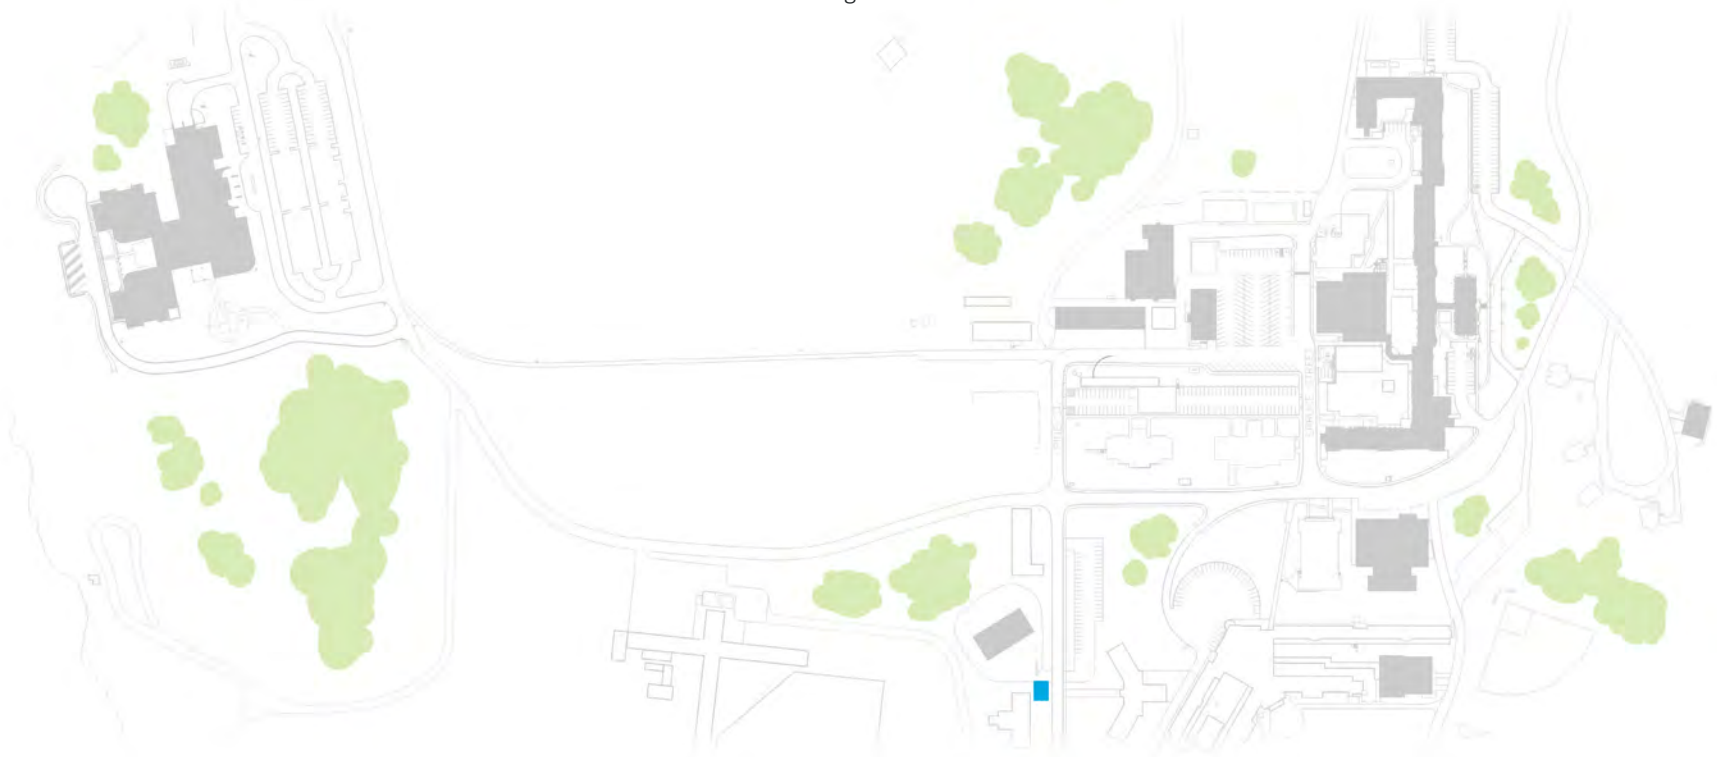
WATER TANK (NORTH OF CAMPUS)

NO ROOM NUMBER - TR

Primarily dedicated to radio equipment and connected via copper this TR is located within a small building next to the water tank.
