DSHS RAINIER SCHOOL

WA STATE PROJECT NUMBER: 2024-429 K (8)

EXECUTIVE SUMMARY

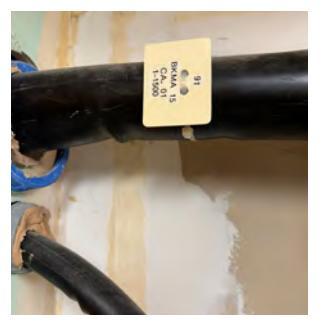
Existing Copper Backbone.

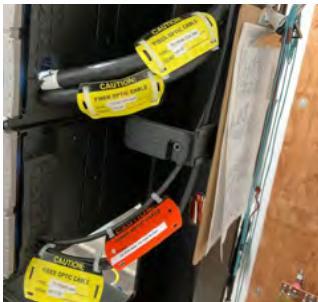
Existing Fiber Backbone.

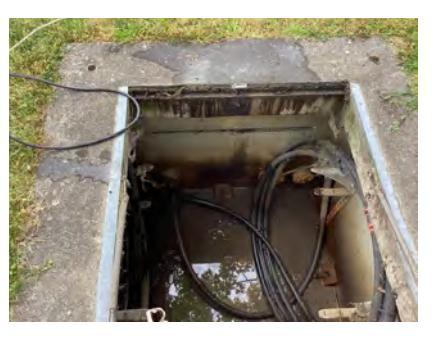
Existing Interbuilding Backbone Cabling.

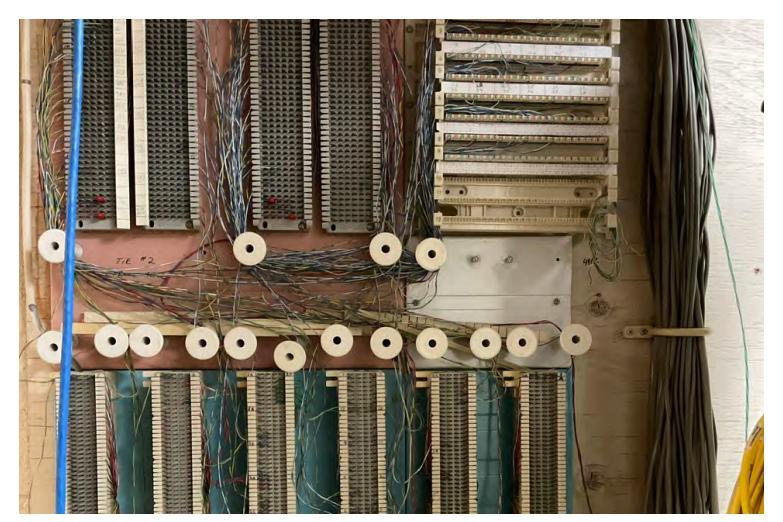
Existing Intrabuilding Backbone.

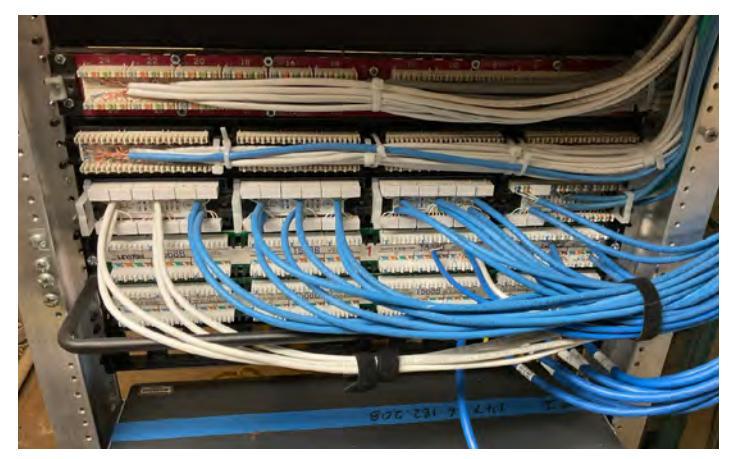
Existing Category 5e Cabling.

The existing Category 5e infrastructure is not adequate to meet the current and future needs of Rainier School nor does it comply with TIA standards for infrastructure in healthcare facilities. It is recommended that the existing cabling infrastructure be replaced with a new Category 6A cabling infrastructure and that additional data ports be added throughout the facility to provide employees with an adequate quantity of network port connections to support required device connections. New cabling infrastructure installation requires cabling to be secured and outlet boxes to be fitted with the appropriate faceplates to protect the cabling.

Meeting TIA-1179 standards will require the entire channel to be Category 6A certified. Meeting this standard will require all new patch panels, modular jacks, and wall outlets comprising a replacement of the entire infrastructure. Existing Category 5 and 5e patch panels will be removed in favor of the Category 6A infrastructure. See Sequencing and Recommendations for sequencing of the project to minimize down time while the infrastructure is replaced.

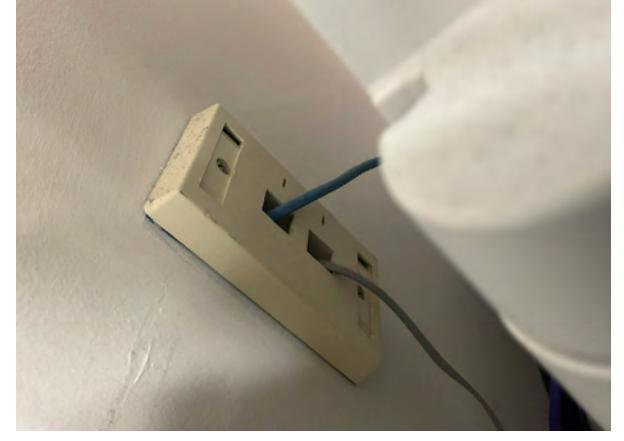
Existing Voice and Data Outlet.

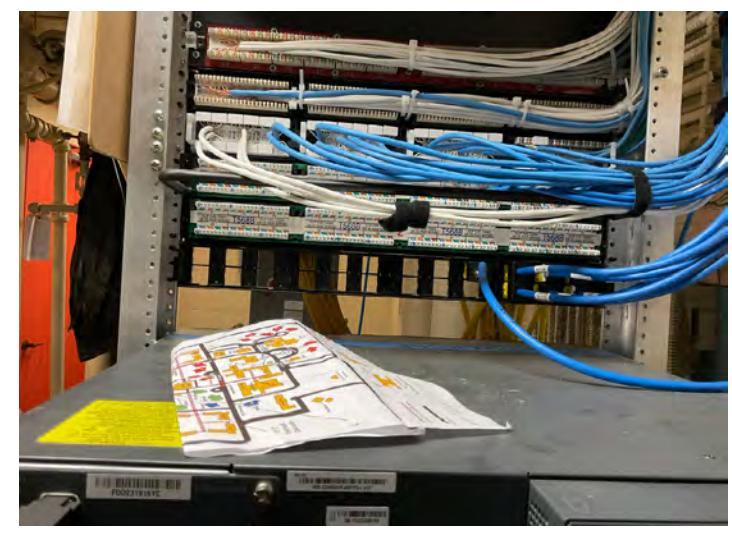
Telecommunications Room TR-004 is in the basement. There is no dedicated telecommunications room. The space is a pump room, and the telecommunications equipment shares spaces with mechanical pumps. There is a single floor mounted rack with a rack mount fiber cabinet along with multiple copper patch panels and network switches. Connectivity is provided by a 24-strand OM1 multi-mode optical fiber backbone cable from TR-74. There is space for expansion on the existing rack. Neither a telecommunications grounding busbar nor dedicated cooling were observed within the room. Electrical infrastructure is not standards compliant.

- » No dedicated telecommunications room.
- » Horizontal Cabling infrastructure does not meet minimum standards per TIA-1179.
- » Backbone Cabling Infrastructure does not meet minimum standards per TIA-1179.
- » Minimal cable support, leading to cables being draped or placed directly on equipment.
- » No grounding busbar for the telecommunications equipment.
- » No dedicated cooling system to maintain temperature of equipment.
- » Electrical infrastructure does not meet minimum requirements per standards.

Existing Data Patching.

- » Provide a dedicated telecommunications room.
- » Upgrade existing port locations to Category 6A.
- » Provide labels for all new cabling and existing cables to remain.
- » Add additional Category 6A 8P8C RJ45 ports to meet standards.
- » Provide new 12-strand single-mode and 12-strand OM4 multimode optical fiber backbone from the MER.
- » Add proper grounding Telecommunications Grounding Busbar.
- » Add cable management as needed.
- » Add dedicated cooling system.
- » Add power circuits and receptacles as needed.
- » Control access to authorized individuals.

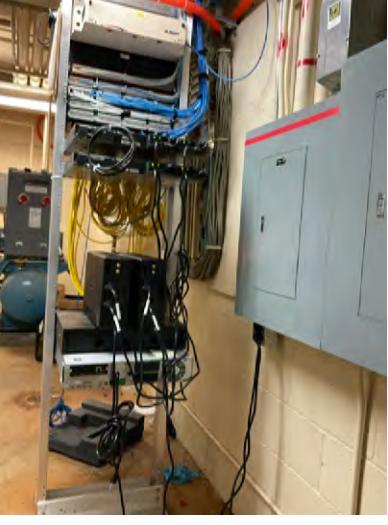
Existing Telecom Rack.

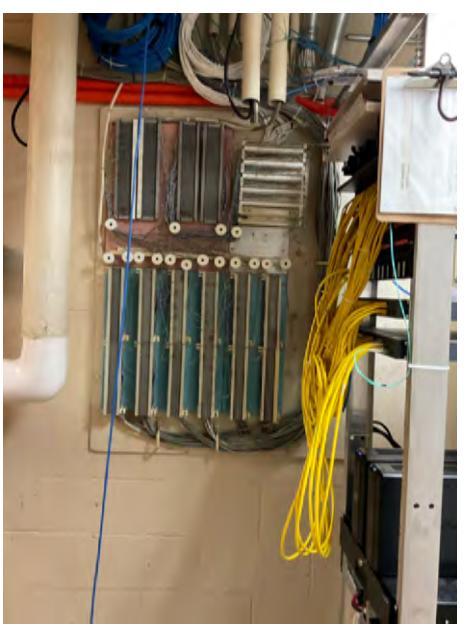
Existing Voice Patching.

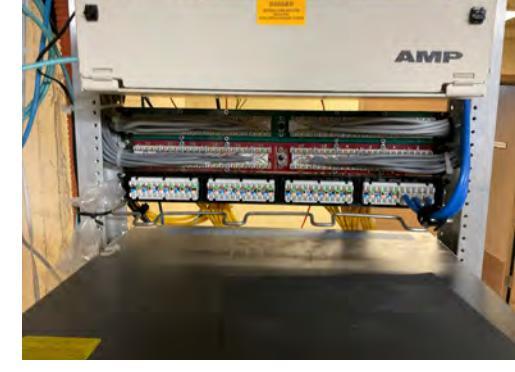
The existing telecommunications space is not standards compliant. The existing backbone and horizontal cabling do not meet current TIA standards for healthcare facilities. To meet industry standards, it is recommended to provide a new, dedicated telecommunications room with standards compliant backbone and horizontal cabling. Additional Category 6A data ports should be provided as required to meet standards. Dedicated cooling, rack space, cable management, and proper grounding are required to meet current standards. The addition of card-based access control is recommended to control and track access to the space.

Existing Data Patching.

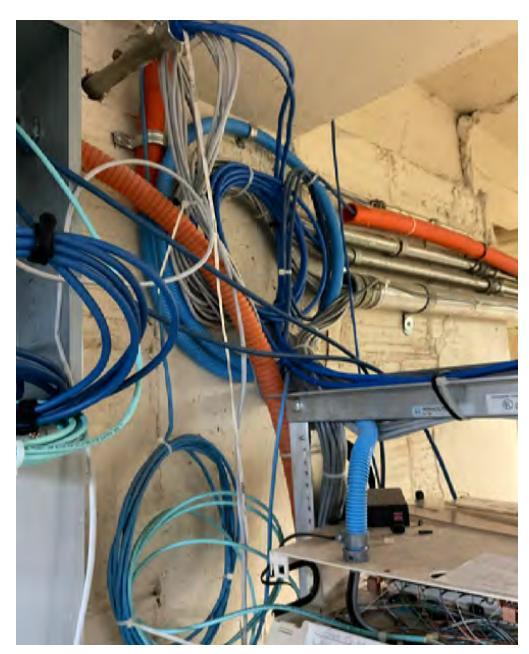
Existing Cables in Telecom Room.

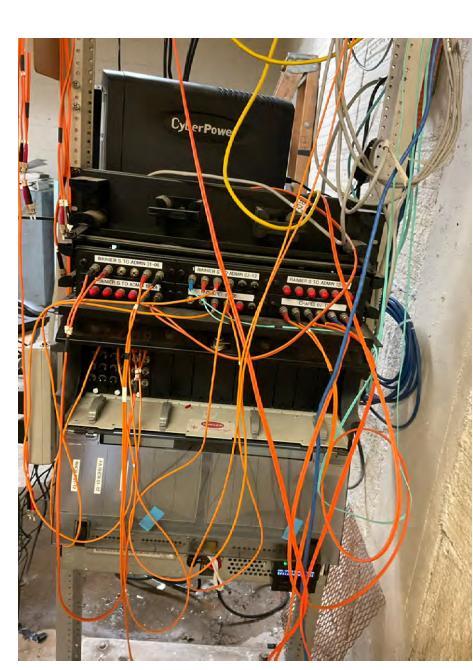
Existing Fiber Patching.

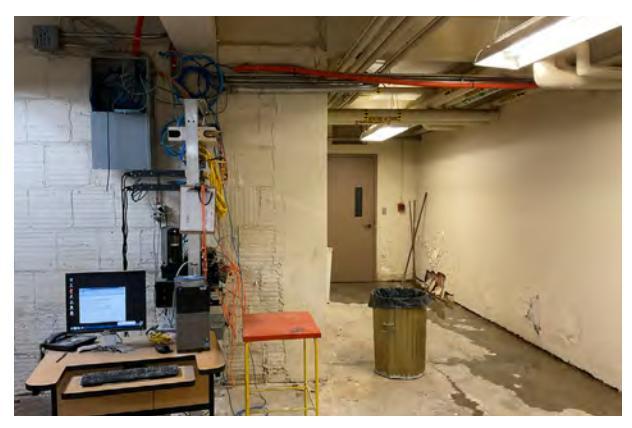
Existing Telecom Room Layout.

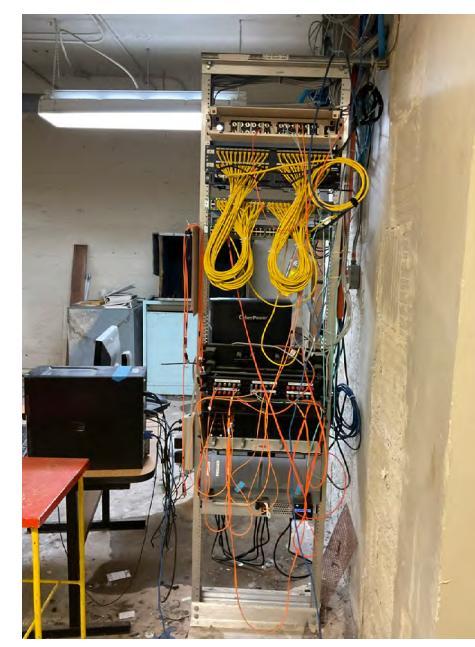
Existing Telecom Rack.

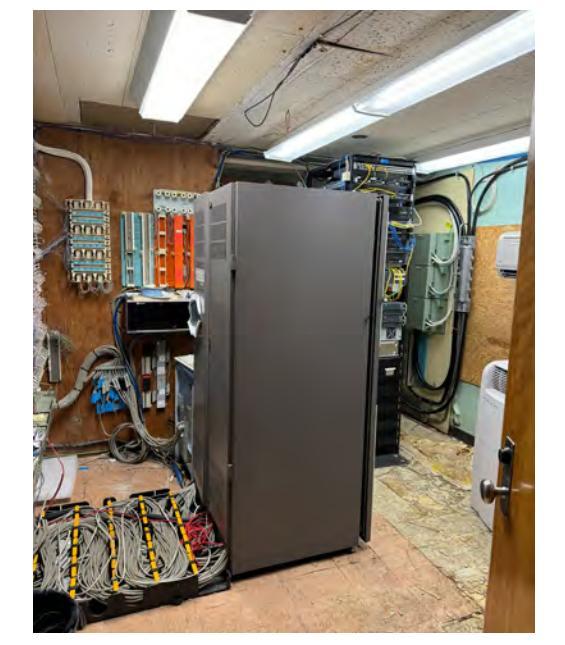
Telecommunications Room, TR-Basement, is in the basement of the Administration Building. There is a single rack dedicated to phone headend equipment. The room serves as the central point for the voice backbone cabling on the campus. There is only a copper connection back to the MER. There is no space for expansion on the existing rack, but there is space for an additional rack. Neither a telecommunications grounding busbar nor dedicated cooling were observed within the room.

Existing Telecom Room Layout.

The existing backbone and horizontal cabling do not meet current TIA standards for healthcare facilities. To meet industry standards, it is recommended to upgrade the existing backbone and horizontal cabling. Additional Category 6A data ports should be provided as required to meet standards. Dedicated cooling, and dedicated equipment and convenience receptacles are required to meet standards. The addition of card-based access control is recommended to control and track access to the space.

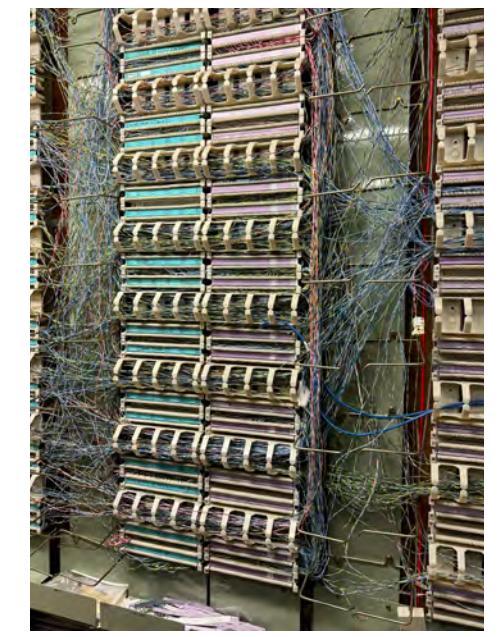
Existing Voice Patching.

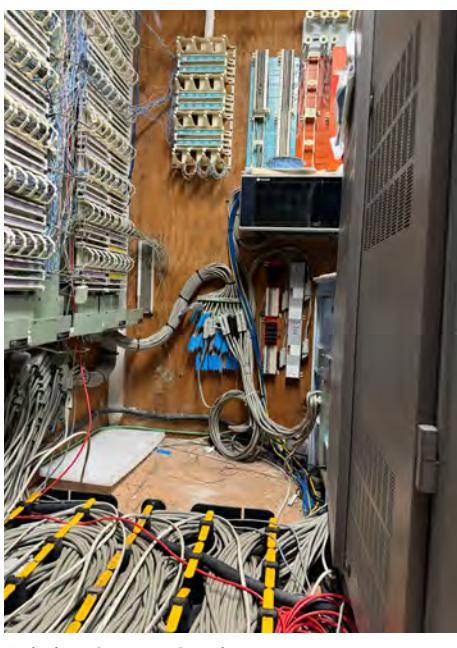
Existing Copper Cabling.

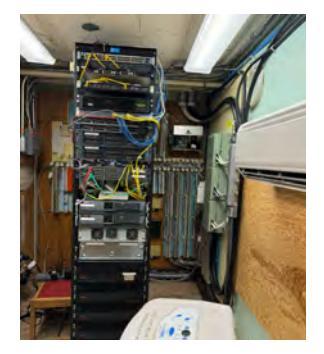
Existing Telecom Rack.

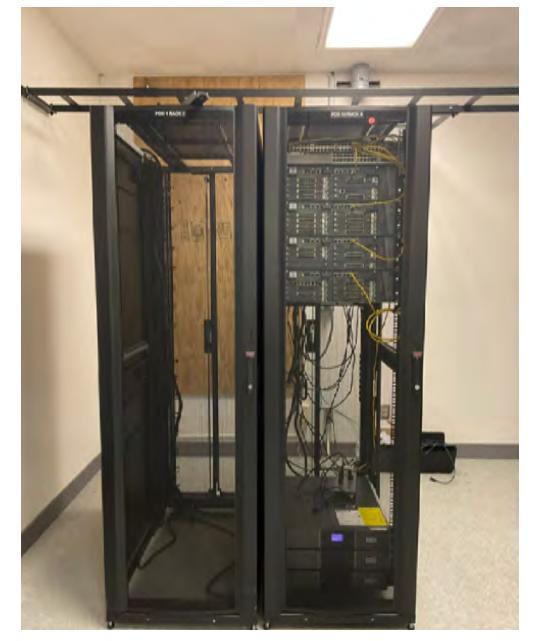
Telecommunications Room, TR-Admin, is on the first floor. It is a dedicated telecommunications room. There are three server enclosures, with only one in use for the Avaya phone system. There is only a copper backbone connection back to the MER. Neither a telecommunications grounding busbar nor dedicated cooling were observed within the room. Electrical infrastructure is not standards compliant.

Existing Telecom Racks.

- » Upgrade existing port locations to Category 6A.
- » Provide labels for all new cabling and existing cables to remain.
- » Add additional Category 6A 8P8C RJ45 ports to meet standards.
- » Provide new 12-strand single-mode and 12-strand OM4 multimode optical fiber backbone from the MER.
- » Add a Telecommunications Grounding Busbar.
- » Add cable management as needed.
- » Add dedicated cooling system.
- » Add power circuits and receptacles as needed.
- » Control access to authorized individuals.

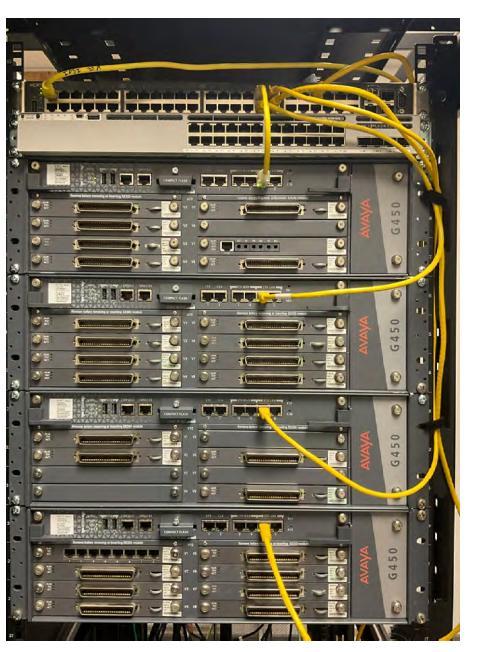
Existing Servers.

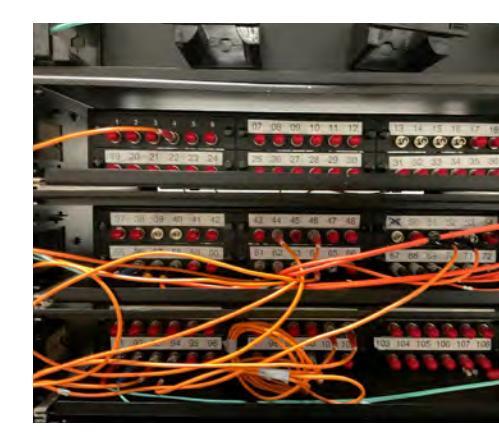
The Main Equipment Room for the campus is on the first floor. There are three telecommunication racks, each containing multiple fiber cabinets, patch panels, UPS, and switches. This room is the main fiber hub for the campus, with 12 or 24 strand OFC backbone cables connecting to most building on campus. There is space for expansion on the existing racks. There is an overhead ladder tray for cable management, but there is no dedicated cooling for temperature and humidity control. There is a grounding busbar present in the room, but not all racks are bonded to it.

Existing Fiber Patching.

- » Upgrade existing port locations to Category 6A.
- » Provide labels for all new cabling and existing cables to remain.
- » Add additional Category 6A 8P8C RJ45 ports to meet standards.
- » Provide new 12-strand single-mode and 12-strand OM4 multimode optical fiber backbone to connected buildings.
- » Add bonding to Telecommunications Grounding Busbar.
- » Add cable management as needed.
- » Add dedicated cooling system.
- » Control access to authorized individuals.

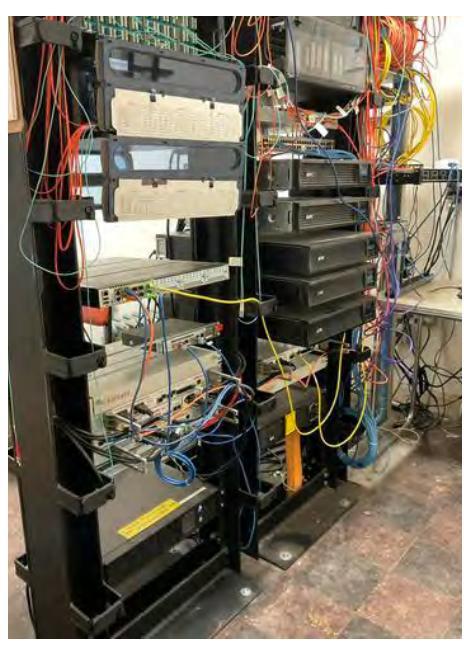
Existing Telecom Racks.

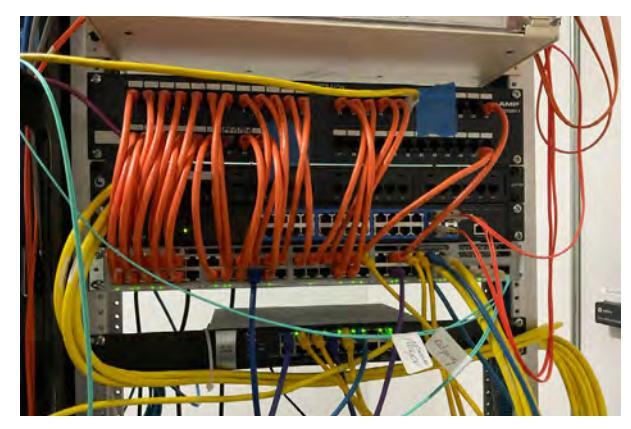
Existing Data Patching.

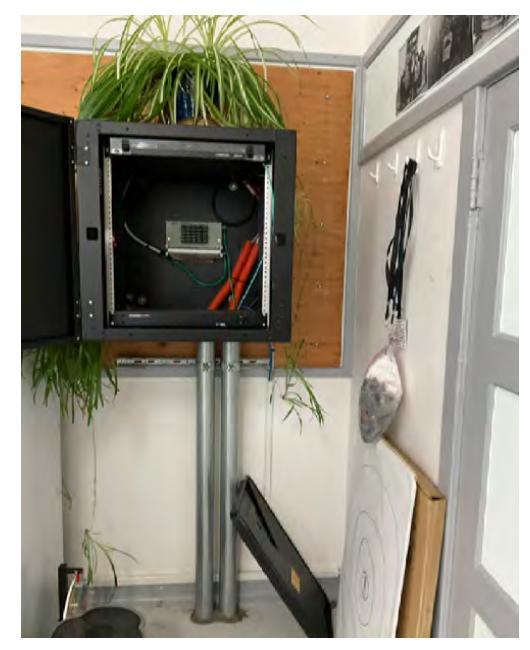
Existing Telecom Cabinet.

While the enclosure is sufficient to meet current needs, it is recommended to move the telecommunications space to a dedicated room. To meet industry standards, it is recommended to upgrade the existing backbone and horizontal cabling. Additional Category 6A data ports are required to meet standards. Dedicated cooling, cable management, and dedicated equipment receptacles are required to meet standards. The addition of card-based access control is recommended to control access and track access to the space.

- » Provide a dedicated telecommunications room.
- » Upgrade existing port locations to Category 6A.
- » Provide labels for all new cabling and existing cables to remain.
- » Add additional Category 6A 8P8C RJ45 ports to meet standards.
- » Provide new 12-strand single-mode and 12-strand OM4 multimode optical fiber backbone from the Administration Building (Building 1).
- » Add Telecommunications Grounding Busbar.
- » Add cable management as needed.
- » Add a dedicated cooling system.

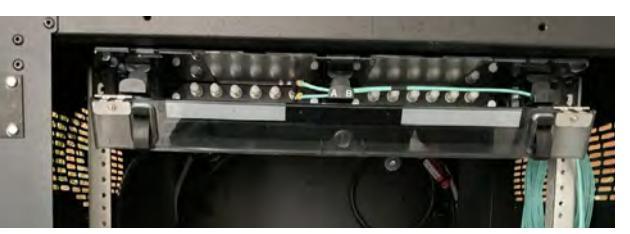
Existing Fiber Patching.

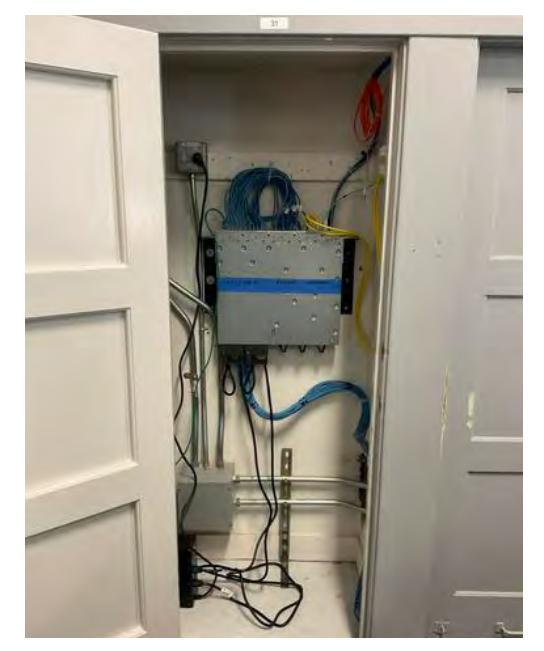
The Telecommunications Room, TR-Closet, is in a supply closet. There is no dedicated telecommunications room. There is a single UPS on the floor and ethernet switch mounted on the wall. There is a 2-strand OM3 multi-mode optical fiber backbone cable from TR-Conference that connects to the switch. There is no space for expansion. There is no dedicated cooling for temperature and humidity control.

Existing Telecom Closet.

Due to the small size of the room, it is recommended that the telecommunications room be abandoned, with all cabling and equipment relocated to the new TR-Conference telecommunications room.

» Abandon the room and relocate all telecom equipment and cabling to the new TR-Conference telecommunications room.

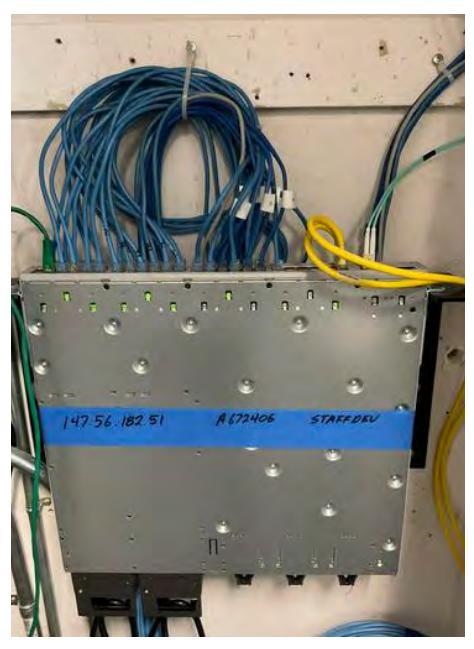
Existing Data Patching.

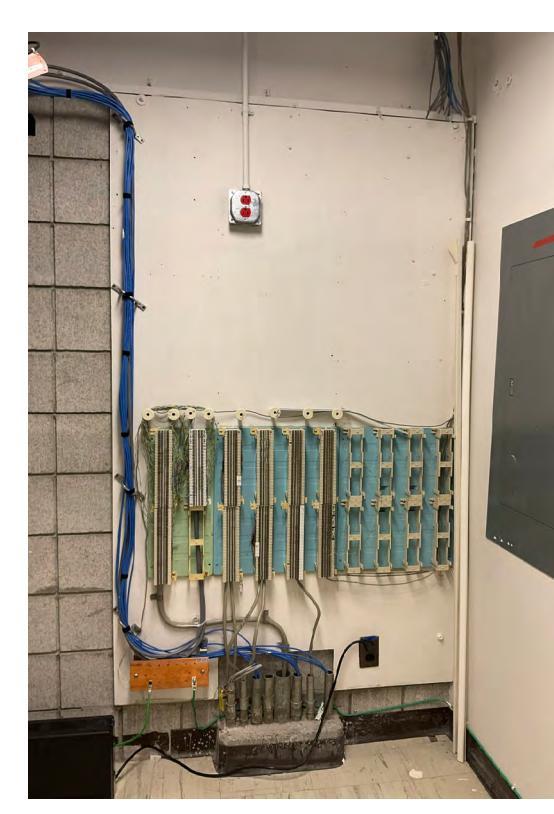
The existing backbone and horizontal cabling do not meet current TIA standards for healthcare facilities. To meet industry standards, it is recommended to upgrade the existing backbone and horizontal cabling. Additional Category 6A data ports should be provided as required to meet standards. Dedicated cooling, and dedicated equipment and convenience receptacles are required to meet standards. The addition of card-based access control is recommended to control and track access to the space.

Existing Voice Patching.

- » Upgrade existing port locations to Category 6A.
- » Provide labels for all new cabling and existing cables to remain.
- » Add additional Category 6A 8P8C RJ45 ports to meet standards.
- » Provide new 12-strand single-mode and 12-strand OM4 multimode optical fiber backbone from the Administration Building (Building 1).
- » Add a dedicated cooling system.
- » Add power circuits and receptacles as needed.
- » Control access to authorized individuals.
- » Bond telecommunications equipment to the existing telecommunications grounding busbar.

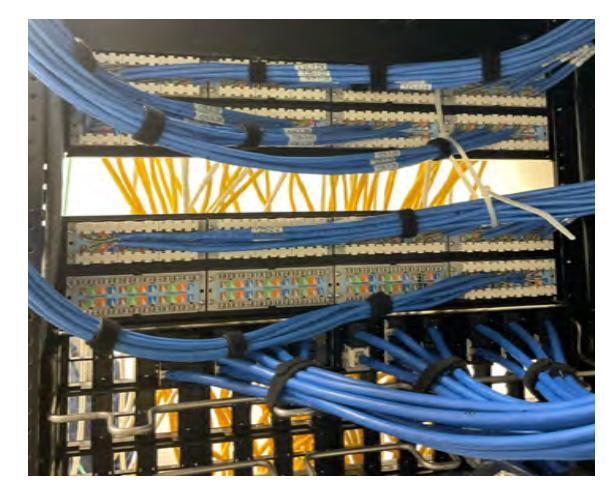
Existing Data Patching.

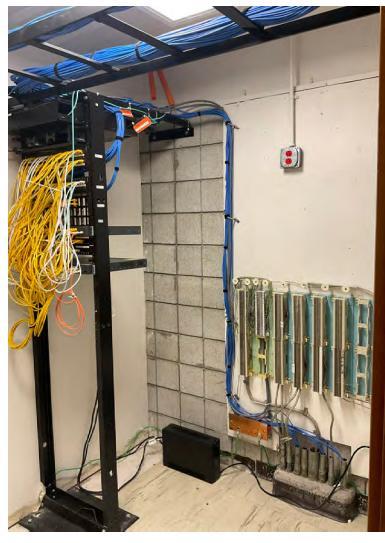
Existing Telecom Room Overall Plan.

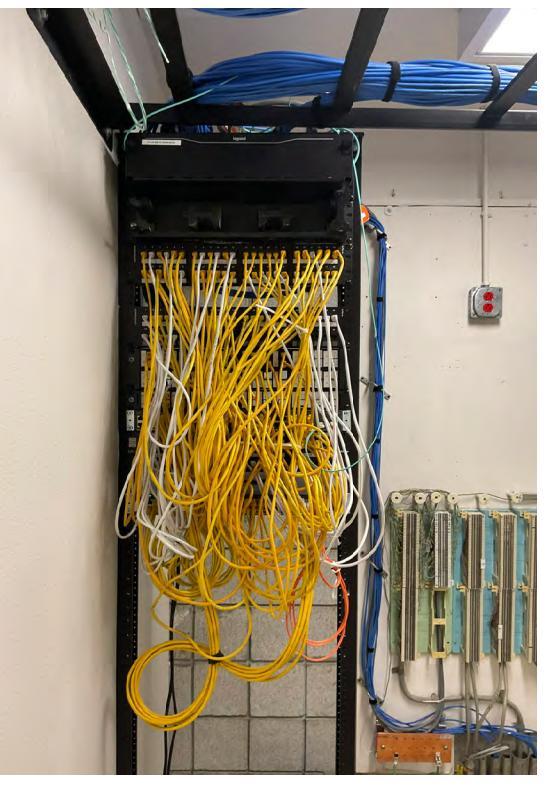
Existing Telecom Racks.

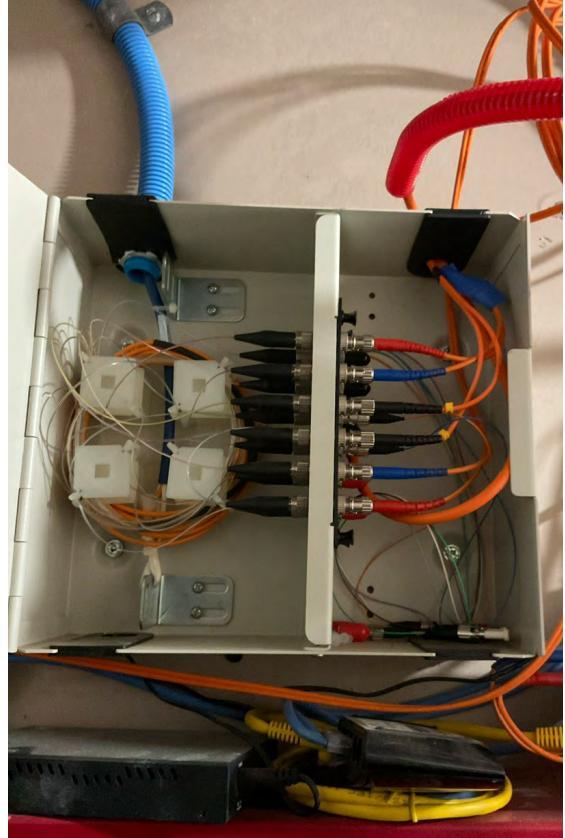
Telecommunications Room TR-Chapel contains a single wall mount fiber cabinet with 12-strand OM1 multi-mode optical fiber backbone cable and a 25-pair Category 3 twisted-pair copper backbone cable from the Administration Building 1. The room is very small and is not a dedicated telecommunications space. From the wall mount fiber cabinet, two strands of fiber connect to a media converter that then connects to a wireless access point in the room. Neither a telecommunications grounding busbar nor dedicated cooling were observed within the room. Electrical infrastructure is not standards compliant.

Existing Fiber Patching.

- » Upgrade existing port locations to Category 6A.
- » Provide labels for all new cabling and existing cables to remain.
- » Add additional Category 6A 8P8C RJ45 ports to meet standards.
- » Provide new 12-strand single-mode and 12-strand OM4 multimode optical fiber backbone from the Administration Building (Building 1).
- » Add Telecommunications Grounding Busbar.
- » Add ladder tray and cable management as needed.
- » Add a dedicated cooling system.
- » Add power circuits and receptacles as needed.
- » Control access to authorized individuals.

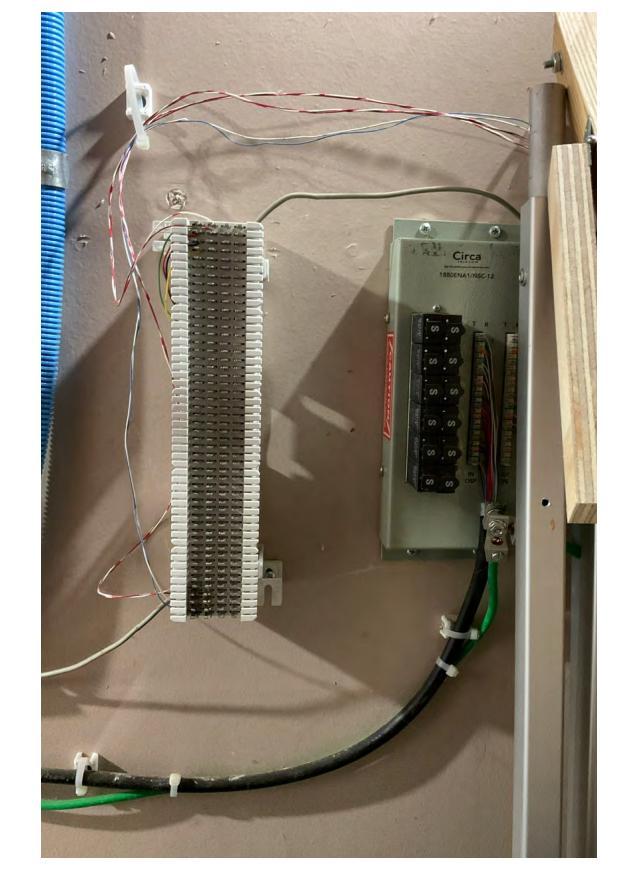
Existing Voice Patching.

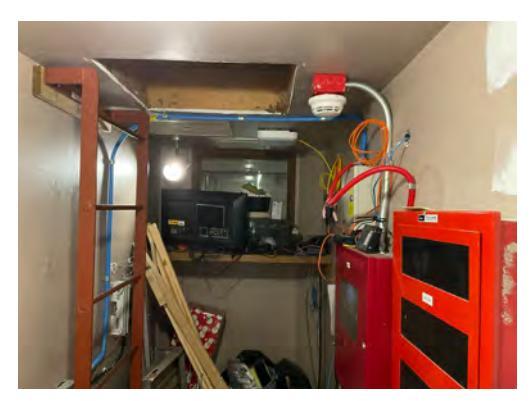
The existing telecommunications space is not standards compliant. The existing backbone and horizontal cabling do not meet current TIA standards for healthcare facilities. To meet industry standards, it is recommended to provide a new, dedicated telecommunications room with standards compliant backbone and horizontal cabling. Additional Category 6A data ports should be provided as required to meet standards. Dedicated cooling, rack space, cable management, and proper grounding are required to meet current standards. The addition of cardbased access control is recommended to control and track access to the space.

Existing Telecom Room.

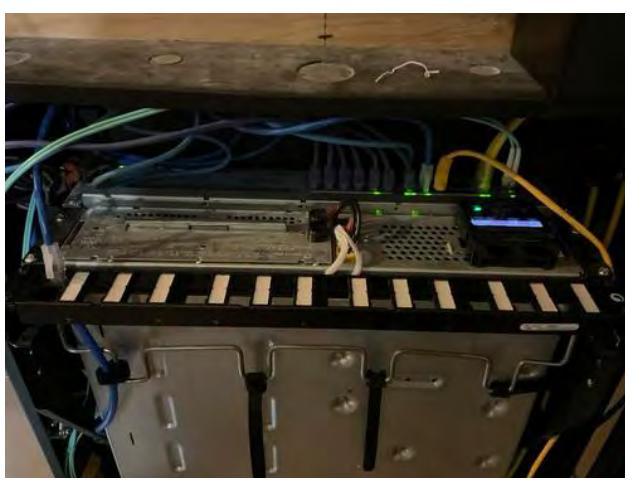
The telecommunications space is in the attic. There is no dedicated telecommunications room. The TR space contains a wall mounted vertical rack. The wall mounted rack includes a patch panel, network switch, and a UPS. The vertical rack was grounded to a telecommunications grounding busbar. There is no dedicated cooling for temperature and humidity control.

Existing Data Patching.

The existing telecommunications space is not standards compliant. The existing backbone and horizontal cabling do not meet current TIA standards for healthcare facilities. To meet industry standards, it is recommended to provide a new, dedicated telecommunications room with standards compliant backbone and horizontal cabling. Additional Category 6A data ports should be provided as required to meet standards. Dedicated cooling, rack space, cable management, and proper grounding are required to meet current standards. The addition of cardbased access control is recommended to control and track access to the space.

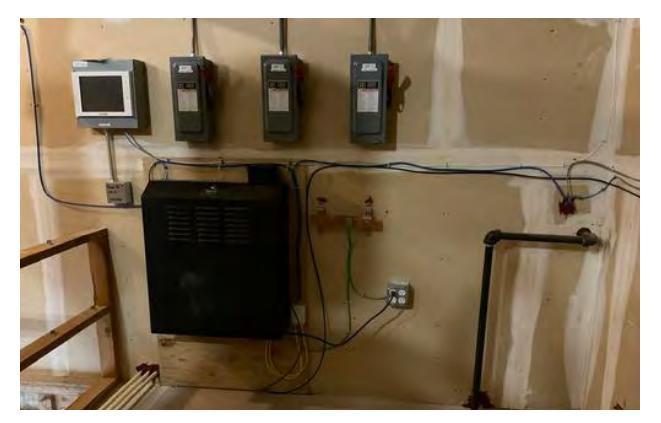
Existing Telecom Cabinet.

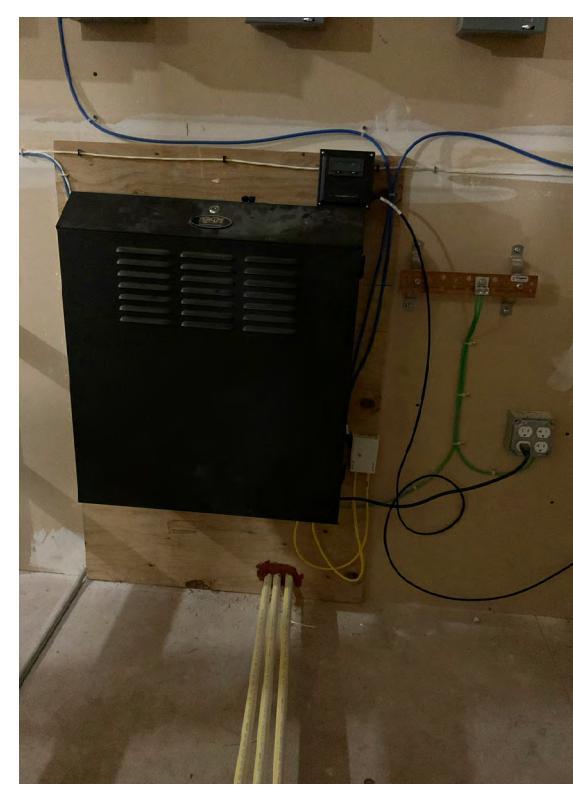
The telecommunications space is in the attic. There is no dedicated telecommunications room. The TR space contains a wall mounted vertical rack. The wall mounted rack includes a patch panel, network switch, and a UPS. The vertical rack was grounded to a telecommunications grounding busbar. There is no dedicated cooling for temperature and humidity control.

Existing Telecom Cabinet.

- » Provide a dedicated telecommunications room.
- » Upgrade existing port locations to Category 6A.
- » Provide labels for all new cabling and existing cables to remain.
- » Add additional Category 6A 8P8C RJ45 ports to meet standards.
- » Provide new 12-strand single-mode and 12-strand OM4 multimode optical fiber backbone from the Administration Building (Building 1).
- » Add Telecommunications Grounding Busbar.
- » Add ladder tray and cable management as needed.
- » Add a dedicated cooling system.
- » Add power circuits and receptacles as needed.
- » Control access to authorized individuals.

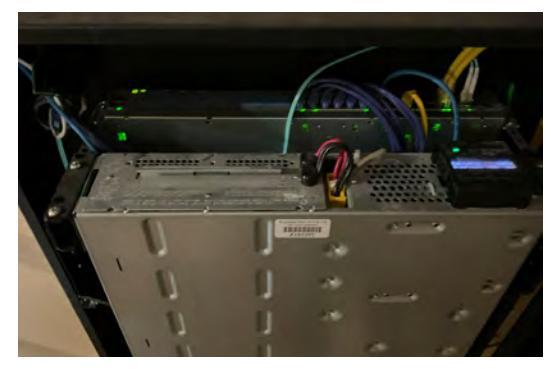
Existing Data Patching.

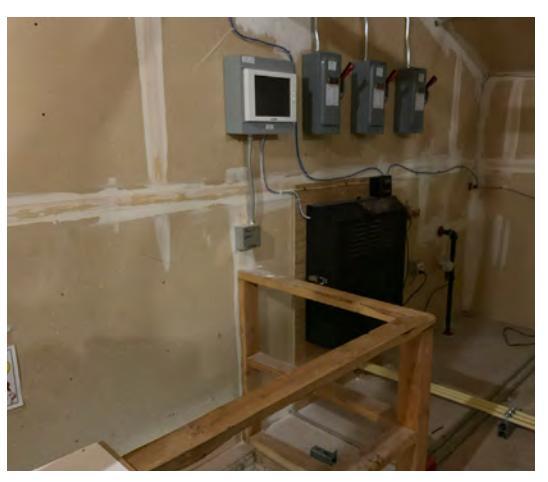
Existing Telecom Room Layout.

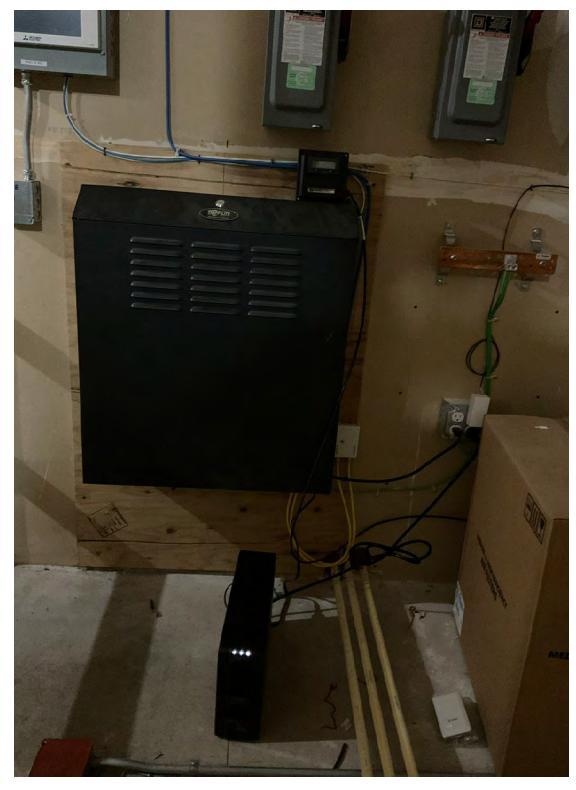
The telecommunications space is in the attic. There is no dedicated telecommunications room. The TR space contains a wall mounted vertical rack. The wall mounted rack includes a patch panel, network switch, and a UPS. The vertical rack was grounded to a telecommunications grounding busbar. There is no dedicated cooling for temperature and humidity control.

- » No dedicated telecommunications room.
- » Horizontal Cabling infrastructure does not meet minimum standards per TIA-1179.
- » Backbone Cabling Infrastructure does not meet minimum standards per TIA-1179.
- » Minimal cable support, leading to cables being draped or placed directly on equipment.
- » No grounding busbar for the telecommunications equipment.
- » No dedicated cooling system to maintain temperature of equipment.
- » Electrical infrastructure does not meet minimum requirements per standards.

Existing Telecom Cabinet.

- » Provide a dedicated telecommunications room.
- » Upgrade existing port locations to Category 6A.
- » Provide labels for all new cabling and existing cables to remain.
- » Add additional Category 6A 8P8C RJ45 ports to meet standards.
- » Provide new 12-strand single-mode and 12-strand OM4 multimode optical fiber backbone from the Administration Building (Building 1).
- » Add Telecommunications Grounding Busbar.
- » Add ladder tray and cable management as needed.
- » Add a dedicated cooling system.
- » Add power circuits and receptacles as needed.
- » Control access to authorized individuals.
CROSS-CONNECT ROOM & TELECOMMUNICATIONS ROOM - TR-ATTIC

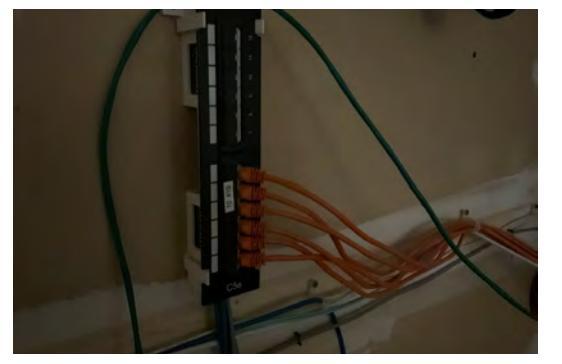
Existing Data Patching.

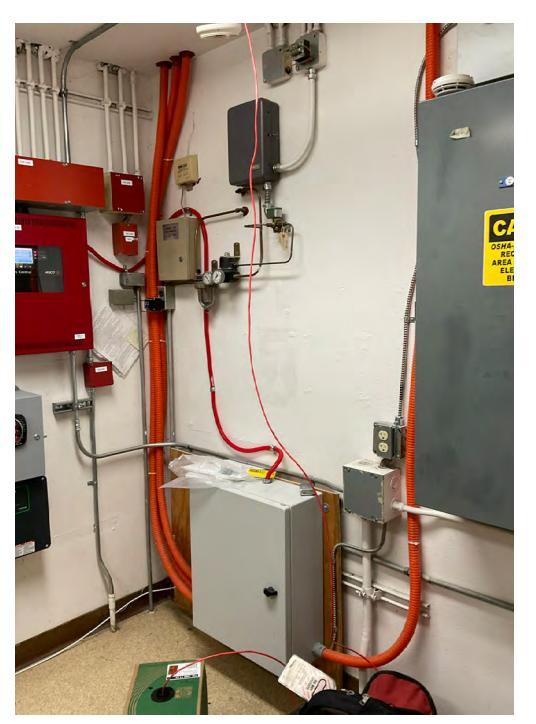
Existing Cross-Connect Room.

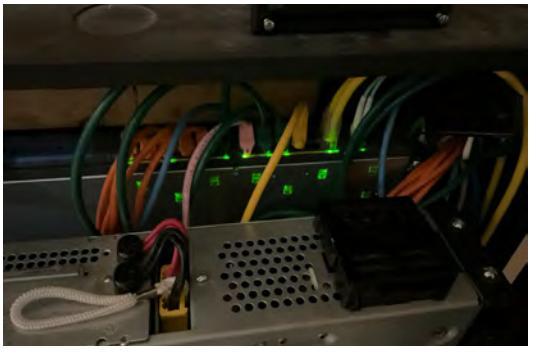
Existing Grounding.

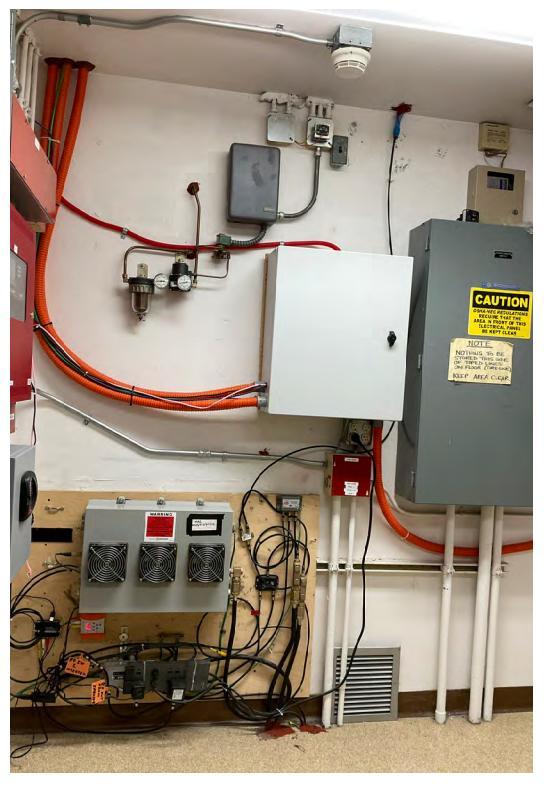
Existing Telecom Cabinet.

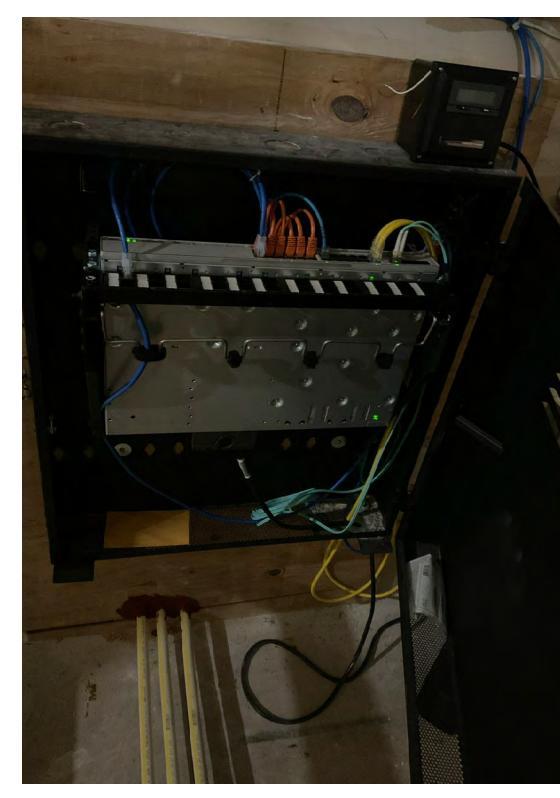
The telecommunications space is in the attic. There is no dedicated telecommunications room. The TR space contains a wall mounted vertical rack. The wall mounted rack includes a patch panel, network switch, and a UPS. The vertical rack was grounded to a telecommunications grounding busbar. There is no dedicated cooling for temperature and humidity control.

Existing Telecom Cabinet.

- » Provide a dedicated telecommunications room.
- » Upgrade existing port locations to Category 6A.
- » Provide labels for all new cabling and existing cables to remain.
- » Add additional Category 6A 8P8C RJ45 ports to meet standards.
- » Provide new 12-strand single-mode and 12-strand OM4 multimode optical fiber backbone from the Administration Building (Building 1).
- » Add Telecommunications Grounding Busbar.
- » Add ladder tray and cable management as needed.
- » Add a dedicated cooling system.
- » Add power circuits and receptacles as needed.
- » Control access to authorized individuals.

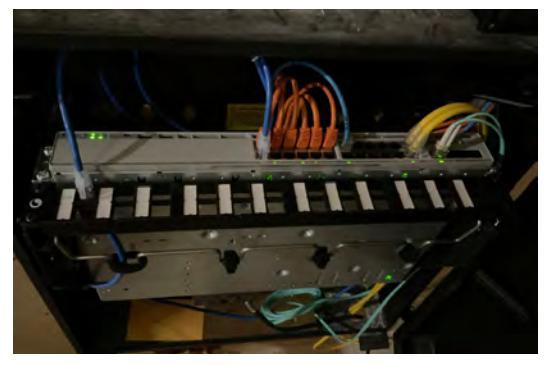
Existing Data Patching.

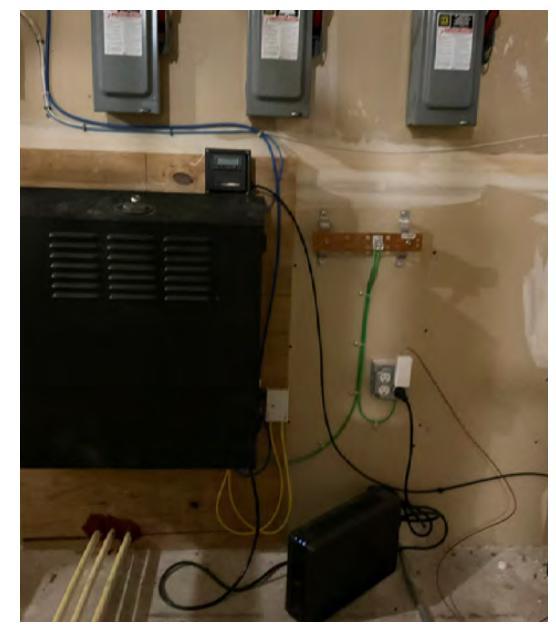
Existing Telecom Room Layout.

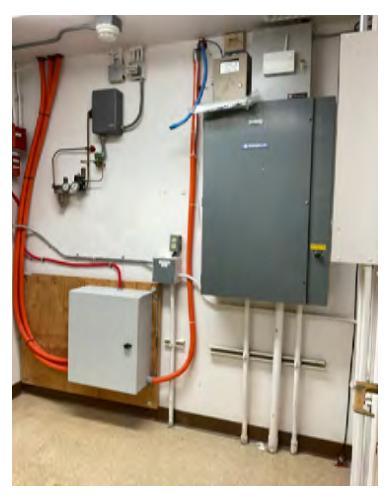
Existing Cross-Connect Room.

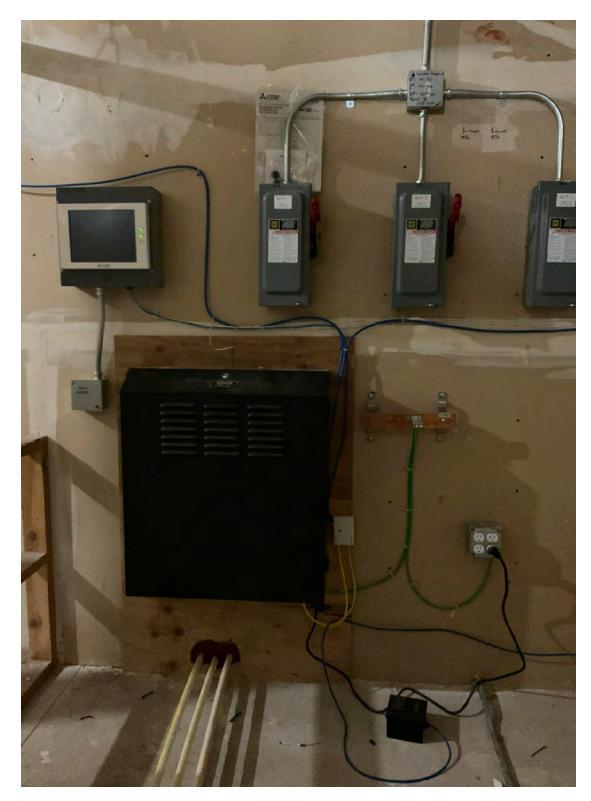
The telecommunications space is in the attic. There is no dedicated telecommunications room. The TR space contains a wall mounted vertical rack. The wall mounted rack includes a patch panel, network switch, and a UPS. The vertical rack was grounded to a telecommunications grounding busbar. There is no dedicated cooling for temperature and humidity control.

Existing Telecom Cabinet.

- » Provide a dedicated telecommunications room.
- » Upgrade existing port locations to Category 6A.
- » Provide labels for all new cabling and existing cables to remain.
- » Add additional Category 6A 8P8C RJ45 ports to meet standards.
- » Provide new 12-strand single-mode and 12-strand OM4 multimode optical fiber backbone from the Administration Building (Building 1).
- » Add Telecommunications Grounding Busbar.
- » Add ladder tray and cable management as needed.
- » Add a dedicated cooling system.
- » Add power circuits and receptacles as needed.
- » Control access to authorized individuals.

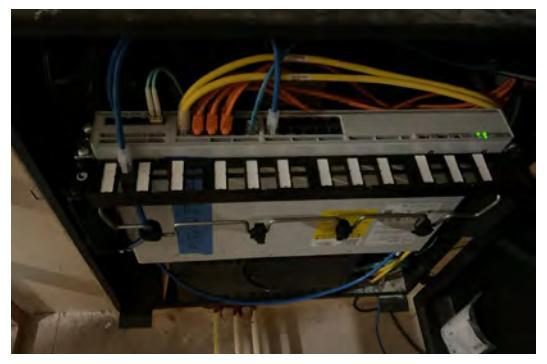
Existing Data Patching.

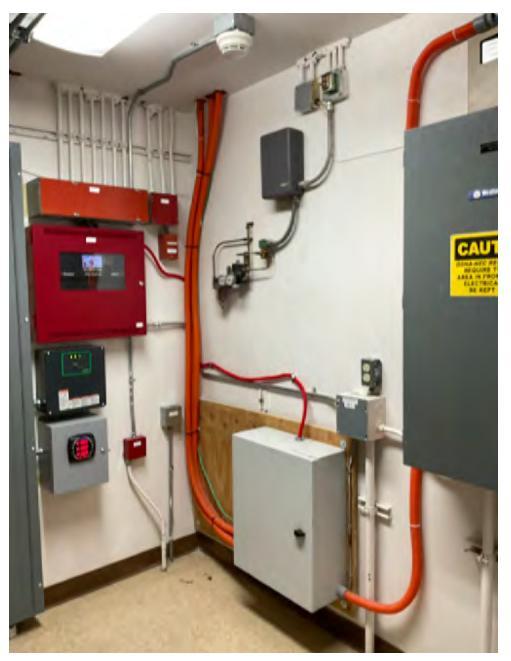
Existing Cross-Connect Room.

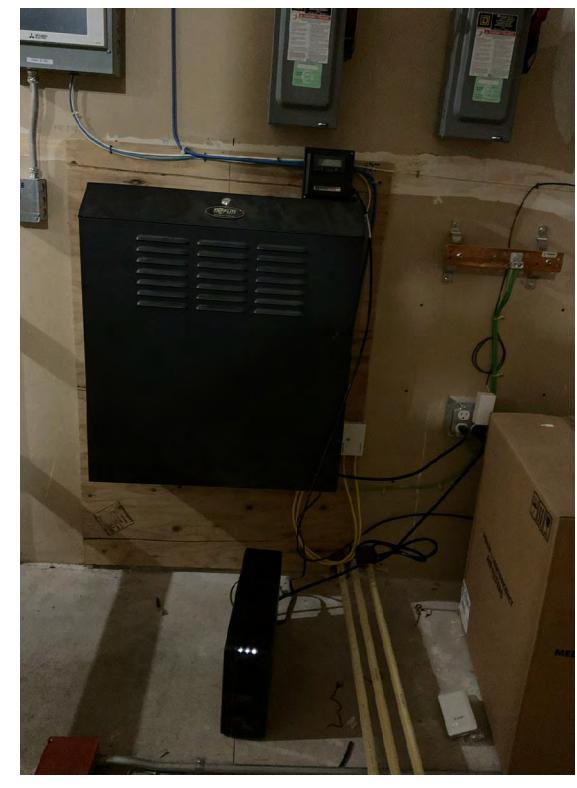
The telecommunications space is in the attic. There is no dedicated telecommunications room. The TR space contains a wall mounted vertical rack. The wall mounted rack includes a patch panel, network switch, and a UPS. The vertical rack was grounded to a telecommunications grounding busbar. There is no dedicated cooling for temperature and humidity control.

- » No dedicated telecommunications room.
- » Horizontal Cabling infrastructure does not meet minimum standards per TIA-1179.
- » Backbone Cabling Infrastructure does not meet minimum standards per TIA-1179.
- » Minimal cable support, leading to cables being draped or placed directly on equipment.
- » No grounding busbar for the telecommunications equipment.
- » No dedicated cooling system to maintain temperature of equipment.
- » Electrical infrastructure does not meet minimum requirements per standards.

Existing Telecom Cabinet.

- » Provide a dedicated telecommunications room.
- » Upgrade existing port locations to Category 6A.
- » Provide labels for all new cabling and existing cables to remain.
- » Add additional Category 6A 8P8C RJ45 ports to meet standards.
- » Provide new 12-strand single-mode and 12-strand OM4 multimode optical fiber backbone from the Administration Building (Building 1).
- » Add Telecommunications Grounding Busbar.
- » Add ladder tray and cable management as needed.
- » Add a dedicated cooling system.
- » Add power circuits and receptacles as needed.
- » Control access to authorized individuals.

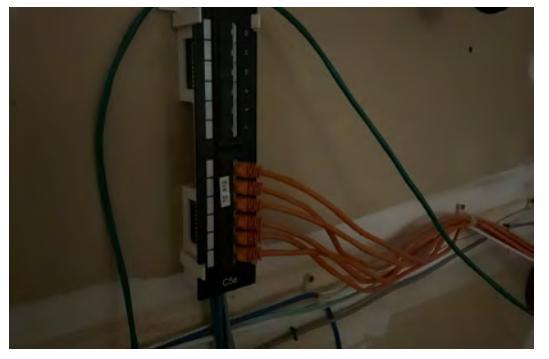
Existing Data Patching.

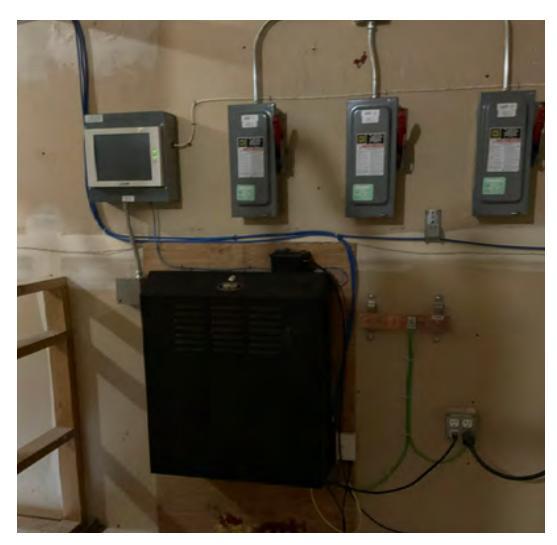
Existing Telecom Room Layout.

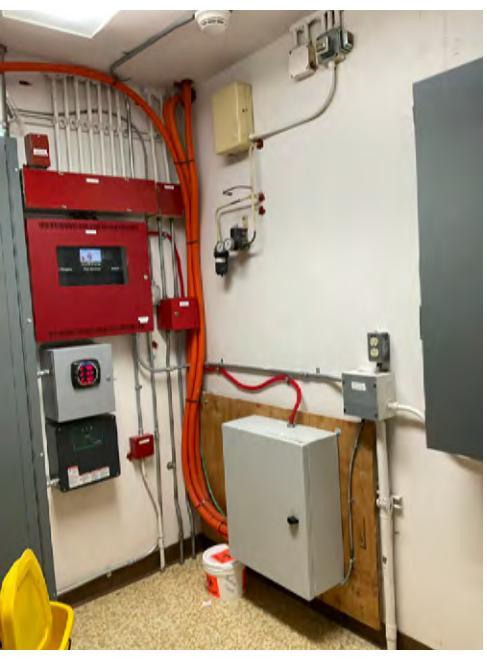
Existing Cross-Connect Room.
