DSHS RAINIER SCHOOL

WA STATE PROJECT NUMBER: 2024-429 K (8)

EXECUTIVE SUMMARY

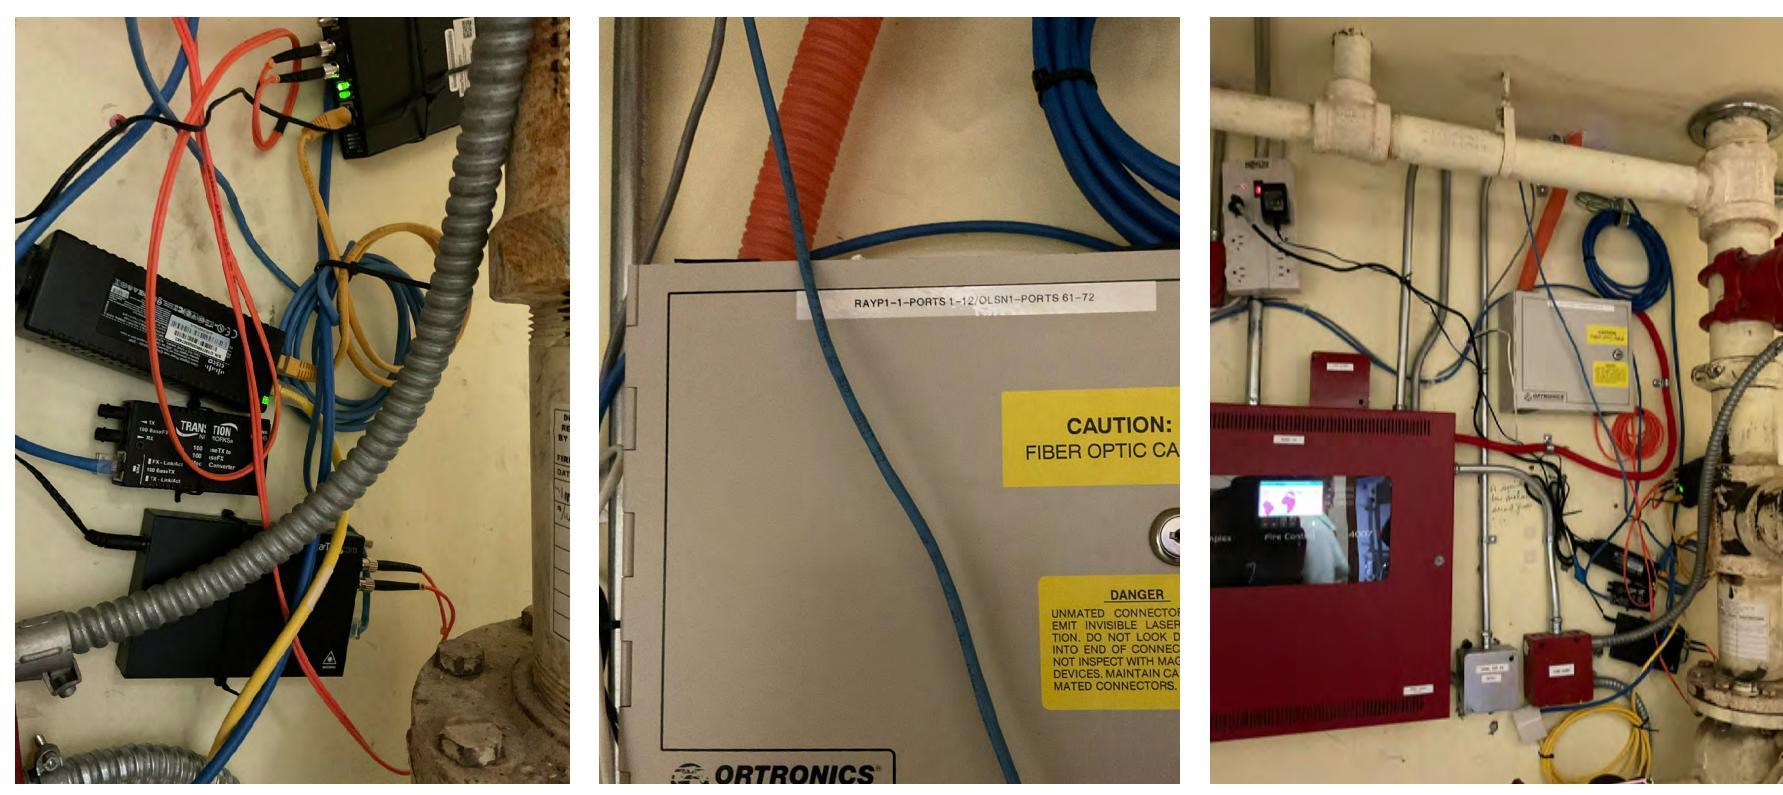
The telecommunications space is on the wall in the utility room. It is a shared space utilized for the fire alarm panel and fire sprinkler riser. There is not a dedicated telecommunications room. The telecommunications space contains a wall mount fiber cabinet and media converters with unsupported cables. Connectivity is provided by a 12-strand OM1 multi-mode optical fiber backbone cable from the Olsen Building (Building 19). Neither a telecommunications grounding busbar nor dedicated cooling were observed within the room. Electrical infrastructure is not standards compliant.

Existing Fiber Patching.

Existing Fiber Cabinet.

- » Provide a dedicated telecommunications room.
- » Upgrade existing port locations to Category 6A.
- » Provide labels for all new cabling and existing cables to remain.
- » Add additional Category 6A 8P8C RJ45 ports to meet standards.
- » Provide new 12-strand single-mode and 12-strand OM4 multimode optical fiber backbone from the Olsen Building (Building 19).
- » Add Telecommunications Grounding Busbar.
- » Add ladder tray and cable management as needed.
- » Add a dedicated cooling system.
- » Add power circuits and receptacles as needed.
- » Control access to authorized individuals.

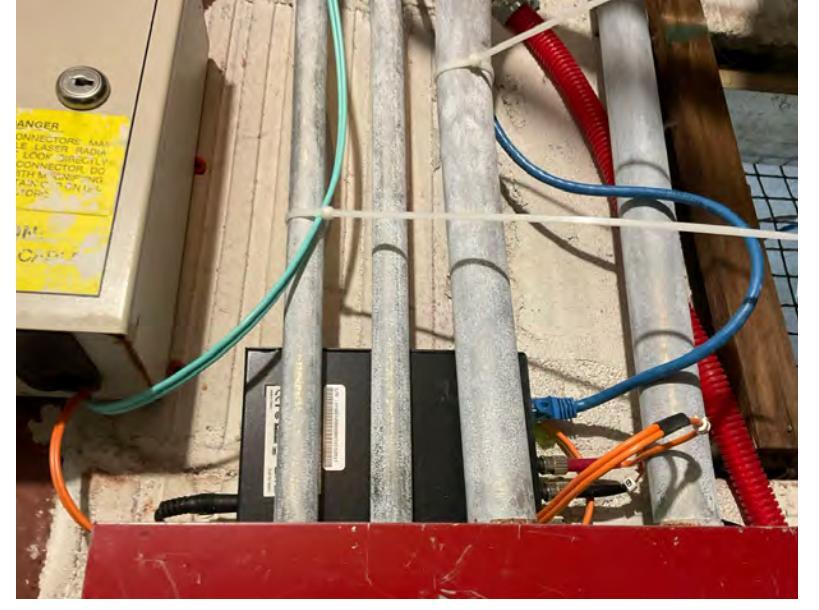
The telecommunications space is on the wall in the utility room. It is a shared space utilized for the fire alarm panel and fire sprinkler riser. There is not a dedicated telecommunications room. The telecommunications space contains a wall mount fiber cabinet and media converters with unsupported cables. Connectivity is provided by a 12-strand OM1 multi-mode optical fiber backbone cable from the Olsen Building (Building 19). Neither a telecommunications grounding busbar nor dedicated cooling were observed within the room. Electrical infrastructure is not standards compliant.

Existing Fiber & Data Patching.

- » Provide a dedicated telecommunications room.
- » Upgrade existing port locations to Category 6A.
- » Provide labels for all new cabling and existing cables to remain.
- » Add additional Category 6A 8P8C RJ45 ports to meet standards.
- » Provide new 12-strand single-mode and 12-strand OM4 multi-mode optical fiber backbone from the Olsen Building (Building 19).
- » Add Telecommunications Grounding Busbar.
- » Add ladder tray and cable management as needed.
- » Add a dedicated cooling system.
- » Add power circuits and receptacles as needed.
- » Control access to authorized individuals.

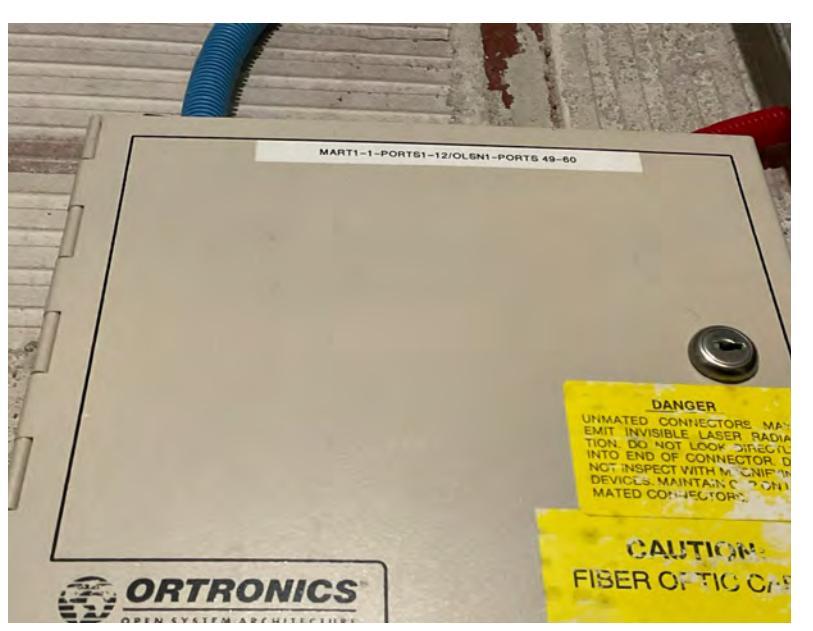
Existing Fiber Cabinet.

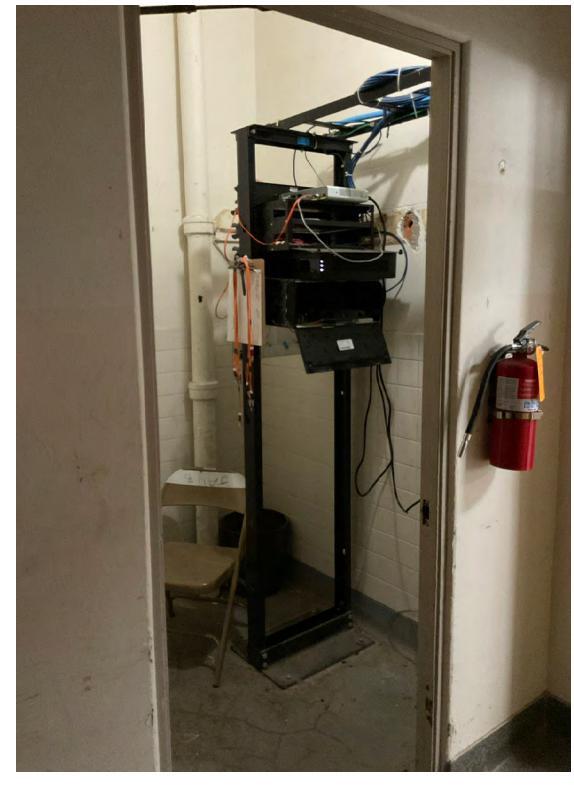
Existing Telecom Rack.

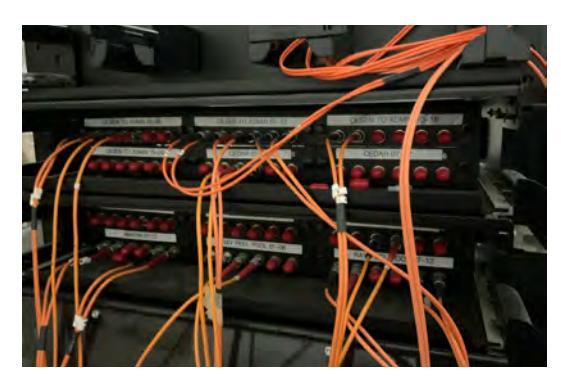
Existing Fiber Patching.

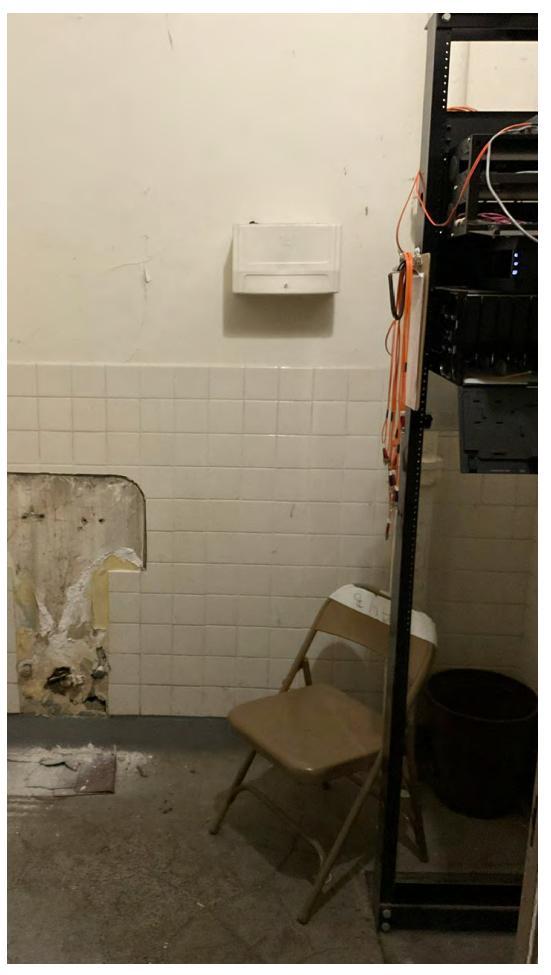
Existing Telecom Room Layout.

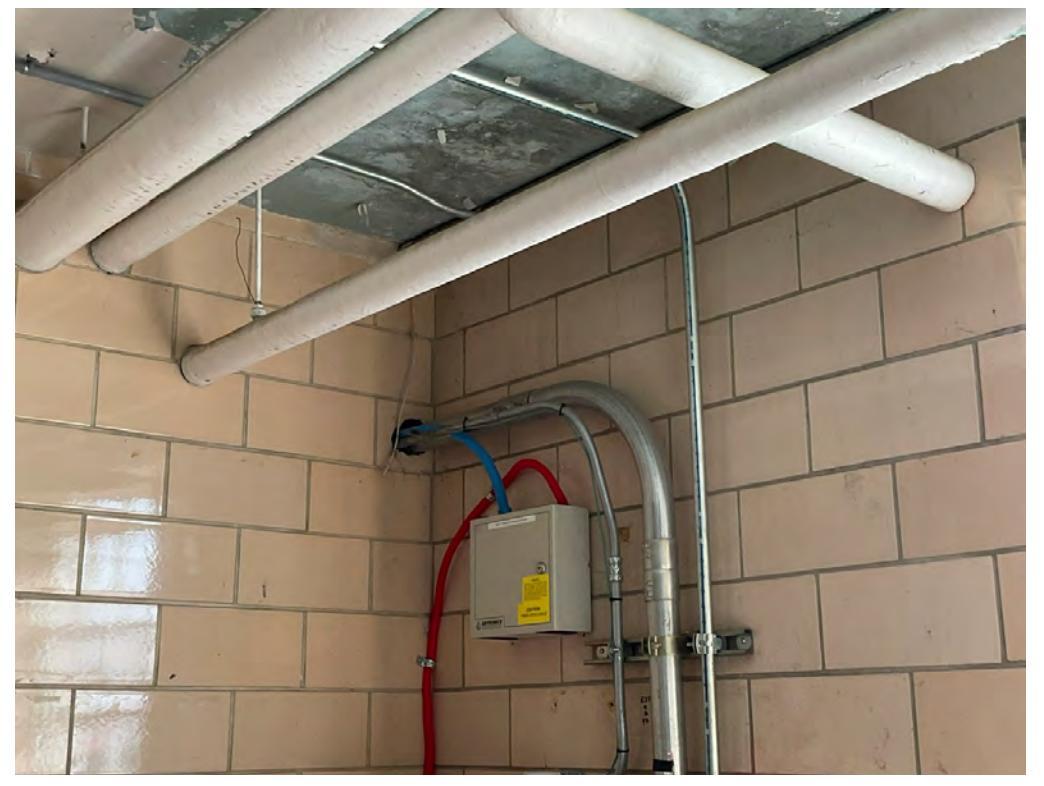
Telecommunications Room TR-Cedar contains a single wall mount fiber cabinet. There is not a dedicated telecommunications room. There are no switches or patch panels in the room. Connectivity is provided by a 12-strand OM1 multi-mode optical fiber backbone cable from the Olsen Building (Building 19). Neither a telecommunications grounding busbar nor dedicated cooling were observed within the room.

Existing Fiber Cabinet.

- » Provide a dedicated telecommunications room.
- » Upgrade existing port locations to Category 6A.
- » Provide labels for all new cabling and existing cables to remain.
- » Add additional Category 6A 8P8C RJ45 ports to meet standards.
- Provide new 12-strand single-mode and 12-strand OM4 multi-mode optical fiber backbone from the Olsen Building (Building 19).
- » Add Telecommunications Grounding Busbar.
- » Add ladder tray and cable management as needed.
- » Add a dedicated cooling system.
- » Add power circuits and receptacles as needed.
- » Control access to authorized individuals.

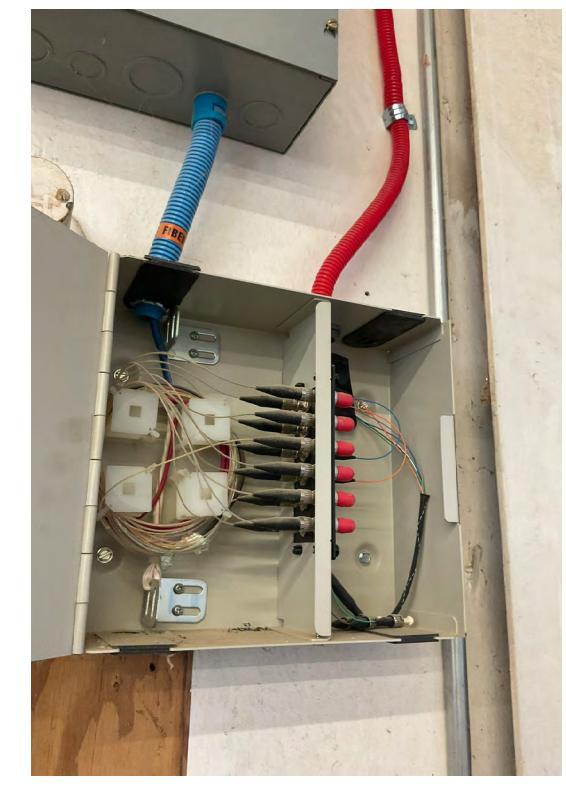
Existing Fiber Patching.

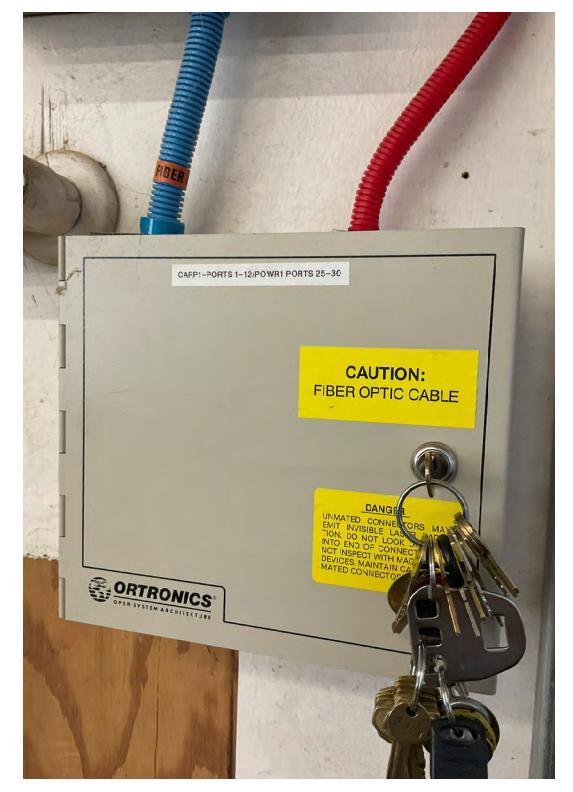
The telecommunications space is on the wall in an open area within the facility. There is no dedicated telecommunications space. The telecommunications space contains a wall mounted fiber cabinet. Connectivity is provided by a 12-strand OM1 multi-mode optical fiber backbone cable from the Powerhouse Building (Building 30) and a 50-pair twisted-pair copper backbone cable from the Administration Building (Building 1). Neither a telecommunications grounding busbar nor dedicated cooling were observed within the room.

Existing Fiber Cabinet.

- » Provide a dedicated telecommunications room.
- » Upgrade existing port locations to Category 6A.
- » Provide labels for all new cabling and existing cables to remain.
- » Add additional Category 6A 8P8C RJ45 ports to meet standards.
- Provide new 12-strand single-mode and 12-strand OM4 multi-mode optical fiber backbone from the Olsen Building (Building 19).
- » Add Telecommunications Grounding Busbar.
- » Add ladder tray and cable management as needed.
- » Add a dedicated cooling system.
- » Add power circuits and receptacles as needed.
- » Control access to authorized individuals.

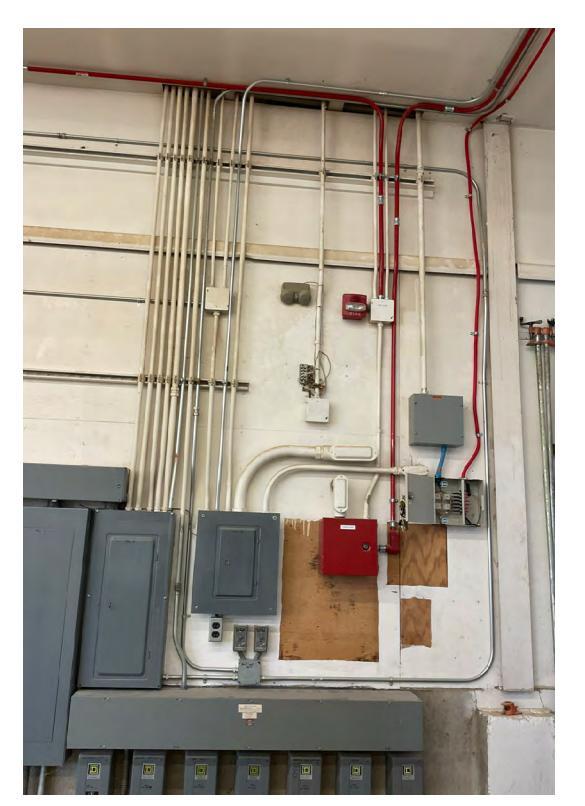
Existing Telecom Room Layout.

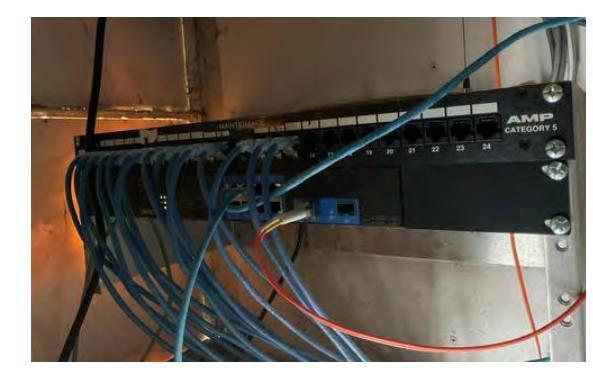
Existing Data Patching.

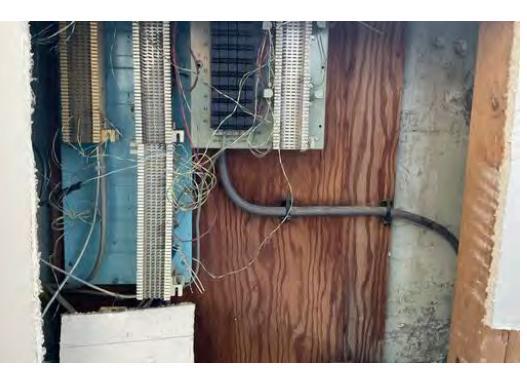
Existing Voice Patching.

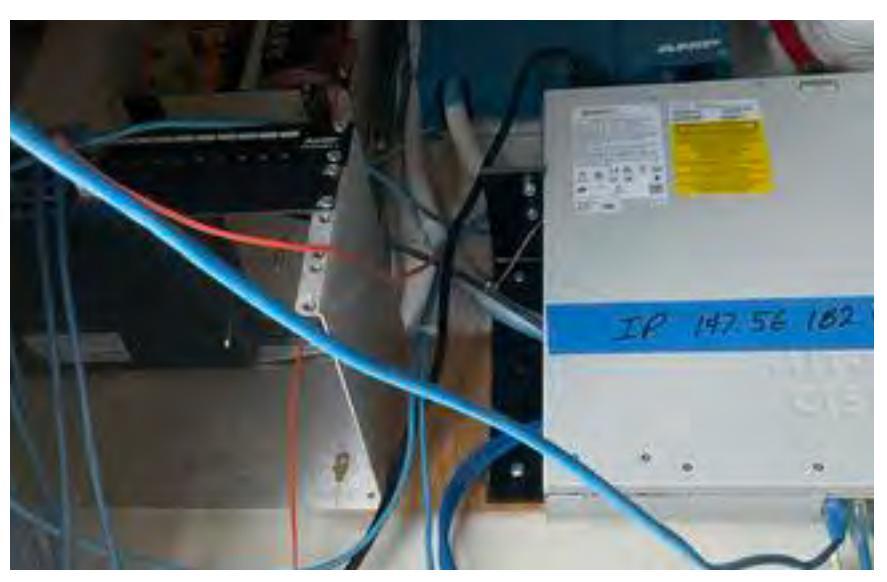
The telecommunications space is in the ceiling space above the reception area. There is no dedicated telecommunications room. The telecommunications space consists of two wall mount fiber cabinets, a patch panel, and a vertically mounted network switch. Connectivity is provided by 12-strand and 6-strand OM1 multi-mode optical fiber backbone cables from the Powerhouse Building (30) and a 50-pair twisted-pair copper backbone cable from the Administration Building (Building 1). Neither a telecommunications grounding busbar nor dedicated cooling were observed within the room.

- » No dedicated telecommunications room.
- » Horizontal Cabling infrastructure does not meet minimum standards per TIA-1179.
- » Backbone Cabling Infrastructure does not meet minimum standards per TIA-1179.
- » Minimal cable support, leading to cables being draped or placed directly on equipment.
- » No grounding busbar for the telecommunications equipment.
- » No dedicated cooling system to maintain temperature of equipment.
- » Electrical infrastructure does not meet minimum requirements per standards.

Existing Telecom Room.

- » Provide a dedicated telecommunications room.
- » Upgrade existing port locations to Category 6A.
- » Provide labels for all new cabling and existing cables to remain.
- » Add additional Category 6A 8P8C RJ45 ports to meet standards.
- » Provide new 12-strand single-mode and 12-strand OM4 multi-mode optical fiber backbone from the Powerhouse Building (Building 30).
- » Add Telecommunications Grounding Busbar.
- » Add ladder tray and cable management as needed.
- » Add a dedicated cooling system.
- » Add power circuits and receptacles as needed.
- » Control access to authorized individuals.

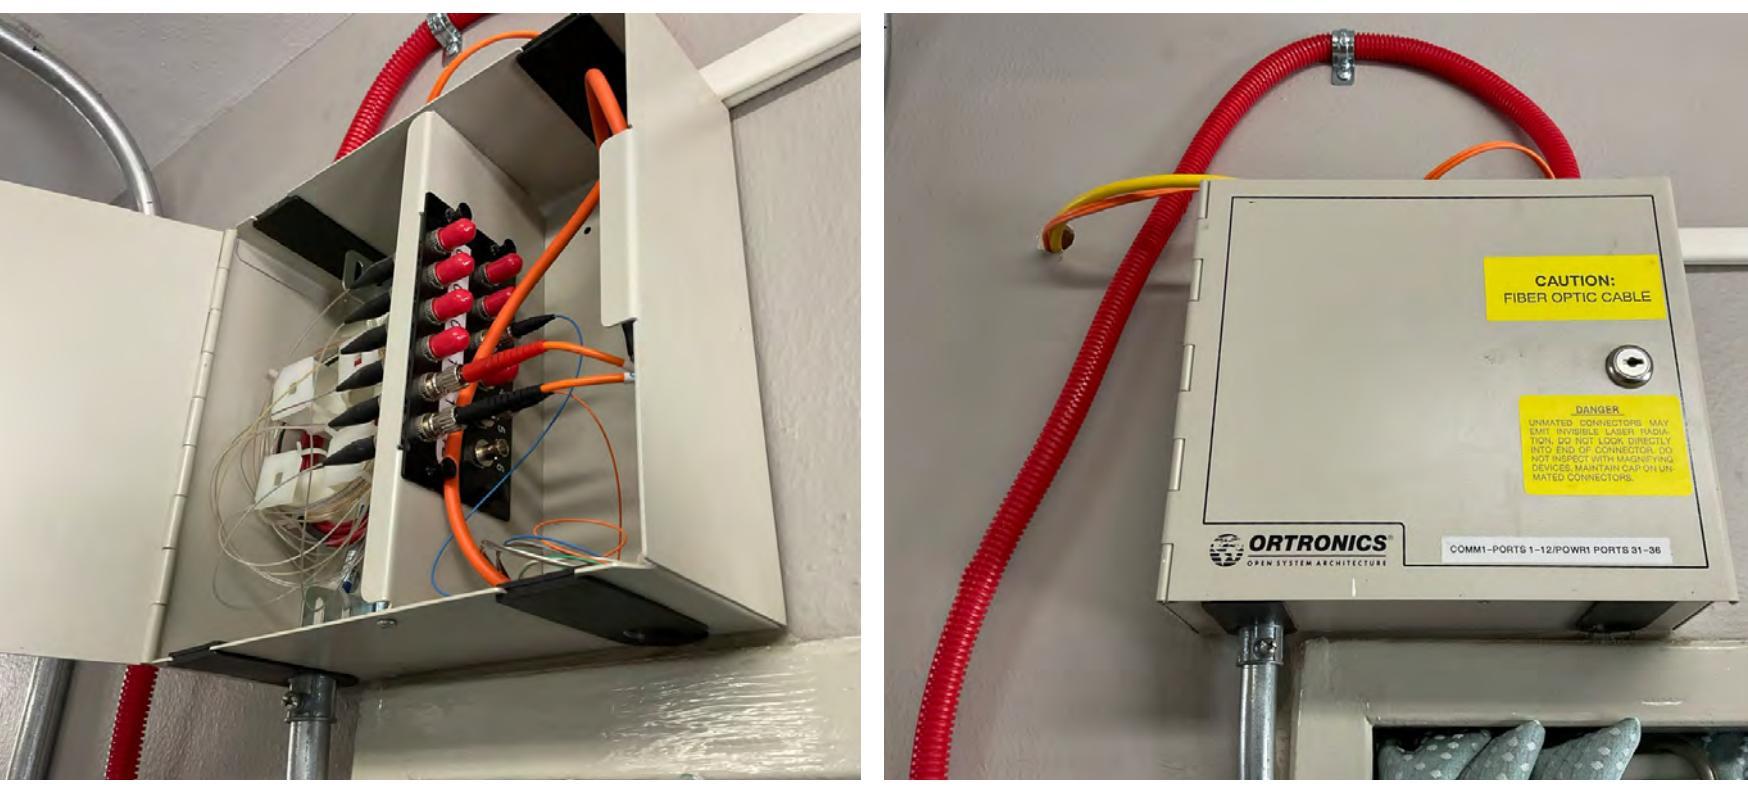
The Telecommunications Space, TR-commissary, is in an open area within the facility. There is no dedicated telecommunications room. The TR space contains a wall mounted fiber cabinet. Connectivity is provided by a 12-strand OM1 multi-mode optical fiber backbone cable from the Powerhouse Building (Building 30). Neither a telecommunications grounding busbar nor dedicated cooling were observed within the room.

Existing Fiber Patching.

Fiber Cabinet Above Window.

- » Provide a dedicated telecommunications room.
- » Upgrade existing port locations to Category 6A.
- » Provide labels for all new cabling and existing cables to remain.
- » Add additional Category 6A 8P8C RJ45 ports to meet standards.
- Provide new 12-strand single-mode and 12-strand OM4 multimode optical fiber backbone from the Powerhouse Building (Building 30).
- » Add Telecommunications Grounding Busbar.
- » Add ladder tray and cable management as needed.
- » Add a dedicated cooling system.
- » Add power circuits and receptacles as needed.
- » Control access to authorized individuals.

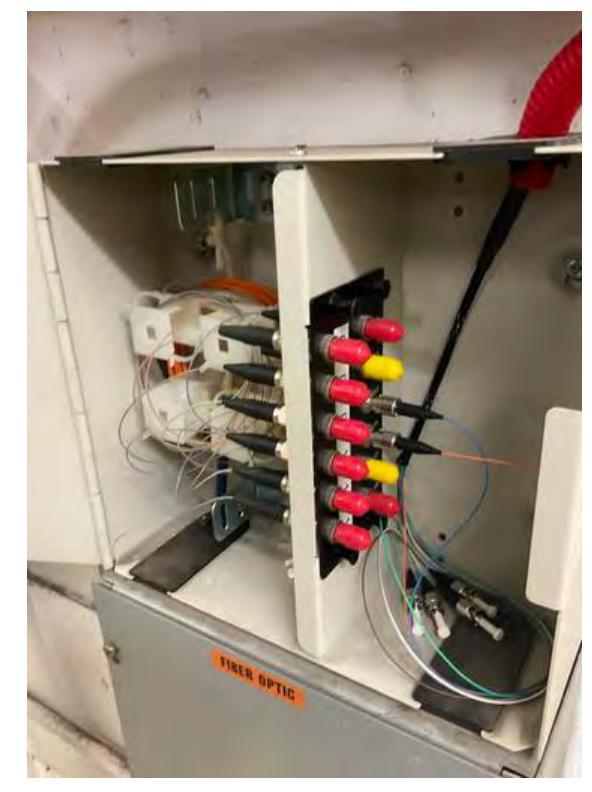
Existing Fiber Patching.

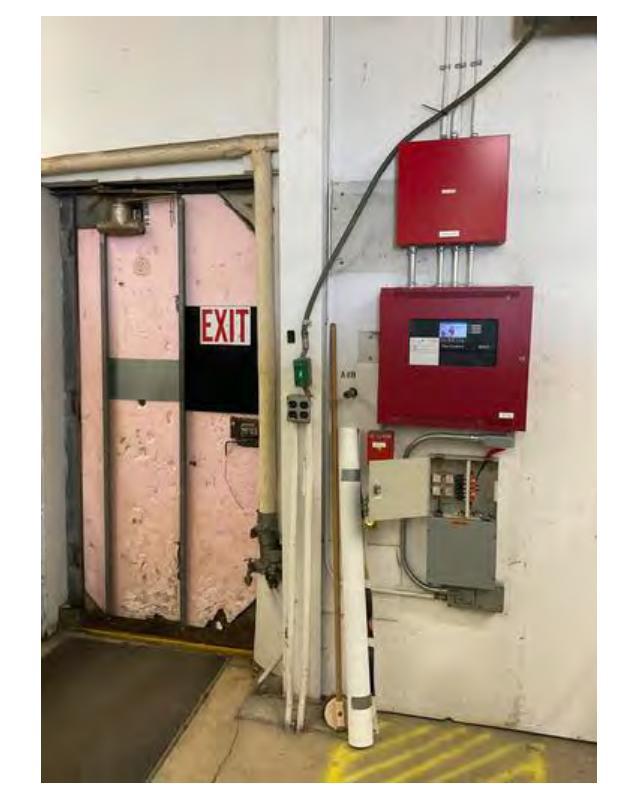
The telecommunications space in the Motorpool is in an open area within the welding shop area. There is no dedicated telecommunications room. The telecommunications space consists of a wall mounted fiber cabinet and a network switch. Connectivity is provided by a 12-strand OM1 multi-mode optical fiber backbone cable from the Powerhouse Building (Building 30). Neither a telecommunications grounding busbar nor dedicated cooling were observed within the room.

Existing Telecom Room Layout.

- » Provide a dedicated telecommunications room.
- » Upgrade existing port locations to Category 6A.
- » Provide labels for all new cabling and existing cables to remain.
- » Add additional Category 6A 8P8C RJ45 ports to meet standards.
- Provide new 12-strand single-mode and 12-strand OM4 multimode optical fiber backbone from the Powerhouse Building (Building 30).
- » Add Telecommunications Grounding Busbar.
- » Add ladder tray and cable management as needed.
- » Add a dedicated cooling system.
- » Add power circuits and receptacles as needed.
- » Control access to authorized individuals.

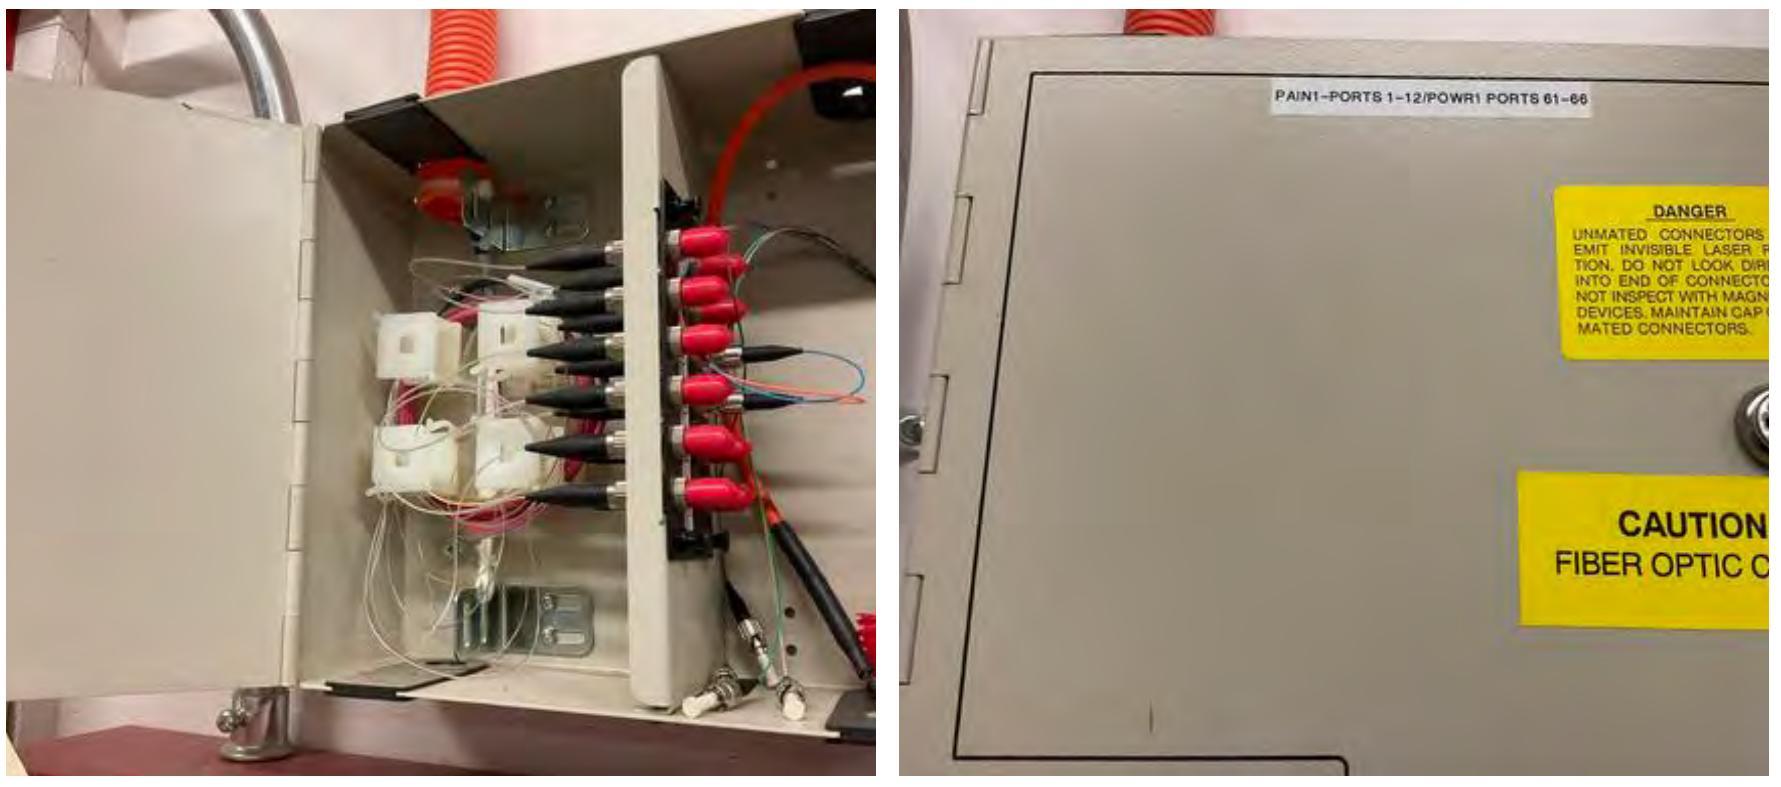
The telecommunications space in the Paint Shop is in an open area within the facility. There is no dedicated telecommunications room. The telecommunications space contains a wall mounted fiber cabinet. Connectivity is provided by a 12-strand OM1 multi-mode optical fiber backbone cable from the Powerhouse Building (Building 30) and a 50-pair twisted-pair copper backbone cable from the Administration Building (Building 1). The network switch is in the office area and it hangs by cables from the ceiling. Neither a telecommunications grounding busbar nor dedicated cooling were observed within the room.

- » No dedicated telecommunications room.
- » Horizontal Cabling infrastructure does not meet minimum standards per TIA-1179.
- » Backbone Cabling Infrastructure does not meet minimum standards per TIA-1179.
- » Minimal cable support, leading to cables being draped or placed directly on equipment.
- » No grounding busbar for the telecommunications equipment.
- » No dedicated cooling system to maintain temperature of equipment.
- » Electrical infrastructure does not meet minimum requirements per standards.

Existing Fiber Patching.

Existing Fiber Cabinet.

- » Provide a dedicated telecommunications room.
- » Upgrade existing port locations to Category 6A.
- » Provide labels for all new cabling and existing cables to remain.
- » Add additional Category 6A 8P8C RJ45 ports to meet standards.
- Provide new 12-strand single-mode and 12-strand OM4 multimode optical fiber backbone from the Powerhouse Building (Building 30).
- » Add Telecommunications Grounding Busbar.
- » Add ladder tray and cable management as needed.
- » Add a dedicated cooling system.
- » Add power circuits and receptacles as needed.
- » Control access to authorized individuals.

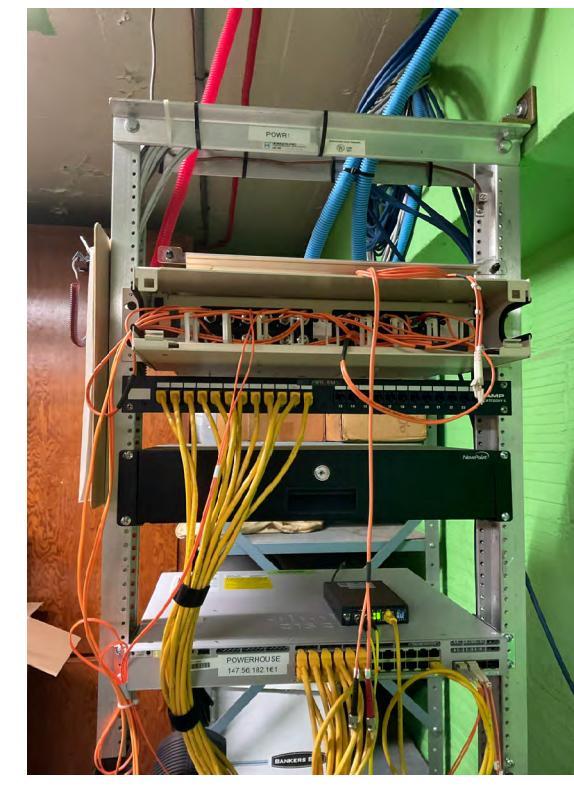
The existing telecommunications space is not standards compliant. The existing backbone and horizontal cabling do not meet current TIA standards for healthcare facilities. To meet industry standards, it is recommended to provide a new, dedicated telecommunications room with standards compliant backbone and horizontal cabling. Additional Category 6A data ports should be provided as required to meet standards. Dedicated cooling, rack space, cable management, and proper grounding are required to meet current standards. The addition of card-based access control is recommended to control and track access to the space.

Existing Telecom Rack.

- » Provide a dedicated telecommunications room.
- » Upgrade existing port locations to Category 6A.
- » Provide labels for all new cabling and existing cables to remain.
- » Add additional Category 6A 8P8C RJ45 ports to meet standards.
- Provide new 12-strand single-mode and 12-strand OM4 multimode optical fiber backbone from the Powerhouse Building (Building 30).
- » Add Telecommunications Grounding Busbar.
- » Add ladder tray and cable management as needed.
- » Add a dedicated cooling system.
- » Add power circuits and receptacles as needed.
- » Control access to authorized individuals.

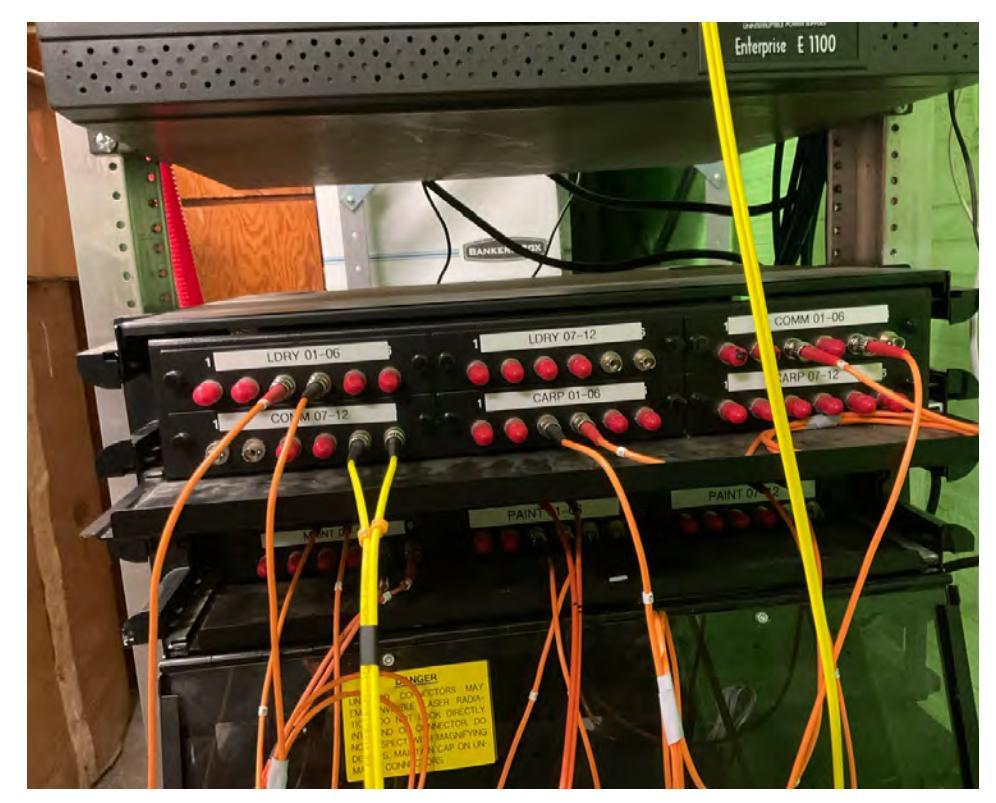
Existing Fiber Patching.

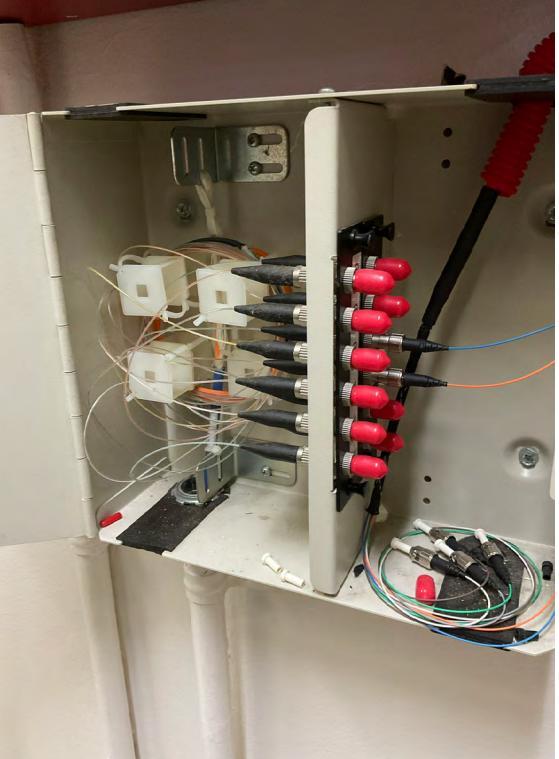
The telecommunications space is in the facility's office area. There is no dedicated telecommunications room. The telecommunications space is located on the North wall of the office space. The space contains a wall mounted fiber cabinet. Connectivity is provided by a 12-strand OM1 multi-mode optical fiber backbone cable and a Category 5e cable from the Powerhouse Building (Building 30) and a 50-pair twisted-pair copper backbone cable from the Administration Building (Building 1). Neither a telecommunications grounding busbar nor dedicated cooling were observed within the room.

The existing telecommunications space is not standards compliant. The existing backbone and horizontal cabling do not meet current TIA standards for healthcare facilities. To meet industry standards, it is recommended to provide a new, dedicated telecommunications room with standards compliant backbone and horizontal cabling. Additional Category 6A data ports should be provided as required to meet standards. Dedicated cooling, rack space, cable management, and proper grounding are required to meet current standards. The addition of card-based access control is recommended to control and track access to the space.

Existing Fiber Patching.

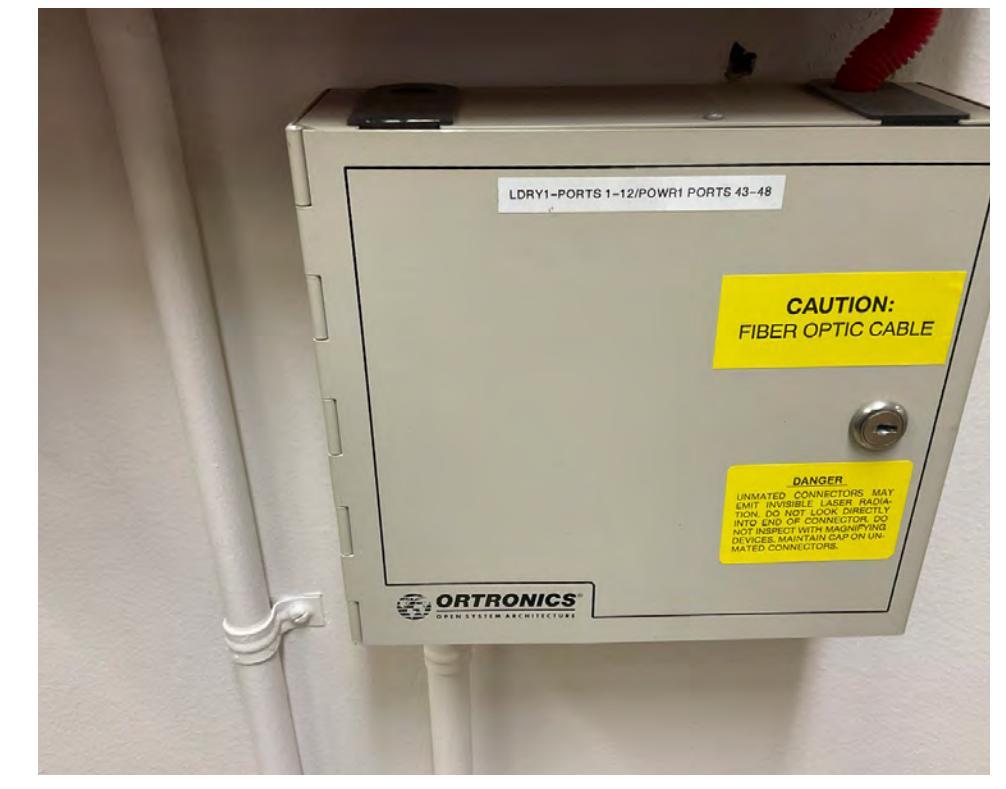
Existing Fiber Cabinet.

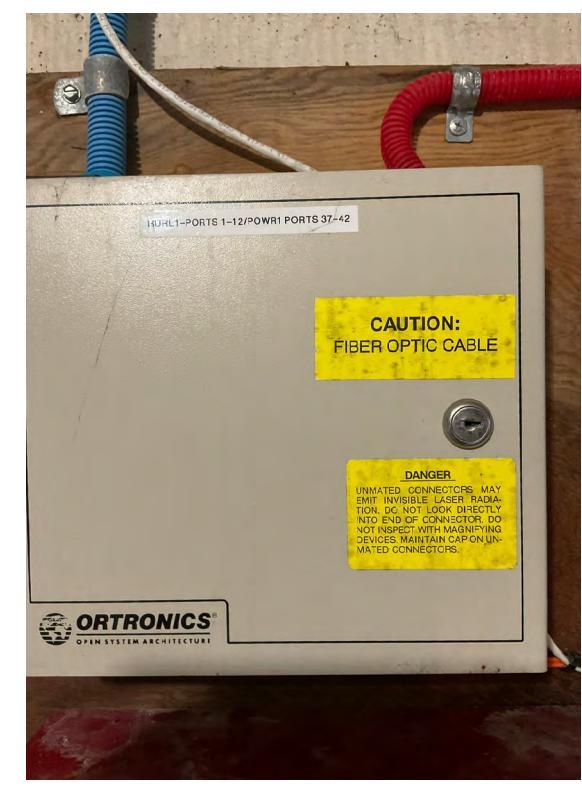
The telecommunications space is a shared area in the basement of the building. There is no dedicated telecommunications room. The telecommunications space contains a wall mounted fiber cabinet and it is shared with the fire alarm control panel. Connectivity is provided by a 12-strand OM1 multi-mode optical fiber backbone cable from the Powerhouse Building (Building 30) and a 50-pair twisted-pair copper backbone cable from the Administration Building (Building 1). Neither a telecommunications grounding busbar nor dedicated cooling were observed within the room.

The existing telecommunications space is not standards compliant. The existing backbone and horizontal cabling do not meet current TIA standards for healthcare facilities. To meet industry standards, it is recommended to provide a new, dedicated telecommunications room with standards compliant backbone and horizontal cabling. Additional Category 6A data ports should be provided as required to meet standards. Dedicated cooling, rack space, cable management, and proper grounding are required to meet current standards. The addition of card-based access control is recommended to control and track access to the space.

Existing Fiber Cabinet.

- » Provide a dedicated telecommunications room.
- » Upgrade existing port locations to Category 6A.
- » Provide labels for all new cabling and existing cables to remain.
- » Add additional Category 6A 8P8C RJ45 ports to meet standards.
- » Provide new 12-strand single-mode and 12-strand OM4 multimode optical fiber backbone from the Powerhouse Building (Building 30).
- » Add Telecommunications Grounding Busbar.
- » Add ladder tray and cable management as needed.
- » Add a dedicated cooling system.
- » Add power circuits and receptacles as needed.
- » Control access to authorized individuals.

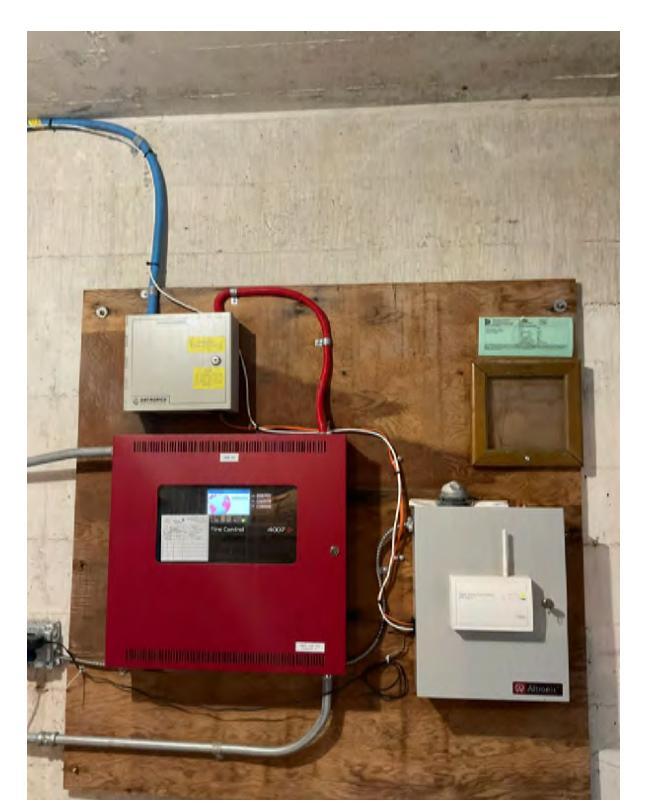
Existing Telecom Room Layout.

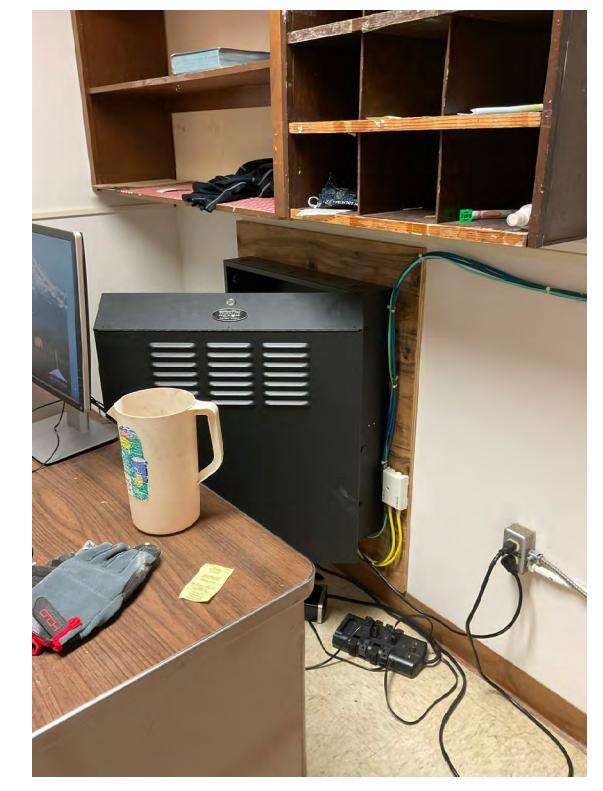
from the Oakley Building (Building 35), and a 50-pair Category 3 twisted-pair copper backbone cable from the Administration Building (Building 1). Neither a telecommunications grounding busbar nor dedicated cooling were observed within the room. An OM3 patch cable was utilized to patch to the OM1 backbone cable resulting in a cable mismatch and added reflectivity and noise in the system.

The existing telecommunications space is not standards compliant. The existing backbone and horizontal cabling do not meet current TIA standards for healthcare facilities. To meet industry standards, it is recommended to provide a new, dedicated telecommunications room with standards compliant backbone and horizontal cabling. Additional Category 6A data ports should be provided as required to meet standards. Dedicated cooling, rack space, cable management, and proper grounding are required to meet current standards. The addition of card-based access control is recommended to control and track access to the space.

Existing Telecom Cabinet.

- » Provide a dedicated telecommunications room.
- » Upgrade existing port locations to Category 6A.
- » Provide labels for all new cabling and existing cables to remain.
- » Add additional Category 6A 8P8C RJ45 ports to meet standards.
- » Provide new 12-strand single-mode and 12-strand OM4 multi-mode optical fiber backbone from the Oakley Building (Building 35).
- » Add Telecommunications Grounding Busbar.
- » Add ladder tray and cable management as needed.
- » Add a dedicated cooling system.
- » Add power circuits and receptacles as needed.
- » Control access to authorized individuals.

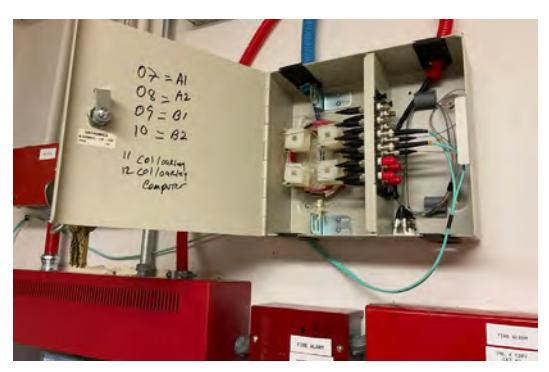
Existing Fiber Patching.

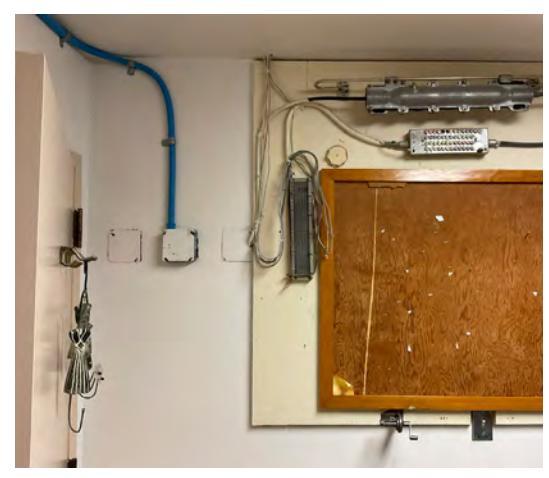
Existing Voice Patching.

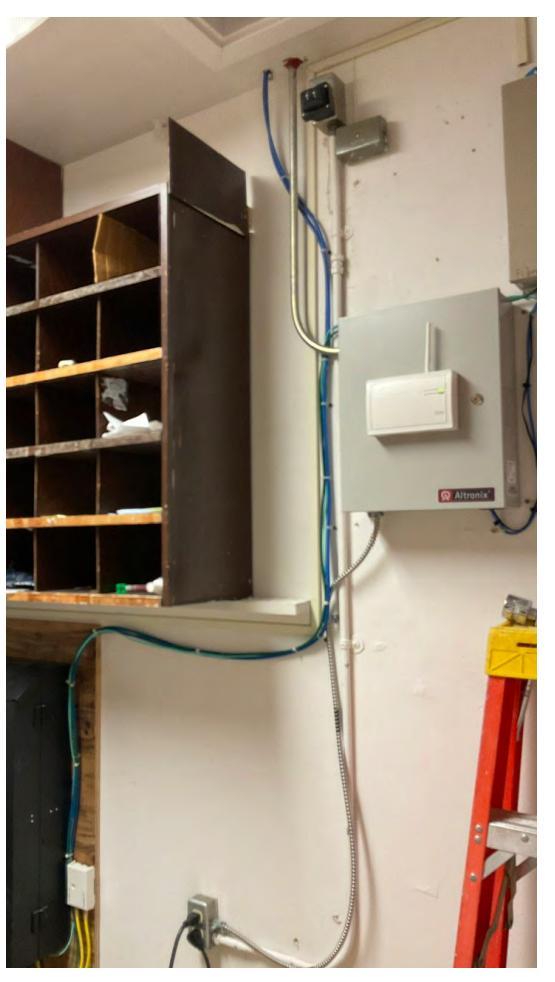
Existing Telecom Room Layout.

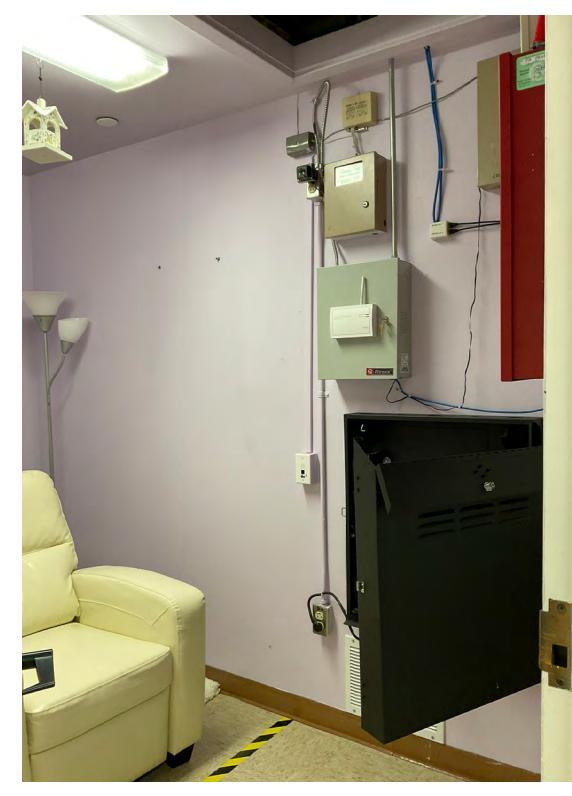
from the Oakley Building (Building 35), and a 50-pair Category 3 twisted-pair copper backbone cable from the Administration Building (Building 1). Neither a telecommunications grounding busbar nor dedicated cooling were observed within the room.

The existing telecommunications space is not standards compliant. The existing backbone and horizontal cabling do not meet current TIA standards for healthcare facilities. To meet industry standards, it is recommended to provide a new, dedicated telecommunications room with standards compliant backbone and horizontal cabling. Additional Category 6A data ports should be provided as required to meet standards. Dedicated cooling, rack space, cable management, and proper grounding are required to meet current standards. The addition of card-based access control is recommended to control and track access to the space.

Existing Telecom Room Layout.

- » Provide a dedicated telecommunications room.
- » Upgrade existing port locations to Category 6A.
- » Provide labels for all new cabling and existing cables to remain.
- » Add additional Category 6A 8P8C RJ45 ports to meet standards.
- » Provide new 12-strand single-mode and 12-strand OM4 multi-mode optical fiber backbone from the Oakley Building (Building 35).
- » Add Telecommunications Grounding Busbar.
- » Add ladder tray and cable management as needed.
- » Add a dedicated cooling system.
- » Add power circuits and receptacles as needed.
- » Control access to authorized individuals.

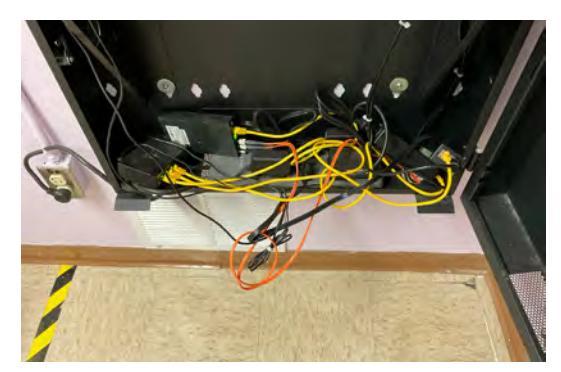
Existing Fiber & Data Patching.

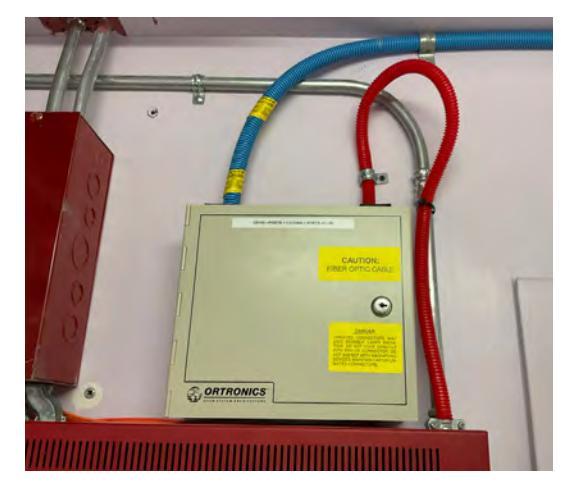
Existing Fiber Cabinet.

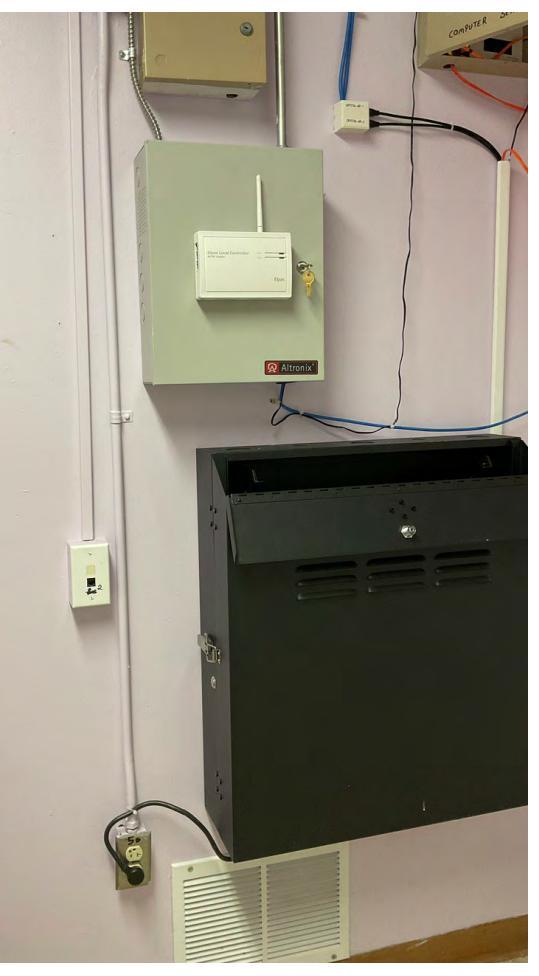
Existing Telecom Cabinet.

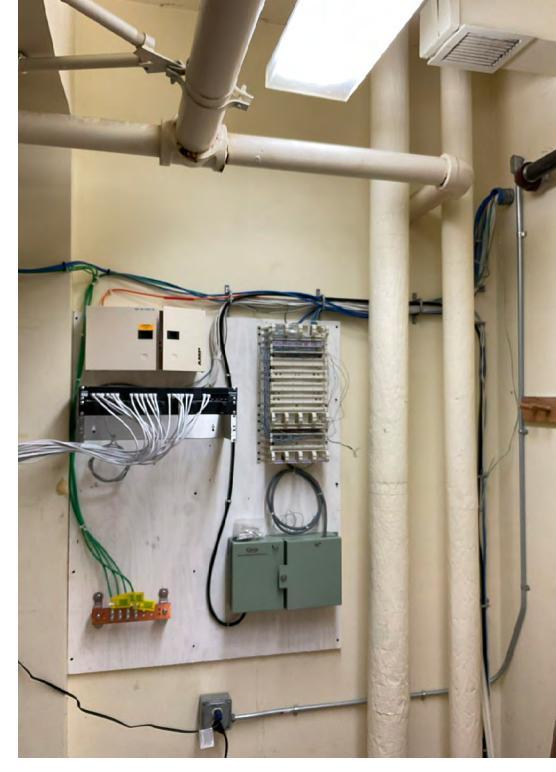
The existing backbone and horizontal cabling do not meet current TIA standards for healthcare facilities. To meet industry standards, it is recommended to upgrade the existing backbone and horizontal cabling. Additional Category 6A data ports should be provided as required to meet standards. Dedicated cooling, and dedicated equipment and convenience receptacles are required to meet standards. The addition of card-based access control is recommended to control and track access to the space.

Existing Voice & Data Patching.

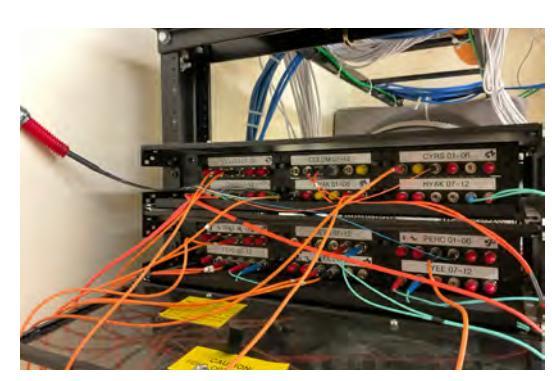
Existing Fiber Patching.
