DSHS RAINIER SCHOOL

WA STATE PROJECT NUMBER: 2024-429 K (8)

EXECUTIVE SUMMARY

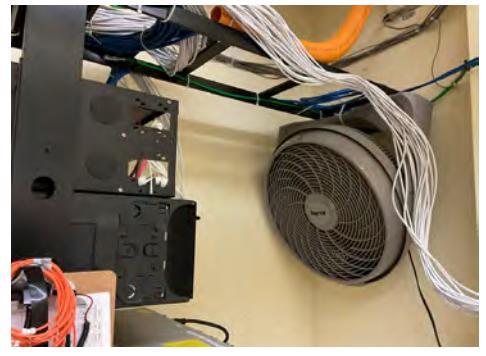
and a UPS. Connectivity is provided by a 24-strand OM1 multi-mode optical fiber backbone cable from the Administration Building (Building 1) and a 6-strand OM1 multi-mode optical fiber backbone cable from the Meyer Building (Building 37). Oakley is a fiber hub for the campus, with 12-strand OM1 multi-mode optical fiber backbone cables to Percival, Devenish, Tyee, Hyak, Columbia, and Crystal. A telecommunications grounding busbar was observed. There was no dedicated cooling for temperature and humidity control. A fan was hung on the wall to cool the telecommunications equipment.

Existing Fan Used for Cooling.

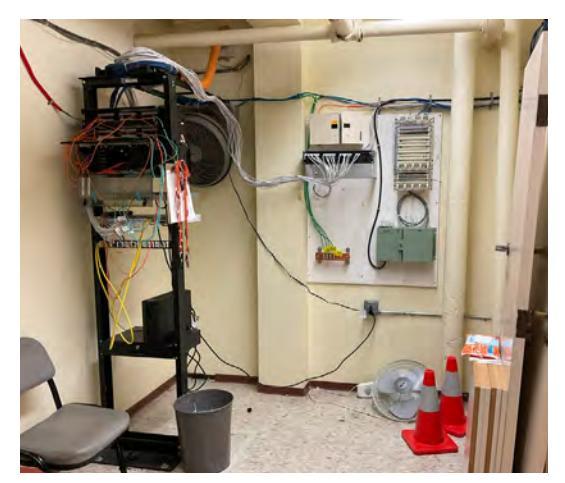
Existing Telecom Room Layout.

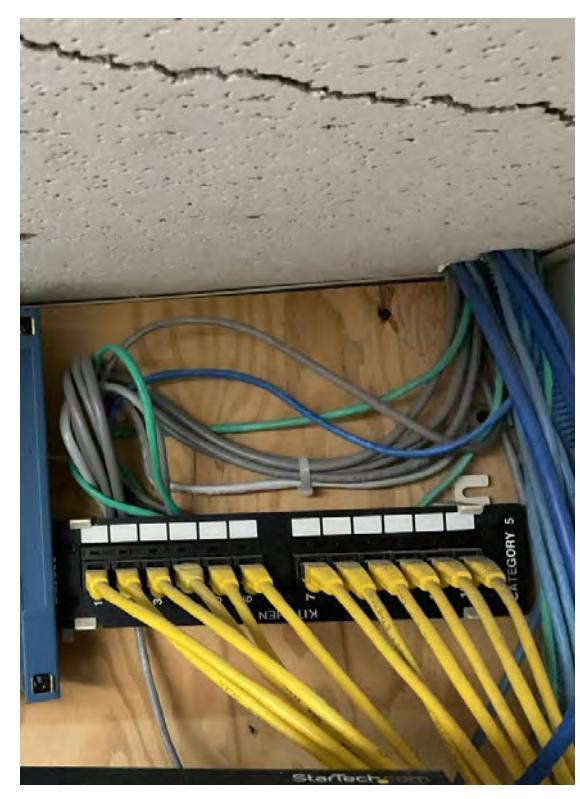
The Telecommunications Room, TR-115, contains three wall mount fiber cabinets. Connectivity is provided by 6-strand and 12-strand OM1 multi-mode optical fiber backbone cables and a 12-strand OM3 multi-mode optical fiber cable from the Meyer Building (Building 37), and a 50-pair copper from the Administration Building. There is a wall mounted ethernet switch and patch panel. Neither a telecommunications grounding busbar nor dedicated cooling were observed within the room.

The existing backbone and horizontal cabling do not meet current TIA standards for healthcare facilities. To meet industry standards, it is recommended to upgrade the existing backbone and horizontal cabling. A rack to support equipment and cable management should be added. Additional Category 6A data ports should be provided as required to meet standards. Dedicated cooling, and dedicated equipment and convenience receptacles are required to meet standards. The addition of card-based access control is recommended to control and track access to the space.

Existing Data Patching.

- » Upgrade existing port locations to Category 6A.
- » Provide labels for all new cabling and existing cables to remain.
- » Add additional Category 6A 8P8C RJ45 ports to meet standards.
- » Provide new 12-strand single-mode and 12-strand OM4 multimode optical fiber backbone from Meyer Building (37).
- » Add Telecommunications Grounding Busbar.
- » Add rack, ladder tray, and cable management as needed.
- » Add a dedicated cooling system.
- » Add power circuits and receptacles as needed.
- » Control access to authorized individuals.

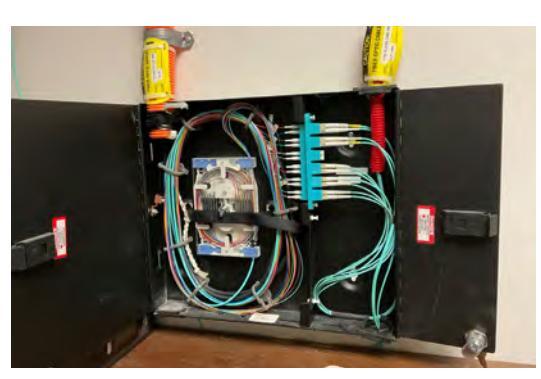
Existing Fiber Patching.

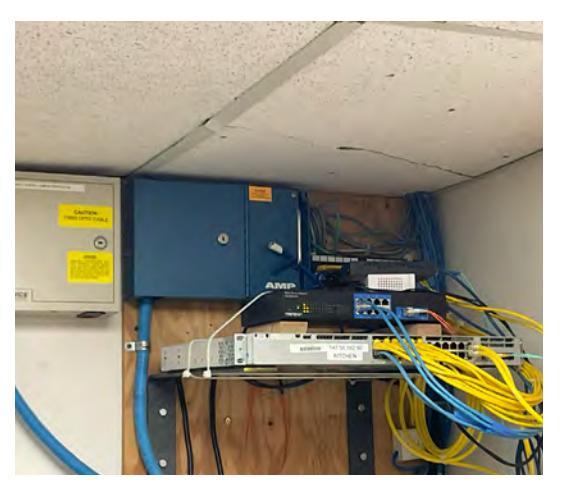
Existing Telecom Wall Elevation.

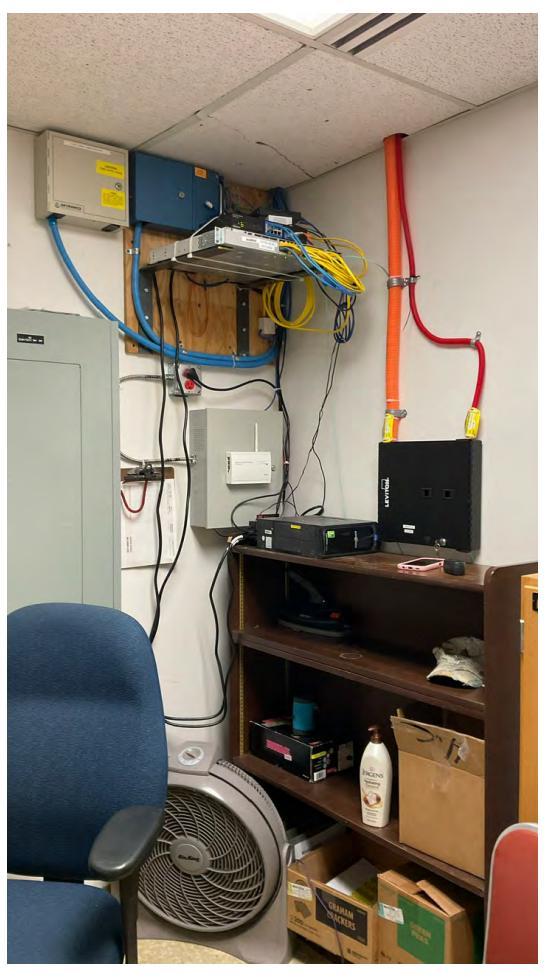
Existing Telecom Room Layout.

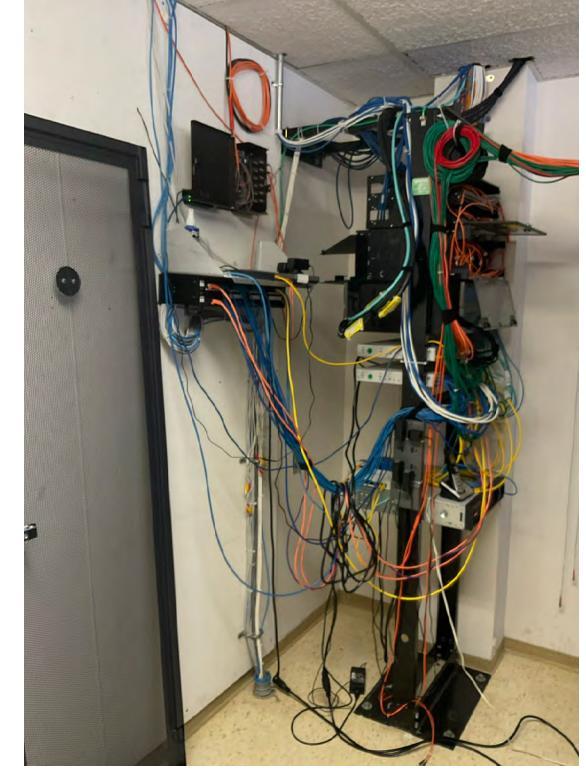
Existing Telecom Room Layout.

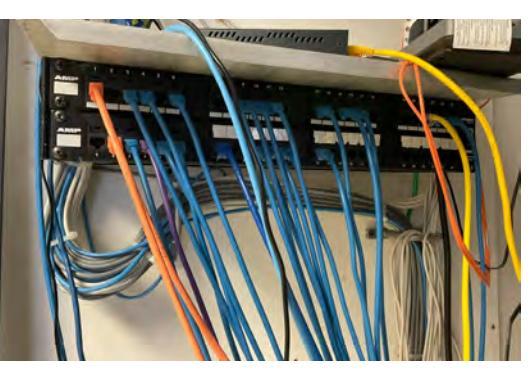
Existing Data Patching.

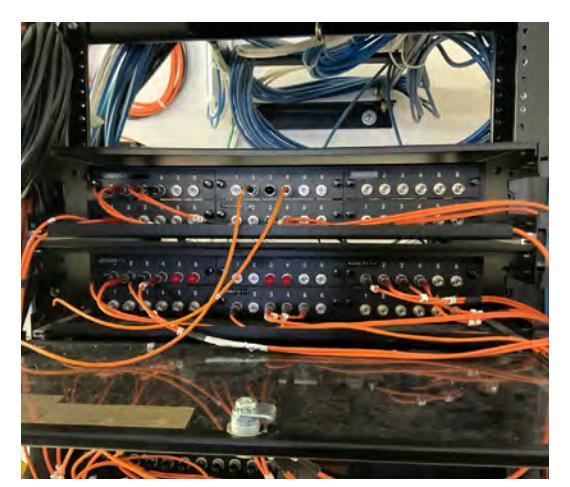
Existing Fiber Patching.

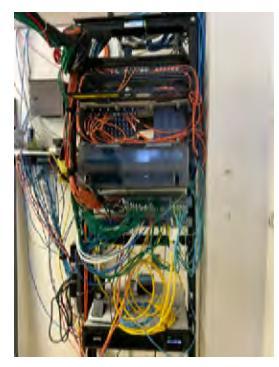
Existing Telecom Rack.

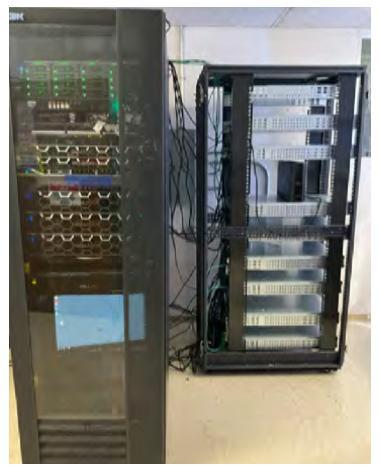
Existing UPS & Server Racks.

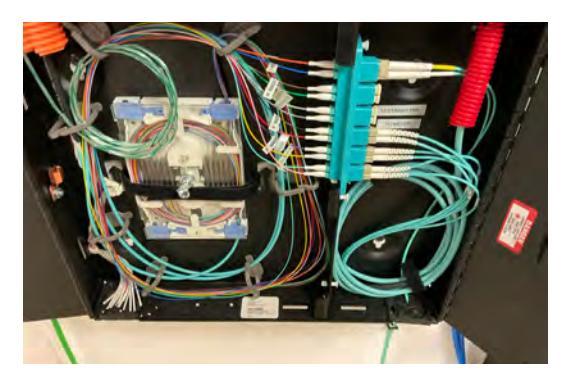
Existing Fiber Patching.

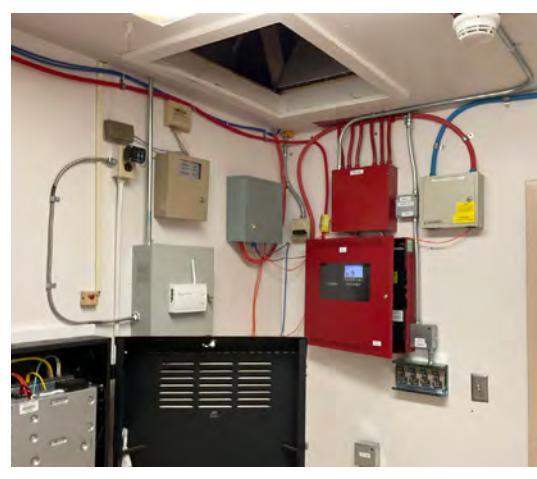
Existing Telecom Room Layout.

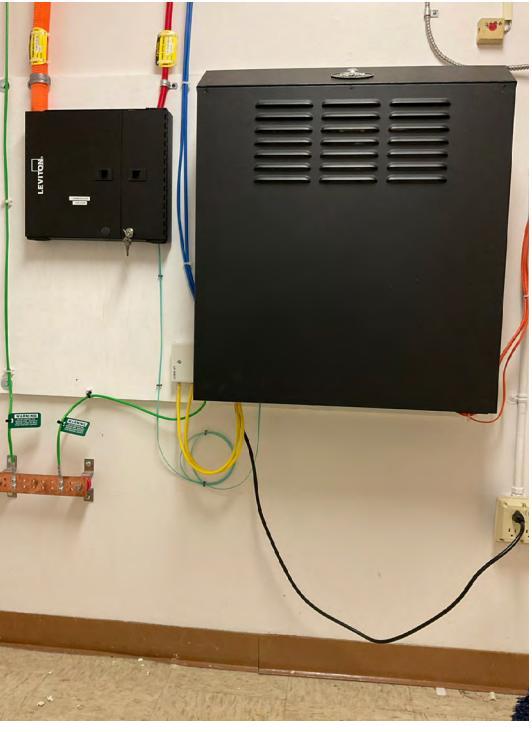
Existing Telecom Cabinet.

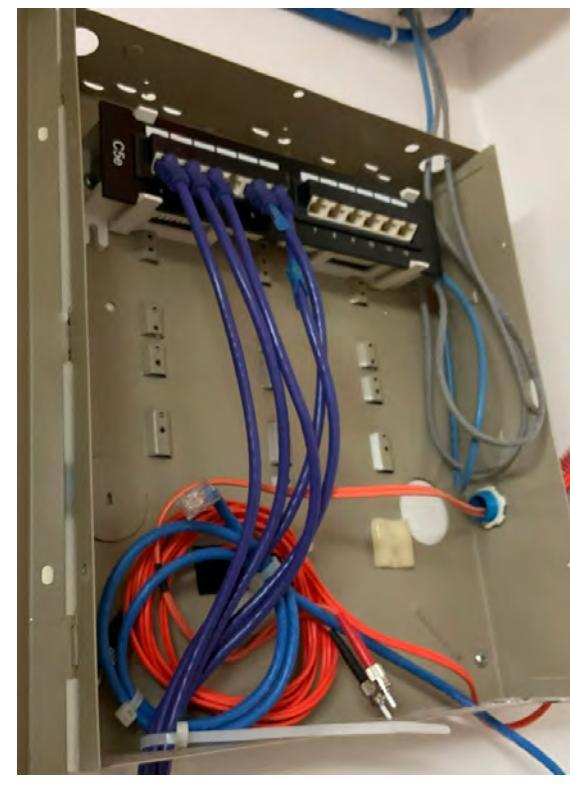
Existing Data Patching.

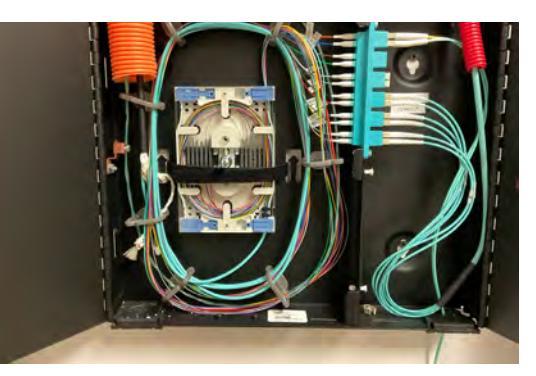
Existing Fiber Patching.

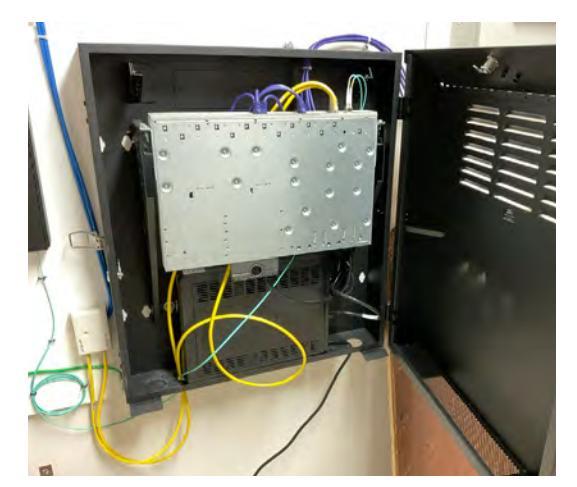
Existing Telecom Cabinet.

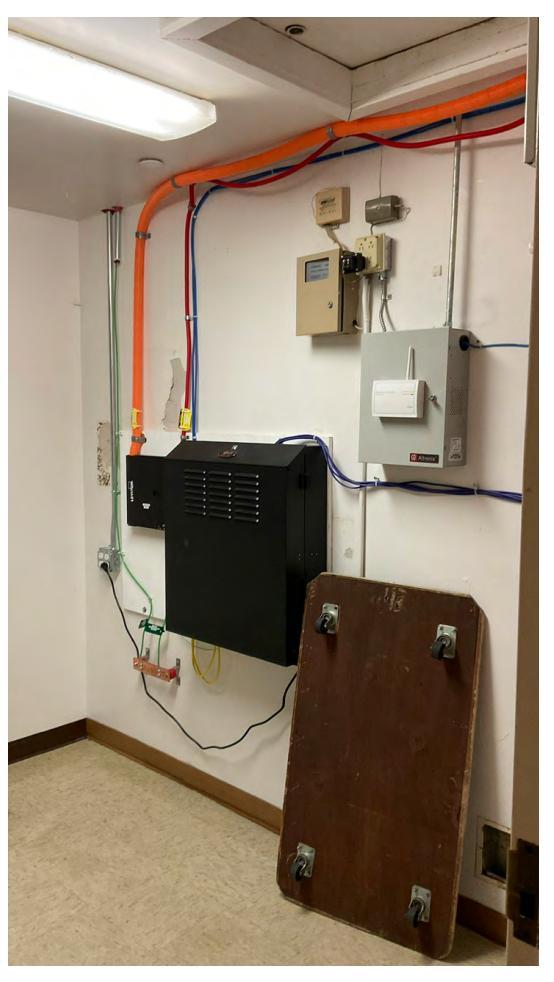
Existing Telecom Room Layout.

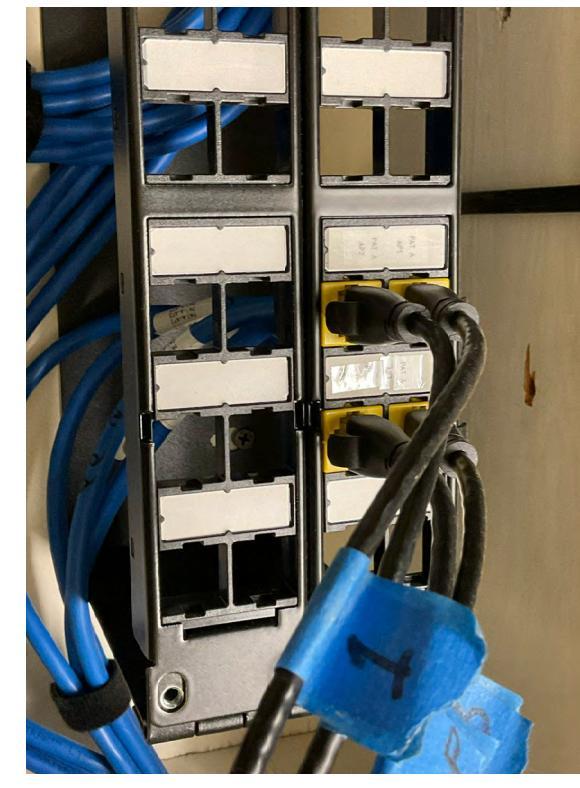
Existing Data Patching.

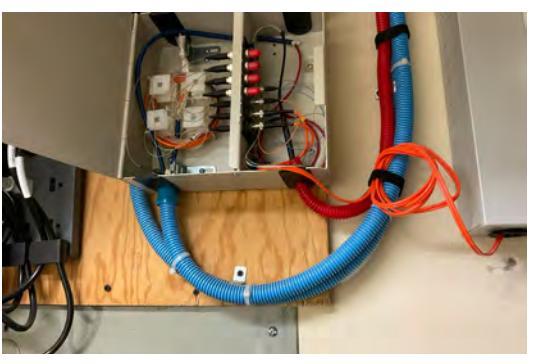
Existing Fiber Patching.

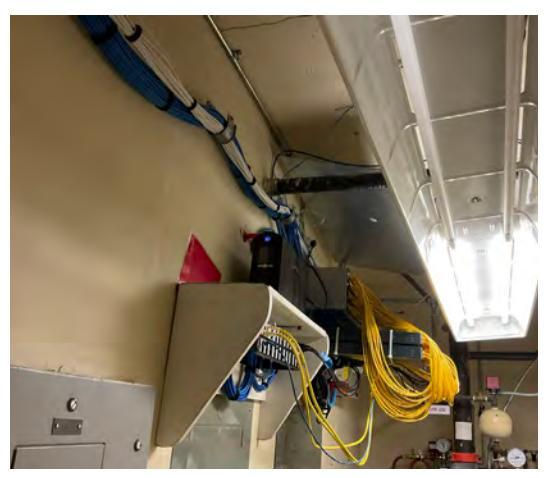
Existing Telecom Equipment.

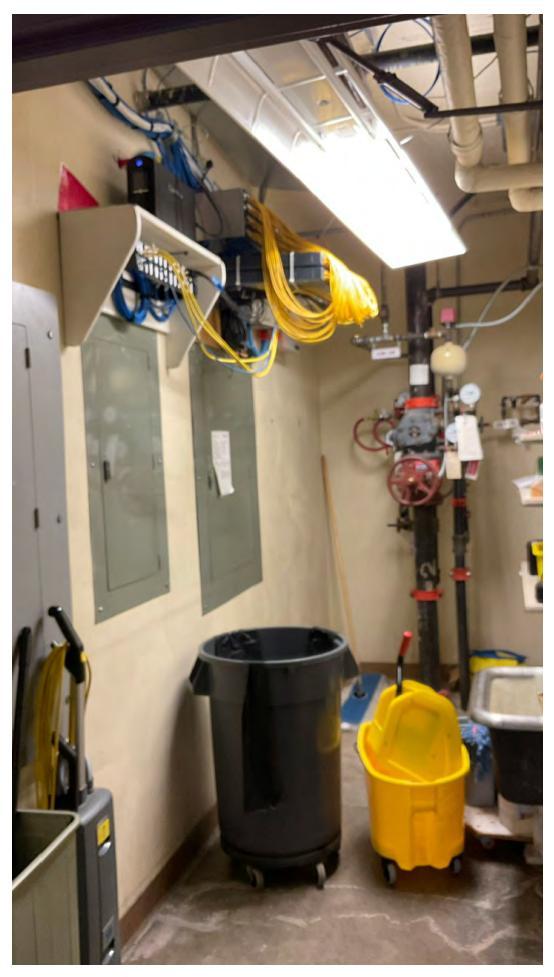
Existing Telecom Room Layout.

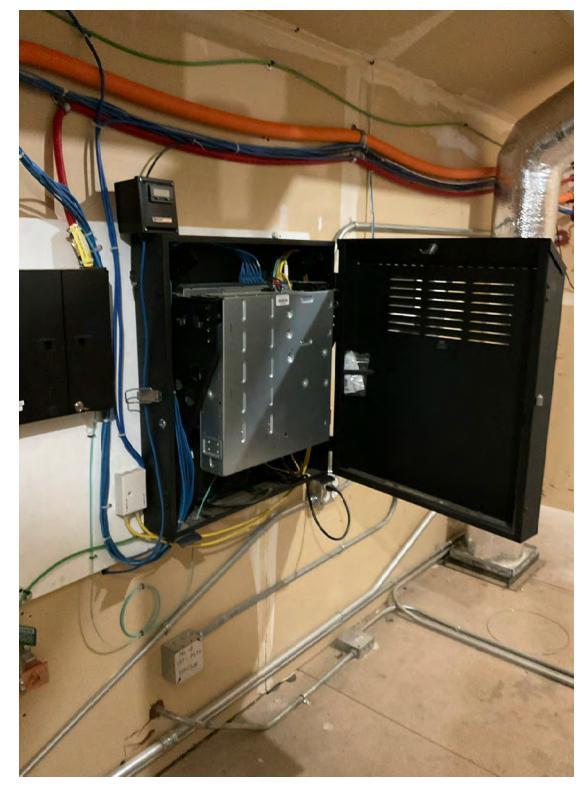
Existing Telecom Cabinet.

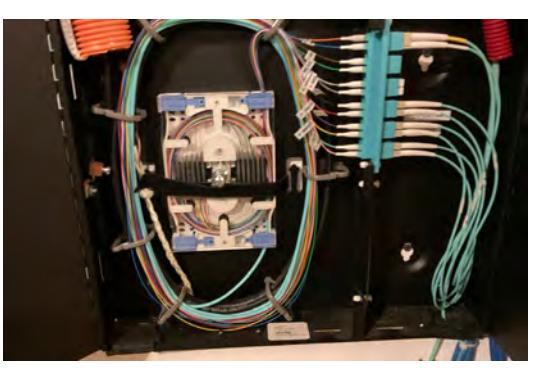
Existing Fiber Patching.

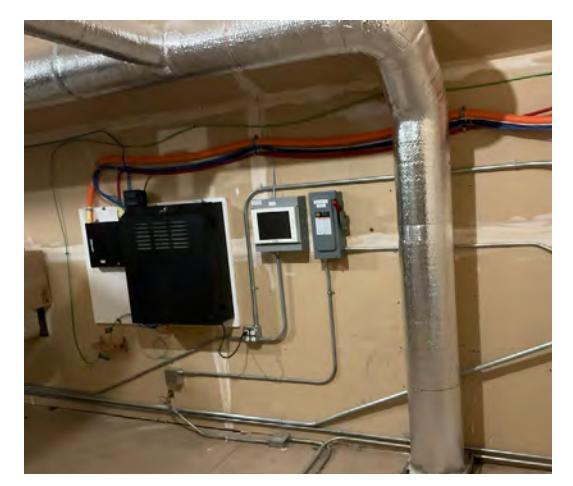
Existing Telecom Room Layout.

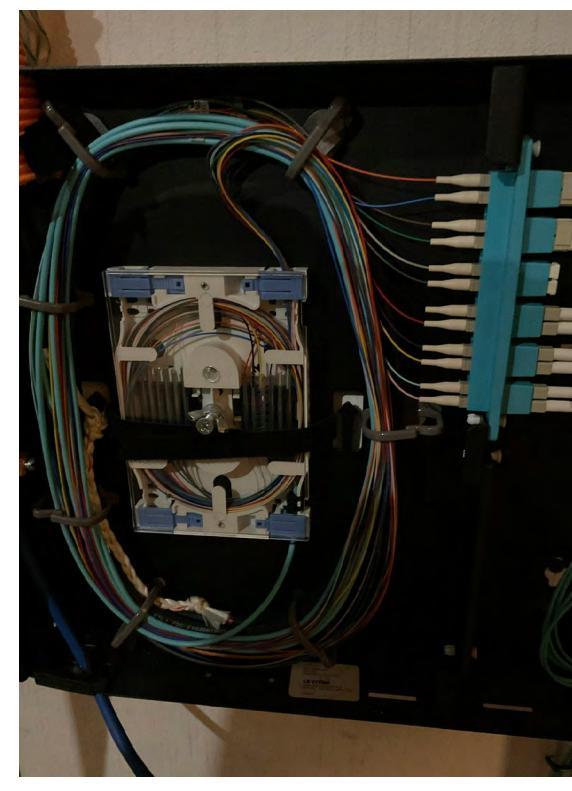
Existing Fiber Patching.

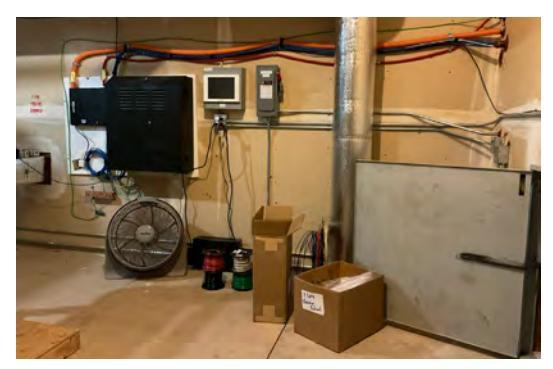
Existing Telecom Room Layout.

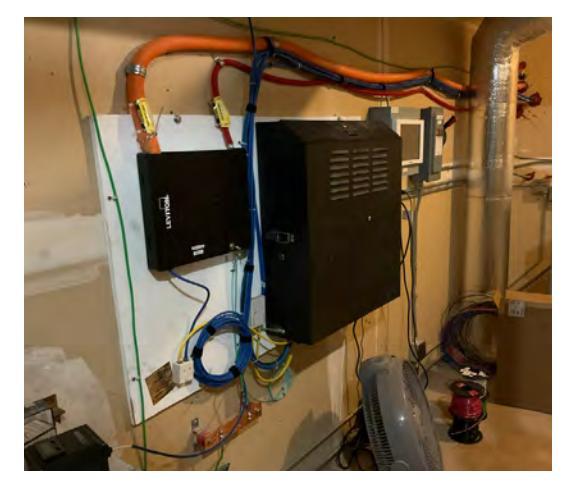
Existing Telecom Cabinet.

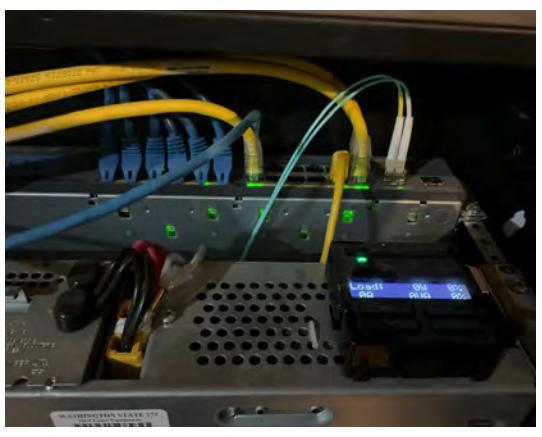
Existing Data Patching.

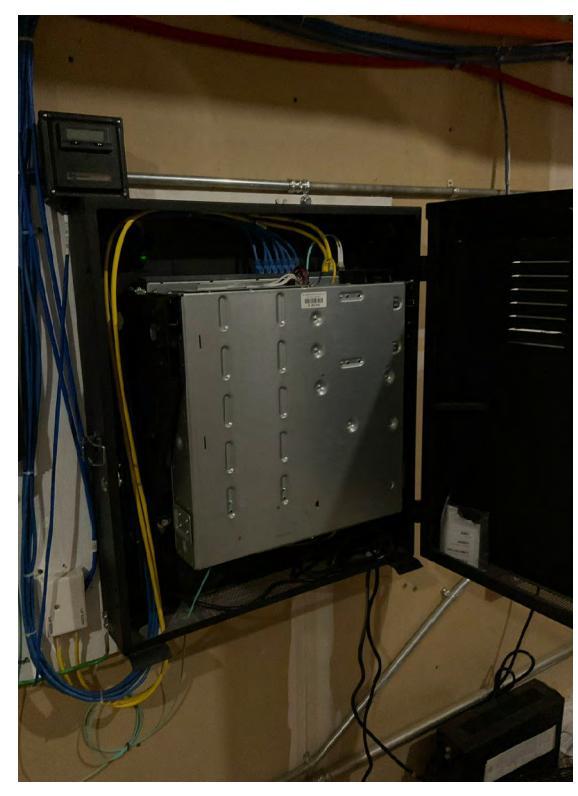
Existing Telecom Cabinet.

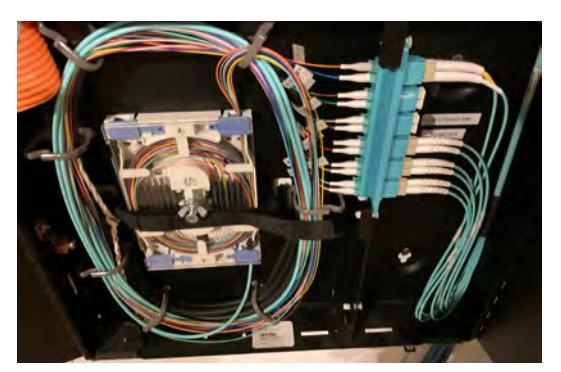
Existing Fiber Cabinet.

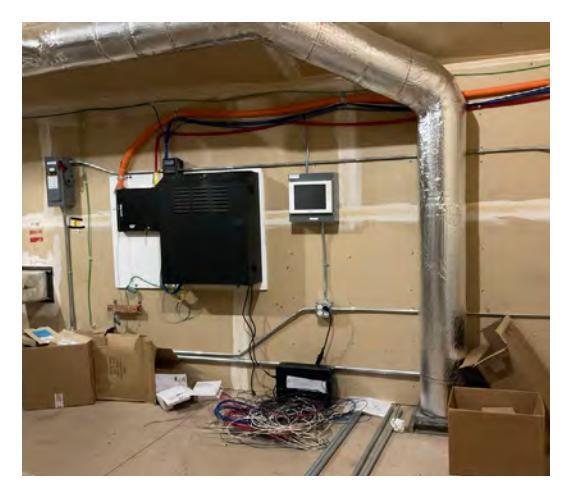
Existing Telecom Room Layout.

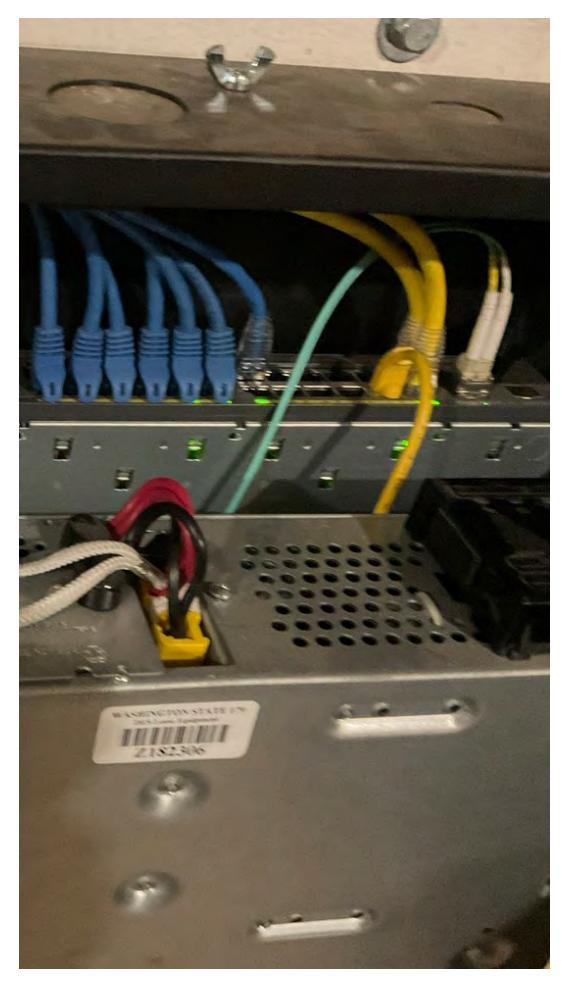
Existing Data Patching.

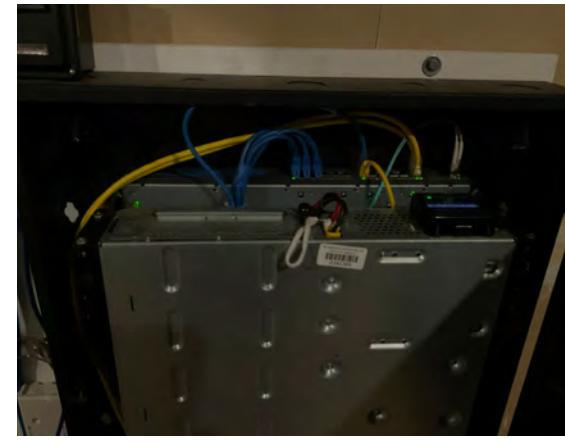
Existing Fiber & Data Patching.

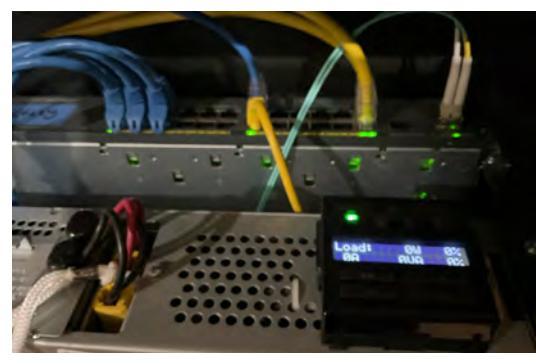
Existing Data Patching.

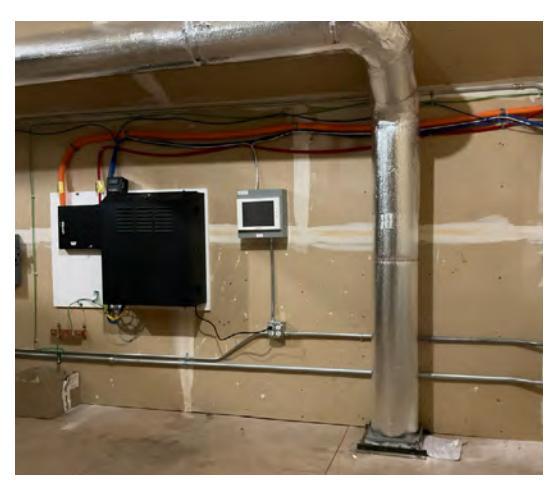
Existing Telecom Room Layout.

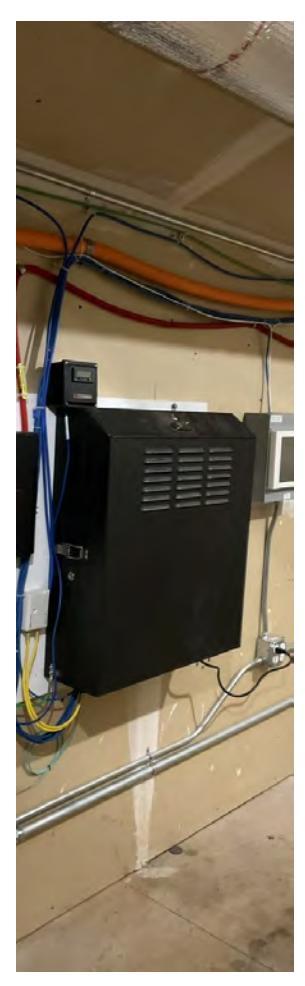
Existing Telecom Cabinet.

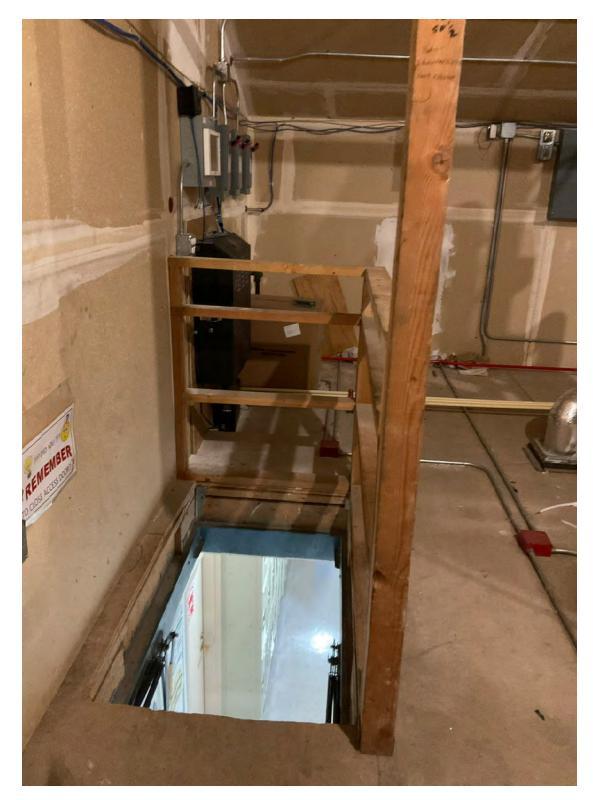
Existing Telecom Room Layout.

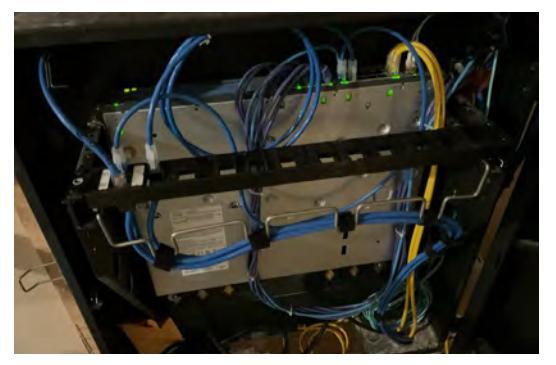
Existing Data Patching.

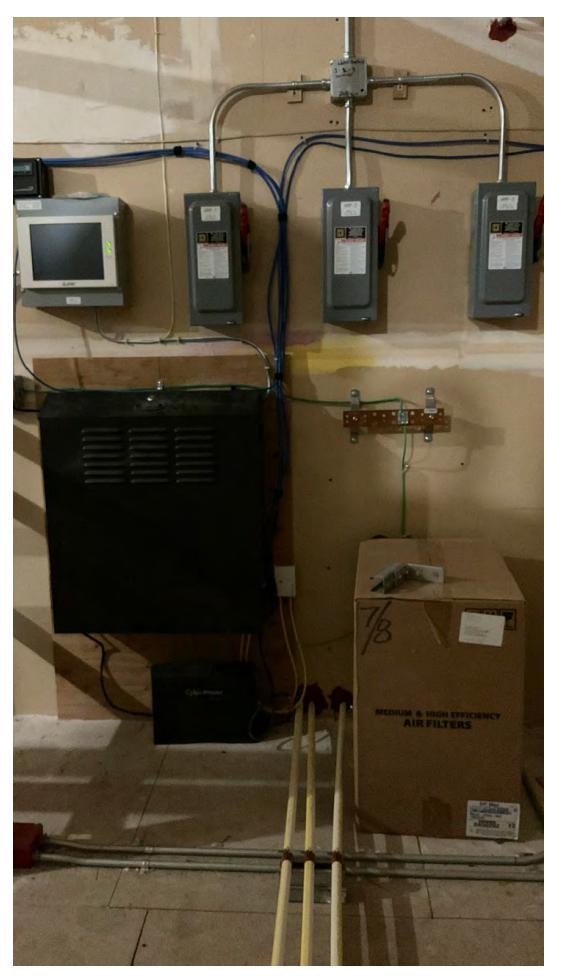
Existing Telecom Cabinet.

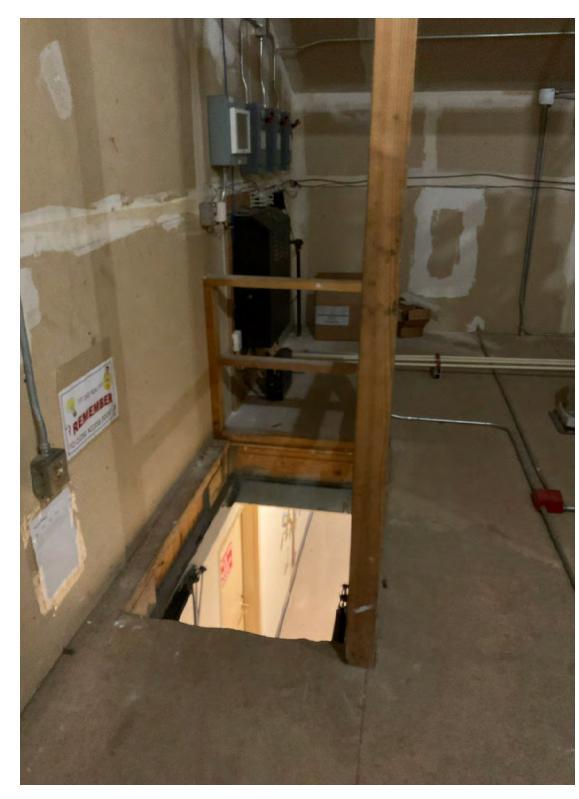
Existing Telecom Room Layout.

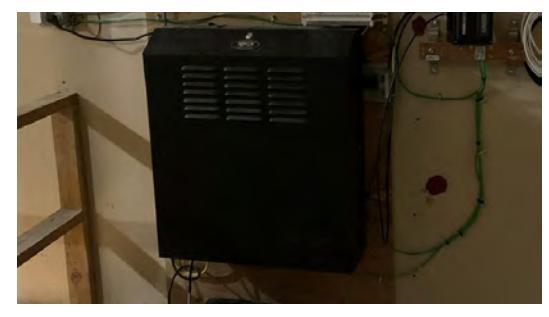
Existing Grounding.

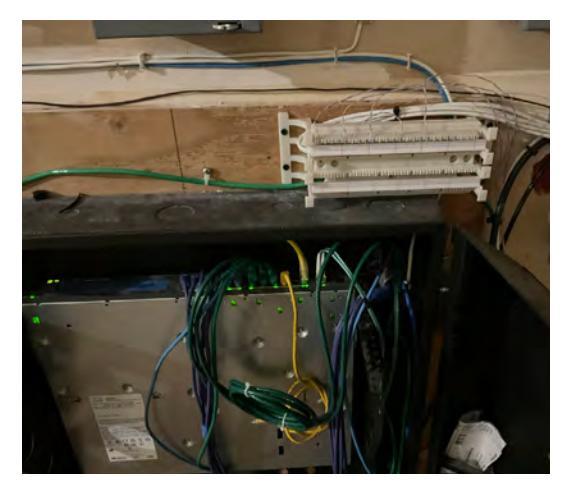
Existing Voice Patching.

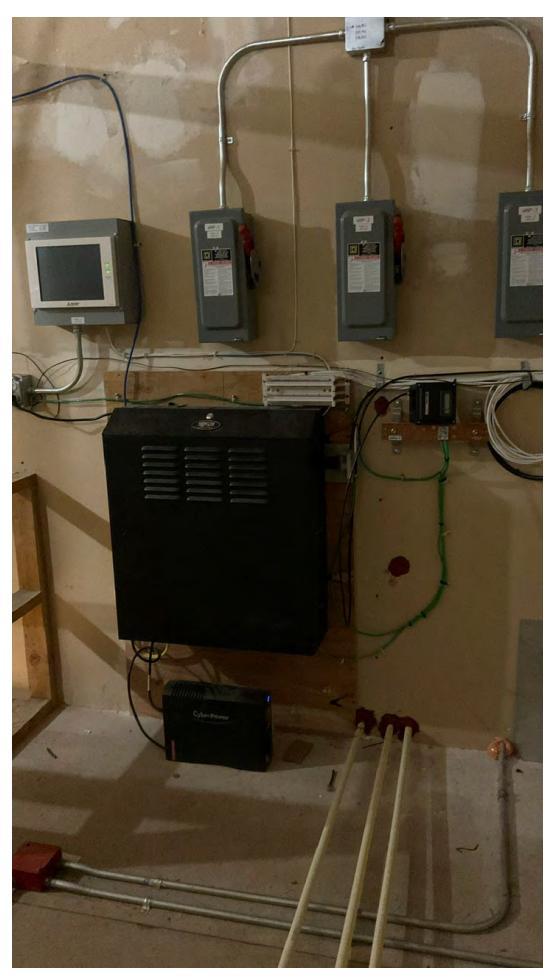
Existing Telecom Cabinet.

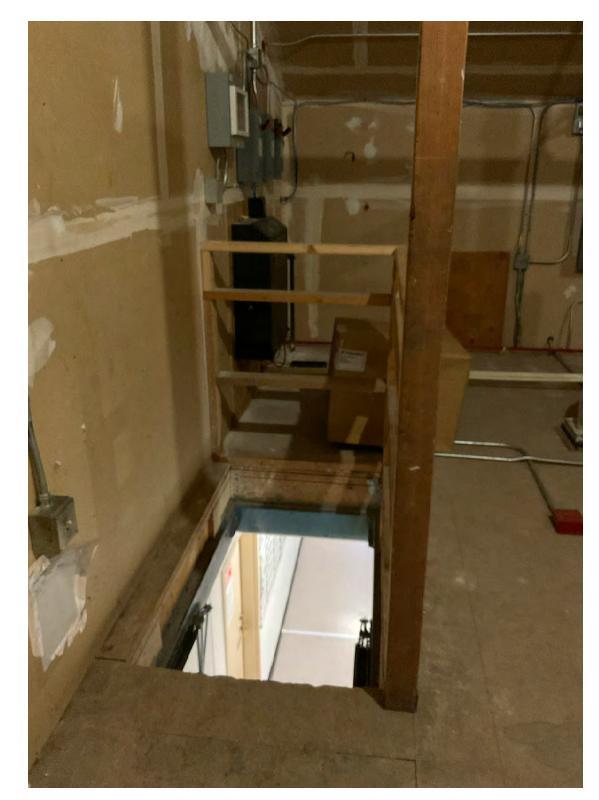
Existing Telecom Room Layout.

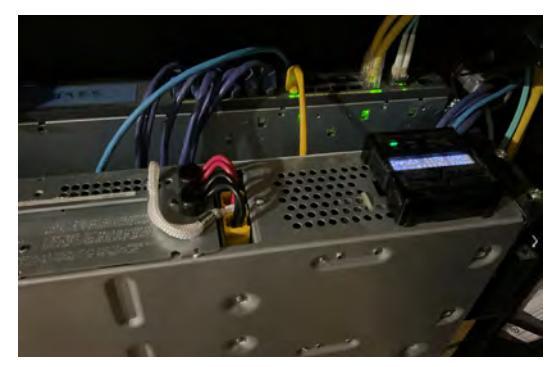
Existing Data Patching.

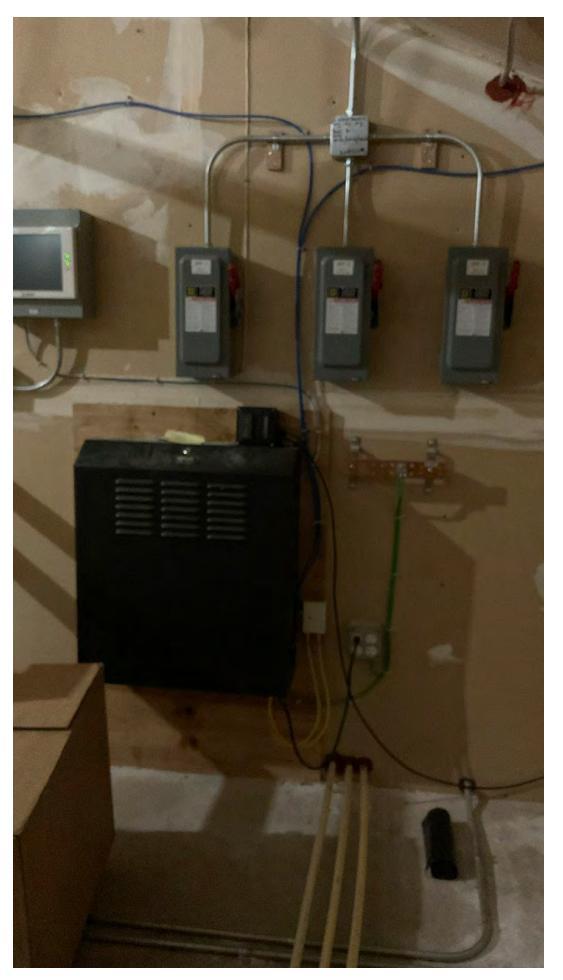
Existing Telecom Cabinet.

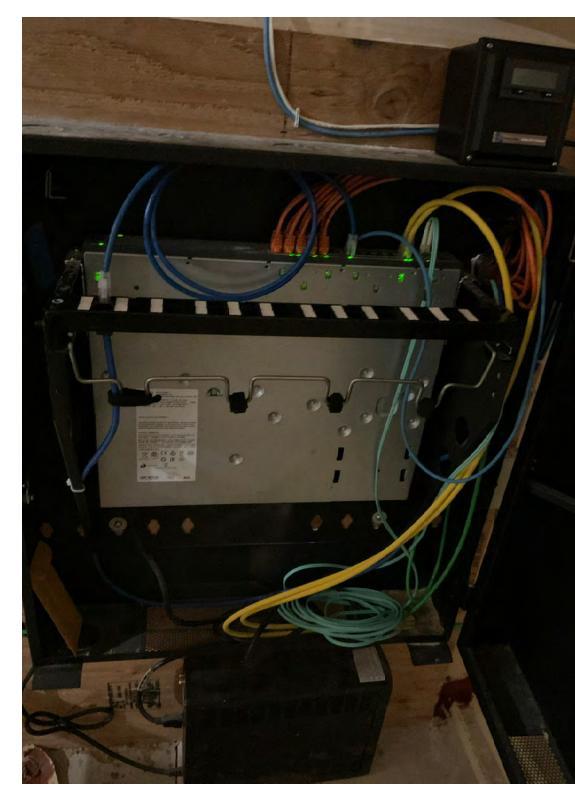
CROSS-CONNECT ROOM & TELECOMMUNICATIONS ROOM - TR-ATTIC

The telecommunications space is in the attic. There is no dedicated telecommunications room. The telecommunications space contains a wall mounted vertical rack that includes a patch panel, network switch, and a UPS. Connectivity is provided by a 12-strand OM3 multi-mode optical fiber backbone cable from the Oakley Building (Building 35). The vertical rack was grounded to a telecommunications grounding busbar. There is no dedicated cooling for temperature and humidity control.

The existing telecommunications space is not standards compliant. The existing backbone and horizontal cabling do not meet current TIA standards for healthcare facilities. To meet industry standards, it is recommended to provide a new, dedicated telecommunications room with standards compliant backbone and horizontal cabling. Additional Category 6A data ports should be provided as required to meet standards. Dedicated cooling, rack space, and cable management are required to meet current standards. The addition of card-based access control is recommended to control and track access to the space.

Existing Telecom Cabinet.

- » Provide a dedicated telecommunications room.
- » Upgrade existing port locations to Category 6A.
- » Provide labels for all new cabling and existing cables to remain.
- » Add additional Category 6A 8P8C RJ45 ports to meet standards.
- » Provide new 12-strand single-mode and 12-strand OM4 multi-mode optical fiber backbone from the Oakley Building (Building 35).
- » Add ladder tray and cable management as needed.
- » Add a dedicated cooling system.
- » Add power circuits and receptacles as needed.
- » Control access to authorized individuals.

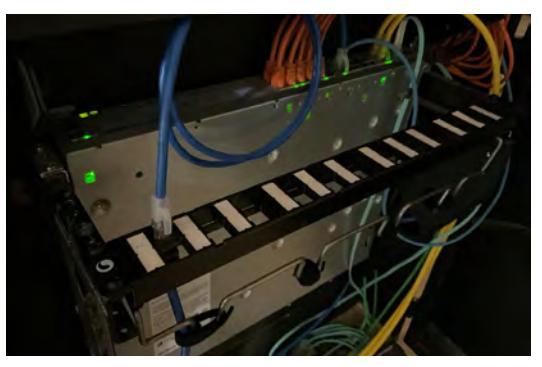
Existing Data Patching.

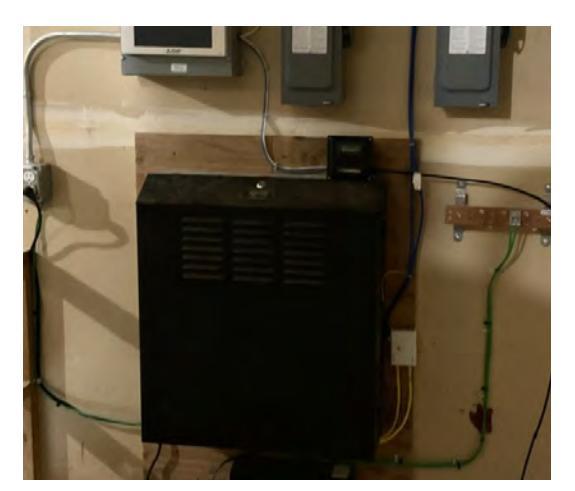
Existing Grounding.

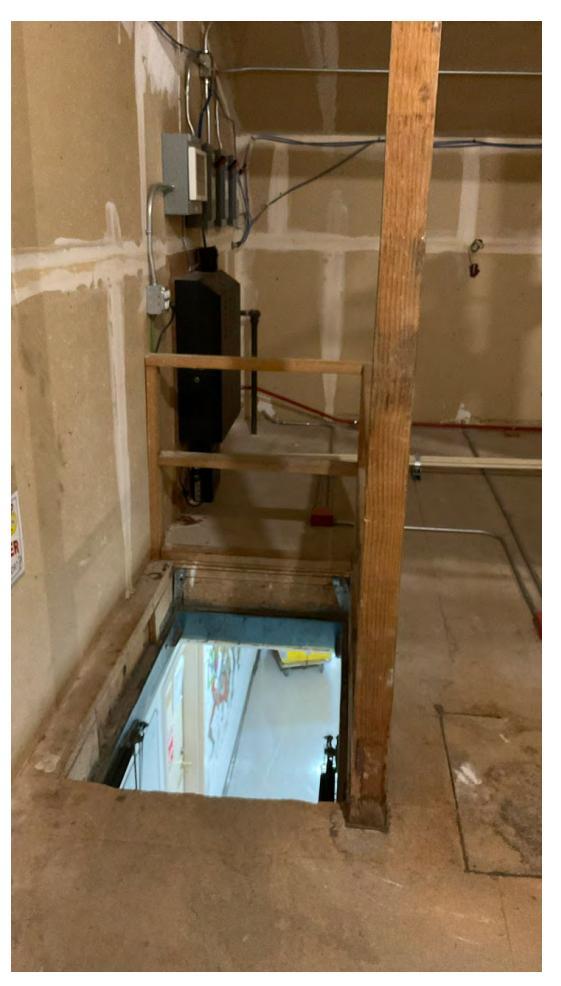
Existing Telecom Room Layout.

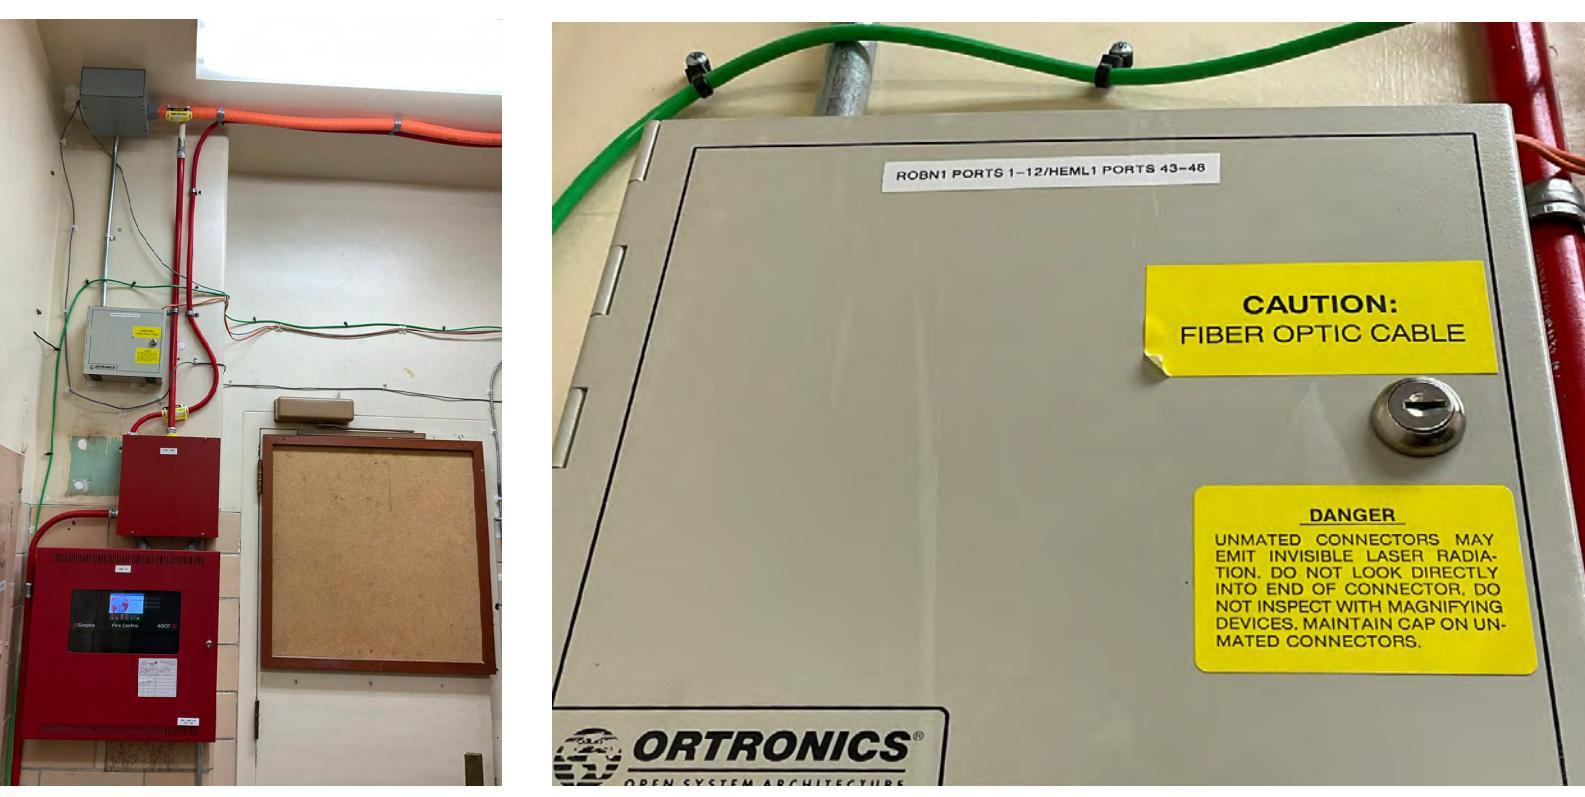
TELECOMMUNICATIONS ROOM - TR-08

The telecommunications room contains a wall mount fiber cabinet, a wall mounted rack, and shares space with the fire alarm control panel. The wall mounted rack includes a network switch and UPS. Connectivity is provided by a 24-strand OM3 multi-mode optical fiber backbone cable and a 50-pair Category 3 twisted-pair copper backbone cable from the Administration Building (Building 1). A telecommunications grounding busbar was observed. There is no dedicated cooling for temperature and humidity control.

The existing backbone and horizontal cabling do not meet current TIA standards for healthcare facilities. To meet industry standards, it is recommended to upgrade the existing backbone and horizontal cabling. Additional Category 6A data ports should be provided as required to meet standards. Dedicated cooling, and dedicated equipment and convenience receptacles are required to meet standards. The addition of card-based access control is recommended to control and track access to the space.

Existing Telecom Room Layout.

Existing Fiber Cabinet.

- » Upgrade existing port locations to Category 6A.
- » Provide labels for all new cabling and existing cables to remain.
- » Add additional Category 6A 8P8C RJ45 ports to meet standards.
- » Provide new 24-strand OM4 multi-mode optical fiber backbone from Administration Building (Building 1).
- » Add ladder tray and cable management as needed.
- » Add a dedicated cooling system.
- » Add power circuits and receptacles as needed.
- » Control access to authorized individuals.

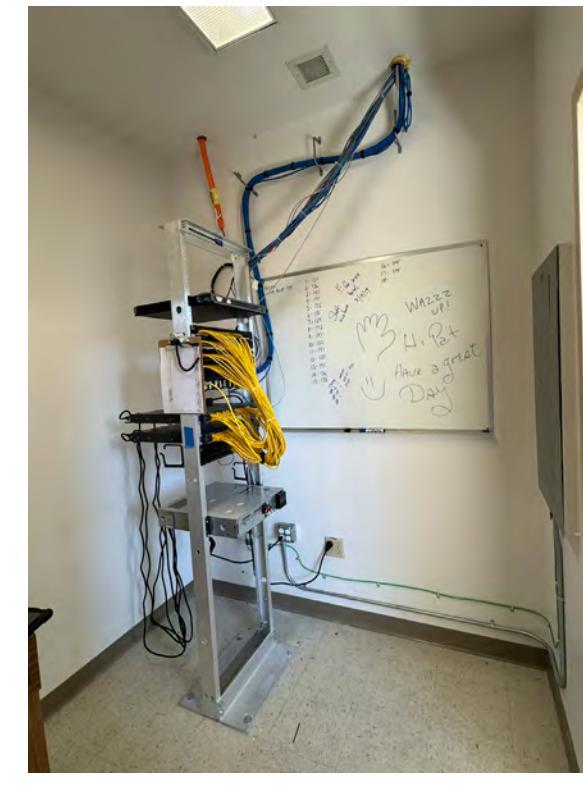
The telecommunications room contains a single two-post equipment rack with a rack mount fiber cabinet, multiple patch panels, network switches, and a UPS. Connectivity is provided by a 12-strand OM3 multi-mode optical fiber backbone cable from the Hemlock Building (Building 50B). A telecommunications grounding busbar was observed. There is no dedicated cooling for temperature and humidity control.

The existing backbone and horizontal cabling do not meet current TIA standards for healthcare facilities. To meet industry standards, it is recommended to upgrade the existing backbone and horizontal cabling. Additional Category 6A data ports should be provided as required to meet standards. Dedicated cooling is required to meet standards. The addition of card-based access control is recommended to control and track access to the space.

- » Horizontal Cabling infrastructure does not meet minimum standards per TIA-1179.
- » Backbone Cabling Infrastructure does not meet minimum standards per TIA-1179.
- » Minimal cable support, leading to cables being draped or placed directly on equipment.
- » No dedicated cooling system to maintain temperature of equipment.

Existing Telecom Room Layout.

- » Upgrade existing port locations to Category 6A.
- » Provide labels for all new cabling and existing cables to remain.
- » Add additional Category 6A 8P8C RJ45 ports to meet standards.
- » Provide new 24-strand OM4 multi-mode optical fiber backbone from Hemlock Building (Building 50B).
- » Add ladder tray and cable management as needed.
- » Add a dedicated cooling system.
- » Control access to authorized individuals.

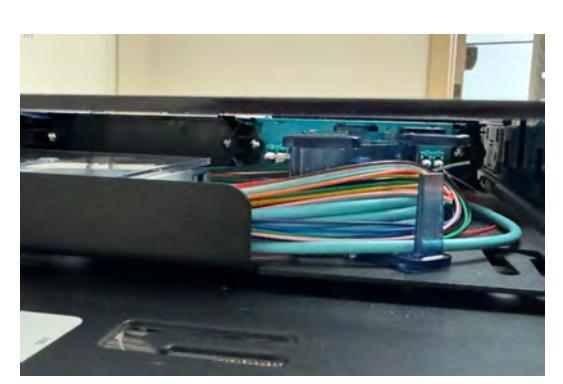
Existing Fiber Patching.

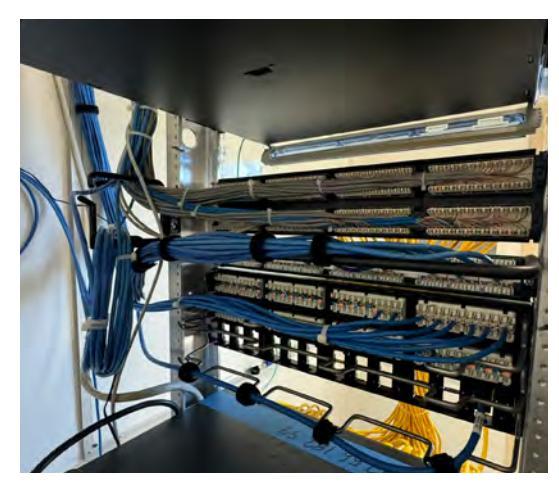
Existing Data Patching.

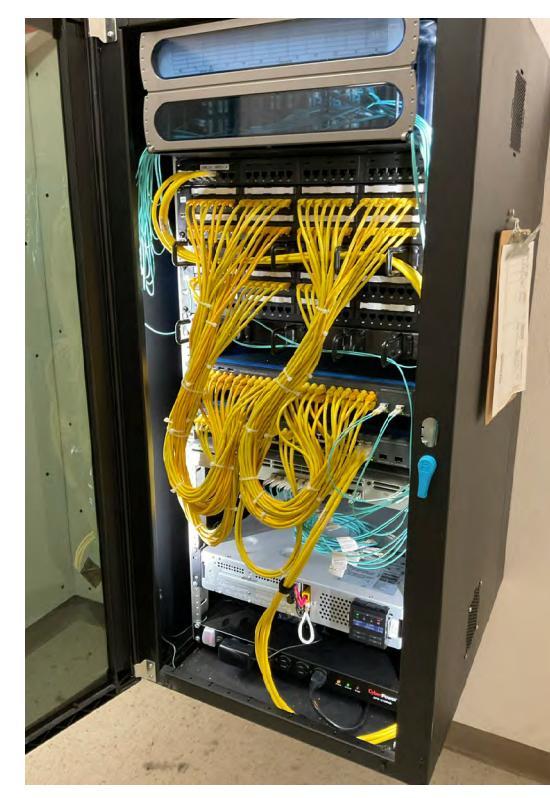
The existing backbone and horizontal cabling do not meet current TIA standards for healthcare facilities. To meet industry standards, it is recommended to upgrade the existing backbone and horizontal cabling. Additional Category 6A data ports should be provided as required to meet standards. Dedicated cooling is required to meet standards. The addition of card-based access control is recommended to control and track access to the space.

- » Horizontal Cabling infrastructure does not meet minimum standards per TIA-1179.
- » Backbone Cabling Infrastructure does not meet minimum standards per TIA-1179.
- » Minimal cable support, leading to cables being draped or placed directly on equipment.
- » No dedicated cooling system to maintain temperature of equipment.
- » Electrical infrastructure does not meet minimum requirements per standards.

Existing Telecom Cabinet.

- » Upgrade existing port locations to Category 6A.
- » Provide labels for all new cabling and existing cables to remain.
- » Add additional Category 6A 8P8C RJ45 ports to meet standards.
- » Provide new 48-strand single-mode optical fiber backbone from the Administration Building (Building 1).
- » Add floor mounted racks for equipment.
- » Add ladder tray and cable management as needed.
- » Add a dedicated cooling system.
- » Add power circuits and receptacles as needed.
- » Control access to authorized individuals.

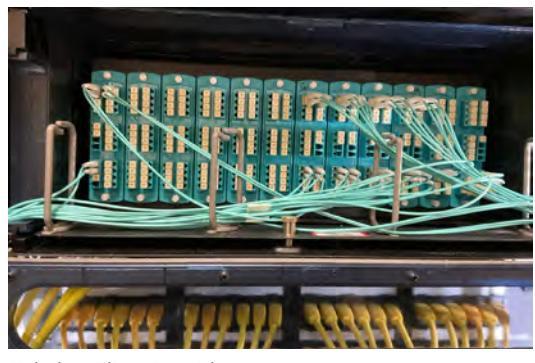
Existing Fiber Patching.

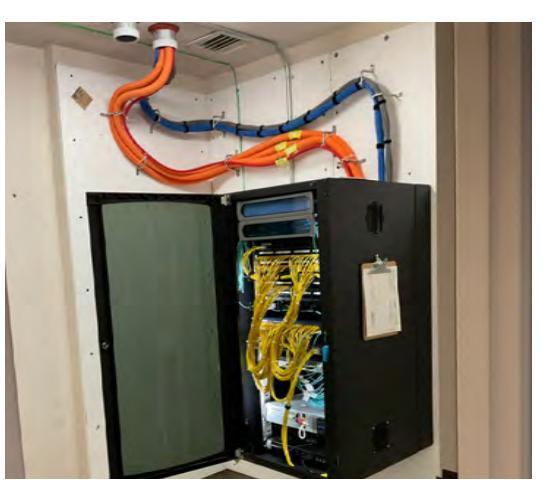
Existing Telecom Room Layout.
