DSHS RAINIER SCHOOL

WA STATE PROJECT NUMBER: 2024-429 K (8)

EXECUTIVE SUMMARY

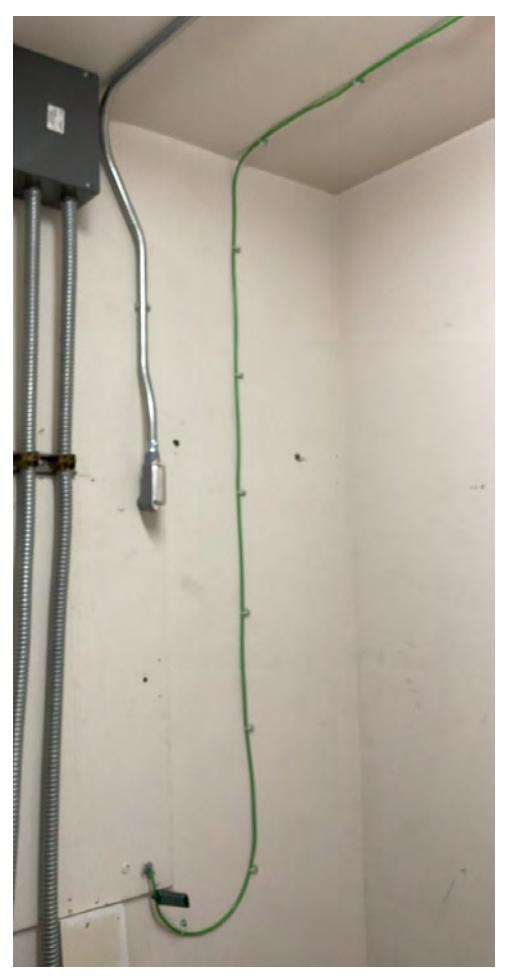
Existing Grounding.

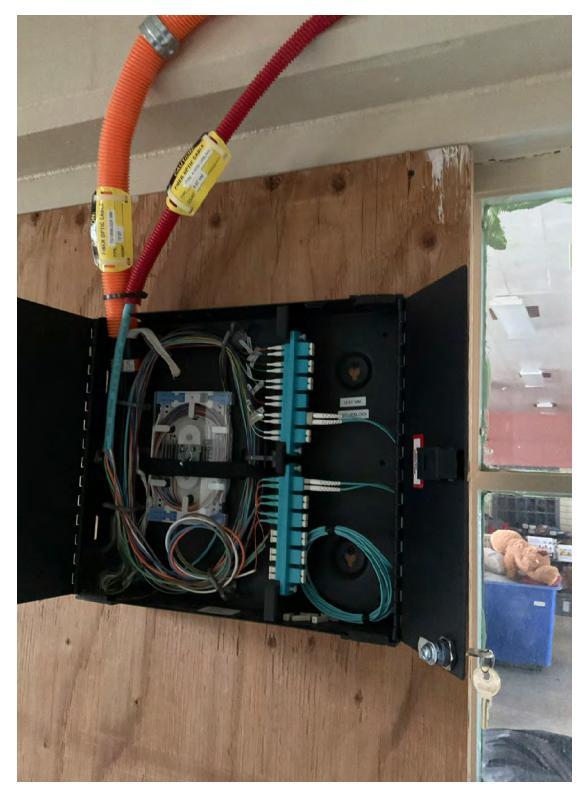
TELECOMMUNICATIONS ROOM - TR-118

The Telecommunications room is in the fire control panel room. The space contains two wall mounted fiber cabinets. There is not a dedicated telecommunications room. Connectivity is provided by a 12-strand OM3 multi-mode optical fiber backbone cable from the Hemlock Building (Building 50B). A telecommunications grounding busbar was observed. There is no dedicated cooling for temperature and humidity control.

The existing telecommunications space is not standards compliant. The existing backbone and horizontal cabling do not meet current TIA standards for healthcare facilities. To meet industry standards, it is recommended to provide a new, dedicated telecommunications room with standards compliant backbone and horizontal cabling. Additional Category 6A data ports should be provided as required to meet standards. Dedicated cooling, rack space, cable management, and proper grounding are required to meet current standards. The addition of card-based access control is recommended to control and track access to the space.

Existing Fiber Cabinet.

- » Provide a dedicated telecommunications room.
- » Upgrade existing port locations to Category 6A.
- » Provide labels for all new cabling and existing cables to remain.
- » Add additional Category 6A 8P8C RJ45 ports to meet standards.
- » Provide new 12-strand single-mode and 12-strand OM4 multi-mode optical fiber backbone from the Hemlock Building (Building 50B).
- » Add Telecommunications Grounding Busbar.
- » Add ladder tray and cable management as needed.
- » Add a dedicated cooling system.
- » Add power circuits and receptacles as needed.
- » Control access to authorized individuals.

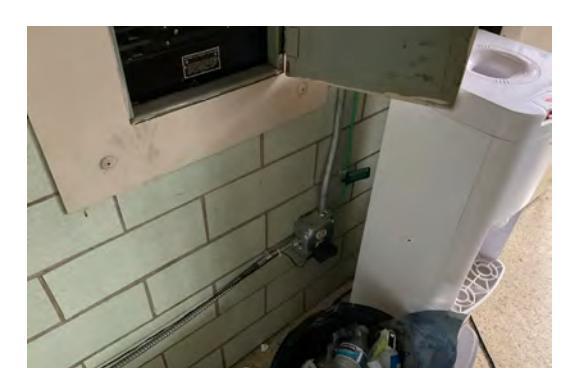
Existing Grounding.

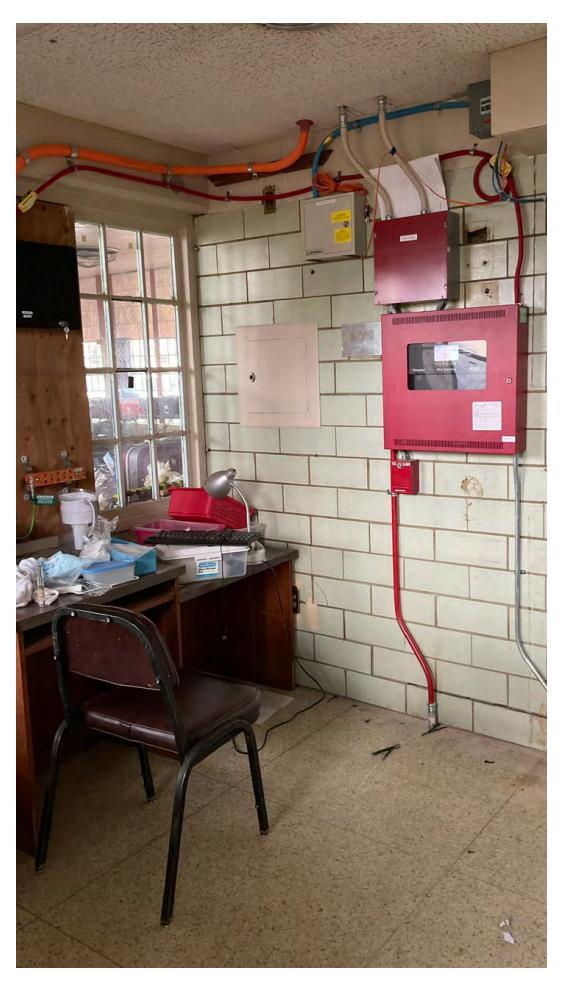
Existing Telecom Room Layout.

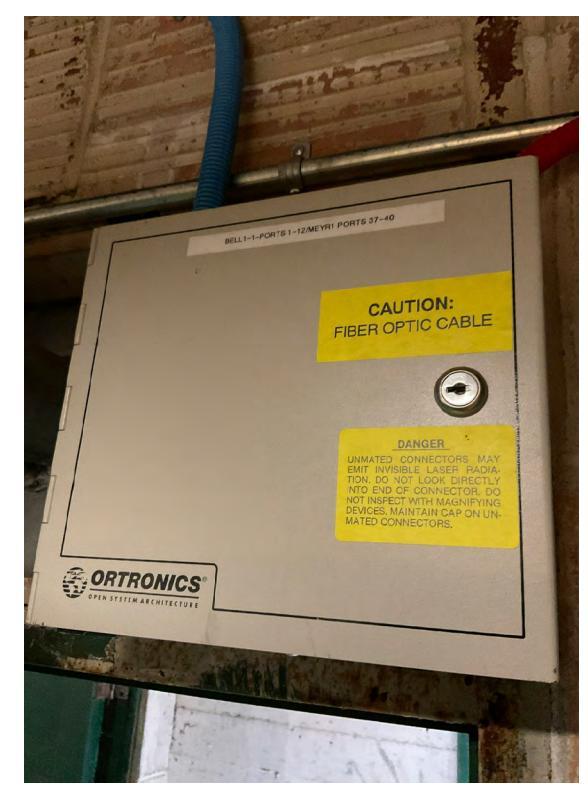
TELECOMMUNICATIONS ROOM - TR-BASEMENT

The telecommunications space is in the fire alarm control panel room in the basement. There is no dedicated telecommunications space. The space contains a single wall mount fiber cabinet. Connectivity is provided by a 12-strand OM1 multi-mode optical fiber backbone cable from the Meyer Building (Building 37) and a 50-pair Category 3 twisted-pair copper backbone cable from the Administration Building (Building 1). Neither a telecommunications grounding busbar nor dedicated cooling were observed within the room.

The existing telecommunications space is not standards compliant. The existing backbone and horizontal cabling do not meet current TIA standards for healthcare facilities. To meet industry standards, it is recommended to provide a new, dedicated telecommunications room with standards compliant backbone and horizontal cabling. Additional Category 6A data ports should be provided as required to meet standards. Dedicated cooling, rack space, cable management, and proper grounding are required to meet current standards. The addition of card-based access control is recommended to control and track access to the space.

Existing Fiber Cabinet.

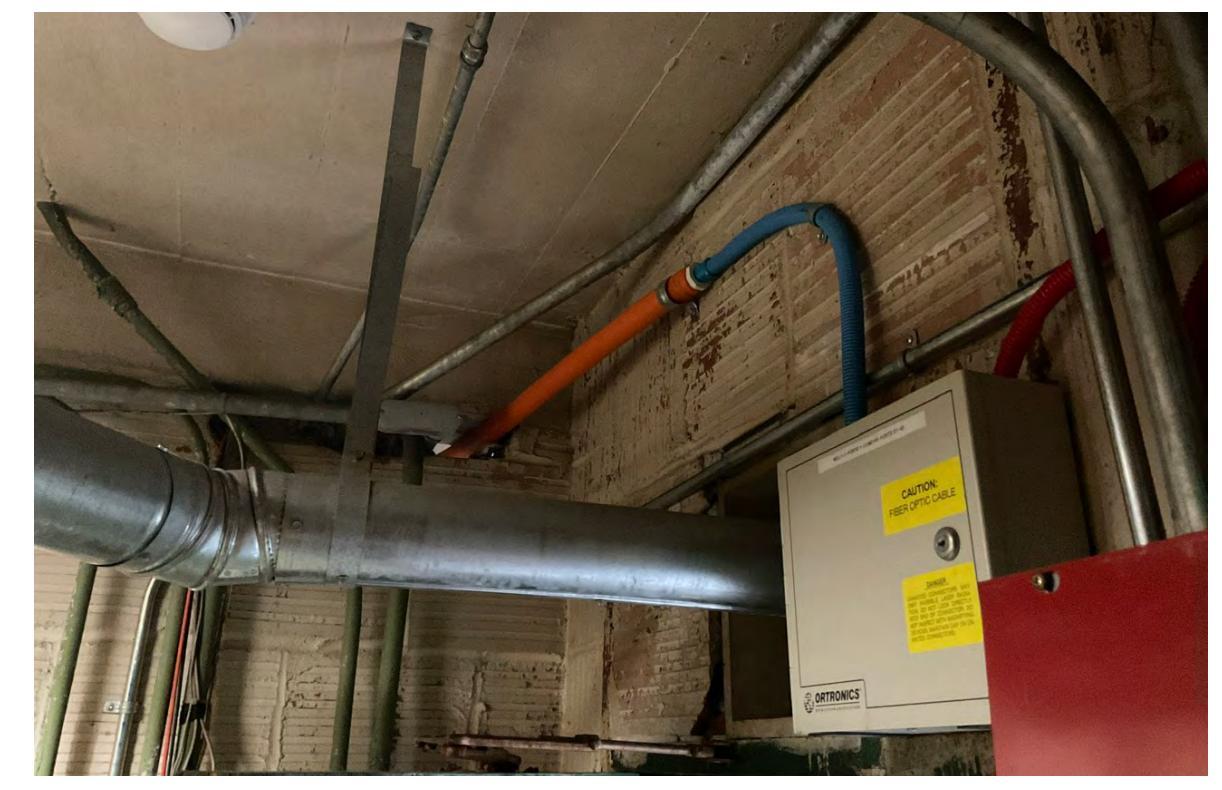
Existing Fiber Routing.

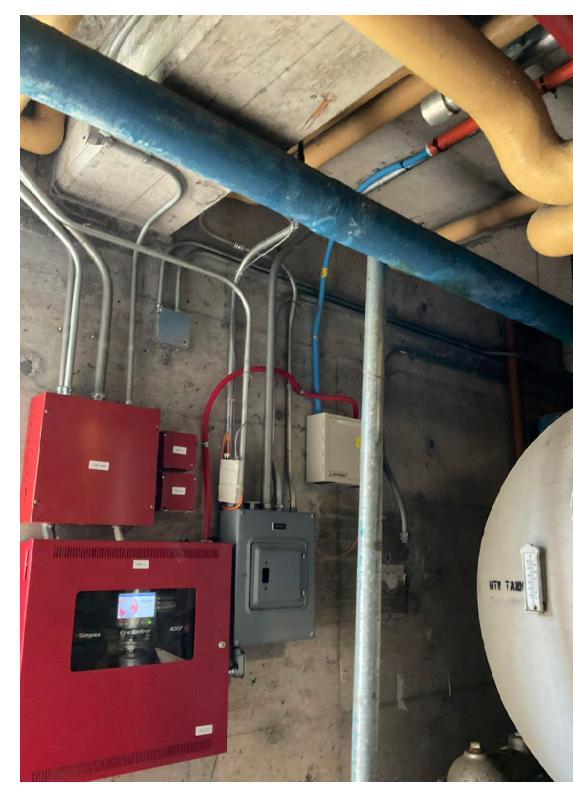
TELECOMMUNICATIONS ROOM - TR-BASEMENT

The telecommunications space is in the fire alarm control panel room in the basement. There is no dedicated telecommunications space. The space contains a single wall mount fiber cabinet. Connectivity is provided by a 12-strand OM1 multi-mode optical fiber backbone cable from the Meyer Building (Building 37) and a 50-pair Category 3 twisted-pair copper backbone cable from the Administration Building (Building 1). Neither a telecommunications grounding busbar nor dedicated cooling were observed within the room.

The existing telecommunications space is not standards compliant. The existing backbone and horizontal cabling do not meet current TIA standards for healthcare facilities. To meet industry standards, it is recommended to provide a new, dedicated telecommunications room with standards compliant backbone and horizontal cabling. Additional Category 6A data ports should be provided as required to meet standards. Dedicated cooling, rack space, cable management, and proper grounding are required to meet current standards. The addition of card-based access control is recommended to control and track access to the space.

Existing Telecom Room Layout.

- » Provide a dedicated telecommunications room.
- » Upgrade existing port locations to Category 6A.
- » Provide labels for all new cabling and existing cables to remain.
- » Add additional Category 6A 8P8C RJ45 ports to meet standards.
- » Provide new 12-strand single-mode and 12-strand OM4 multi-mode optical fiber backbone from the Meyer Building (Building 37).
- » Add Telecommunications Grounding Busbar.
- » Add ladder tray and cable management as needed.
- » Add a dedicated cooling system.
- » Add power circuits and receptacles as needed.
- » Control access to authorized individuals.

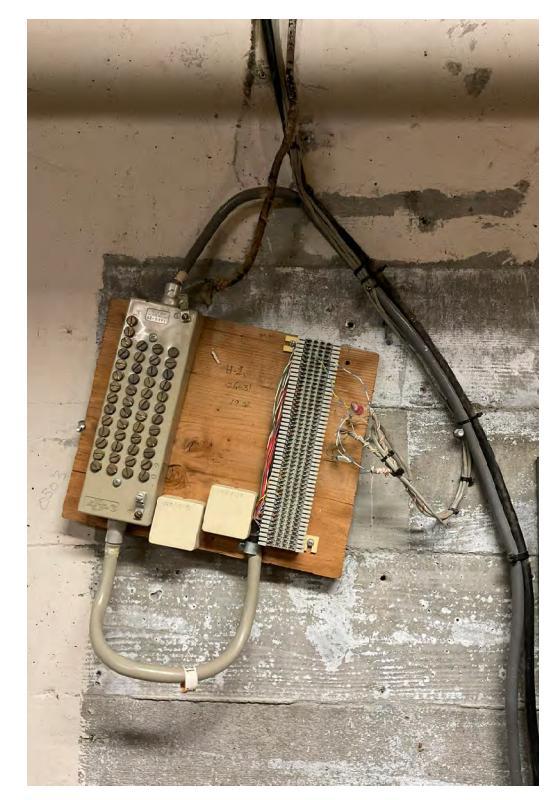
The superintendent's residence is served by a point-to-point wireless mesh network interconnected between the Modular Classroom Building (Building 58) and the 2010 4th Avenue building (Building 40) and a 50-pair Category 3 twisted-pair copper backbone cable from the Administration Building (Building 1). Neither a telecommunications grounding busbar nor dedicated cooling were observed. There is no dedicated telecommunications space.

Existing Voice Patching.

- » Provide a dedicated telecommunications enclosure.
- » Upgrade existing port locations to Category 6A.
- » Provide labels for all new cabling and existing cables to remain.
- » Provide new 12-strand single-mode and 12-strand OM4 multimode optical fiber backbone from the 2010 4th Ave Building (Building 40).
- » Add Telecommunications Grounding Busbar.
- » Add ladder tray and cable management as needed.
- » Add a dedicated cooling system.
- » Add power circuits and receptacles as needed.
- » Control access to authorized individuals.

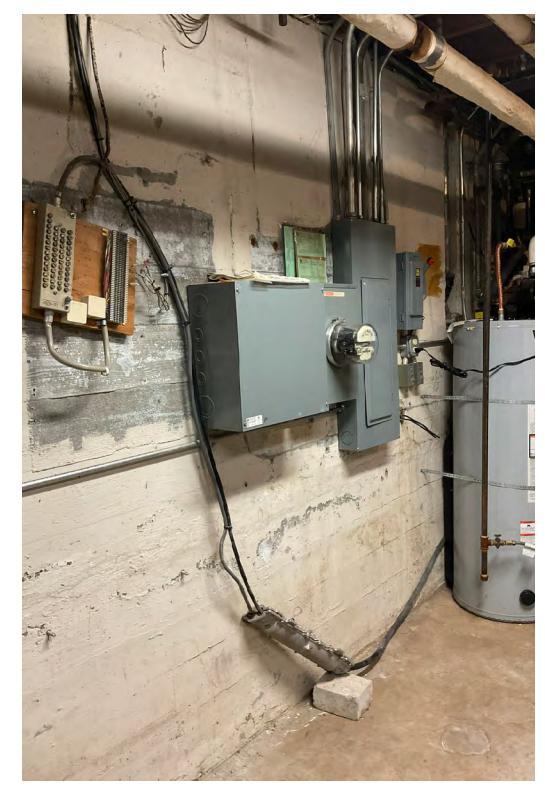
Existing Room Layout.

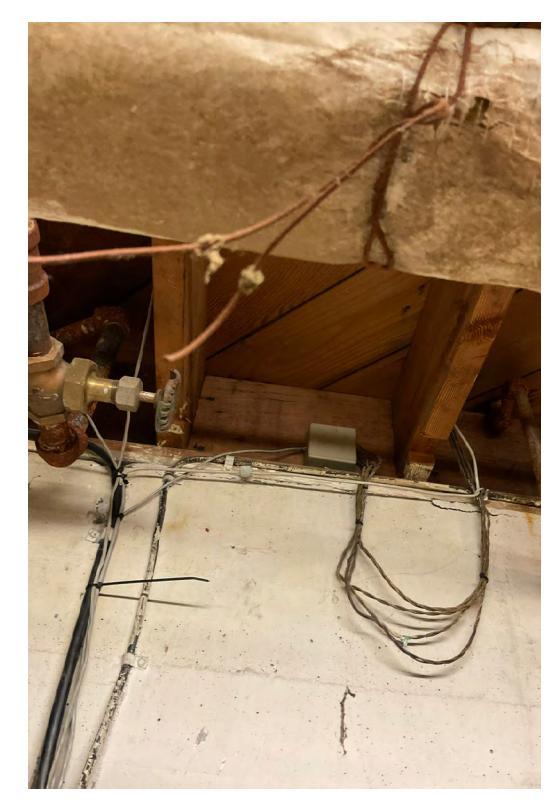
Existing Category 3 Cabling.

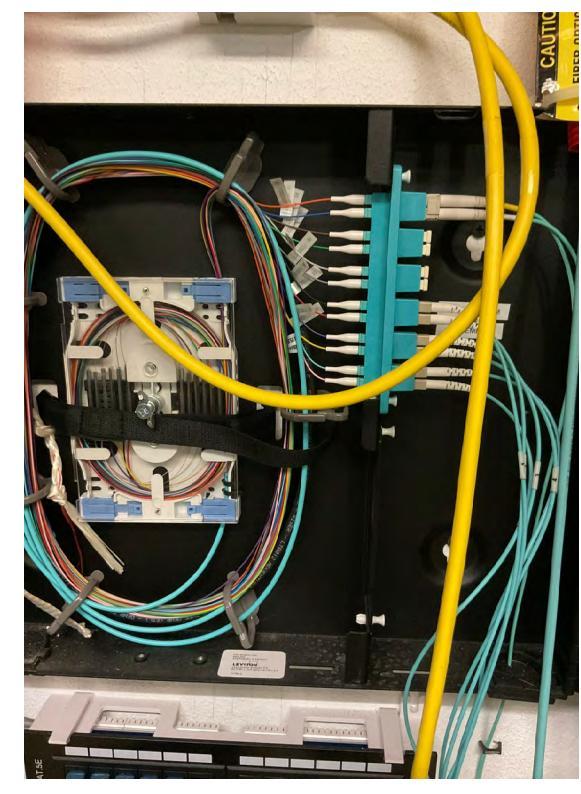
Existing Fiber Patching.

- » Provide a dedicated telecommunications room.
- » Upgrade existing port locations to Category 6A.
- » Provide labels for all new cabling and existing cables to remain.
- » Add additional Category 6A 8P8C RJ45 ports to meet standards.
- » Provide new 12-strand single-mode and 12-strand OM4 multi-mode optical fiber backbone from the Hemlock Building (Building 50B).
- » Add Telecommunications Grounding Busbar.
- » Add ladder tray and cable management as needed.
- » Add a dedicated cooling system.
- » Add power circuits and receptacles as needed.
- » Control access to authorized individuals.

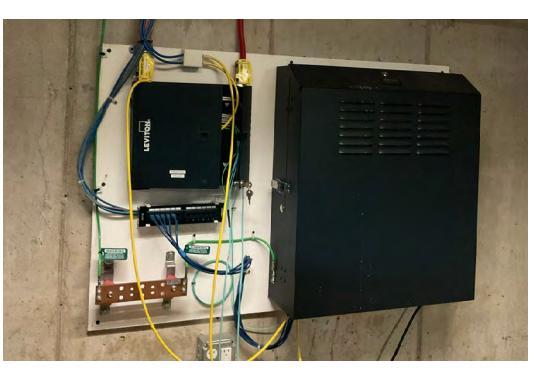
Existing Telecom Room Layout.

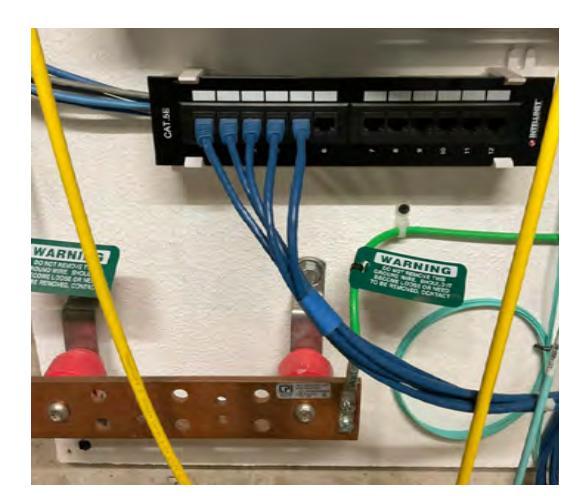
Existing Data Patching.

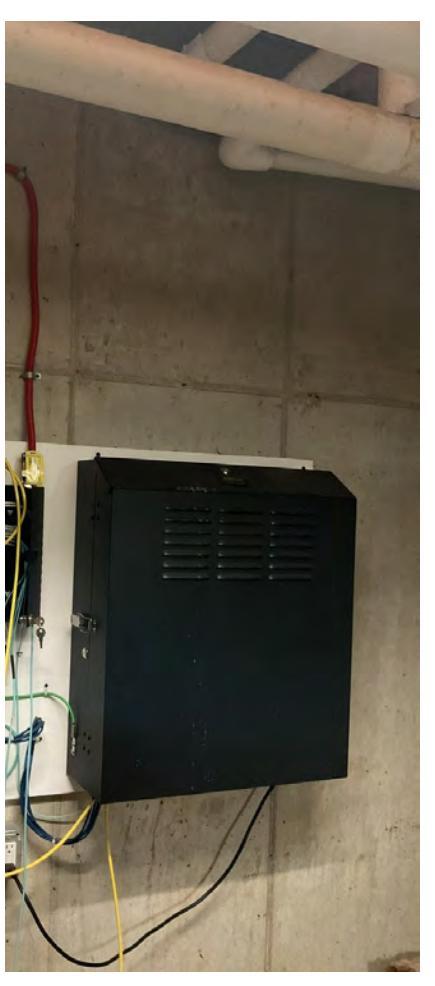
Existing Telecom Cabinet.

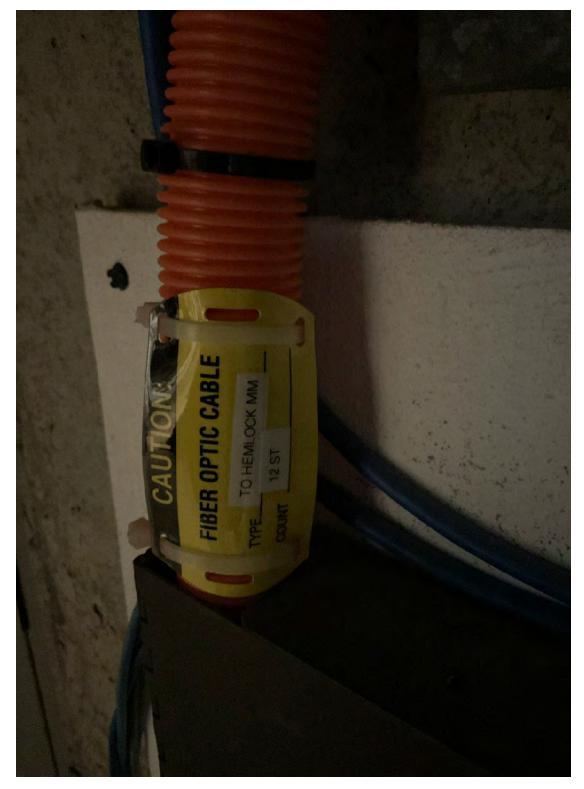
- » No dedicated telecommunications room.
- » Horizontal Cabling infrastructure does not meet minimum standards per TIA-1179.
- » Backbone Cabling Infrastructure does not meet minimum standards per TIA-1179.
- » Minimal cable support, leading to cables being draped or placed directly on equipment.
- » No grounding busbar for the telecommunications equipment.
- » No dedicated cooling system to maintain temperature of equipment.
- » Electrical infrastructure does not meet minimum requirements per standards.

Existing SM Fiber Infrastructure.

- » Provide a dedicated telecommunications room.
- » Upgrade existing port locations to Category 6A.
- » Provide labels for all new cabling and existing cables to remain.
- » Add additional Category 6A 8P8C RJ45 ports to meet standards.
- » Provide new 12-strand single-mode and 12-strand OM4 multi-mode optical fiber backbone from the Hemlock Building (Building 50B).
- » Add Telecommunications Grounding Busbar.
- » Add ladder tray and cable management as needed.
- » Add a dedicated cooling system.
- » Add power circuits and receptacles as needed.
- » Control access to authorized individuals.

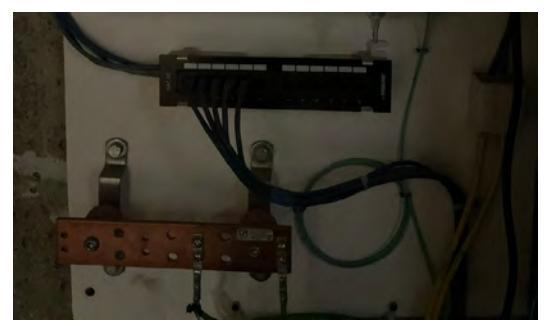
Existing Category 5e Patch Panel.

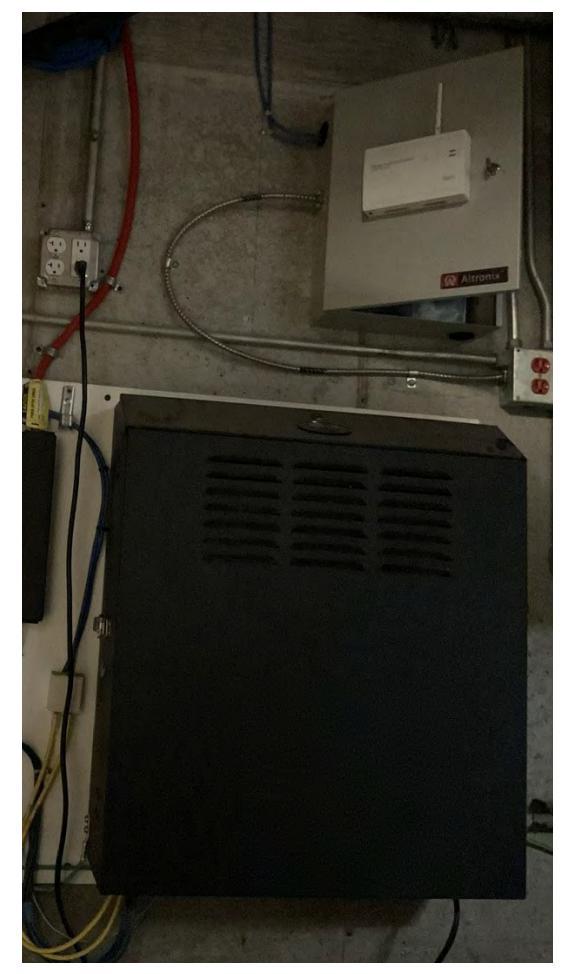
Existing Telecom Cabinet.

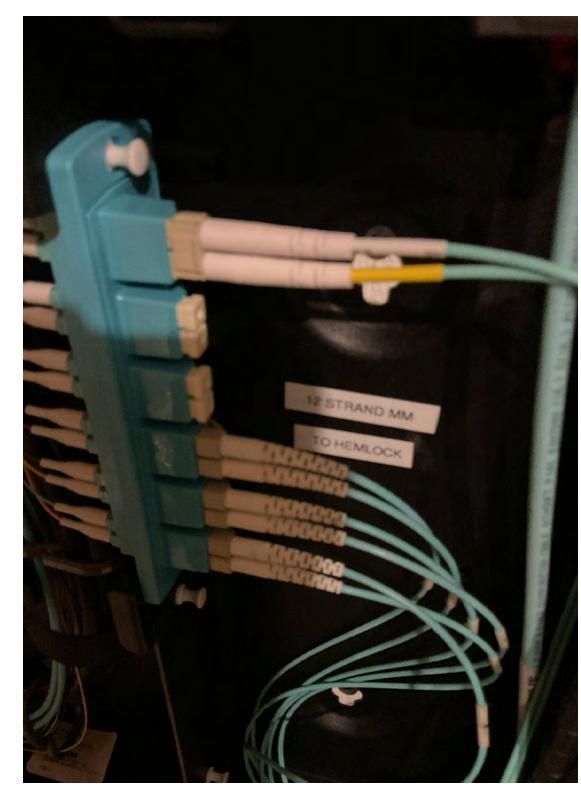
The telecommunications space is in the attic. There is no dedicated telecommunications room. The telecommunications space contains a wall mount fiber cabinet, and a wall mounted vertical rack that includes a patch panel, network switch, and a UPS. Connectivity is provided by a 12-strand OM3 multi-mode optical fiber backbone cable from the Hemlock Building (Building 50B). The vertical rack was grounded to a telecommunications grounding busbar. There is no dedicated cooling for temperature and humidity control.

Existing Fiber Patching.

The existing telecommunications space is not standards compliant. The existing backbone and horizontal cabling do not meet current TIA standards for healthcare facilities. To meet industry standards, it is recommended to provide a new, dedicated telecommunications room with standards compliant backbone and horizontal cabling. Additional Category 6A data ports should be provided as required to meet standards. Dedicated cooling, rack space, and cable management are required to meet current standards. The addition of card-based access control is recommended to control and track access to the space.

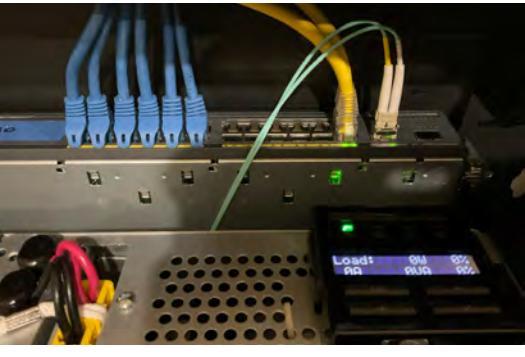
Existing Data Patching.

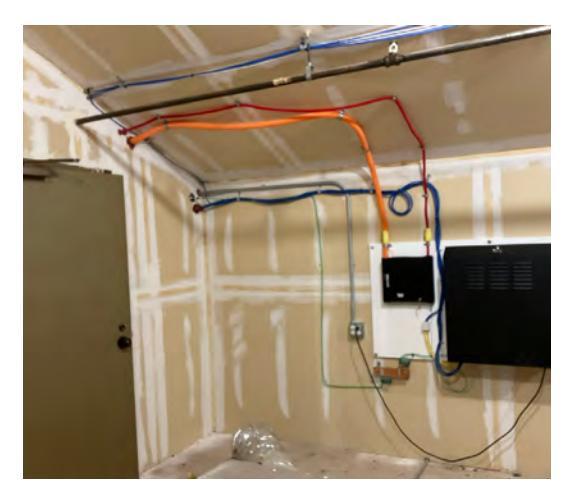
Existing Telecom Room Layout.

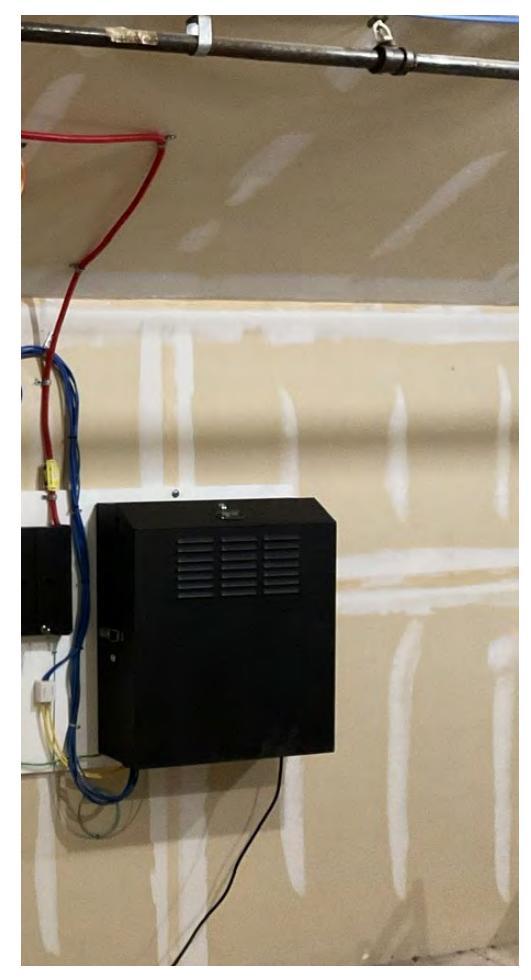
Existing Telecom Cabinet.

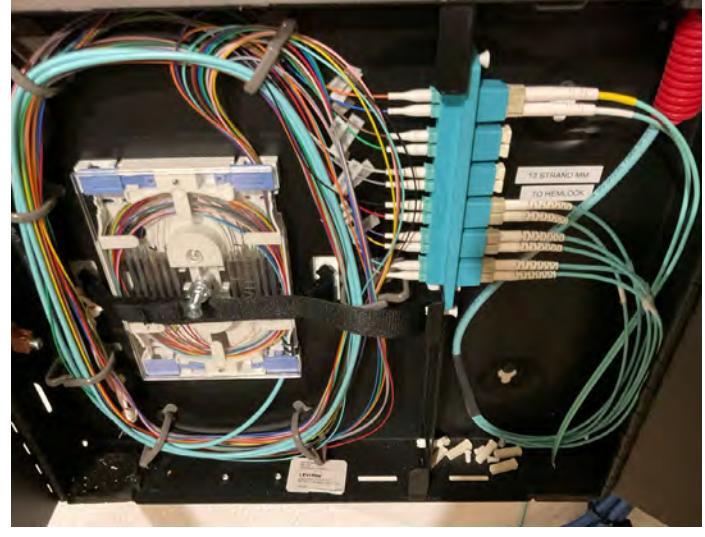
The telecommunications space is in the attic. There is no dedicated telecommunications room. The telecommunications space contains a wall mount fiber cabinet, and a wall mounted vertical rack that includes a patch panel, network switch, and a UPS. Connectivity is provided by a 12-strand OM3 multi-mode optical fiber backbone cable from the Hemlock Building (Building 50B). The vertical rack was grounded to a telecommunications grounding busbar. There is no dedicated cooling for temperature and humidity control.

Existing Fiber Patching.

The existing telecommunications space is not standards compliant. The existing backbone and horizontal cabling do not meet current TIA standards for healthcare facilities. To meet industry standards, it is recommended to provide a new, dedicated telecommunications room with standards compliant backbone and horizontal cabling. Additional Category 6A data ports should be provided as required to meet standards. Dedicated cooling, rack space, and cable management are required to meet current standards. The addition of card-based access control is recommended to control and track access to the space.

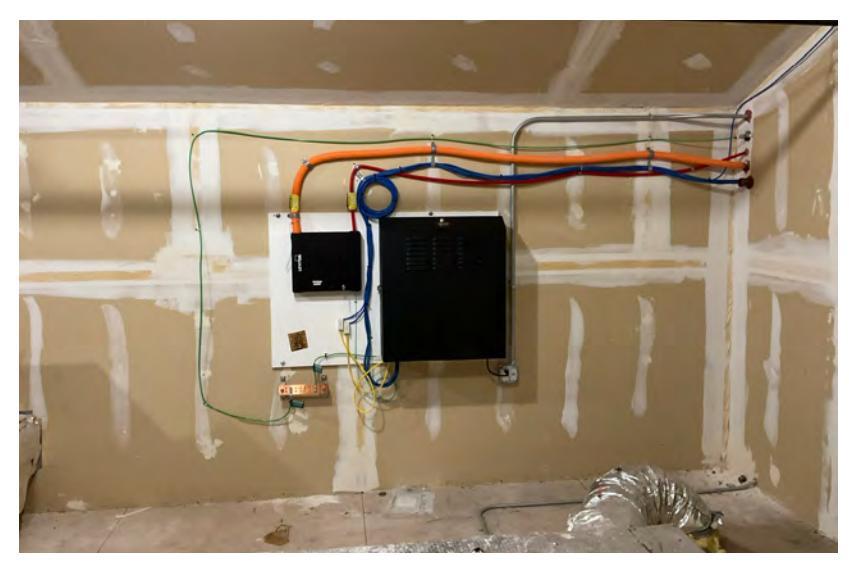
Existing Telecom Room Layout.

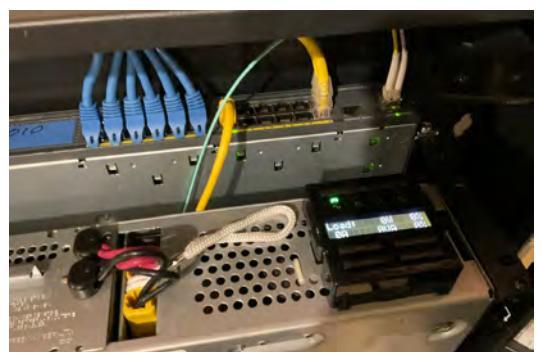
The telecommunications space is in the attic. There is no dedicated telecommunications room. The telecommunications space contains a wall mount fiber cabinet, and a wall mounted vertical rack that includes a patch panel, network switch, and a UPS. Connectivity is provided by a 12-strand OM3 multi-mode optical fiber backbone cable from the Hemlock Building (Building 50B). The vertical rack was grounded to a telecommunications grounding busbar. There is no dedicated cooling for temperature and humidity control.

Existing Data Patching.

- » Provide a dedicated telecommunications room.
- » Upgrade existing port locations to Category 6A.
- » Provide labels for all new cabling and existing cables to remain.
- » Add additional Category 6A 8P8C RJ45 ports to meet standards.
- » Provide new 12-strand single-mode and 12-strand OM4 multi-mode optical fiber backbone from the Hemlock Building (Building 50B).
- » Add ladder tray and cable management as needed.
- » Add a dedicated cooling system.
- » Add power circuits and receptacles as needed.
- » Control access to authorized individuals.

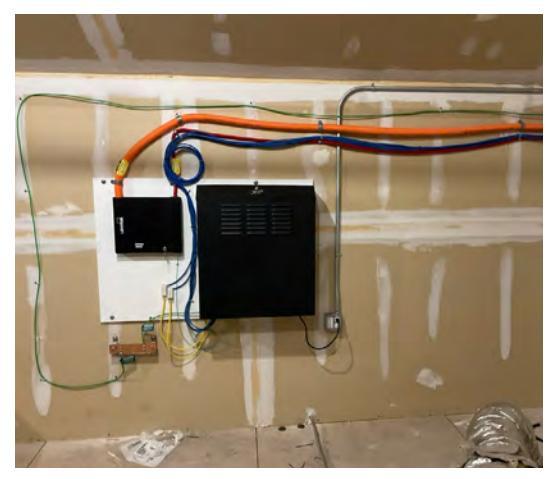
Existing Telecom Room Layout.

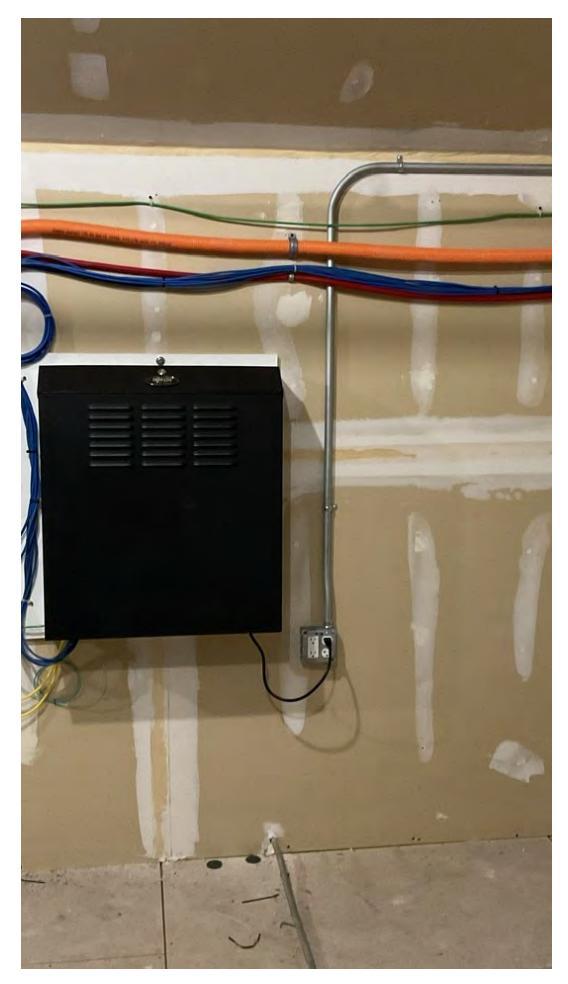
Existing Telecom Cabinet.

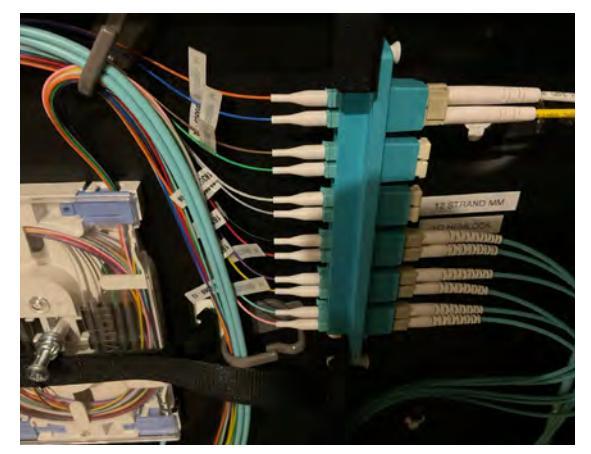
Existing Fiber Patching.

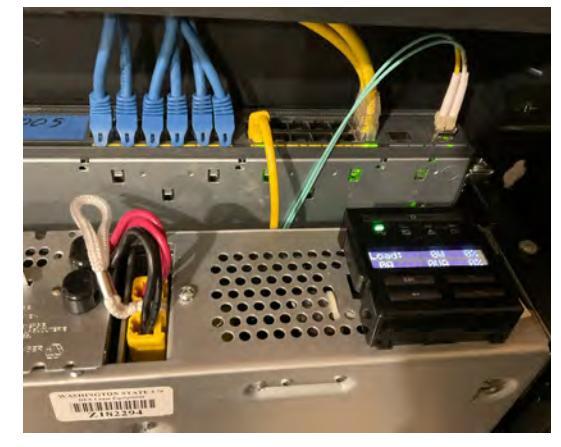
Existing Data Patching.

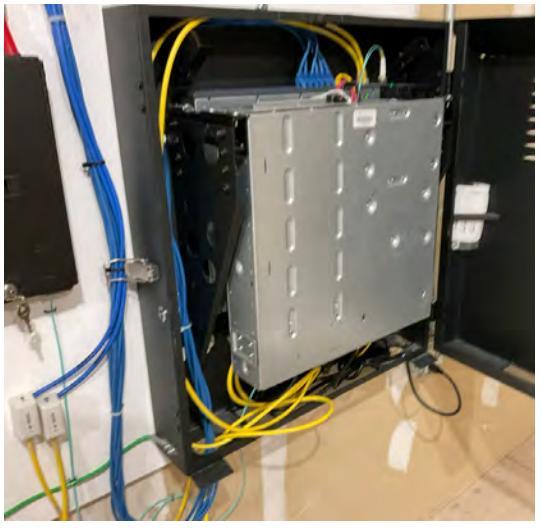
Existing Fiber Patching.

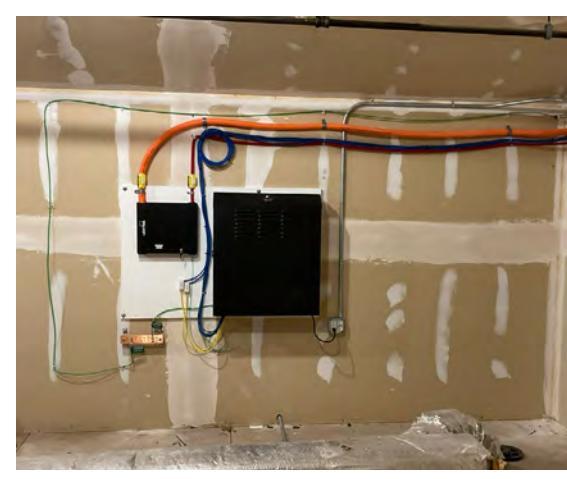
The telecommunications space is in the attic. There is no dedicated telecommunications room. The telecommunications space contains a wall mount fiber cabinet, and a wall mounted vertical rack that includes a patch panel, network switch, and a UPS. Connectivity is provided by a 12-strand OM3 multi-mode optical fiber backbone cable from the Hemlock Building (Building 50B). The vertical rack was grounded to a telecommunications grounding busbar. There is no dedicated cooling for temperature and humidity control.

The existing telecommunications space is not standards compliant. The existing backbone and horizontal cabling do not meet current TIA standards for healthcare facilities. To meet industry standards, it is recommended to provide a new, dedicated telecommunications room with standards compliant backbone and horizontal cabling. Additional Category 6A data ports should be provided as required to meet standards. Dedicated cooling, rack space, and cable management are required to meet current standards. The addition of card-based access control is recommended to control and track access to the space.

Existing Telecom Room Layout.

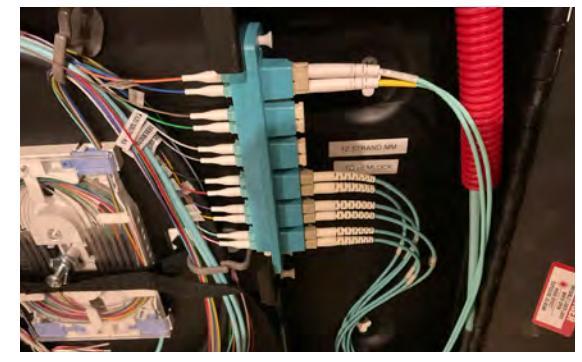
Existing Fiber Patching.

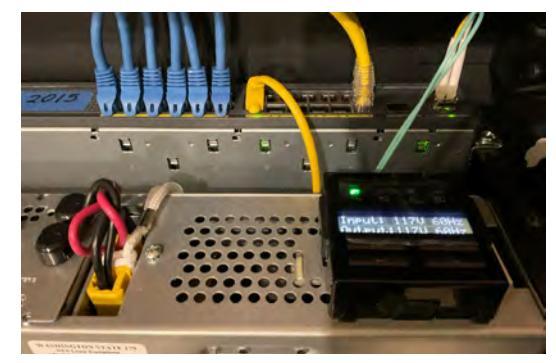
Existing Data Patching.

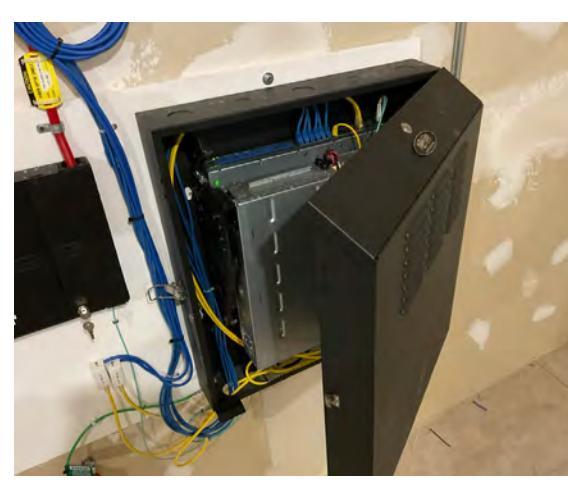
Existing Telecom Cabinet.

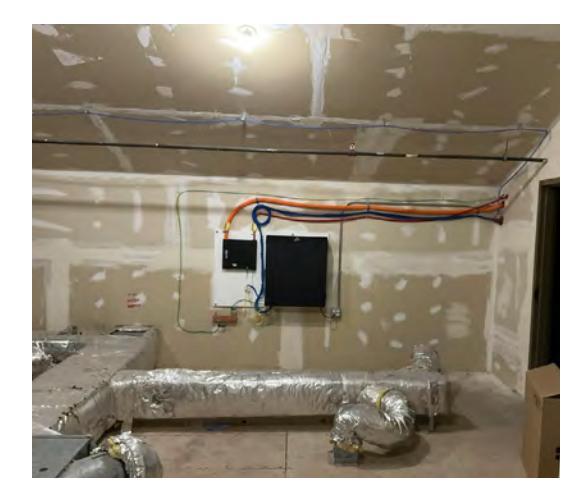
The telecommunications space is in the attic. There is no dedicated telecommunications room. The telecommunications space contains a wall mount fiber cabinet, and a wall mounted vertical rack that includes a patch panel, network switch, and a UPS. Connectivity is provided by a 12-strand OM3 multi-mode optical fiber backbone cable from the Hemlock Building (Building 50B). The vertical rack was grounded to a telecommunications grounding busbar. There is no dedicated cooling for temperature and humidity control.

The existing telecommunications space is not standards compliant. The existing backbone and horizontal cabling do not meet current TIA standards for healthcare facilities. To meet industry standards, it is recommended to provide a new, dedicated telecommunications room with standards compliant backbone and horizontal cabling. Additional Category 6A data ports should be provided as required to meet standards. Dedicated cooling, rack space, and cable management are required to meet current standards. The addition of card-based access control is recommended to control and track access to the space.

Existing Telecom Room Layout.

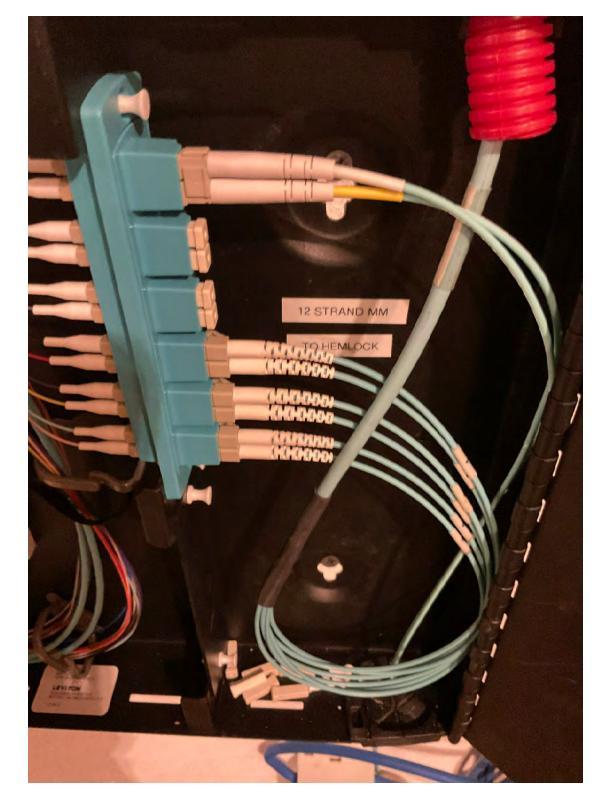
Existing Fiber Patching.

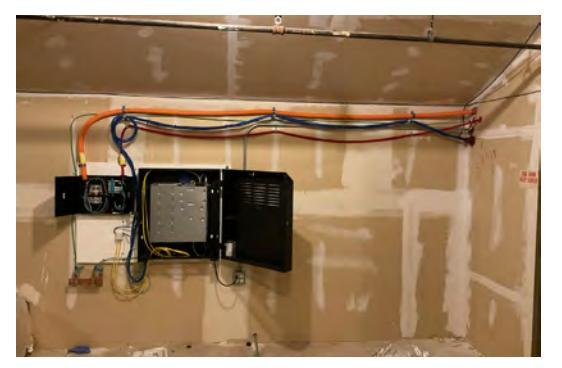
The telecommunications space is in the attic. There is no dedicated telecommunications room. The telecommunications space contains a wall mount fiber cabinet, and a wall mounted vertical rack that includes a patch panel, network switch, and a UPS. Connectivity is provided by a 12-strand OM3 multi-mode optical fiber backbone cable from the Hemlock Building (Building 50B). The vertical rack was grounded to a telecommunications grounding busbar. There is no dedicated cooling for temperature and humidity control.

The existing telecommunications space is not standards compliant. The existing backbone and horizontal cabling do not meet current TIA standards for healthcare facilities. To meet industry standards, it is recommended to provide a new, dedicated telecommunications room with standards compliant backbone and horizontal cabling. Additional Category 6A data ports should be provided as required to meet standards. Dedicated cooling, rack space, and cable management are required to meet current standards. The addition of card-based access control is recommended to control and track access to the space.

Existing Telecom Room Layout.

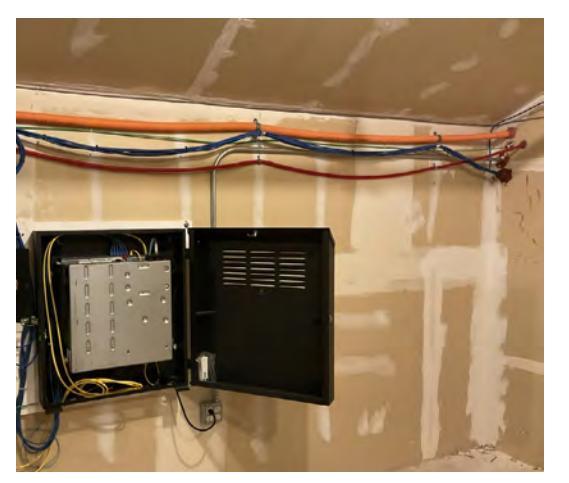
Existing Telecom Cabinet.
