DSHS  
**WESTERN STATE  
HOSPITAL**

**WA STATE PROJECT NUMBER: 2024-429 B (2)**

## EXECUTIVE SUMMARY

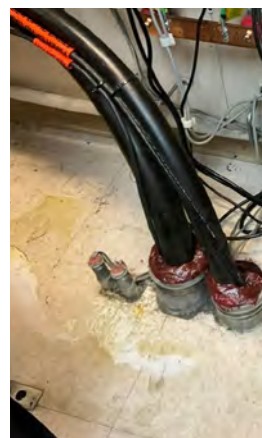
*Existing Backbone Fiber and Copper.*

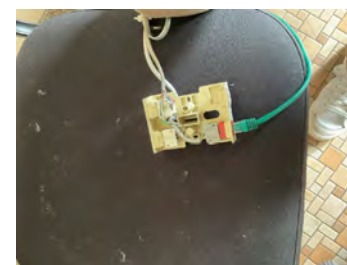
*Existing Split Pair Voice Ports.*

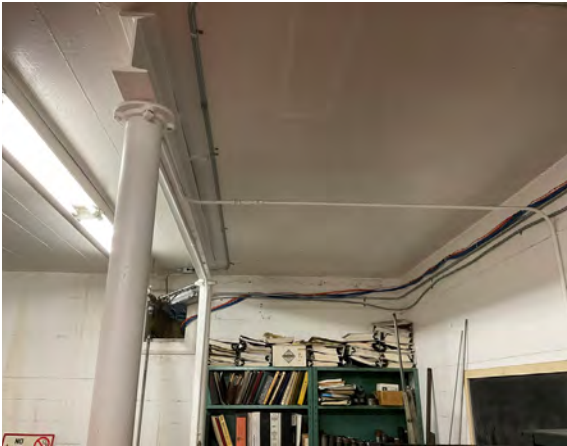
Existing Cabling.

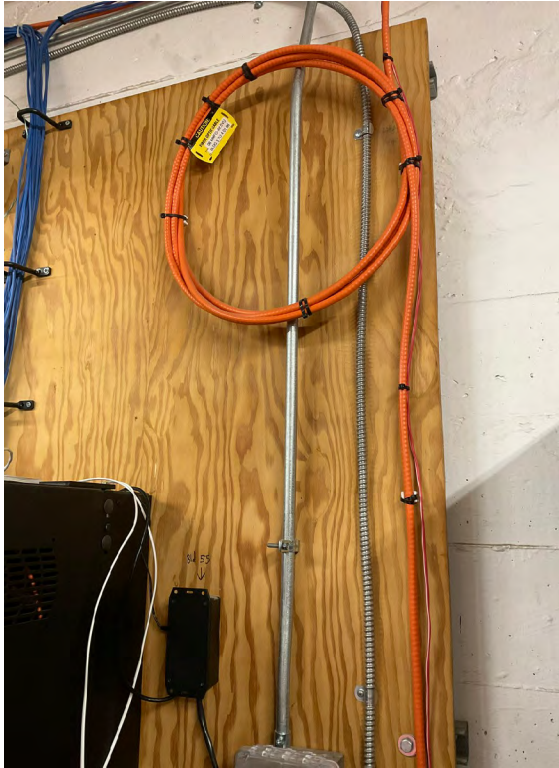
Existing Backbone Fiber.

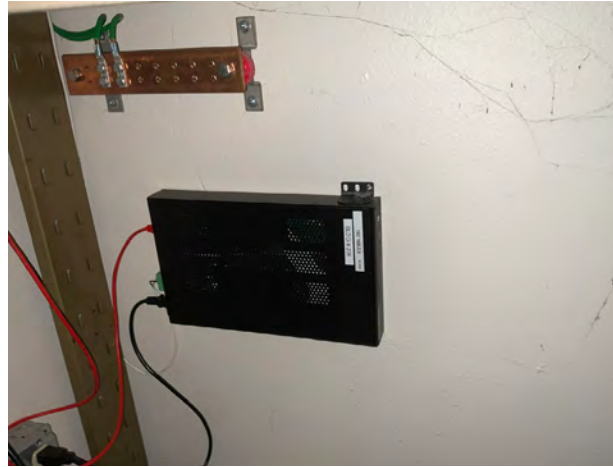
*Existing Fiber Cabinet.*

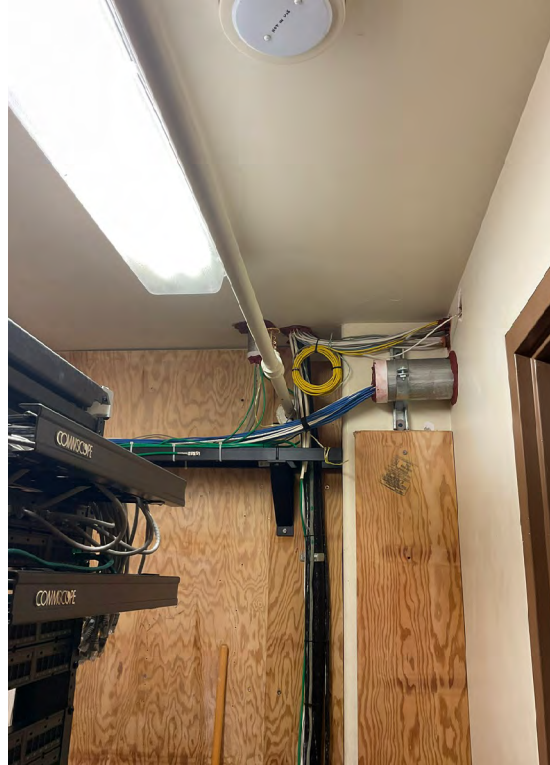
TELECOMMUNICATIONS ROOM – TR-003

*Existing Cabling.*

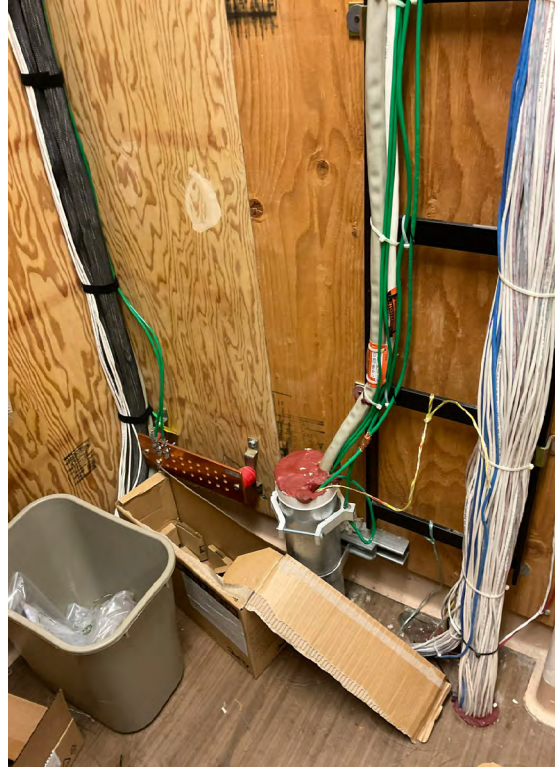
TELECOMMUNICATIONS ROOM – TR-229

*Existing Grounding.*

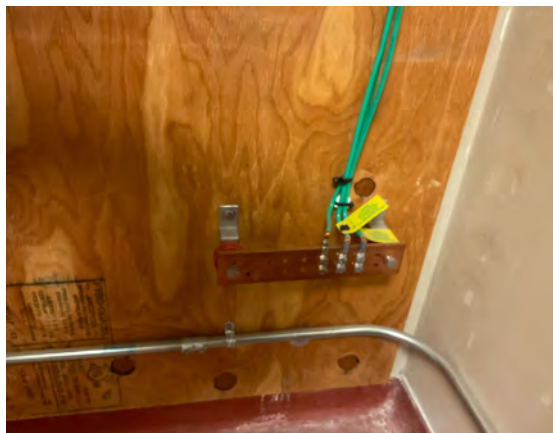
# TELECOMMUNICATIONS ROOM – TR-116

*Existing Grounding.*

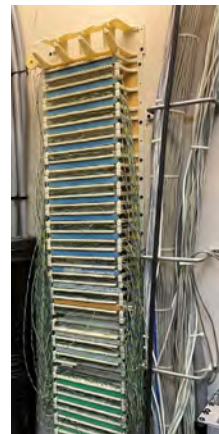
Voice Patching.

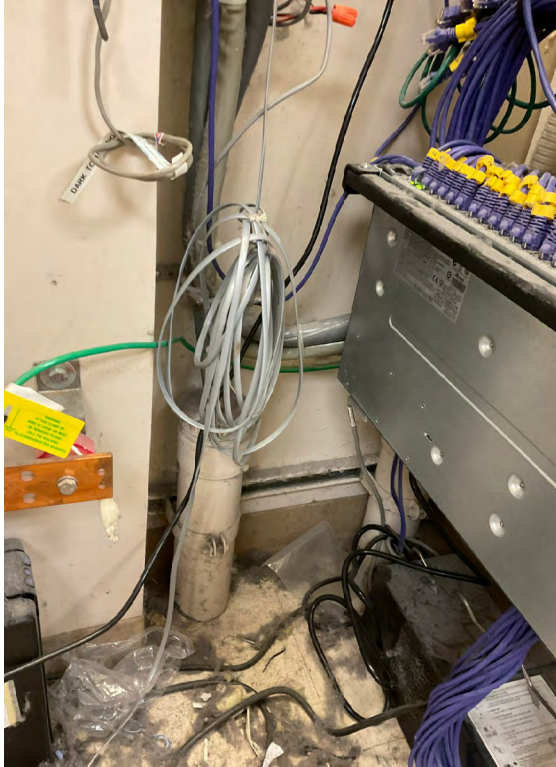
Existing Cabling.

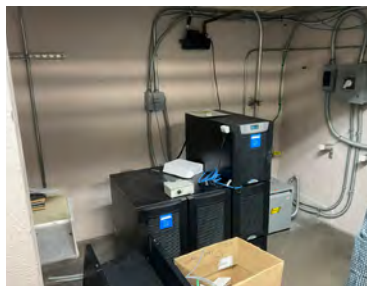
Existing UPS.

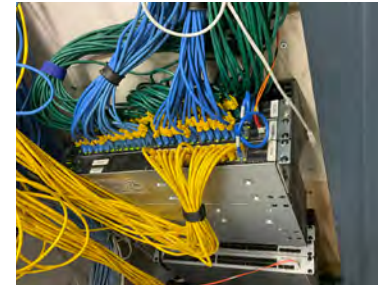
*Existing Cabling.*

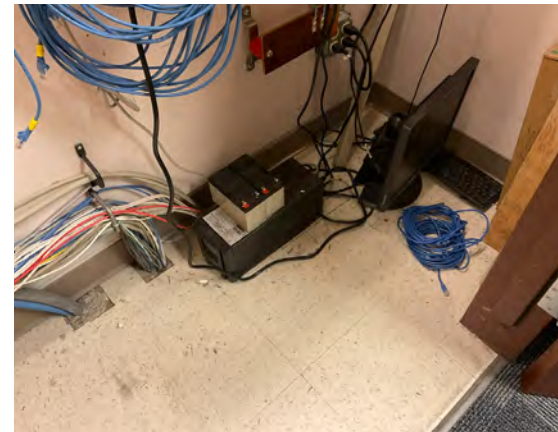
*Existing UPS.*

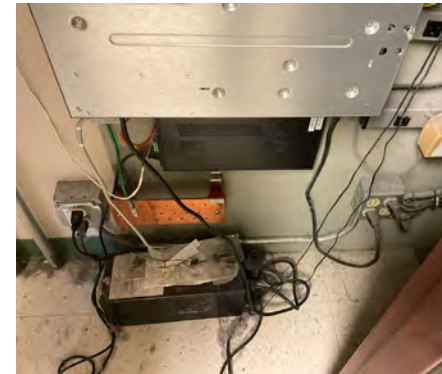
*Existing Grounding.*

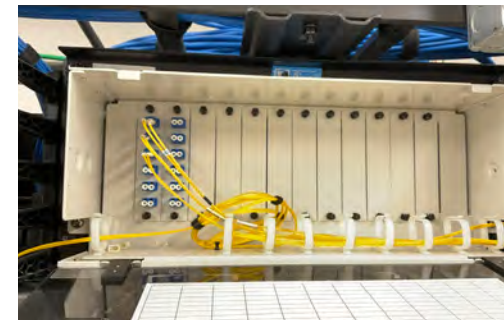
*Existing Backbone SM OFC.*

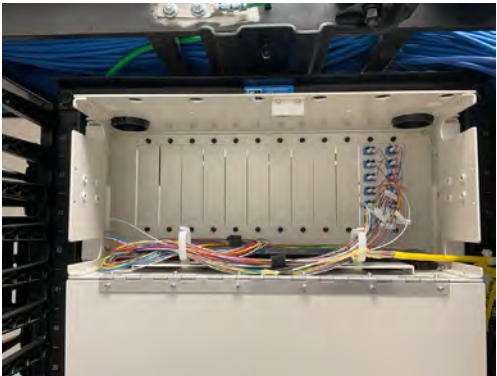
Existing Backbone SM OFC.

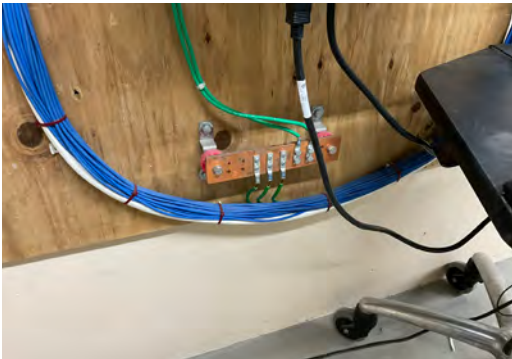
TELECOMMUNICATIONS ROOM – TR-A020

Existing Grounding.

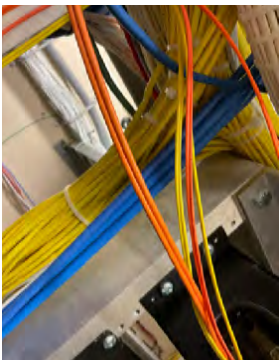
TELECOMMUNICATIONS ROOM – TR-F101

Existing OFC.

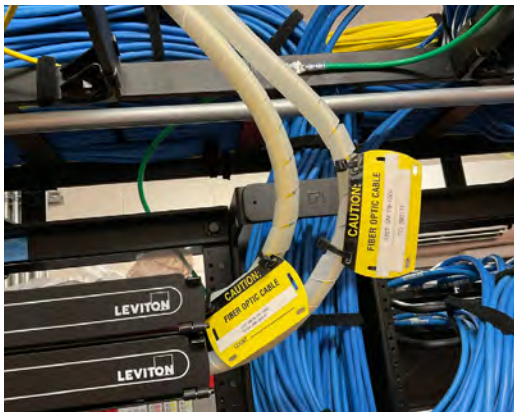
TELECOMMUNICATIONS ROOM – TR-G102

Existing SM OFC.

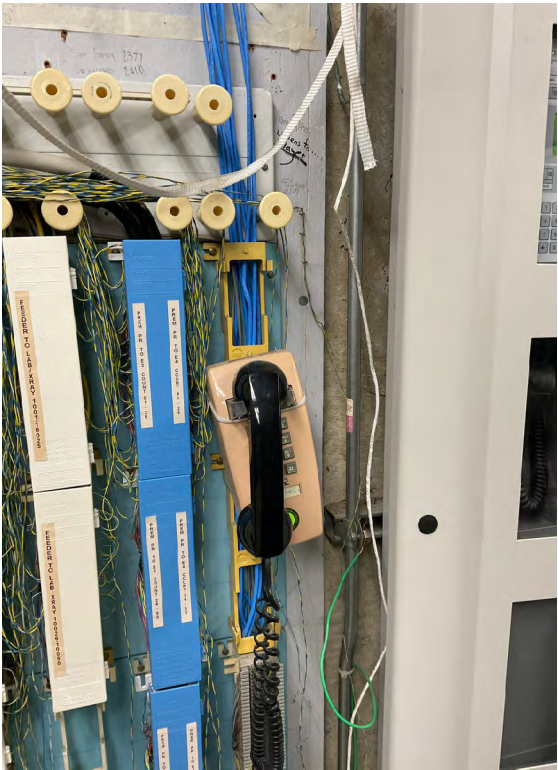
TELECOMMUNICATIONS ROOM – TR-003

Existing Voice Cross-Connect.

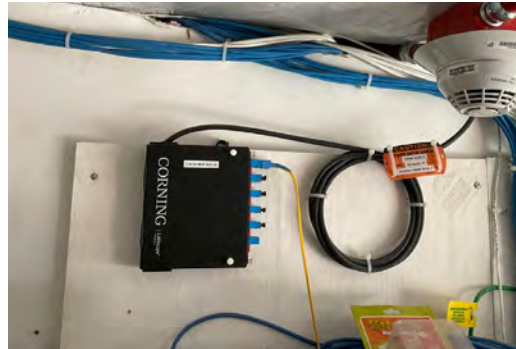
# TELECOMMUNICATIONS ROOM – TR-CARPENTER SHOP

Existing Backbone OFC.
