# McNeil Island Repair and Replacement Options 10182200022

Prepared by KPFF Consulting Engineers  
Draft Repair and Replacement Options  
June 30, 2022

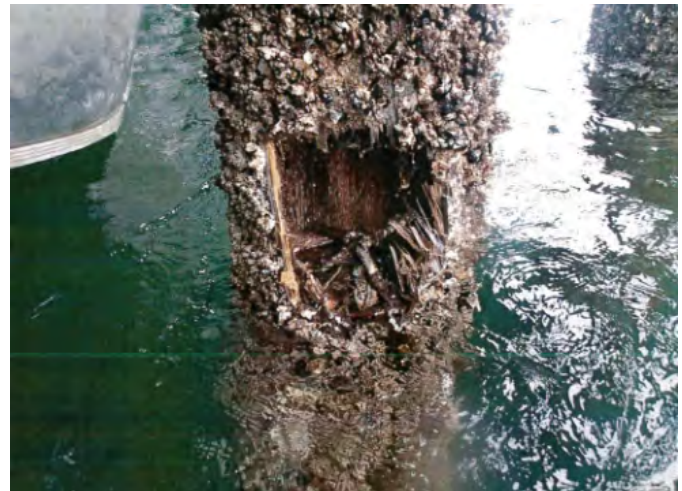
Photo 9: Pile 8.9A Rot cavity (2017)  
9"W x 16"H x 8"D

**Minimum Repairs** – Fiber reinforced jacket on pile 8.9A, replace timber curbing along trestle, sandblast and coat pile collars, repair leaking cell, relocate conduit, and replace keeper bolts.

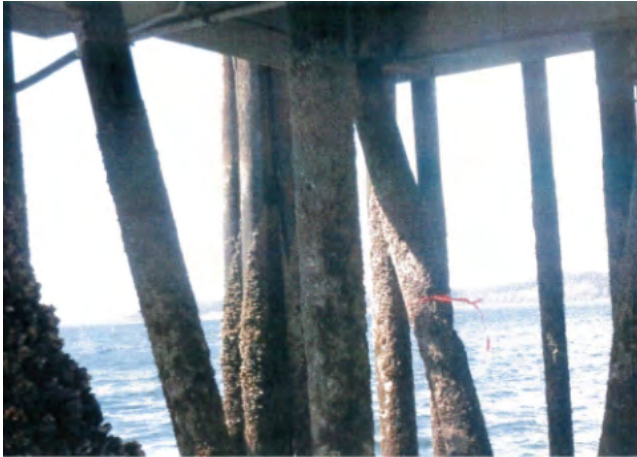
Photo 10: Pile 8.9A Rot cavity (2021)  
12"W x 21"H x 12"D

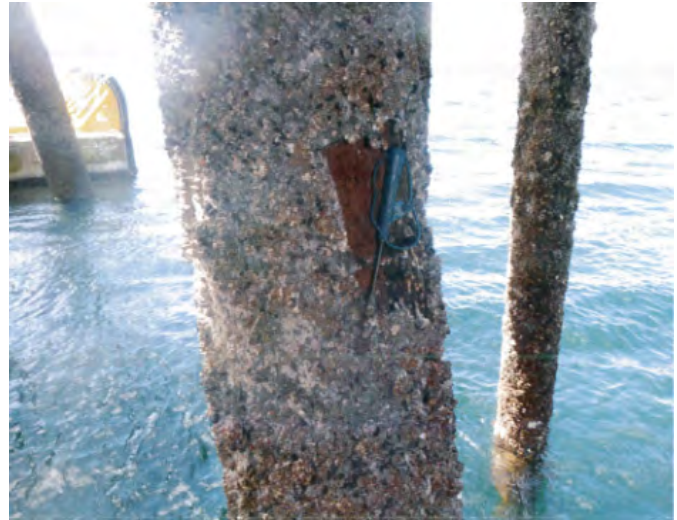
Photo 11: Pile 8.9A Rot cavity (2019)

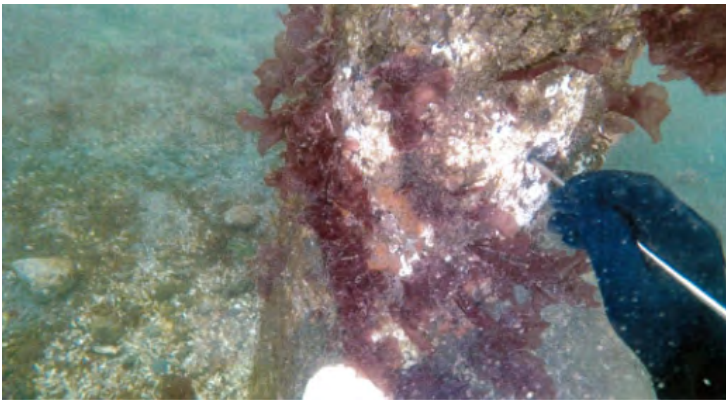
Photo 12: Pile 3B two marine borer entries (MBE)

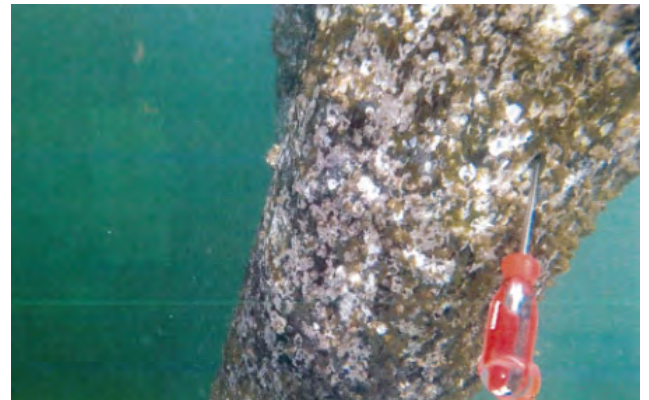
Photo 13: Pile 7.1H marine borer entry (MBE)

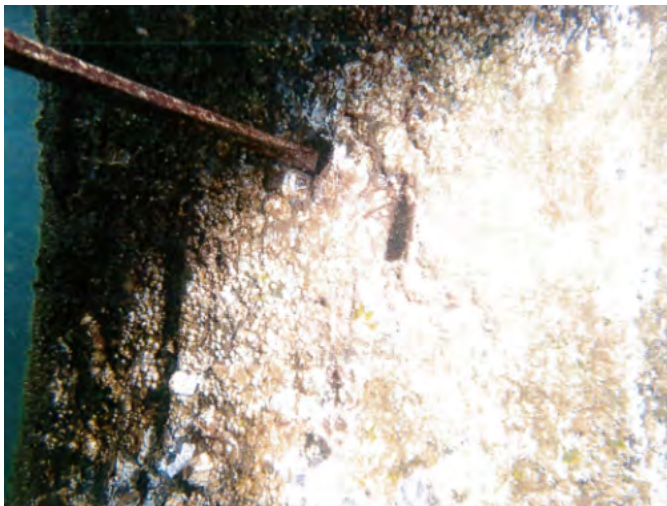
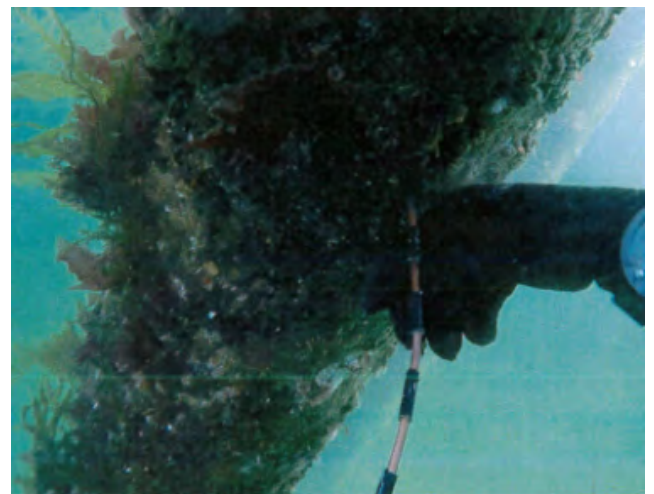
Photo 14: Pile 9B 3 marine borer entry (MBE) holes

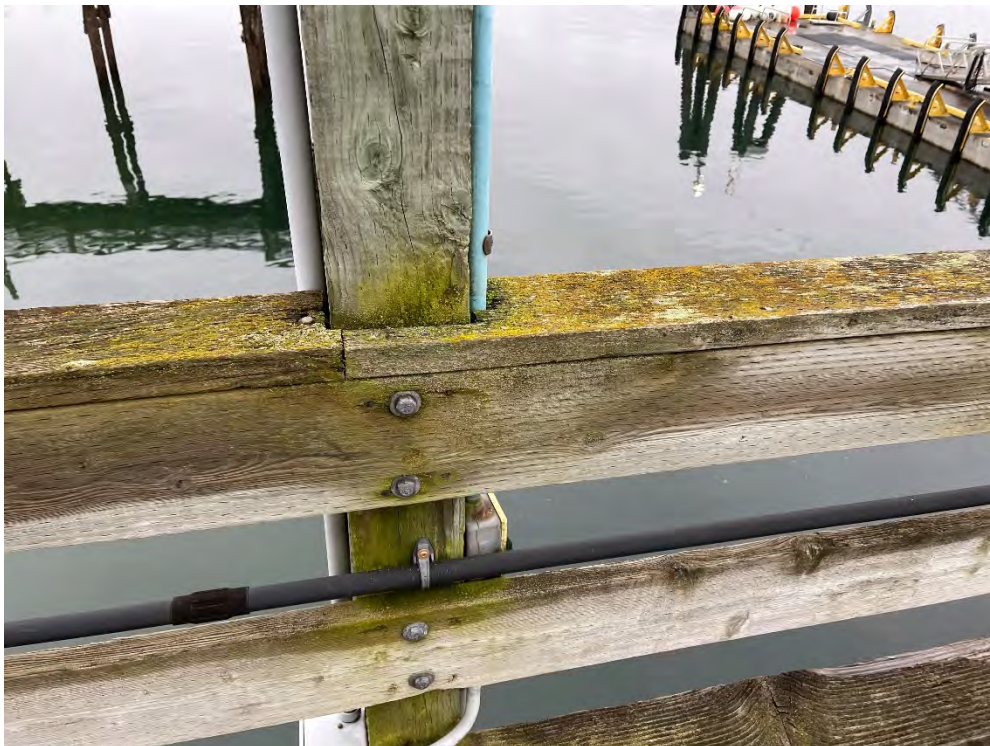
Photo 20: Wooden guard rail with heavy green moss algae

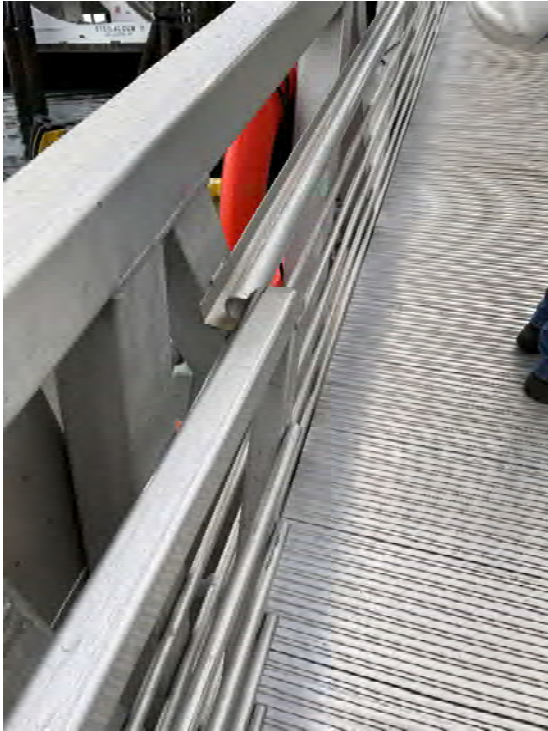
Photo 21: Loading ramp handrail with sharp edge

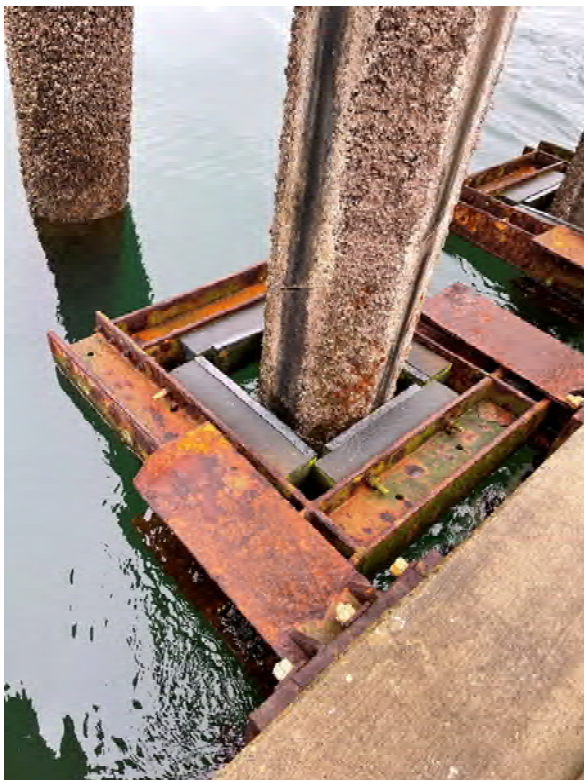
Photo 27: Pile collar with bent angle

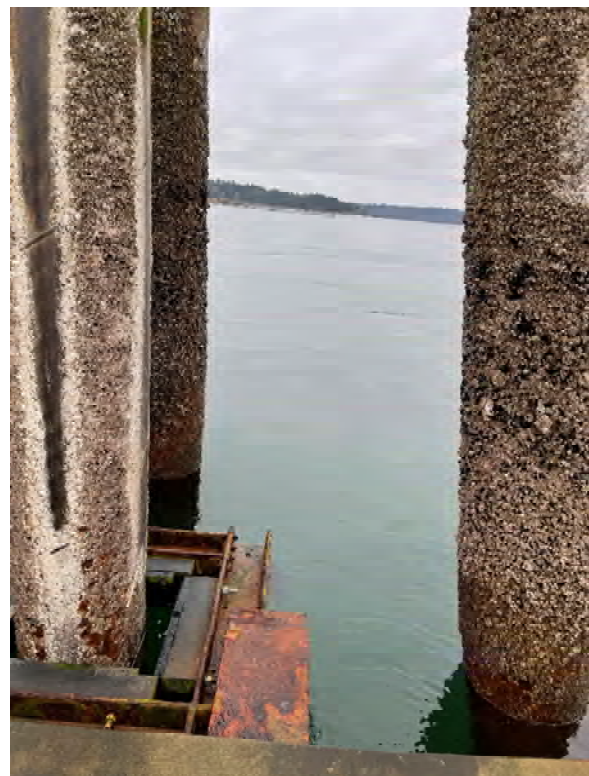
Photo 28: Pile collar with bent angle from batter pile

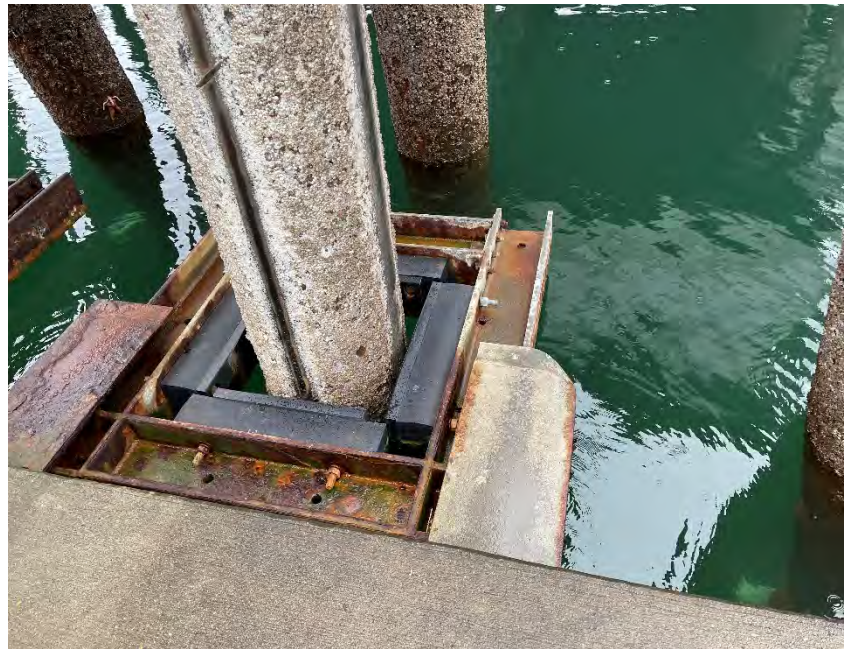
Photo 30: Pile collar with bent angle from batter pile

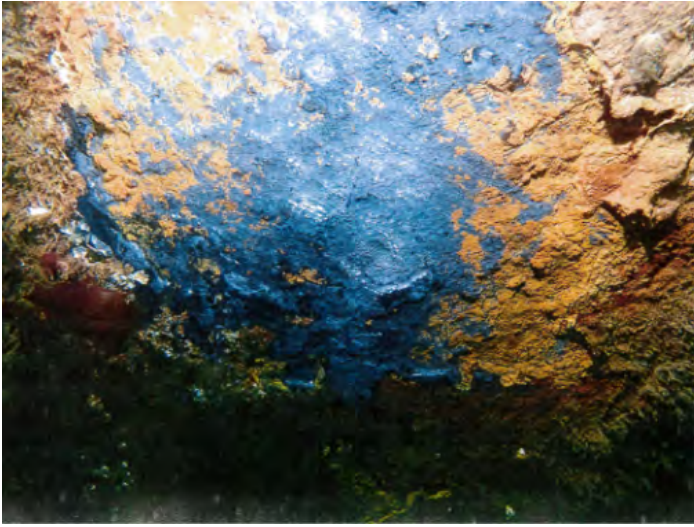
Photo 33: SP3B surface corrosion and section loss

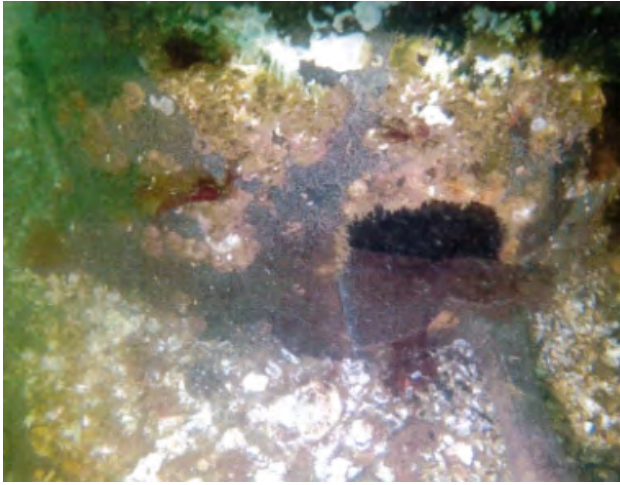
Photo 35: SP1-D holed through

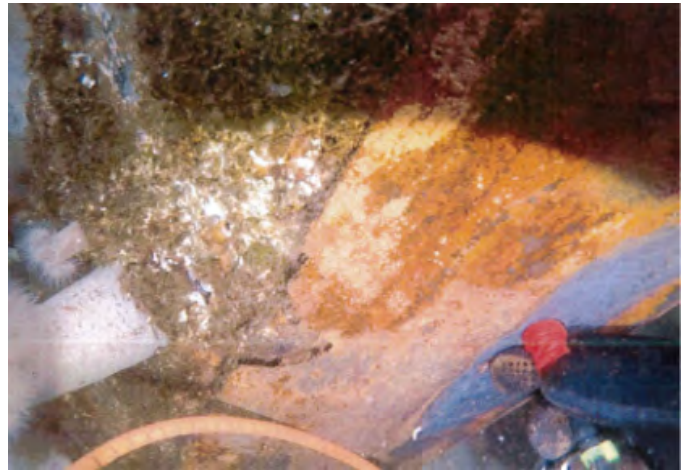
Photo 36: SP2-A heavy corrosion and section loss

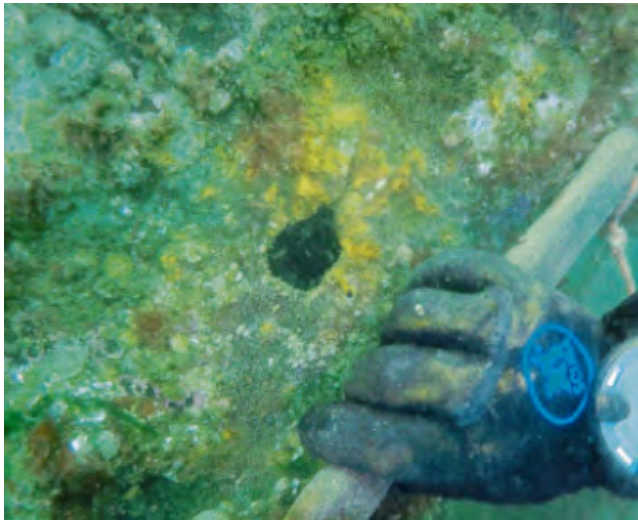
Photo 37: SP3-B holed through

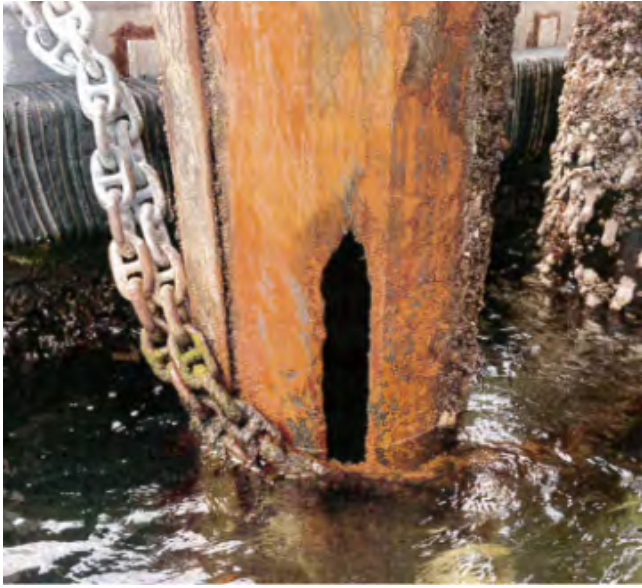
Photo 39: SP4-A holed through

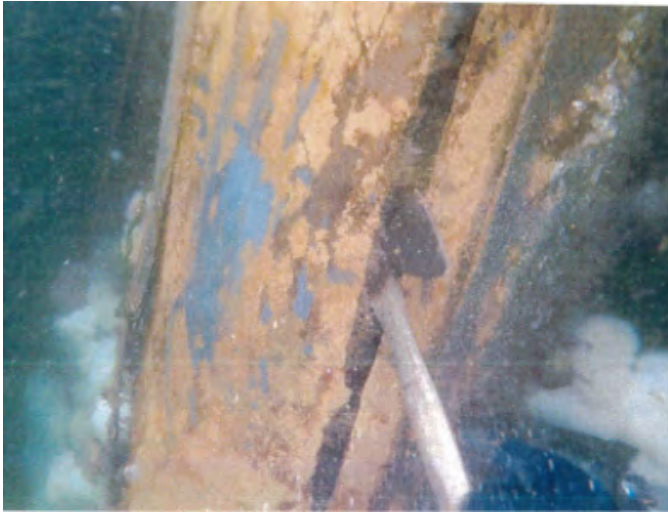
Photo 43: SP1-A holed through

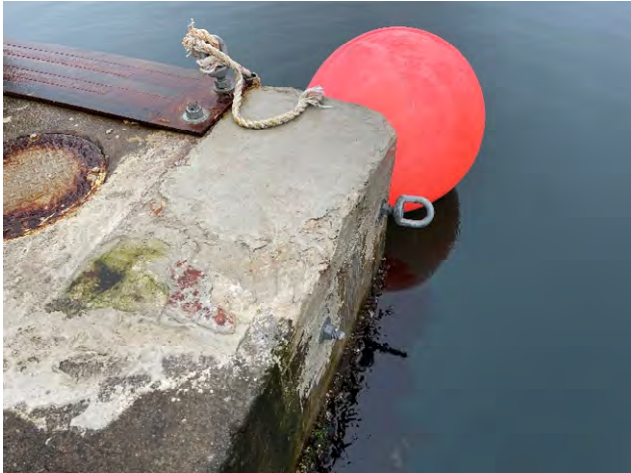
Photo 51: Fender removed and concrete float patched

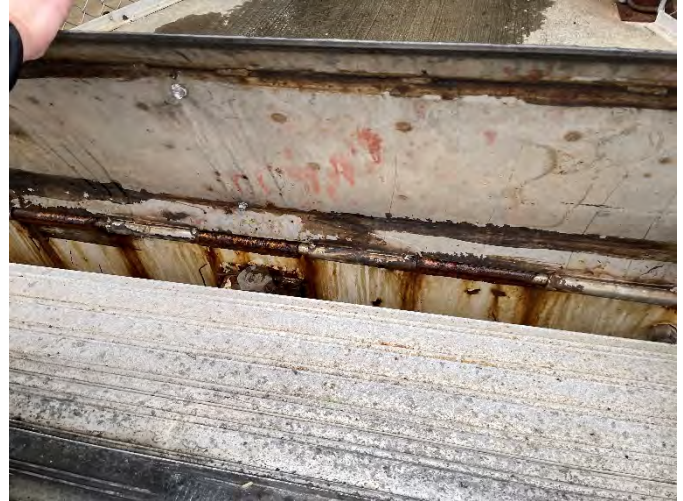
Photo 60: Surface corrosion on connections between floats

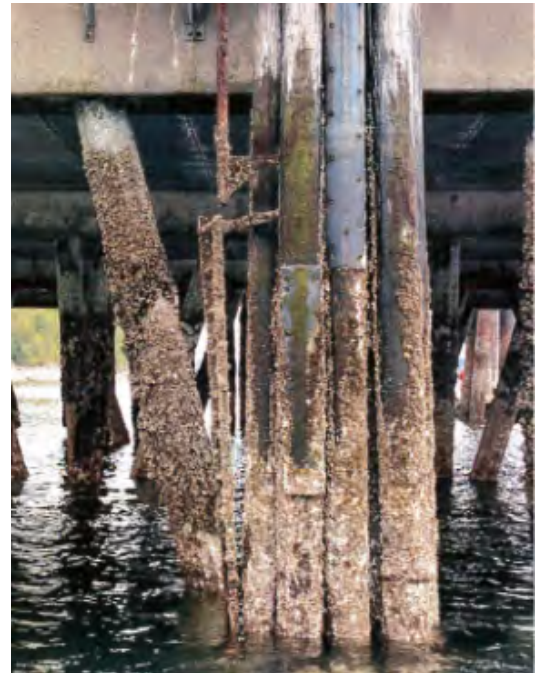
Photo 66: Dolphin D2 with abrasion damage, ladder detached

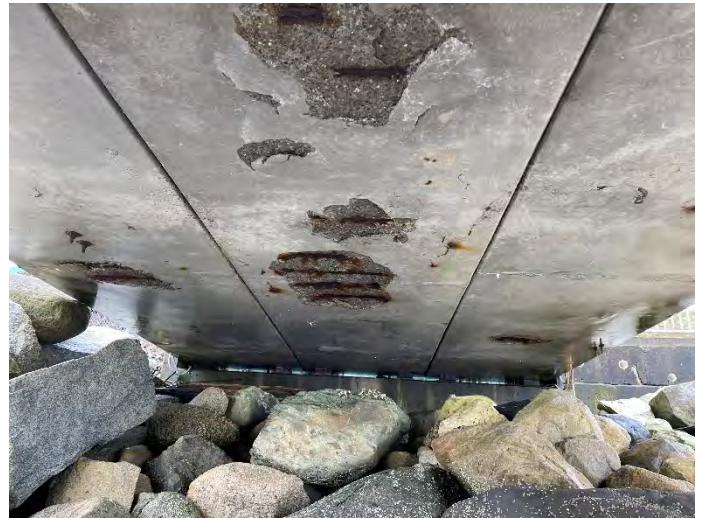
Photo 72: Concrete spalling below trestle

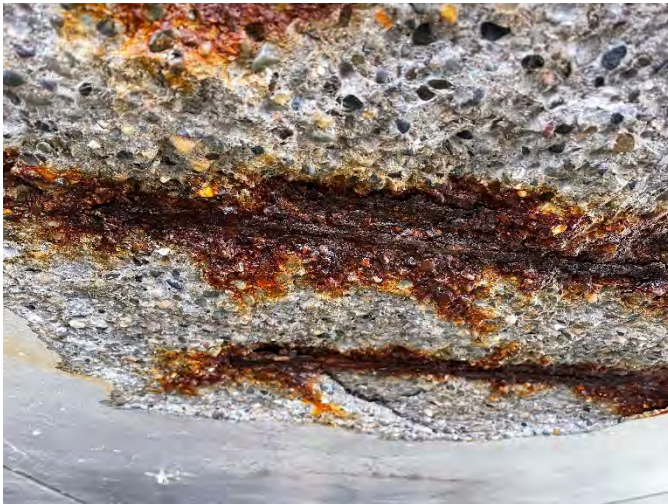
Photo 73: Exposed reinforcement from concrete spalling

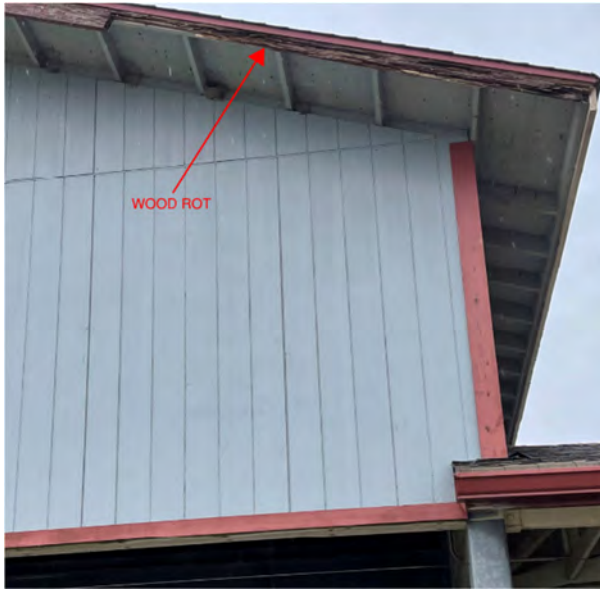
Photo 79: Wood rot on Fascia board

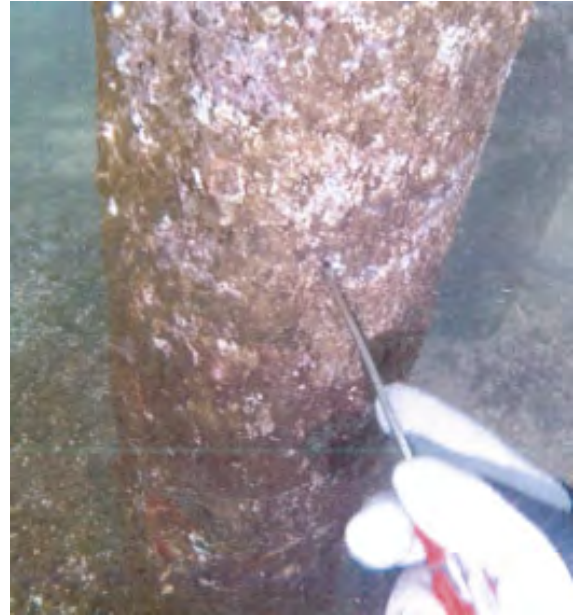
Photo 82: Pile 4A Marine borer entry

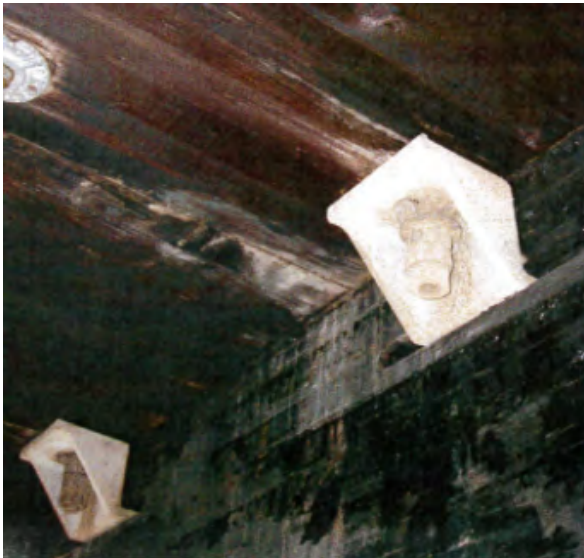
Photo 83: Loose timber deck hold down bolts

Minimum Repairs – Replace girder brackets, replace tie rings, repair lower section of wingwalls, repair top end of wingwall piles, repair hold down bolts, grease cables, repair perforated deck bolts.

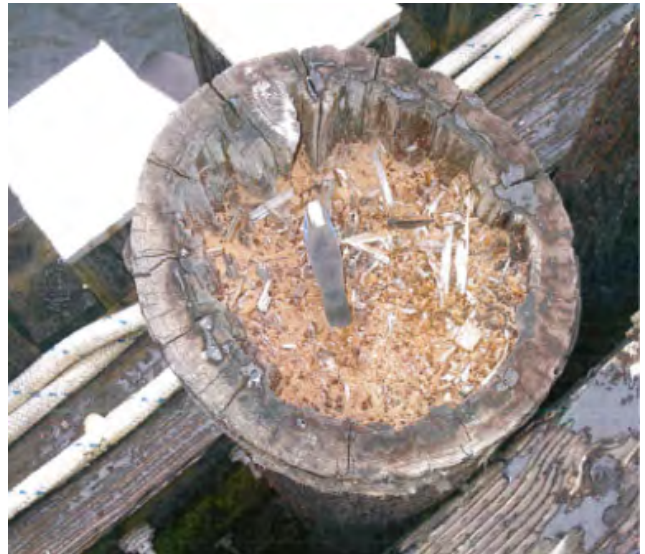
Photo 84: Typical wingwall pile with top rot

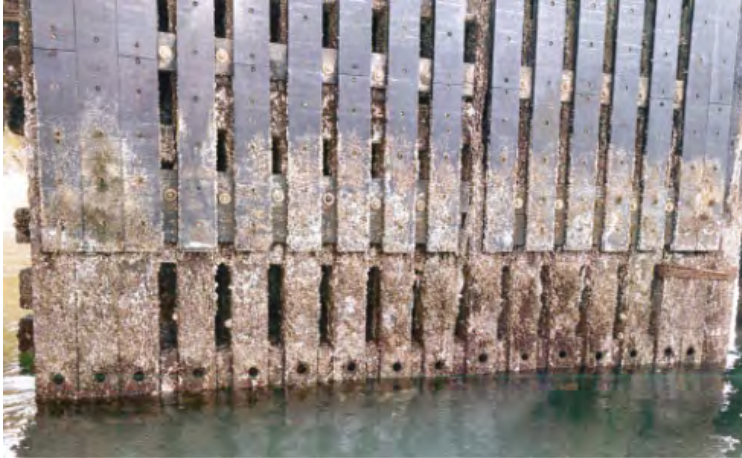
Photo 85: Left wingwall with rot below UHMW sheets

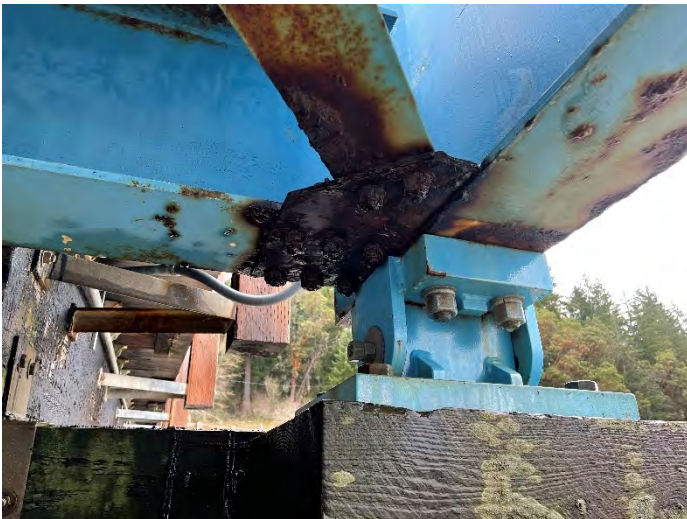
Photo 97: Heavy surface corrosion on fasteners

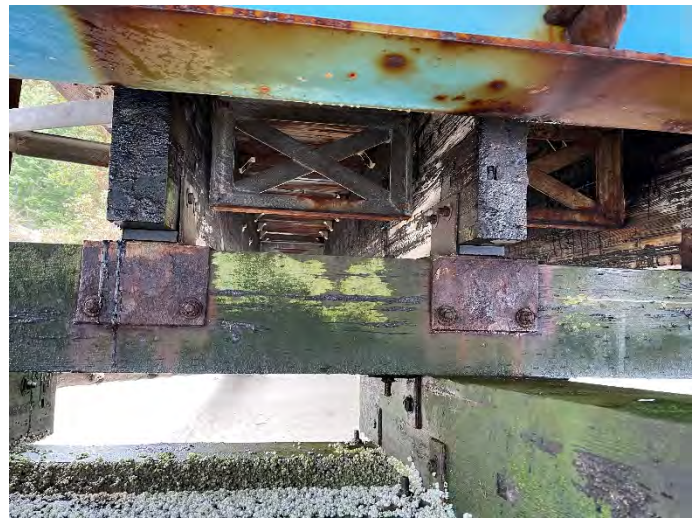
Photo 98: Heavy surface corrosion on girder brackets

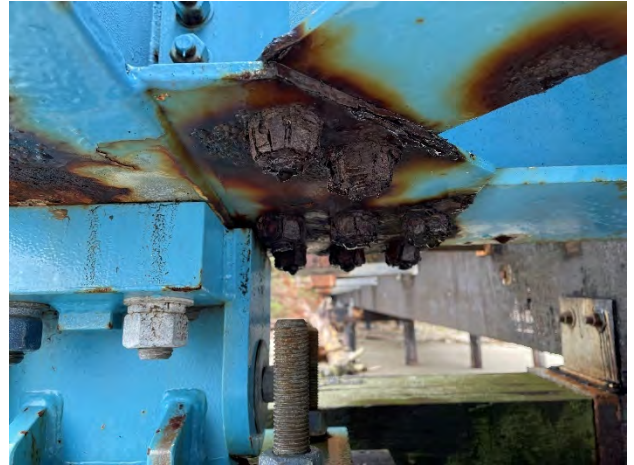
Photo 100: Heavily corroded and delaminating nuts

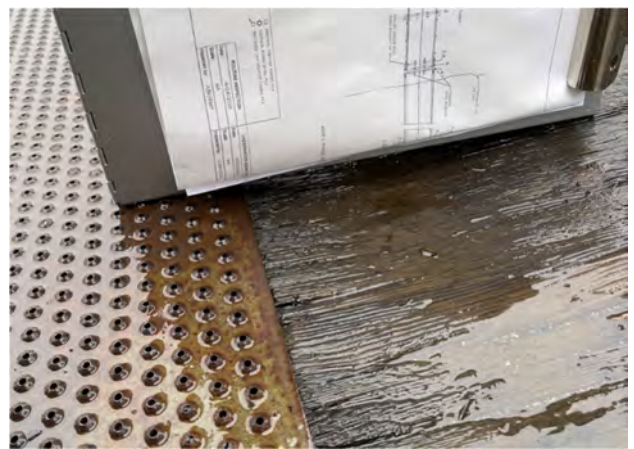
Photo 102: 0.625" deep rutting

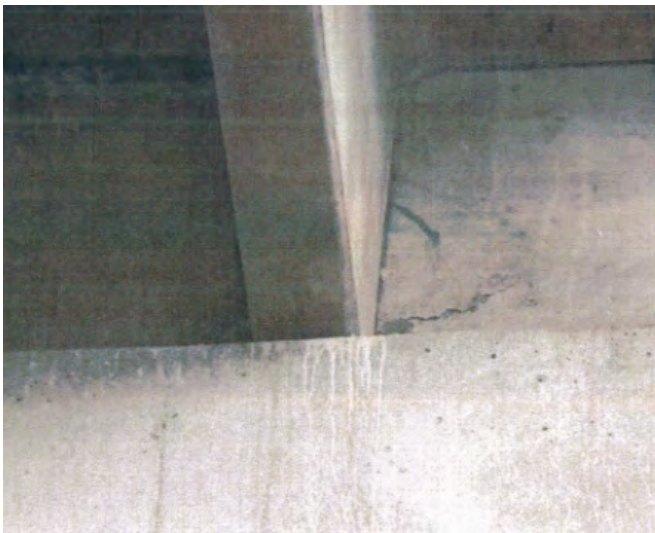
Photo 106: Pier 7 end diaphragm has delamination at the left web of Span 7

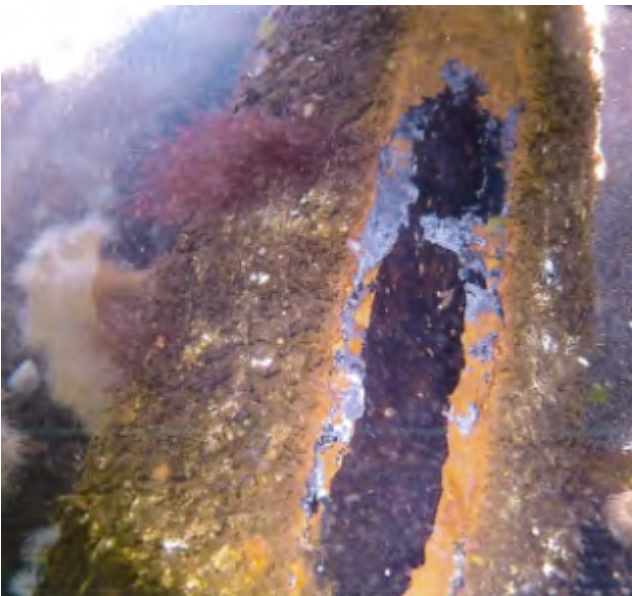
Photo 110: Pile A, 18" H x 4" W hole from mechanical abrasion

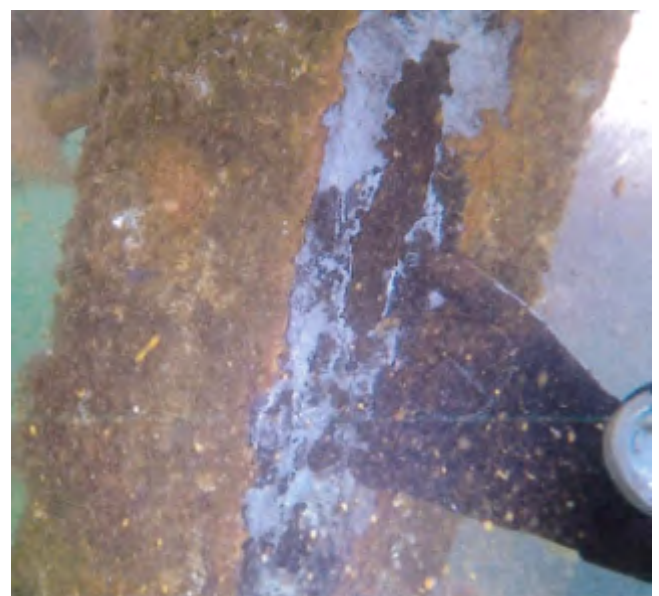
Photo 111: Pile J, 12" H x 2.5" W hole from mechanical abrasion

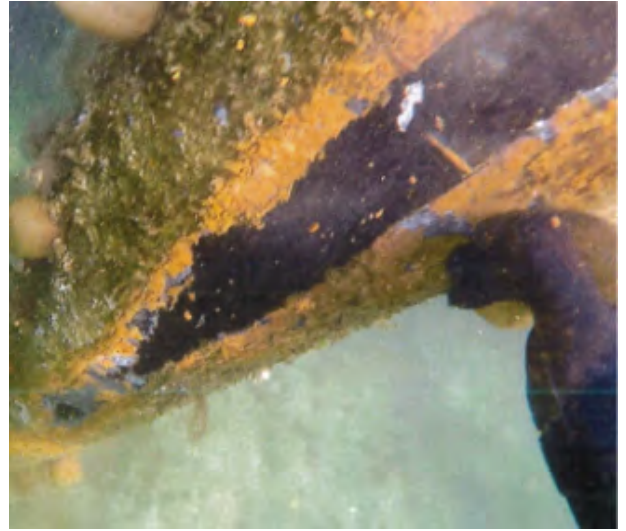
Photo 112: Pile P, 3 ft vertical  
hole from mechanical abrasion

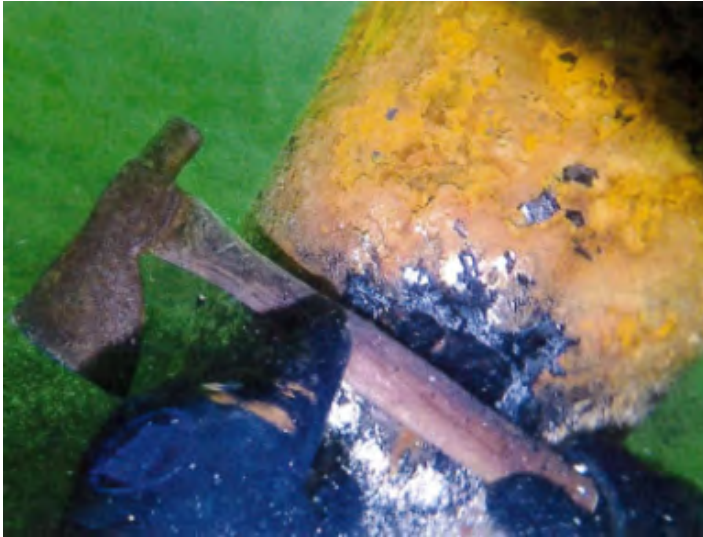
Photo 115A: Pile D, 5" W x 2" H hole

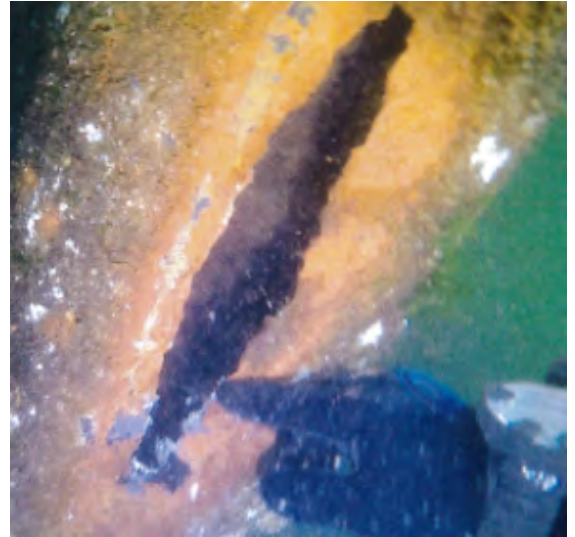
Photo 115B: Pile E, 2" W x 18" H hole from mechanical abrasion

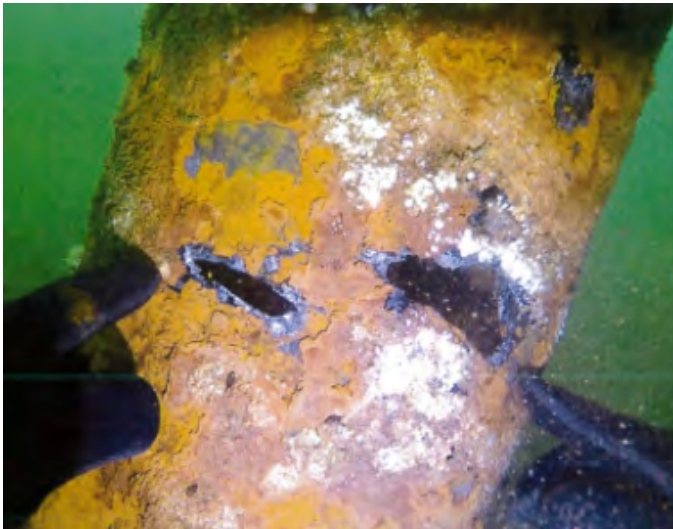
Photo 116: Pile E, 4.5" W x 1.5" H hole and 3.5" W x 0.75" H hole

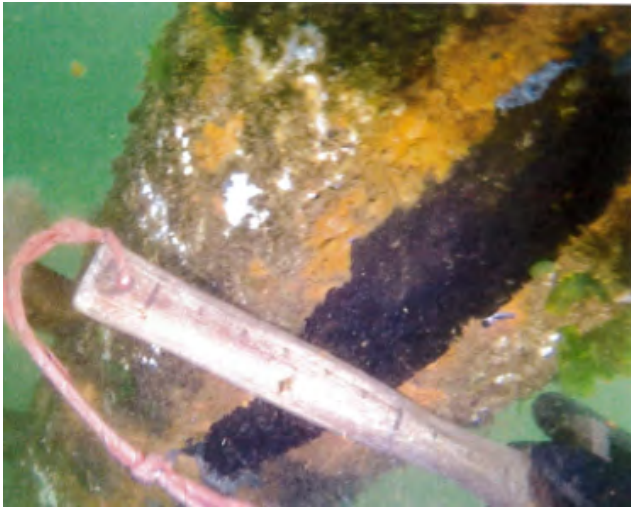
Photo 118: Pile J, 3" W x 18" H hole from mechanical abrasion

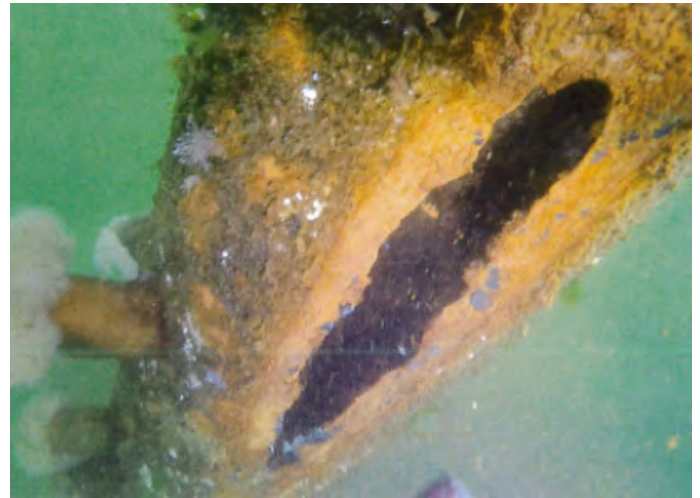
Photo 119: Pile L, 3" W x 24" H hole from mechanical abrasion

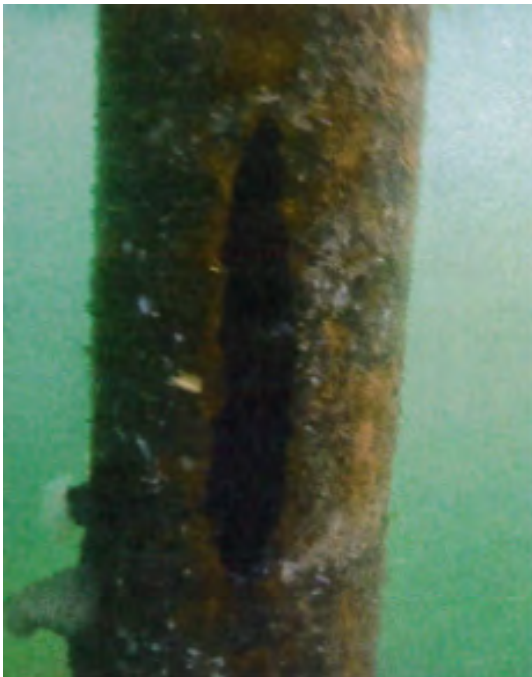
Photo 120: Pile O, 4" W x 24" H hole from mechanical abrasion

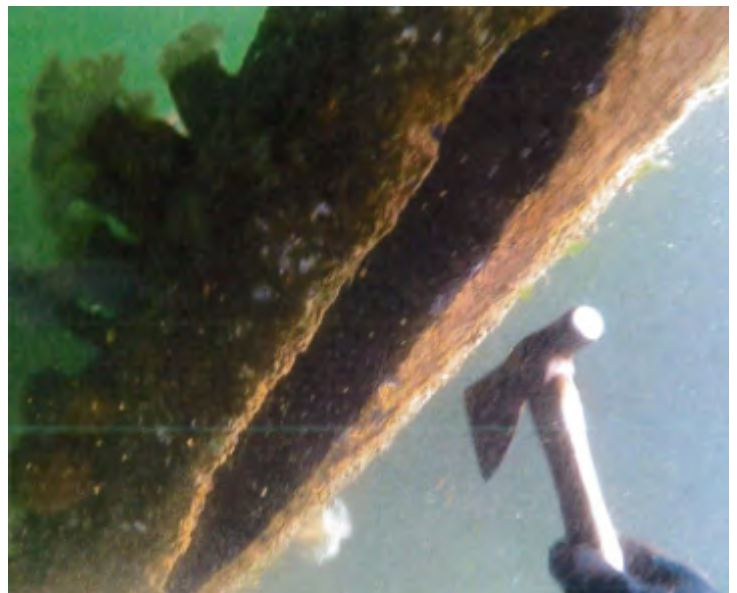
Photo 121: Pile P, 5" W x 54" H hole from mechanical abrasion

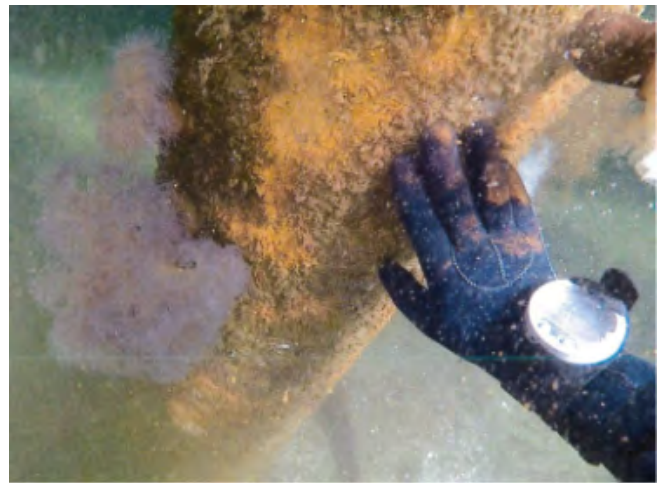
Photo 125: Typical pile condition underwater, 25%-50% coating failure and surface corrosion

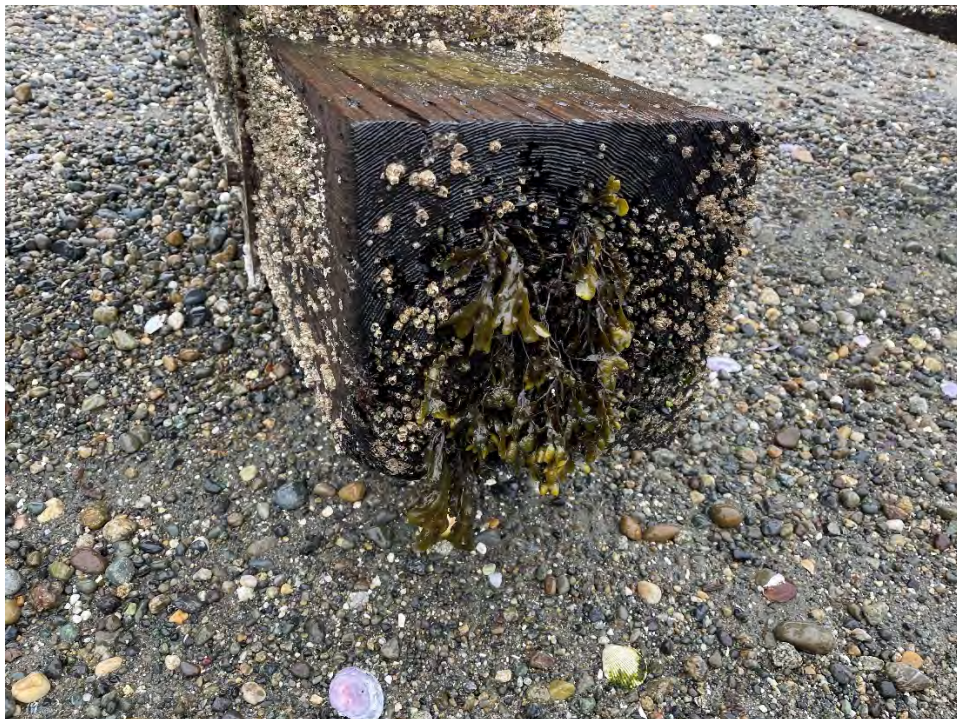
Photo 143: 17<sup>th</sup> pile cap with early stages of hollowing

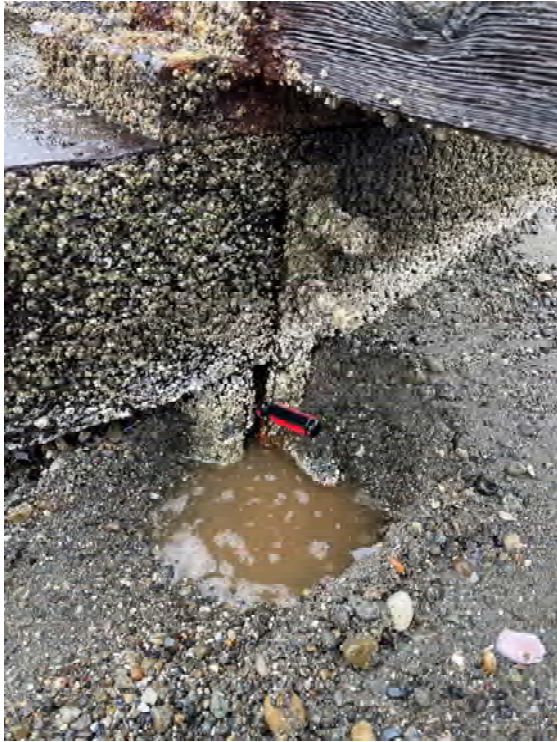
Photo 146: Pile 10B, hollowing around pile cap fastener

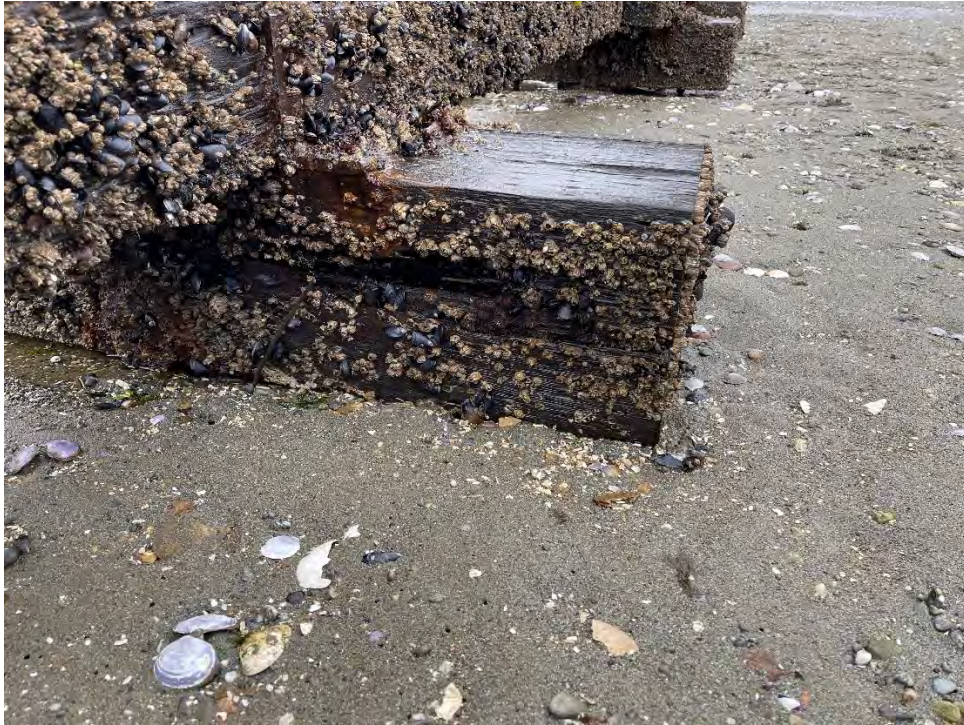
Photo 150: 16<sup>th</sup> pile cap with hollowing

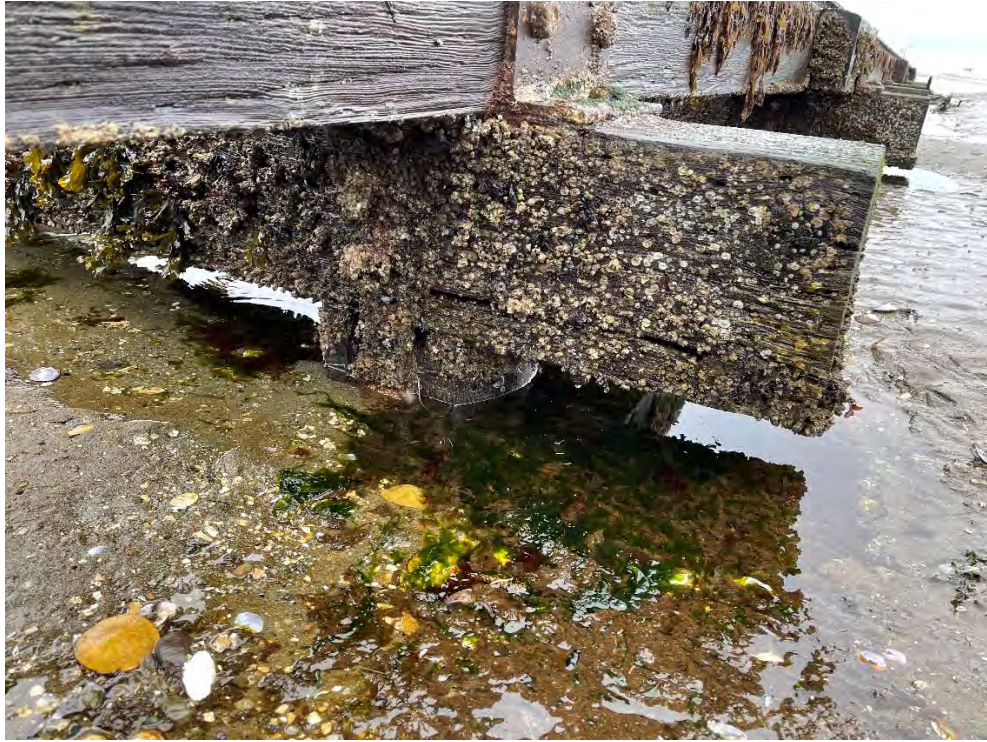
Photo 152: Pile 8B, early stages of hollowing

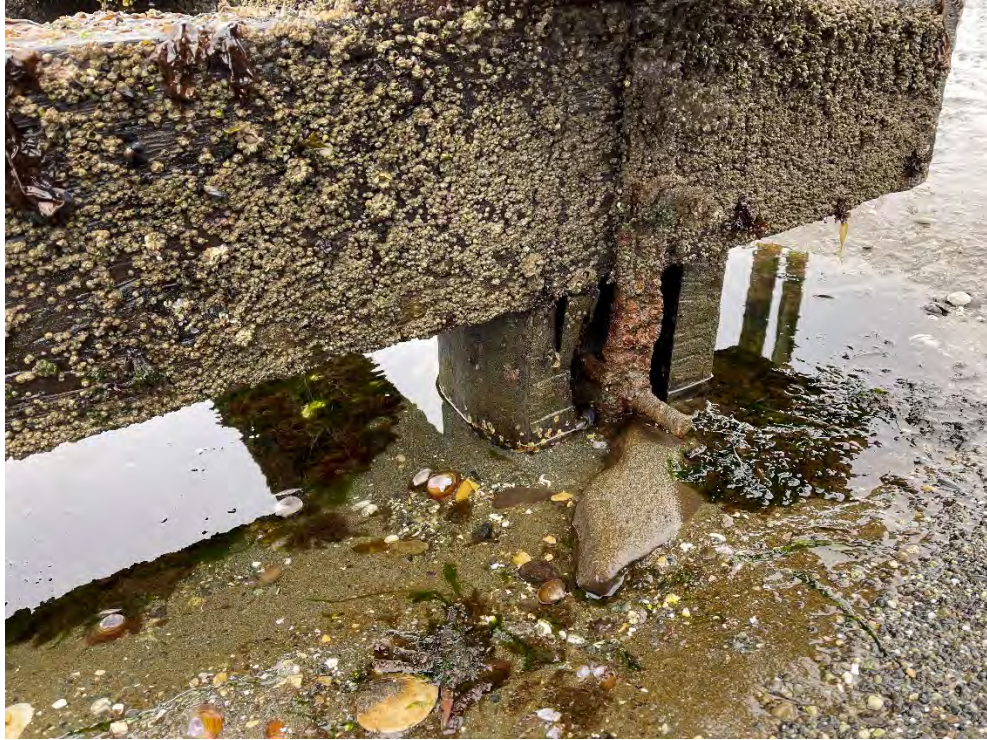
Photo 153: Pile 12A, hollowing around pile cap fastener

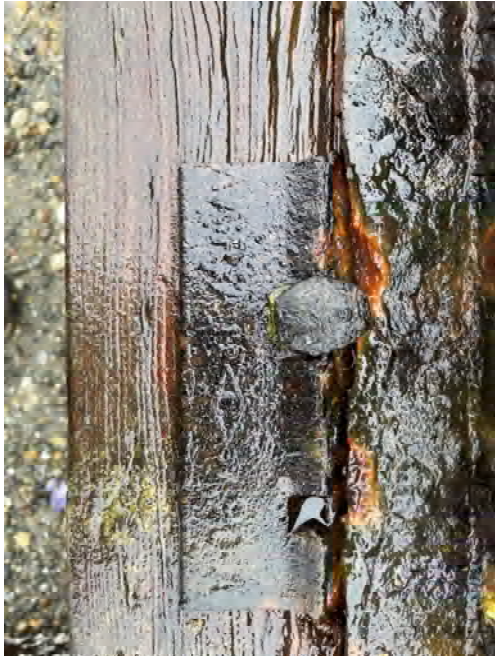
Photo 169: Rail clip and rail near bulkhead burning up

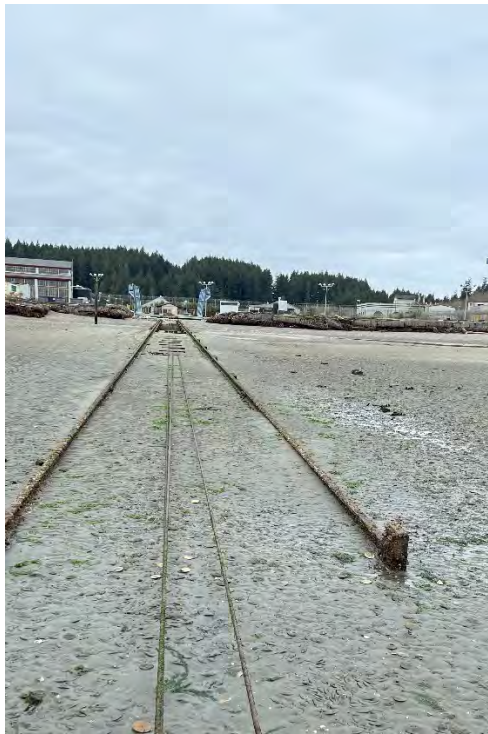
Photo 171: Buried members on Southern section of rail system

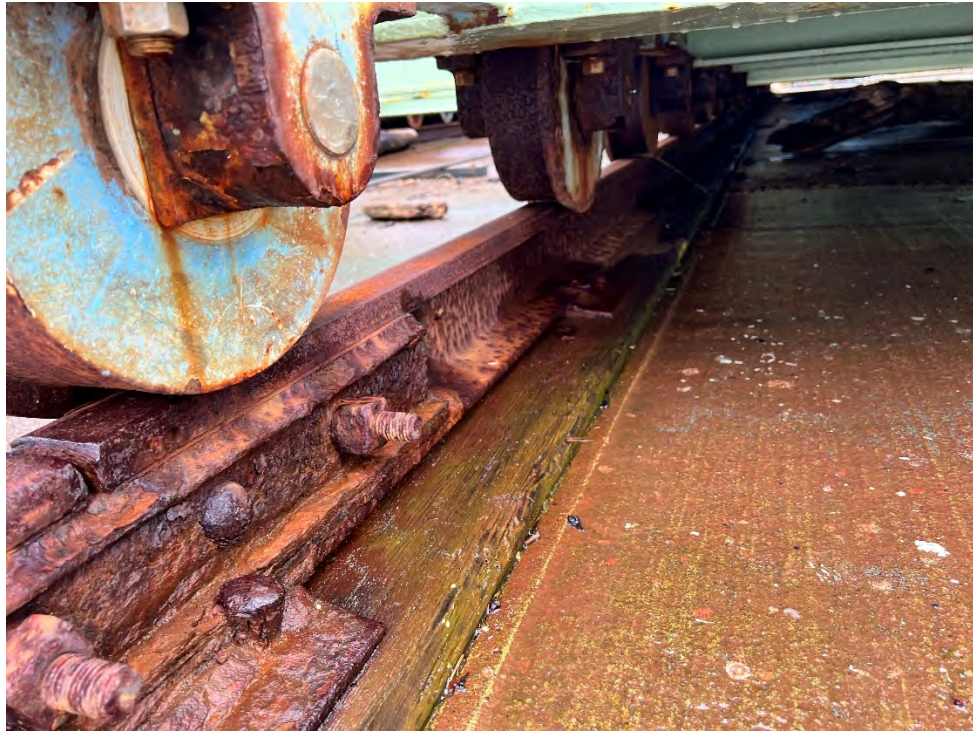
Photo 196: Cradle wheels and rails

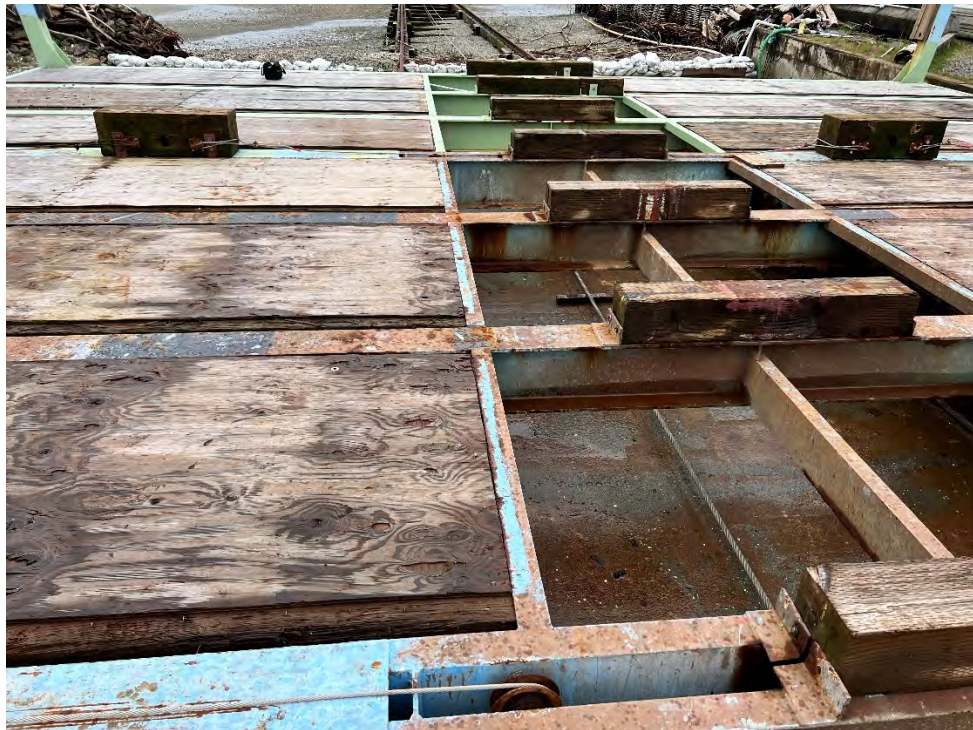
Photo 197: Center of cradle
